MORESBY HALL, MORESBY, WHITEHAVEN, CUMBRIA

Archaeological Desk-Based Assessment

October 2014

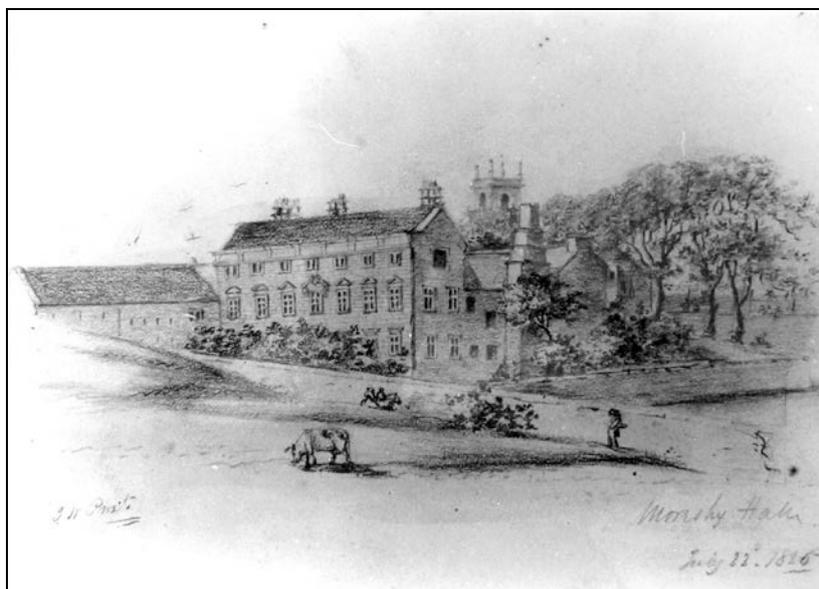
Plate 5: Sketch of Moresby Hall from 1826

3.3.6 **Drawing of 1826:** a pencil drawing of the hall dated 22nd July 1826 is also held by the present owners of Moresby Hall (the original is in the Beacon at Whitehaven) (Plate 5). This primarily shows the main south façade, but is again useful in showing the east side of the stable block positioned to the west of the front entrance, which has rows of what are presumably ventilation slots and a mullion window on the first floor at the north end.

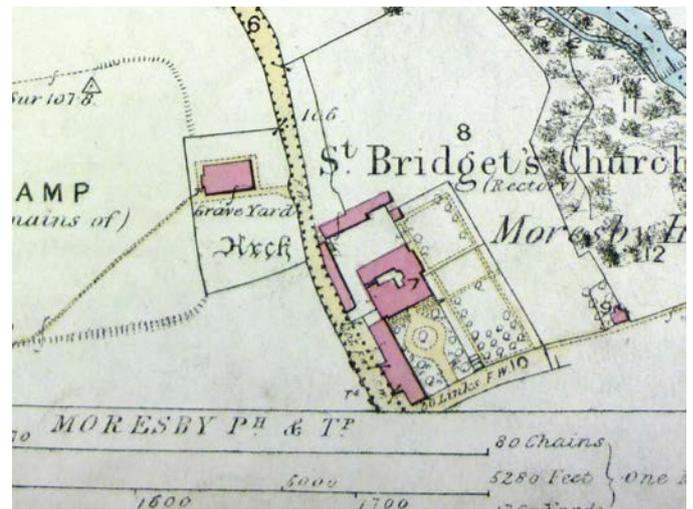
Plate 7 (right): Extract from the Ordnance Survey map, c1865

3.3.8 **Ordnance Survey, c1865:** this shows a similar arrangement to the earlier plan with some alterations (Plate 7). Most notably a new group of buildings has been built to the north but other alterations have also occurred to the main block and the range to the south.

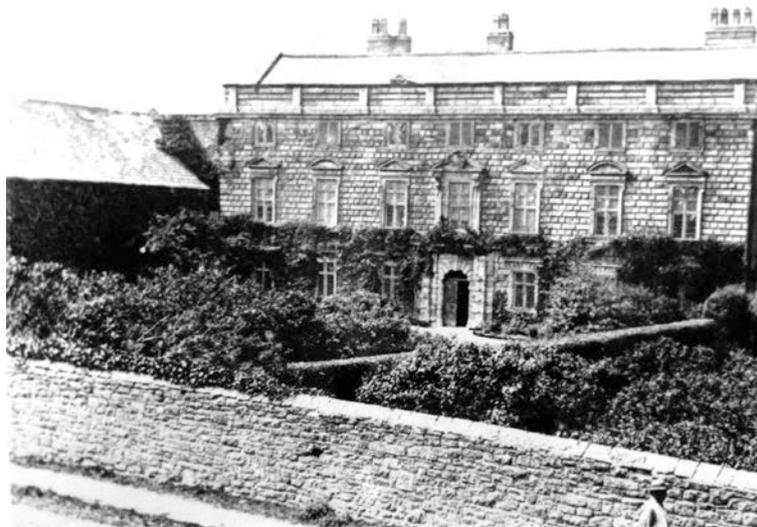
Plate 8: Undated photograph from client

3.3.9 **Photograph, from client:** this undated photograph must pre-date the Ordnance Survey map of 1899 as it shows not only the south-east external elevation of the Hall and gardens, but also the stable block to the west as still extant, although it does not show much additional detail (Plate 8).

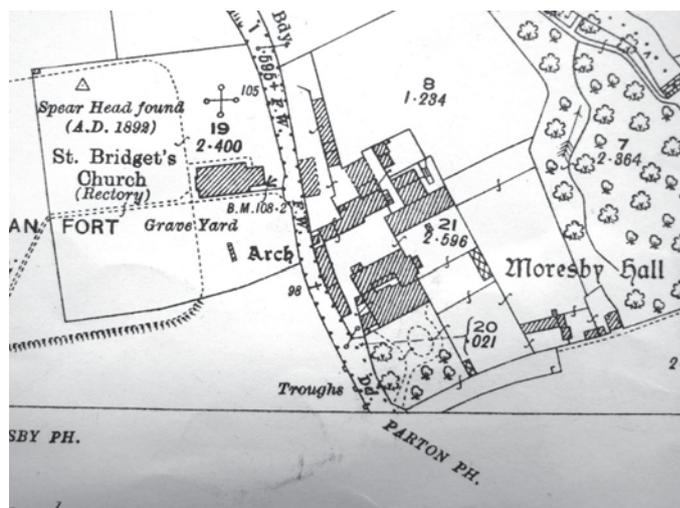
Plate 10 (right): Extract from the Ordnance Survey map, 1925

3.3.11 **Ordnance Survey, 1925:** the main structures appear unchanged although the buildings to the north have again been extended (Plate 10).

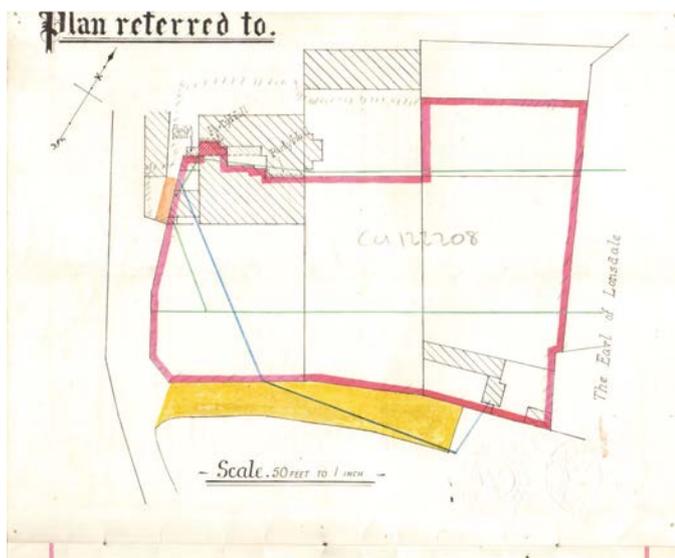
Plate 11 (left): Conveyance Plan, 1927

3.3.12 **Conveyance Plan, 27th February 1927**: the conveyance plan of 1927 seems to be based on the earlier Ordnance Survey mapping (Plate 11; cf. Plate 9). Although a block plan and so not providing much detail, it is useful in showing the point at which the building was split in two at this time (marked as a thick red line; Plate 12).

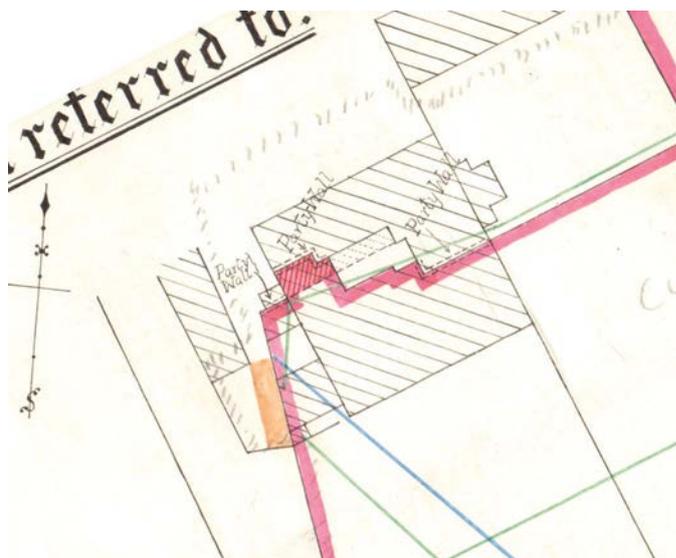
Plate 12 (right): Re-orientated extract from the Conveyance Plan, 1927

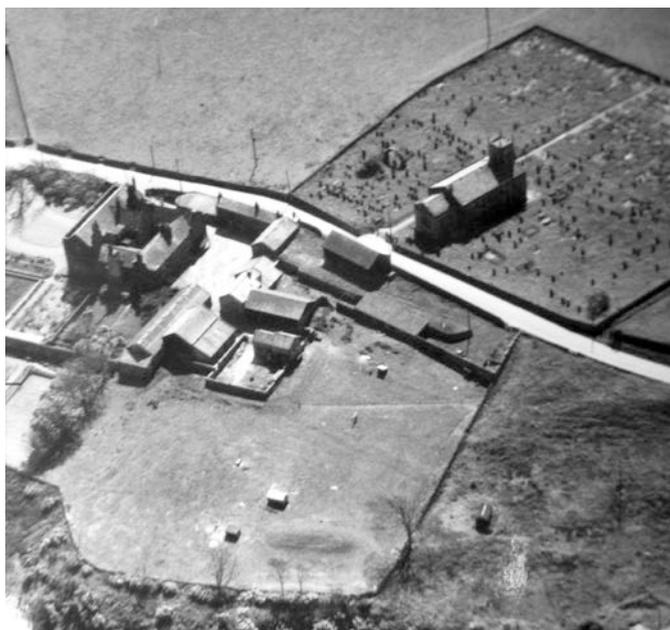
Plate 13: Aerial photograph of the church and Moresby Hall viewed from the north-east (St Joseph 1939, NX9281/A)

3.3.13 **Aerial photograph, 1939**: this aerial photograph shows the church and hall from approximately the north-east (Plate 13). It is not zoomed in sufficiently to discern much further detail about the Hall buildings, although it is clear that the area to the north has not yet been fully developed.

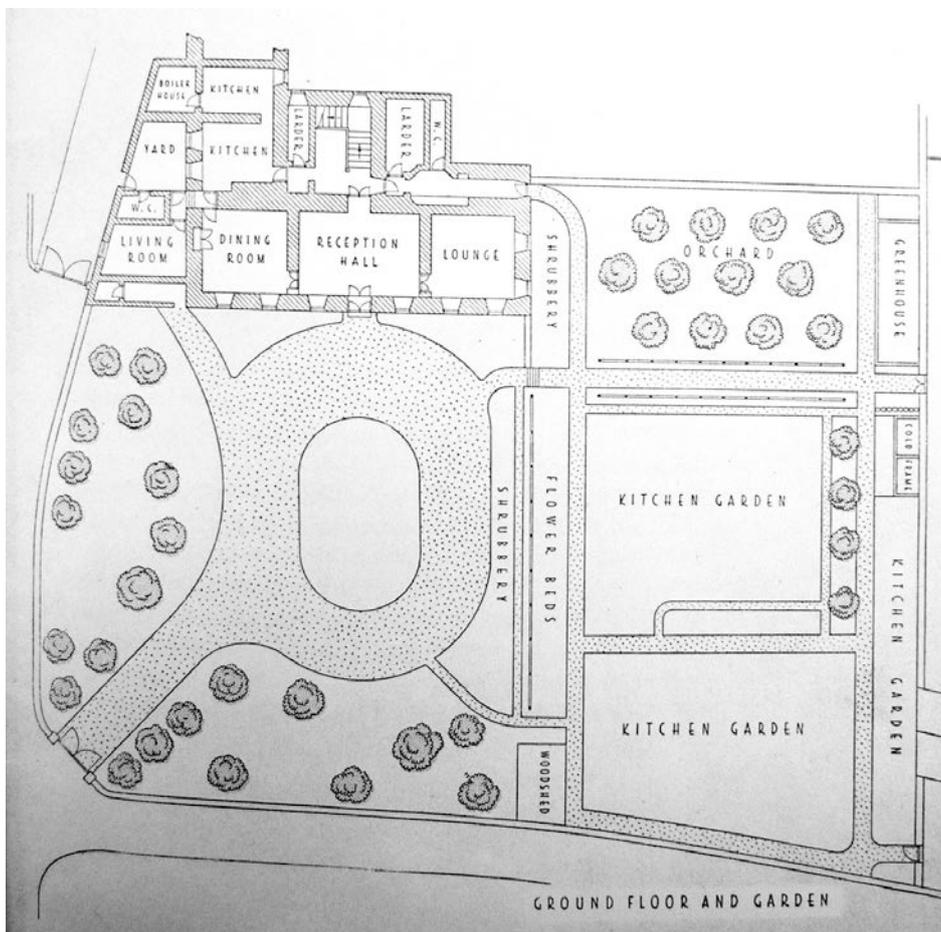
Plate 17: Ground floor and garden plan, c1949 (High Duty Alloys Ltd c1949)

3.3.15 *The House and Land of Moresby, c1949*: these plans reproduced from *The House and Land of Moresby* (High Duty Alloys Ltd c1949) following its purchase by High Duty Alloys in 1940 (see Section 4.5.6 below) show the layout of the garden and internal arrangement of the Hall (Plate 17, Plate 18, and Plate 19). The alterations and additions proposed in 1940 have been implemented.

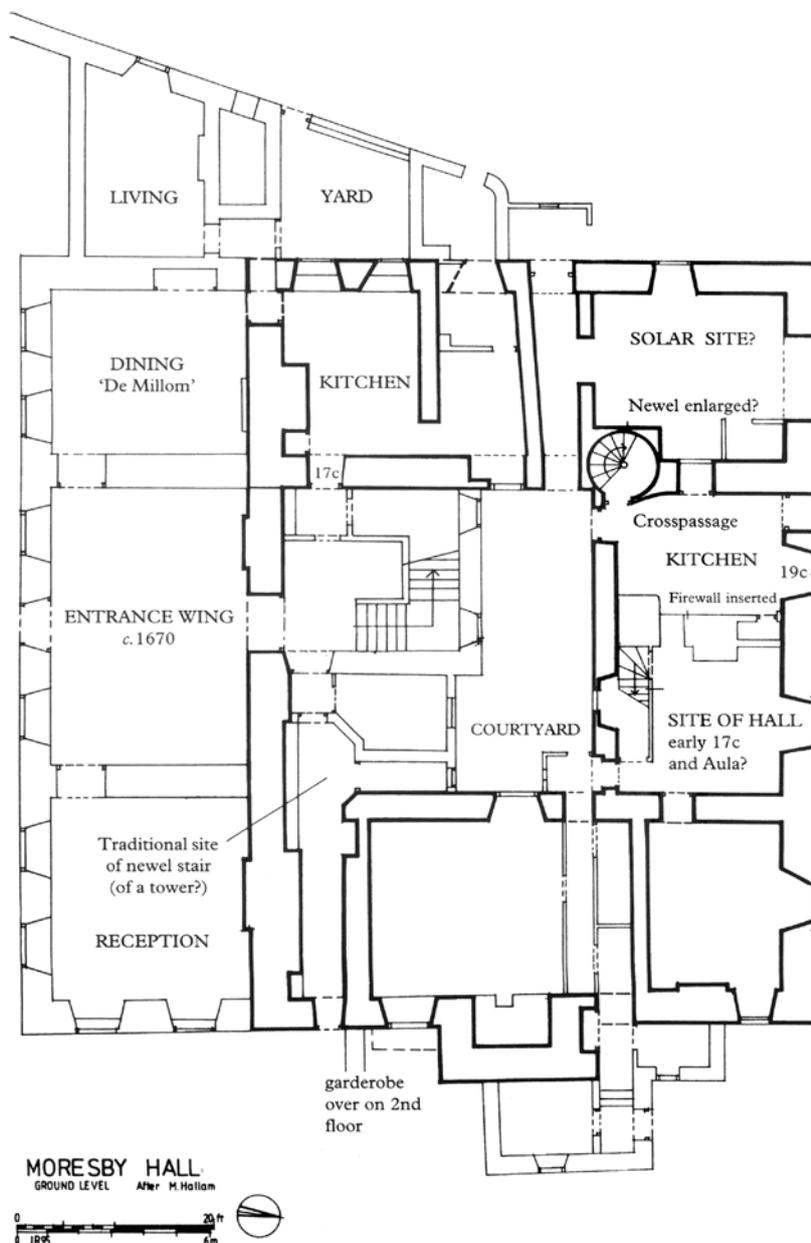
Plate 57: Plan showing the historical development of the Hall, 1998 (Perriam and Robinson 1998)

3.3.25 **Plan showing the historical development of the Hall, 1998:** this ground floor plan shows the historical development of the Hall with approximate dates for the various additions (Perriam and Robinson 1998; Plate 57).

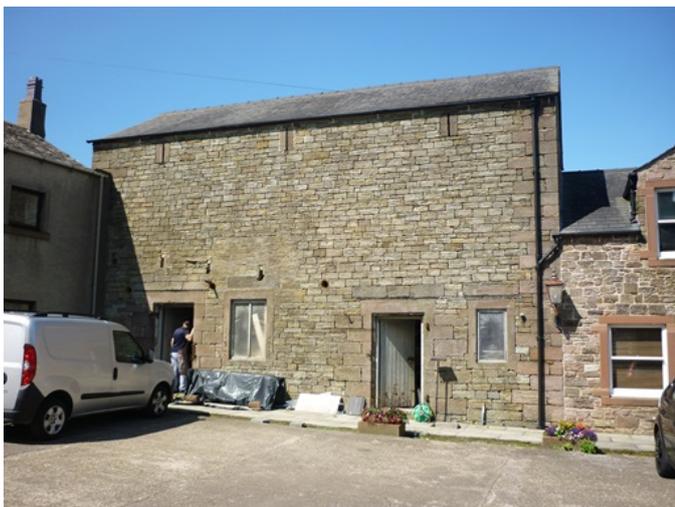
Plate 58 (left): Front (south) elevation of the west farm building

3.5.3 **The farm buildings:** the buildings to the north of the hall, across the yard, are clearly all agricultural in character. On the west side is a two-storey barn, with a pair of ground floor doorways on the south side, each with a flanking window and a row of ventilation slots at first floor level (Plate 58). The lower part was evidently originally animal housing, with the remains relating to the position of the stalls inside (Plate 59), while the upper floor was presumably a hay loft. Attached to the east of this is what was presumably originally a cart shed or similar, which has now been converted into a domestic dwelling (Plate 60). There is evidence for two wide openings, now blocked up, and gabled dormer windows on the first floor. At the east end is a largely ruinous building with no roof (Plate 61). This perhaps had a wide opening on the ground floor, although the large arch may just be for support, and there are windows on the first floor. The original purpose of this building is not certain, but like the one to the west it probably housed animals on the ground floor with hay lofts above; both may have been stables. To the north of the easternmost building is the remains of a further building, now little more than the remnants of the outer walls and a row of iron columns along the east side (Plate 62). This was clearly open fronted on the east side, and so was perhaps a hay barn or Dutch barn. However, the iron columns have sockets that appear to be for angled braces at the top, suggesting the building perhaps had a porch or similar projecting structure, or that these are reused from elsewhere.

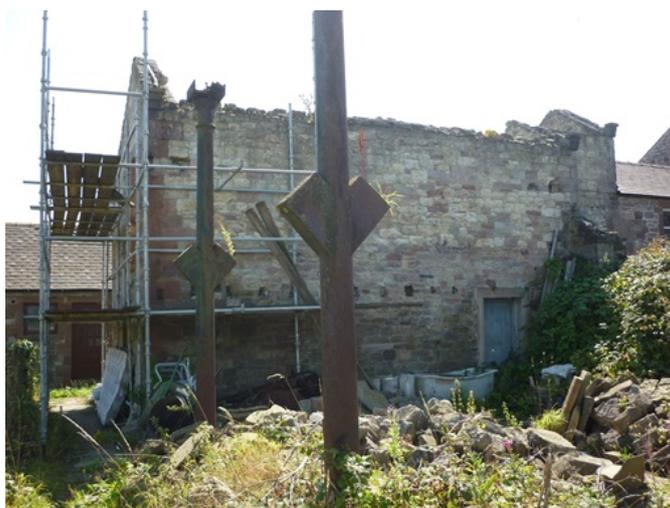
Plate 62: North side of the eastern farm building, and iron columns representing remains of building to north

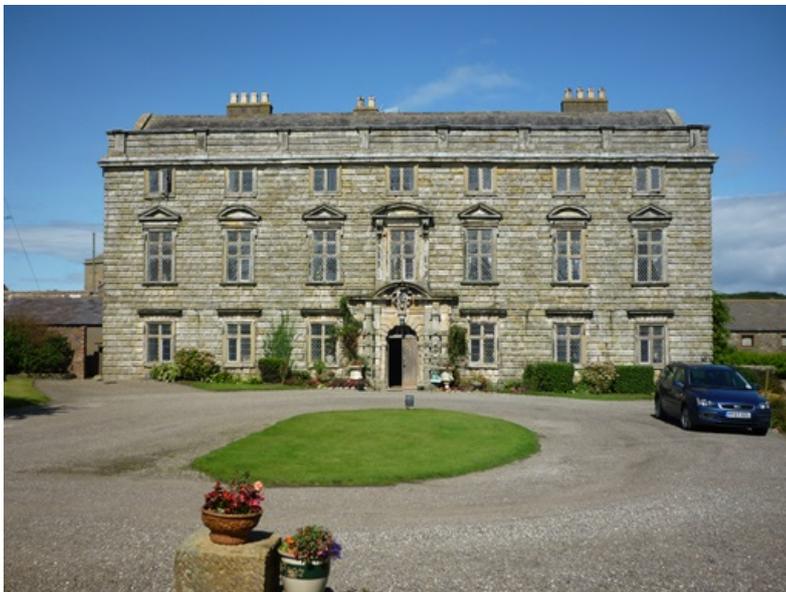
Plate 63 (left): Front (south) external elevation

3.5.4 **The hall:** externally the front (south) part of the hall is finished in the rusticated stonework corresponding with the work thought to have been carried out in the 1670s, with elaborate mullion and transom windows finished with various types of pediment, and with an even more elaborate front door with a broken pediment and flanking pilasters (Plate 63). The east and west side elevations are finished with render, the east with further mullion and transom windows on the south side (although blocked on the first floor; Plate 64), and a more irregular arrangement of windows to the north, but including a further mullion and transom. Towards the centre is a large projecting tiered chimney, with outshuts attached around the base, and at the north end there is the truncated remains of a projecting garderobe, with a presumably inserted window with square-section stone surrounds of 18th or 19th century style below (Plate 65). The west elevation is also rendered and relatively plain, although with attached single storey outshuts and a variety of windows, including one with a hood mould at the north end (Plate 66). The north elevation is rendered and very plain, with regular rows of windows with square-section surrounds on the ground and first floor (Plate 67) and a large ground floor window at the west end, below a gable, the line of which extends beyond the roof to form a parapet (Plate 68).

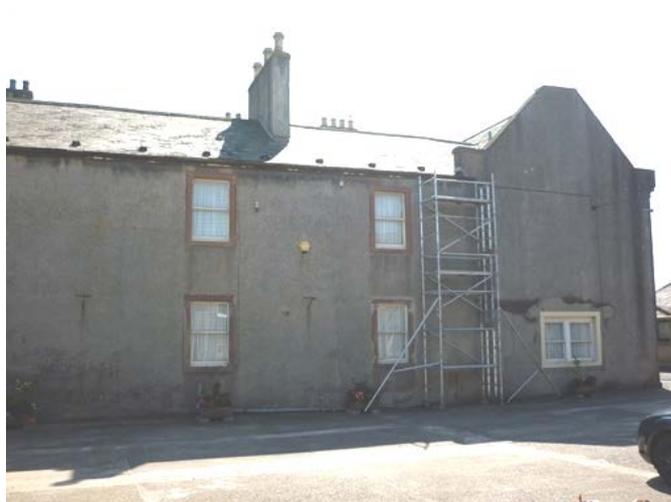
Plate 68 (right): West end of the north external elevation

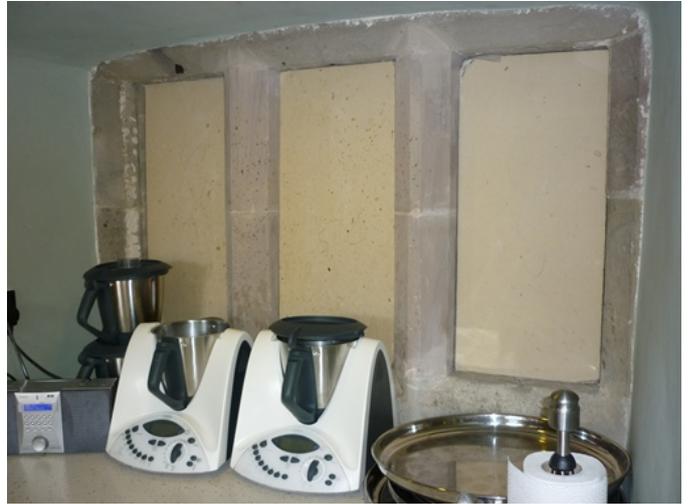
Plate 70 (right): Blocked mullion window in the west wing behind the south section

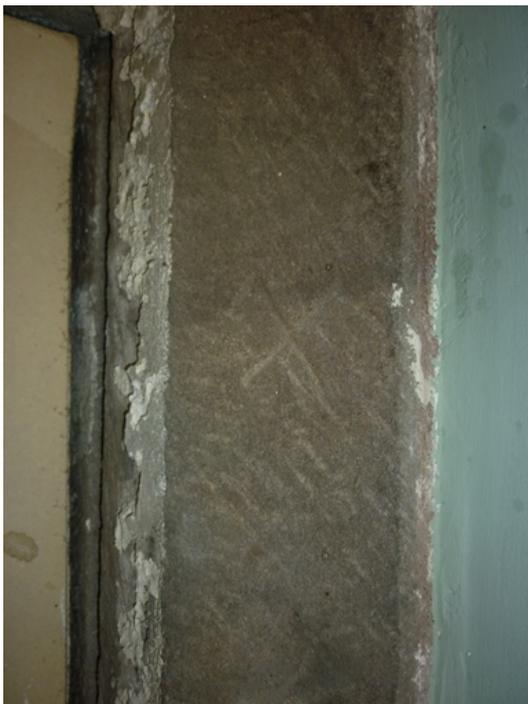
Plate 71 (left): Mason's mark on the blocked mullion window

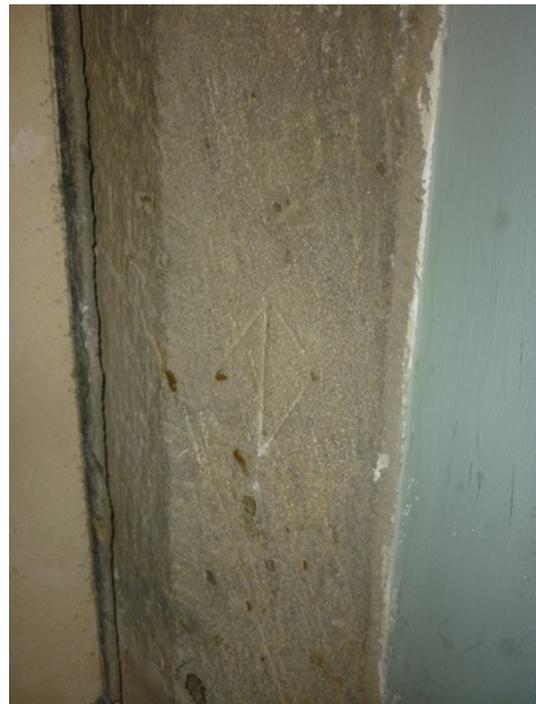
Plate 72 (right): Mason's mark on the blocked mullion window

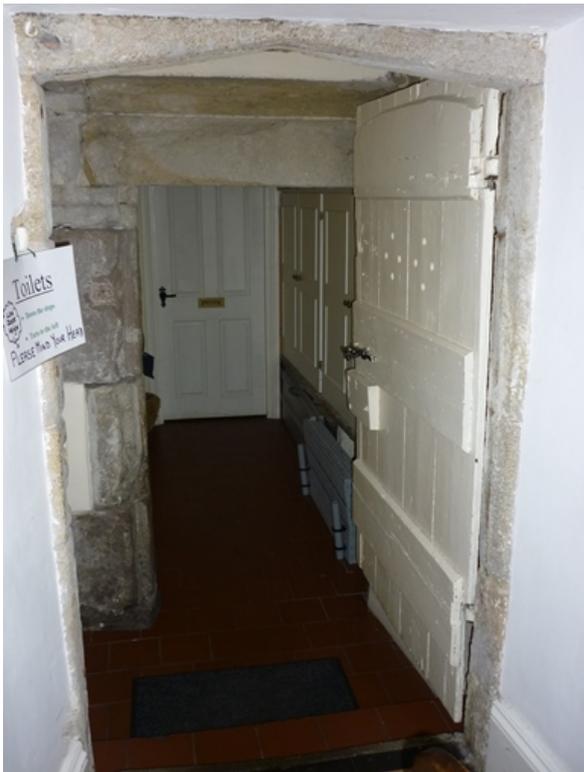
Plate 73 (left): Doorway with pointed lintel leading east

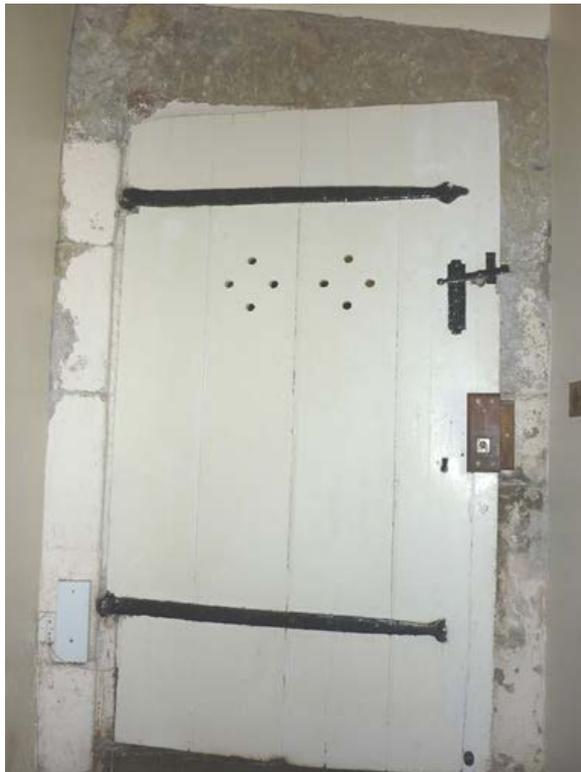
Plate 74 (right): Early plank door with long strap hinges leading east

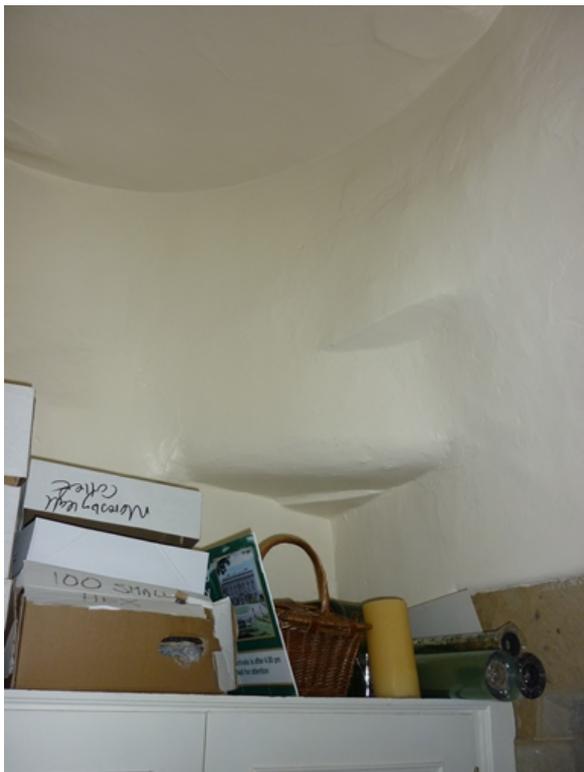
Plate 75 (left): Corbelled remnants of spiral stair in east wing behind south section

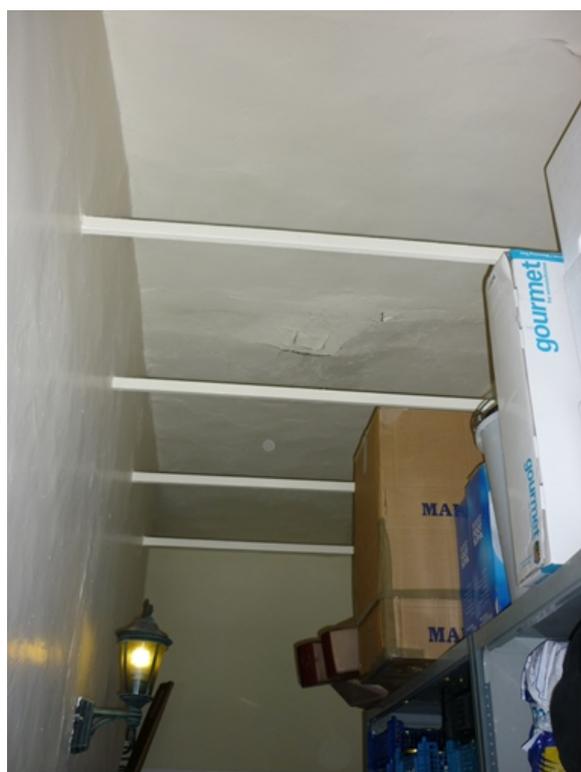
Plate 76 (right): Iron bars in ceiling of room to east

running across the room (Plate 76), presumably for hanging items from. The rooms behind this, on the east side, are extensively modernised, as are those on the west. The upper floors are generally extensively modernised, with only those to the south retaining many features of interest, including more bolection moulded fireplaces (Plate 77) and panelled doors (Plate 78). In the attic, the roof above the south section comprises a simple tie beam truss (Plate 79), although on the west side it also has a collar (Plate 80).

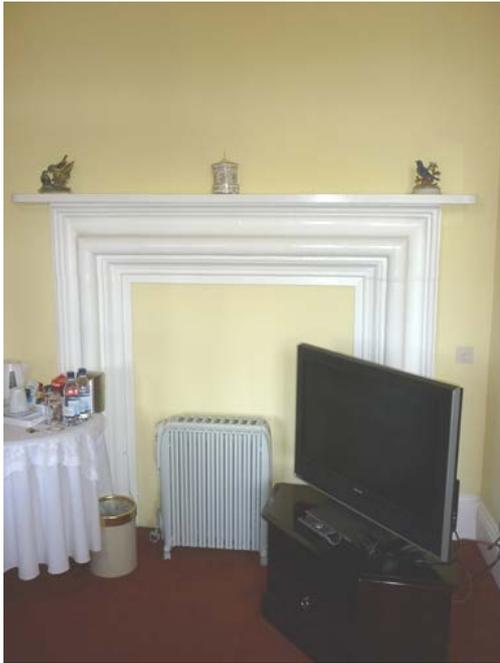
Plate 77 (left): Bolection moulded fireplace on first floor

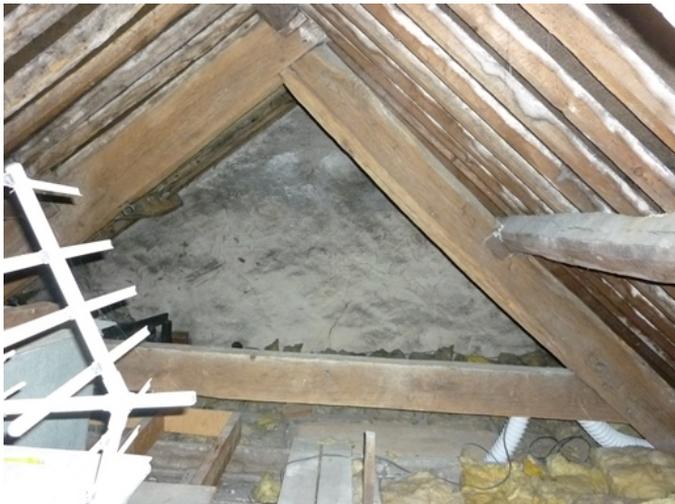
Plate 79 (left): Typical roof truss over the southern section of the hall

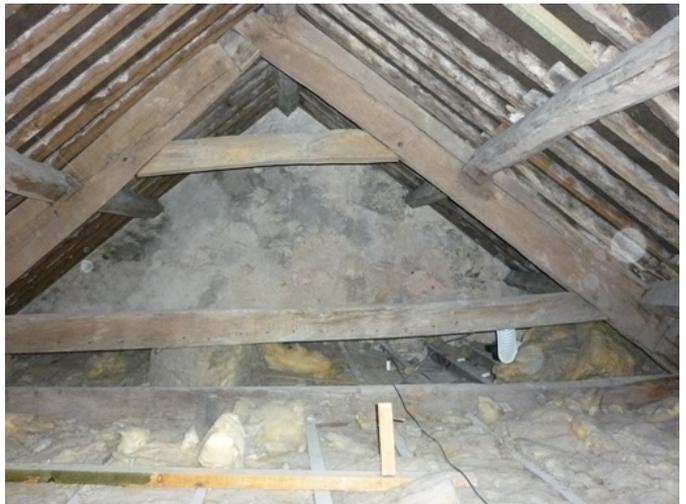
Plate 80 (right): Roof truss with collar on the west side of the south section of the hall

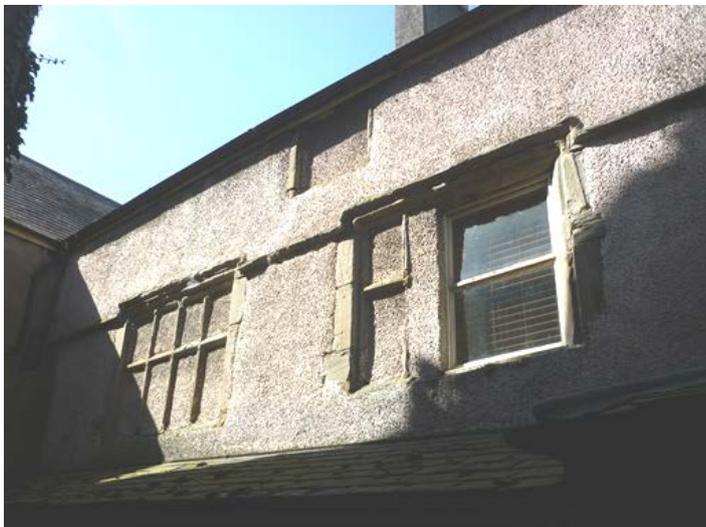
Plate 81 (left): Mullion and transom windows with hood moulds on the north side of the courtyard

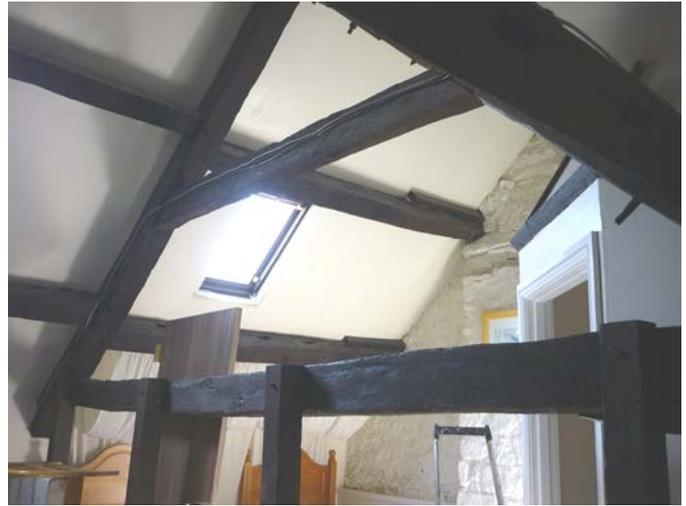
Plate 86 (right): Roof truss in the north wing

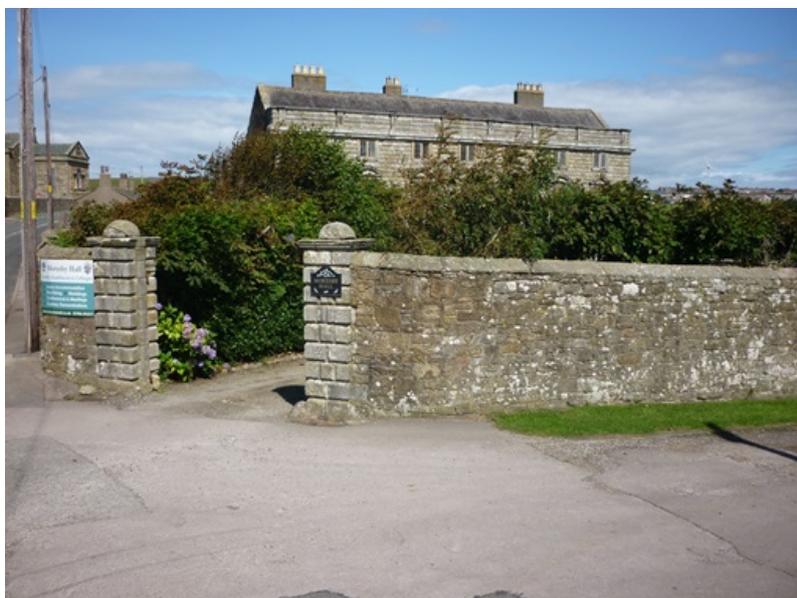
Plate 91: The gate piers in the south-west corner

3.5.7 The gardens and boundary walls: the garden immediately to the south of the hall mainly comprises a drive with, now somewhat irregular, turning circle. The garden to the east is slightly lower, and is accessed via short flight of steps, and in the north-east corner it becomes a gravel covered parking area. On the south side there is a small stone built garden store with a slate roof (Plate 87), and on the east side there is a modern glazed garden room (Plate 88). The walls (to the west, east and south) are stone and very tall. In terms of features of interest only the south wall really displays any. The former main entrance is apparent in the middle of the south wall as an area of blocked stonework (Plate 89). It is also evident that the wall has been raised in height either side of this and that the west end has been rebuilt, either as a result of the gate being repositioned to its present location, or because the wall is retaining elements of the gable end of the former stable block (Plate 90). The gate piers are constructed from rusticated stonework finished to imitate ashlar v-jointed stone, as per the south façade of the house, capped with damaged hemispheres (Plate 91), and so are presumably of similar date.
