ROWELL FARM, MILNTHORPE, CUMBRIA

Archaeological Building Recording

Client: Tim Robinson
Planning Ap. Ref.: 5/05/1360
NGR: SD 5149 8271

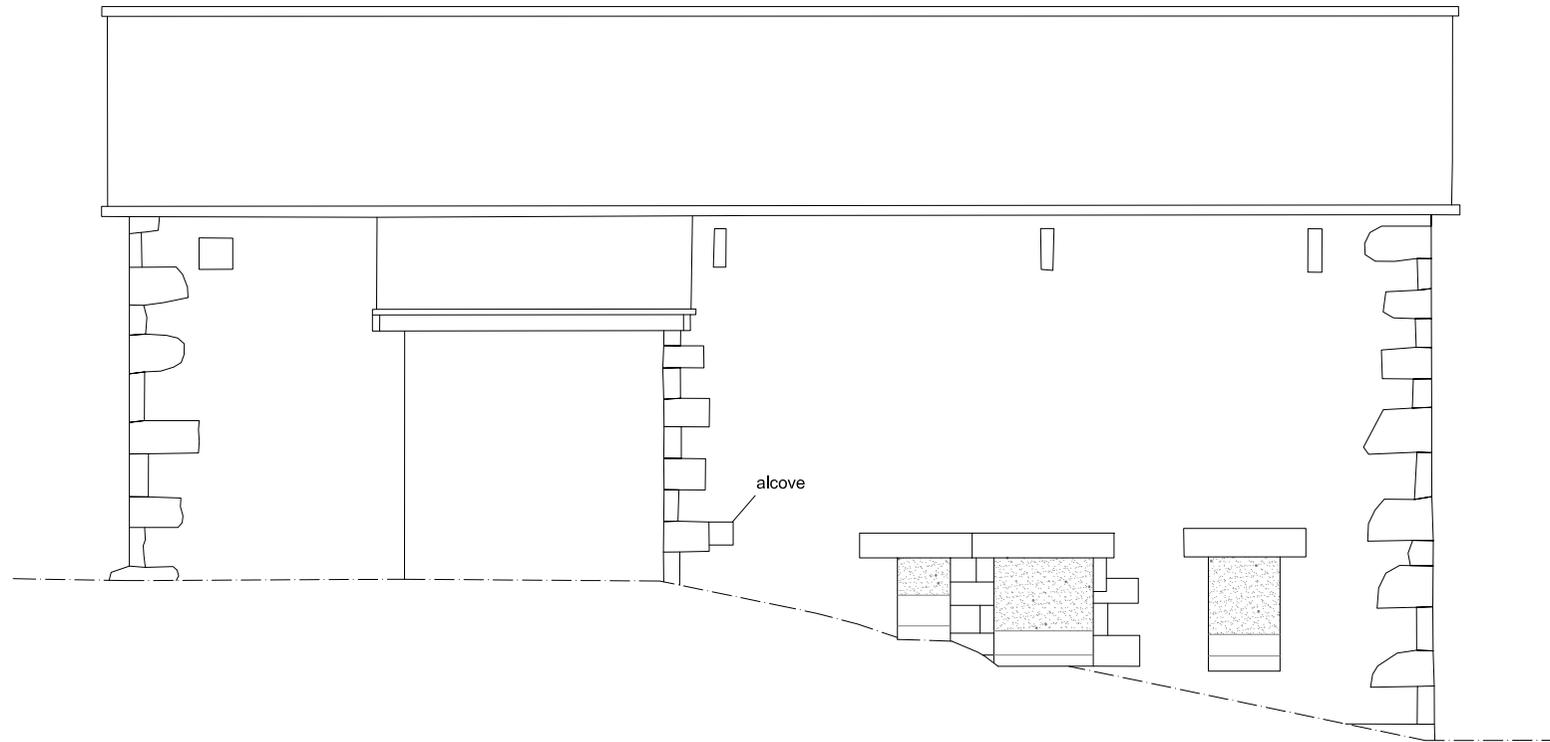
Figure 3: South external elevation

4.3.2 **South elevation:** this is the front of the building (Fig 3; Plates 5-6). There is a central wagon doorway slightly west of the centre, with rock-faced ashlar limestone quoins with droved margins forming the east jamb and no real quoins in the west. The lintel comprises three machine-cut timbers, perhaps re-used railway sleepers, with smaller battens between them. Over the door the roof extends into a canopy supported on timber beams. Below the eaves, to the west of the door is a small square hole, presumably for ventilation, and to the east there are three ventilation slots. East of the doorway the build is noticeably different to the rest of the building, the mortar is smoother and brown in colour and the stonework appears fresher, suggesting it has been rebuilt or at least re-pointed. There are three windows at low level on the east side providing light to the lower floor; each of these has rock-faced lintels and quoins and concrete sills, and all have been entirely or partially blocked with concrete leaving a slight recess.

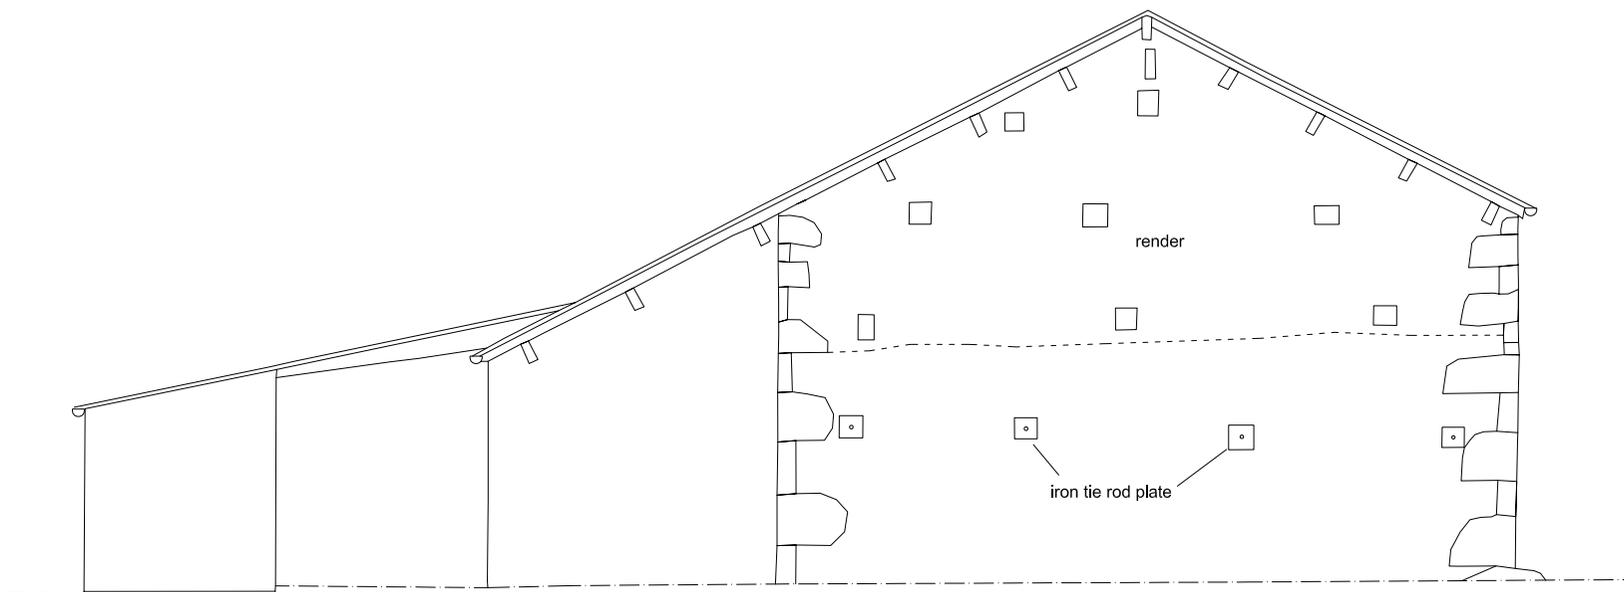
Figure 4: West external elevation

4.3.3 **West elevation:** the south side comprises the gable of the main part of the building (Fig 4; Plate 7). There are three lines of through stones and large dressed quoins at the corners. Four iron tie rod plates are present across the elevation at low level and there are nine square vents and a single slit vent. The upper part of the elevation is finished with a rough concrete (?) render and the ends of the purlins, four per pitch, project through the wall. The north side is extended by a monopitch outshut. It too is built of rough courses of rock-faced limestone, but with smaller quoins at the north end and the ends of three purlins projecting through the wall. The elevation is continued, following a return to the east, by the later outshut on the north-east side of the building. This is constructed from tongue and groove planks attached

to a stud wall sat on a stone plinth, with a large doorway to the south and a corrugated metal roof with plastic rainwater goods.

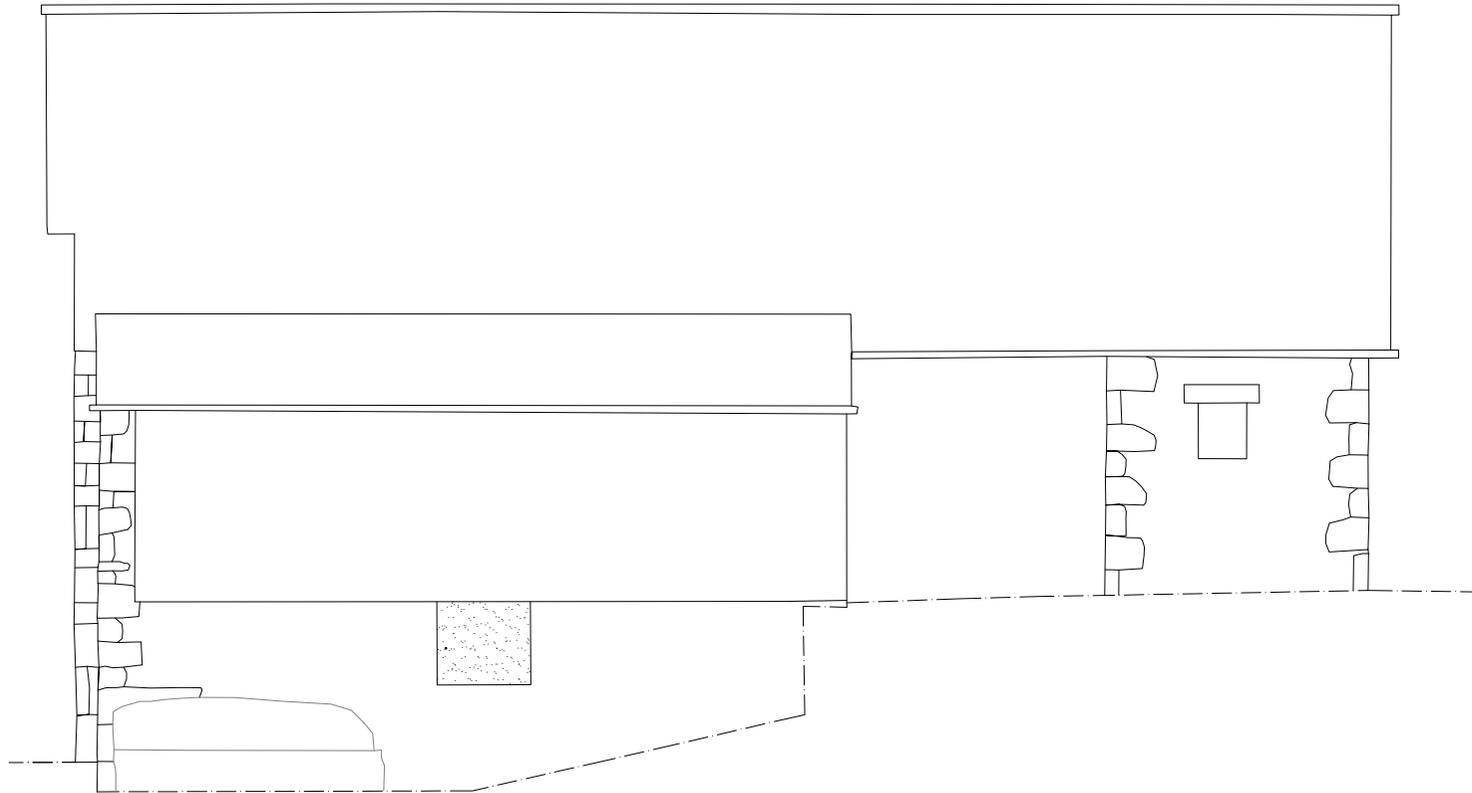
Figure 5: North external elevation

4.3.4 **North elevation:** this is made up of several parts on account of the numerous outshuts that have been attached to it (Fig 5; Plates 8-9). The west end is covered by the small monopitch outshut, which has a slate roof with plastic rainwater goods and a small central window with a stone lintel and sill. To the east of this the wall of the outshut returns to the south where there is a doorway into the west outshut, before returning to form the main wall of the barn proper. Here there is a large wagon doorway under a slate canopy roof formed by an extension of the main roof, with quoined jambs (Plate 11). East of this the wall returns to the north where it forms part of the west elevation (see *Section 4.3.3* above), before returning to the east. The upper part of this section is covered by corrugated aluminium sheeting, while the lower part, which continues to form the lower floor, comprises rough courses of limestone. A rough concrete 'buttress' has been added to the east side of the stonework, and there is a small aperture in the centre, which has been filled with concrete blocks. The east end is finished with ashlar quoins.

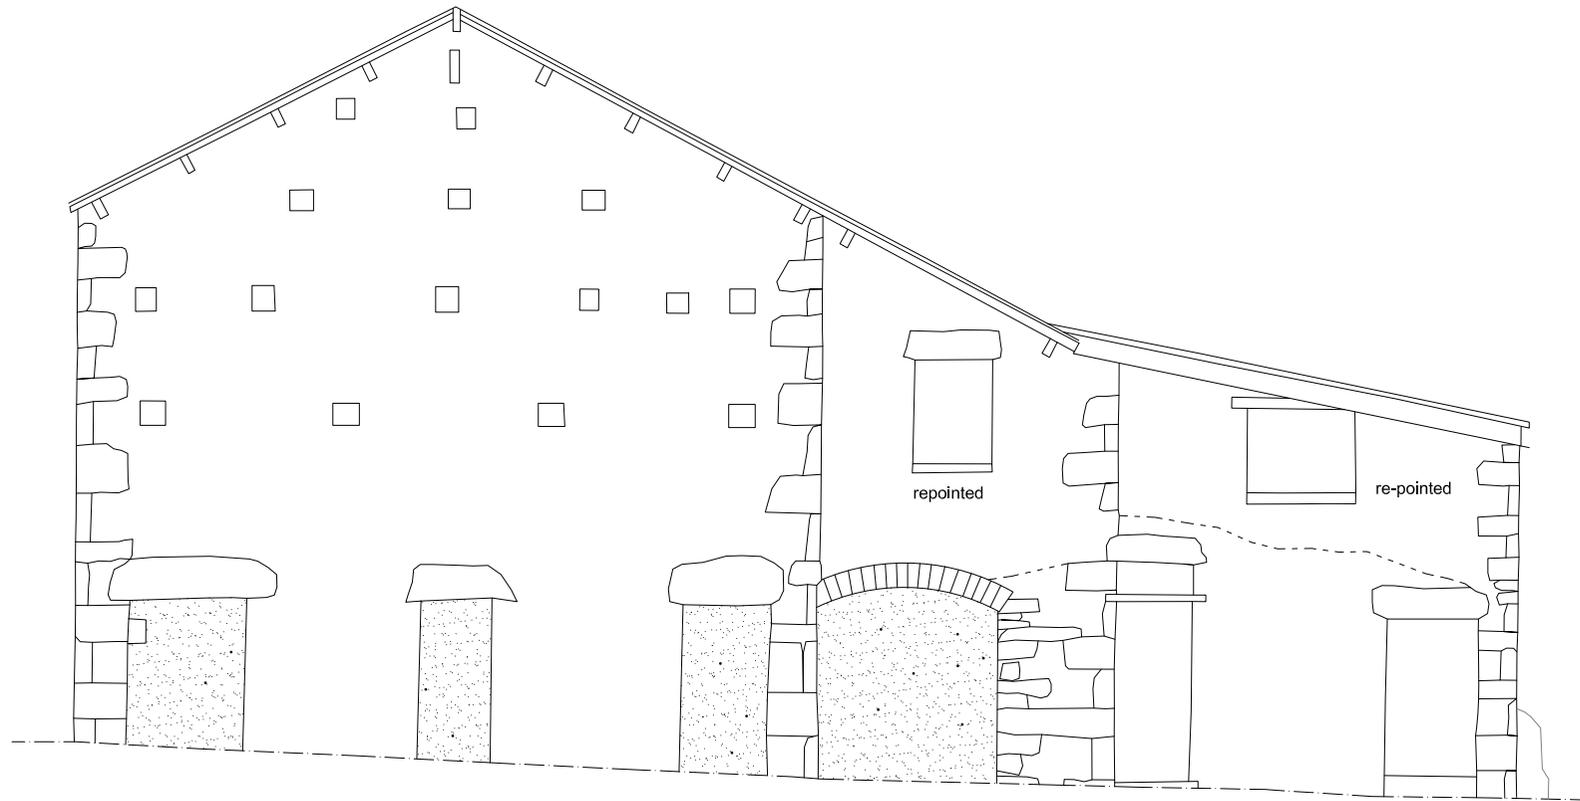
Figure 6: East external elevation

4.3.5 **East elevation:** the southern side of this forms the opposing gable of the main barn (Fig 6; Plate 10). It is the same build as the rest of the structure, but with some slabs of yellow sandstone, and there are two rows of through stones and the occasional others. Eight purlin ends project through the wall, and there are 13 square vents and one slit vent and dressed ashlar quoins at the corners. On the lower floor there are three doorways, all of which have been blocked with stone and concrete and have heavy stone lintels. A plastic downpipe is attached to the north, beyond which the elevation is continued by two later extensions. The first of these is two storeys high, and constructed from small angular pieces of limestone with modern cement pointing and quoins at the north end. There is a small window on the first floor with a nine-light timber casement and a large doorway on the ground floor, which has been blocked with stone and has a voussoir arched head. The second extension is slightly lower in height but still two storeys, and comprises rough courses of smaller stone, the upper part of which has been repointed with concrete mortar. There is a long low window on the first floor with an eight-light iron night-vent casement. On the ground floor there are two doorways, the southernmost of which is taller and has a tongue and groove plank door and a low timber lintel leaving an overlight window, which looks into the room above, and a stone lintel above. The northern doorway is smaller and has a stone lintel. The corner at the north end is finished with small quoins.

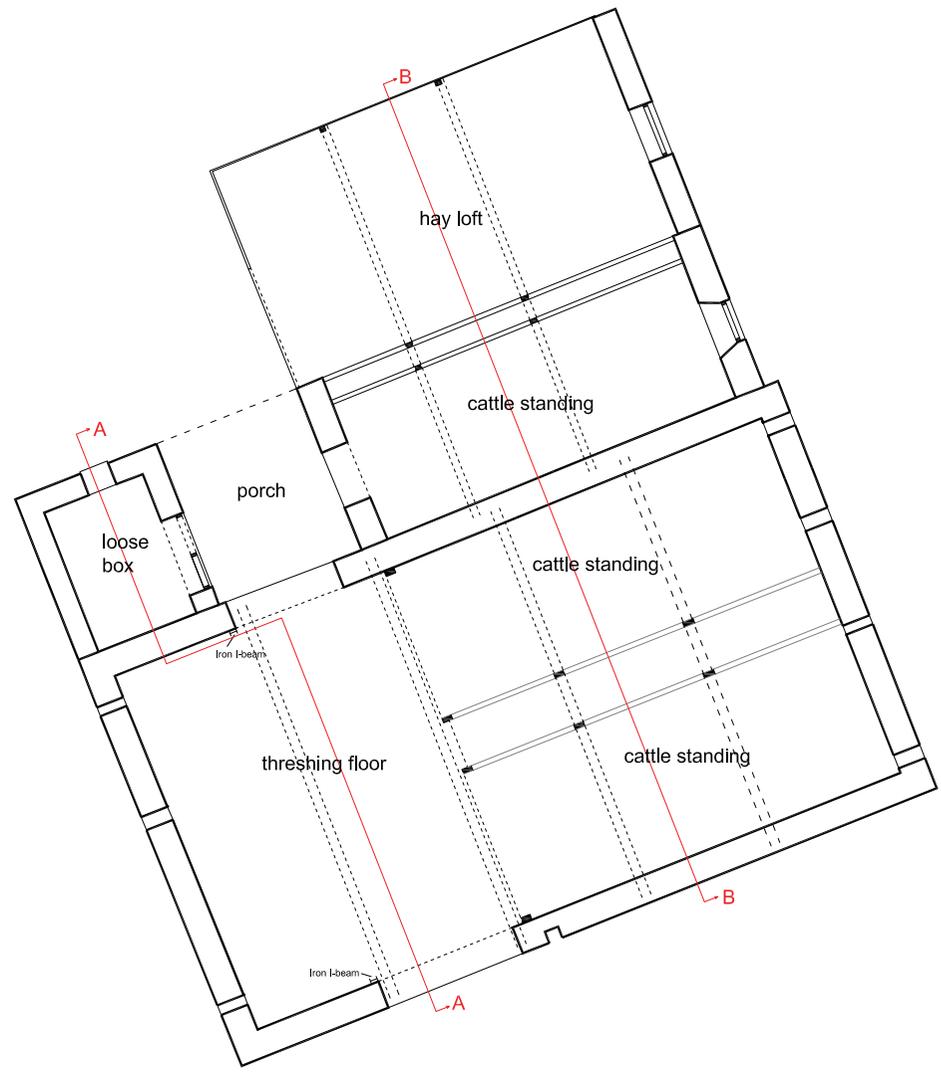
Figure 7: Ground floor plan

4.4.1 **Internal arrangement:** the building is made up of seven internal spaces. On the ground floor these comprise the main part of the original barn (comprising a threshing floor and cattle standing), a loose box to the north-west, further cattle standing and a hay loft to the north-east, and with a porch between the two northern extensions (Fig 7). The lower floor comprises two rooms forming a large slurry collection area beneath the main part of the original barn and the first of the north-east extensions, and a derelict cow house beneath the hay loft (Fig 8). The two rooms forming the slurry collection area could not be accessed, but had clearly been extensively altered and were considered unlikely to retain any features of interest.

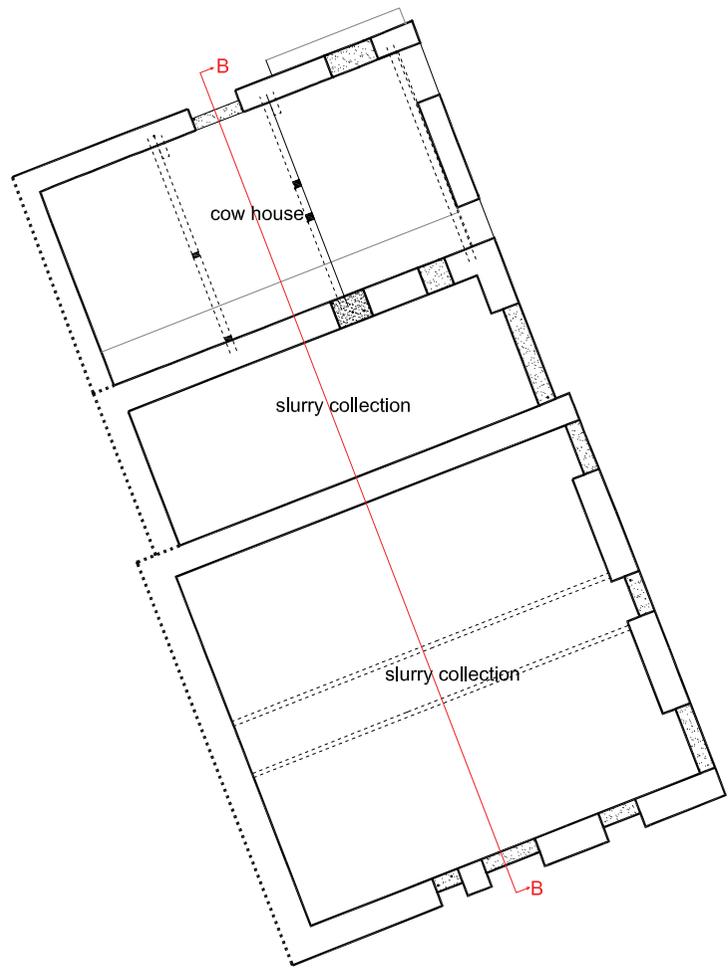
Figure 8: Lower ground floor plan

4.4.8 Lower floors – slurry storage: the rooms comprising the lower floors beneath the barn and earlier extension to the north-east could not be accessed as all of the doorways have been blocked. These rooms are currently used for slurry collection, with manure coming directly from the rooms above via the slatted floors. Although this area is in effect sealed, a small amount of access was clearly available to allow the slurry to be occasionally pumped out. The current owner was present when this part of the building was converted to its present use and confirmed that the original stalls and associated fittings were removed at this time (Tim Robinson pers comm.). The walls were then apparently shuttered and the whole area sealed with concrete so there is unlikely to be anything of interest surviving in these rooms.

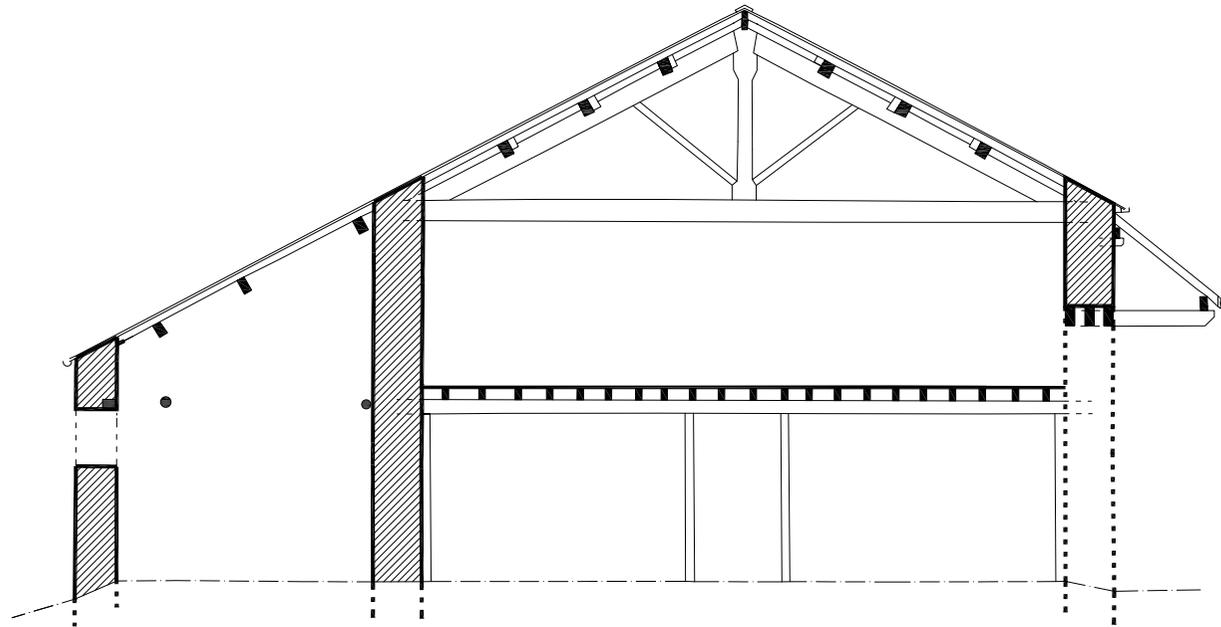
Figure 9: West-facing cross-section A-A

4.4.2 **Main barn:** the floor is concrete on the west side, and comprises iron slats on the east side over the lower floor beneath it. There are timber- and brick-built stalls on the east side, corresponding to the area of the slatted floor, with a hay loft above and with an iron mesh feed trough attached. The roof is supported by four king-post trusses, each with a pair of raking braces on sloping joggles (Campbell 2000, 49).

The king posts are bolted to the tie beams and have notched and splayed heads which house the ridge purlins (*op cit*, 47) (Figs 9-10; Plate 12). There are three purlins per pitch, which appear to be saw-pit cut, and these overlap at the trusses which are soffitted to fit. All of the walls are finished with a rough render or cement skim. The north elevation has a tie rod at the west end running along the wall, which connects to an upright iron I-beam post. There are two square vents visible on the west side and a wagon doorway west of the centre, which has several hand-finished and re-used timbers forming the lintel. The lower part of the east side of the north elevation is finished with a skim of concrete. The west elevation is the gable, which is plain except that the lower part is also finished with a skim of concrete and there are square ventilation slots in the upper part, as per the external elevation. The south elevation, like the north, has a tie rod fixed to an upright iron I-beam on the west side and a wagon doorway west of the centre, with a machine-cut timber lintel. The door is constructed from tongue and groove boards supported by chamfered battens and held by iron T-shaped hinges. The lower part of the elevation is again covered by a skim of concrete. The east elevation is relatively plain, although there are several ventilation slots, as per the external elevation

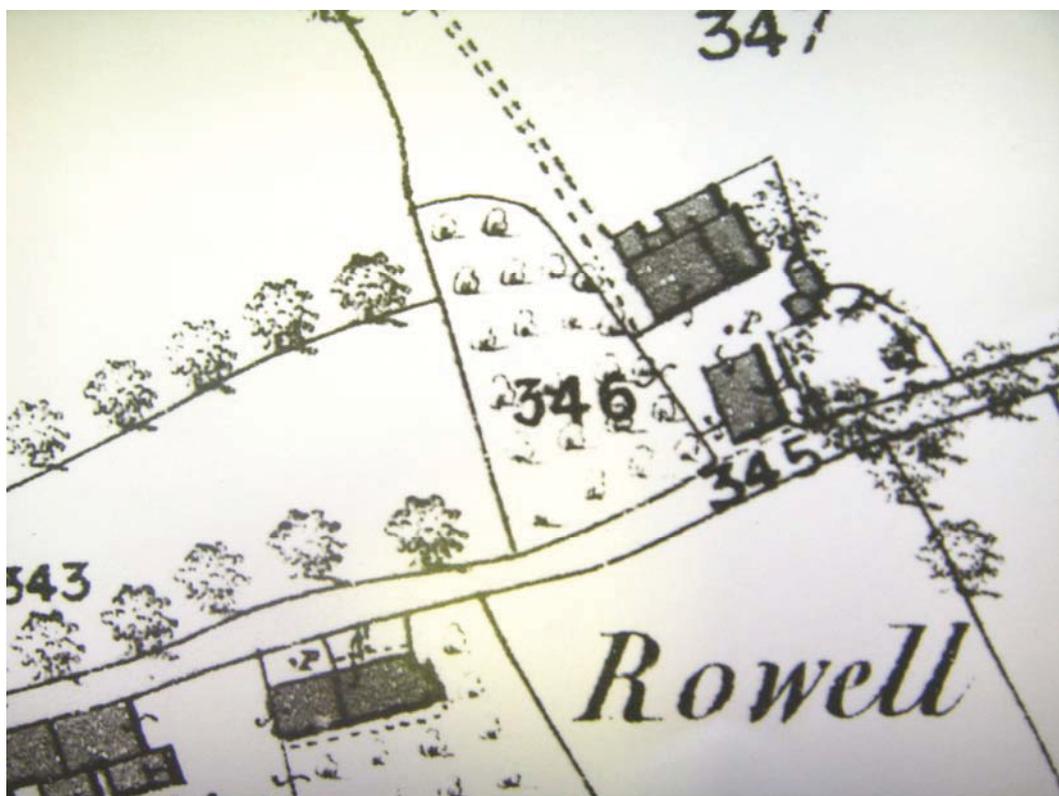
Plate 2: Part of the Ordnance Survey map of 1859 showing Rowell

- **Ordnance Survey 1859**: this shows much of the same detail as the previous map, but because of its scale it is possible to discern the internal divisions within the building (Plate 2). It is clear, therefore, that both of the extensions to the north and the canopied porch had been constructed by this point. Confusingly the east end of the barn is shown as a separate division, although this may be marking the position of the lower floor;

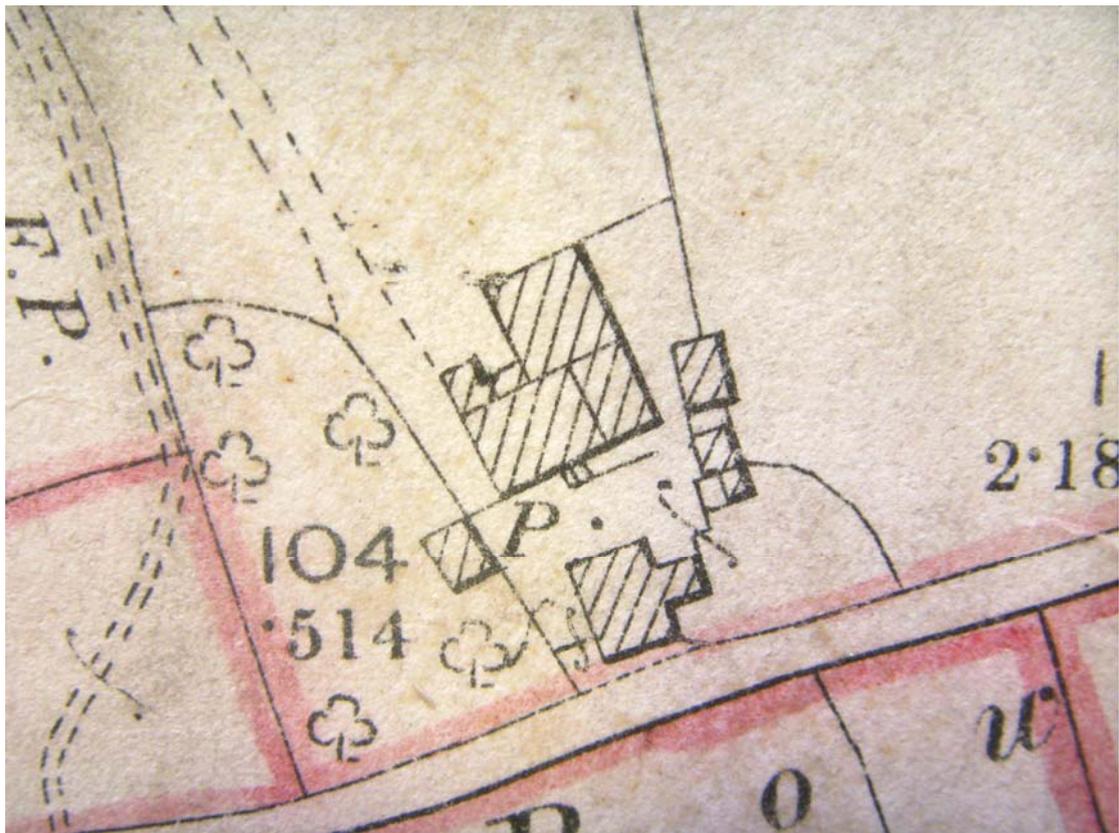
Plate 3: Part of the Ordnance Survey map of 1898 showing Rowell

- **Ordnance Survey 1898**: this is also very detailed and shows similar features (Plate 3). The canopy to the south is depicted for the first time and the north-east extension has been enlarged and the two parts combined on the first floor.

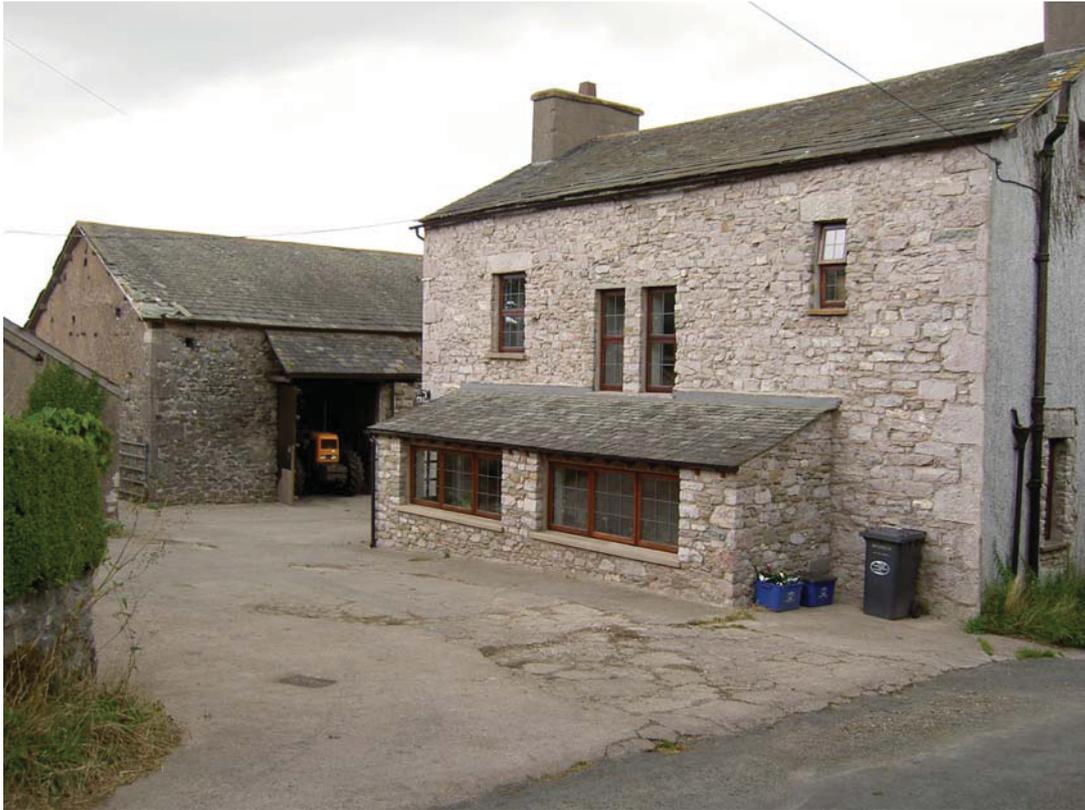
Plate 4: General view of the barn (background) in relation to the house (foreground), looking north

4.1.1 Rowell Farm is situated on the north side of Rowell Lane, opposite Lower Rowell to the south and with Higher Rowell a short distance to the west. The barn is situated on the north side of the farm yard, with the farmhouse to the south and other agricultural buildings to the east and west (Fig 2; Plate 4).

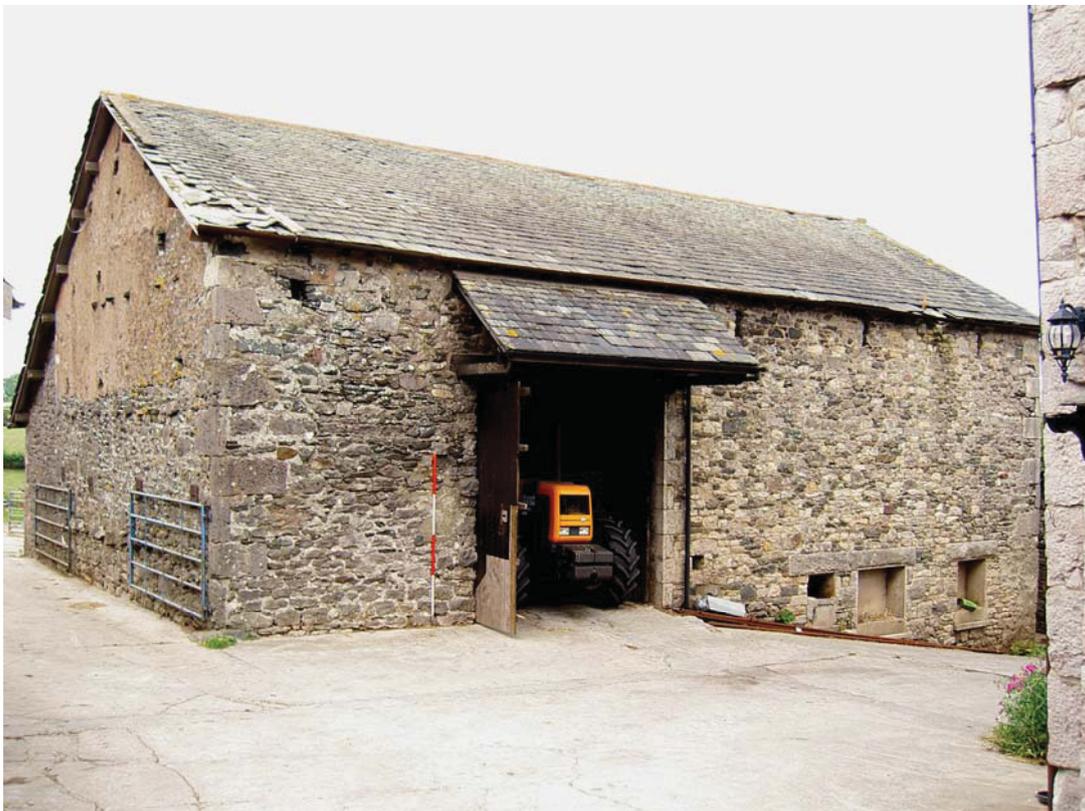
Plate 5: General view of the south external elevation, looking north

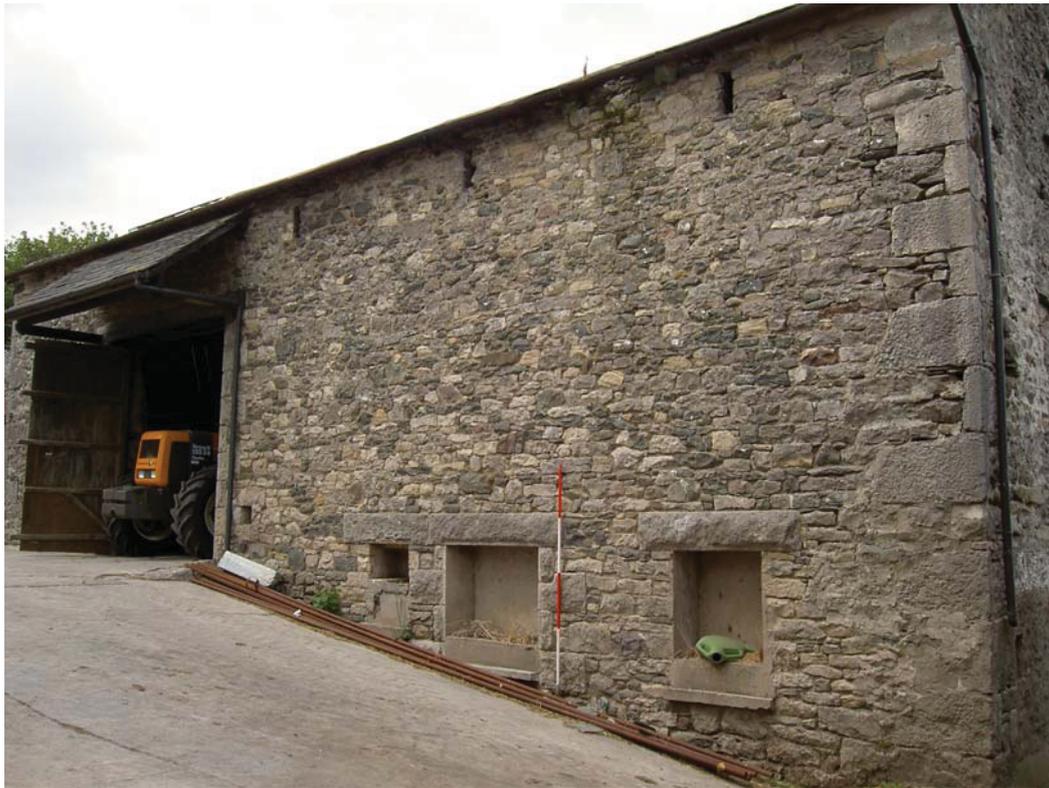
Plate 6: The inserted and blocked windows on the east side of the south external elevation, looking north-west

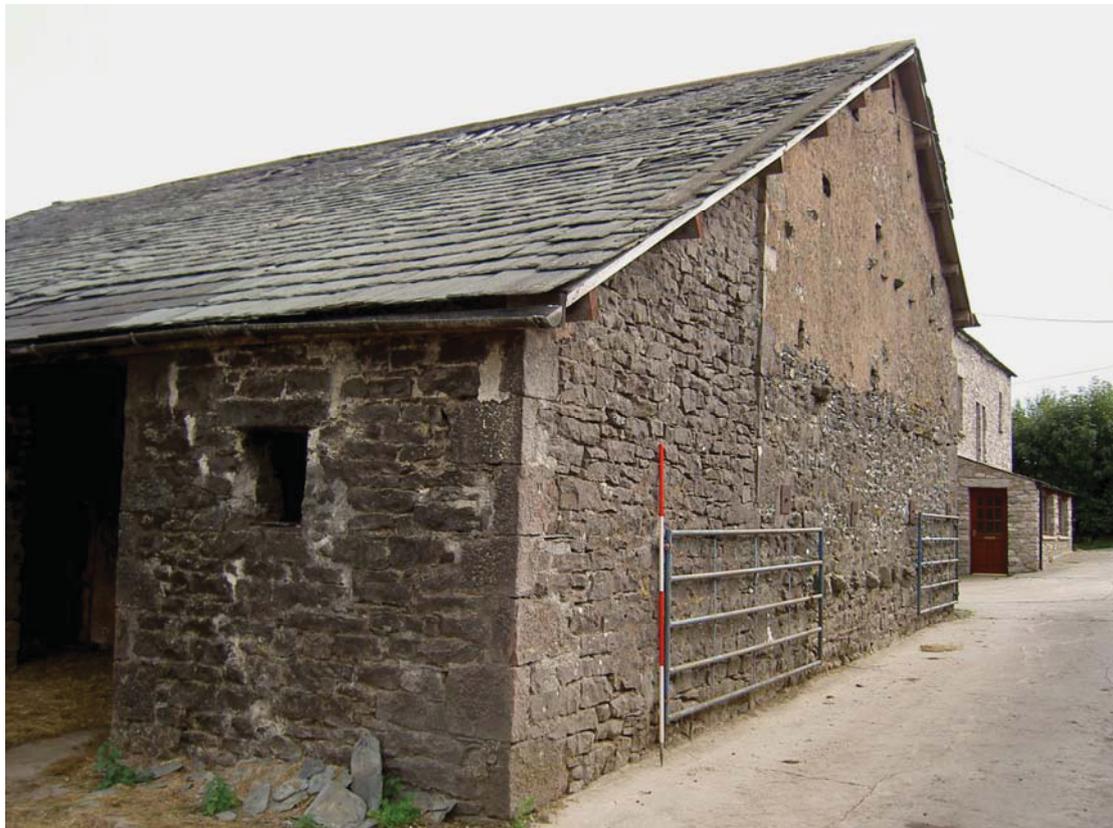
Plate 7: West external elevation, looking south-east

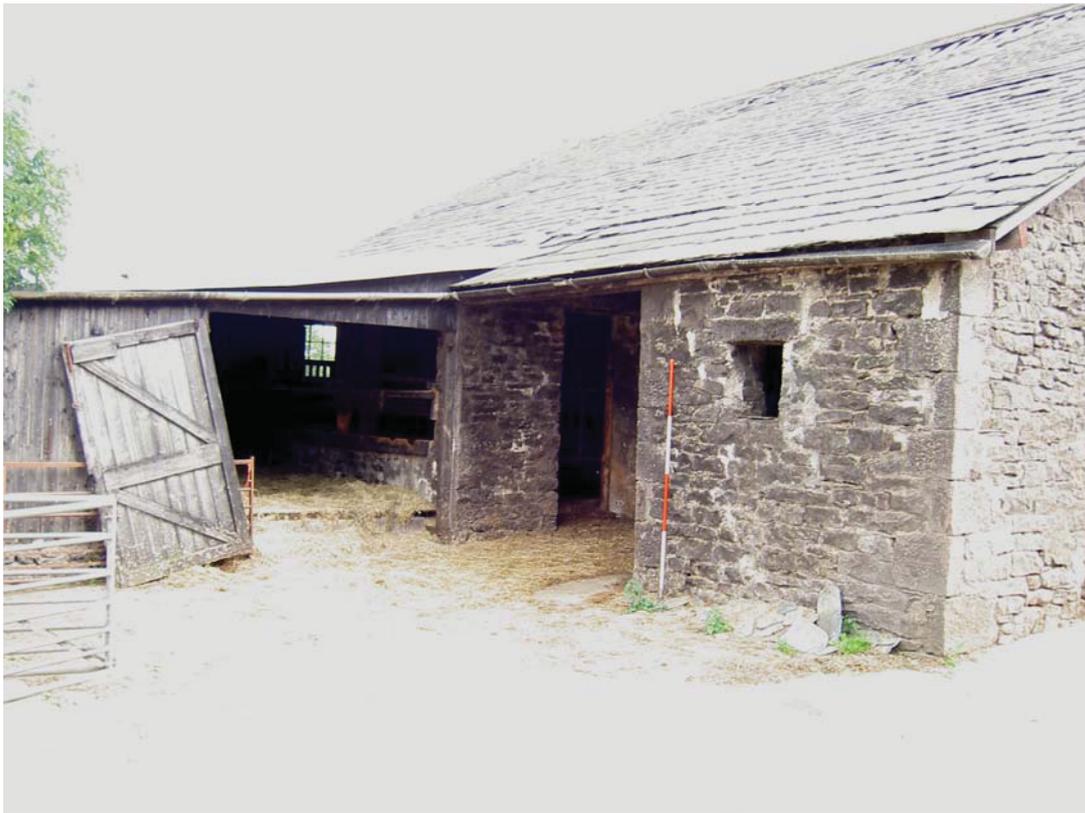
Plate 8: West end of the north external elevation, looking south-east

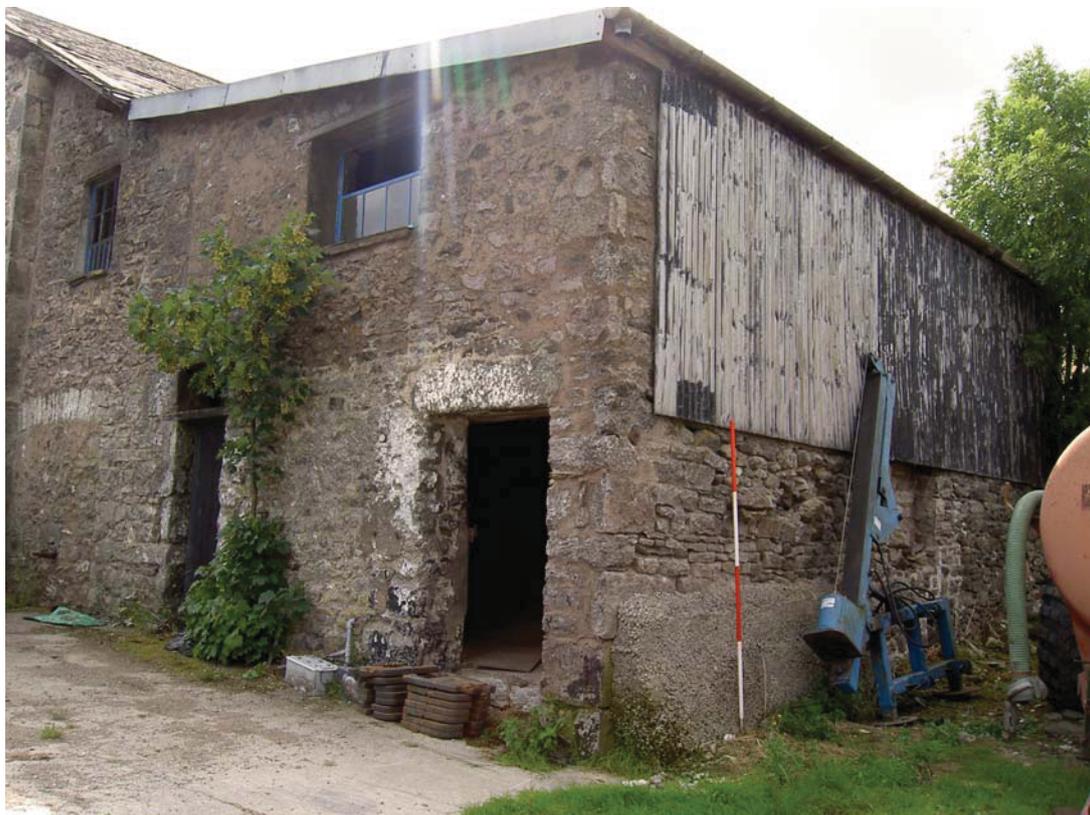
Plate 9: North end of the north-east extensions, looking south-west

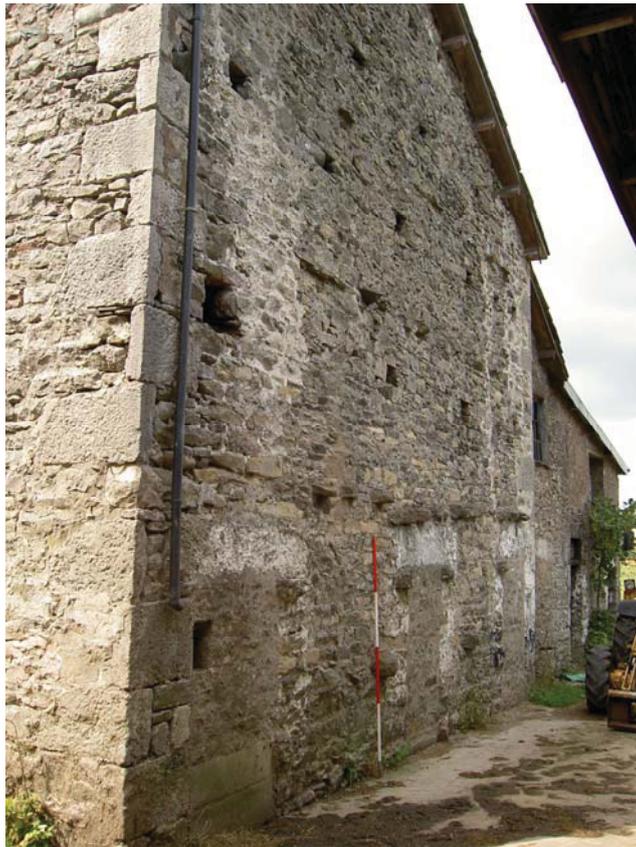
Plate 10: East external elevation, looking north

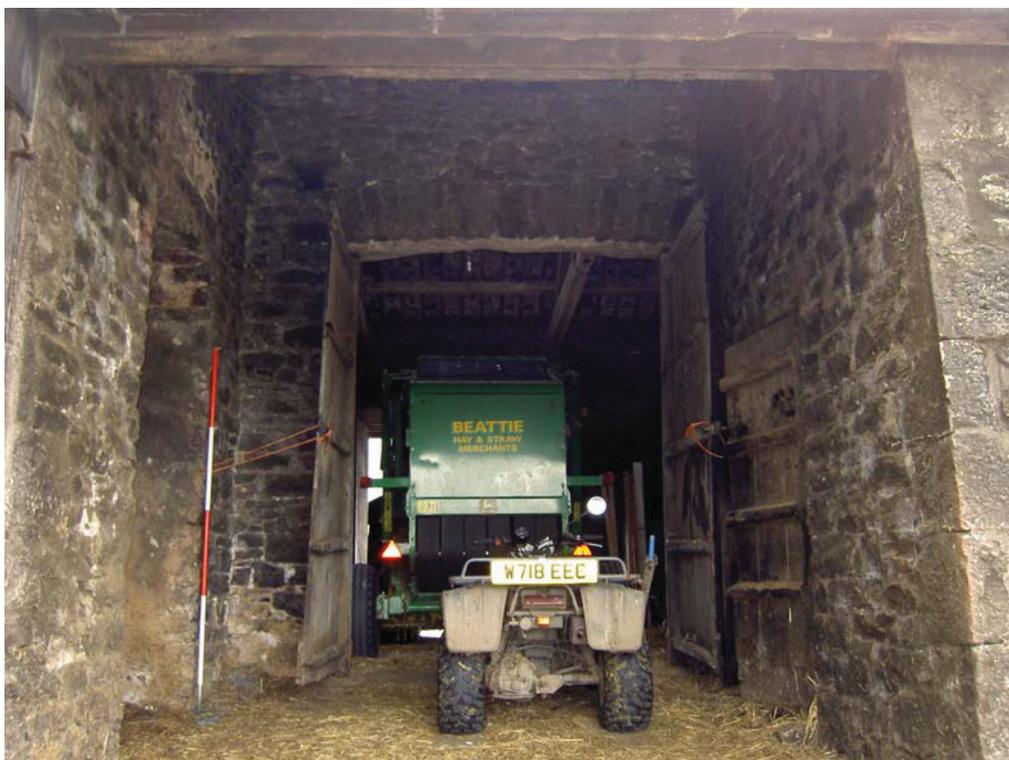
4.4.3 Porch, north side: the external canopy over the northern wagon doorway essentially forms a small porch between the outshuts to the east and west. This has a monopitch roof supported by four purlins comprising three re-used pieces of timber and one machine-cut piece (Plate 13). It is open to the north and has a large wagon doorway to the south with a voussoir arch, above which are two square ventilation slots. The door is constructed from beaded tongue and groove planks with stop chamfer battens. The west side of the porch has a large doorway to the north-western outshut. This has a machine-cut timber lintel and the southern half of the doorway is filled with timber planks, leaving a working door on the north side constructed from half of a complete door comprising beaded tongue and groove planks with stop chamfer battens and decorative strap hinges. The east side of the porch is constructed from courses of rock-face finished stone, with a central doorway with a stone lintel.

Plate 11: Wagon doorway and porch on the north side of the building, looking south

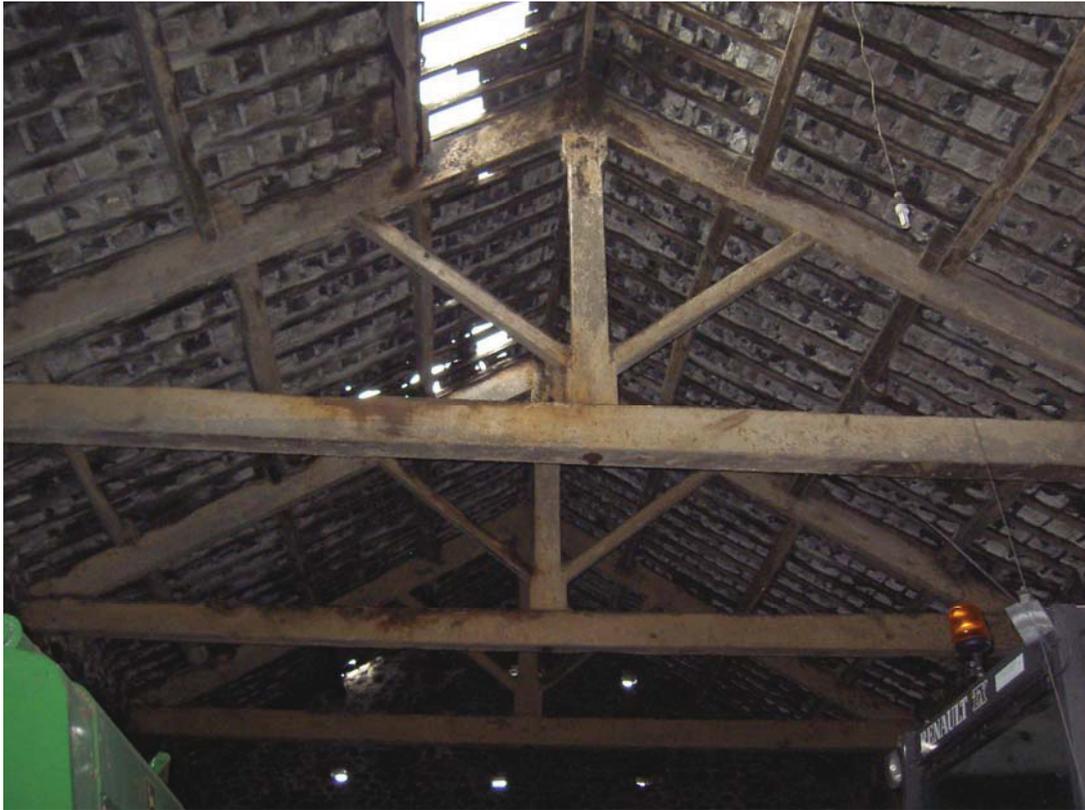
Plate 12: The trusses within the main barn, looking east

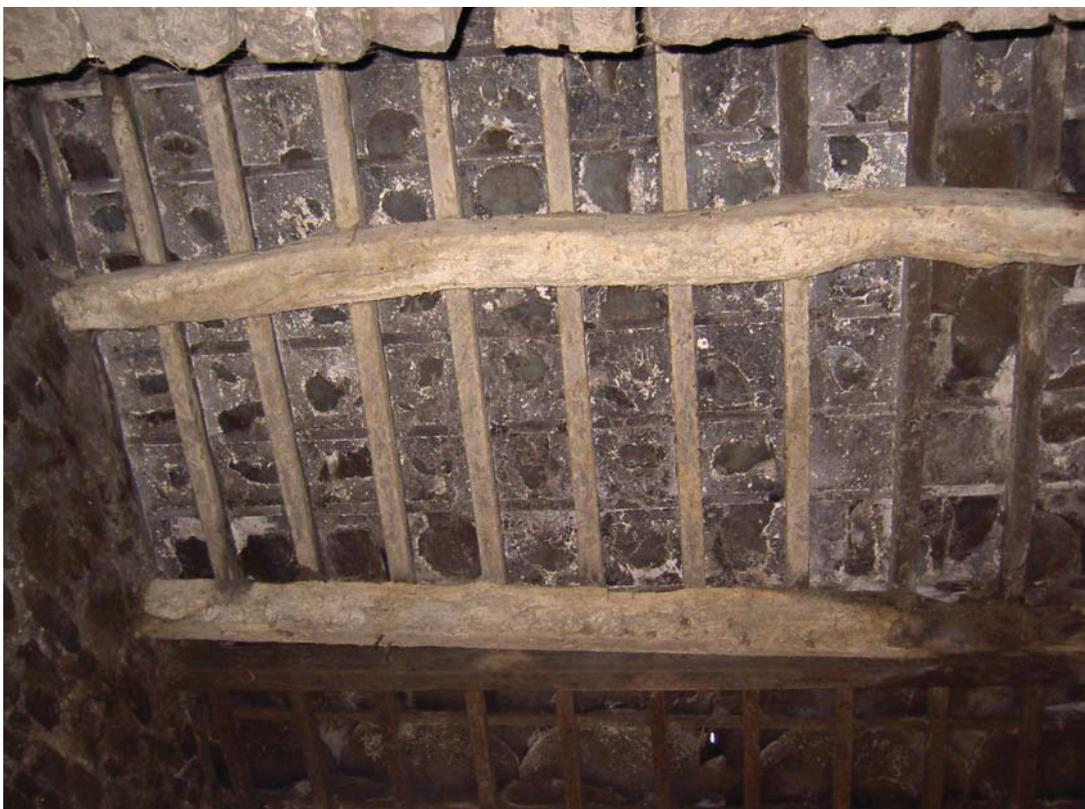
Plate 13: Roof of porch on the north side of the barn showing the hand-finished timbers, looking up

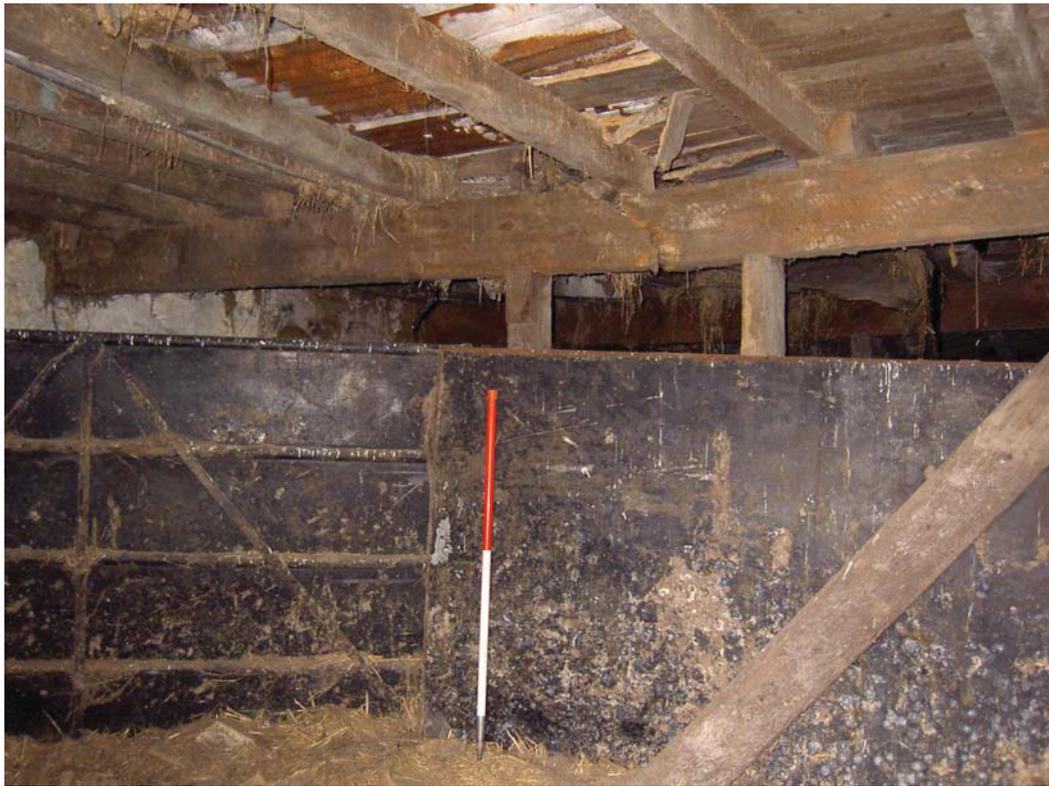
4.4.7 North-east extension, lower floor– cow house: this is situated beneath the hay store and is currently unused. It has a concrete floor with a dung channel along the south side orientated east/west and stalls constructed from saw-pit cut timbers (Fig 10; Plate16). The ceiling comprises timber joists supporting a mix of timber tongue and groove boards and corrugated aluminium sheets. The walls are all finished with a rough limewash and there is a concrete skim against the north and east walls. There are two doorways in the east elevation, a blocked doorway and window in the north, and two blocked apertures to the south. There is no access to the west side of this room due to the unsafe condition of the ceiling.

Plate 16: Stalls and unstable ceiling in the lower floor of the northern of the north-east extensions, looking south-west
