SLACK HOUSE COTTAGES, ST HELENS ROAD, ORMSKIRK, LANCASHIRE

Archaeological Building Recording

November 2015

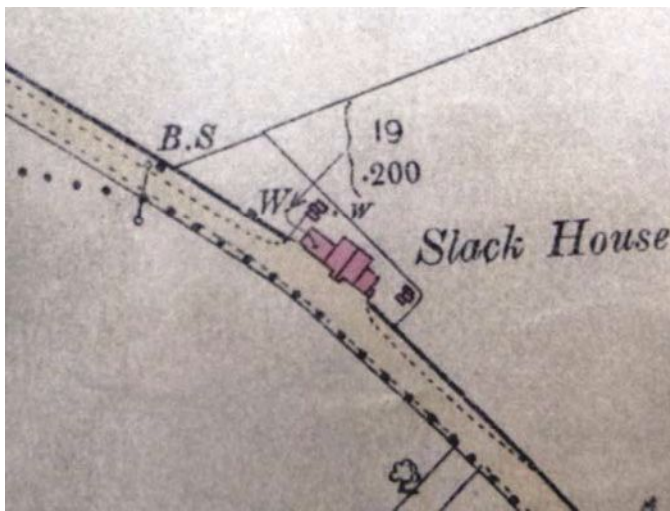
Plate 3 (left): Extract from the Ordnance Survey map of 1893

3.1.4 **Ordnance Survey 1893:** this is the first 1:2,500 scale plan to depict the site, and is therefore considerably more detailed than its predecessors. It is difficult to overlay this map onto the earlier maps due to various differences in the footprint of the building and changes to the nearby field boundaries. The building has evidently been modified since the production of the earlier map but it still comprises the same linear block on the same orientation and even has a similar block of detached outbuildings to the north-west, although another detached block has also appeared to the south-east (Plate 3; cf. Plate 1).

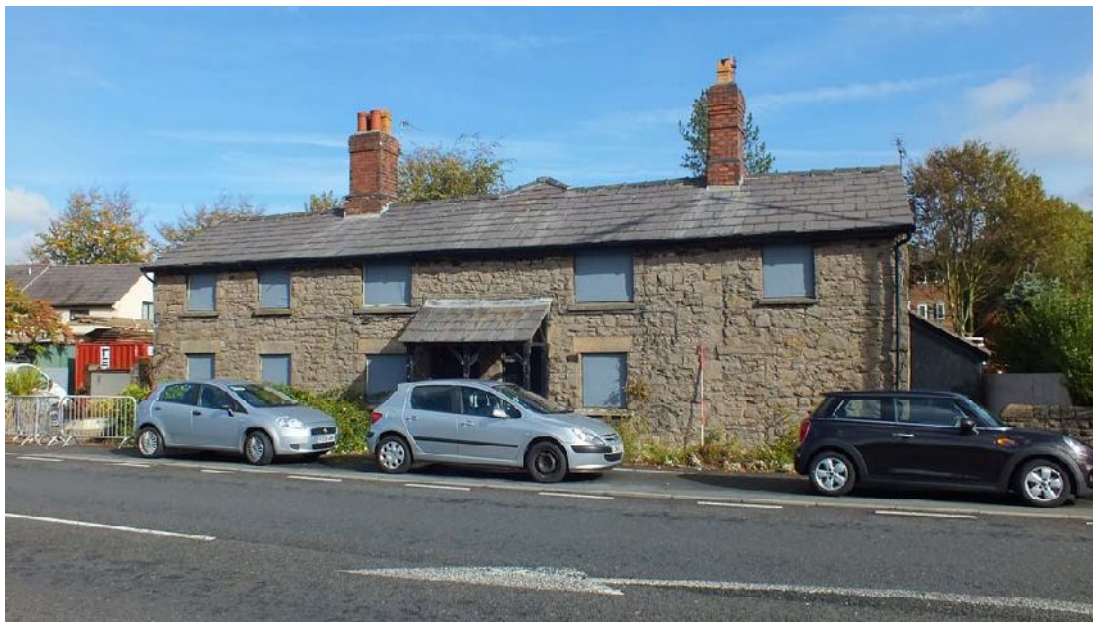
Plate 6: General view of the Slack House Cottages from St Helens Road

4.1.1 The building comprises an essentially linear range orientated approximately north-west/south-east with the front facing to the south-west onto St Helens Road (Plate 6), although the projection from the north-east side makes it closer to a truncated T-shape. The building is two storeys throughout, with a small attic space over the central part and rear extension. The roof is finished with grey slate with ceramic bonnet ridge tiles, and there are two square-section brick chimney stacks projecting through the roof of the main section, each of tiered construction, although the north-west is largely rebuilt. The lower part of the north-west stack and the entire south-east stack is constructed from dark orangey-red handmade bricks, while the upper part of the north-west stack is constructed from modern dark red bricks. Both stacks have ceramic pots; four on the north-west and two on the south-east, mostly of relatively early crenulated types and square in plan, but two on the north-west stack are circular in plan. Externally the build is largely in buff gristone laid in random courses, with rough quoins at the corners and dressed stone of the same type used in sills and lintels. Elsewhere there is evidence for building in brick, of both handmade and machine made types, especially evident internally. However, the projecting central block to the rear (north-east) is finished externally with smooth concrete render. There are monopitch timber porches with slate roofs projecting from the front (south-west) and south-east elevations. Internally the structural timber, where visible, is machine cut, although some rougher timber is evident in some of the purlins.

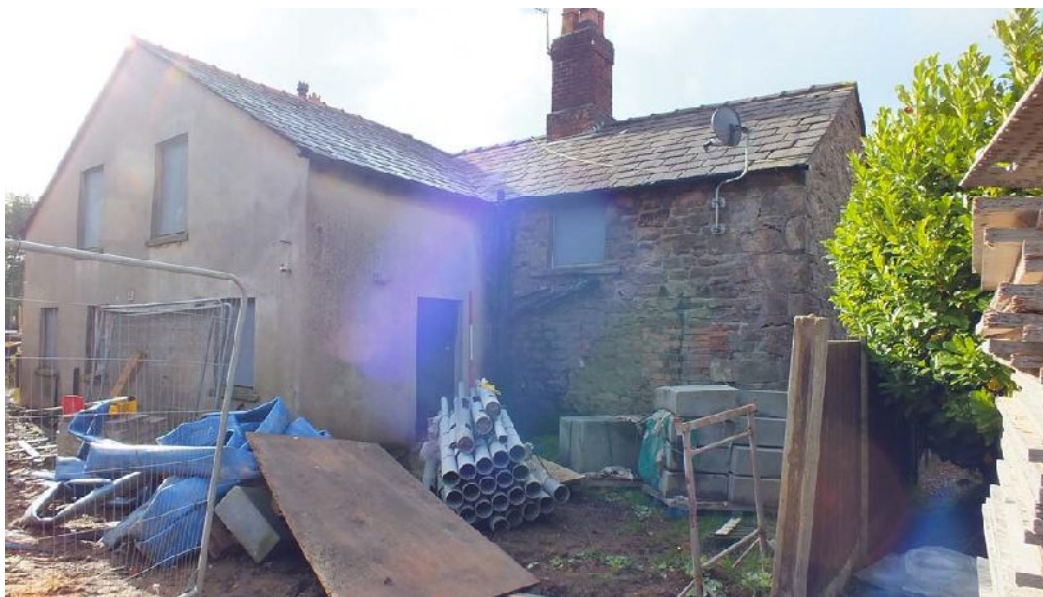
Plate 7: The north-west end of the north-east external elevation, viewed from the north

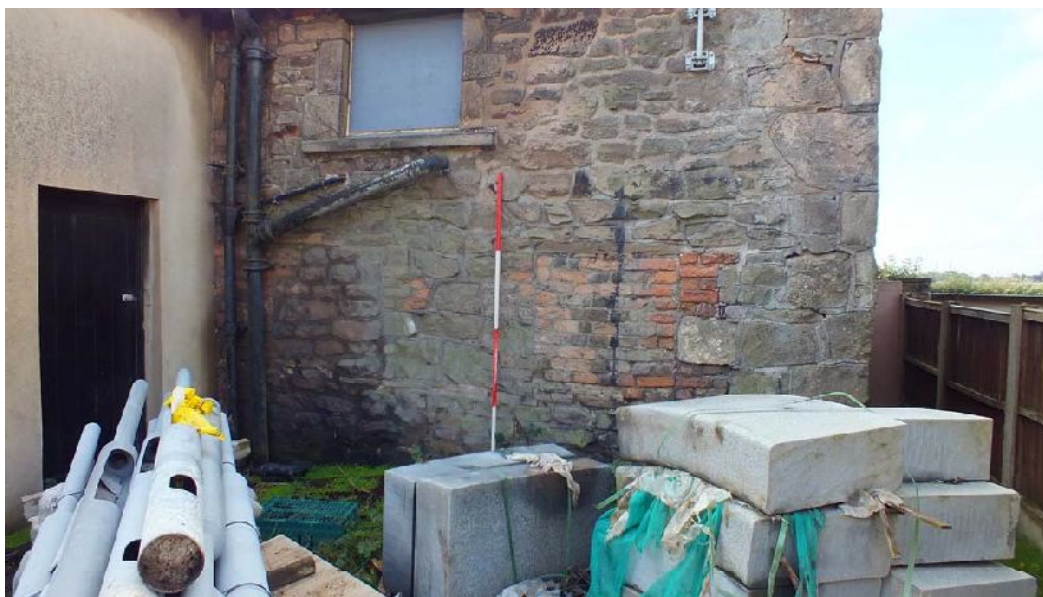
Plate 8: The blocked windows in the north-west end of the north-east external elevation, viewed from the north

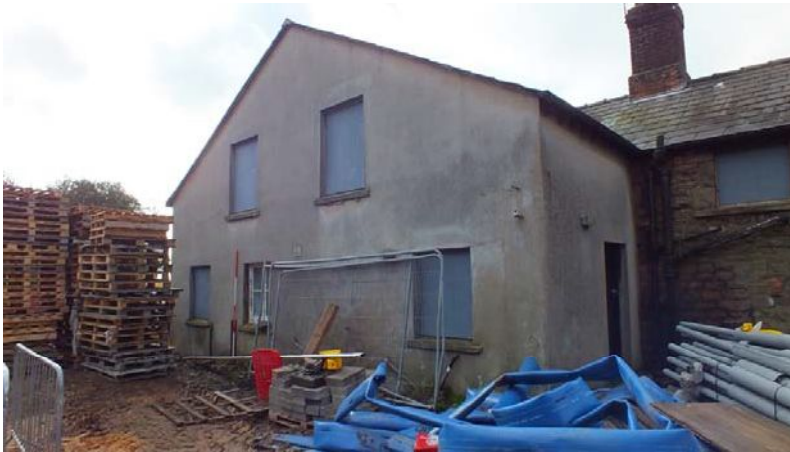
Plate 9 (left): The central part of the north-east external elevation, viewed from the north

4.2.1 **North-east elevation:** this forms the rear elevation, facing onto what was presumably originally a garden. The north-west end is of stone construction, with quoins at the north-west end and two windows on the ground floor (Plate 7). These are both blocked with handmade orangey-red brick filling the north-west and stone filling the south-east, with additional brick incorporated into the jambs, perhaps replacing large quoins (Plate 8). Both windows have round and thin stone quoins and the north-west has a similar lintel. At first floor level there is another window, which is relatively wide and has a dressed stone sill and timber lintel at eaves level. It is covered by a board and has quoins in the jambs with rock-faced finish and dressed bands along the edges. The ends of the purlins project along the roof line and there is a band of concrete skim between these. After the return for the projecting central section the elevation forms a gable, finished with smooth concrete render (Plate 9), although where this has come away it is evidently brick (possibly hand made) below. There are three ground floor windows with dressed sloping

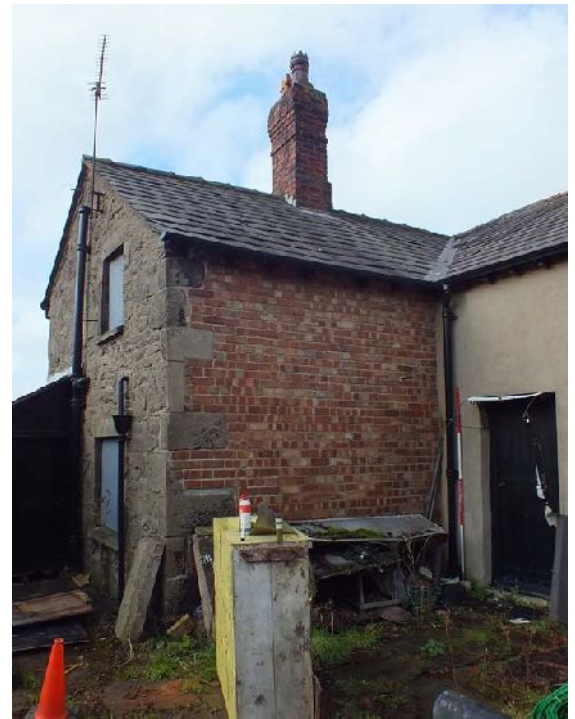
Plate 10 (right): The south-east end of the north-east external elevation, viewed from the east

stone sills, two of which are boarded up, while the third has a four-light hinged timber casement. A plastic vent and ceramic ventilation brick are inserted through the wall at ground floor level. At first floor level there are two more windows in the same style, also boarded up. The south-east end, after the return of the projecting section, is constructed from machine-made brick laid in English garden wall bond at a ratio of four rows of stretchers to one row of headers (Plate 10). The elevation is essentially plain, although there are quoins at the south-east end.

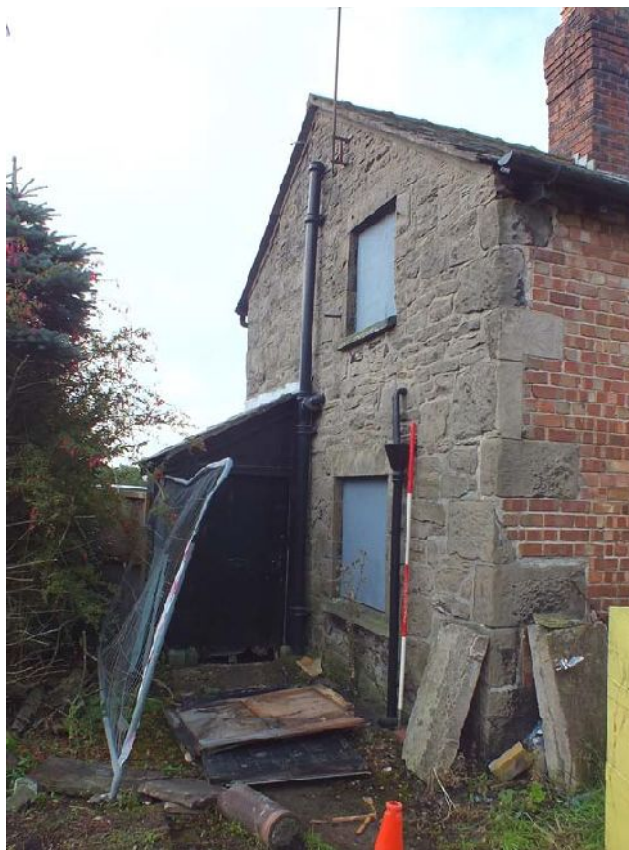
Plate 11: The south-east external elevation, viewed from the east

4.2.2 **South-east elevation:** this comprises the irregular gable end of the building, and the side of the projecting extension to the rear (Plate 11). The lower part on the south-west side is covered by a monopitch timber outshut sat on a dressed stone plinth, clad with timber sheets and with a central window (covered by a board) and slate roof. The north-east return of the outshut to the north-west contains a doorway with a plank and batten door below the tongue and groove plank construction of the wall of the outshut. The main elevation beyond this is of stone construction, with a single ground floor window on the north-east side, covered by board, with a sloping dressed stone sill and heavy dressed stone sill. There is a further window, of similar size and form, but slightly narrower, on the first floor. There are quoins at the north-east end and attached iron waste water pipes and a television aerial. The extension to the north-east is finished with smooth concrete render, hiding any detail, but there is a doorway with a plank and batten door, a stone step up from the external ground level, and an *ad hoc* canopy above formed by iron brackets covered with metal sheeting. To the north-east there is also a ceramic ventilation brick inserted into the wall with a projecting slate lintel above. The roof above this section is appears to have been replaced as the ridge tiles are notably newer or at least of a different form, although the ends of the purlins project below the roof line as elsewhere.

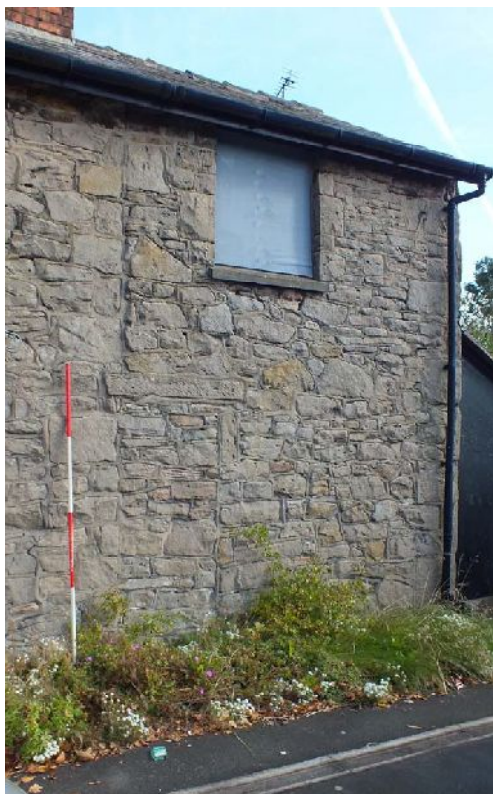
Plate 12 (left): The south-east end of the south-west external elevation showing the later addition, viewed from the south-west

4.2.3 **South-west elevation:** this comprises the main front elevation of the building and is all of stone construction, with the exception of the monopitch porches, one of which extends the north-east end and comprises just timber sheeting over the frame, which is sat on a dressed stone plinth. The south-east end of the stone section is clearly an extension, butting onto the main part, with quoins at the end and a doorway with a rough stone lintel blocked with stone at the junction with the main section (Plate 12). There is a window on the first floor with a dressed stone sill and small quoins, the lintel extending beyond the line of the roof which the purlins project beyond, although they are largely hidden by a barge board. The main part of the elevation has four relatively regularly spaced windows on the ground floor, matched by similarly-positioned and similarly-sized windows on the first floor (Plate 13). All have the same type of dressed stone sills and heavy stone lintels seen elsewhere in the building, with small dressed quoins. Near the centre of the ground floor is a pair of doorways, each also with small quoins and heavy stone lintels and beaded plank and batten doors. These are enclosed by a monopitch porch of timber construction, although with a slate roof, comprising upright posts with angled braces between rails, the bottom one sat on a dressed stone plinth, with a hand rail mid way supported by a row of narrow stop-chamfered square-section spindles (Plate 14). This hand rail also extends to the wall to the north-east where it divides the access to the two doorways. The floor of the porch is finished with red and black quarry tiles laid in a diagonally-set chequer-board pattern and each has a stone step up from the pavement.

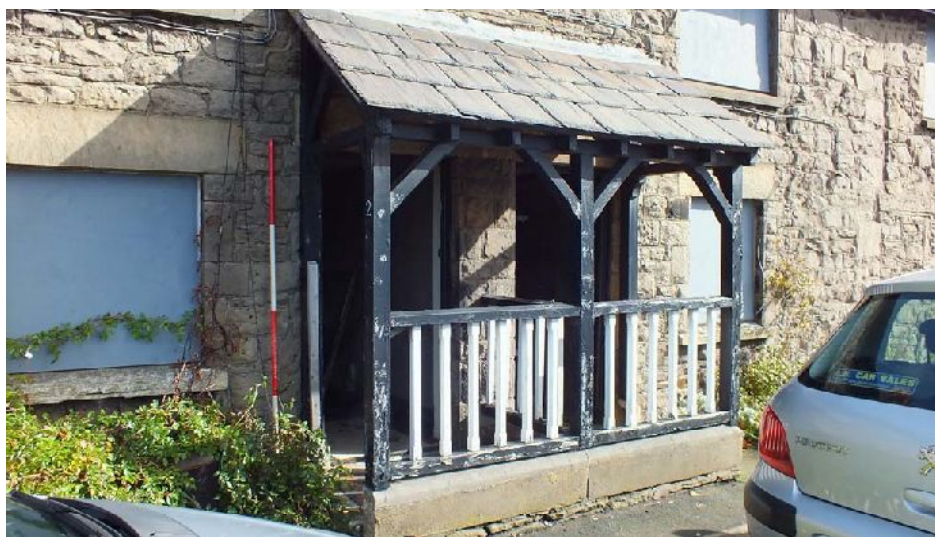
Plate 14: The porch attached to the centre of the south-west external elevation, viewed from the west

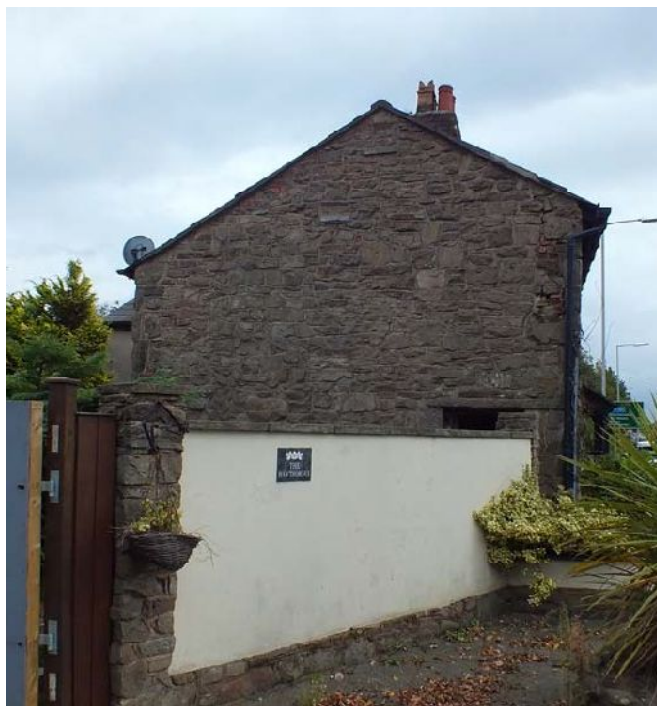
Plate 15 (left): General view of the north-west external elevation, viewed from the north-west

4.2.4 **North-west elevation:** the south-west end of this forms an irregular gable constructed of stone, with some evident rebuilding below the roof line on the north-east side comprising rough brick and concrete sheeting (Plate 15). There is also a possible rebuild line high on the south-west side, perhaps suggesting that the stone finish is just a skim over an earlier brick surface, as suggested elsewhere (see below). There is a tall opening in the centre, blocked with stone and now with no lintel, and to the south-west there is a doorway with a rough and over-long stone lintel and some brick visible in the jamb (Plate 16), again suggesting the stonework is just cladding. The south-west end is finished with quoins, although these are not as neat as elsewhere. After the return to the south-east the projection extension to the north-east is finished with smooth concrete render and largely featureless, although it has a doorway

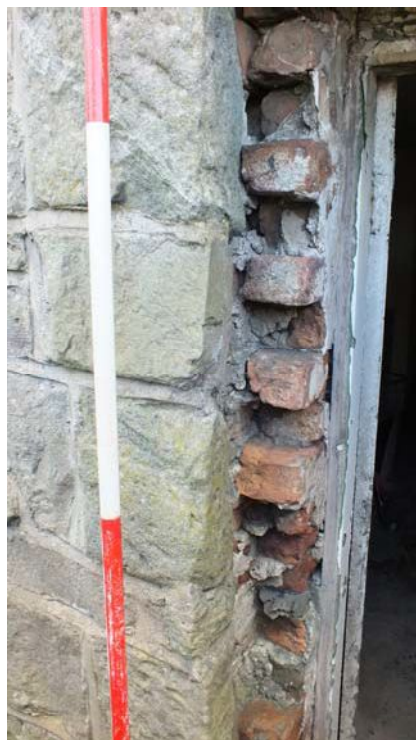
Plate 16 (right): Brick exposed in the jamb of the doorway on the south-west side of the north-west external elevation, viewed from the north-west

on the south-west side with a plank and batten door, there is an attached light to the north-east of this, and the ends of the purlins project below the roof line.

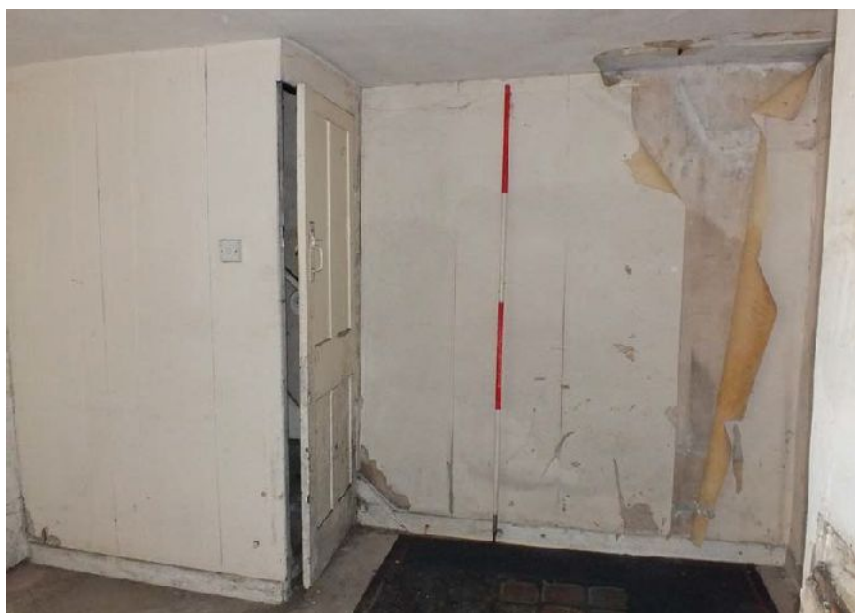
Plate 17 (left): The north-east internal elevation, Room G1, viewed from the south-west

4.3.1 **Ground floor Room 1:** this most recently comprised a living room, and has an exposed concrete floor and flat lath and plaster ceiling finished with flock wallpaper. The walls are finished with plaster and paint and the remains of flock wallpaper and there is a plain low skirting board throughout. The stairs to the first floor are set against the north-east elevation (Plate 17) and run up towards the north corner and there is large cupboard against these and the north-west wall. The north-west side of the north-east elevation is covered by the stairs, which are boxed in with timber constructed from wide planks, with the cupboard extending beneath the stairs at the north-west end (Plate 17). The underside is whitewashed and has applied plywood or hardboard cladding the walls and chipboard shelves. The return in the centre of the elevation has a doorway to the stairs with a plain four panel door (Plate 18); inside the stairs the skirting board is ogee moulded. The rest of the north-east elevation is plain. The south-east elevation is mostly plain although there is a chimney breast in the centre (Plate 19) with a mid-20th century tiled surround, now removed and lying loose on the floor. Behind this what was presumably the original wider opening of the fireplace, which is filled with buff coloured brick. The south-west elevation is essentially plain, apart from two windows with thin timber sills, square jambs, and timber four-light hinged casements of probable early 20th century date (Plate 19). The north-west elevation is also plain, apart a doorway on the south-west side with a plain four-panel door in a wide moulded surround. In addition, the cupboard at the north-east end is constructed from large beaded planks and has a plank and batten door on the north-east side on strap hinges with rounded ends (Plate 22).

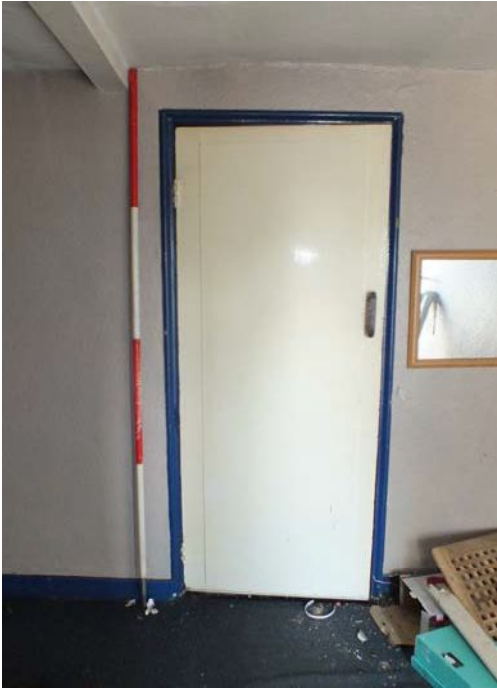
Plate 23 (left): Doorway in the north-east elevation, Room G2, viewed from the south-west

4.3.2 **Ground floor Room 2:** this too was most recently a living room. The floor is concrete, finished with carpet and the ceiling is lath and plaster, finished with flock wallpaper, with a single beam finished with plaster orientated north-east/south-west. The walls too are finished with painted flock wallpaper over plaster, with a plain shallow skirting board throughout. The north-east elevation is plain but with a doorway on the south-east side with a plain modern panel door in a moulded surround (Plate 23). The south-east elevation is plain. The south-west elevation has a doorway on the south-east, which is of plank and batten construction but backed with three panels on the internal side (Plate 24). There is a window to the north-west of this with a thin timber sill, now removed and lying loose on the floor, and a

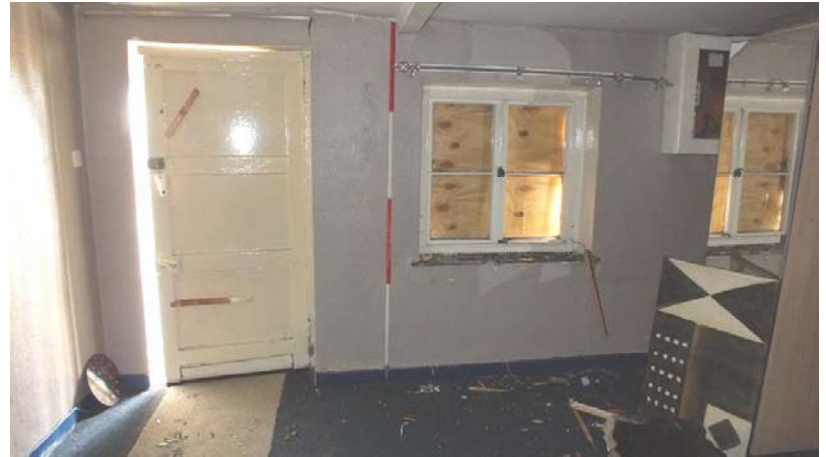
Plate 24 (right): South-west elevation, Room G2, viewed from the north-east

four-light hinged timber casement of probable early 20th century date. There is a box fixed to the wall at the north-west end that originally housed the fuse box. The north-west elevation is essentially plain apart for central chimneybreast, the mid-20th century tile surround now lying loose on the floor and the original opening blocked with buff coloured brick with elements of the earlier stone surround just visible at either side (Plate 25).

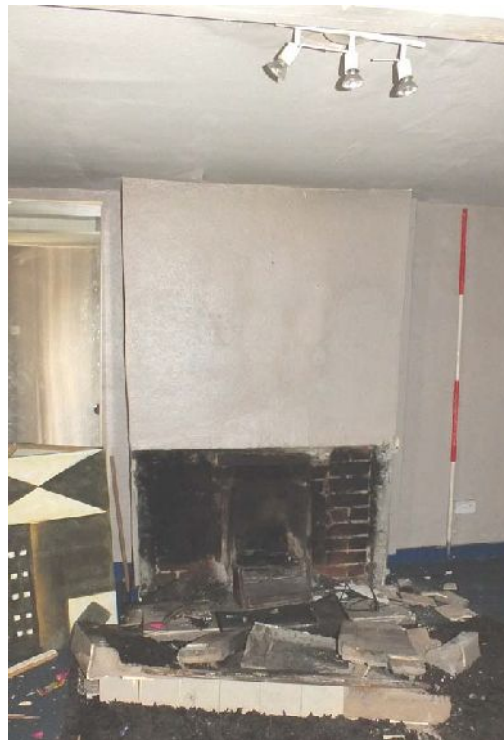
Plate 25: Fireplace in the north-west elevation, Room G2, viewed from the south-east

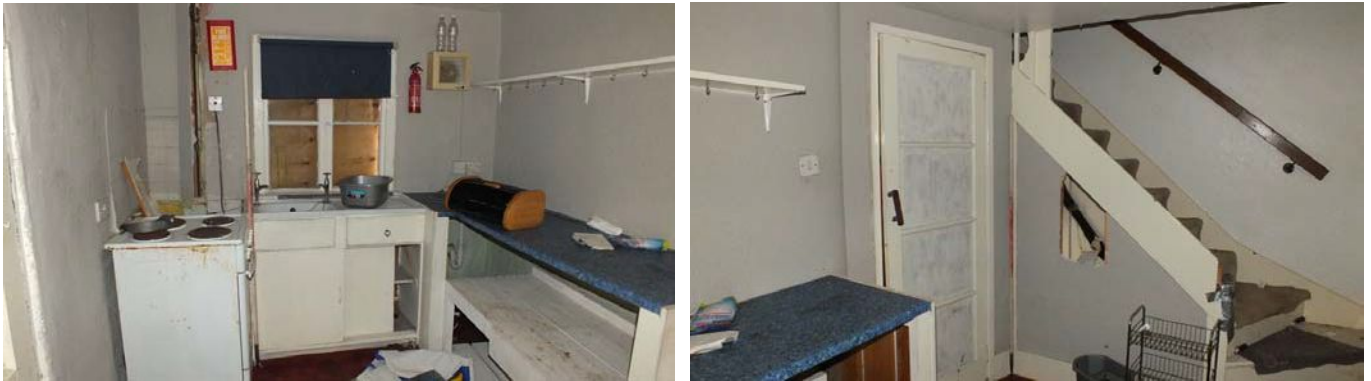
and painted flock wallpaper. The stairs to the first floor extend up on the south-west side and are of timber construction finished with carpet. The lower part of the north-east elevation is covered with mid to late-20th century kitchen units and a sink but in the centre there is a window with a four-light hinged timber casement of probable early 20th century date (Plate 26). There are boxed pipes to the north-west of this and an electric vent to the south-east. The south-east elevation has an attached shelf, more kitchen units attached (Plate 26), and a doorway at the south-west end at a slight step in the wall, perhaps denoting the position of the original doorway. The door has four plain panels in a plain surround and is probably late 20th century in date (Plate 27). The lower part of the south-west elevation is boarded below the stairs with part of run of plain square-section balusters sat on a rail on top, the rest of which are presumably missing. The main wall behind the stairs is plain apart for an attached modern hand rail. The north-west elevation has a step on the south-west side at the stairs and a doorway near the centre, which is of plank and batten construction but is backed with plain panels internally (Plate 28). The wall is partially tiled in the north corner.

Plate 26 (left): The north-east and south-east elevations, Room G3, viewed from the south-west

Plate 27 (right): The south-east and south-west elevations, Room G3, viewed from the north

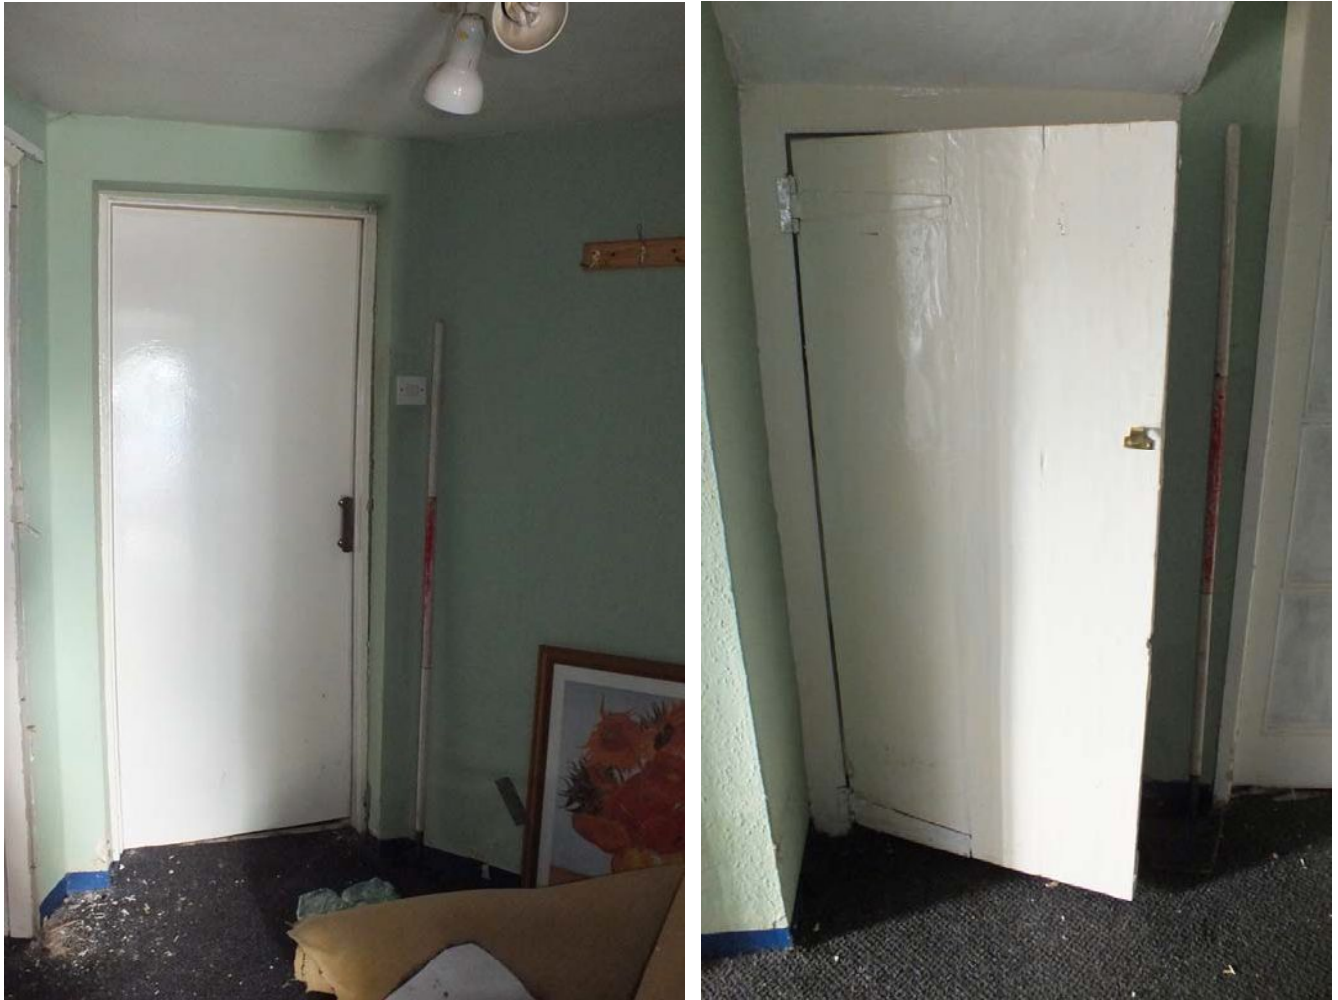
plain modern door in plain surrounds, and the wall is angled to the south-east side of this, where there was presumably originally a fireplace (as per Room G7) into the east corner (Plate 29). The south-east elevation is plain, with modern attached timber shelves. The south-west elevation is plain apart from a doorway with a plain surround and plain panel door. The north-west elevation has a cupboard under the stairs on the south-west side with a beaded plank and batten door on plain long strap hinges in a beaded surround (Plate 30). The underside of the timber stairs is painted white. To the north-east is a doorway with a plain surround and late 20th century four panel door (Plate 31).

Plate 29 (left): North-east elevation, Room G4, viewed from the south-west

Plate 30 (right): Door to the cupboard under the stairs, north-west elevation Room G4, viewed from the south-east

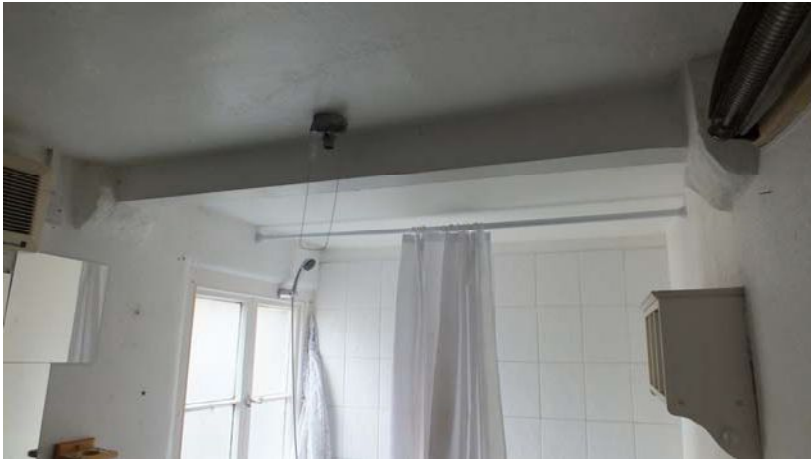
Plate 32 (left): Beam and corbels supporting the ceiling of Room G5, viewed from the west

4.3.5 **Ground floor Room 5:** this was most recently a bathroom. The floor is finished with carpet over concrete, the ceiling is plaster with a single beam orientated north-east/south-west supported on projecting corbels set in the wall at either end. The walls are finished with a mixture of paint, flock wallpaper and tiles and a plain skirting board. The north-east elevation has an attached sink and toilet on the north-west side, with a window to the south-east with a four-light hinged timber casement with a beaded surround, of probable early 20th century date. The south-east elevation is plain, and tiled. The south-west elevation is also plain, the lower part is tiled up to a doorway, which has a plain surround and plain panel door. The north-west elevation is plain.

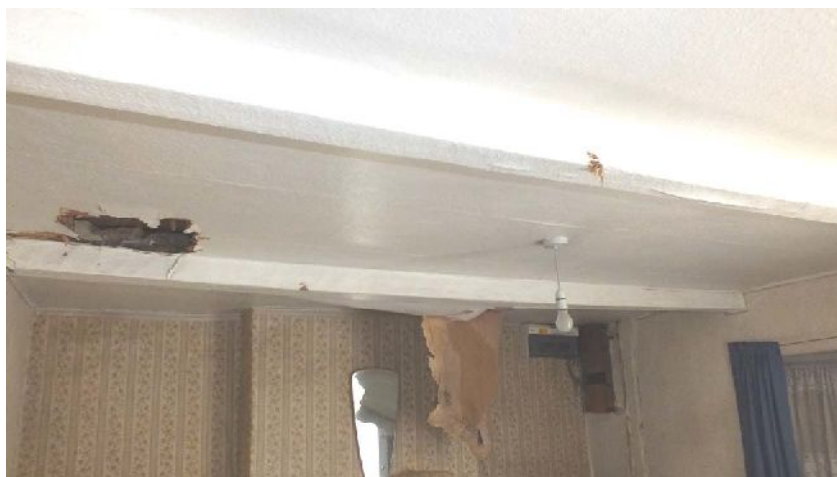
Plate 34 (left): Beams supporting the ceiling, Room G6, viewed from the north

4.3.6 **Ground floor Room 6:** this was most recently a living room. The floor is finished with carpet over concrete and the ceiling comprises boards finished with flock wallpaper with two beams orientated north-east/south-west finished in the same fashion (Plate 34). The north-east elevation is plain apart from a doorway on the north-west side with a four-panel door in a moulded surround (Plate 35). The south-east elevation has a central projecting chimney breast; the mid-20th century tiled fire surround is now lying loose and the opening behind it is filled with buff coloured brick (Plate 36). There is boxing to the south-west housing piping. The south-west elevation is mostly plain with a window in the centre with a two-light hinged and locking UPVC casement, with applied bars to make it four lights and a thin timber sill, now removed (Plate 37). To the north-west is a doorway, which is of plank and batten construction but internally has been backed with boards to form three panels. The north-west elevation is plain.

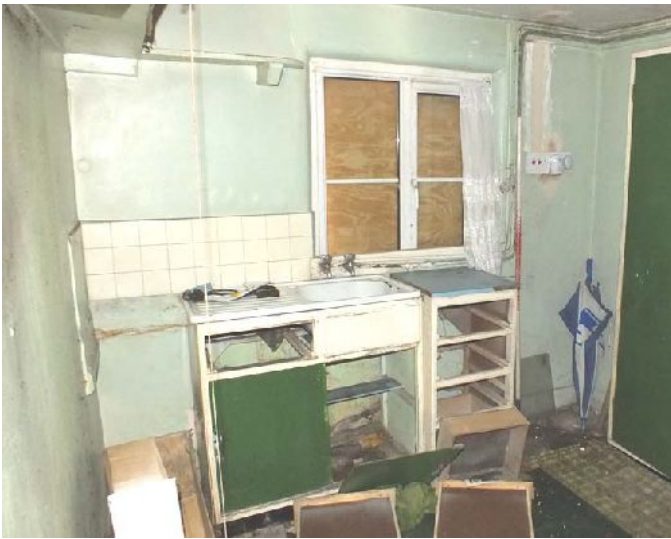
Plate 38 (left): North-east elevation, Room G7, viewed from the south-west

4.3.7 **Ground floor Room 7:** this was most recently a kitchen, and comprises a relatively irregular, almost L-shaped, room with a flight of stairs against the south-west elevation. The floor is polished concrete finished with lino, the flat plaster ceiling is painted, and the walls are plaster finished with paint and a low plain skirting board. The north-east elevation returns from an angled section of wall (described as part of the north-west elevation below) round a rounded corner with relatively early shelves on plain timber brackets attached. The north-east elevation has mid-20th century kitchen units attached with tiled splash backs, but also includes a window with a two-light UPVC hinged and locking casement with added bars to make four lights, the jambs, sill, and lintels of which are rounded (Plate 38). There are timber battens below this and along the south-east jamb then along the top of the wall to which water pipes are attached. The south-east elevation has the timber batten running along the top and a central doorway with a plank and batten door backed with boards to form two panels (Plate 39). The south-west elevation

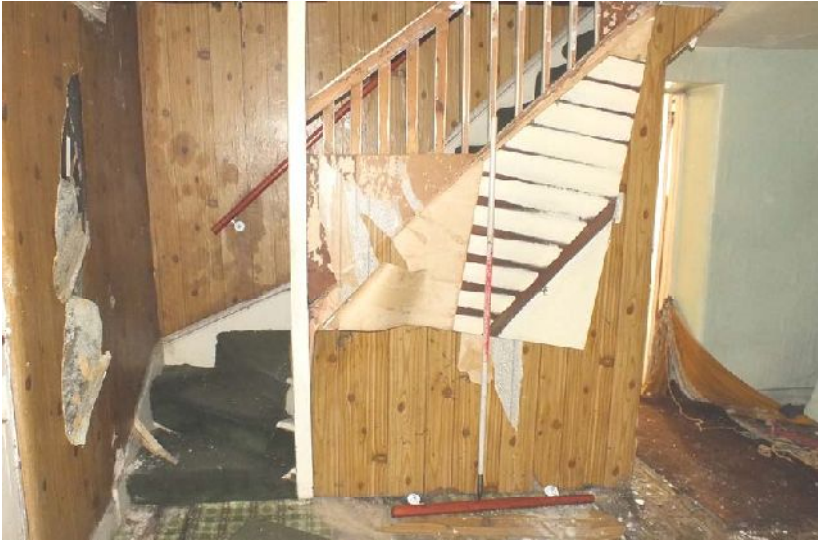
Plate 40 (left): South-west elevation, Room G7, viewed from the north-east

is open to the flight of stair on the south-east side where there is a beaded skirting board and the timber stairs are finished with carpet. The site of the stairs is finished with plain timber panelling, the lower part of which is clearly earlier and topped with a beaded edge, while the balusters on top are a mixture of original and modern but all square section, with a modern and very plain hand rail and newel post (Plate 40). The return at the north-west end includes a doorway into the cupboard beneath the stairs, which has a beaded surround and plank and batten door on short hinges, although the scars for earlier longer hinges are visible (Plate 40). Inside the cupboard the timber structure of the stairs is painted white. The north-west end of the south-west elevation has a doorway with a chamfered surround and four panel door. The north-west elevation is plain up to an angled section. This includes a fireplace, which until recently was covered with timber sheeting and wallpaper, the timber apparently re-used, perhaps from a piece of furniture and decorated with a Greek key pattern. The fireplace comprises a plain stone surround and stone mantle, broken on the east side, with an iron hob grate insert and brick back, with a low brick arch just visible behind the surround (Plate 42).

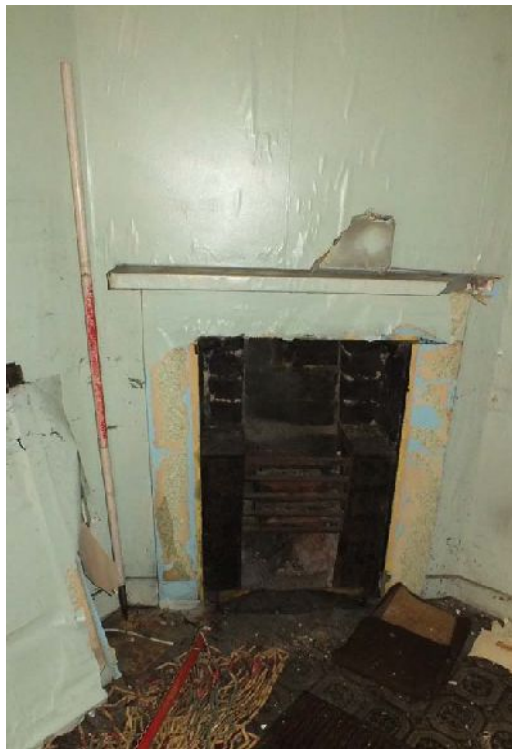
Plate 42: Fireplace in the north-west elevation, Room G7, viewed from the south

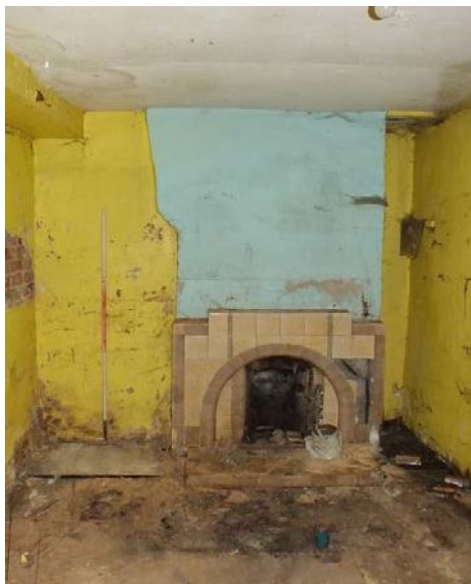
Plate 43 (left): The north-east elevation, Room G8, viewed from the south-west

4.3.8 Ground floor Room 8: this most recently seems to have formed a store. The floor is concrete, finished with the remnants of lino. The ceiling is timber boards painted and fixed to the joists, some of which are exposed at the south-west end and are machine cut with tongue and groove floor boards on top (Plate 45). The walls are generally finished with rough plaster and paint. The north-east elevation has a projecting chimney breast on the south-east side, with a deeper recess on the south-east side. The fireplace has a tiled mid-20th century surround still *in situ* (Plate 43). The south-east elevation has a window on the north-east side with a UPVC hinged and locking two-light casement with attached bars to give the appearance of four lights and a timber sill, with an attached timber shelf on brackets below (Plate 44). To the south-west is a doorway with a plank and batten door and plain surround. The scar of a former staircase, running against the south-west elevation, is evident in the south corner, with an upright batten attached to the wall probably forming part of it. The south-west elevation is dominated by the scar of the former staircase running across it and there is an evident butt joint on the north-west side representing the blocked doorway visible externally, which has a low stone step at its base (Plate 45). The north-west elevation also has elements relating to the former staircase on the south-west side, including a horizontal batten and an upright post (Plate 46), as well as a large area of timber of boxing below the ceiling. At the north-east end the plaster has been partially removed revealing the butt joint between the earlier projecting section of the building and the extension containing Room G8 (and Room F9) (Plate 47).

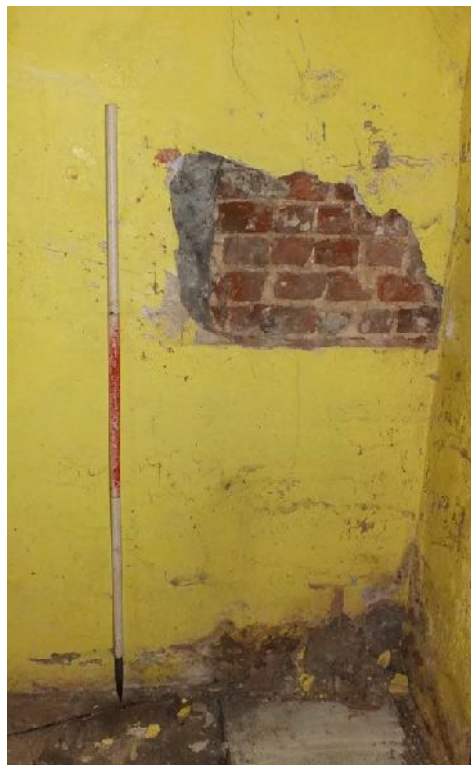
Plate 47: The junction at the north-east end of the north-west elevation, Room G8, viewed from the south-east

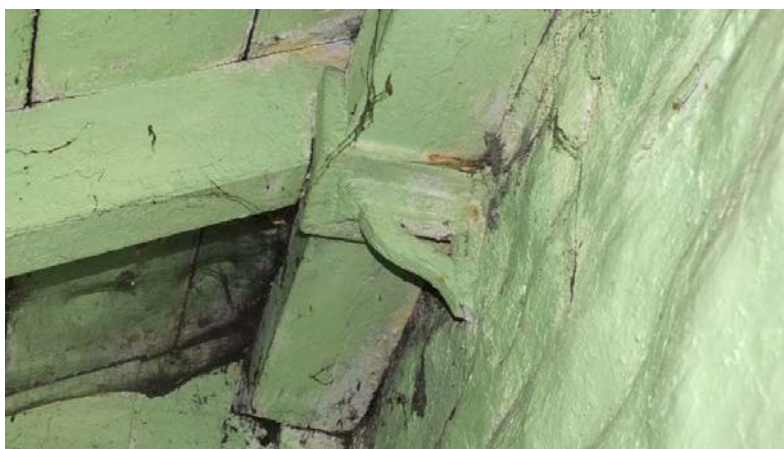
Plate 48 (left): Bracket supporting the beam against the north-west elevation, Room G9, viewed from the north-east

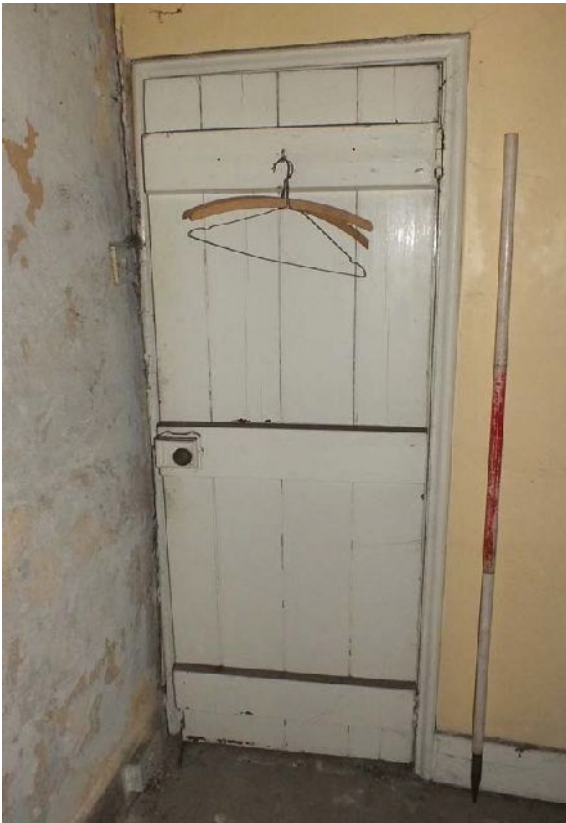
Plate 52(left): Door in the north-east elevation, Room F1, viewed from the south-west

4.3.10 **First floor Room 1:** this was most recently a bedroom. The floor is timber boards orientated north-east/south-west, finished with the remnants of carpet. The ceiling is plaster finished with paint and sloping down on the south-west side, and the walls are finished with plaster and paint and there is a plain skirting board throughout. The north-east elevation is mostly plain but has a doorway in the north-west side with a beaded plank and batten door in a moulded surround (Plate 52). The south-east elevation has a chimney breast on the north-east side, with a vent brick denoting the original presence of a fireplace, which is otherwise blocked, although the hearth stone is present in the floor in front (Plate 53). The recess to the south-west of the fireplace contains an airing cupboard constructed from modern timber and housing both hot and cold water tanks. The south-west elevation has two windows, each with timber sills (now removed) and four-light hinged timber casements of probable early 20th century type (Plate 54). The north-west elevation is plain.

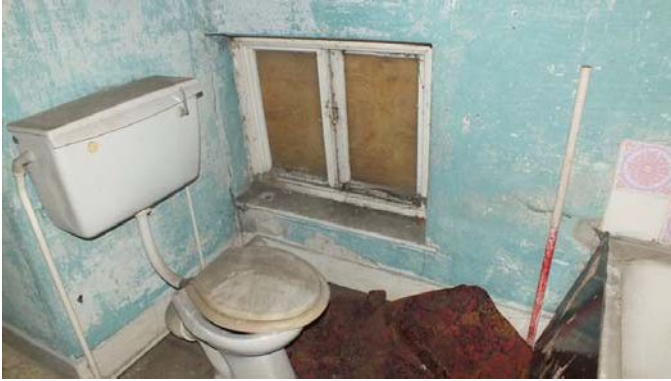
Plate 55 (left): North-east elevation, Room F2, viewed from the south

4.3.11 First floor Room 2: this was most recently a bathroom, which connects to a small landing at the top of the stairs down to the ground floor. The floor is timber boards orientated north-east/south-west finished with carpet, while the ceiling is plaster, sloping down to the north-east and with a single purlin orientated north-west/south-east on the south-west side, which is finished with plaster and paint. The walls are finished with plaster and paint and there are some areas that are tiled. The north-east elevation returns out on the north-west side where there is a partition around the stairs, and the return to the north-west has a toilet attached. The main part of the elevation has a window with a two-light timber casement with a hinged opening (Plate 55). There is a bath against it at the south-east end, with tiles forming a splash back at this point. The south-east elevation has the bath set against most of its length, and tiles attached to the wall along the edge of this. The south corner steps out for the chimney breast, which forms a step in both the south-east and south-west elevations (Plate 56). There is a sink attached to the

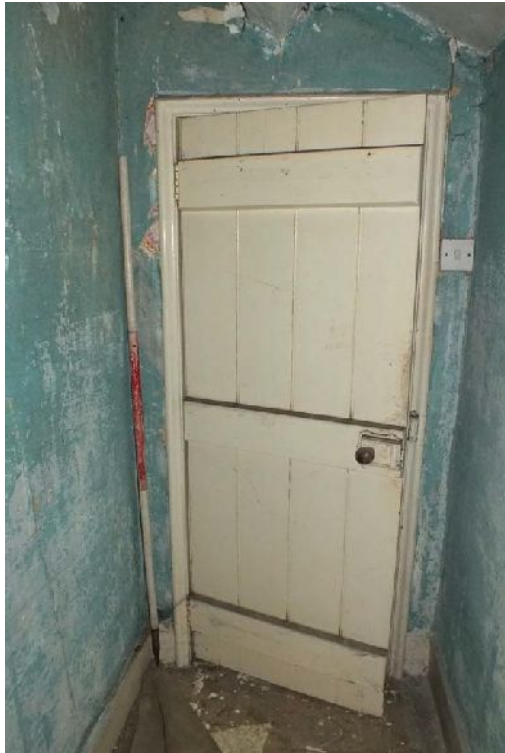
Plate 57 (left): Door in the north-west elevation, Room F2, viewed from the south-east

south-west elevation beyond this with a tiled splash back. The north-west elevation is essentially just a doorway, with a beaded plank and batten door in a moulded surround (Plate 57). The adjoining landing also has timber stairs finished with carpet and the roof continues the slope of Room F2 and shares the same purlin. The space is essentially plain, with doorways with plank and batten doors to the south-west and south-east. The north-west elevation has a blocked opening, presumably just an alcove, on the south-west side, evident as a mark in the plaster (Plate 58).

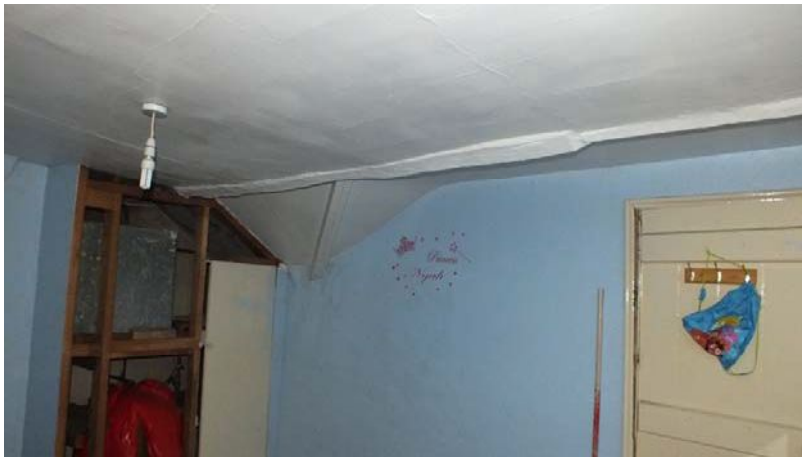
Plate 59 (left): Purlin and hipped ceiling, north-east side of Room F3, viewed from the south

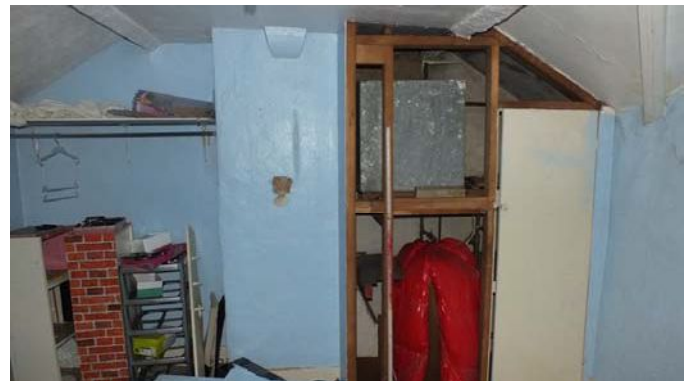
Plate 62 (right): Chimney breast and cupboard, north-west elevation, Room F3, viewed from the south-east

the north-west side with a timber sill, now removed, and a four-light hinged timber casement of probable early 20th century date (Plate 61). The north-west elevation has a projecting central chimney breast with no surviving fireplace and a corbel projecting near the top. The recess to the north-east is filled with an airing cupboard of simple timber construction containing both hot and cold water tanks (Plate 62).

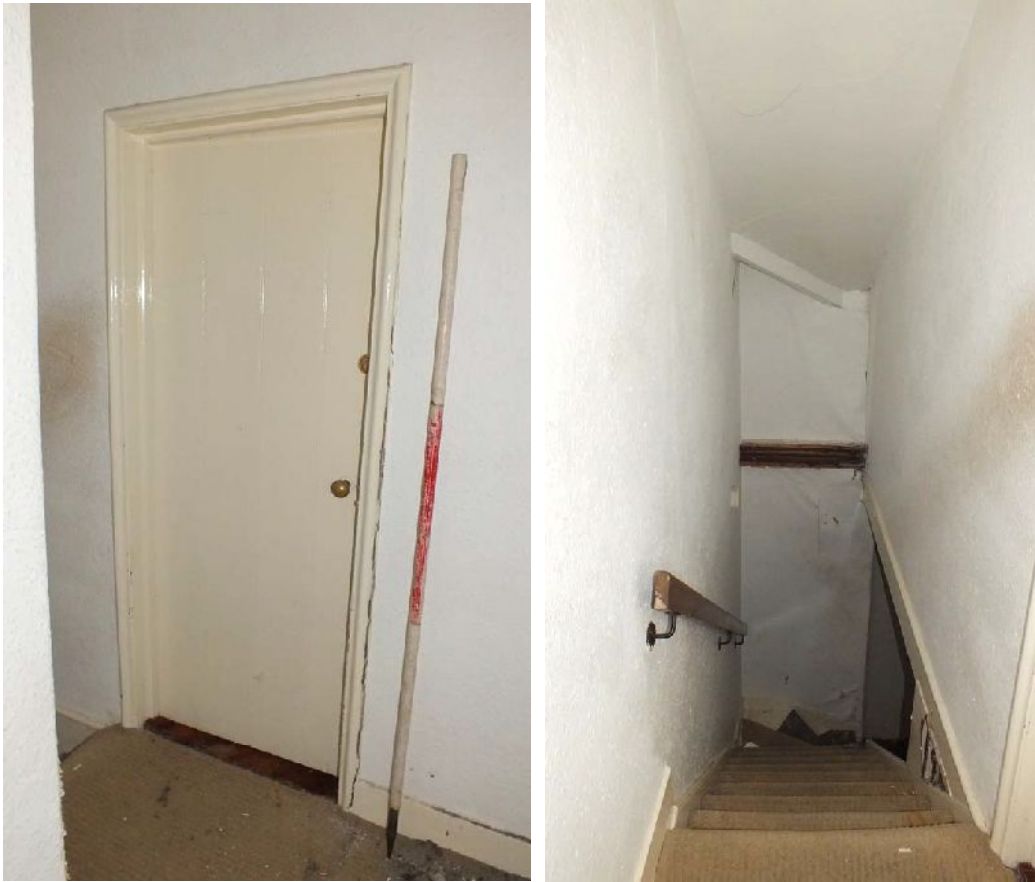
Plate 63 (left): Door to the north-east, Room F4, viewed from the south

Plate 64 (right): North-west elevation and stairs, Room F4, viewed from the south-east

4.3.13 First floor Room 4: this comprises a staircase leading down to the ground floor and a short corridor linking Rooms F3 and F5 to it and to each other. The floor is timber boards finished with carpet, with the steps leading down on the north-west side (Plate 64), and the plaster ceiling slopes down to the north-west and has two exposed purlins, one angled to follow the slope of the roof (Plate 64), as well as an attic access hatch in the flat section on the south-east side. The walls are finished with plaster and flock wallpaper or paint. The north-east elevation is open at the bottom where the stairs pass through although there is a small number of square section balusters at the top partially boxed in. At the top of the stairs there is a doorway with a moulded surround and plank and batten door (Plate 63) and the wall is clearly a stud partition. The south-east elevation is plain. The south-west elevation has a similar door to

that to the north-east, with a step down into Room F3, and the wall is solid masonry and relatively thick. The north-west elevation is plain, with boxed horizontal pipes above the stairs (Plate 64).
