SLACK HOUSE COTTAGES, ST HELENS ROAD, ORMSKIRK, LANCASHIRE

Archaeological Building Recording

November 2015

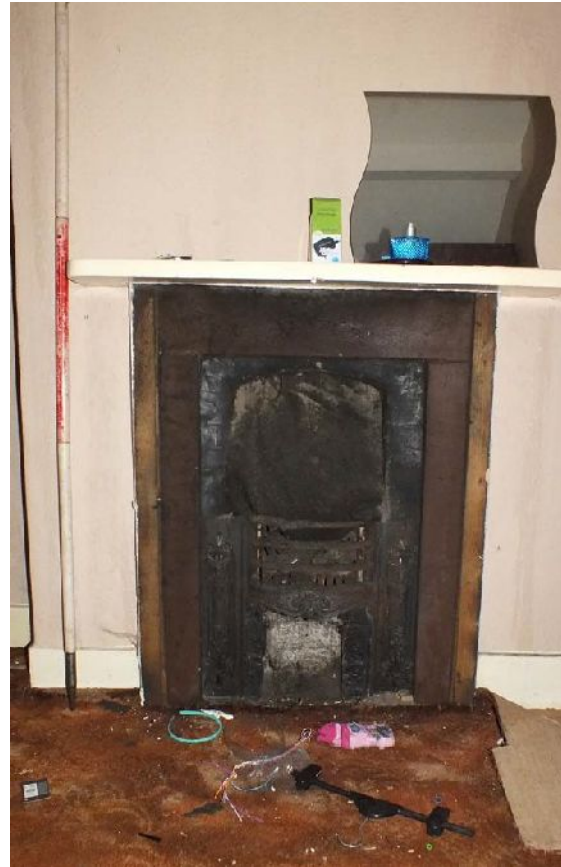
Plate 66 (right): Fireplace in the south-east elevation, Room F5, viewed from the north-west

4.3.14 **First floor Room 5:** this most recently comprised a bedroom. It has a timber floor finished with carpet and a plaster ceiling, sloping down to the north-west with a single beam orientated north-east/south-west finished with plaster and paint. The walls are finished with plaster and flock wallpaper and paint and there is a low plain skirting board throughout. The north-east elevation is plain apart from a window on the south-east side with a two-light top opening hinged timber casement in a moulded surround (Plate 65). The south-east elevation has a modern shelf on the north-east side and a central chimney breast. The fireplace has a plain stone surround and timber mantle piece with an iron hob grate insert and brick backing the flue and low brick arch just visible behind the stone surround (Plate 66). The grate is decorated with moulded floral patterns and until recently was boxed in and hidden. The south-west elevation is plain apart from a doorway on the south-east side, which has a moulded surround and plank and batten door (Plate 67). The north-west elevation is very low due to the slope of the roof, and a hole in the ceiling shows that the joists are machine cut.

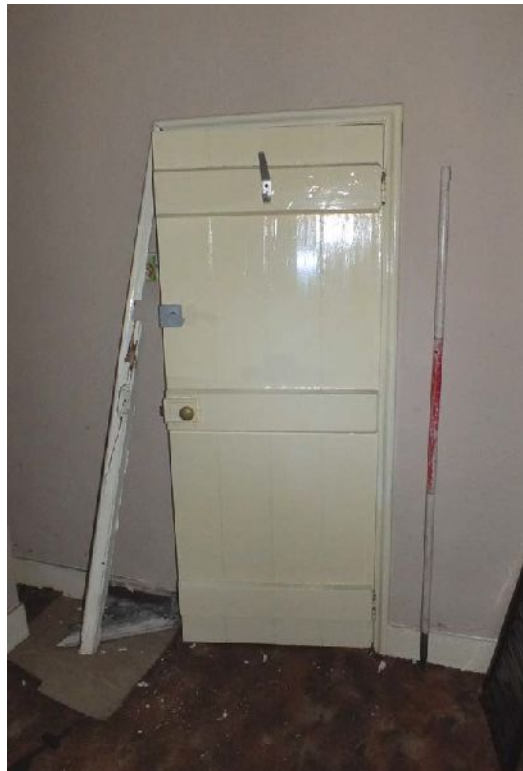
Plate 67: Door in the south-west elevation, Room F5, viewed from the north-east

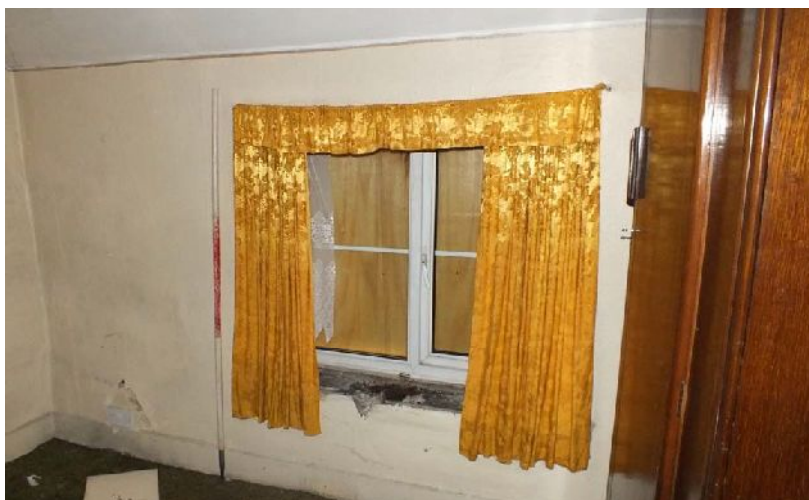
Plate 70: Window in the south-west elevation, Room F6, viewed from the north

4.3.15 First floor Room 6: this was most recently a bedroom. The floor is timber boards orientated north-east/south-east finished with carpet. The ceiling is plaster, sloping down to the south-west with a single purlin orientated north-west/south-east and an attic access hatch on the north-west side. The walls are finished with plaster and flock wallpaper and there is a plain skirting board throughout. The north-east elevation is essentially plain, with a doorway on the north-west side with a modern panel door in a plain surround. The south-east elevation has a projecting chimney breast on the north-east side, which tapers at the top and has a projecting corbel at ceiling level. The fireplace has an iron surround incorporating a grate and mantle piece, and has some minor moulded floral and bead decoration. The south-west elevation has a single window with a timber sill, now removed, and a two-light hinged and locking UPVC casement with applied bars to give the appearance of four lights. The north-west elevation is plain, with a missing patch of plaster showing the brickwork beneath.

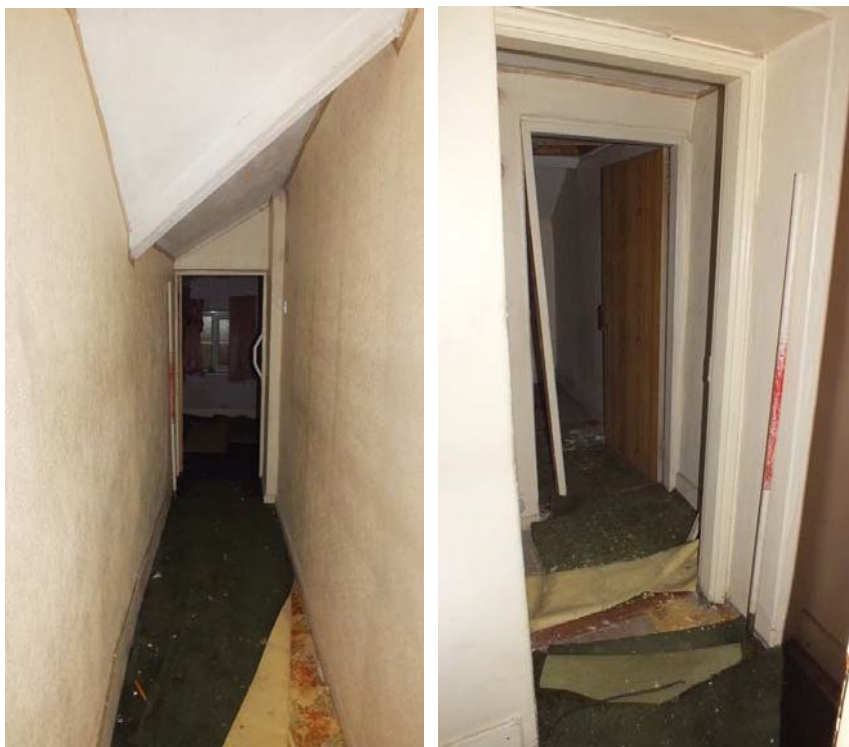
Plate 71 (left): General view of Room F7, viewed from the north-west

Plate 72 (right): Doorway in the south-west elevation, Room F7, viewed from the north-east

4.3.16 **First floor Room 7:** this comprises a long corridor orientated north-west/south-east connecting the various rooms at this end of the building to the stairs to the ground floor. The floor comprises timber boards orientated north-east/south-west with an obvious junction on the south-west side. The ceiling is plaster and mostly sloping down to the north-east but with an angle mid way along matching the roof line of the projecting section to the rear (Plate 71). The walls are finished with plaster and textured wallpaper. The north-east elevation has a doorway on the north-west side with a plank and batten door, a moulded surround, and a slight step up through what is evidently a solid masonry wall. The south-east elevation is essentially just a doorway, with a modern panel door and no surround as such, stepping down into room F9 beyond. There is a step in the wall on the south-west side, perhaps just boxing for pipes, and the south-west elevation is essentially plain apart from a doorway at the north-west end with a plain modern panel door and plain surround (Plate 72). The north-west elevation is also plain.

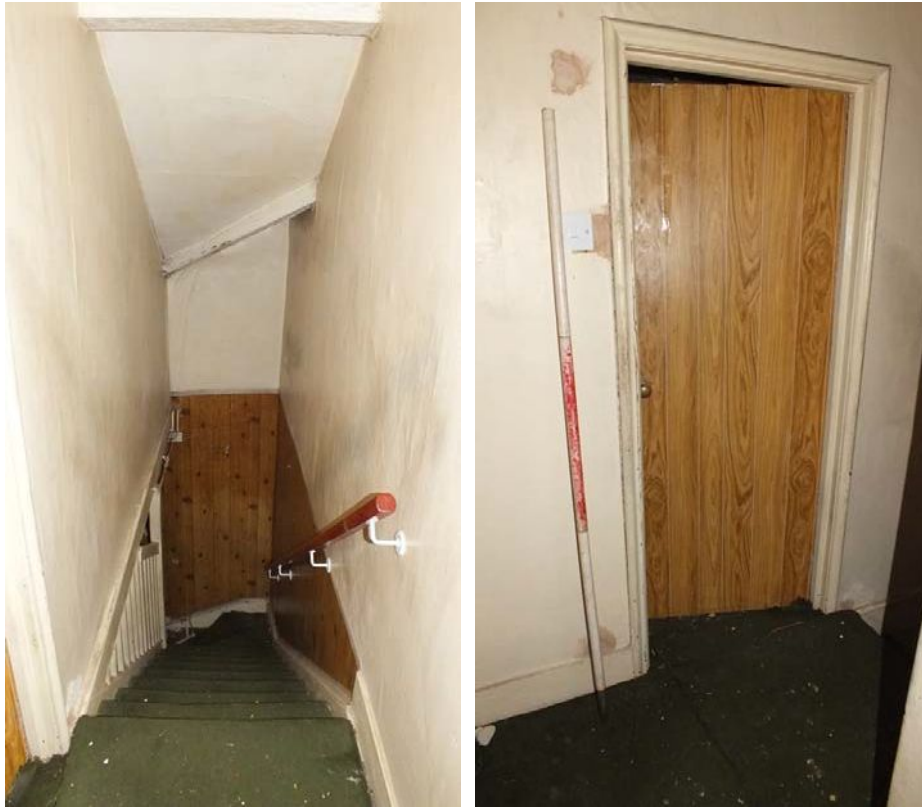
Plate 73 (left): Stair, Room F8, viewed from the north-west

Plate 74 (right): Doorway in north-east elevation, Room F8, viewed from the west

4.3.17 **First floor Room 8:** this room comprises the stairs and landing. The floor has carpet covering north-east/south-west aligned floorboards. The ceiling is plastered and slopes down to the south-east with two purlins, one following the angle of the roof to the north-east. The timber purlins are painted and the walls are plastered and painted and there is plain skirting throughout. The stairs down to the south-east are timber and there is a hand rail along the south-west side and square balusters below the handrail to the north-east (Plate 73). The north-east elevation has a doorway on the north-west side with a moulded surround and a plank and batten door (Plate 74). The south-east elevation is plain as is the south-west elevation apart from a doorway at the north-west end which has a moulded and chamfered surround but no door. There is a slight step down through the door to the corridor (room F7). The north-west elevation is also plain.

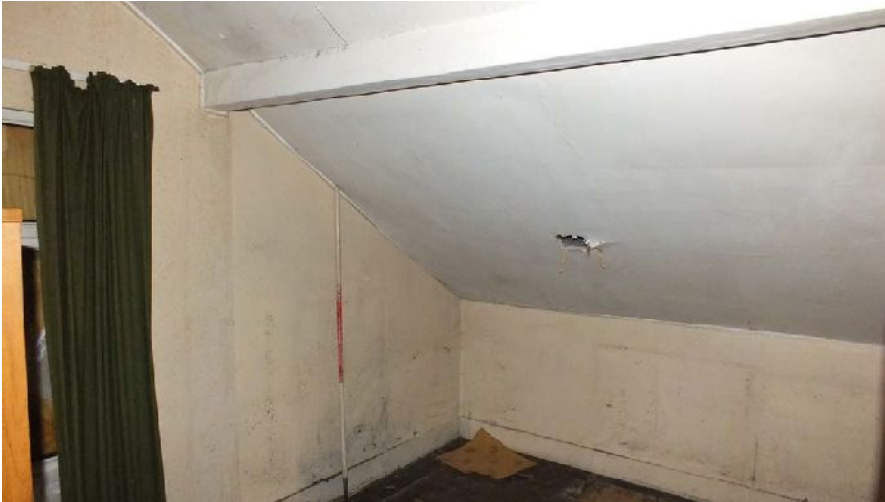
Plate 75 (left): The south-east end of the north-east and the north-east end of the south-east elevation of Room F9, viewed from the west

4.3.18 **First floor Room 9:** this room was a bedroom. The north-east/south-west floorboards are carpeted over and the ceiling is plastered and painted. The walls are finished with textured wallpaper and plain skirting. The ceiling slopes down to the south-east (Plate 75) and there is a single north-east/south-west aligned purlin close to the centre and a hatch to the attic on the north-west side of the room (Plate 78). The north-east elevation has a tall, UPVC, four-light, hinged (and locking) casement window on the north-west side with applied bars to create six-lights (Plate 76). The south-east elevation is plain and very low due to the sloping roof (Plate 75). The south-west elevation has a doorway on the north-west side with a plank and batten door and moulded surround (Plate 77). The north-west elevation has a projecting chimneybreast with fireplace and stone surround (Plate 78). The fireplace has a timber mantel with a plain iron insert with a rounded top (Plate 79).

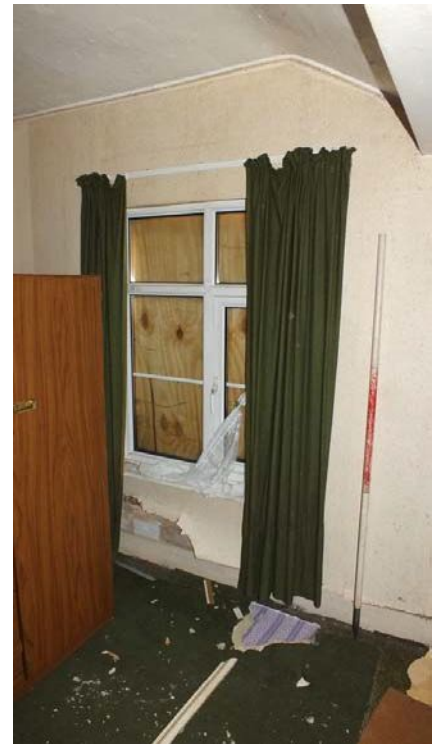
Plate 76 (right): Window in the north-east elevation, Room F9, viewed from the south

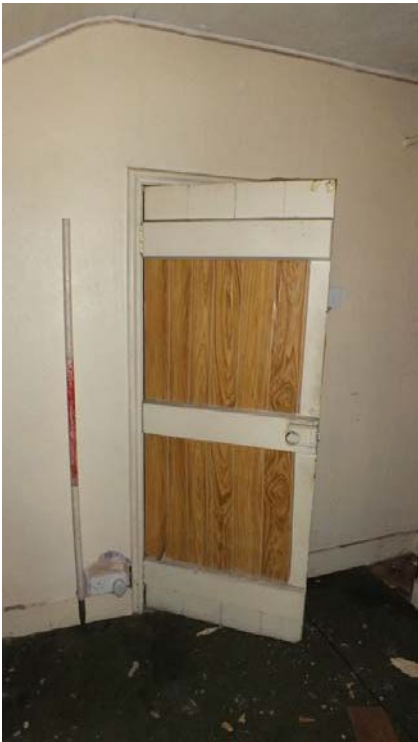
Plate 77 (left): Doorway in south-west elevation, Room F9, viewed from the north-east

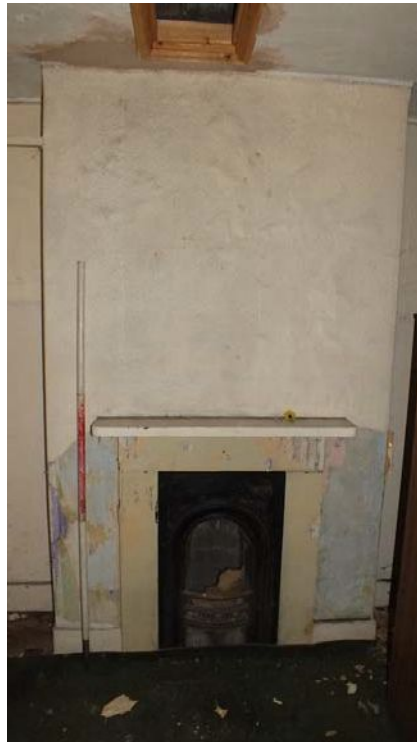
Plate 78 (centre): Projecting chimneybreast, Room F9, viewed from the south-east

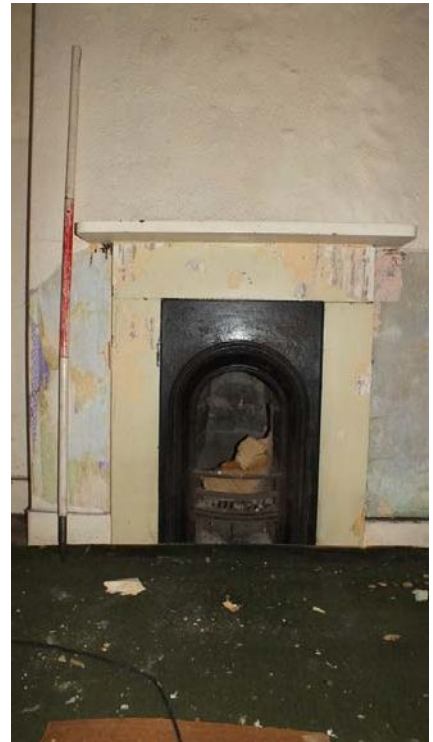
Plate 79 (right): Detail of the fireplace, Room F9, viewed from the south-east

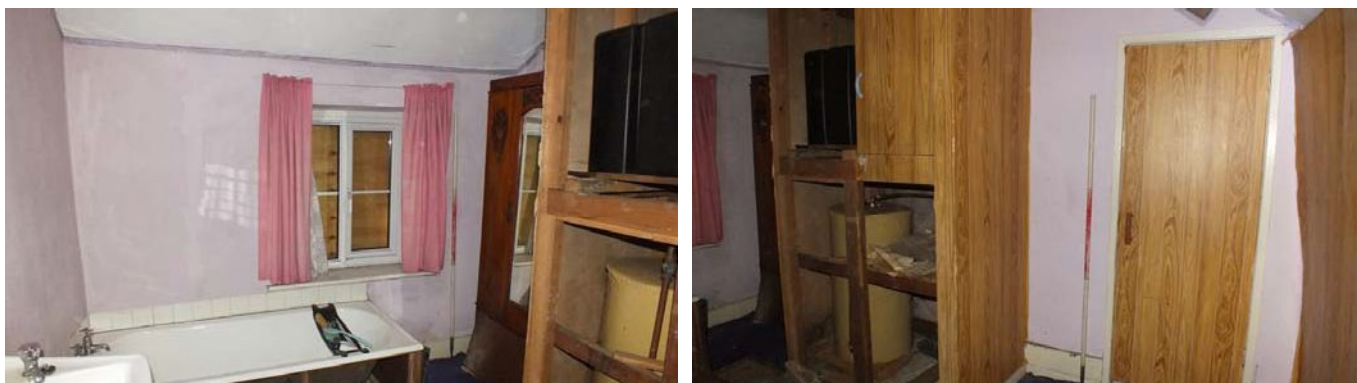
Plate 80 (left): General view of Room F10, viewed from the north-east

Plate 81 (right): General view of Room F10, viewed from the east

4.3.19 **First floor Room 10:** this was the bathroom. It has carpet covering north-west/south-east aligned boards and the bath is in the south corner (Plate 80). It has a timber airing cupboard housing a water

tank and hot water tank to the north-west (Plate 81). The north-east side is partitioned off by a piece of timber board attached to a rail fixed to the ceiling (Plate 82). The ceiling is plastered and painted and slopes down to the north-east and south-west with a large purlin on the north-east side covered by wallpaper. The walls are finished with plaster and painted and there are some tiled areas and plain skirting. The north-east elevation is plain. The south-east elevation has a window on the north-east side with a timber sill and UPVC hinged casement and locking two-light window with attached bands to make four-lights (Plate 83). The toilet and sink are to the south-west and the sink has tiled splashback. The south-west elevation has a window with a timber sill, UPVC casement, hinged and locking, two-lights with applied bands to make four (Plate 80). The north-west elevation is mostly plain but is obscured by the attached airing cupboard (Plate 81). There is a step up to room F7 through the doorway to the north-east side, which has a modern surround and a modern panel door.

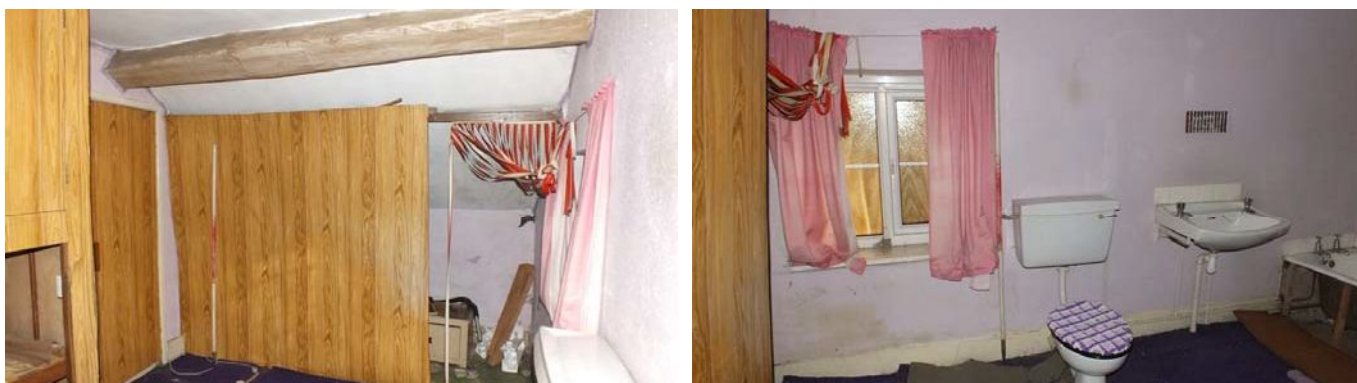
Plate 82 (left): General view of Room F10, viewed from the south-west

Plate 83 (right): General view of Room F10, viewed from the north

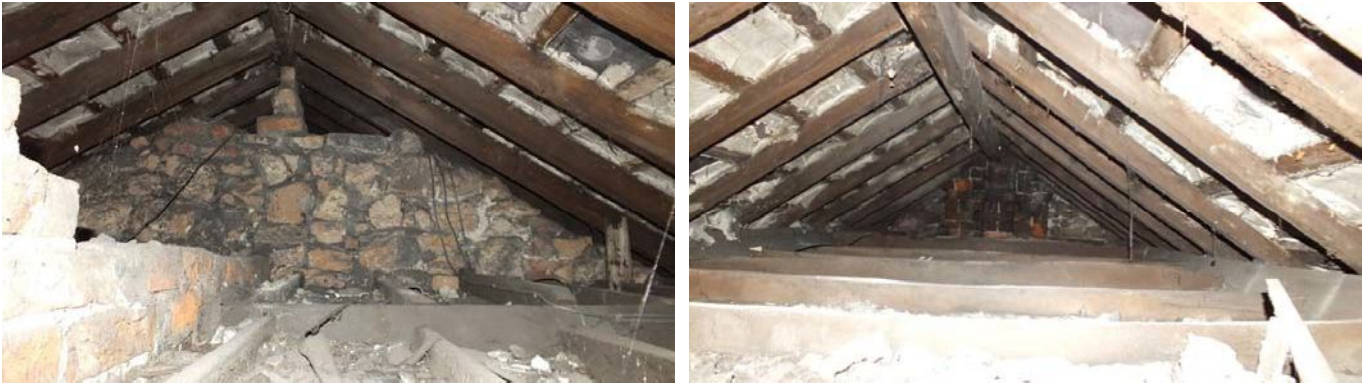
Plate 84 (left): General view of the roof space above Room F6, viewed from the south-west

Plate 85 (right): General view of the roof space above Room F6, viewed from the north-west

4.3.21 **Attic over F6 and F7:** the handmade brick dividing wall to the north-west is not full height so access is in theory possible to the space above room F3 (Plate 84). The stone wall to the north-east is truncated at the roofline. The wall to the south-east is stone but the flue is handmade brick (Plate 85). The roof timbers, just purlins and rafters but no trusses, are all machine cut.
