SLACK HOUSE COTTAGES, ST HELENS ROAD, ORMSKIRK, LANCASHIRE

Archaeological Evaluation

December 2015

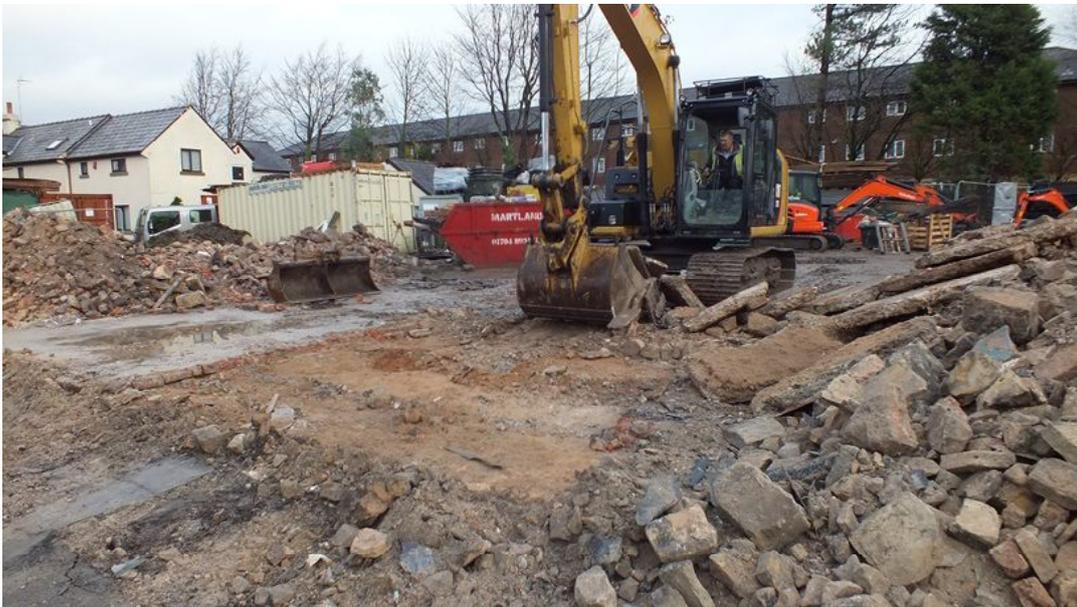
Plate 3: The concrete floor being removed

2.3.2 The concrete floor of the house was removed using a mechanical excavator with a toothed bucket (Plate 3). Bulky deposits below that were removed using a toothless bucket and subsequently cleaned and further investigated by hand. The location of each trench was recorded relative to nearby property boundaries and other structures that were evident on the site plans and Ordnance Survey mapping utilising a total station. All finds were collected from all deposits, as far as was practical. The following recording techniques were used during the evaluation:

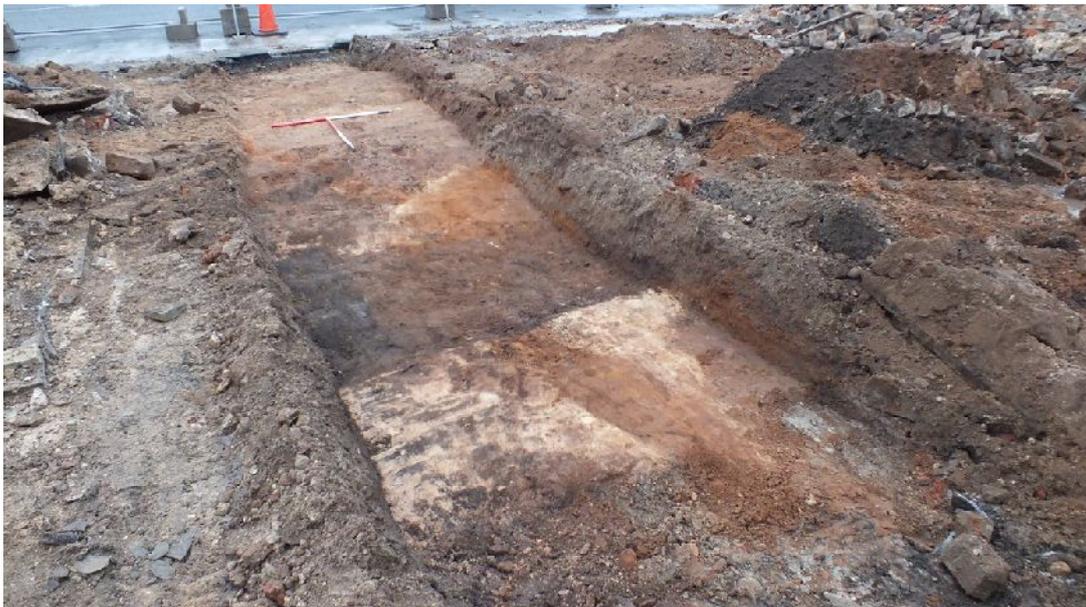
Plate 9: General view of the trench, viewed from the north-east

4.1.1 The concrete floor (**100**) of the cottage, which was not very apparent in the north-east extension to the house, was c0.1-0.15m thick. The bedding layer (**101**) below that, below the older part of the cottages at the south-west end of the trench only, was a pale reddish orange sand, up to 0.1m thick. A thin layer of soft sandy-clay (**103**) was encountered below the floor of the extension to the north-east and a soft, dark, loamy topsoil (**102**) was exposed outside the building to the south-west. The underlying geological deposits (**110**) or 'natural' layer into which the lower lying features were cut varied from a compacted, pale creamy-yellow to orange sand to a firm, dark pink clay (Plate 9). Some linear variations within the natural had the look of 'features', filled with very compacted sterile sand on the north-east side, but these were presumably caused by natural processes. The bedrock, which was exposed in places, was a pale yellow sandstone.

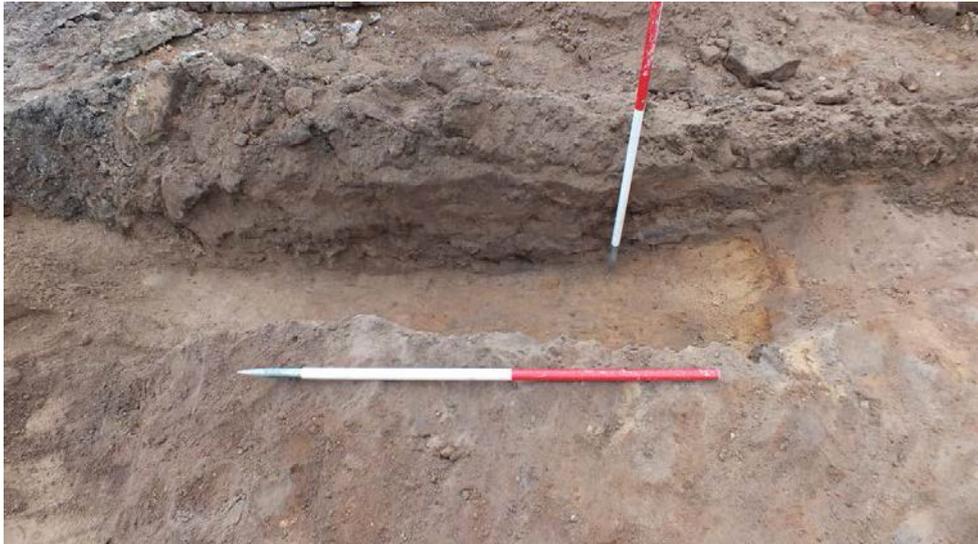
Plate 10: Sondage cut through deposit (108) and its corresponding cut [109], truncated by the wall of the cottages at the south-west end of the trench, viewed from the south-east

4.1.2 A soft, dark greyish-orange, sand (**108**), seemingly truncated by the south-west wall of the cottages, was encountered below the bedding layer (**101**), laid in a shallow cut [**109**] at the south-west end of the trench (Plate 10 and Plate 11). There was a charcoal lense towards the base of the cut (Plate 12), which was thicker where it was exposed by the wall footings to the south-west. The cut was north-west/south-east aligned, c1.8m wide and up to 0.3m deep, with a flat base and sides sloping at more than 45° on the north-east side and truncated to the south-west.

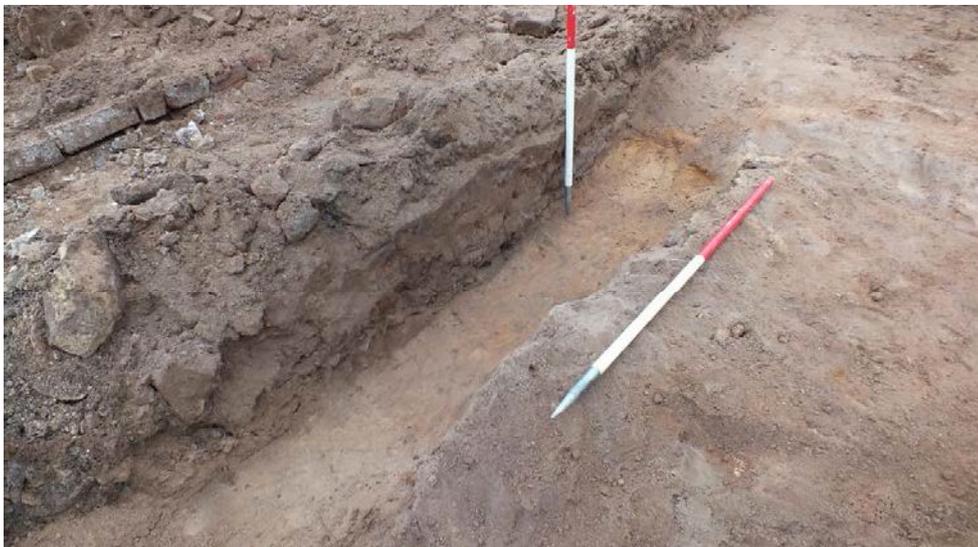
Plate 11: Oblique view of sondage through deposit 108 and cut [109] at the south-west end of the trench, viewed from the south

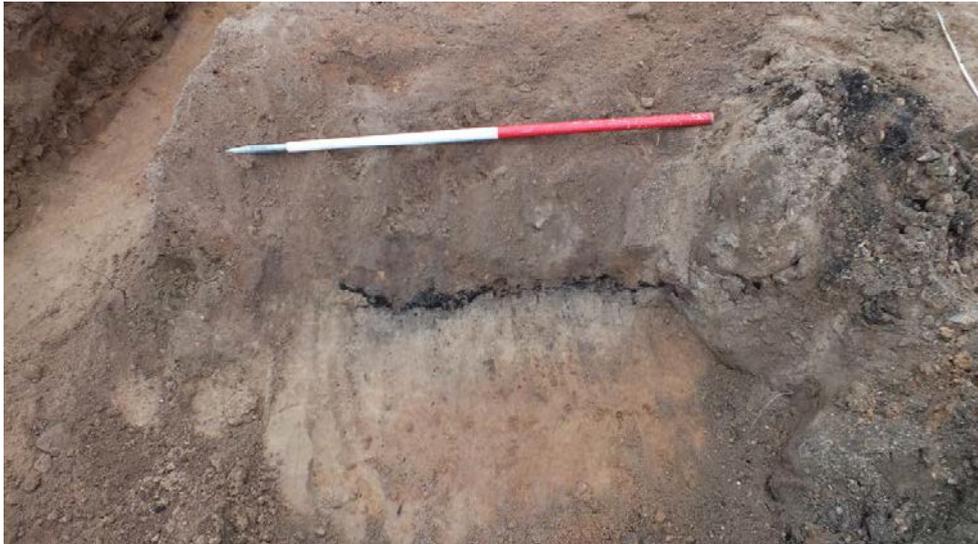
Plate 12: Charcoal lense within deposit (108) exposed where the wall of the cottage cut through it, viewed from the south-west

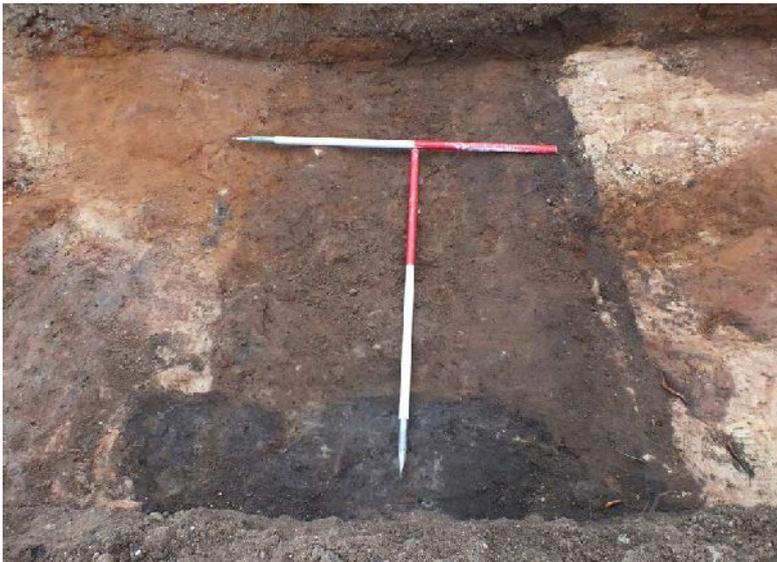
Plate 13 (left): Pre-excitation view of ditch [107] and pit [105], viewed from the south-east

4.1.3 A linear ditch [107] c1.2m wide on a north-west/south-east alignment was exposed close to the north-east end of the trench (Plate 13 and Plate 14). The south-west side of the cut sloped at approximately 40° to the horizontal and broke gently to a slightly concave base about c0.3m deep. The north-east side stepped slightly at the top and then followed the underlying bedrock (Plate 15 to Plate 17). The ditch was filled by a firm mid orange-brown loam (106) and contained small orange brick and slate fragments and infrequent sub-rounded and sub-angular stone inclusions.

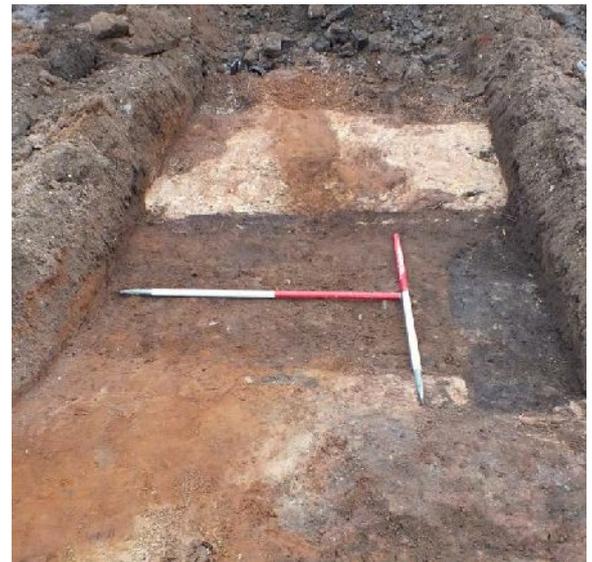
Plate 14 (right): Pre-excitation view of ditch [107] and pit [105], viewed from the south-west

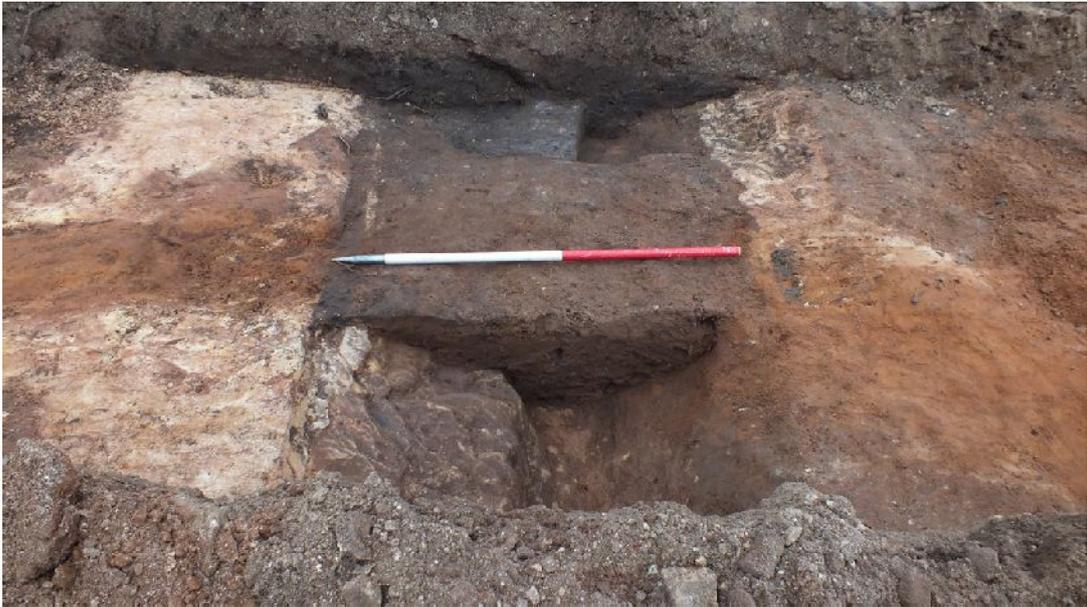
Plate 15: Section of ditch [107] and pit (105), viewed from the north-west

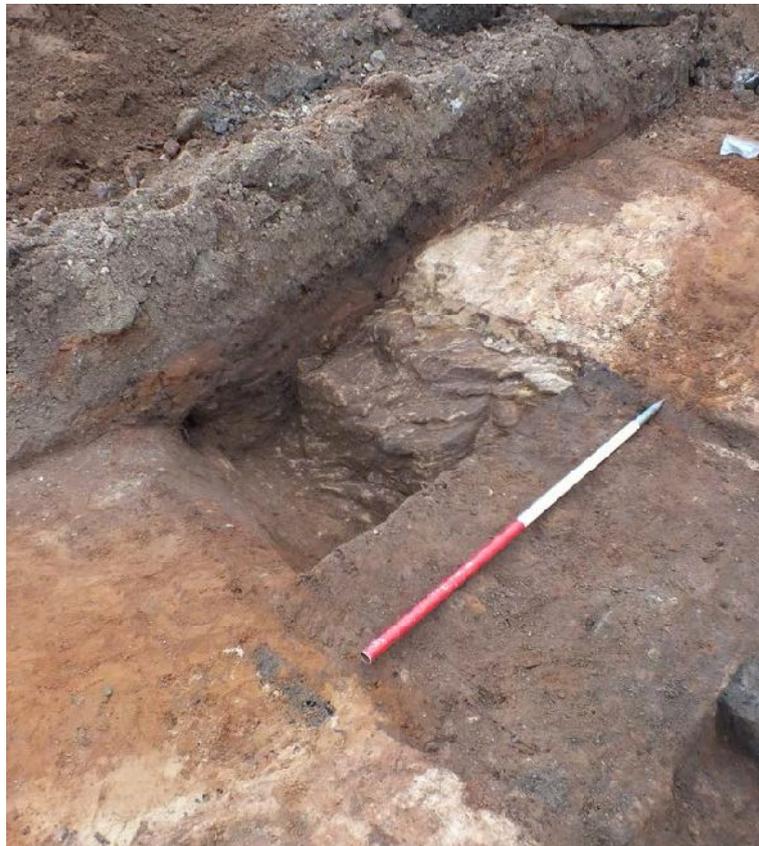
Plate 16: Bedrock exposed in the north-east side of the ditch [107], viewed from the south

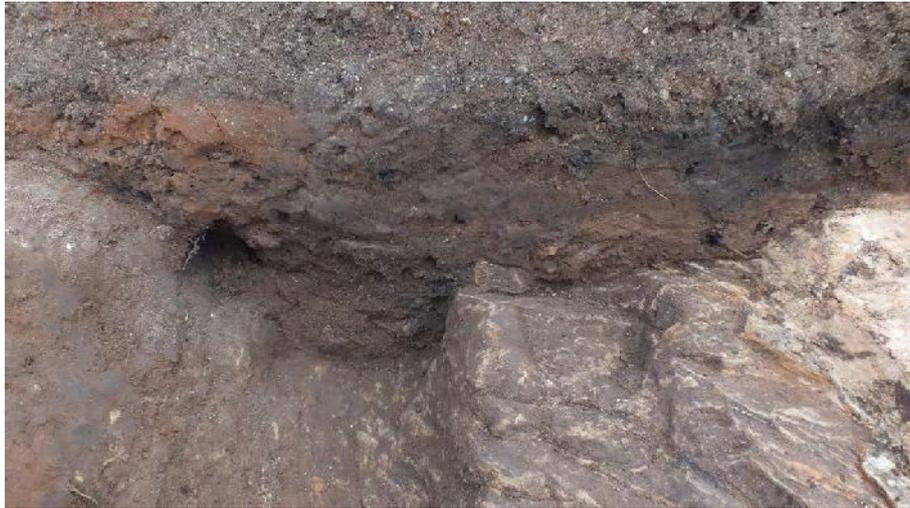
Plate 17: Close-up view of the south-east facing section through ditch 107, viewed from the south-east

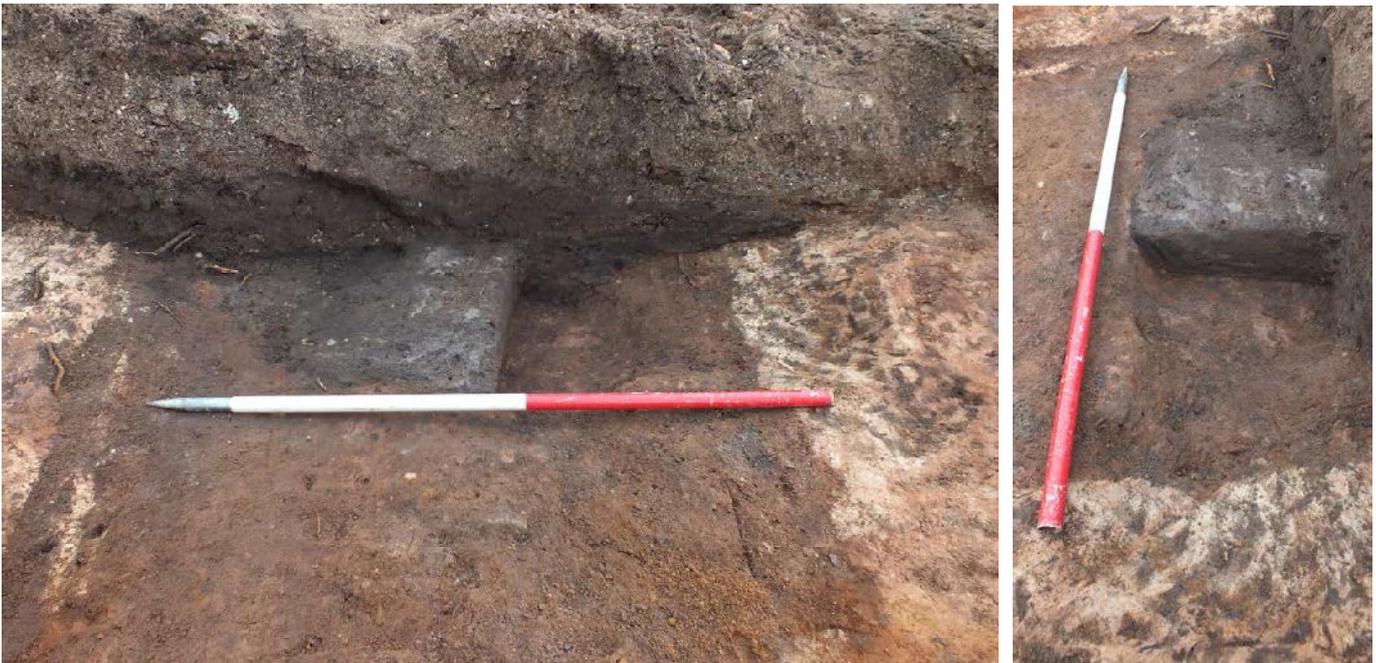
Plate 18 (left): Section of pit [105], viewed from the north-west

Plate 19 (right): Section of pit [105], viewed from the south-west

4.1.4 A shallow pit [105] to the south-east side of the trench was cut into the top of linear ditch 107 (cutting the fill of 107 (deposit 106)) and the natural (110) to the south-west of that). This pit [105] was a long oval shape, aligned north-east/south-west, c1.3m long by 0.4m wide by 0.15m deep (Plate 18). It was steeper on the north-west side and very shallow to the south-west and had an irregular base. It was filled by a soft, dark grey, sandy silt (104) (Plate 19).
