# DAVEY'S YARD, SALTHOUSE ROAD, BARROW-IN-FURNESS, CUMBRIA

## Archaeological Building Recording

Client:  
Barrow Borough Council

November 2015

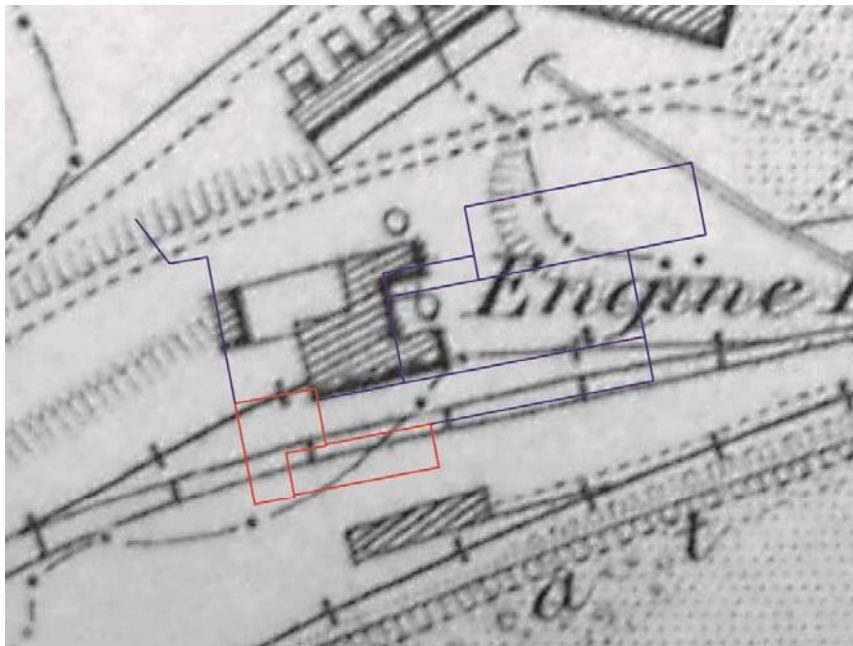
Plate 1: Ordnance Survey map 1851

3.1.2 **Ordnance Survey 1851:** this map (Plate 1) shows the location of the engine house near Barrow Station, prior to the construction of Salthouse Road. None of the buildings surveyed as part of this report had been built.

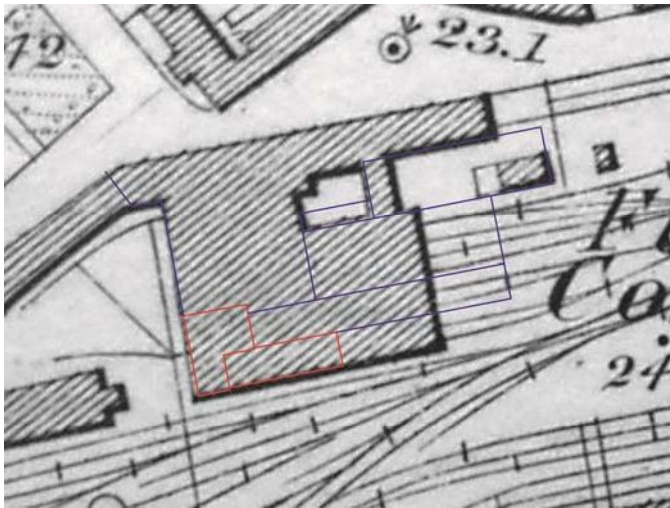
Plate 2 (left): Ordnance Survey 1:10,560 map c1873

3.1.3 **Ordnance Survey c1873:** the main road (Salthouse Road) is now shown to the north of the buildings on site, which form a square block (Plate 2). The current survey records structures marked at the south-west corner of the block in red, the previous phase of survey recorded those marked in blue. Individual buildings are demarcated on the 1:2,500 map (Plate 3) but there is some discrepancy between the two versions. The 1:2,500 map shows the western edge of the square block of buildings further to the east (along the western edge of Room G2), whereas the 1:10,560 map shows the western edge to include the footprint of Room G1 as well. The buildings form part of a much larger site labelled 'Furness Railway Company's Works', which extends to the west and south-east.

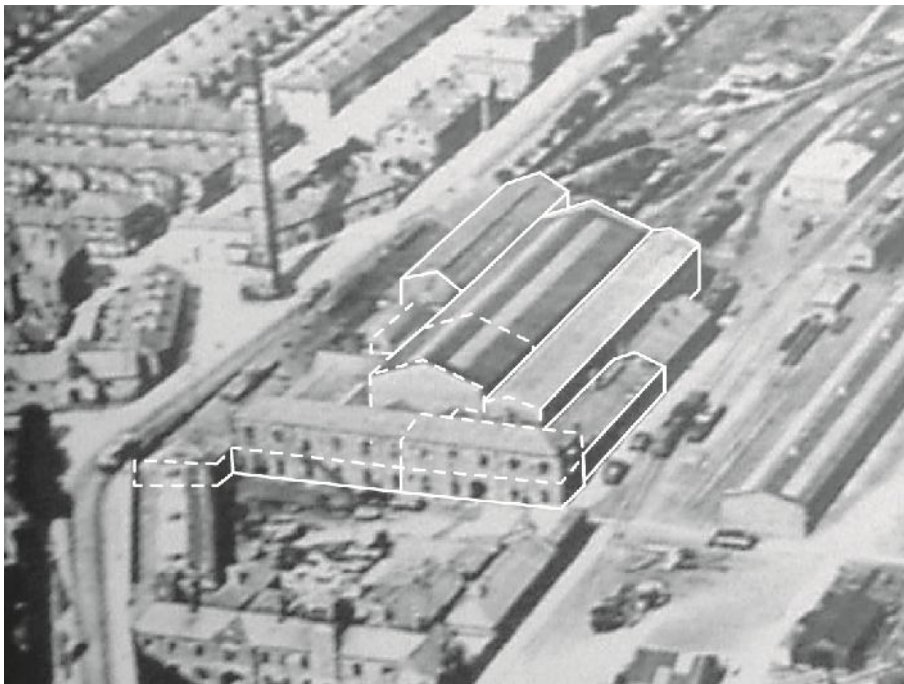
Plate 7: The Furness Railway Company Engineering Works, c1920 (after Andrews 2003, 35)

3.1.7 **Photograph of the Furness Railway Company Engineering Works c1920:** the current survey records what remains of the near corner of the block of buildings shown in this photograph (Plate 7). The white lines on the photograph indicate elements which are recorded as part of the current survey and the earlier building recording carried out in 2009 (Greenlane Archaeology 2010). The dashed lines indicate where features had been demolished prior to the building recording taking place (i.e. before 2009). The photograph demonstrates that several of the larger sheds on the east side of the site had been enlarged to their current (as of 2009) size between 1911 and this date.

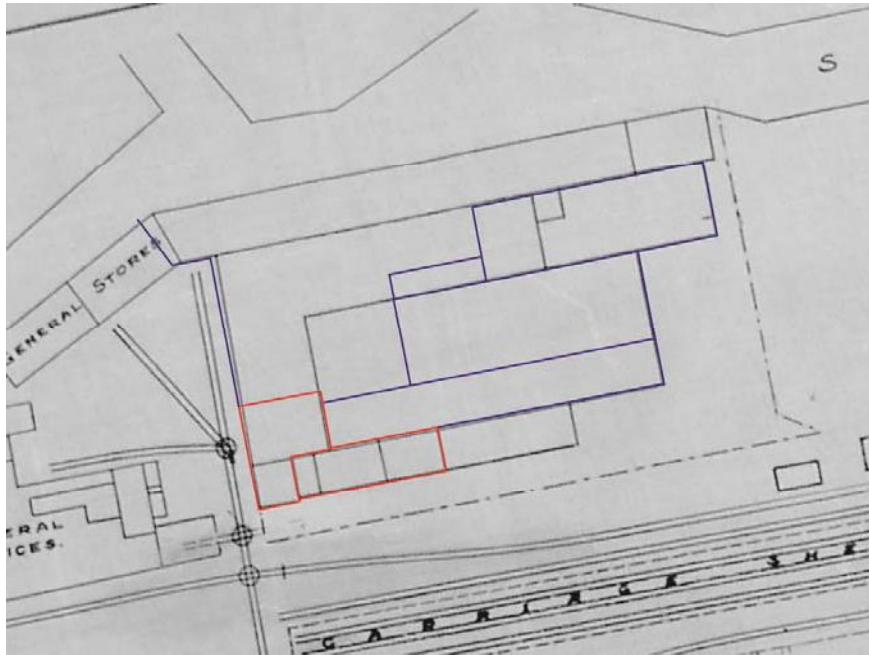
**Plate 10: Internal divisions of the buildings, 1940**

3.1.10 **Plan of Buildings – 1940 (BTBR/Bundle 10/BW 44-40 1940)**: the internal divisions of the offices and stores are shown on this plan of 1940 (Plate 10).

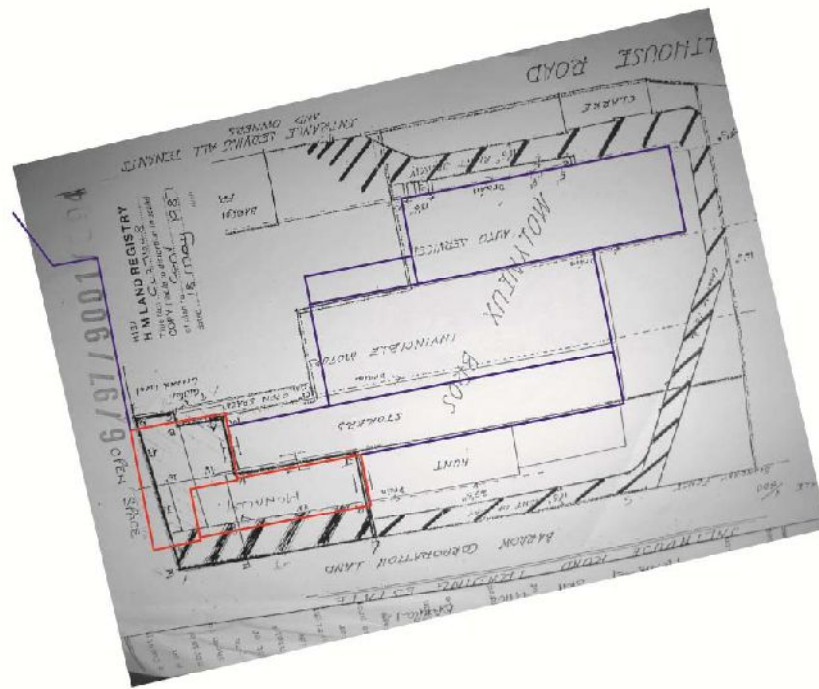
Plate 15: Plan associated with a planning application submitted in 1997

3.1.15 **Planning application no. 6/97/9001/094, 1997:** the erecting shop had clearly been foreshortened by this time. 'McNally' occupied the offices and stores and what remains of the fitting shop to the south-east corner of the block.

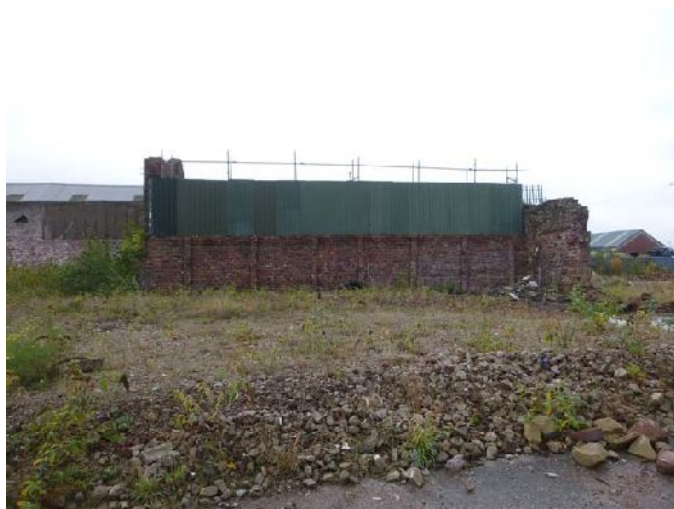
Plate 16 (left): West end of the north external elevation

4.2.1 **North elevation:** the west end is a very rough inserted brick wall, butting the stone wall to the west, which has a concrete scar for a lean-to roof on it. The brick wall is a mixture of headers and stretchers, with pillars on the north face, topped with corrugated metal sheeting (Plate 16). The elevation returns to the south at the east end of this section and continues in brick, much higher than to the west, in English garden bond in a ratio of 3:1 (Plate 17). The ends of two sawn-off trusses are visible on timber pads and there is a hole for a third. There are two doorways on the ground floor with brick pointed arches, blocked with brick, and a patch of concrete high on the west side with battens attached. The west door has a second door cut through, which is also blocked (Plate 18). The wall is topped with concrete slabs except at the east end. There is a possible butt joint at the east end but high up. The elevation returns to the south again and continues as a single wall, providing essentially an internal view of the south elevation at this point. A blocked round-headed window is visible and the wall is truncated at the east end and finished with concrete blocks (Plate 19). The lower part is whitewashed on the west side and there is a single course of brick on top.

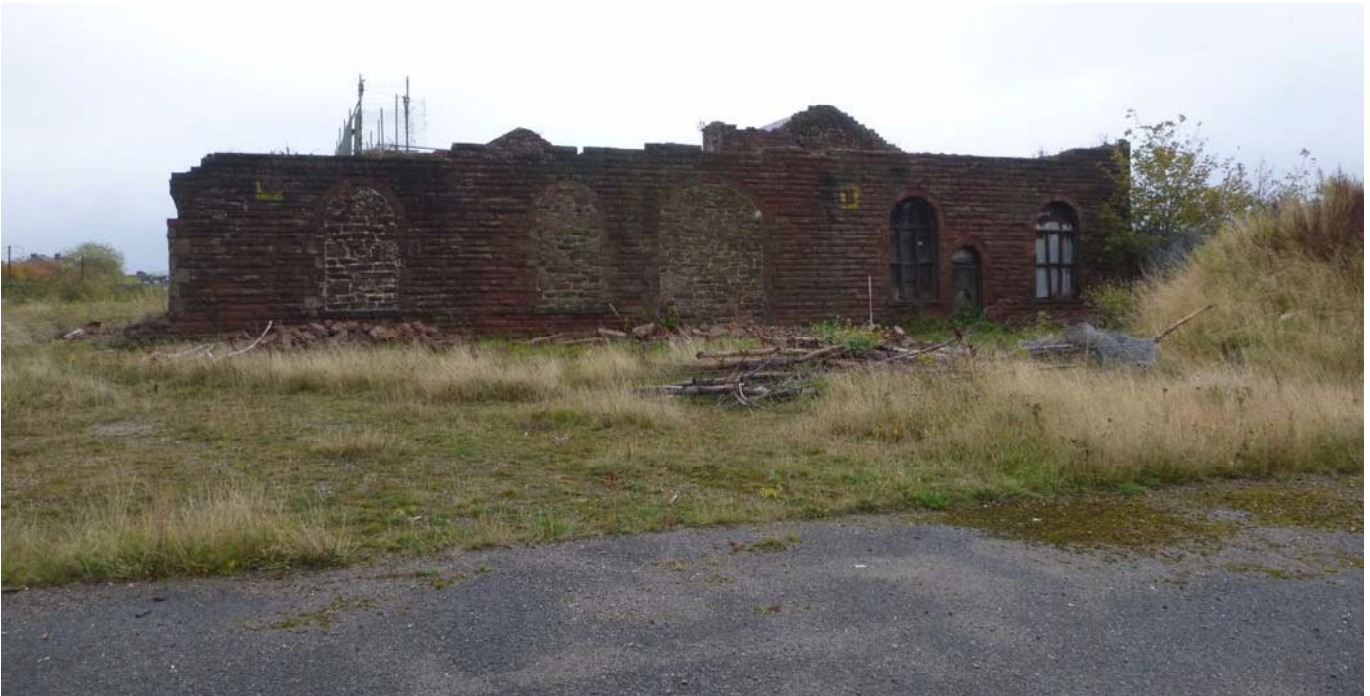
**Plate 20: West external elevation**

4.2.2 **West elevation:** the north end is truncated but was recorded as part of the earlier building recording (Greenlane Archaeology 2010). The remaining section has a row of four windows similar to those on the south elevation, with ashlar round heads, a large doorway, also with a round head, and a smaller doorway to the south sharing a jamb with one of the windows. The windows and large door to the north are blocked with stone. The windows to the south have nine-light casements (or the remains of) and the smaller door has remains of the frame and over-light but no door. The wall is constructed from relatively regular dressed courses but truncated at the top.

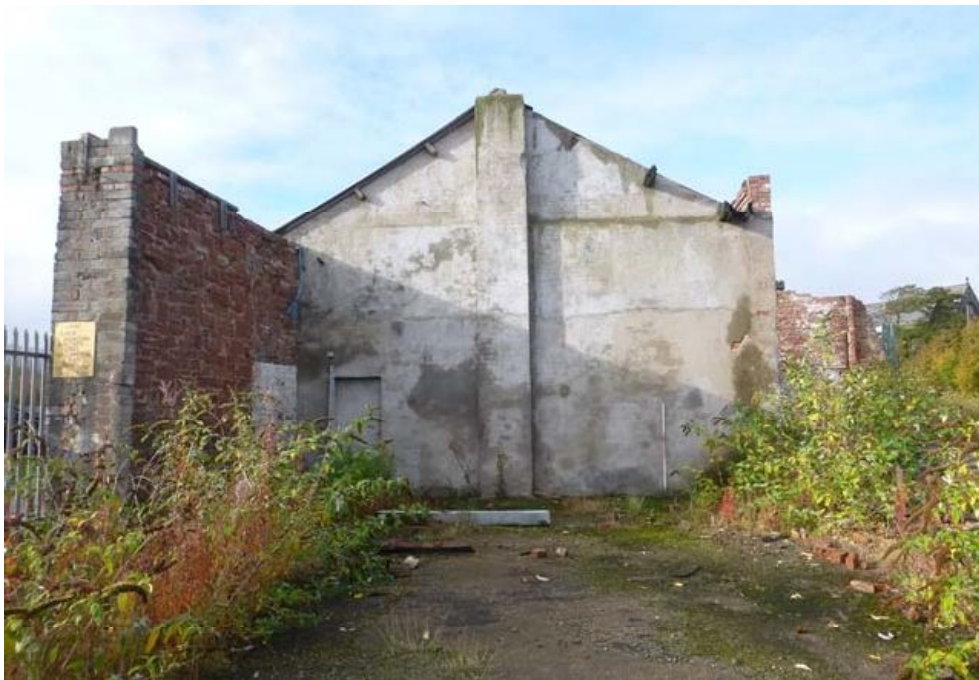
**Plate 22: South end of the east external elevation**

4.2.3 **East elevation:** the south end of the east external elevation is a brick constructed gable end, finished with concrete render (Plate 22). It incorporates a projecting flue/chimney and has a slight step along the top. There are two purlins projecting through the gable end and a gutter on the north side to the north of which the wall is raised by bricks. The doorway to the south has been blocked leaving an alcove. The north section of the elevation used to be an internal wall so has already been recorded (Greenlane Archaeology 2010). It comprises the stone gable and is raised with brick on either side and originally ran to the north with brick running east from this point (Plate 23). There are two large doorways with round heads blocked with stone, the south one of which has an alcove with a stone shelf at the bottom (Plate 24). This also has a brick-blocked opening at the top and two projecting timbers. There is a further doorway to the south, the arch of which has gone and which has been blocked with brick and timber. Large timber battens have been bolted to the wall, scarf-jointed together, with uprights below.

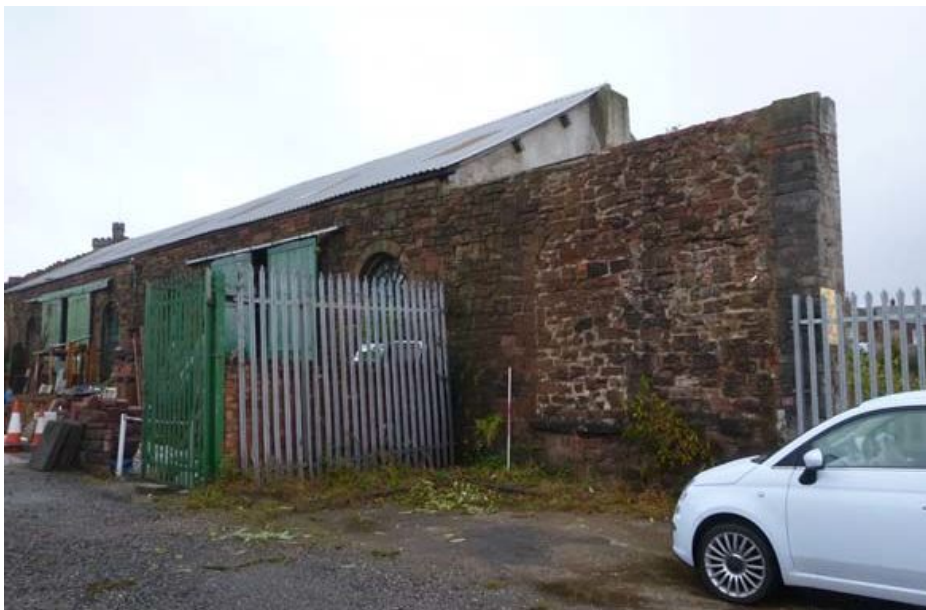
**Plate 25: Truncated wall finished with concrete block at the east end of the south external elevation**

4.2.4 **South elevation:** the east end of the south external elevation is truncated and finished with concrete block (Plate 25). This long elevation has seven tall windows, three of which are blocked, and three large doorways with sliding doors (Plate 26). The east and central doors are timber plank and batten constructions with corrugated metal (Plate 27 and Plate 28). The windows all have round heads and ashlar quoins with projecting stone sills. The east window is blocked with stone and truncated on the east side (Plate 25), the two west ones are blocked with red brick (one is visible to the left hand side in Plate 26, the other is visible to the right of the sliding door in), and the rest have intact multi-light iron casements in timber frames (e.g. Plate 29). A short distance to the south at the east end of the elevation is a large iron column, which is possibly *in situ*, with a flanged top (Plate 30). There is a small door and blocked feature at the end of the elevation before it steps out slightly to the west. The sliding door is inserted and a window is visible on the east side of it, blocked with brick (Plate 31). There is a scar of an outshut roof running above the door and a projecting slab on scrolled corbels at the top of what remains of the wall but the upper part of the wall is truncated.

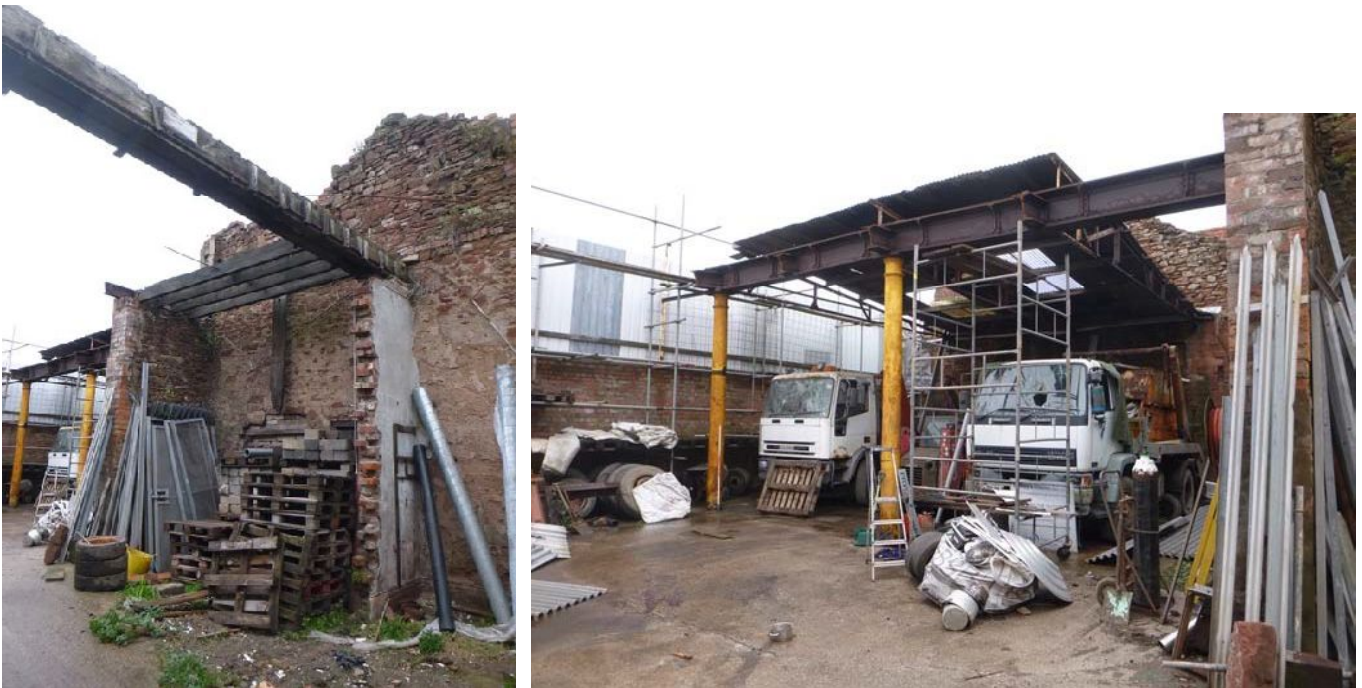
Plate 32 (left): Large east/west beam and joists on the south side of Room G1

4.3.1 **Ground floor Room 1:** this room, at the west end, is not really a room as such but comprises a number of internal and external spaces enclosed by walls. The floor is concrete slab and there is no roof or ceiling. There is a large east/west beam on the south side and some joists indicate an upper floor (Plate 32). Two columns and a heavy iron north/south I-beam with reinforcing braces in the north-east corner indicate that there was also an upper floor over this section. The columns are relatively plain, with flanged tops supporting an *ad hoc* iron framework and corrugated sheeting (Plate 33). The walls are mostly stone but the north elevation is brick topped with corrugated metal sheets (Plate 34). The brickwork is much neater on this side than the north side, and mostly stretcher bond with occasional rows of headers. The north end of the east elevation forms the gable end, raised with brick on either side (Plate 35 and Plate 36). There are two large doorways with rounded tops blocked with stone and another smaller doorway on the south side.

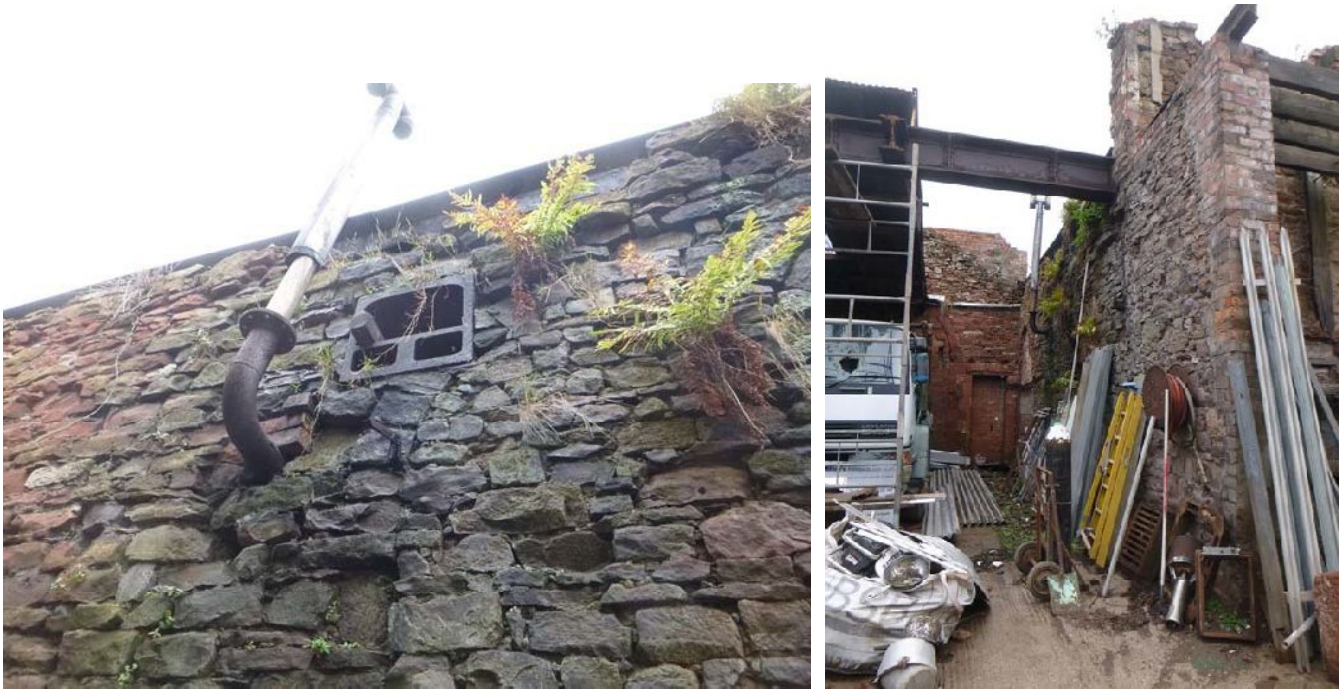
**Plate 37 (left): Iron bearing box and blocked feature in the east end of the south elevation of Room G1**

4.3.2 The smaller doorway is inserted, with brick in the jambs and a timber lintel, and blocked with brick leaving an alcove (Plate 36). There is a block of masonry forming a buttress between the large doors. The wall returns to the west at this point, forming part of the south elevation (Plate 36). This section is stone in very rough courses. There are two round-headed windows in the east side, both of which are blocked. The east one is blocked with brick leaving a small alcove (Plate 36); the west one is blocked with stone (Plate 37). An iron bearing box cuts through the arch of the one to the west (Plate 37).

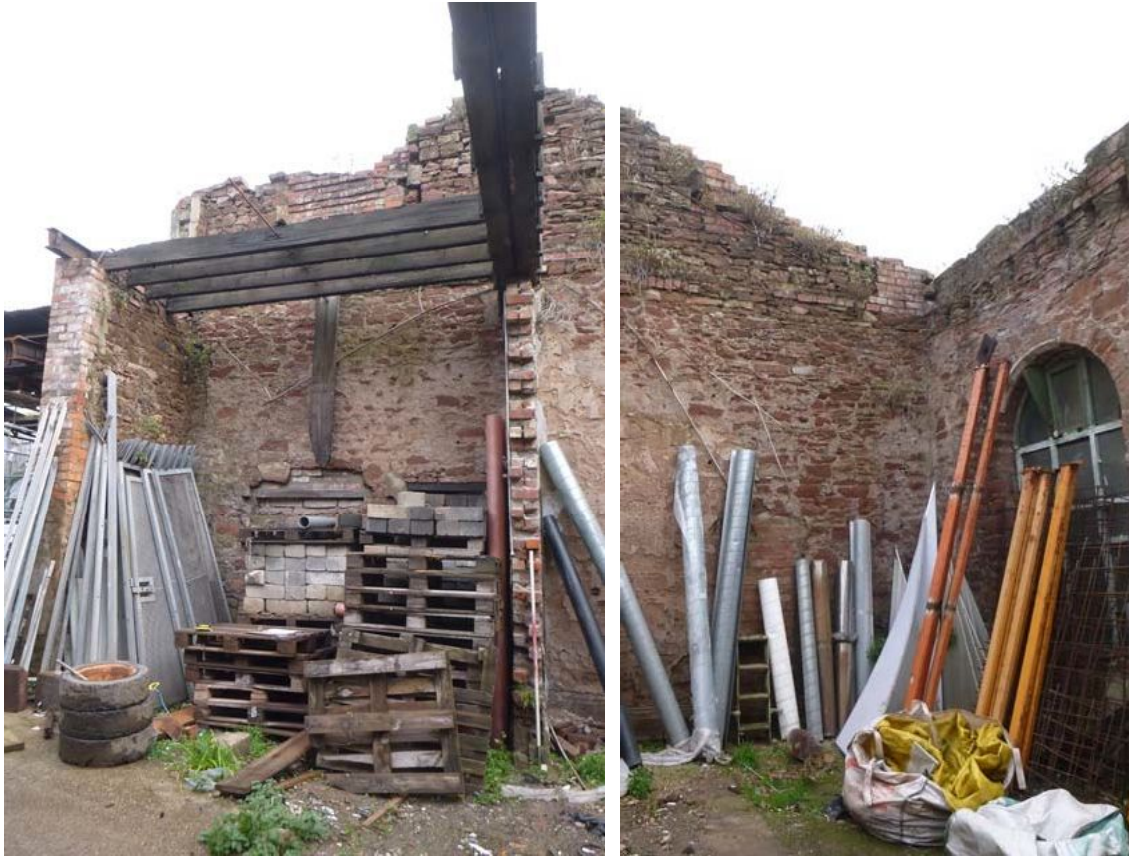
**Plate 39 (left): South end of the east elevation of Room G1**

4.3.3 The remainder of this section of wall is truncated at the west end and finished with brick (Plate 38). Here it returns to the south and continues as the south end of the east elevation (Plate 39 and Plate 40). There are two rough doorways on the north side which are blocked with a mix of concrete block and brick, with timber lintels (just visible behind the pallets and bricks in Plate 39). There are truncated remains of a wall to the south (Plate 41) then a further door blocked with brick (Plate 40). The stub of the partition wall in this section has remains of plaster, including cornice and skirting (Plate 41), both moulded, and wall paint (Plate 42). The wall top has lots of brick and possibly two remnants of windows.

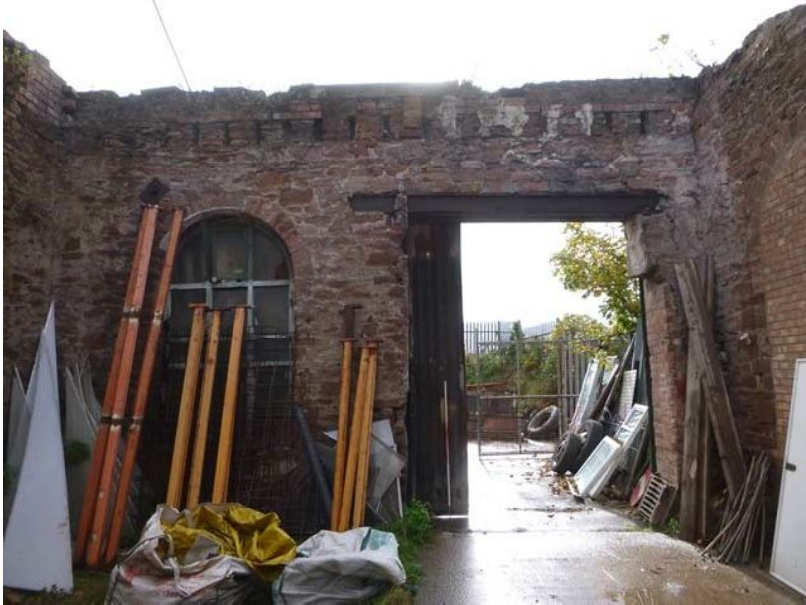
**Plate 43 (left): West end of the south elevation of Room G1**

widened on the west side, and has iron I-beam lintels (Plate 43). The angled masonry in the south-west corner with a wider base formed a flue (Plate 44).

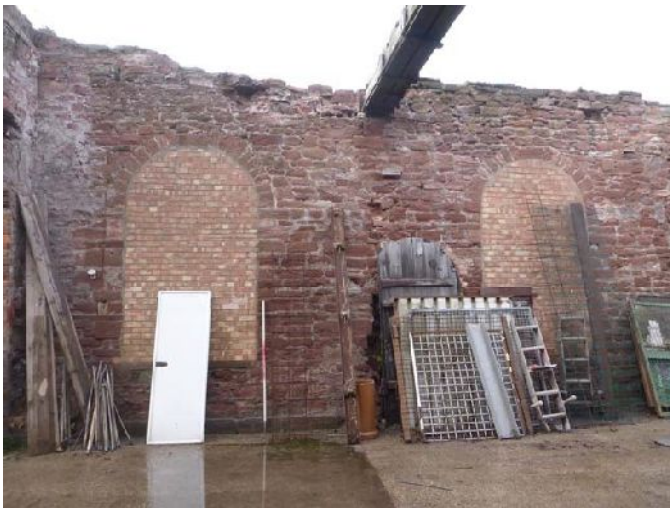
**Plate 45 (left): South end of the west elevation of Room G1**

4.3.5 The two round-headed windows at the south end of the west elevation are blocked with buff brick (Plate 45) and built more roughly internally than outside. The doorway between also has a round head and, although the jambs are damaged, the door might still be *in situ* just behind the board covering it. The large opening to the north of these is blocked with stone and there are another two blocked windows to the north of that also blocked with stone (Plate 46).

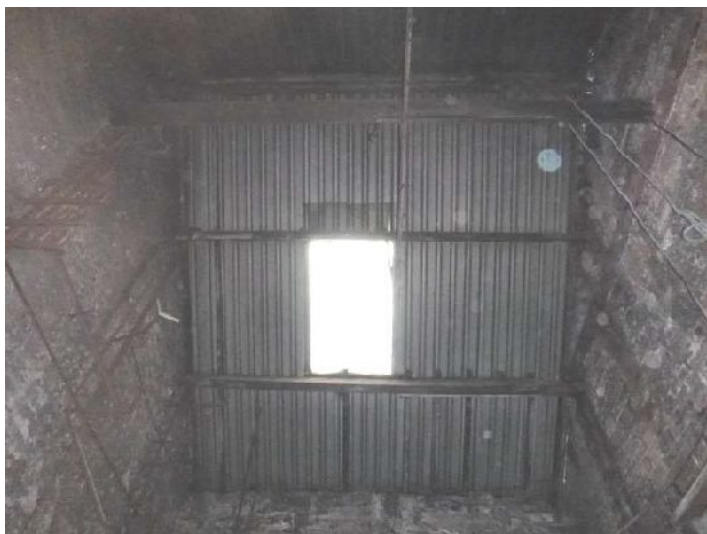
**Plate 47 (left): Corrugated sheet roof of Room G2**

4.3.6 **Ground floor Room 2:** this room has a concrete floor and is open to the modern corrugated metal sheets of the roof on two purlins per pitch with a ridge purlin (Plate 47). The joists from the first floor remain on the south side where it still forms the ceiling over the two small rooms below. The east side of the south elevation is timber stud wall and the west side is brick with a doorway with a chamfered surround (Plate 48). The south-east room also has a doorway with a plain surround and rough window and there is a spiral iron staircase against the west elevation leading to a small surviving section of the

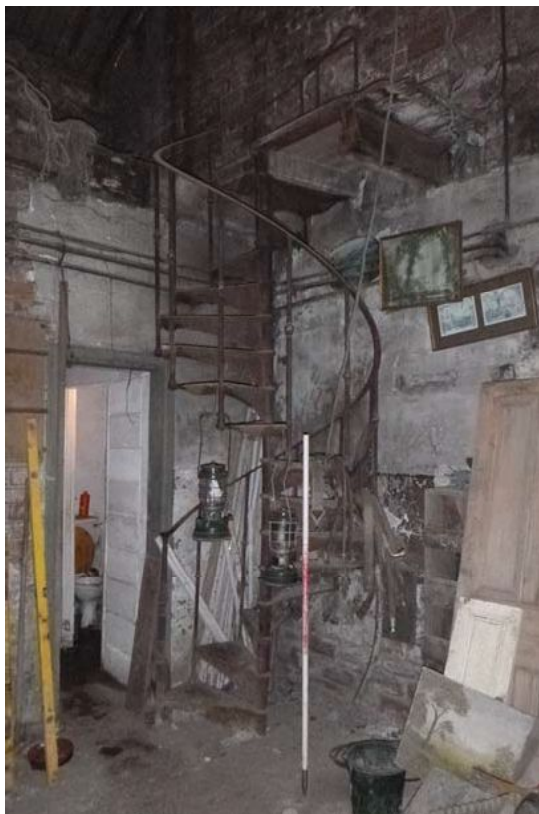
**Plate 49 (left): Spiral staircase against the west elevation of Room G2**

first floor (Plate 49 and Plate 52). The stairs have a decorative post but are otherwise fairly plain. Inside the south-east room the floor is finished with vinyl and the walls are plastered. There is an alcove in the south elevation which was probably a former window. The south-west room is divided in two by concrete blocks into a room with a toilet and a room with sink, both of which are attached to the south wall. The wall of the floor above is stone.

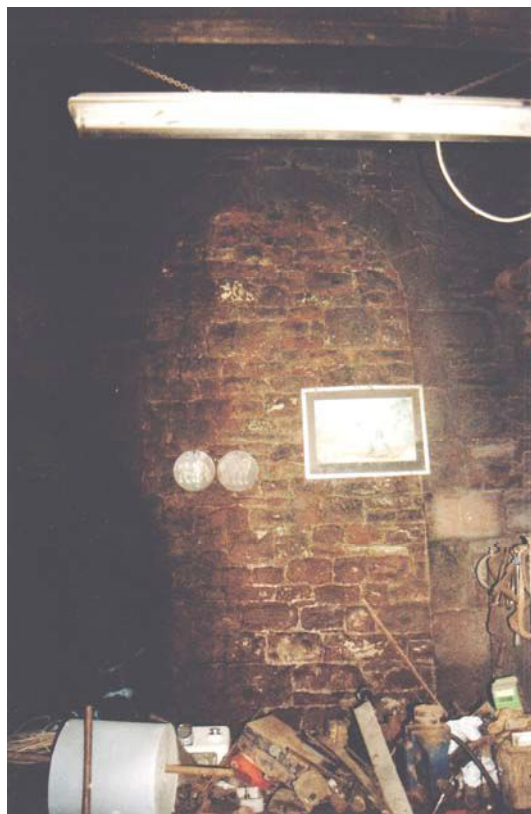
**Plate 50 (right): North elevation of Room G2 showing blocked doorway**

4.3.7 The north elevation is dominated by a large doorway with a round head and ashlar quoins with an iron pipe passing through on the east side forming a flue from the stove below (Plate 50). The east wall butts the north. The east elevation has a rough plaster finish throughout, with joist holes denoting the first floor level and attached metal shelving at first floor level above. The doorway on the north side is

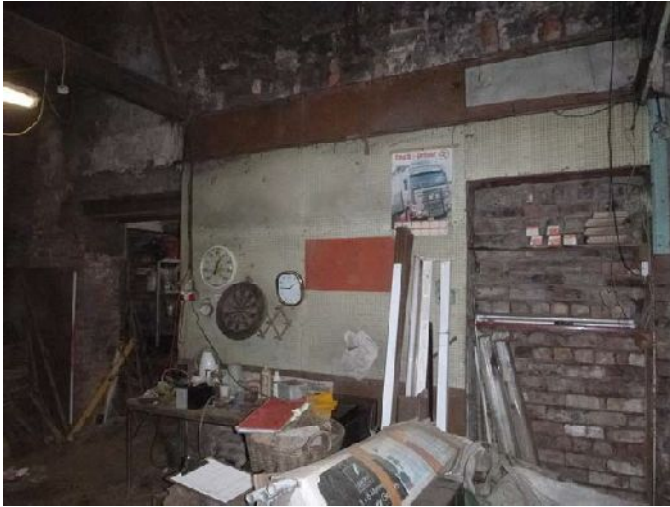
Plate 51 (left): The east elevation of Room G2

inserted and has an iron I-beam lintel and brick in the jambs. There is a further doorway to the south, which is possibly also inserted, which is blocked with brick to leave an alcove (Plate 51). The west elevation has joist holes at first floor level and is plain above (Plate 52). There is some plaster below and the remnants of the original paint scheme. There are two blocked openings filled with concrete block or brick to the north.

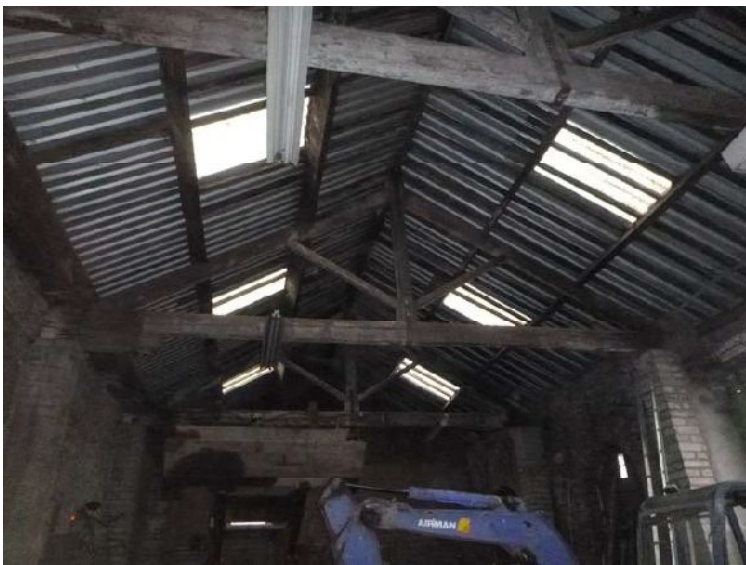
Plate 53 (left): Trusses in Room G3

4.3.8 **Ground floor Room 3:** this room has a brick floor with some concrete at the east end stepping down. It is open to the roof, which is supported by three trusses, each a king post truss with angled braces (Plate 53). The king posts are strapped to the tie beam with an extra bracket below the north end of the central truss and pillars of concrete blocks support both ends of all three. There are two purlins per pitch and a ridge plank and a large timber gutter along the north side.

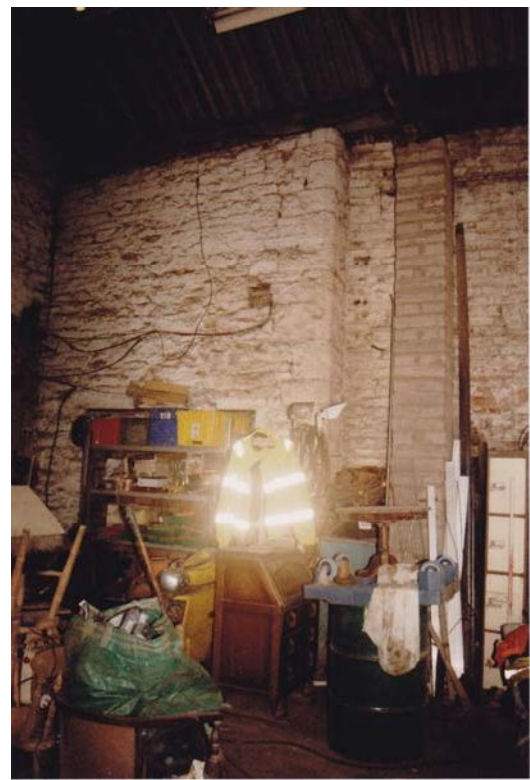
Plate 54 (right): West end of the north elevation of Room G3

4.3.9 The walls are mostly whitewashed stone. The north elevation is stone at the west end with a wide doorway, which is probably inserted, with an iron lintel and brick blocking leaving an alcove (Plate 54). The return is chamfered and the wall to the east is brick in English garden bond at 3:1 with three concrete pillars below the trusses and a doorway at the west end with a pointed brick arch cut for another door, both of which are blocked (Plate 55). There must be a second door to the east, which is visible from the north side, but it is obscured by shelving internally (see *Section 4.2.1*). There is a truncated returning/cross wall at the east end (see Figure 2). The lower part of the east elevation is concrete block, the upper section is plywood, and there are concrete block pillars at either end (Plate 56).

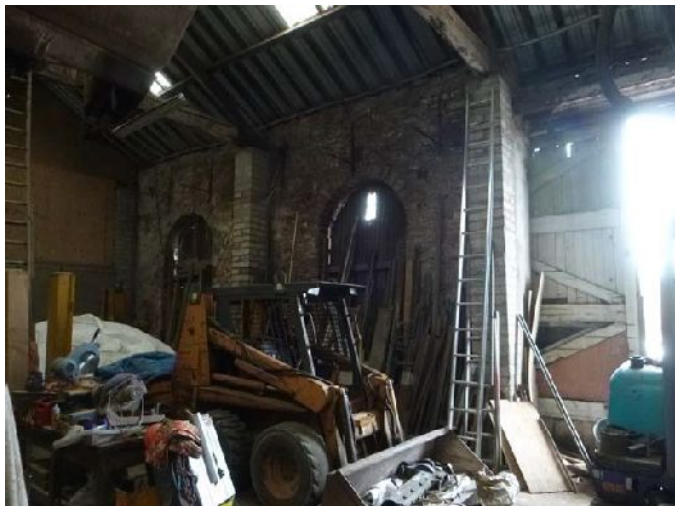
**Plate 57 (left): East end of the south elevation of Room G3**

4.3.10 The south elevation has two windows on the east side, with round heads, covered by corrugated metal sheeting and with a concrete block pillar in between (Plate 57). The wide doorway to the west of centre has sliding timber plank and batten double doors and is presumably inserted and there is a further window to the west, which is the same as those to the east (Plate 58).

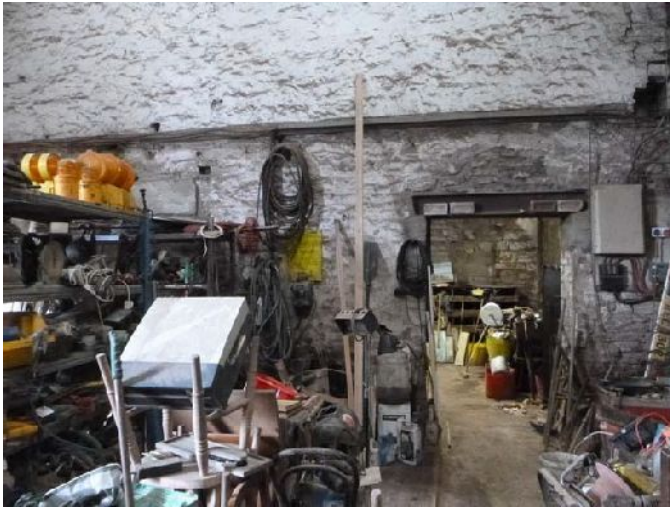
**Plate 59 (left): North end of the west elevation of Room G3**

4.3.11 The west elevation is mostly plain, with a blocked doorway on the south side and patchy plaster and an inserted door to the north with an iron I-beam lintel (Plate 59). There is a large threshold stone in the centre of the large door to the west in the south elevation, which is presumably original but not for this door (Plate 60).

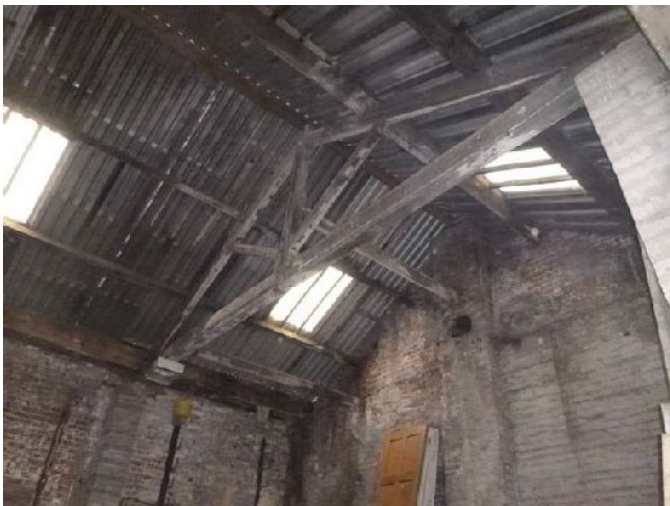
**Plate 61 (left): Truss in Room G4**

4.3.12 **Ground floor Room 4:** the concrete floor is stepped up in the north-east corner with vinyl tiles and the room is open to the roof. The trusses are the same as those in Room G3 as this is a continuation of what was originally one larger room. There are two trusses, one against the west wall and one near the centre. Both are king post trusses, with angled braces, two purlins per pitch and a ridge plank, supported on concrete block pillars at either end (Plate 61) and there are additional timber supports under the west one on the north end, and an iron brace strapped between each tie beam and king post. The north elevation is brick laid in English garden bond in a ratio of 3:1 with concrete block columns set against it and, as in Room G3, there is a timber gutter along the top (Plate 62). The east elevation is also brick laid in English garden bond in a ratio of 3:1 (Plate 63) with a projecting flue in the centre raised off the ground (Plate 64). The base of the projecting flue is corbelled (Plate 64) and there is a step in the wall near the top.
