# LOWTHER CASTLE, PENRITH, CUMBRIA

## Archaeological Watching Brief

Client:  
Lowther Castle and Gardens  
Trust

© Greenlane Archaeology Ltd  
February 2016

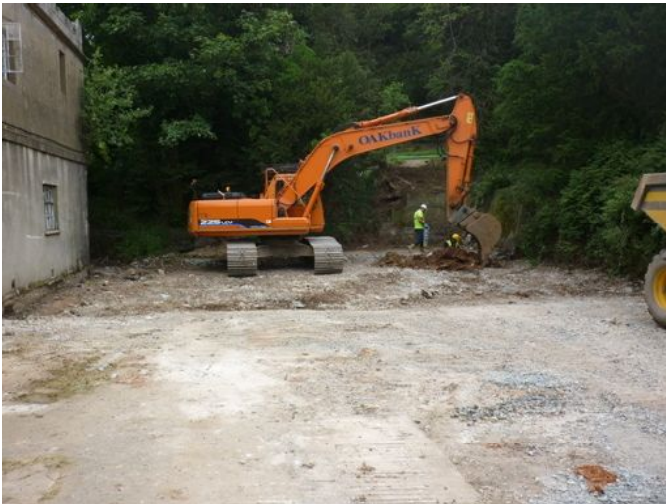
**Plate 1 (left): The concrete forecourt to the south-east side of the Coach House (Area A)**

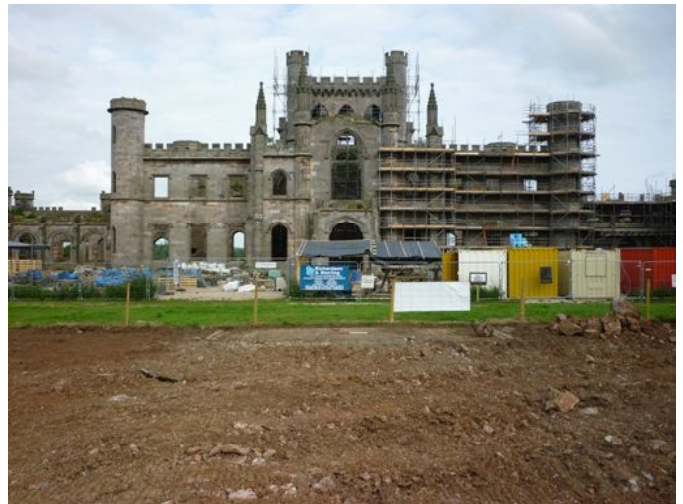
**Plate 2 (right): Topsoil stripped from the South Lawn**

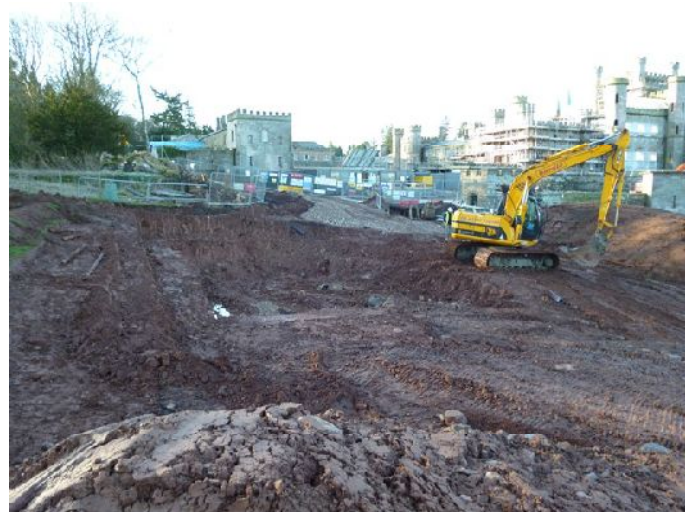
**Plate 3: Area to the north of the Stable Courtyard (Area B)**

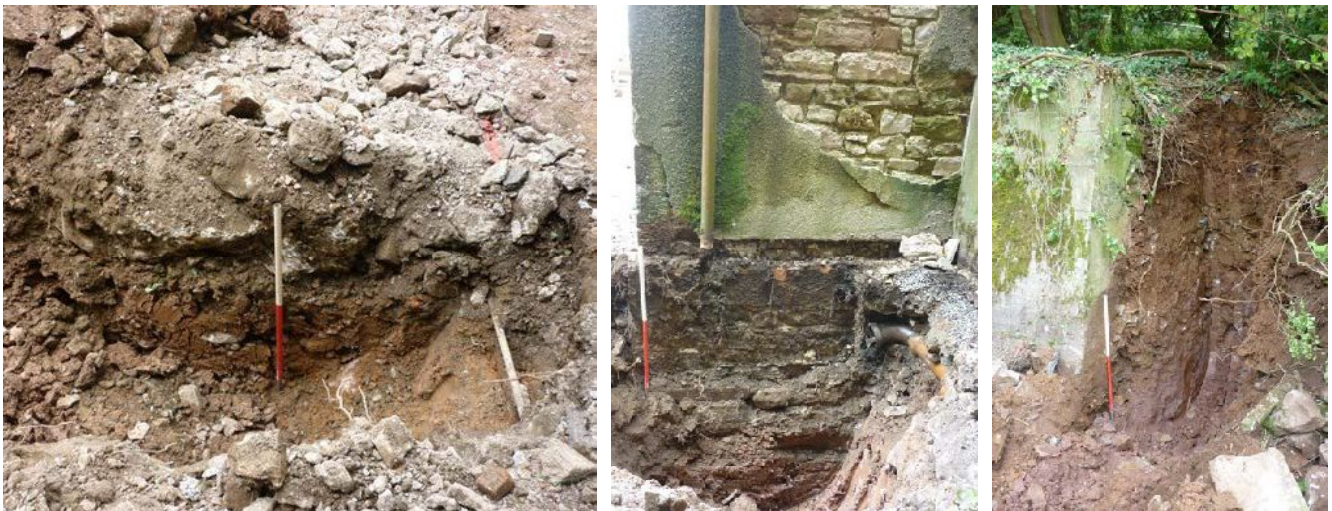
4.2.1 **Area to the south-east of the Coach House (Area A):** removal of the concrete surface revealed a layer of rubble (**100**) up to 0.6m thick above very firm red clay (**102**) (Plate 4). This clay layer (with some minor variation) continued to the depth of the excavation which was stopped at a depth of approximately 1.9m below the original ground level. The rubble layer contained late post-medieval and modern finds (see *Section 4.3.3* and *Appendix 3*). A cable along the south-east side of the Coach House was exposed in a trial hole and another small trial hole against the corner of the Coach House revealed a large ceramic drain pipe (Plate 5). The large coarse gritty sandstone or gritstone blocks of the Coach House continued to a depth of 0.9m then stepped out slightly before continuing another 0.4m into the red clay. A slot was also extended to the south-east of the area at the limit of the concrete skim of the retaining wall on the south-east elevation. The retaining wall extended up to 0.9m into the firm reddish-orange to red clay of the embankment to the south-east (Plate 6).

**Plate 4 (left): Clay layer exposed below the layer of rubble**

**Plate 5 (centre): The footings of the Coach House exposed**

**Plate 6 (right): Section of the retaining wall and embankment**

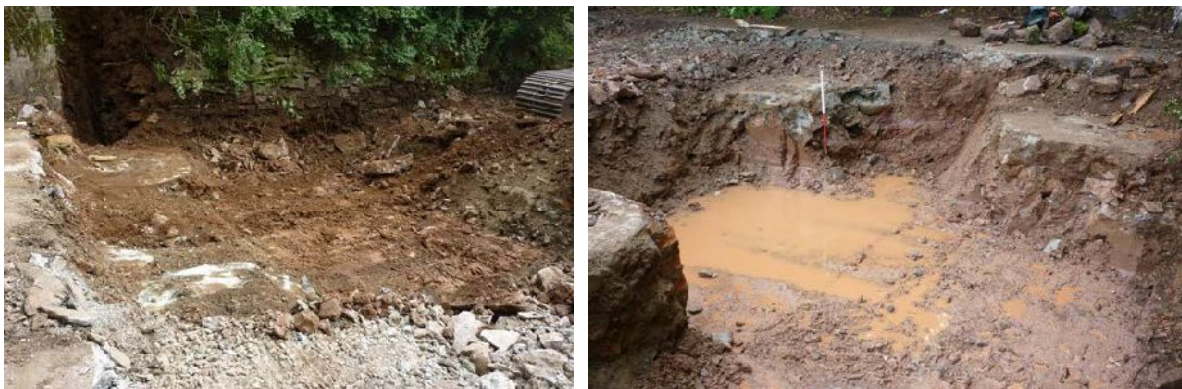
4.2.2 Excavation of a large rectangular area to the south-east of the area exposed four large concrete stanchions (Plate 7 and Plate 8), three of which were running parallel and up against the south-east retaining wall and the fourth of which was positioned perpendicular to the others a short distance to the north-west at the north-east end of the row of three (Figure 2). All of the stanchions were at roughly the same level below the concrete and rubble and those which it was possible to observe during the course of the groundworks had steel attachments on the top. The foundations included cement filled paper bags marked 'Ribblesdale' (Plate 9).

**Plate 7 (left): Concrete stanchions (to the left) and retaining wall (to the rear)**

**Plate 8 (right): Foundation of the concrete stanchions below the concrete surface**

5.1.1 **The area to the south-east of the Coach House (Area A):** the concrete stanchions show that a building stood on the site of the concrete forecourt to the south-east of the Coach House at some point in the 20<sup>th</sup> century; more specifically, it was probably built at some point between the 1930s and the 1980s and seems likely to have served as part of a boiler house. The brick-built structure is likely associated with these other structural elements and might have been an inspection pit located inside the building.

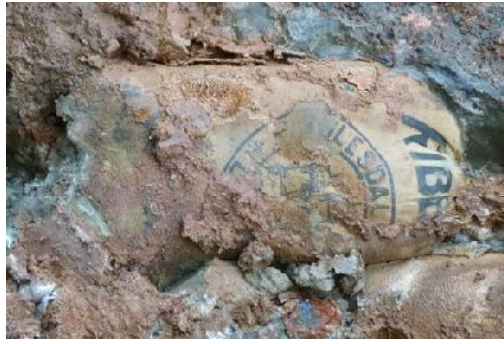
**Plate 9: 'Ribblesdale' cement sack from the foundations of the concrete stanchions**

4.3.3 The finds recovered from the rubble deposit within Area A (**100**) were all fairly late post-medieval in date and included modern items, such as a plastic comb from the late 20<sup>th</sup> century (see *Appendix 3*). Paper sacks of 'Ribblesdale Cement' used in the foundation of the concrete stanchions date from between the 1930s and the 1980s; Ribblesdale Cement was formed in the 1930s in Ribblesdale, near Clitheroe, and was amalgamated with Ketco Cement and Tunnel Cement to form Castle Cement in the 1980s, which was rebranded as Hanson Cement in 2009 ([http://en.wikipedia.org/wiki/Hanson\\_Cement](http://en.wikipedia.org/wiki/Hanson_Cement)).

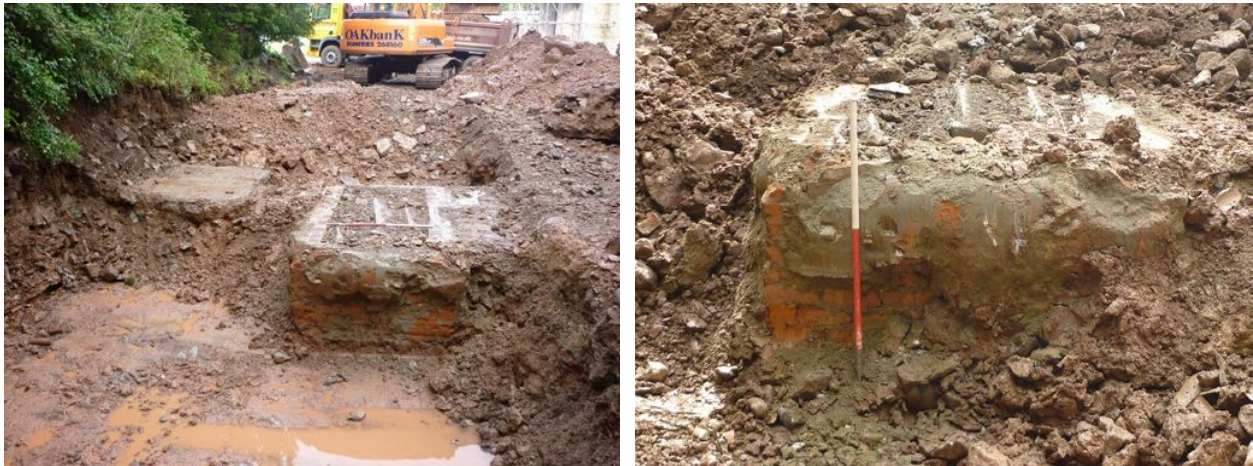
**Plate 10 (left): Concrete stanchion (left) and brick-built structure (centre)**

**Plate 11 (right): Detail of the north-east external elevation of the brick-built structure**

4.2.3 A red brick built structure was exposed at a similar level to the surrounding concrete stanchions, which stood approximately 0.9m high from the base of the trench (Plate 10). Each brick measured exactly three by five by nine inches (76x127x229mm) and was set in smooth concrete cement (Plate 11). Ten courses remained of the structure, which might have been an inspection pit. Removal of the concrete stanchions along the south-east edge of the area revealed a large quantity of ceramic drain pipes in the trench section below the limestone blocks of the retaining wall and above the clay (Plate 12).

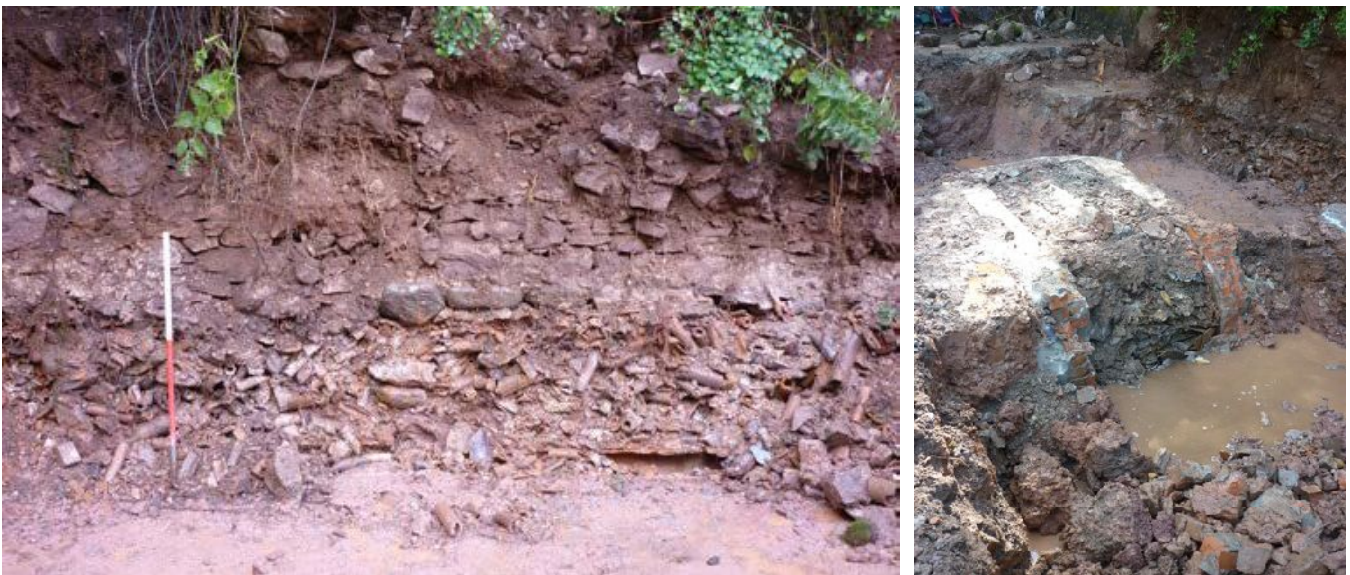
**Plate 12 (left): Section below the south-east retaining wall showing dump of ceramic drain pipes**

**Plate 13 (right): Asbestos dumped inside the brick-built structure**

The pipe was present in an unusually large quantity and included a superabundance of 'wasters' or misfires (see *Section 4.3.2*). This pipe dump (**101**) did not intrude into the area of excavation at this point but appeared to continue below the embankment to the south-east and along the trench edge. When the end of the possible inspection pit was removed to reveal the section across it, its base was found to contain a large quantity of dumped asbestos sheeting (Plate 13) and the job was halted.

5.1.2 The ceramic pipe dump (**101**) along the edge of the trench and beneath the embankment is difficult to account for in the grounds of the Castle. It contained wasters associated with manufacture and was likely being produced on an industrial scale nearby, possibly at Hackthorpe. How it came to be dumped in the grounds of the Castle is unknown, but it seems likely that this material was simply being used as a means to raise the ground in this area. The dump did not intrude into the area of excavation except in what may have been a small cut along the north-east edge; unfortunately, since the north-easternmost end of the area could not be monitored due to health and safety issues arising from the presence of asbestos on site, it is difficult to determine if the clay pipe dump had indeed filled a cut along the trench edge. The dump clearly continued below the embankment to the south-east but it is not known how far. It may have helped drainage of the site along the north-east edge, been used to raise the embankment for some reason, or merely provided a convenient place to dump the material at some stage.

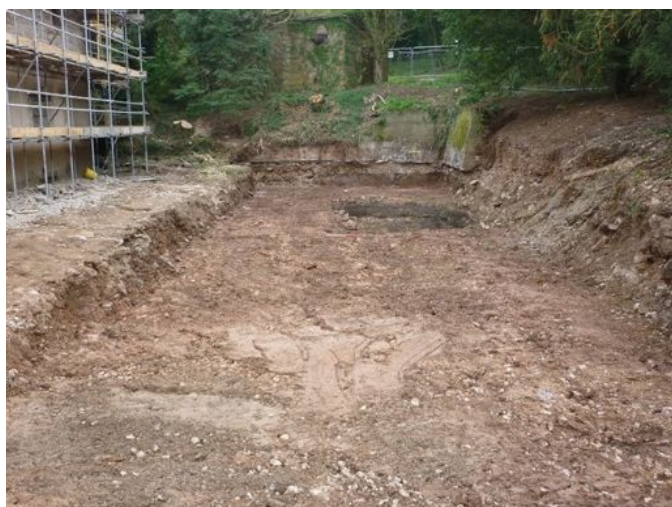
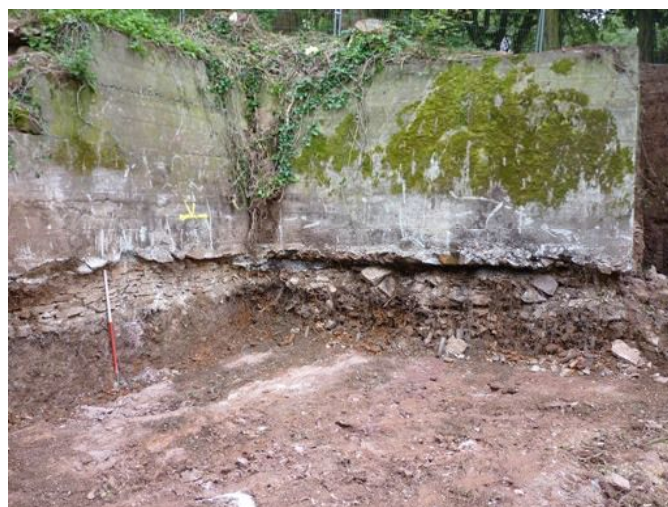
4.2.4 Removal of the contamination extended the area of excavation to the south-west and to the retaining wall to the north-east (Figure 3). The maximum depth of excavation was maintained at roughly 1.9m, which was cut into the pinkish clay (Plate 14). No features were apparent to the south-west of the area. The dump of ceramic drain pipes continued below the retaining wall to the north-east along the south-east elevation (Plate 15; Figure 3). The concrete skim continued part of the way to the north-west along the north-west/south-east aligned section of the retaining wall before becoming exposed red brick mostly in a stretcher bond (roughly 3:1 stretcher / header ratio, although the headers did not form a complete course; Plate 16). Below this section of the wall was an almost dry built angular stone wall (Plate 17); it appeared to be flush with the retaining wall above it. It was not clear if this wall continued along the south-east elevation which appeared to be more disturbed and contained a rubble deposit at a similar level in the trench section (Plate 15). The ceramic pipe dump did not continue in section below the lower angular stone wall which sat on top of the clay layer; it did appear to continue part of the way along the trench at this end of the site but only a small quantity was noted possibly in a cut along the north-east edge of the area.

**Plate 14 (left): Area of excavation after the removal of the asbestos**

**Plate 15 (right): South-east corner of the retaining wall**

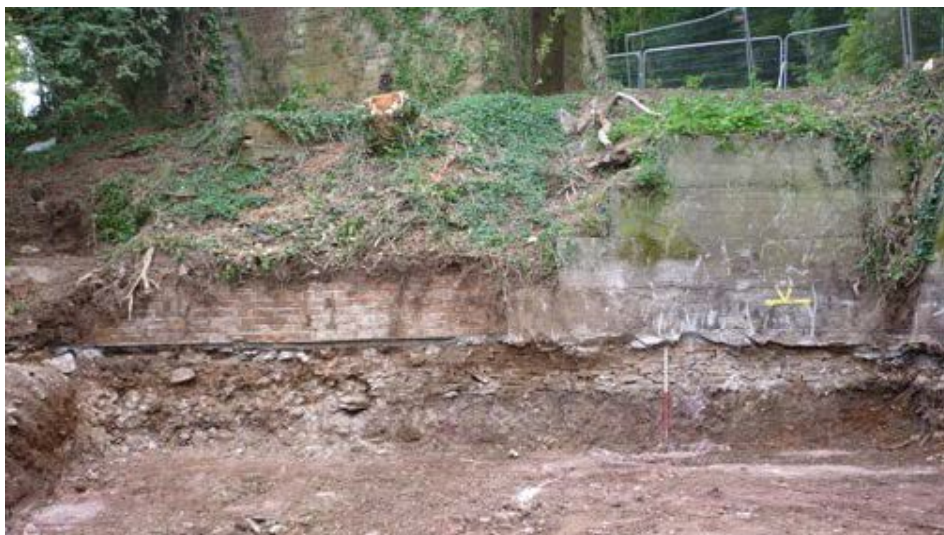
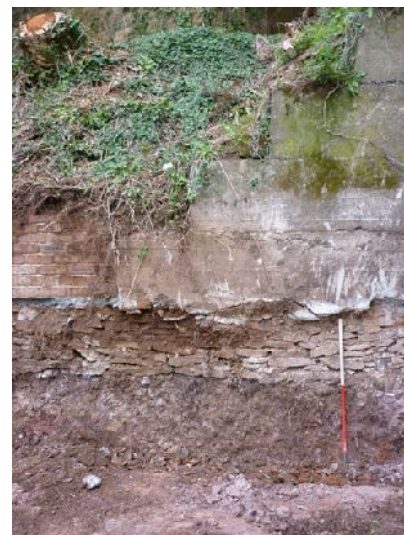
**Plate 16 (left): North-east trench section**

**Plate 17 (right): Detail of the dry stone wall below the north-east section of the retaining wall**

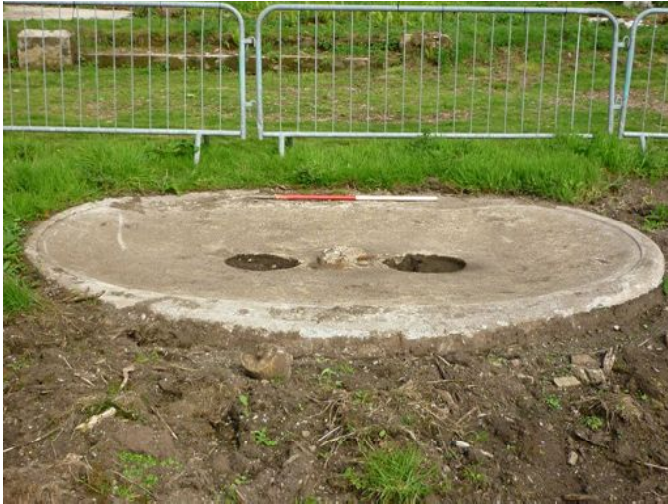
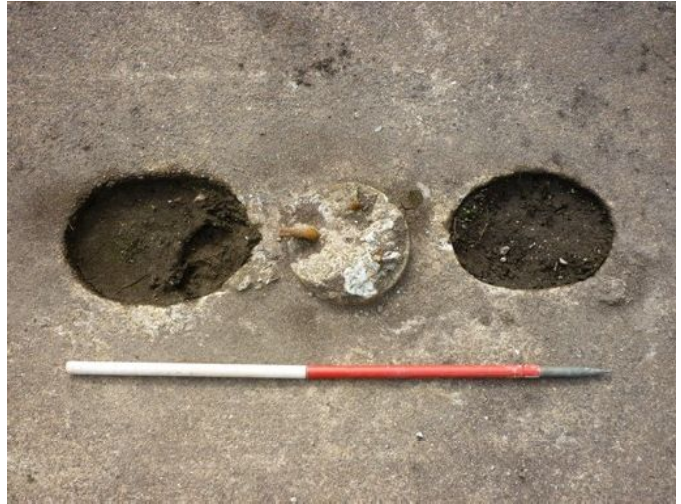
4.2.5 **Features in the South Lawn:** removal of the topsoil in the South Lawn exposed a long oval-shaped concrete feature (Plate 18) in front of the west outer wing of the Castle near to the steps to the Sunken Garden (Figure 4). It had a slight lip around the outer edge and had a sunken centre. There was a round protuberance in the centre, with rusted attachments, flanked by two ovoid orifices (Plate 19). The holes either side appeared to have been filled with cement and packed with stone. It is thought to have been a fountain base or possibly a sculpture base.

**Plate 18 (left): Possible fountain base exposed in the South Lawn**

**Plate 19 (right): Detail of the central section of the possible fountain base**

5.1.3 **Features in the South Lawn:** the South Lawn contained two concrete features which are fairly late in date; the guttering was aligned to the entrance of the Castle and was presumably used when the Castle was in its heyday. A road is first shown at this location on the Ordnance Survey map, surveyed in 1859 (**Error! Reference source not found.**). Similarly, the concrete fountain base in front of the west outer wing perhaps also dates from the 19<sup>th</sup> or 20<sup>th</sup> century and finds recovered from the cobbled surface near the summerhouse were also post-medieval in date.

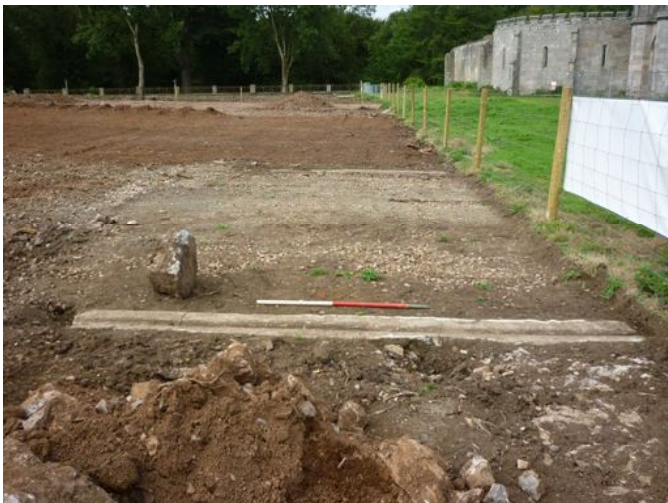
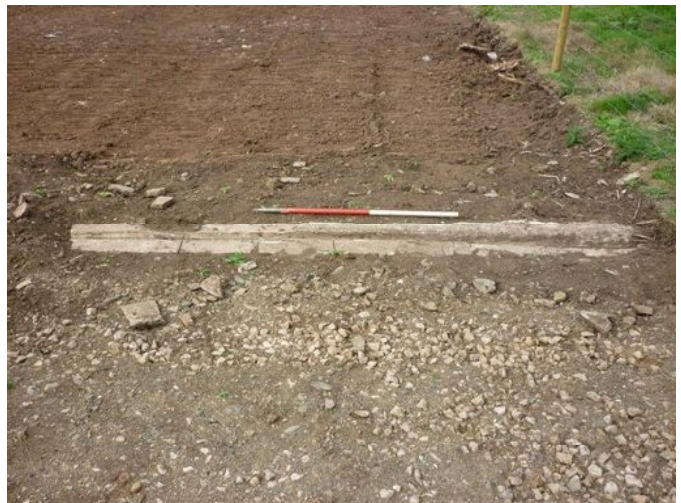
4.2.6 Some distance to the east of this concrete feature two concrete gutters were exposed either side of a possibly tarmacked area (Plate 20 and Plate 21; Figure 5). The tarmacked area and gutters appeared to line up with the central entrance to the Castle and were perpendicular to it and presumably would have led up to the entrance to the Castle in its heyday in the late 19<sup>th</sup> to 20<sup>th</sup> century. A track is first shown to extend to the south from this entrance to the Castle on the Ordnance Survey map of 1863 (**Error! Reference source not found.**; Land Use Consultants 2010, figure 14a and b). It was later extended all the way to the summerhouse by 1939 (**Error! Reference source not found.**; Land Use Consultants 2010, figure 18a and c; CAC(C) D Lons L5/3/2/Low10 1939).

**Plate 20 (left): Concrete gutters either side of a possibly tarmacked area**

**Plate 21 (right): Detail of the south-west gutter**

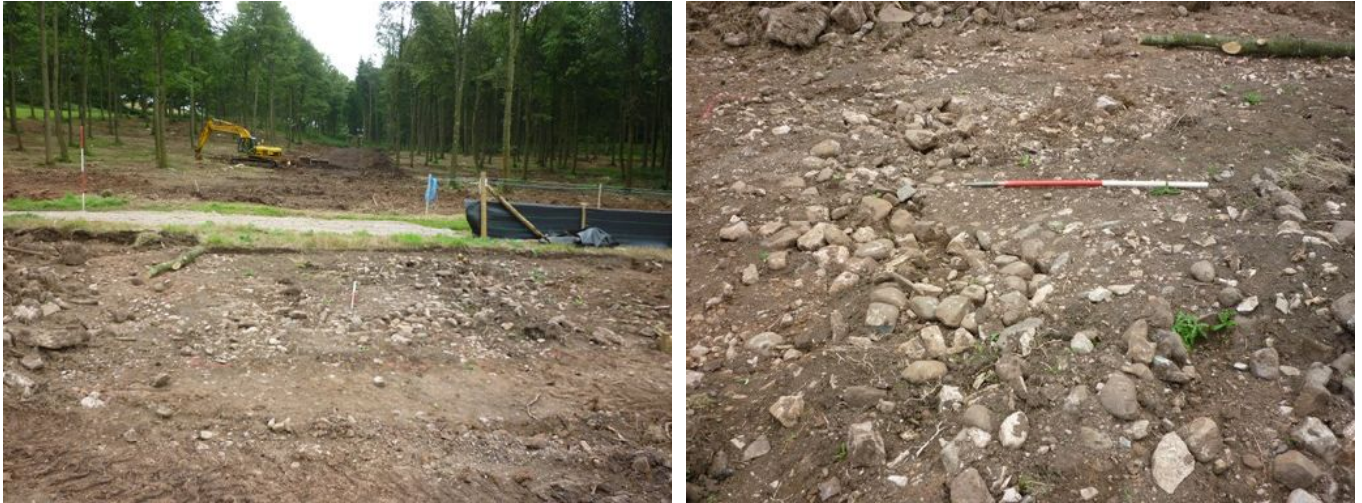
4.2.7 A small area of cobbles (each approximately 0.15x0.10x0.06m) was also recorded to the south end of the Lawn, beginning approximately four or five metres to the north-west side of the track to the north-west of the summerhouse (Plate 22). Some of the cobbles appeared to be packed in a brown

sandy-silt, possibly for consolidation or a path (Plate 23). It did not appear to be associated with any other structural remains and some unstratified glass and post-medieval pottery was recovered from its surface (see *Section 4.3.4* and *Appendix 4*).

**Plate 22 (left): Cobbled surface, looking south-east towards the summerhouse**

**Plate 23 (right): Detail of the cobbled surface**

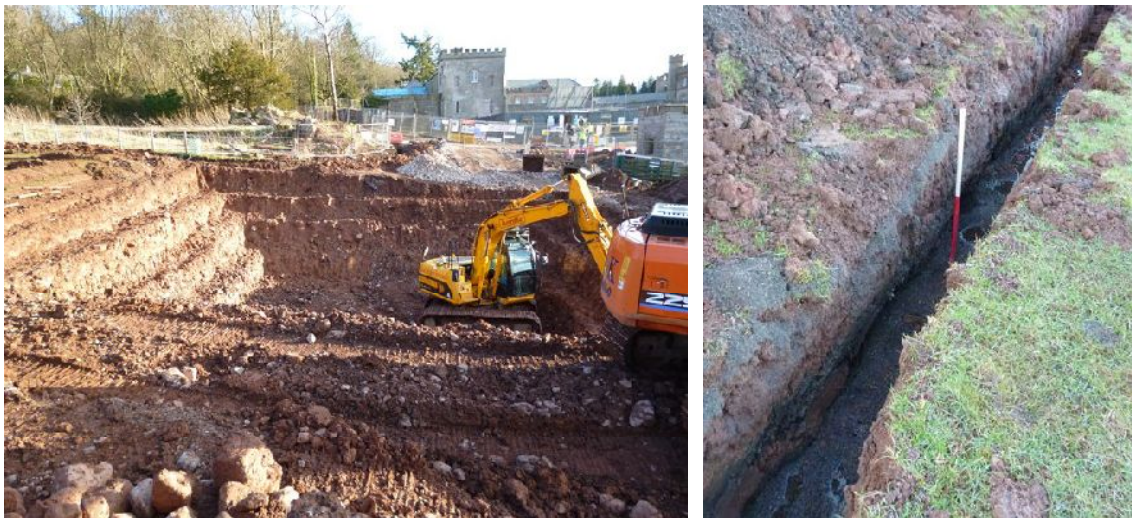
**4.2.8 Area to the North of the Stable Courtyard (Area B):** there was very little topsoil across Area B (**200**), perhaps only 0.2 to 0.3m thick on top of the subsoil (**202**), and the underlying clay natural (**203**) was encountered at a depth of approximately 0.4 to 0.7m. The subsoil was hard to distinguish from the underlying natural as it was a similar colour, but the natural was noted to be stonier and contained some large boulders (Plate 24). Some post-medieval pottery and glass was recovered from a thin layer of gravelly ash (**201**) below the topsoil in the pipe trench (*Appendix 3*; see also Figure 6). This ashy deposit measured approximately 6.3m long from east to west and was up to 0.2m thick (Plate 25). Some pieces of ceramic water pipe were also observed in the spoil along the pipe trench and an old iron water pipe was observed elsewhere. A ceramic pipe ran north/south to the east of the ash layer and a stone built drain ran north/south to the west of it. The stone drain was built from slabs and dressed stone and was c.0.4m wide.

**Plate 24 (left): Stepped excavation in Area B**

**Plate 25 (right): Gravelly ash deposit visible in the section of the pipe trench**
