JUNCTION OF HINDPOOL ROAD AND CORNMILL CROSSING, BARROW-IN- FURNESS, CUMBRIA

Archaeological Watching Brief

Client: Positive Location
Properties Ltd
Planning Ap. Ref.: 6/05/1530
NGR: SD 1955 6905

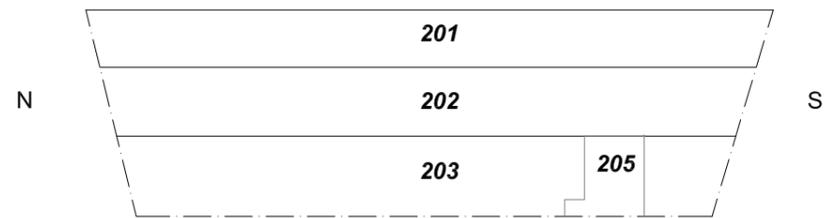
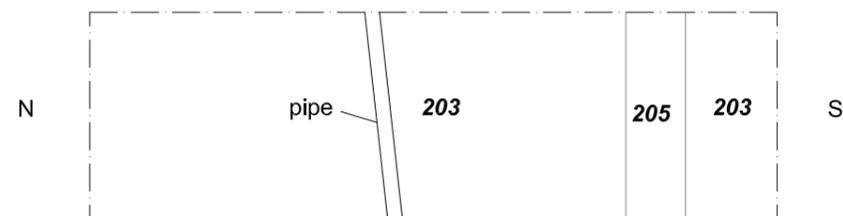
West-facing section and plan of Test Pit 2

3.3.2 **Test Pit 2 (TP18)**: this was orientated north/south, measured 3m by 0.9m, and was 0.9m deep (Fig 3). The upper layer of reinforced concrete (**201**), which was 0.25m thick, was laid on a single sheet of blue plastic on top of a bed of loose mid orange gravel bedding (**202**) 0.3m thick. This lay on top of a loose black sandy gravel containing some brick, slag, concrete, and ash (**203**), up to 0.35m thick. This butted against a brick wall orientated east/west positioned at the south end of the trench (**205**), which comprised at least four courses of frogged red bricks and was 0.26m thick. This wall was sat on firm mid orange brown clay containing 10% small rounded stones (**204**), which had an iron pipe orientated east/west cut through it.

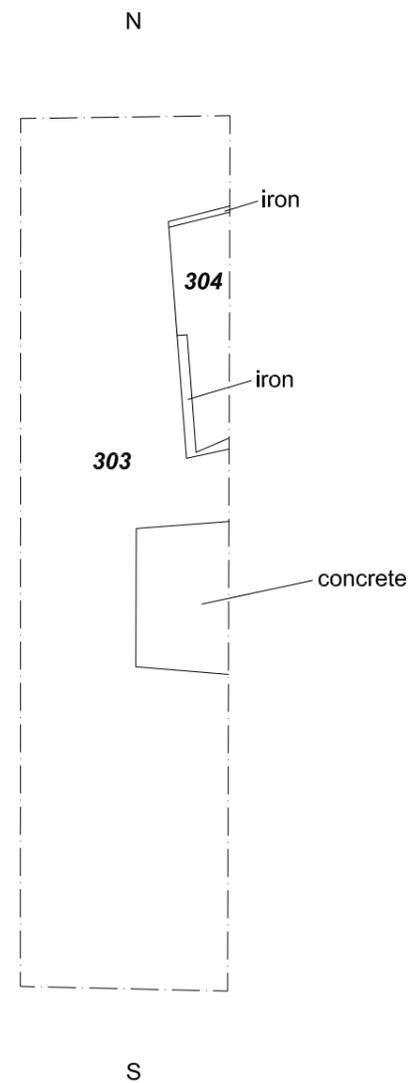
Plan of Test Pit 3

3.3.3 **Test Pit 3 (TP19)**: this was orientated north/south, measured 3.8m by 0.9m, and was only excavated to a depth of approximately 0.3m (Fig 3). The upper layer of reinforced concrete (**301**), which was 0.2m thick, was laid on a single sheet of blue plastic on top of a bed of loose mid orange gravel c0.1m thick (**302**). Beneath this was a surface (**303**) constructed from red bricks, at least some of which were frogged, with patches of concrete surfacing and iron brackets attached (Plate 1). A small hole in the brick surface on the east side was filled with a loose dark brown sandy soil with some brick fragments (**304**).

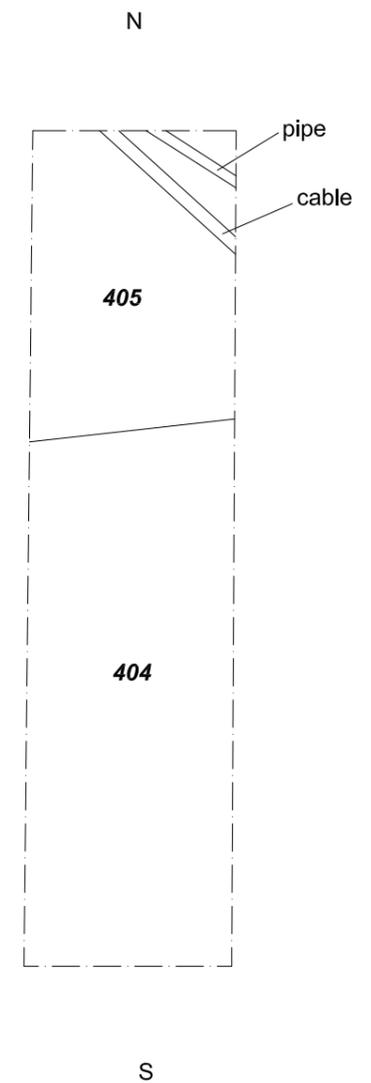
Plan of Test Pit 4

3.3.4 **Test Pit 4 (TP20)**: this was orientated north/south, measured 3.6m by 0.9m, and was excavated to a depth of 1.3m (Fig 3). The upper layer of reinforced concrete (**401**) was 0.2m thick and laid on a single sheet of blue plastic on top of a bed of mid orange gravel 0.1m thick (**402**). This was deposited on a thin layer of loose mid orange sand (**403**) at the north end and on top of a reinforced concrete surface (**404**) in most of the trench (Plate 2). Beneath sand **402** was a layer of loose black gravelly material (**405**) up to 0.5m thick, cut through by two cables. Beneath this layer was a possible brick wall (**406**), which was sat on top of a firm mid brown silty clay (**407**).

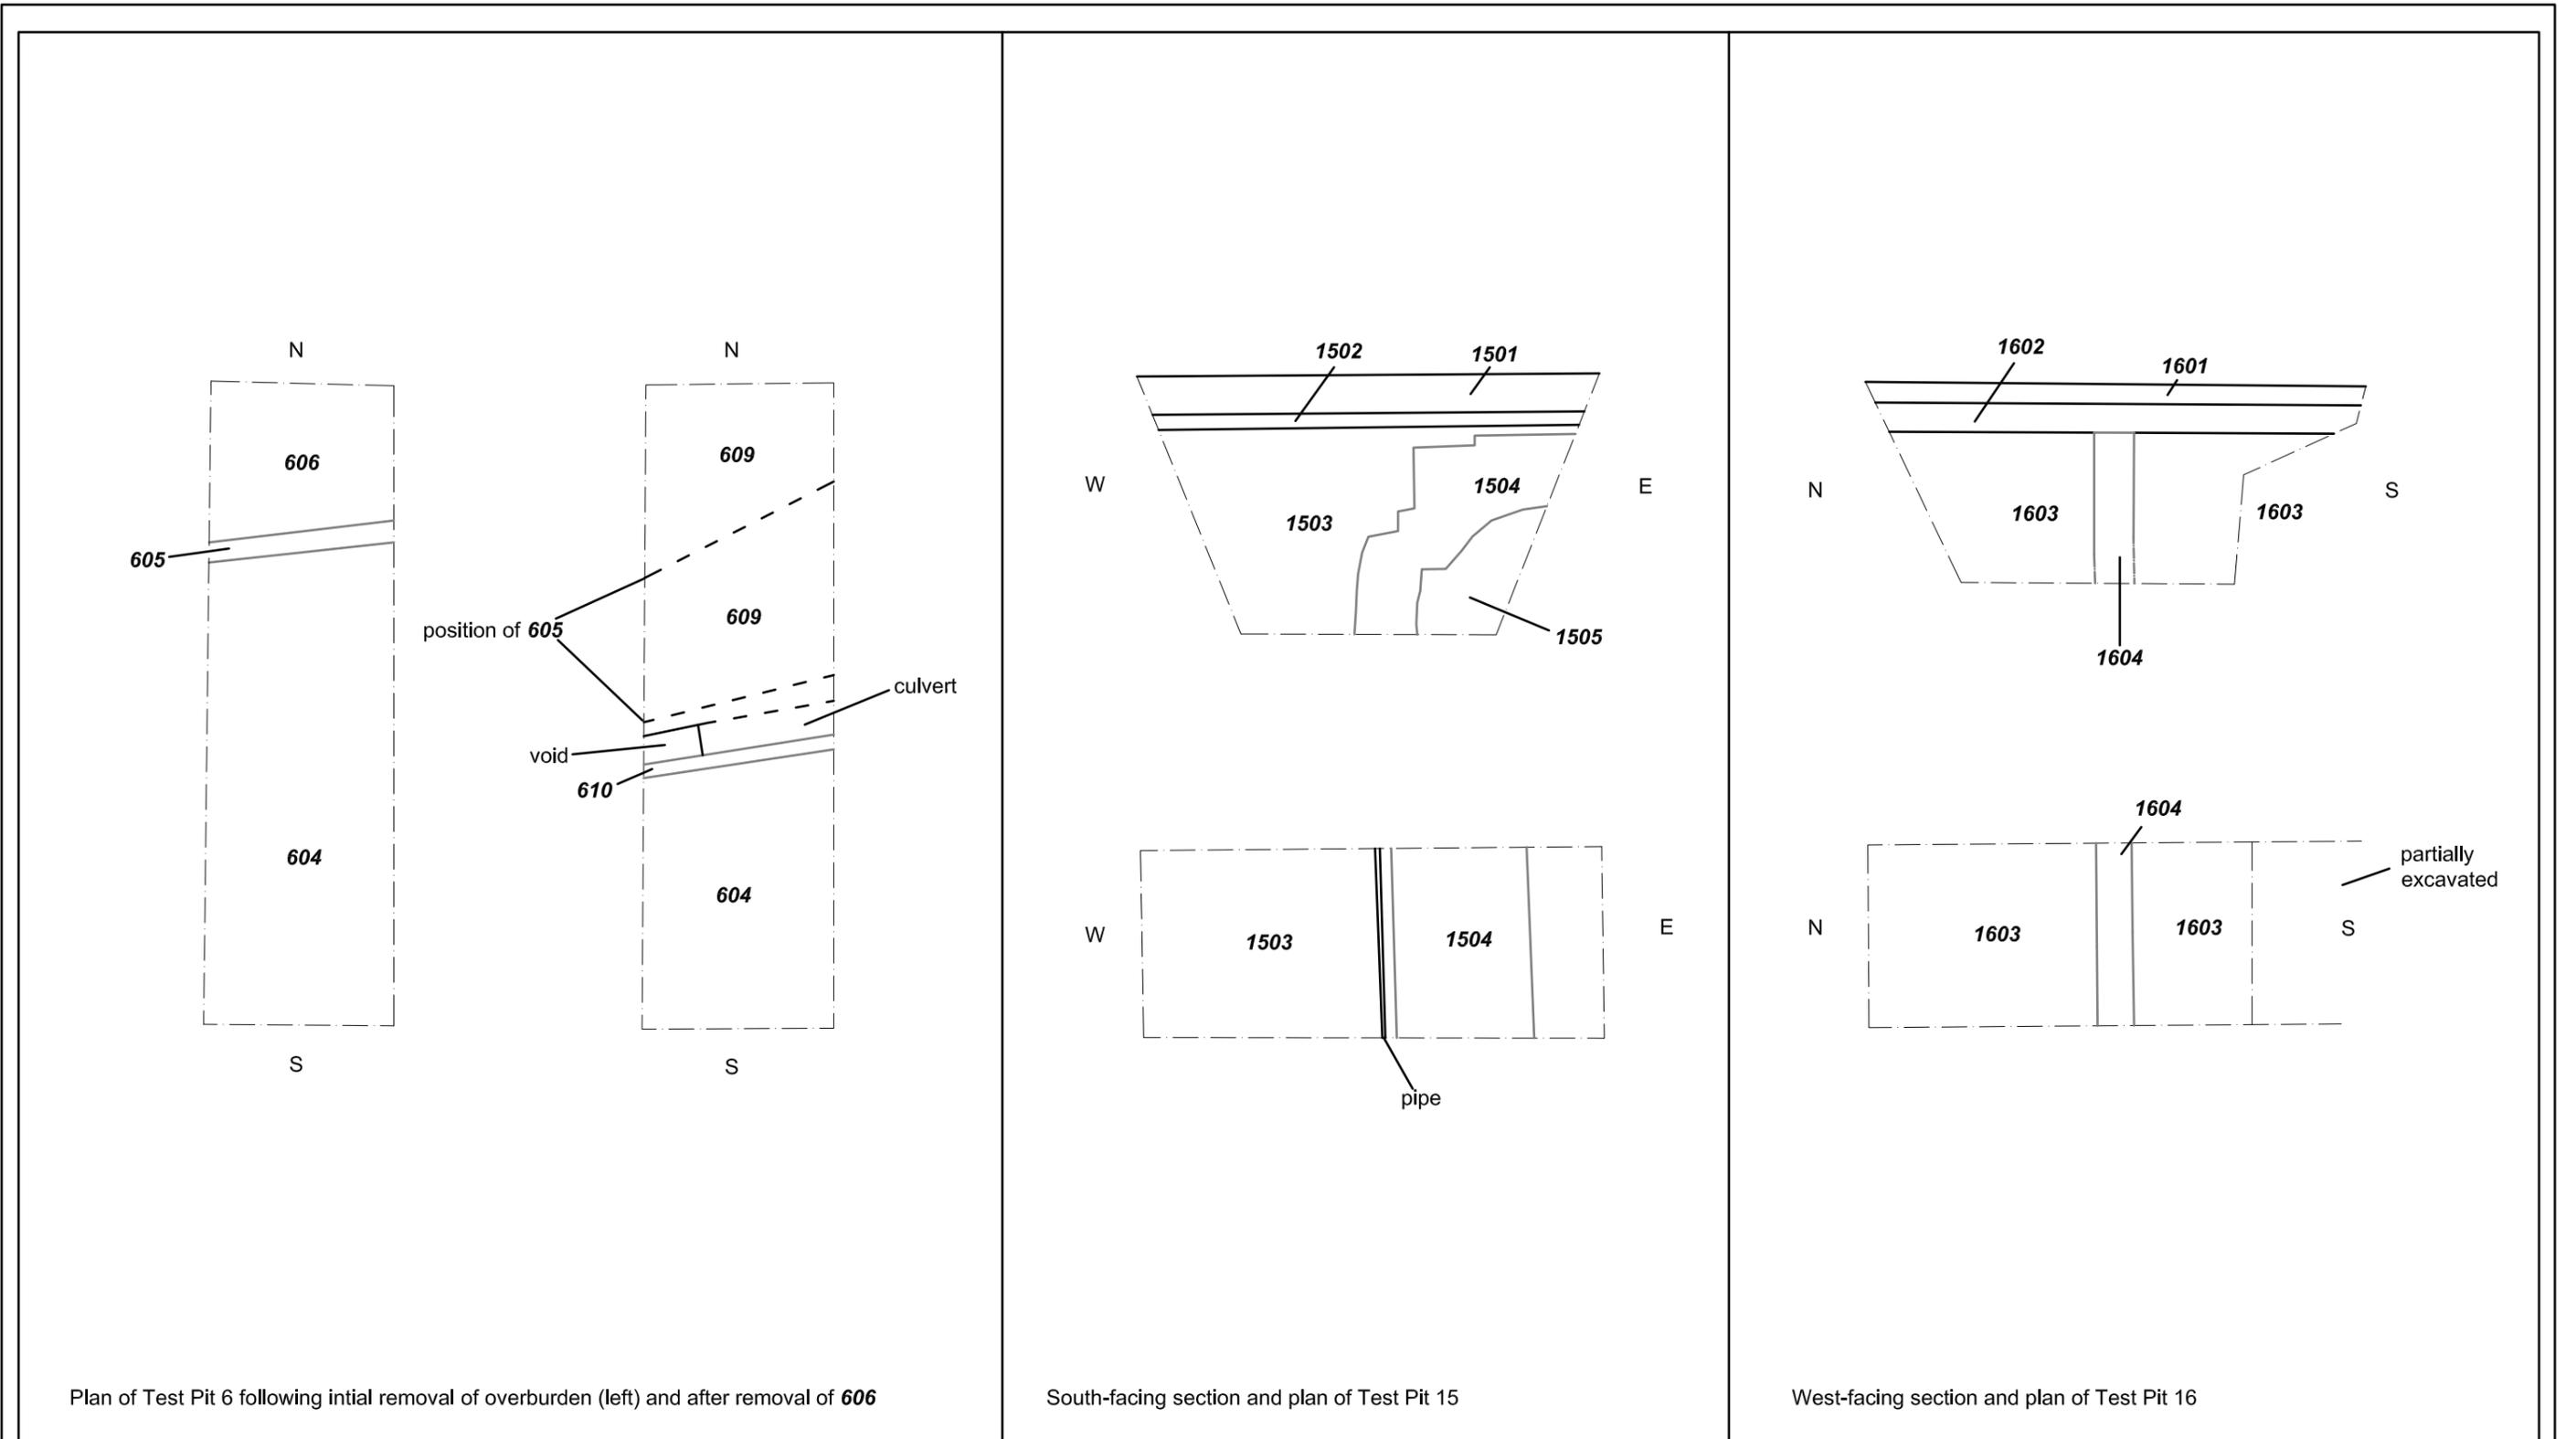
Figure 4: Plans and sections of Test Pits 6, 15 and 16

3.3.15 **Test Pit 15 (TP27)**: this was orientated east/west, measured 2.2m by 0.9m, and was excavated to a depth of 1.2m (Fig 4). The upper layer of reinforced concrete (**1501**) was 0.2m thick and lay on a layer of loose mid orange gravel (**1502**) up to 0.1m thick. Beneath this was a dark brown-black loose sandy silt with foundry and blast furnace slag (**1503**), which sealed a brick wall or culvert (**1504**) built of red brick and orientated north/south (Plate 8). Between four and five courses remained and it was at least 0.65m wide, apparently forming a curved profile suggestive of a culvert, with an iron pipe along the west edge. This structure seemed to be sat on or possibly filled with a mid orange firm clay (**1505**), which extended to the base of the trench.

3.3.16 **Test Pit 16 (CBH5)**: this was orientated north/south, measured 1.9m by 0.9m, and was excavated to a depth of 1m (Fig 4). The upper deposit comprised a layer of tarmac (**1601**) up to 0.1m thick, which lay on a loose layer of mid orange gravel (**1602**) up to 0.2m thick. Beneath this was a loose dark brownish black sandy clay containing ash, clinker, slag, and brick (**1603**), up to 0.75m thick, which sealed a brick wall orientated east/west (**1604**), which was two bricks thick and had at least four or five courses remaining (**1605**). This sat on a firm mid-brownish orange clay (**1606**), which extended to the base of the trench.

4.3.11 **Test Pit 15 (TP27):** the early maps of the site show that the wall or culvert revealed in this trench clearly relates to an early part of the iron and brass foundry. A large block of buildings is shown in this location between 1873 and 1891 before the site was substantially rebuilt (Greenlane Archaeology 2006, figs 7-8; Fig 6).

4.3.12 **Test Pit 16 (CBH5):** the early maps show that this trench is located on the site of buildings forming part of the early phase of the iron foundry (Greenlane Archaeology 2006, fig 7) but subsequently outside of buildings belonging to later phases (Fig 6). The wall revealed in this trench undoubtedly therefore corresponds to the earlier buildings. Several fragments of pottery, relating to two individual vessels, were recovered from context **1603**, all of which are considered to date from the late 19th to early 20th century (*Appendix 5*; Plate 12). This fits broadly with the date of the iron foundry although the presence of domestic pottery in this particular location is difficult to explain. It may have originated from the gasworks house, which may have been situated nearby, or from a canteen or similar building within the foundry.

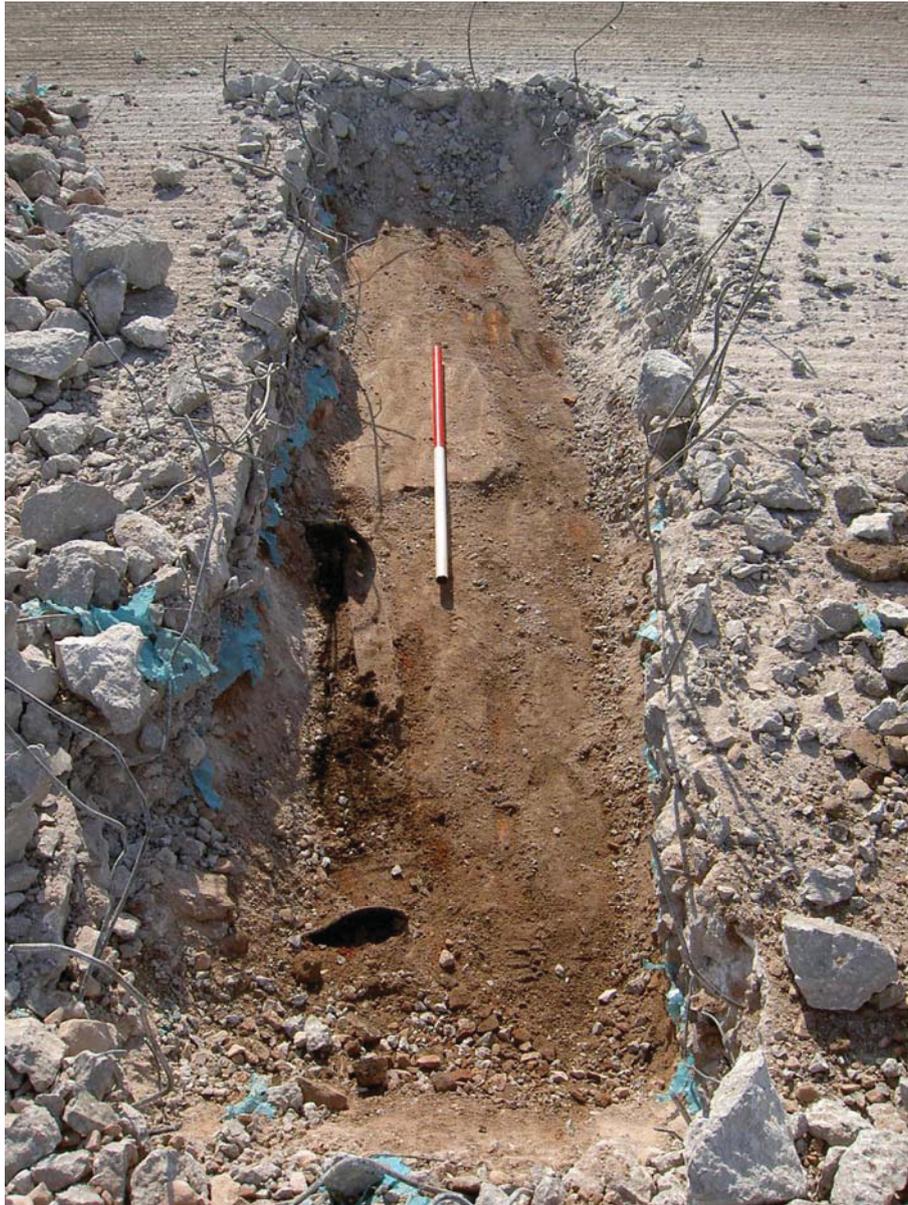
Plate 1: Brick surface **303** with concrete patch and attached iron brackets within Test Pit 3

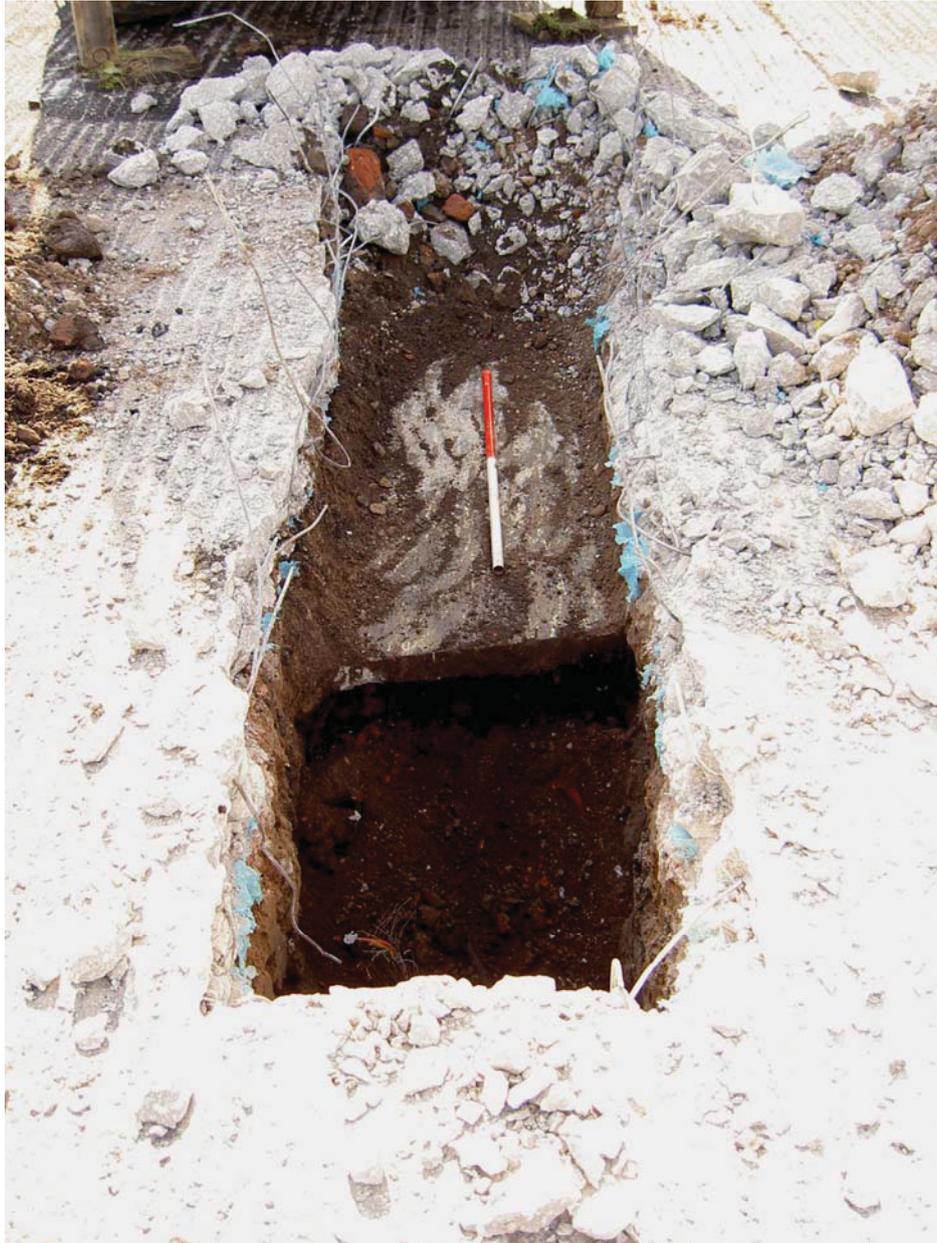
Plate 2: Concrete surface **404** in Test Pit 4

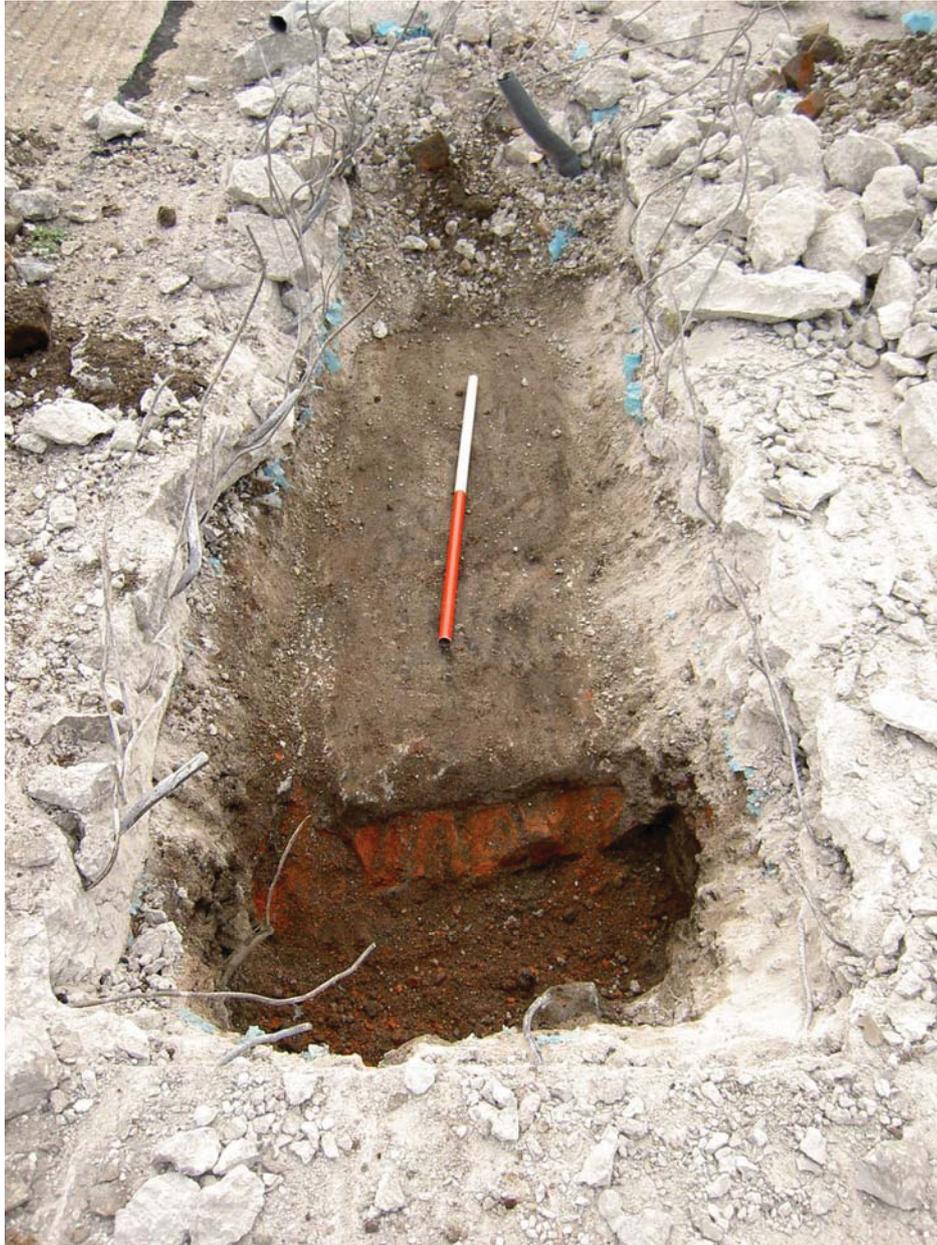
Plate 3: Concrete surface **604** and brick wall **605** in Test Pit 6

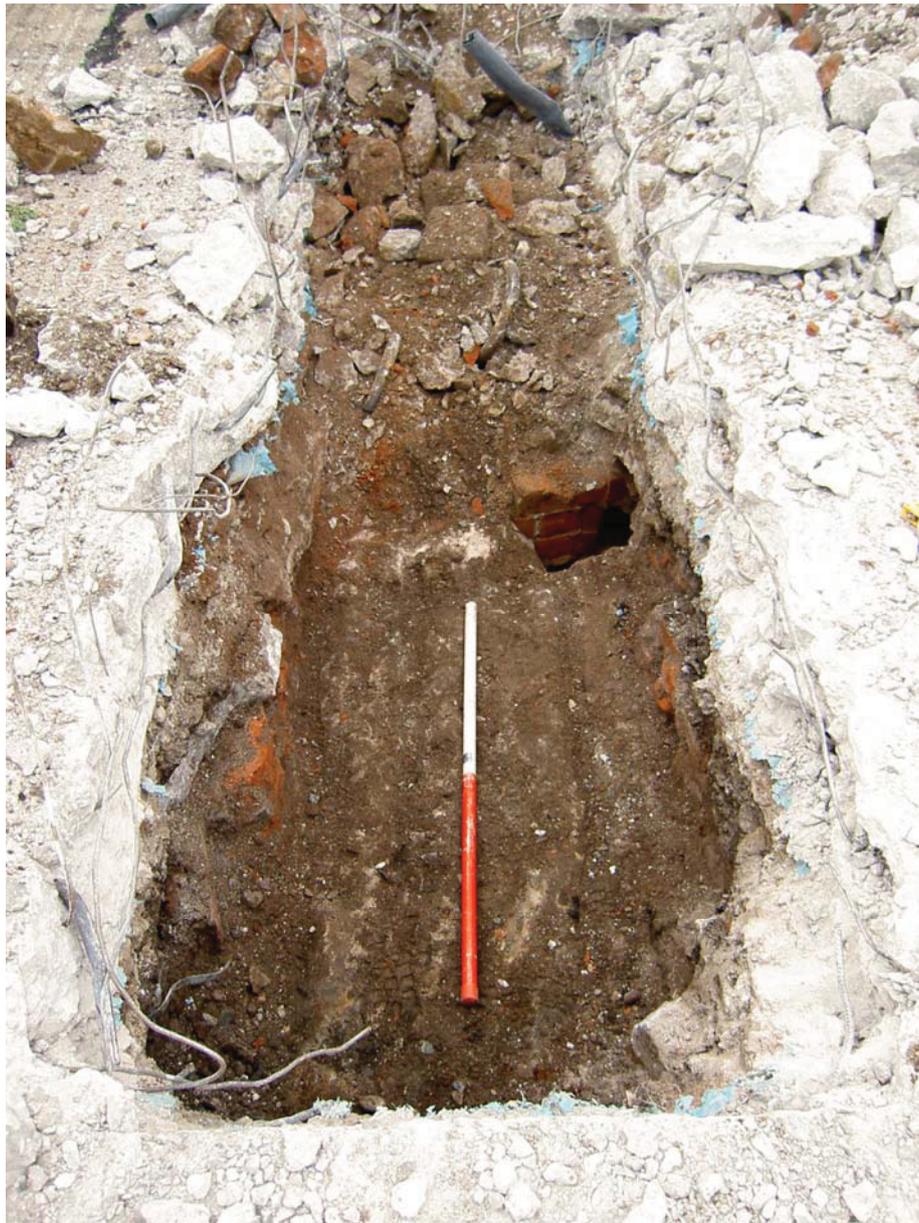
Plate 4: Lower concrete surface **609** and brick wall **610** in Test Pit 6

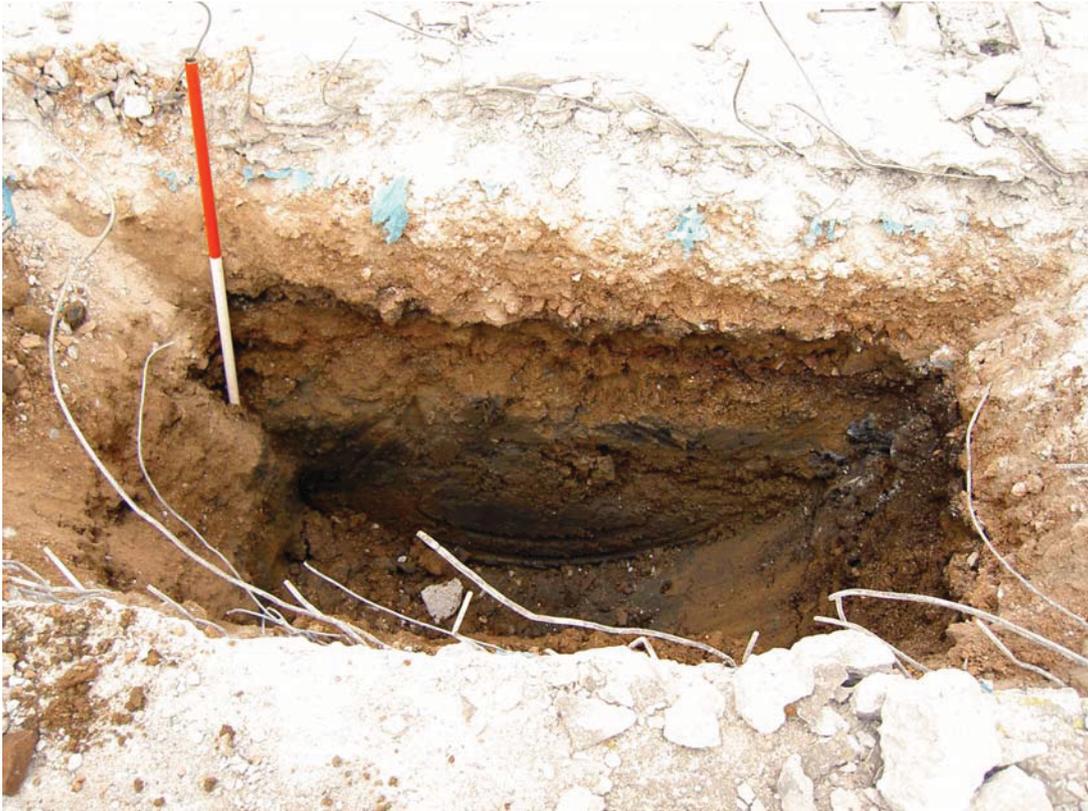
Plate 5: East-facing section of Test Pit 8 showing the cobbled surface (**805**) and layers of grey silty clay (**806** and **808**) and orange clay (**807**)

3.3.8 Test Pit 8 (TP24): this was orientated north/south, measured 2.5m by 0.9m, and was excavated to a depth of 1.7m. The upper layer of reinforced concrete (**801**) was 0.2m thick and laid on a single sheet of blue plastic on top of a bed of mid orange gravel (**802**) 0.2m thick. This was laid on a dark brown to blackish orange layer of ash and sand (**803**) up to 0.02m thick, on top of a loose dark brown sand (**804**) 0.15m thick. Beneath this was a firm pink sandy clay (**805**) 0.02m thick, which was on top of a soft mid orange brown sandy clay containing 75% medium rounded stones (**806**) up to 0.25m thick (Plate 5). Beneath this was a mid grey silty clay (**807**) containing small fragments of shell and 2% small rounded stones, which was on top of a firm mid orange brown clay (**808**) 0.3m thick (Plate 5), beneath which was another layer of mid grey clay the same as **807** (**809**), which extended to the base of the trench.

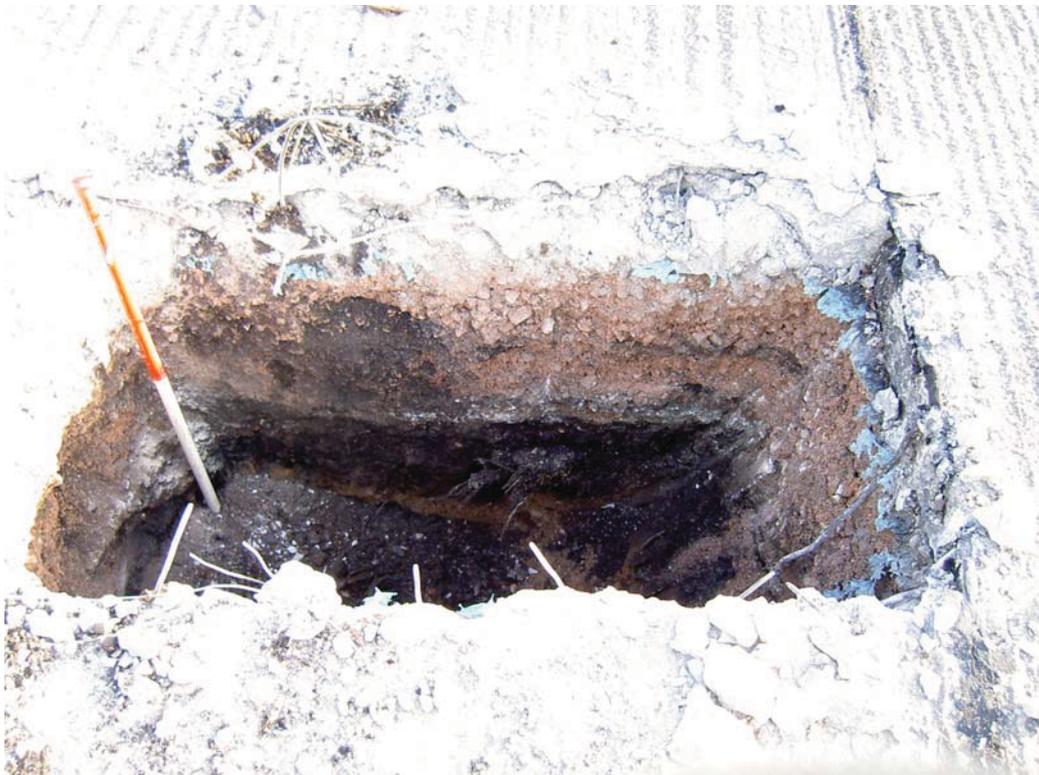
Plate 6: South-facing section of Test Pit 10 showing the clinker layer and remains of railway sleeper (**1003**) and underlying sand (**1004**)

3.3.10 Test Pit 10 (CBH1): this was orientated east/west, measured 1.6m by 0.9m, and was excavated to a depth of 1.15m. The upper layer of reinforced concrete (**1001**) was 0.2m thick and laid on a single sheet of blue plastic on top of a bed of loose mid orange gravel (**1002**) 0.2m to 0.3m thick. Beneath this was a loose dark brown-black sandy clay containing ash and clinker (**1003**) 0.4m thick and with a railway sleeper orientated east/west at the base (Plate 6). This was laid on top of a loose mid orange sand (**1004**), which extended to the base of the trench.

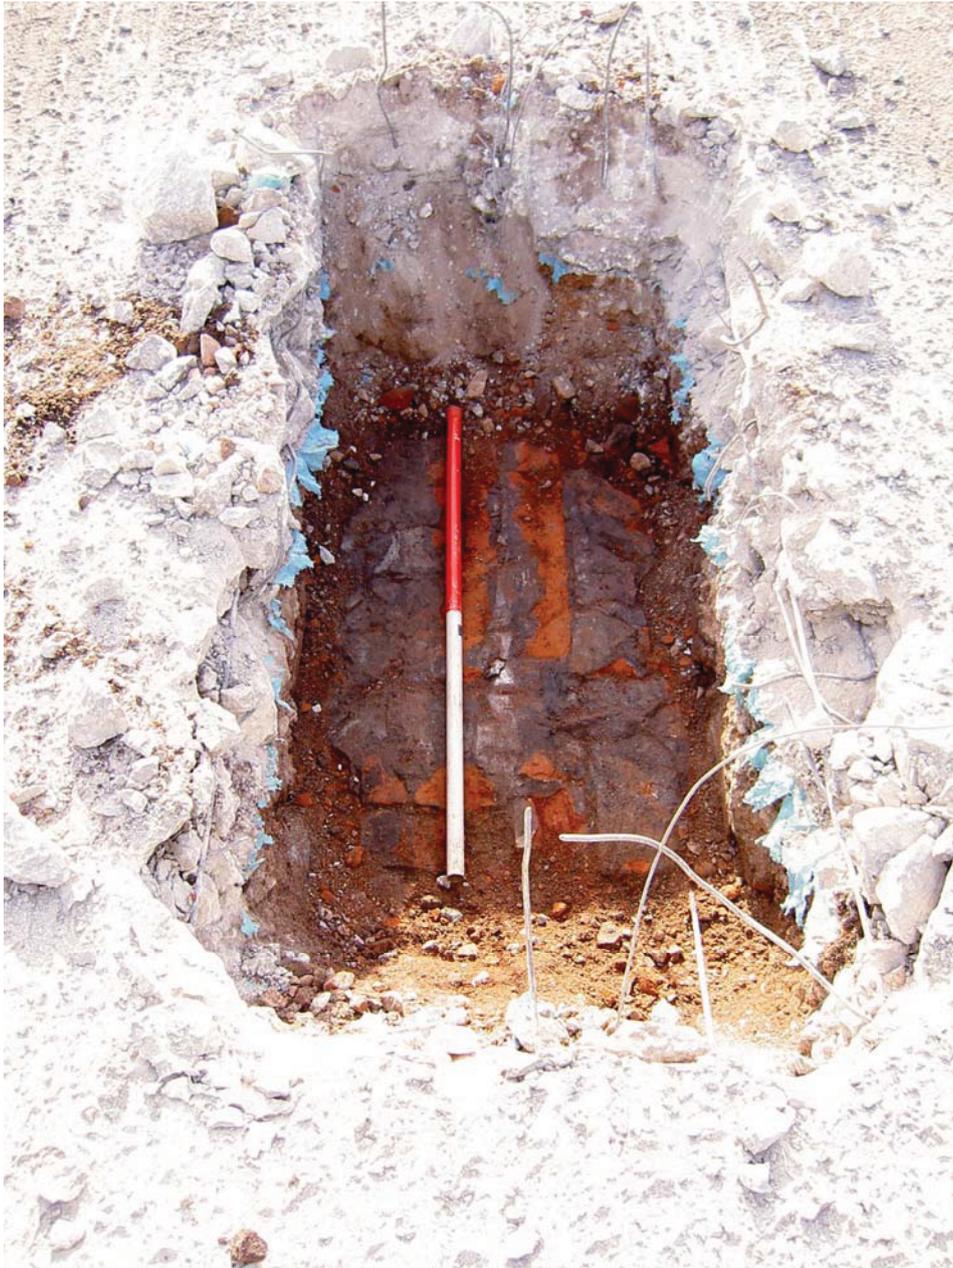
Plate 7: Brick surface (**1303**) in Test Pit 13

3.3.13 **Test Pit 13 (c6m south-east of CBH2)**: this was orientated east/west, measured 1.8m by 0.9m, and was excavated to a depth of 0.46m. The upper layer of reinforced concrete (**1301**) was 0.22m thick and lay on a single sheet of blue plastic on top of a bed of loose mid orange gravel (**1302**) up to 0.2m thick. Beneath this was a red brick surface set in a thick concrete mortar (**1303**) extending across the trench (Plate 7).

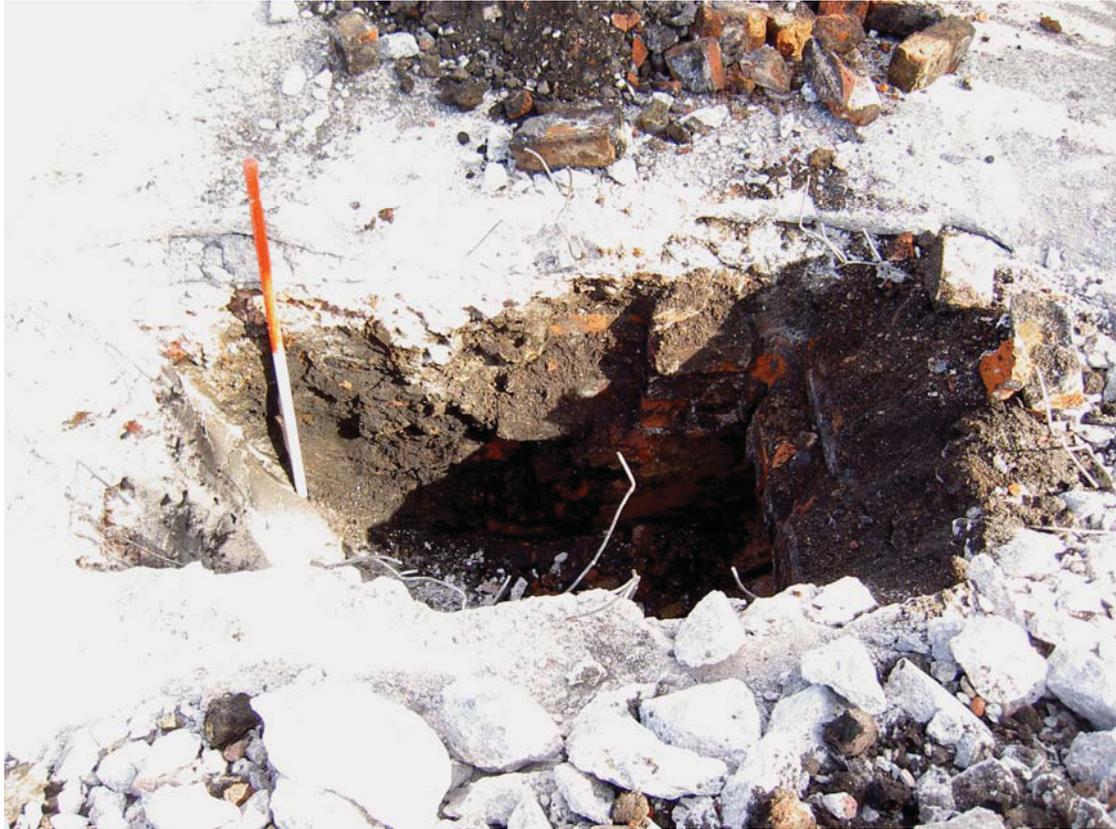
Plate 8: Wall or culvert **1504** in the south-facing section of Test Pit 15

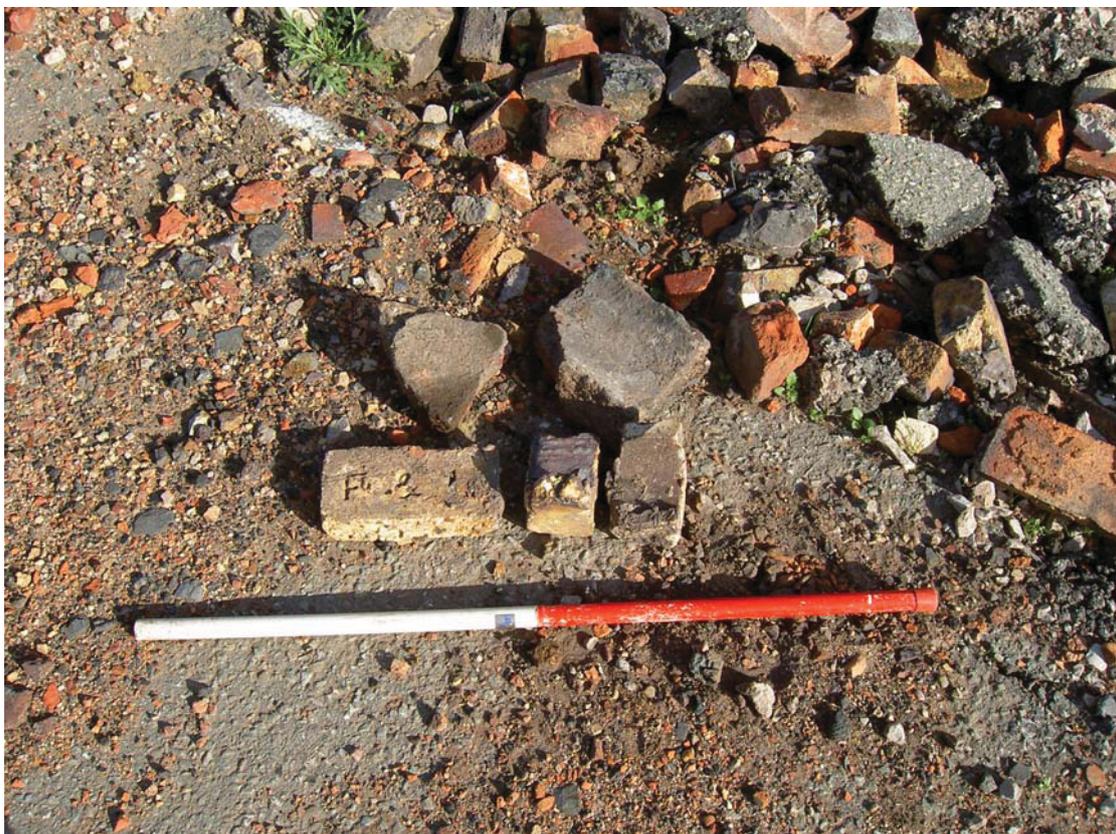
Plate 9: Vitrified foundry bricks from the spoil of CTP12

3.3.17 **Additional Observations**: a number of features of interest were observed in the spoil of the previous test pits. Test pit TP12 had uncovered a large amount of brick including several that were vitrified, and at least one narrow yellow brick marked 'F & L' (Plate 9). Pottery was recovered from the spoil of TP3 which is considered to be of broadly 19th to 20th century date (see *Appendix 5*).

structure. The discovery of vitrified bricks in the spoil suggests that this area may have been where the retort house for the gasworks was situated, or that material from the furnaces used in the foundry was dumped here.

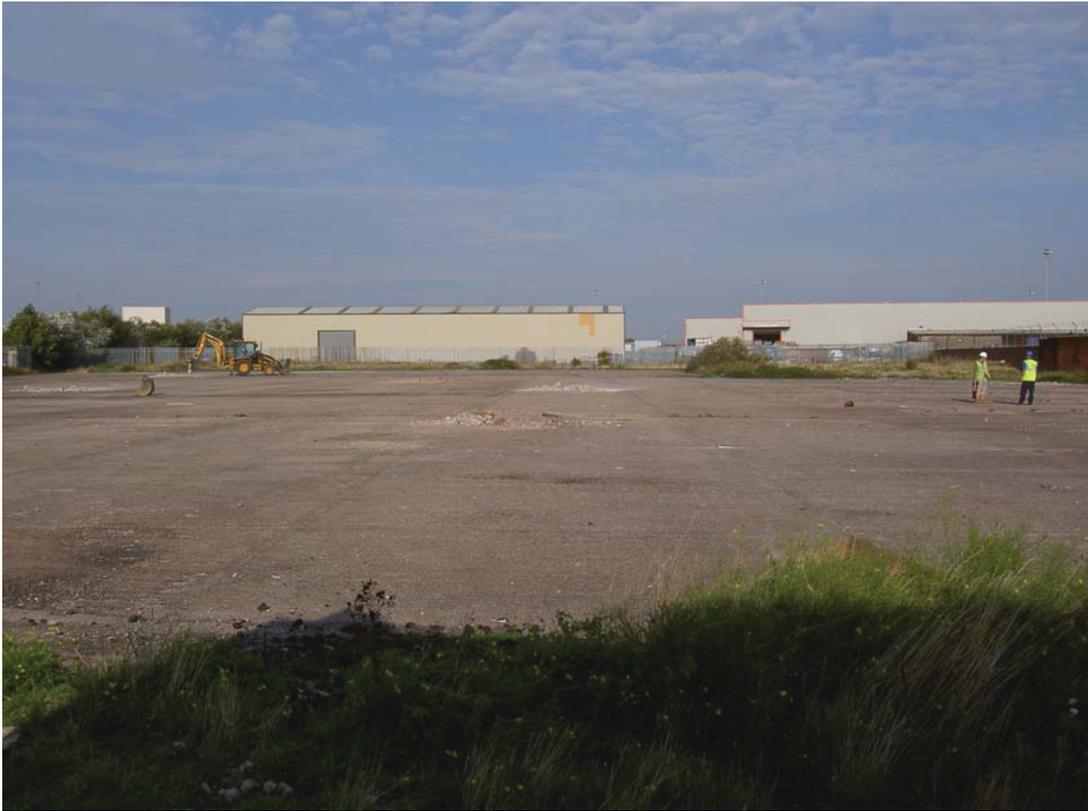
Plate 10: Working shot of the main area of excavation (Area 1)

3.1.1 Prior to the watching brief a total of 16 test pits were excavated without archaeological supervision, in addition 11 boreholes (two of which were re-started) were excavated without archaeological supervision, some before the watching brief and some after, although in the case of the latter the launch pits were monitored. The results of this work are discussed below (*section 3.2.1-3.2.5*). In addition, 11 test pits and five borehole launch pits were excavated under archaeological supervision. These were positioned in various places across the site (Fig 2), the majority within Area A of the original desk-based assessment (Greenlane Archaeology 2006; Plate 10) and excavated to various depths. On average the test pits and borehole launch pits were 2m long and 0.9m wide (one machine bucket width). All of them were excavated using a toothed ditching bucket (Plate 11), in most cases following the removal of concrete or tarmac using a hydraulic pecker (Plate 10).

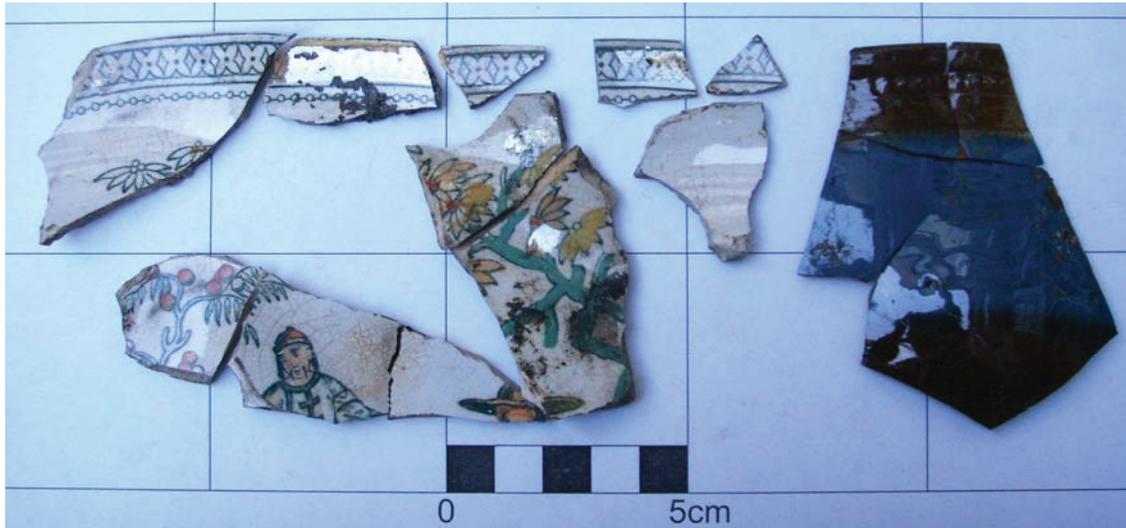
Plate 12: Late 19th to early 20th century pottery from context **1603**

6	1603	Ceramic	4	Refitting factory-produced red earthenware bowl rim and body fragments with blue slip band and rouletted rim	Late 19 th – early 20 th century
7	1603	Glass	12	Colourless window pane fragments	18 th – 20 th century
8	1603	Fe	1	Corroded bar fragment	Not closely dateable
8	1603	Graphite?	1	Fragment	20 th century?
9	Unstratified from spoil of Celtic TP3	Ceramic	1	Black-glazed red earthenware coarseware fragment	Late 17 th – early 20 th century
9	Unstratified from spoil of Celtic TP3	Ceramic	1	Bone china saucer base fragment	19 th – 20 th century
9	Unstratified from spoil of Celtic TP3	Glass	1	Colourless bottle fragment	19 th – 20 th century
