LOW FELL GATE FARM, CARTMEL ROAD, GRANGE-OVER-SANDS, CUMBRIA

Archaeological Building Recording

Client: Mr and Mrs Wilkin
Planning Ap. Ref.: SL/2007/0668
NGR: SD 39907 76942

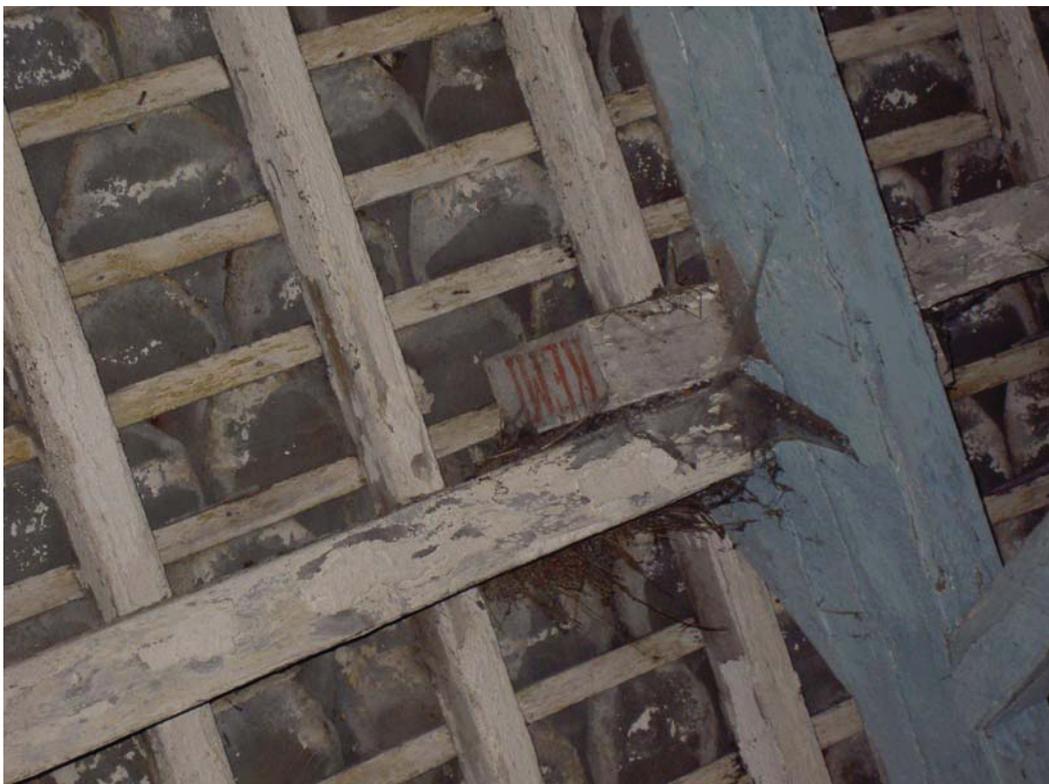
Plate 34: Marked purlin in roof of Building 5

5.2.4 Phase 4, early 20th century: this phase is dominated by the construction of Building 5, a large and modern cow shed which was built between 1889 and 1910. The presence of timber marked KEMI and Baltic timber marks is also significant in understanding the dating. Baltic timber tends to suggest a late 18th to early 19th century date (Greene 1995; 1996), however Kemi, a port in Finland, became the focal point of the Finnish timber industry after 1893, when the first company was founded there (Kumpulainen 2001, 48). This fits remarkably well with the evidence from the map regression and indicates that this extension was added between 1893 and 1910. Most of the northern elevation was provided by Buildings 4 and 6, and certain other changes give away this addition. The porch of Building 4 was renewed, the western cheek having been removed to accommodate the new build. The building in the south-west of the farmyard was also removed to accommodate it. The window in the south side of the upper level of Building 6 went out of use and was covered over and a possible window in the south elevation of Building 4 was also blocked as it no longer looked outside. The removal of the short-lived structure in the south-west of the farmyard hints at some dramatic overhaul of the farm's administration, which may well coincide with its sale in 1904 from the Wilkinsons to Moser and Sons. A letter from Moser and Sons' solicitor describes to them that although the estate was profitable, better use could be made of the land, (see *Section 3.1.4*) this may have prompted them not only to buy the farm in the first place but to subsequently construct the new shippon in order to increase its productivity. The large tin shed to the rear of Building 1 also appears on the 1913 Ordnance Survey map for the first time, although it does not appear to have reached its full size at this point.
