THOMPSON FOLD, LUPTON, CUMBRIA

Archaeological Building Recording

Client: RT Griffin Ltd
Planning Ap. Ref: SL/2006/1361

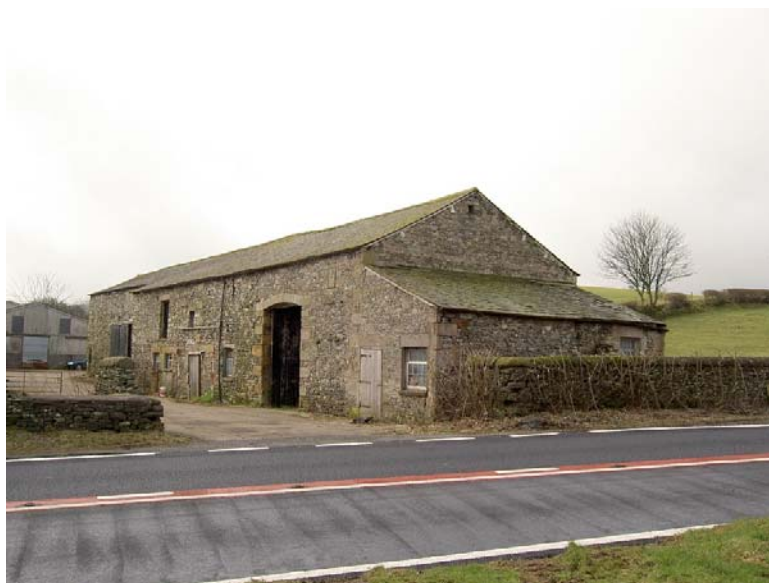
Plate 1: General view from the north-east showing the site relative to the A65

4.2.1 **North elevation (Fig 2):** this forms the gable end of the north threshing barn, although the lower part is covered by a single storey monopitch outshut (Plate 1). This has an iron gutter and large dressed quoins at either end. The east side has evidently been extensively rebuilt and there is an evident junction between the original and the rebuilt section west of the centre. Adjacent to this a rough buttress has been built against the wall. On the west side of the elevation there is a window with a 12-light timber casement, the upper four lights of which tilt, with a stone lintel and concrete sill. This was evidently originally a doorway, the lower part having been blocked with stone. The upper part of the elevation is formed by the gable end of the barn, and is plain apart from a small square owl hole below the apex.

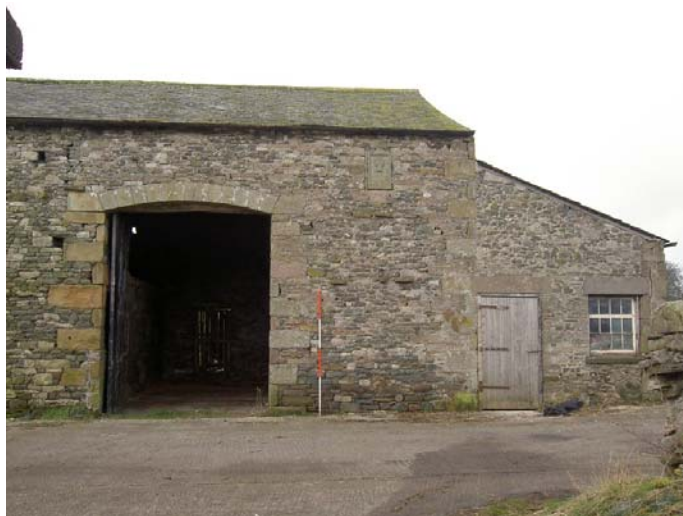
Plate 7: North end of the east external elevation

4.2.2 **East elevation (Fig 3):** at the north end the monopitch outshut butts the building to the south, the corners of which are finished with dressed quoins (Plate 7). At the north end of the elevation, at first floor level, there is a stone plaque with a moulded frame built into the wall decorated in relief with a depiction of a sheaf of corn, with the initials WC and C and the date 1835 (Plate 8). South of this is a large wagon doorway, with a neatly dressed flat stone arch and dressed quoins. There are a series of small square vents at first floor level to the south, and a single ground floor window with a 12-light casement (the top four lights hinged), a stone lintel, and a concrete sill. Rebuilding around the north jamb suggests that it has been inserted. To the south of this there is a doorway blocked with stone with a stone lintel and the scar of a canopy roof evident as a line of concrete render. Above a row of quoins corresponding to the line of the south jamb indicates the butt joint between the central section and an extension to the north. South of this on the ground floor there is another, extant, doorway, with a stone lintel and rebuild around the south jamb, suggesting it is inserted, and a sliding metal door. Above is a small window with a

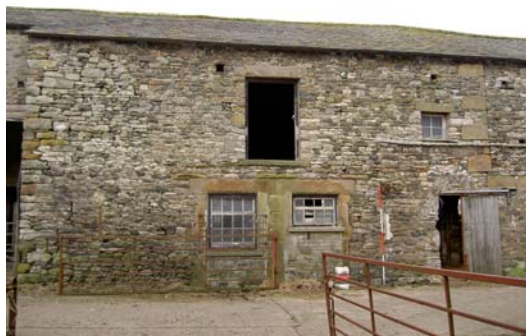
Plate 9: Central section of the east external elevation

4.2.3 In the centre of the central section of the elevation there are two ground floor doorways, each with stone lintels and neatly dressed quoined jambs finished with a chamfer (Plate 9). This is partially obscured, however, as the lower part in each case has been blocked with stone to form a window. That to the north has an eight-light casement, with the top four hinged, while that to the south has a 12-light casement, again with the top four hinged. Above these paired doorways is a more basic pitching door with a rough stone lintel and sill and a timber frame (Plate 9). South of the ground floor doorways is a narrow blocked winnowing slot.

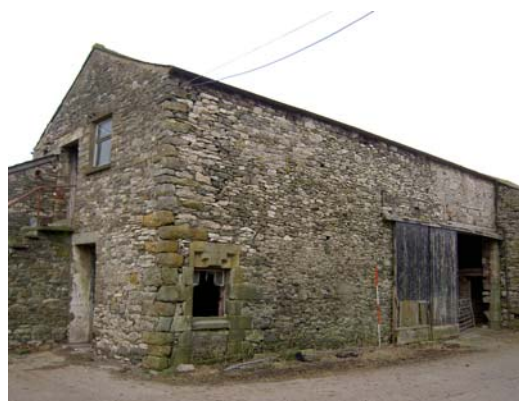
Plate 10: South end of the east external elevation

4.2.4 The south end of the elevation is formed by a large threshing barn, which is slightly narrower than the north end of the block (Plate 10). At the return there is a large wagon doorway, which has neatly dressed quoins finished with a stop-chamfer decoration at the base (Plate 11). The lintel comprises a large piece of sawn timber and has a rail for a large plank-built sliding door, which is positioned against the wall to the south. A row of holes for joists to support a canopy roof over the wagon doorway is evident, as are two narrow slot vents at first floor level and at least one more on the ground floor, which is blocked. At the far south end there is a pedestrian doorway with neatly dressed chamfered quoins and an embattled lintel with the date 1701 and the initials WA and B (Plate 12). Again the chamfer is obscured due to the

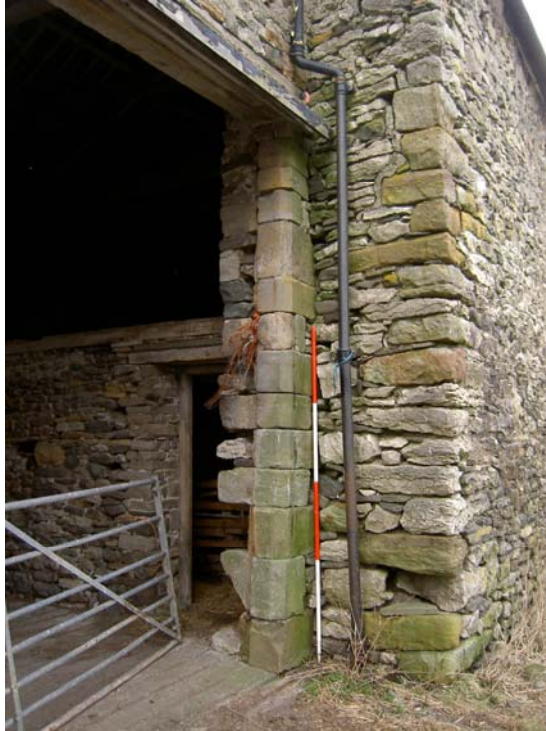
Plate 11: Detail of chamfered surround to wagon doorway, south end of east elevation

lower part having been blocked to form a window, but the quoins have the same stop chamfer evident in the wagon doorway to the north. The remains of a 12-light casement are still *in situ* within the window.

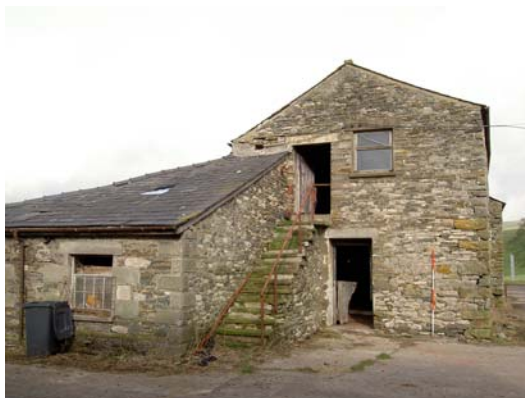
Plate 13: South external elevation, showing the stairs to the first floor

4.2.5 **South elevation (Fig 2):** this forms the opposing gable of the range of buildings, although, like the north end, it is also obscured by later additions. The main building has rough quoins at the corners, and there is a staircase topped with stone steps and with an iron hand rail along the east side west of centre leading to the first floor (Plate 13). Adjacent to the east side of this staircase, on the ground floor, is a doorway, with a concrete lintel, the east jamb of which has possibly been rebuilt, suggesting it is inserted.

4.2.6 On the first floor there is a doorway at the top of the staircase; this too has a concrete lintel and evidence for rebuilding in the jambs suggesting it is inserted. To the east of this is a window, again with a concrete jamb and evidence of rebuilding. It also houses a modern two-light timber casement. It is noticeable that all of the apertures in this elevation have utilised a pinkish-grey sandstone where the jambs have been rebuilt, which does not appear to be common elsewhere on the site. The lower west side of the elevation is extended by the addition of a monopitch outshut that extends around to the west elevation. It has a grey slate roof, laid in diminishing courses and a single skylight. The corners are finished with moulded concrete quoins and there are two windows, both with concrete sills, lintels, and quoins, and the remains of 12-light timber casements (Plate 14). An iron gutter is attached below the eaves.

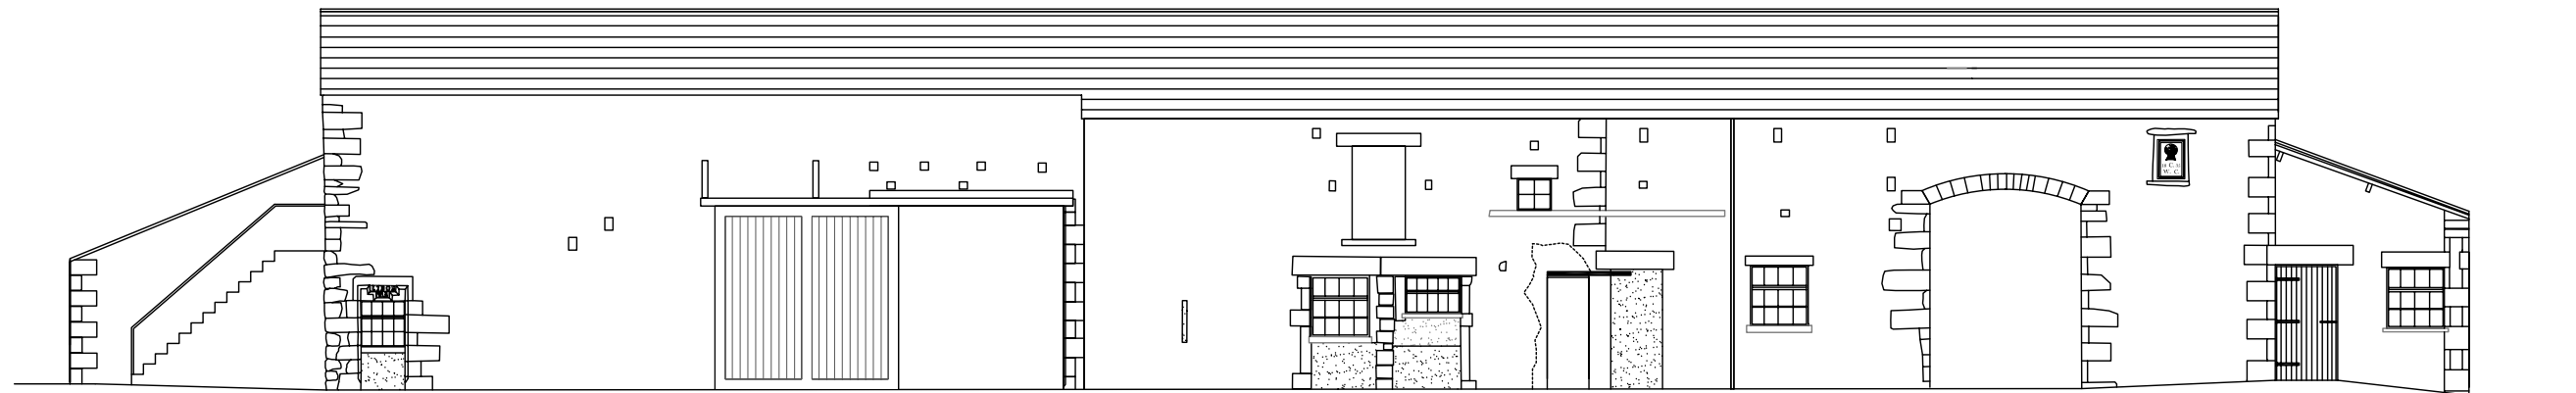
Figure 3: East and west external elevations

4.2.7 **West elevation (Fig 3):** the majority of the south end is obscured by the attached monopitch outshut, the roof of which almost extends across the entire first floor and houses four single-light skylights. The visible upper part of the elevation is finished with a roughcast render and has a row of four small gridded vents below the eaves, plus another where the wall returns to the west. On the ground floor, within the elevation of the outshut there are three pedestrian-type doorways and two windows, one with a six-light casement, all of which have concrete lintels, sills, and quoins (Plate 15). To the north there is a larger doorway with a heavy timber lintel, which is partially decayed, that has been half filled with modern concrete blocks. There is a barge board beneath the eaves, attached to which is an iron gutter. The north end of the outshut returns to the east and has a window with a stone lintel and sill and the remains of a 12-light timber casement, the top four of which are hinged.

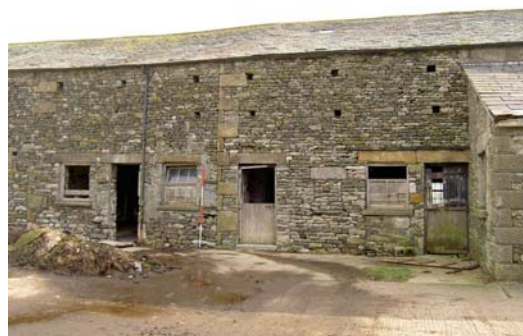
Plate 16: Central section of the west external elevation

4.2.8 Within the central section of the elevation, to the north of the outshut, there is a pair of adjacent ground floor doorways with stone lintels, the northern of which is chamfered on the underside and has been partially blocked to form a window, with a concrete sill and the remains of a 12-light(?) casement (Plate 16). The southern doorway has a split plank door. There is a small aperture to the north of these doors on the ground floor, unusually with a limestone lintel and a narrow sill, which has been blocked with stone. North of this is another doorway with a concrete lintel and evidence for rebuilding in the southern jamb. Above there are two rows of square vents. To the north is a line of quoins denoting the end of one phase of building, which is butted against by the continuation of the line of the structure. Within this section there are two ground floor windows, the southern of which has a chamfered stone lintel, concrete sill, and six-light casement. The northern window has a concrete sill and lintel and there is a doorway between them with a concrete lintel. Above all of these there are five more square vents. Another partial row of quoins is

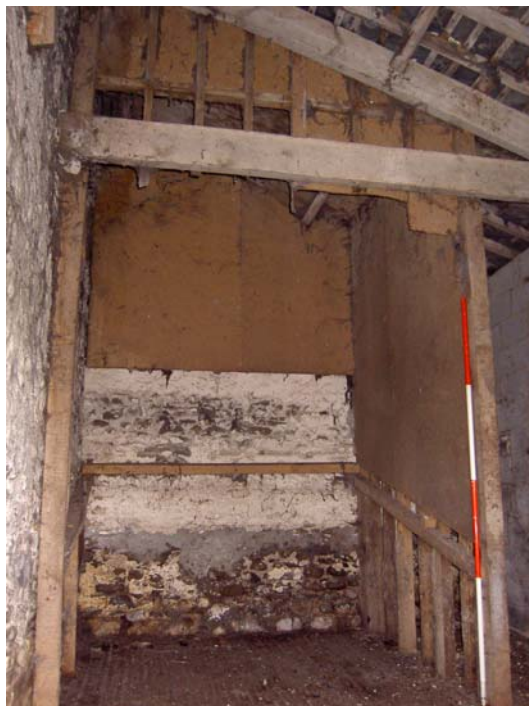
Plate 17: Interior of east side of north outshut showing modern timber structure

4.3.2 **Outshut, north end:** this is divided into two halves, to the east and west. The east side has a grooved ceramic block floor and a monopitch roof supported by a single half tie beam truss and two purlins. Attached to the truss are modern upright posts forming a stud partition wall creating a small 'room' in the south-west corner with sloping battens on the north and south sides and a boarded 'roof' (Plate 17). The north elevation has a large section that has been rebuilt in concrete blocks. The east elevation has a window on the north side with a timber lintel and the wall butts the north elevation. There is a doorway to the south with a timber lintel and a plank and batten door. The south elevation, which forms part of the original external wall of the main barn, has some through stones projecting through it and there is a down pipe, probably extending from the external gutter. The west elevation is a diving wall, which butts the north and south elevations. It does not quite extend to the height of the roof and the gap is filled with board.

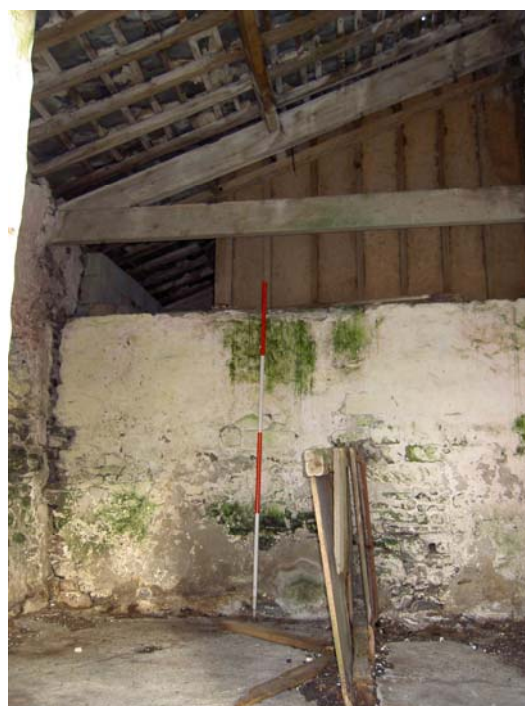
Plate 18: Interior of west side of north outshut showing stall partition

4.3.3 The west side of the outshut has a concrete floor, stepped up on the east side, with a dividing timber stall in the centre, orientated east/west and with an iron fitting attached (Plate 18). It is open to the monopitch roof and there is a half tie-beam truss on this side. All of the walls are finished with whitewash. The north elevation has a window with a timber lintel and a concrete skim over the sill. The west elevation has a doorway with a machine cut timber lintel, a timber surround finished with stop chamfer decoration, and a split plank door. The south elevation is plain, although there are some through stones, and the east elevation does not extend to the roof, as per the east side.

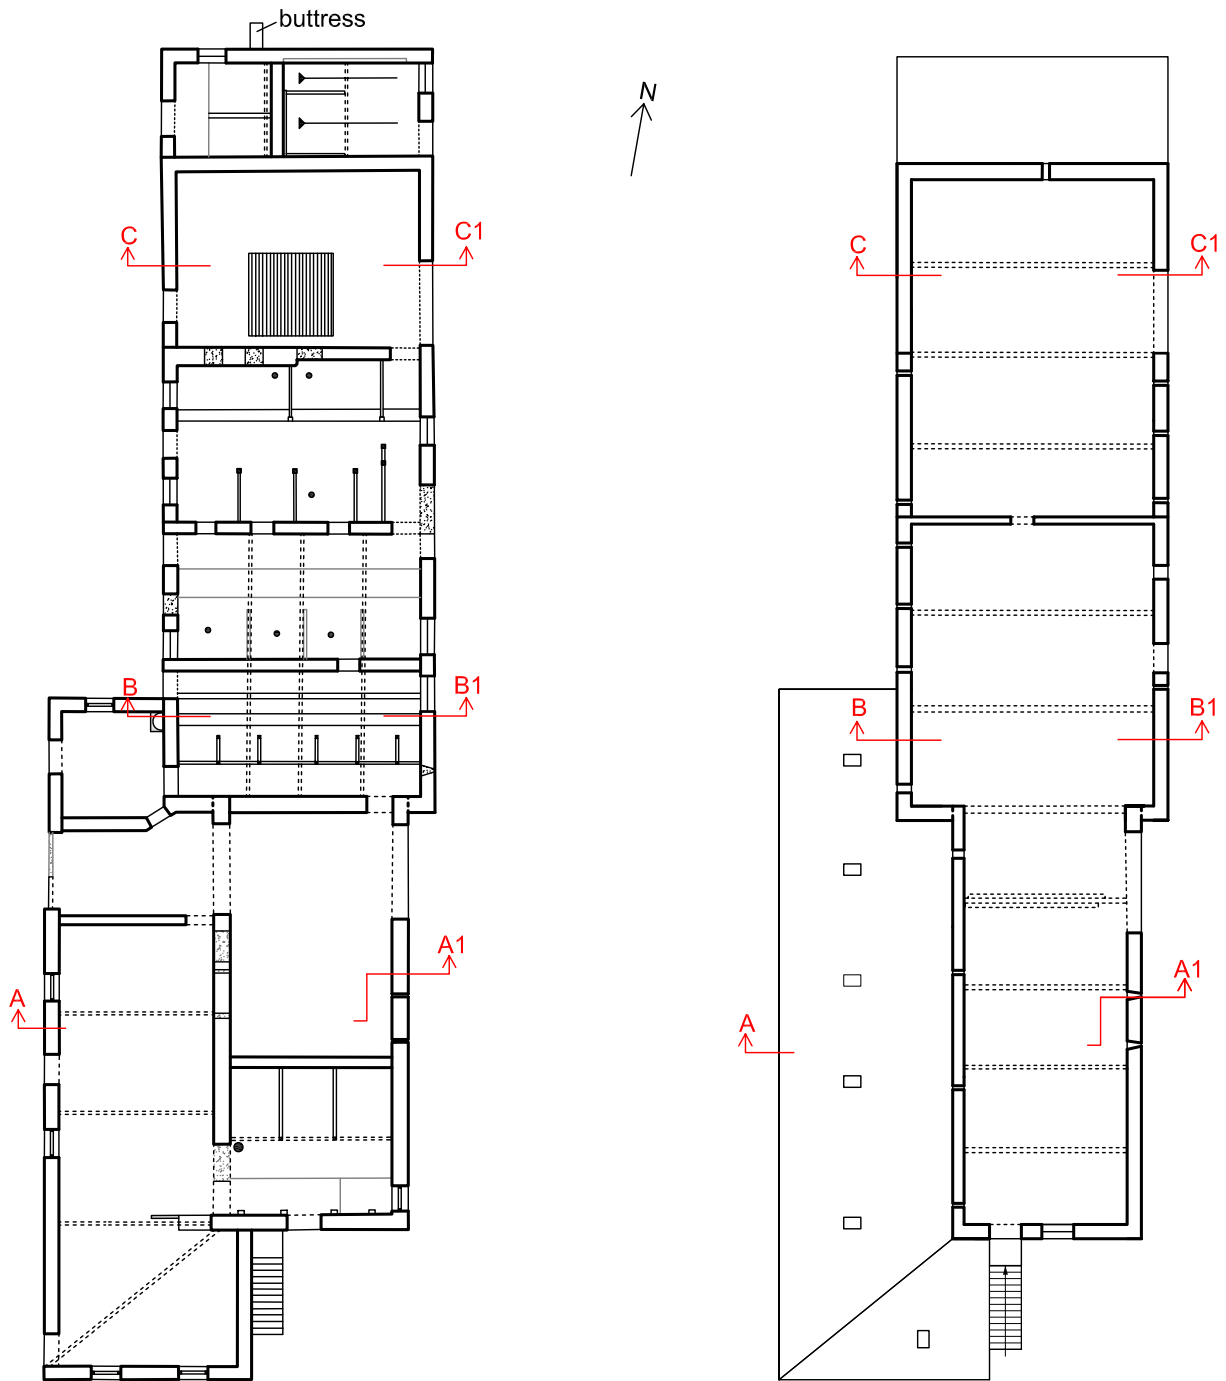
Figure 4: Ground and first floor plans

4.3.1 **Introduction:** the internal descriptions are divided between the various rooms that make up the interior of the buildings, and are described in order from the north to the south. As many of these are within later additions they inevitably include descriptions of what were originally external walls of earlier buildings. These are included in this section for convenience, and to avoid the need to consider the phasing of the building as part of the description.

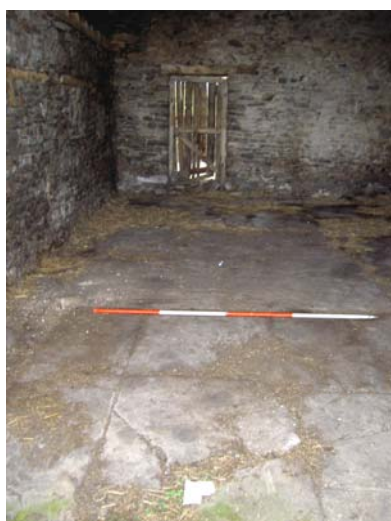
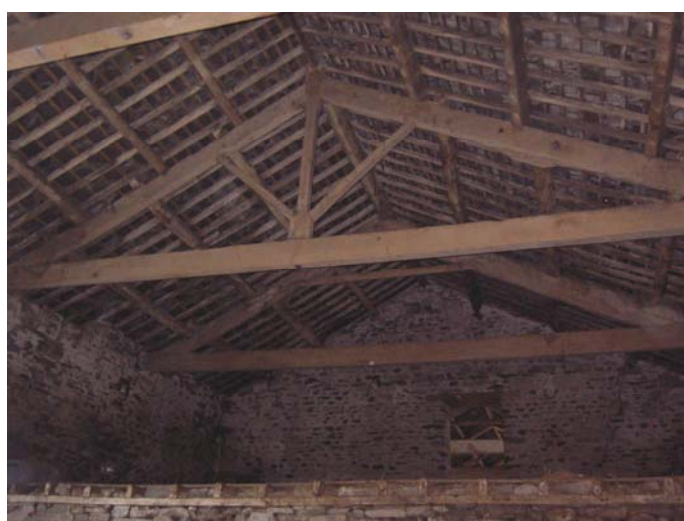
Plate 19: Stone and timber threshing floor within the north threshing barn

4.3.4 **North threshing barn:** this has a stone flag floor in the centre, with a central threshing area constructed from tongue and groove timber boards (Plate 19). It is open to the roof, which is supported by three trusses (Fig 5); the two at the north end have king posts, which are bolted to the tie beams, and angled braces, all of which are sawn and adze finished (Plate 20). An additional thick plate with curved sides has been bolted to the principal rafter of the southernmost of these two trusses, apparently to support the purlins. There are three purlins per pitch at the north end of the room, all of similar timber. The southern truss is a more basic tie beam type with a thin collar, the principal rafters being notch-jointed. All of the purlins and the truss at this end are more roughly finished. The ridge purlin at the north end is an edge-set plank, while at the south it is diagonally set and square. The room is divided by a low wall roughly south of the centre, which supports a hay loft on the south side over a shippon. This wall has a blocked doorway or window and two further blocked windows, all with rough hand-finished lintels on the west side, and an extant doorway on the east side with a timber lintel and a beaded tongue and groove door and chamfered surround. The wall proper to the south, above the level of the hay loft, is plain except for a doorway linking it to the hay loft in the next room to the south, which has a timber lintel. The north elevation is plain, except for an owl hole below the apex, and the east elevation has a large wagon doorway with a rough timber lintel and half of a plank and batten door. The west elevation has a small doorway in the centre, with a rough timber lintel, plank and batten door, and crude chamfered surround. There are square ventilation slots over the hay loft in the east and west elevations.

Plate 20: King post truss within the north threshing barn

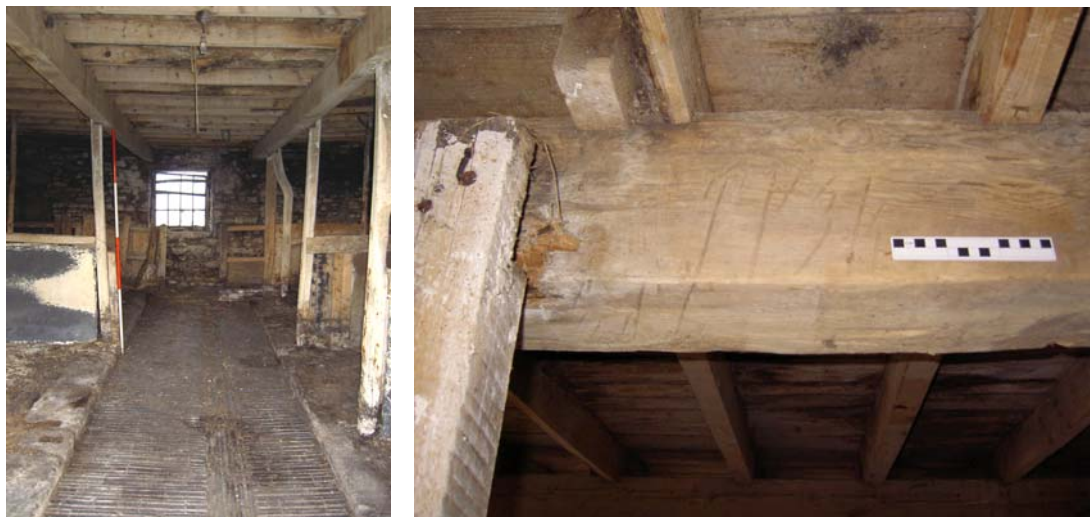
Plate 21: Stalls and dung channel within the north shippon

4.3.5 **North shippon:** below the hay loft contained within the northern threshing barn is a shippon with a grooved ceramic block floor forming a central dung channel orientated east/west with the raised sides to the north and south finished with

Plate 22: Baltic timber marks inscribed into a beam within the ceiling of the north shippon

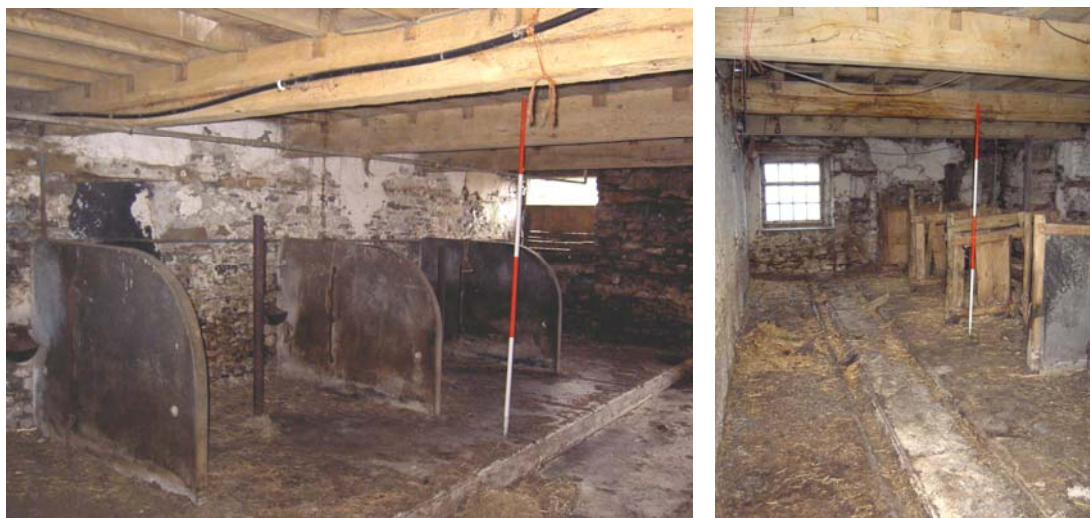
Plate 23: Concrete stall partitions in the north central shippon

4.3.7 **North central shippon:** this is the northern of two shippons formed within a pair of shippons in a single block north of the centre of the building. It has a concrete floor with a dung channel orientated east/west and on the raised floor on the south elevation there are three concrete stalls with iron posts (Plate 23). The ceiling is supported by three stop-chamfered beams orientated north/south with holes for the original joists visible, which have been replaced with new ones. The beams are neatly hand-finished while the joists are sawn. The walls have traces of whitewash remaining. The north elevation has three openings and a doorway on the west side, as per the room to the north. The west elevation has a doorway on the north side with a sawn timber lintel, the southern jamb of which is rebuilt suggesting it is inserted. There is a doorway to the south that has been partially blocked to form a window and has a rough timber lintel. The south elevation has a long timber rail comprising three pieces scarf jointed together built into the wall, with empty peg holes throughout. There is a central aperture below this with a stone sill, and metal water troughs marked 'Sanford' are attached to the wall. The west elevation has a

Plate 24: Stalls and dung channel in the south central shippon

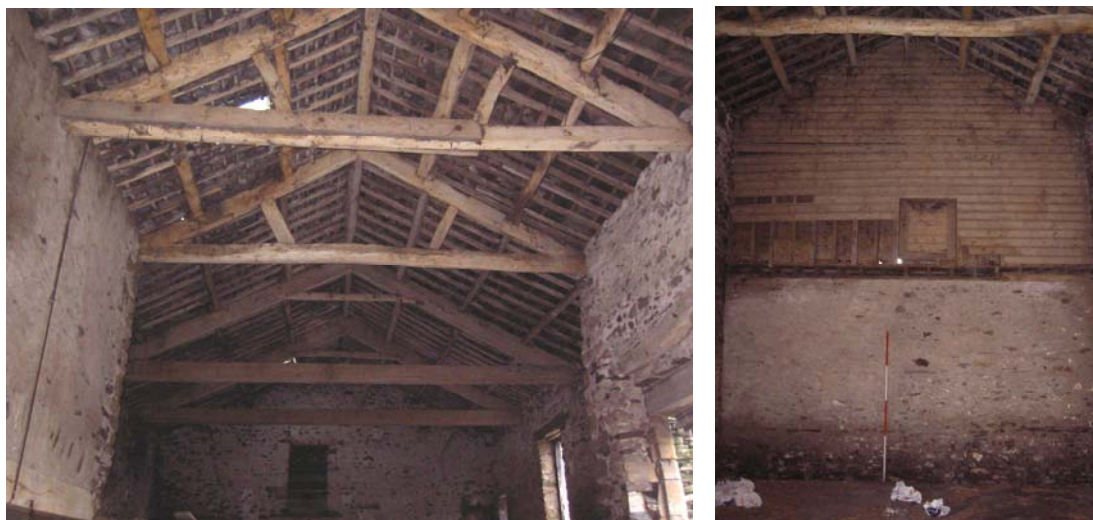
Plate 25: Trusses in the south threshing barn and above the south central shippon

4.3.9 South threshing barn: this is a large threshing barn at the south end of the range of buildings. It is open to the roof, and extends above the two shippons to the north as a hay loft. It has a concrete floor, which is grooved in the centre where it forms a threshing floor. The southern part of the roof is supported by three tie beam trusses the principal rafters of which are notch-jointed together with an additional pair of curved angled struts between the tie beam and principals (Plate 25). All the timber is hand-finished and possibly re-used as there are some large relict joist slots with associated peg holes. The central one of these three trusses has supporting timber bolted to either side of the tie beam (one of which has Baltic timber marks), while the southern truss is missing its western strut. There are two purlins per pitch, and a diagonally set ridge purlin, all of which are hand-finished. To the north, above the hay lofts, there is another truss with a narrow collar, in the same style as those in the northern threshing barn (see *Section 4.3.4* above). The north elevation has a lower dividing wall forming the ground floor shippon (see *Section 4.3.7* above) and

Plate 26: Timber board first floor wall at the south end of the south threshing barn

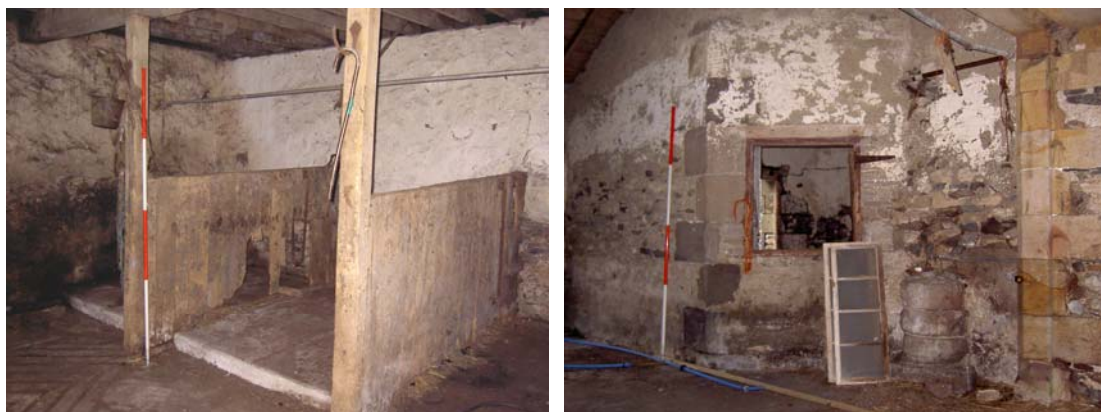
Plate 27: Stalls in the south shippon

Plate 28: Angled wall and stack of grindstones(?) adjacent to chamfered jamb of wagon doorway

4.3.11 **South shippon:** this has a grooved concrete floor with a dung channel orientated east/west with a junction forming a separate section north/south. There are two timber stalls on the north side on a raised section of the floor (Plate 27). There is a single beam orientated east/west supporting the joists, all of which are machine cut. The north elevation is low relative to the rest and a joist sits on top of it. There is a batten attached to the wall with troughs fixed to it, and it butts the east and west elevations. The east elevation has a window on the south side, formed within a blocked doorway with a re-used timber lintel and a concrete skim over the sill. The south elevation has a number of stones projecting from it supporting a beam. There is a central doorway with a split plank door. The west elevation has a doorway on the south side with a sawn timber lintel and a batten attached to the wall with timber hooks to the north.

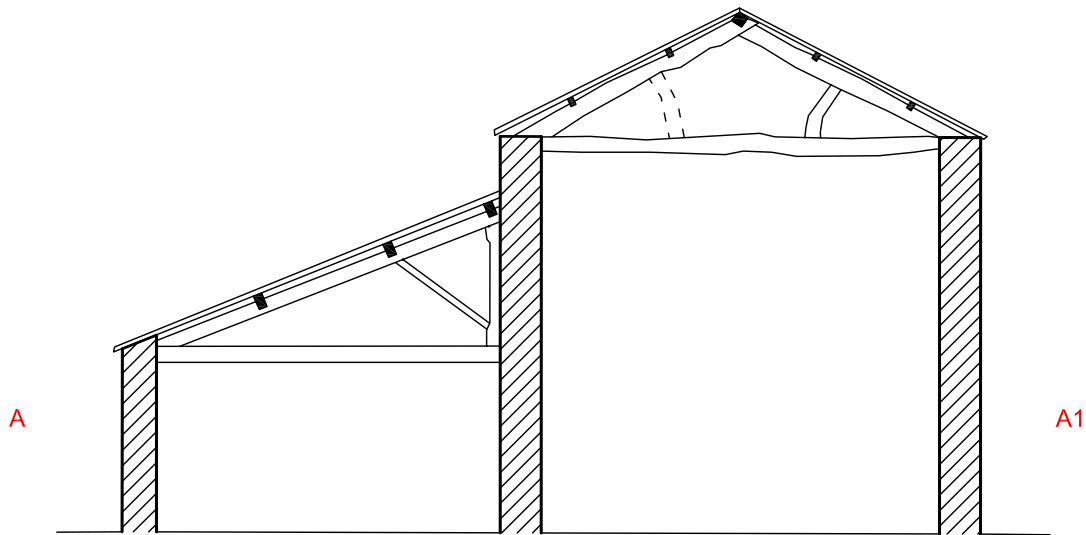
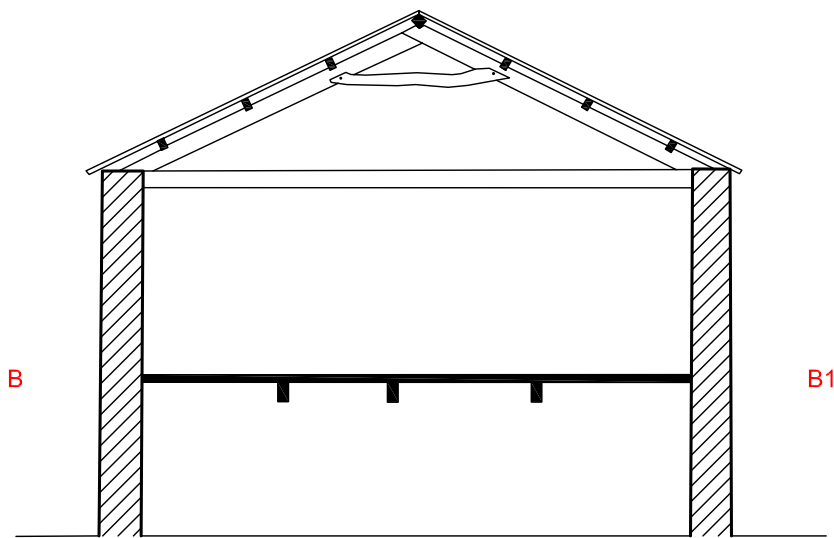
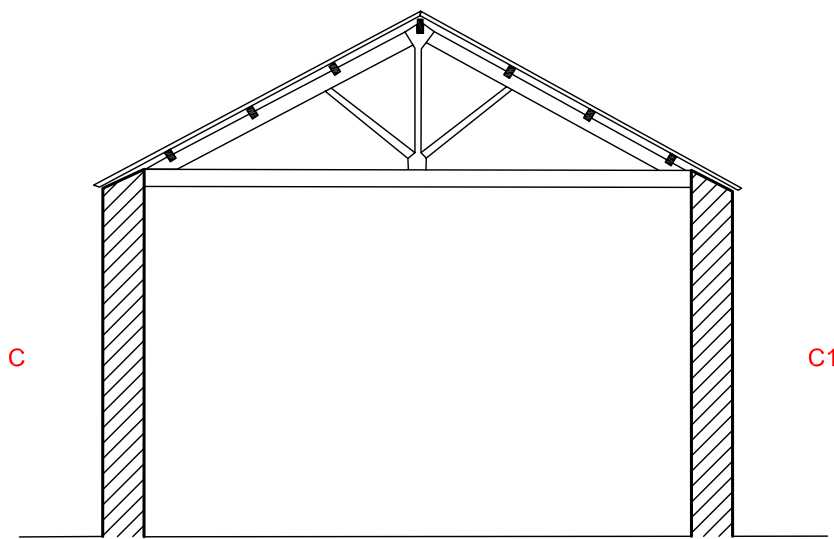
Figure 5: South-facing cross-sections

- ii. 'as existing' elevations of all external aspects, at 1:100;
- iii. in addition, a cross-section showing each of the three different types of truss was produced at a scale of 1: 50.

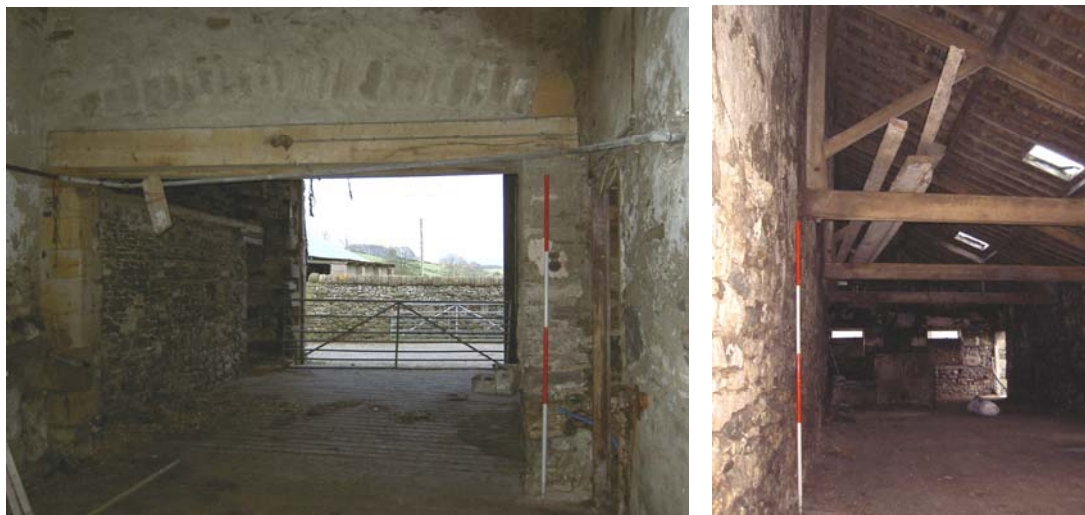
Plate 29: Wagon doorway from within small outshuts to west

4.3.12 **Small outshuts to west:** this effectively forms part of the large outshut extending around the south-west corner of the building, although this part appears to have originally been a separate structure comprising two small rooms. The southern room has a concrete floor and a monopitch roof structure continuing from that to the south (see *Section 4.3.14* below). The north elevation comprises an angled section on the east side, the corner of which is finished with neatly dressed quoins. Immediately to the west is a window with a sawn timber lintel and surround, below which is a metal water trough sat on a stack of semi-circular stones, perhaps old grindstones (Plate 28). The east elevation is dominated by a wagon doorway, which has a flattened round stone arch beneath which is an inserted timber lintel (Plate 29). The quoins forming the northern jamb of the door are finished with a stop chamfer decoration (Plate 28). The south elevation has a doorway on the east side with a sawn timber lintel and surround. The west elevation appears to have been placed against the east and west walls and has a large doorway in the centre with a re-used hand-finished lintel, which has been partially blocked with concrete blocks leaving a slightly narrower opening.

Plate 30: Half trusses in the south-west outshut
