# DALE STREET SCHOOL, LUND TERRACE, ULVERSTON, CUMBRIA

Archaeological Building Recording

Client: Capita Symonds  
Planning Ap. Ref: 5/08/9001  
NGR: SD 2938 7819

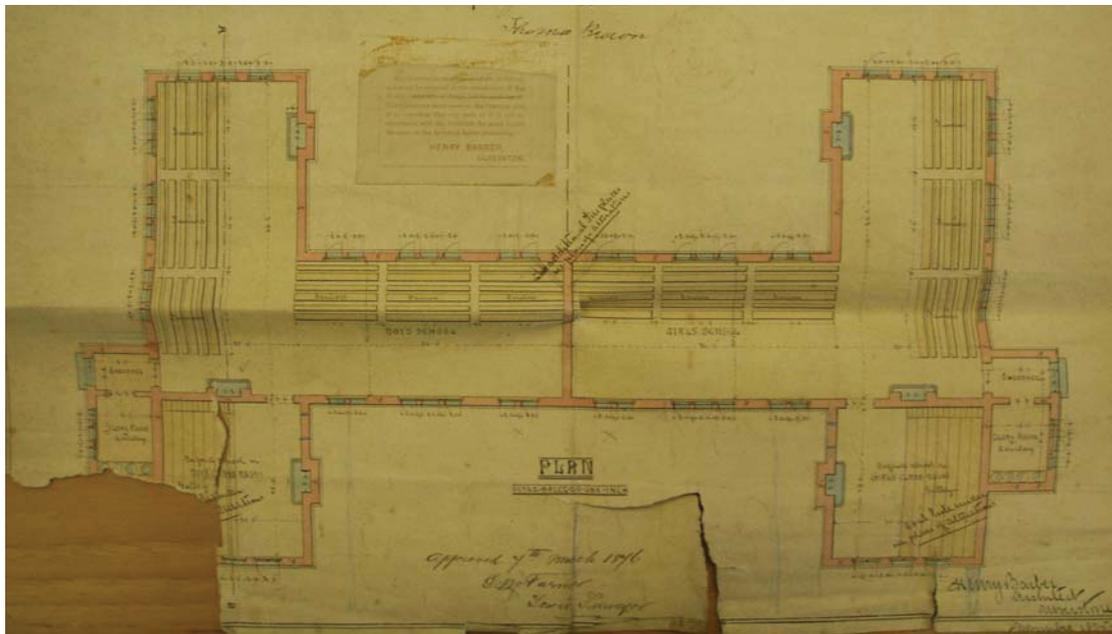
**Plate 1: Original ground floor plan of the building by Henry Barber dated November 1875 (CRO(B) Z1041 1875-1904)**

3.2.2 **Original Plans, 1875:** the school, as initially proposed, was designed by Henry Barber of Ulverston, the plans dated November 1875 (CRO(B) Z1041 1875-1904). The original building comprised a symmetrical H-shaped structure containing the classrooms orientated north-east/south-west parallel to Lund Road (now Lund Terrace), with small projecting sections on either end forming the entrances with attached cloakrooms and toilets (Plate 1). The roof plan shows that two of the windows in the front elevation were topped with dormer gables and one each in the side elevations and there are six chimneys corresponding to the fireplaces shown on the ground floor plan (Plate 2). The front elevation shows the type of detail utilised in the original building, including grouped pointed 'Gothic' arches over the main

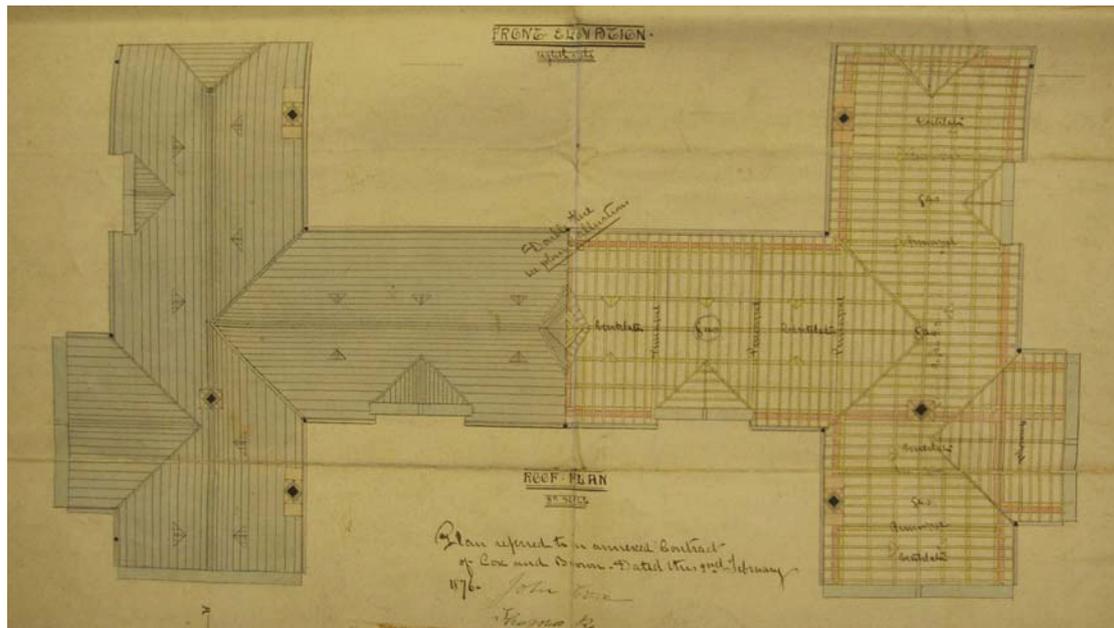
Plate 2: Original roof plan dated November 1875 (CRO(B) Z1041 1875-1904)

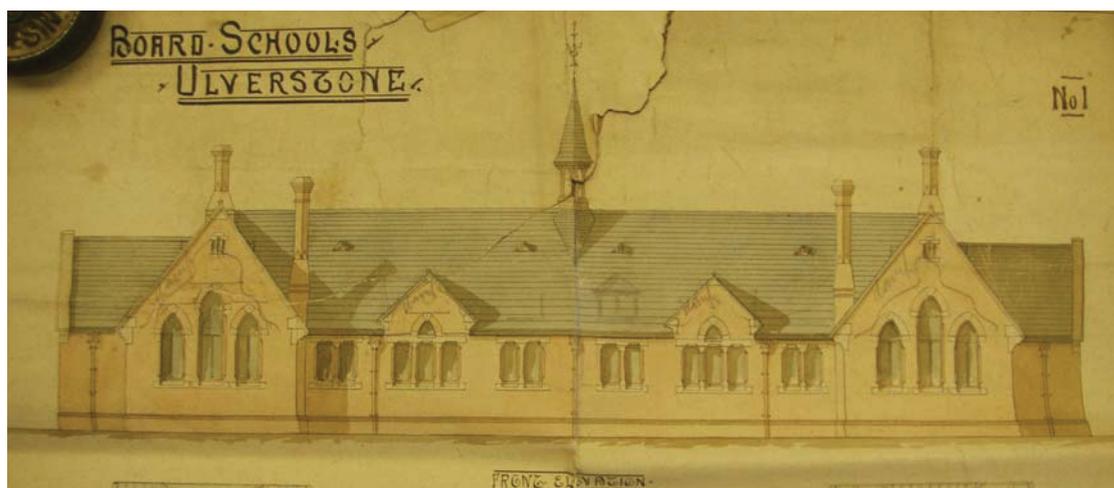
Plate 3: Front (south-east) elevation as shown in the original drawings of 1875 (CRO(B) Z1041 1875-1904)

windows and decorative diagonally-set chimneys and a tall almost spire-like lantern (apparently used for ventilation) in the centre (Plate 3).

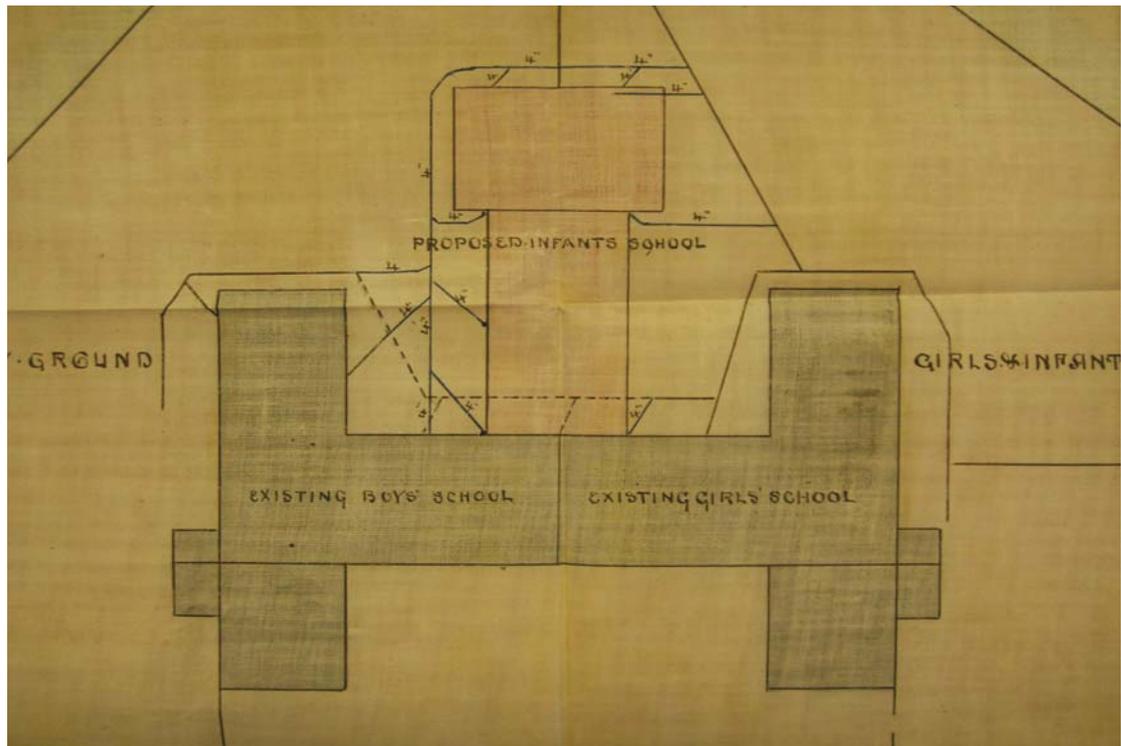
**Plate 4: Proposed plan of infants department from 1886 (CRO(B) WSUD/U/574 1886)**

**3.2.3 Alterations, 1886:** it is evident that the initial building was soon enlarged as plans for a proposed 'Infants Department' were drawn, again by Henry Barber, although this time he is described as being from Manchester (CRO(B) WSUD/U/574 1886). These plans included the addition of a large block projecting from the centre of the rear (north-west) side of the building (Plate 4). Only a block plan of this was available with no elevations, although a subsequent plan provides more detail (see *Section 3.2.5* below).

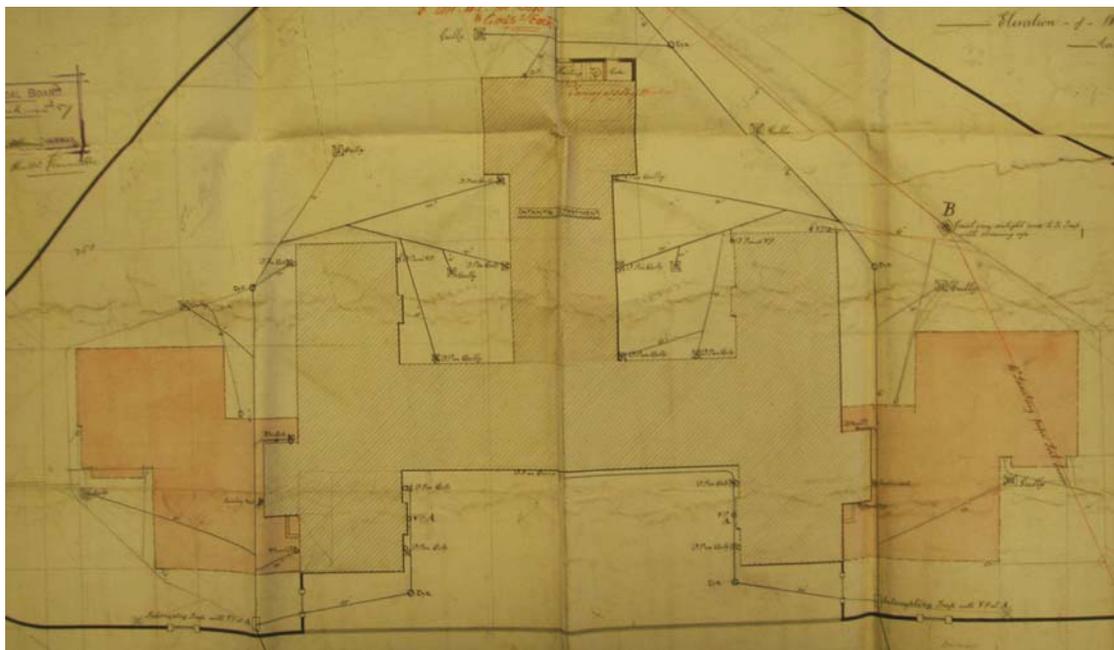
**Plate 5: Plan of 1887 showing proposed additions to north-east and south-west wings (CRO(B) Z1041 1875-1904)**

**3.2.4 Proposed alterations, 1887:** plans dated March 4<sup>th</sup> 1887 appear to show a series of proposed alterations to the building, principally concerning the construction of a new toilet block to the rear (north-west) but also showing additions to the north-east and south-west wings (Plate 5). It is evident that although the new toilets were built, the other additions were not, although similar ones were made subsequently (see *Section 3.2.5* below). These additions were made by JW Grundy Architect of Ulverston, whose practice was responsible for all subsequent changes up to 1904.

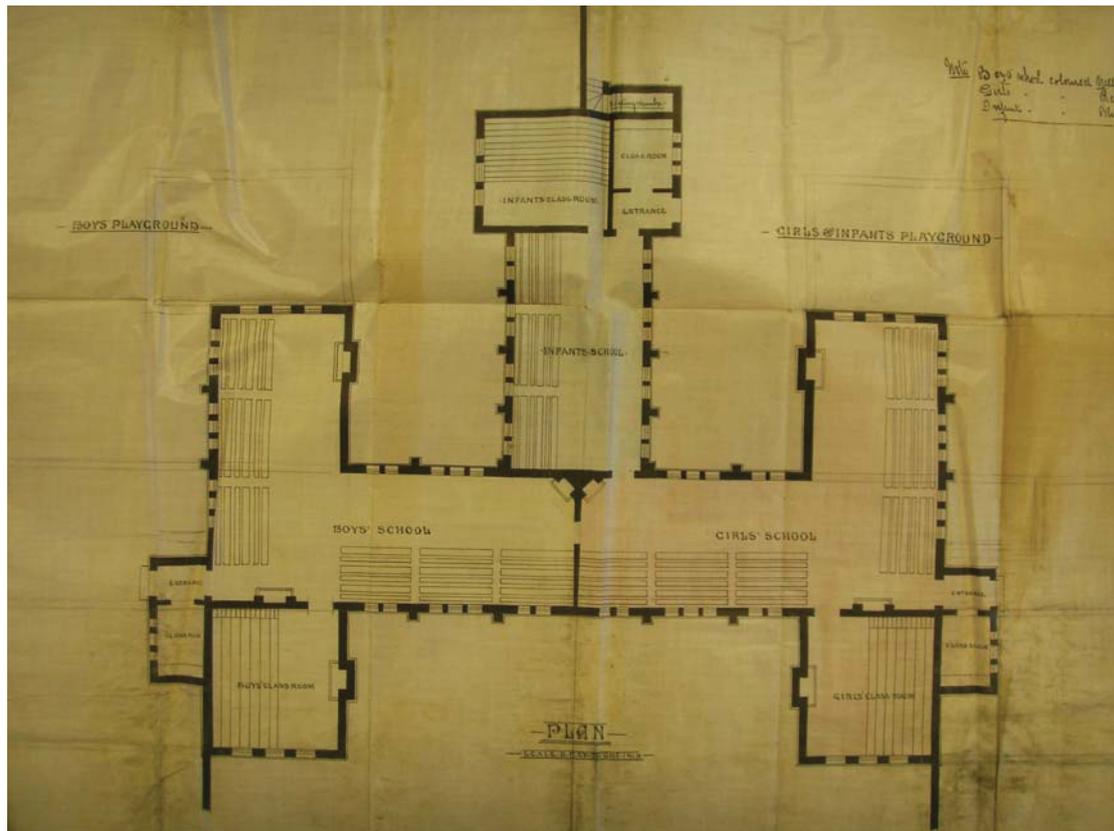
**Plate 6: Plan of 1888 showing the building as existing at that date including the basement access at the north-west end (CRO(B) Z1041 1875-1904)**

3.2.5 **Block plan, 1888:** this plan does not appear to relate to any further proposed alterations to the building and shows the building as existing at this time in some detail (Plate 6). It is useful in showing the arrangement of the building, and reveals the presence of a basement access at the north-west end of the projecting central section added in 1886, gives the names of the rooms, and even shows the arrangement of the desks.

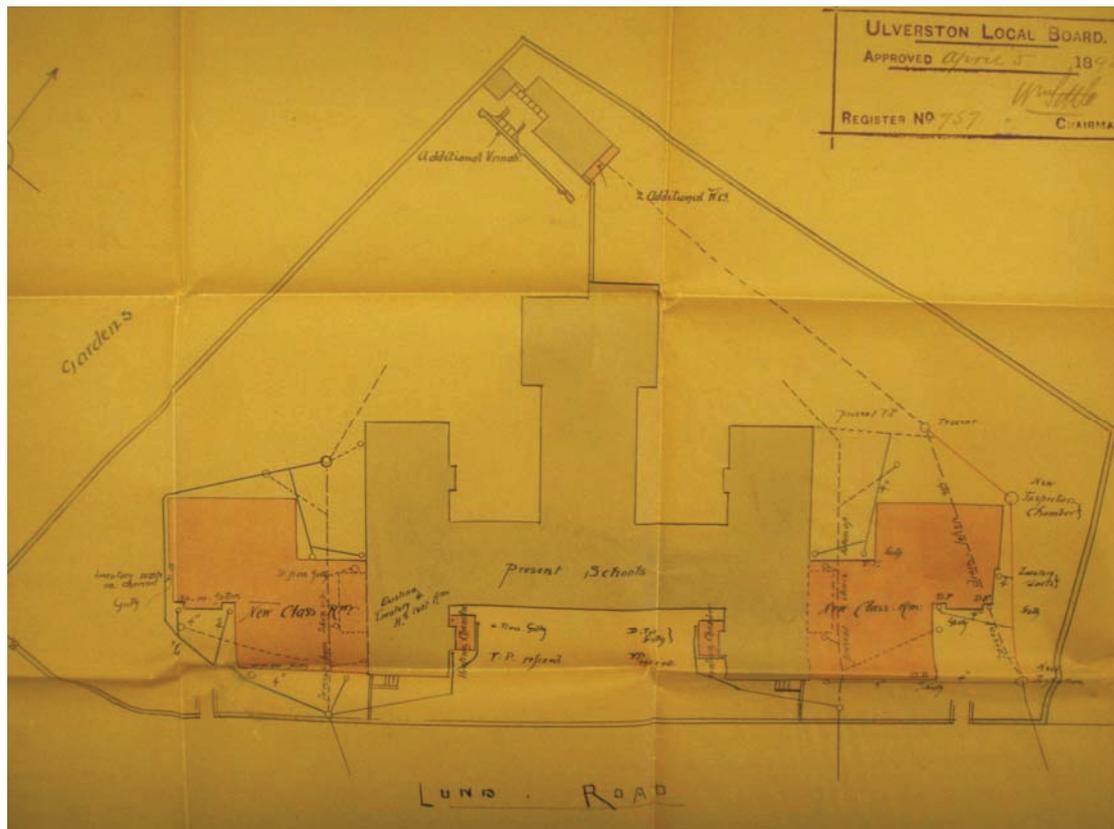
Plate 8: Block plan of proposed additions dated 1891 (CRO(WSUD/U/757 1892)

3.2.7 **Proposed plans, 1891:** the proposed additions drawn up by JW Grundy in 1887 (see Section 3.2.4 above) were revised and there are plans dated June 4<sup>th</sup> 1891, which were approved on the 5<sup>th</sup> April 1892 (CRO(B) WSUD/U/757 1892; Plate 8). Additional plans of the same phase of work are also present in the collection of

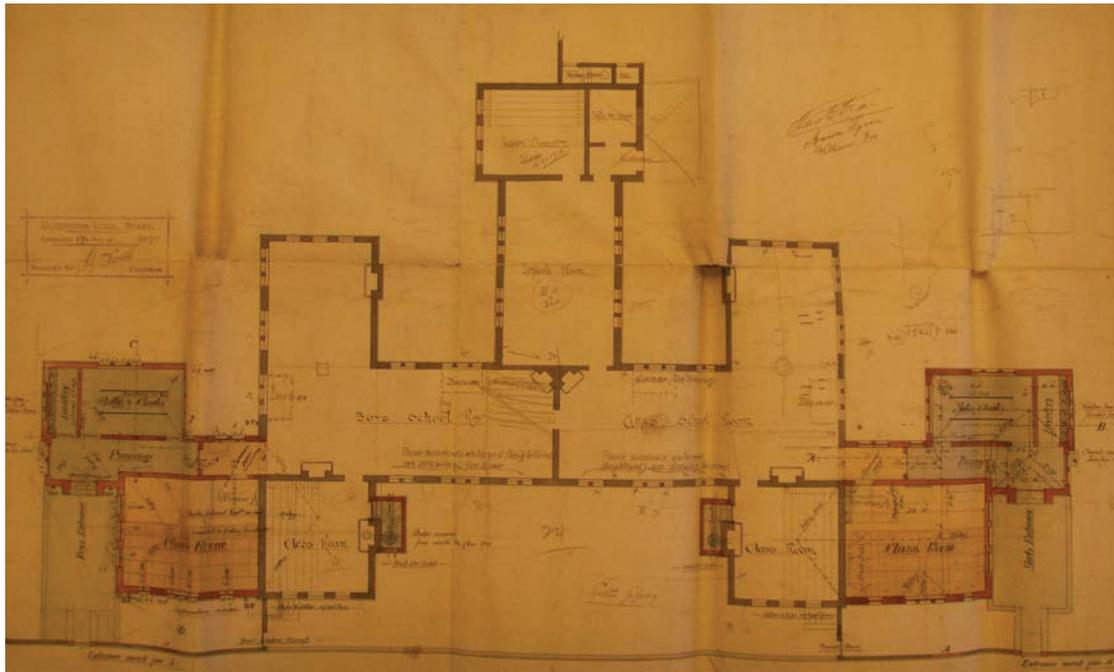
Plate 9: Detailed plan of the proposed additions, 1891 (CRO(B) Z1041 1875-1904)

documents relating specifically to Grundy's work at the site (CRO(B) Z1041 1875-1904; Plates 9-16). These show in considerable detail the proposed addition of new classrooms, cloakrooms and entrance lobbies at either end of the front of the building. Amongst the documents relating to JW Grundy are several letters of tender for carrying out the alterations and details of the specifications, these indicate that the stone used in the new extensions, including the panels labelled 'GIRLS' and 'BOYS', was to be Prudham stone. Tenders were also received from several local companies including TF Tyson and Sons, builders and stonemasons, for the fitting of slate boards to the walls, Penningtons, blacksmiths and agricultural machine makers, for railings (said to be '*with standards similar to those before the County Hotel*' - they are also the same as those in the parish churchyard), and John Stones shutter works, for desks, slate boards, and other furniture.

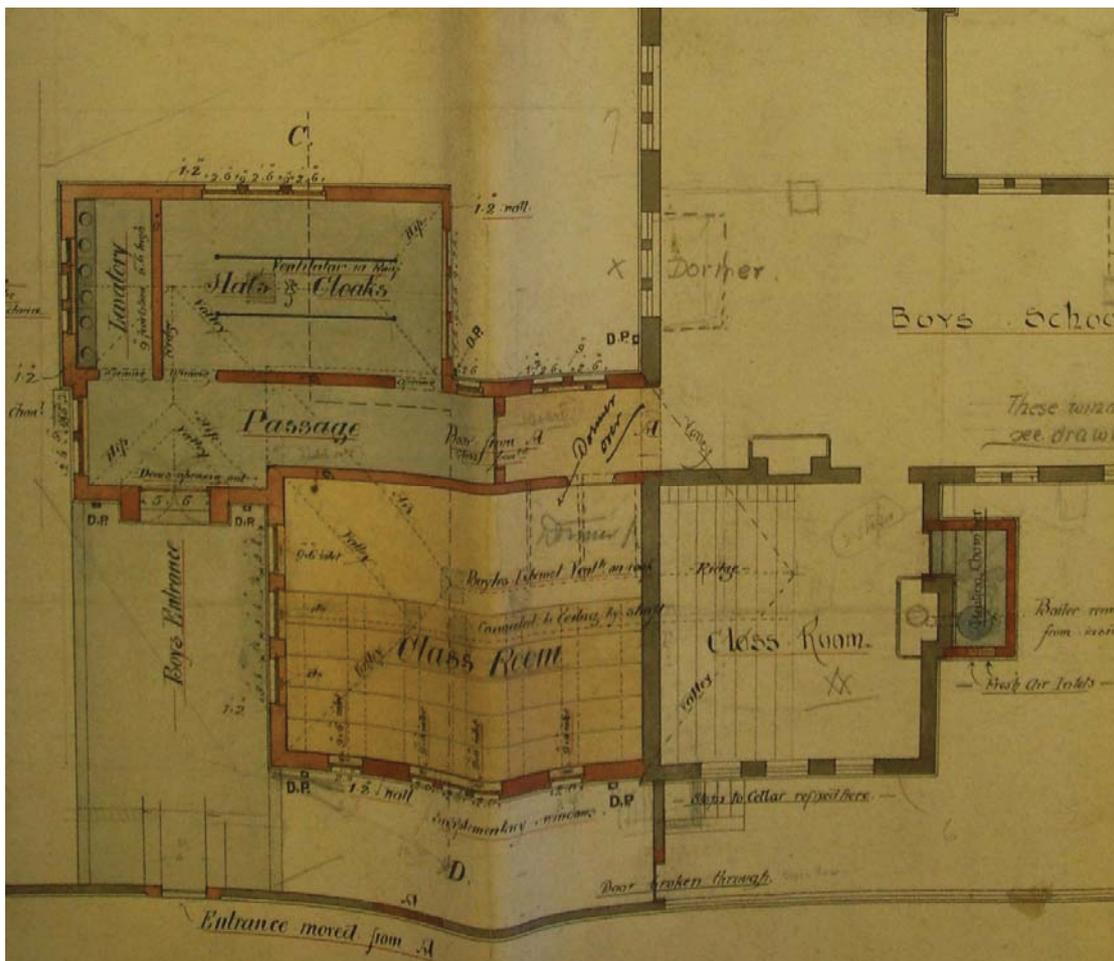
Plate 10: Detail of the proposed additions at the south-west end of the building, 1891 (CRO(B) Z1041 1875-1904)

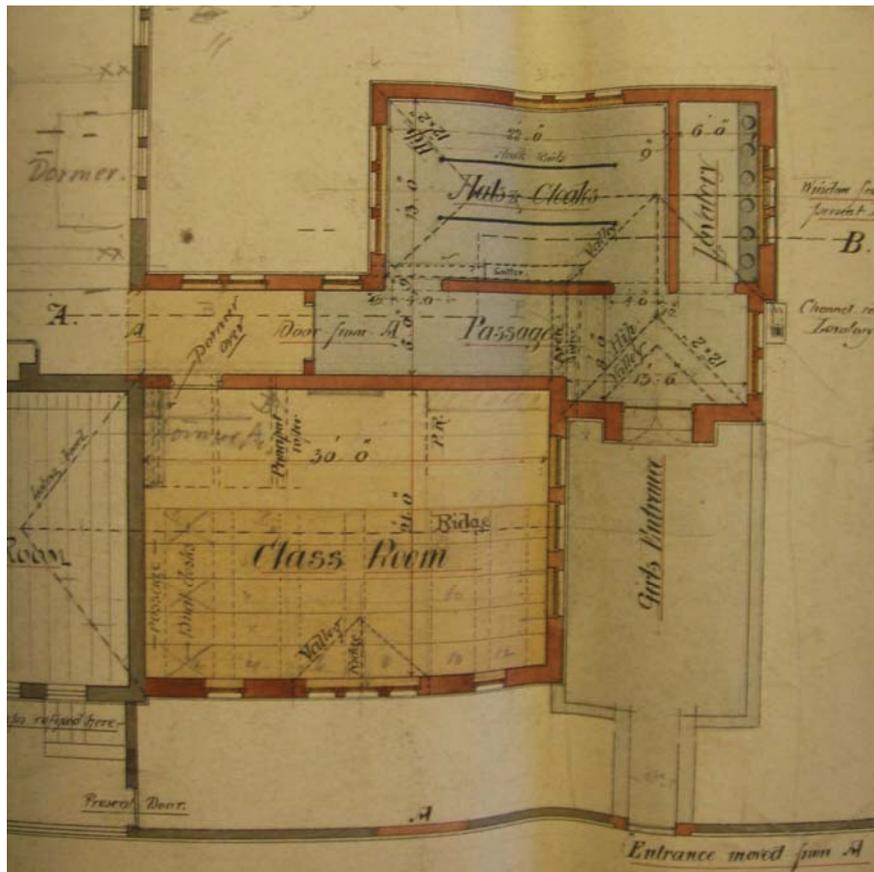
Plate 11: Detail of the proposed additions at the north-east end of the building, 1891 (CRO(B) Z1041 1875-1904)

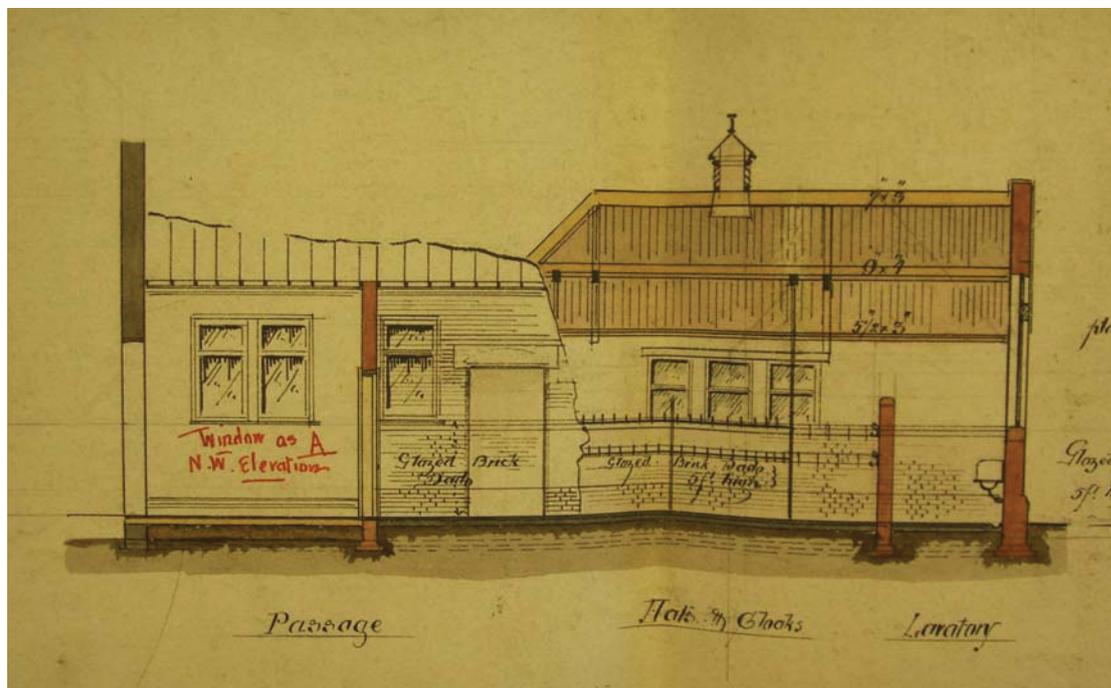
Plate 12: South-east facing section (A-B) through the proposed additions to the north-east end of the building (CRO(B) Z1041 1875-1904)

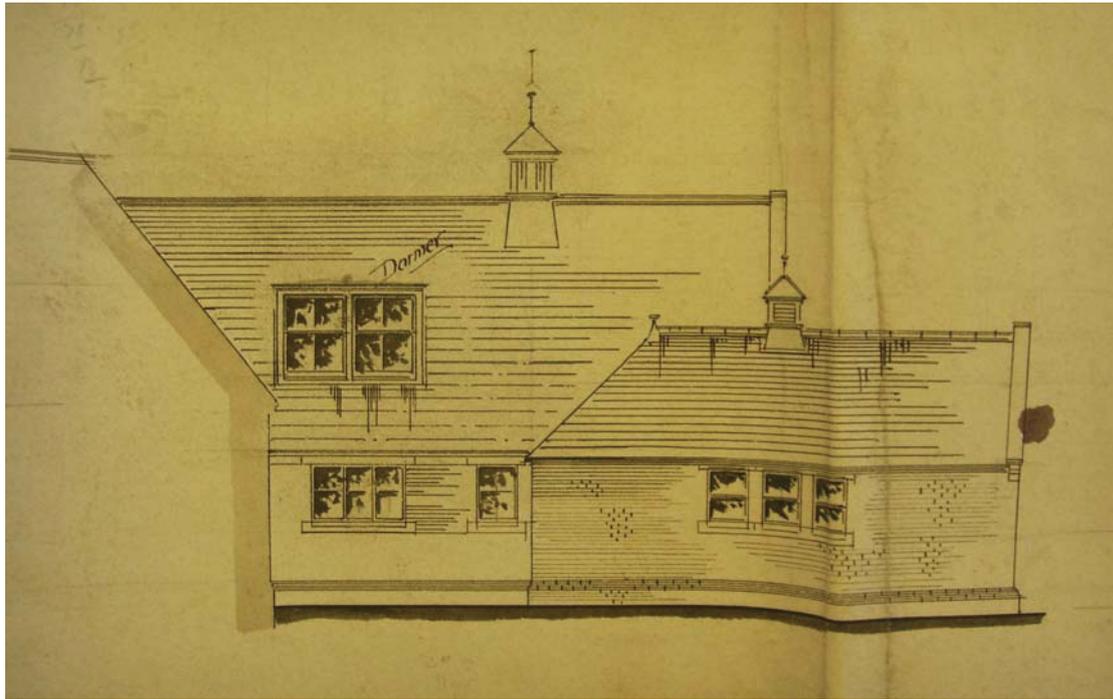
**Plate 15: North-west elevation of the proposed additions at the south-west end of the building, 1891 (CRO(B) Z1041 1875-1904)**

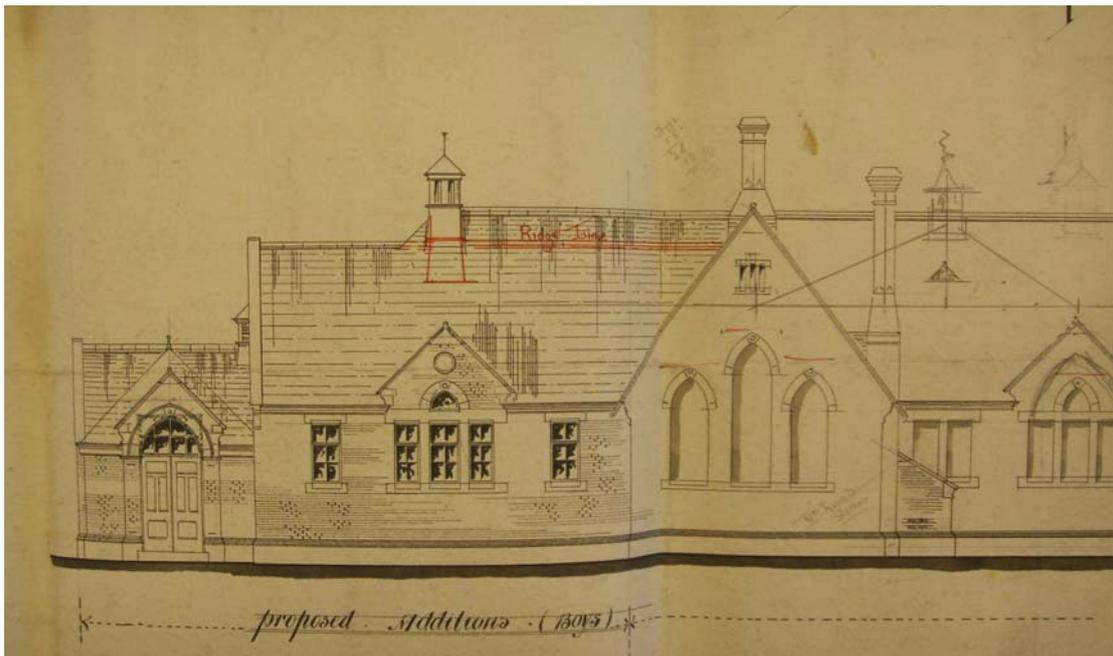
**Plate 16: South-east elevation of the proposed additions at the south-west end of the building, showing its relationship to the existing structure, 1891 (CRO(B) Z1041 1875-1904)**

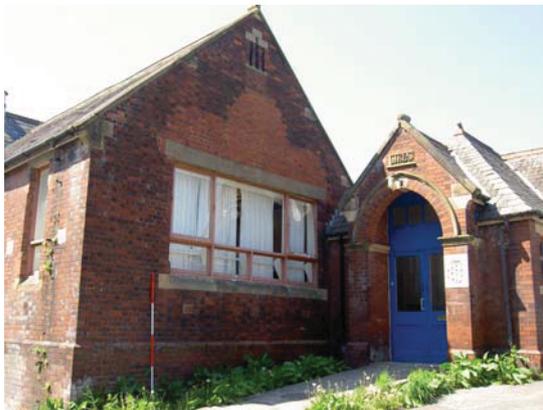
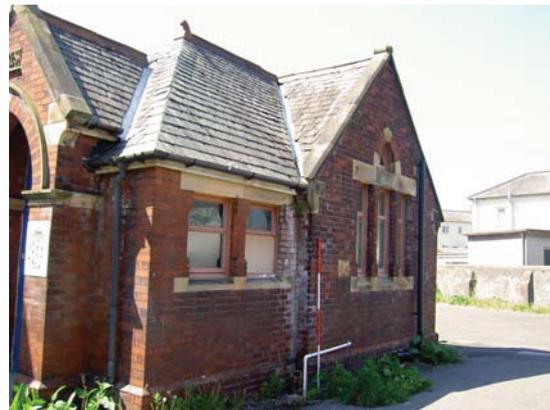
4.2.2 **North-east elevation:** this forms one end of the main part of the building and is made up of several sections. The south-east side is formed by the gable end of the main section of the building, and is constructed from brick laid in Flemish bond, with a chamfered plinth, incorporating several ceramic ventilators (Plate 19). There is a large eight-light window with a hinged casement and chamfered sandstone sill, and there is evident blocking above its concrete lintel denoting the position of what were evidently originally three arched tops. There are three slots, presumably vents, below the apex with stone lintels and the gable is finished with a stone coping with curved kneelers and a finial. The central section of the elevation comprises the side and gable of the entrance porch and corridor, which has two two-light windows with hinged casements and chamfered stone sills and lintels, and stop chamfer brick jambs (Plate 20). The gable has three two-light windows, also with chamfered sills and lintels, and a pointed Gothic arch above housing a single light window. The brick jambs are also stop chamfered, and the lintels and keystone of the arch are decorated with carved circular holes. The gable is again finished with stone coping with a round finial and scrolled kneelers (Plate 20).

**Plate 19: (left) South-east end of the north-east external elevation**

**Plate 20: (right) North-west end of the north-east external elevation**

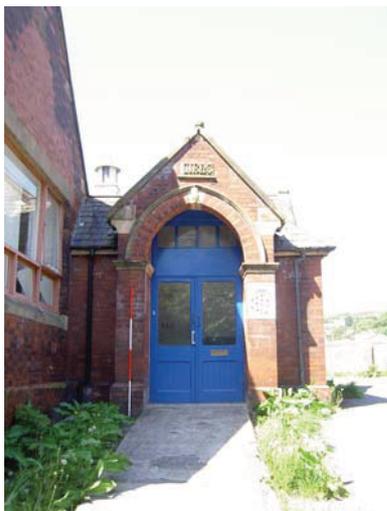
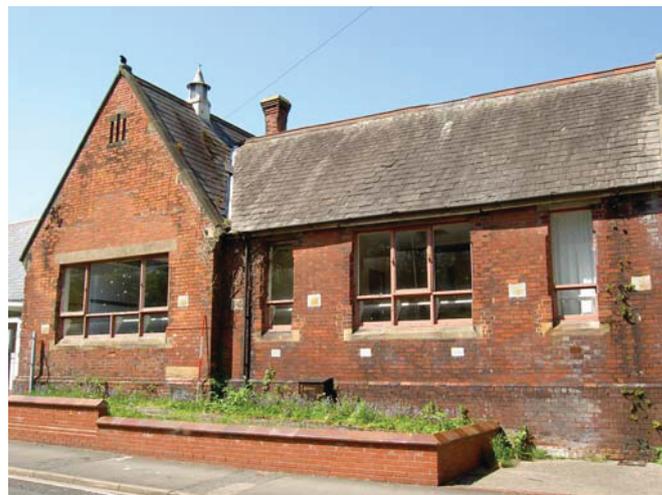
4.2.3 **South-east elevation:** this forms the front of the building, extending between the porched entrances at the north-east and south-west ends. The north-east entrance is gabled, with stone coping including a round finial, and has a stone plaque labelled 'GIRLS' (Plate 21). Beneath this is a large doorway with a pointed Gothic arch finished with decorative edge-set brickwork and a stone hood mould and flanked by flanking walls forming columns topped with cyma moulded stone cornices and with scrolled kneelers above. The north-east side of the main part of the elevation

has two two-light windows with hinged casements either side of a larger six-light window and there are numerous perforated metal vent covers (Plate 22). There is a slight return after this forming a projecting gable, which houses a large seven-light window with a hinged casement, chamfered stone sill and concrete lintel, above which there are the scars of three blocked pointed arches. At the top of the gable there are three small slots (vents?) with stone lintels and sills and the gable sits on scrolled kneelers. The base of the wall has a decorative chamfered brick plinth and a large sandstone block is built into it – perhaps a dedicatory slab that was never used? The return of the elevation to the north-west has a modern single storey addition attached to it, with a large doorway with associated windows in the south-east elevation, and two windows in the south-west. The central part of the elevation is partially covered by further modern single storey additions with flat or monopitch roofs (Plate 23). The roof in this section has evidently been replaced with imported slate or imitation stone topped with plain ceramic tiles. There are several narrow two- or three-light windows across this section with modern casements, stop-chamfer decorated stone sills and lintels, further decorated with carved circular holes at the ends, and stop chamfer decorated brick jambs. The south-west end is essentially a mirror image of the north-east (Plate 24), although part of the roof has been replaced with imitation tiles and the plaque over the entrance is marked 'BOYS' and has a modern double door (Plate 25).

**Plate 21: (left) North-east end of the south-east external elevation showing entrance labelled 'GIRLS'**

**Plate 22: (right) North-east end of centre of south-east external elevation**

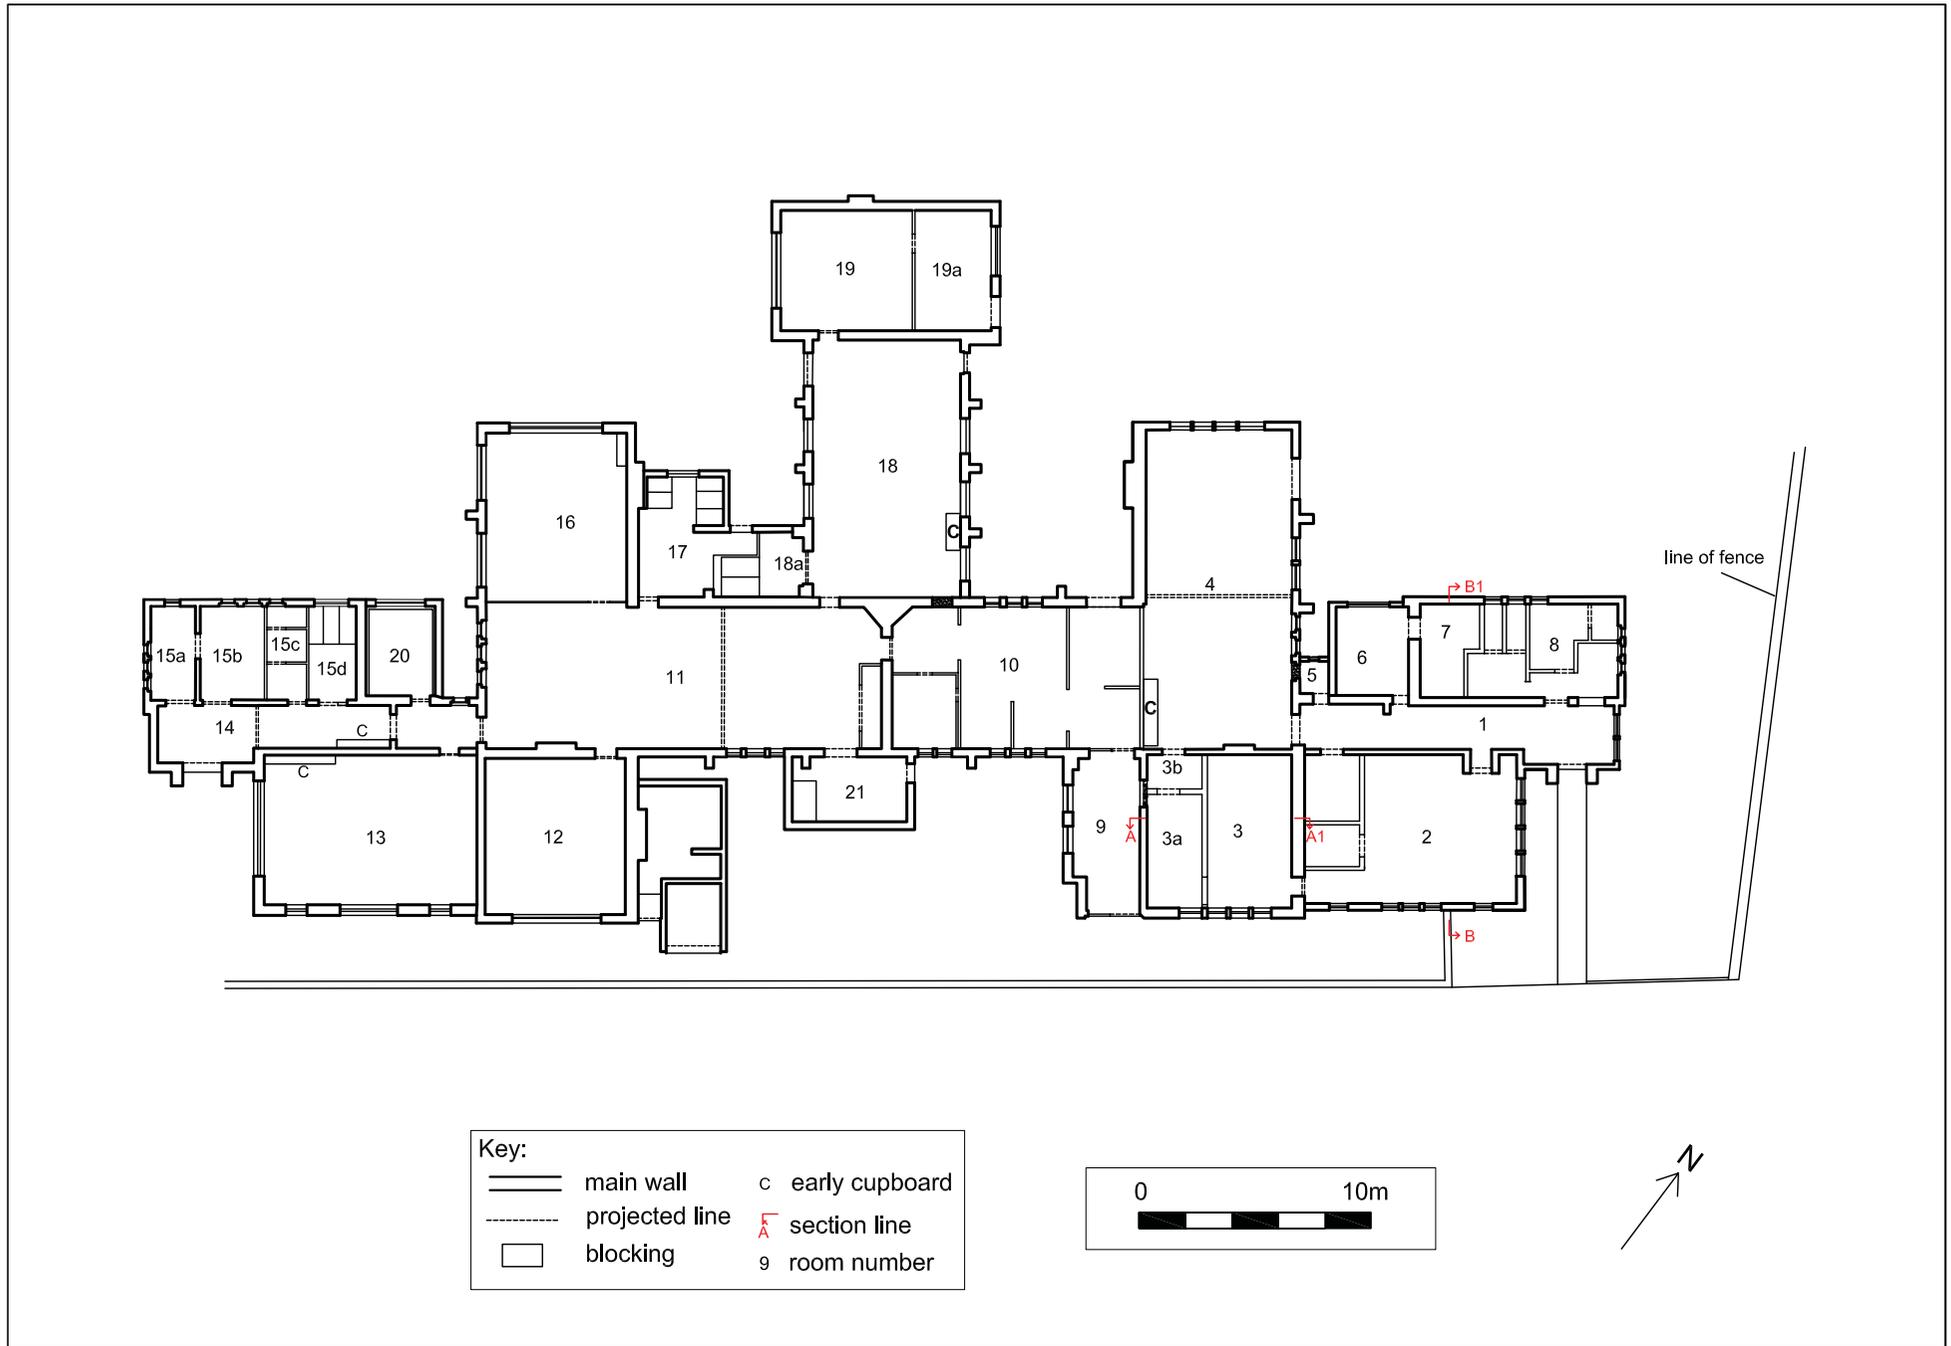
Figure 2: Ground floor plan

4.1.1 The building is orientated approximately north-east/south-west and forms an irregular but essentially symmetrical shape despite the various extensions that have been added (Fig 2). The front entrances are at either end of the south-east elevation facing onto Lund Terrace, although there are also doorways in the rear part of the building.

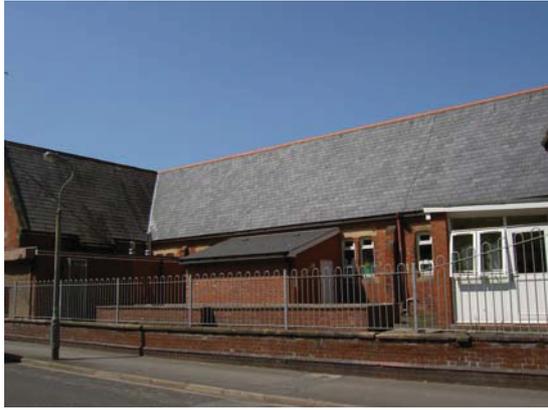
Plate 23: (left) Central part of south-east external elevation

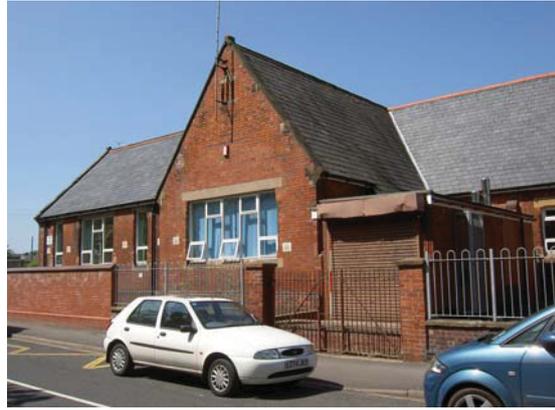
Plate 24: (right) South-west end of centre of south-east external elevation

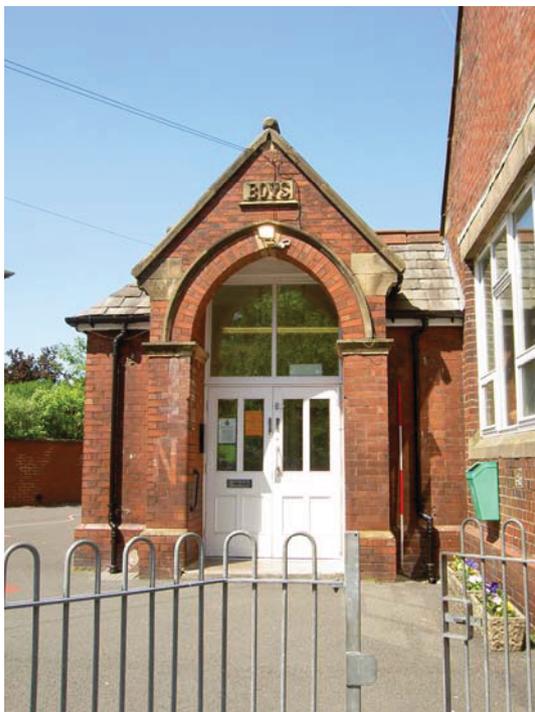
Plate 25: (left) South-west end of south-east external elevation

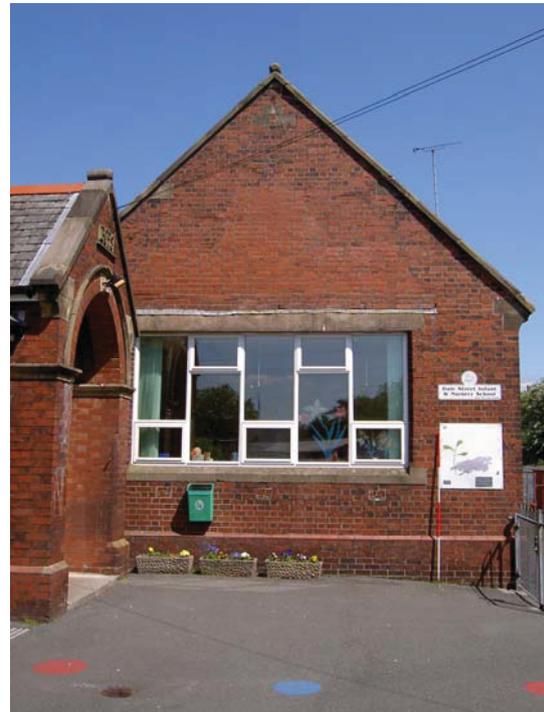
Plate 26: (right) South-east side of south-west external elevation

4.2.4 **South-west elevation:** this is essentially a mirror image of the north-east elevation. The south-east end forms a gable with stone coping and kneelers and a large 10-light window with a modern casement, chamfered stone sill and concrete lintel (Plate 26). There is evident blocking above this showing the position of three former arched heads. Below the eaves there are three sandstone blocks of uncertain function built into the wall, and lower down there are three gridded vents either side of the window. The central section comprises the side of the entrance porch. There are two small two-light windows on the south-east side, with stone stop chamfered sills and lintels, and to the north-west it forms a gable. This houses a group of three single-light windows above the centre of which is a small opening blocked with board formed beneath a pointed Gothic arch (Plate 28). The windows all have stone sills and lintels with stop-chamfer decoration and carved holes in the ends of the lintels, and the jambs comprise stop-chamfer decorated brick. There is a metal vent on either side of the group of windows.

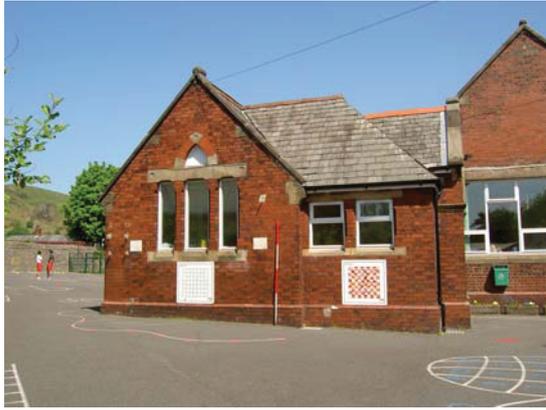
**Plate 27: (left) North-west side of the south-west external elevation**

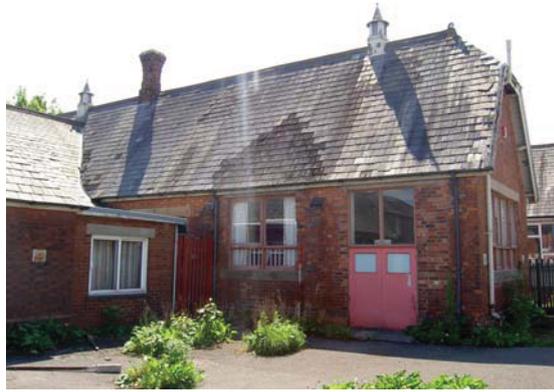
**Plate 28: (right) North-east elevation of the north-east section projecting from the north-west external elevation**

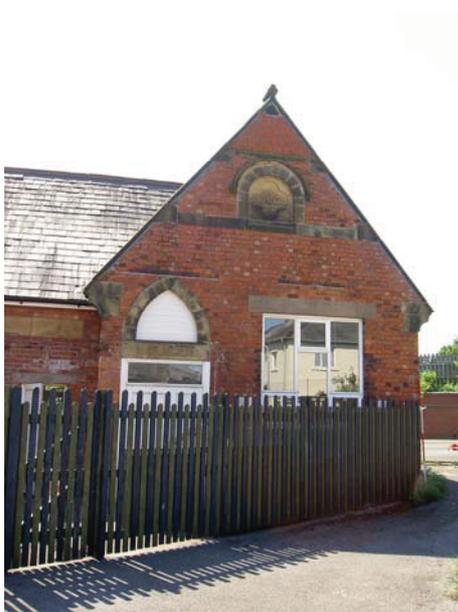
**Plate 29: (left) North-west end of the north-east elevation of the central section projecting from the north-west external elevation**

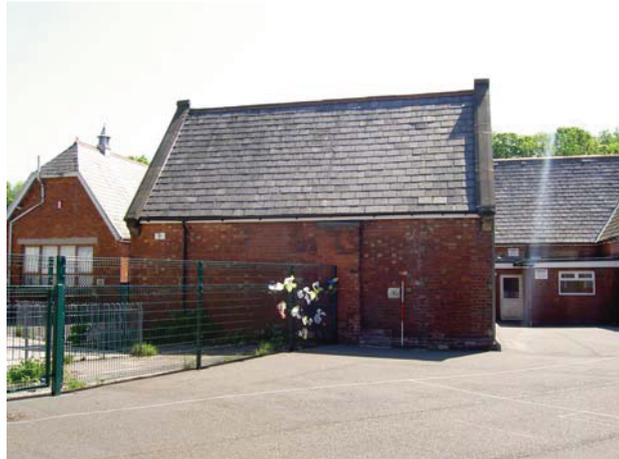
**Plate 30: (right) North-west end of the central section projecting from the north-west external elevation**

4.2.7 The north-west end of the large central projecting section is relatively plain, with a basic chimney breast south-west of the centre, which is apparently truncated at the top, where it is chamfered and finished with concrete (Plate 30). There is a modern barge board and plastic rainwater goods attached and a chamfered plinth runs along on the south-west side of the chimney breast. The south-west side of the main projecting section is essentially a mirror image of the north-east, with a gable at the north-west end; this is mainly finished with render, even over the plinth, but the panel of moulded tiles or bricks at the top has been left exposed and there is a large eight-light window with modern casement flanked by grilled vents below (Plate 31). To the south-east of the gabled end there is a tall doorway with two-light overlight and flanking light and a concrete lintel. To the south-east there are two four-light windows divided by buttresses with concrete lintels and stone sills. A modern flat roof extension has been added at the south-east end, and forms a return to the south-west with a doorway, a return to the north-west, and a three-light window. The modern wall butts against a chimney breast at the return to the north-west, which returns again to the south-west forming a mansard gable with a large 10-light window with concrete lintel and stone sill, above which the scars of three arches filled with brick are evident and the gable is finished with barge boards and the ends of two purlins are exposed (Plate 32). The return to the south-east has two six-light windows with concrete lintels and stone sills, with two buttresses between, and three smaller two-light windows to the south-east. There is a slight return to the south-west, which is butted by a modern wall returning to the north-west forming a flat roofed extension. The return to the south-west contains a modern three-light window. South-west of this there are five two-light windows with stone sills and lintels plus a small aperture at the south-west end, also with a stone lintel and sill, which is filled with board.

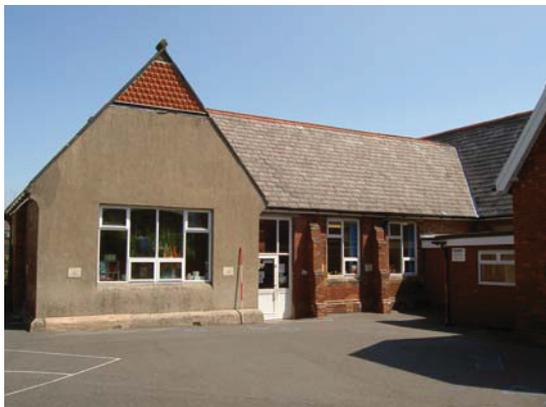
**Plate 31: (left) South-west elevation of the central section projecting from the north-west external elevation**

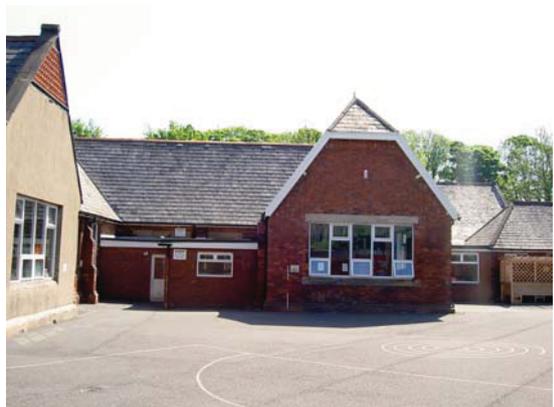
**Plate 32: (right) South-west side of the north-west external elevation**

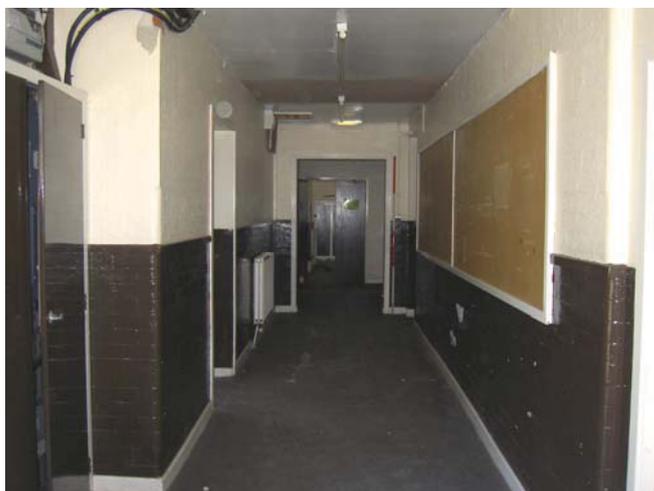
4.3.1 **Room 1:** this comprises a long corridor connecting the various rooms in this half of the building (Plate 33); the floor is finished with vinyl sheeting over concrete(?). The ceiling is largely flat and finished with plaster, but slightly raised at the north-east end where it meets the entrance lobby producing an approximately domed effect. The walls are mostly painted directly onto the brick, but some parts are finished with flock wallpaper and attached fittings and there is a plain dado rail and skirting board throughout. The north-east elevation has a pair of two-light windows with sloping stone sills and stop-chamfer decorated lintels. There is a cavetto moulded rail built into the wall immediately below the angle of the ceiling and part of the roof structure projects through the ceiling in the east corner. The south-east elevation has a large double doorway on the north-east side, with possibly original doors with chamfered battens. The wall returns slightly to the north-west beyond this and there is an inserted doorway with a modern door within added flanking stub walls (which extend into Room 2). Further south-west there is a stub wall projecting into the room, with a corresponding one to the north-west, beyond which the lower part of the wall is finished with tongue and groove boards. Within this area there is an original doorway with an elaborate ogee- and roll-moulded surround sat on plinths decorated with a row of three circles and a cross with rounded edges. The door itself has three panels, the top two tall and narrow and with stop chamfer decoration, the lower more flat and filled with three tongue and groove boards (Plate 34). An original hexagonal escutcheon is still present. The south-west elevation is plain, and essentially comprises a large doorway with a modern double door, leading to Room 4 (Plate 33). The north-west elevation has the same tongue and groove board finish at the south-west end, which respects a doorway at the south-west end into Room 5. Beyond the matching stub wall there is an inserted doorway into Room 7 and at the north-east end there are two further original doorways, with bull-nosed brick jambs and round-chamfered stone lintels. The south-westernmost accesses Room 8 and

**Plate 33: (left) General view of south-west end of Room 1**

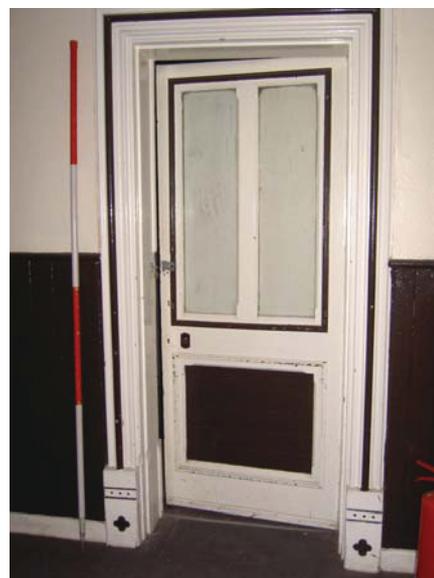
**Plate 34: (right) Decorative doorway between Room 1 and Room 2**

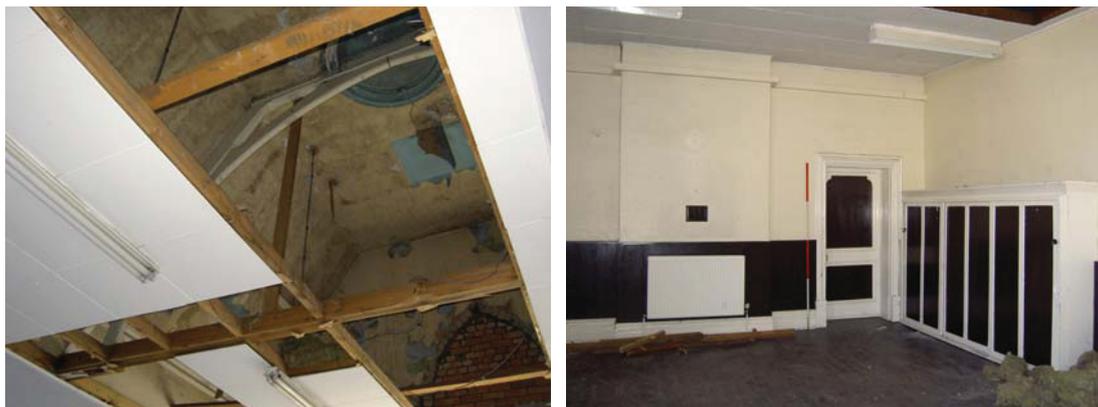
**4.3.3 Room 3:** the floor is finished with timber parquet and the ceiling comprises suspended fibreboard with the original roof structure visible above (which extends above Rooms 3a and 3b). This is finished with lath and plaster with a large central circular plaster boss across which is a single truss (Fig 3). This comprises principal rafters connecting to a collar, which sit on an interrupted tie beam. There are angled braces bolted to the underside of the principals, a single purlin on both sides, and all

of the timber is finished with stop chamfer decoration (Plate 35). The walls are finished with painted flock wallpaper and have a plain modern skirting board. Above the suspended ceiling some of the original yellow paint scheme is evident. The lower part of the north-east elevation is relatively plain, with a doorway on the south-east side, and there is a large moulded batten attached. An original moulded rail is present above the extended ceiling. The south-east elevation has a single vent with a hinged door on the north-east side and a large window, which is divided at the south-west end by the partition wall forming the south-west elevation. Above it the blocked original arched tops of the window are visible. The south-west elevation is a modern partition, with a small glazed opening on the south-east side and doorway to the north-west. The north-west elevation is unremarkable.

**Plate 35: (left) Elaborate roof structure and blocked Gothic arch visible above suspended ceiling in Room 3**

**Plate 36: (right) Chimney breast, decorative doorway and cupboard in south corner of Room 4**
