# DALE STREET SCHOOL, LUND TERRACE, ULVERSTON, CUMBRIA

Archaeological Building Recording

Client: Capita Symonds  
Planning Ap. Ref: 5/08/9001  
NGR: SD 2938 7819

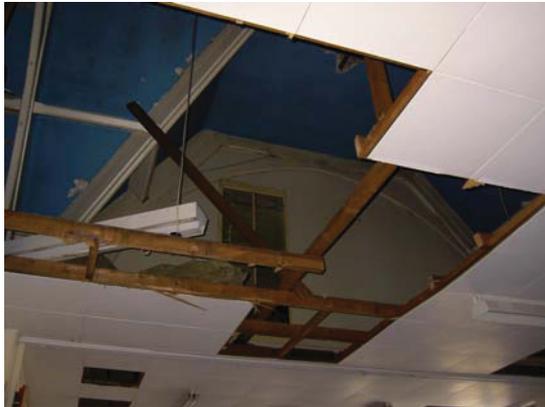
**4.3.5 Room 4:** this forms a large hall on the north-west side of the north-east end of the building. The floor comprises tongue and groove boards orientated north-west/south-east along the length of the room, and there is a scar, presumably marking the position of a folding partition wall, orientated north-east/south-west across the centre of the room. There is a modern fibreboard suspended ceiling, above which the original roof structure is visible. This comprises two trusses whose principal rafters rest on an interrupted tie-beam and have angled braces bolted to the undersides (Plate 37). The south-easternmost of these trusses has a panel wall filling the space between the principal rafters and tie beam, which houses a four-light fixed casement window. The wall on the south-east side of the south-west elevation only extends as far as the height of the suspended ceiling and above it the roof structure is visible (above Room 10; Plate 38). This too is of a similar construction to the main part of the roof. All of the walls are finished with painted flock wallpaper, although the

**Plate 37: (left) Truss visible in Room 4**

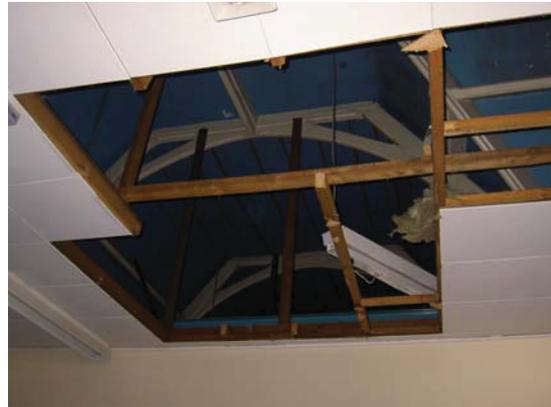
**Plate 38: (right) Truss above Room 10, as visible from Room 4**

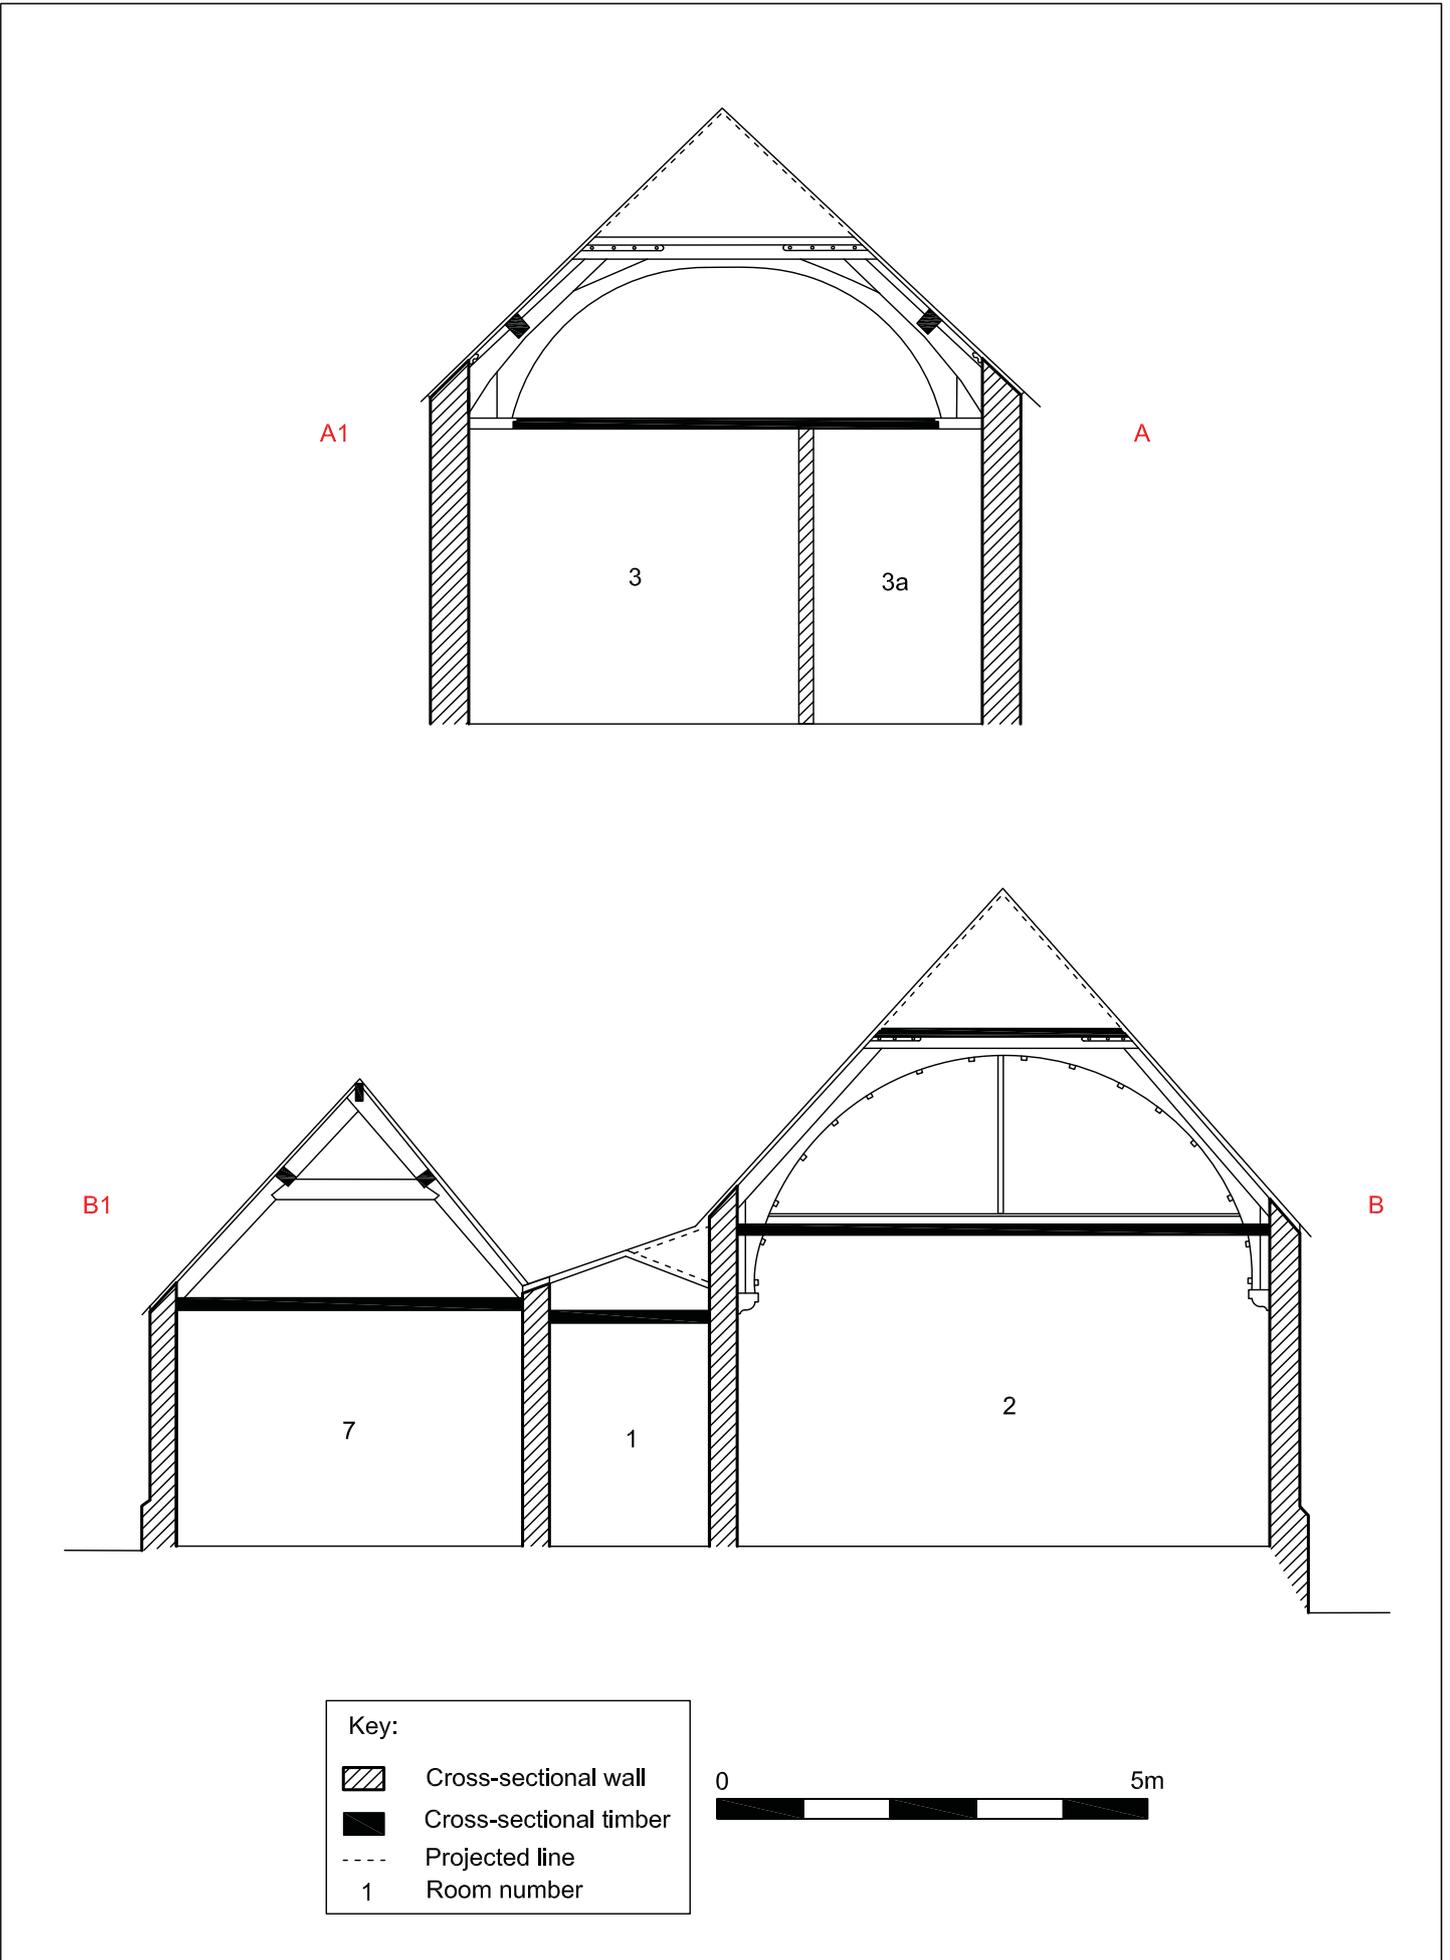
Figure 3: Cross-sections A-A1 and B-B1

has been partially filled to fit a modern door, while the north-eastern has been blocked leaving a slight recess. The roof structure above the room is very basic comprising only a lath and plaster finish. The roof space above could be partially accessed, and revealed a very basic gabled roof shape finished with lath and plaster (Fig 3).

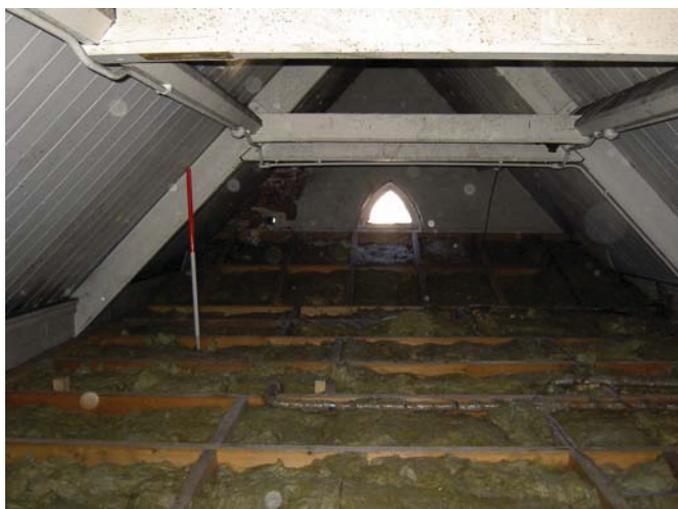
4.3.8 **Room 7:** this forms an adjoining room to Room 6, and has been heavily modernised. The floor is concrete finished with vinyl sheeting, while the ceiling is plaster with an access hatch into the roof space on the north-east side. The walls are finished with plaster and paint. The north-east elevation has boxed pipes along its base and a return in the centre. The south-east elevation is plain and the south-west has kitchen units attached. The north-west elevation is plain. The roof space above, which extends to the north-east over Room 8, is finished with tongue and groove boards attached to the battens, and there are two trusses comprising principal rafters and a collar, as well as other horizontal timbers (Fig 3; Plate 39). There is a single purlin on the south-east side and all of the timber has a stop-chamfer finish and is painted pale grey.

**Plate 39: Roof space above Rooms 7 and 8**

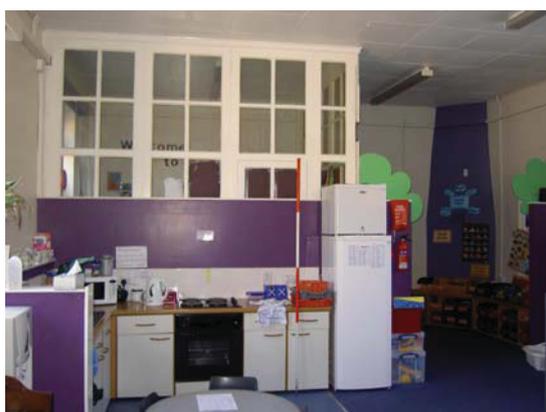
4.3.11 **Room 10:** this is a large room, the floor of which is finished with vinyl and carpet, and which has been sub-divided with low partition walls. In addition, an early glazed timber partition wall has been added in the south corner forming a small room. It has a doorway on the north-east side, which has been effectively blocked by a later partition, and an inserted doorway in the north-west. The framing is all finished with beaded decoration and the lower panels also have stop-chamfer decoration (Plate 40). The main walls are all finished with plaster and paint and the ceiling comprises suspended fibreboard tiles with cut gym ropes projecting through on the north-east side (Plate 41). The north-east elevation is a plain partition. The south-east elevation has an inserted doorway on the north-east side with an adjacent hatch, and a large window comprising three six-light sections with beaded decoration along the edges of the mullions. There is a further window with two six-light sections within the small 'room' in the south corner and part of a tall roll-moulded skirting board. The south-west elevation is finished with tongue and groove boards within the small 'room', which extends around the south-east wall. There is a doorway to the north-west of this with a wide roll-moulded surround on decorative pierced plinths. The west corner is angled at 45°, presumably originally to house a fireplace (a grilled vent marks its position). The north-west elevation has a blocked doorway on the south-west side, with a roll-moulded surround, and there is a large window of three six-light sections in the centre with beaded mullions. At the north-east end there is an inserted fire door.

**Plate 40: (left) Partition walls in the south corner of Room 10**

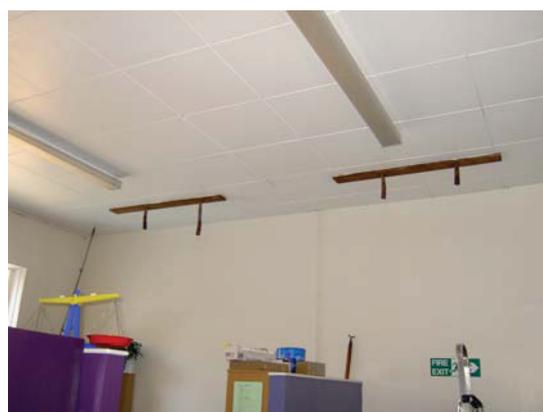
**Plate 41: (right) Gym ropes projecting through the ceiling of Room 10**

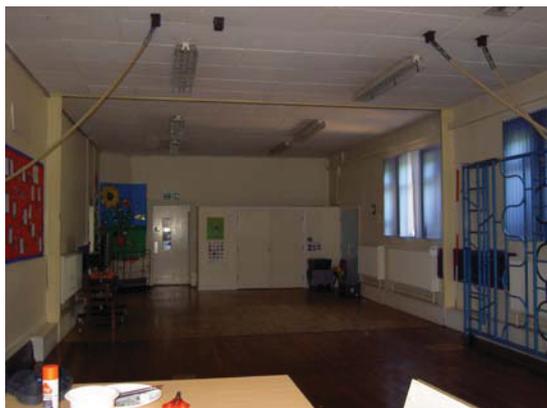
walls against the north-east elevation forming a store cupboard. The ceiling is covered by a suspended ceiling constructed from fibreboards with gym ropes projecting through at the centre (Plate 42). The walls are all finished with painted flock wallpaper with the original tall skirting board remaining in places, although it is frequently covered by boxing for pipes. The north-east elevation is angled on the north-west side, presumably for a fireplace, and there is a doorway immediately to the south-east with a wide roll-moulded surround on pierced plinths (Plate 44). The south-east elevation has a modern inserted doorway on the north-east side and two large windows to the south-west, of two or three four or six-light sections, with beaded edges. There is another original doorway with a similar roll-moulded surround to the south-west (Plate 45), and a projecting chimney breast beyond. The south-west elevation has an original doorway on the south-east side, again with a roll-moulded surround, but retaining the original four-panel door (the top two of which are glazed), with chamfer decoration and an *Art Nouveaux*-style plate around the handle. There is a window to the north-west with three six-light sections with beaded edges, and a vent to the south-west. The south-west side of the north-west elevation comprises a folding partition wall, incorporating glazed panels in the upper part and a doorway in the north-east side housing a four-panel door, the upper two of which are glazed, and having the original round handle (Plate 43). The partition is entirely finished with beaded decoration. North-east of the partition is an inserted doorway with an early(?) ogee-moulded surround and tongue and groove door with two lights over. There is a further inserted doorway to the north-east with a plain surround and modern door, and the north-east end is angled, matching that in Room 10.

**Plate 42: (left) General view of north-east end of Room 11**

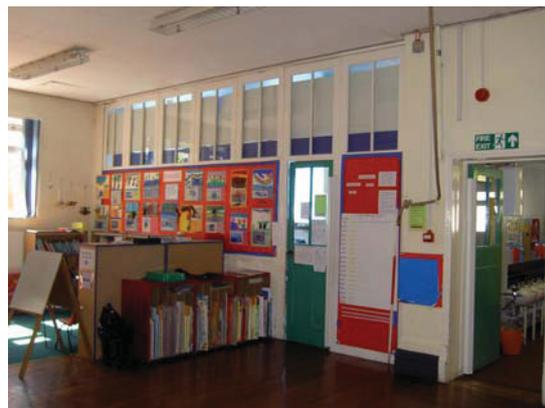
4.3.12 **Room 11:** this forms a large hall with an evident scar across the walls and floor at the centre denoting the position of a folding partition. The floor largely comprises small narrow floorboards, which are at a raised level on the south-west side and partially covered by carpet in the west corner. There are modern partition

**Plate 43: (right) Folding partition wall in west corner of Room 11**

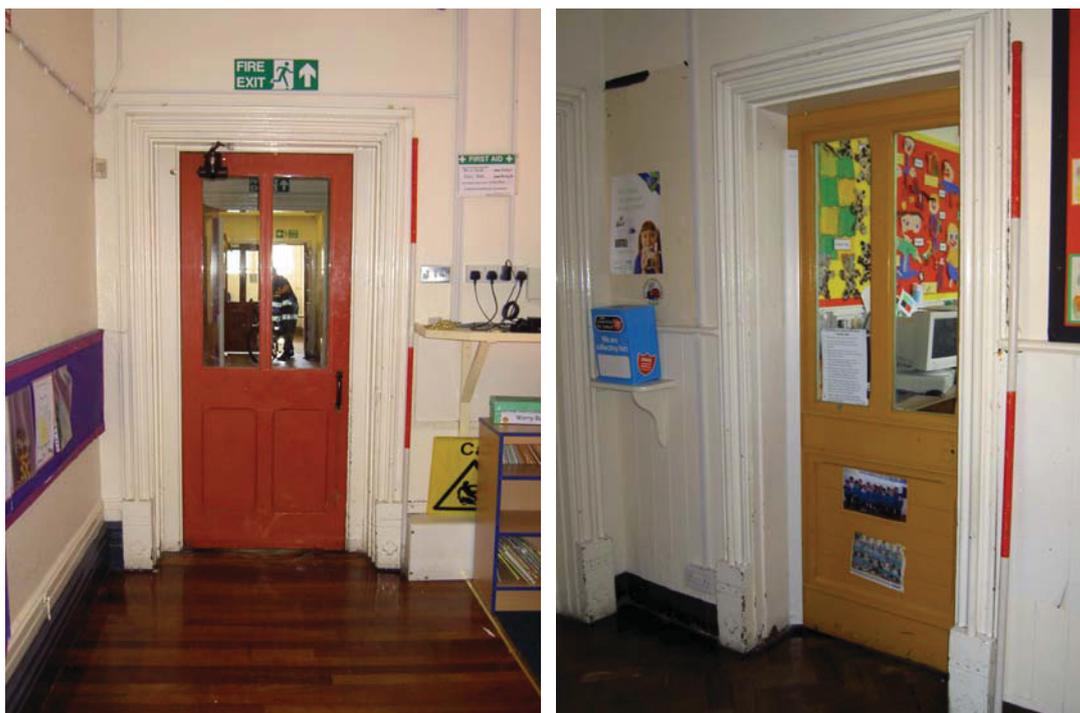
**Plate 44: (left) Decorative doorway in east corner of Room 11**

**Plate 45: (right) Decorative doorway in south-east elevation of Room 11**

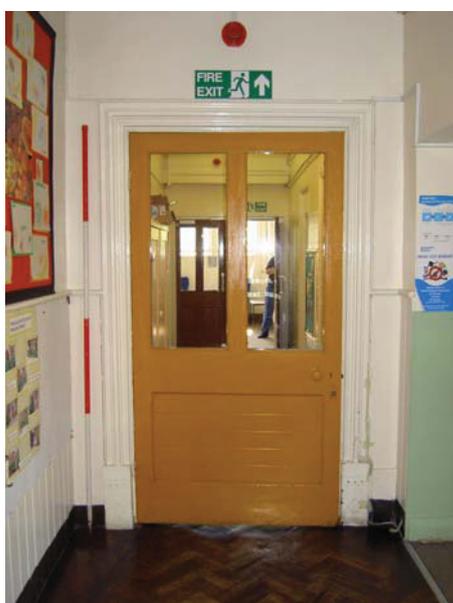
section and two glazed panels above (Plate 46). There is a large early cupboard set against the wall to the south-west of the stub wall, with stop-chamfer decoration, panel doors and brass scoop handles. The wall returns slightly again at the south-west end to house a large double-door finished with chamfered decoration and a plain surround, which is not original. At the south-west end the corridor meets the porch, and there is a double-doorway with a modern door with two overlights. The south-west elevation has two two-light windows with an iron I-beam forming the lintel. The north-west elevation has a pair of doorways at the south-west end with bull-nosed jambs and stone lintels with rounded lower edges. The south-western of these is blocked leaving a recessed area, while the north-east has a modern glazed door (Plate 47). There are two further doorways to the north-east, the smallest of which is evidently inserted and has cement around the jambs and lintel, and the other has bull-nosed jambs and a stone sill with a rounded edge, and modern partitioning has been added to accommodate a modern door. At the north-east end there is an inserted doorway leading into Room 19, and north-east is a small window with a modern two-light casement with beaded edges.

**Plate 46: (left) Decorative doorway in the centre of Room 14**

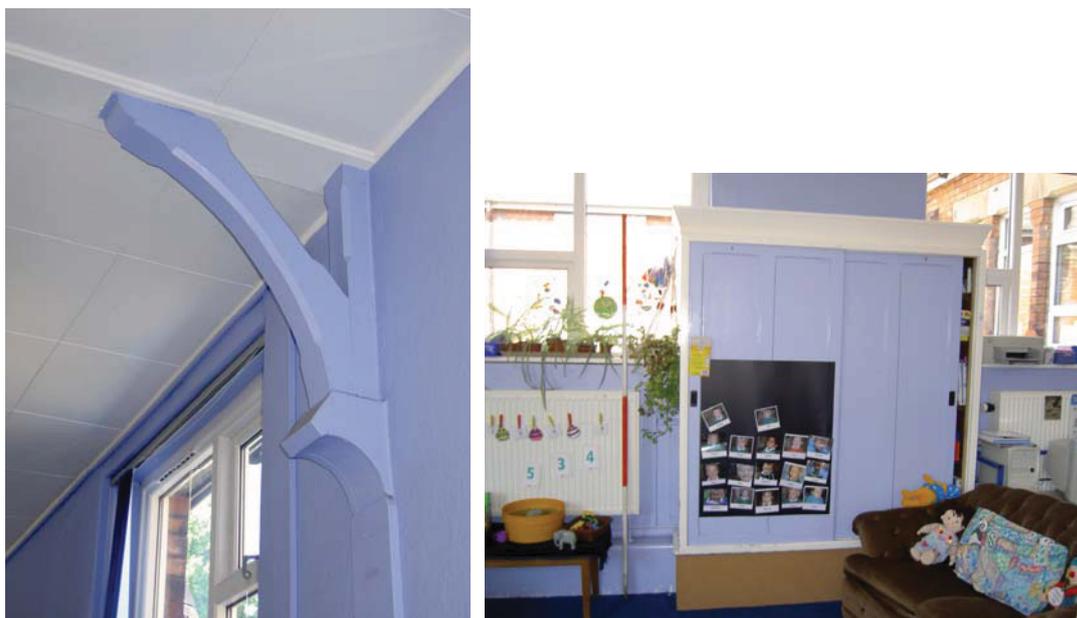
**Plate 48: (left) Bracket from the roof truss in Room 18**

**Plate 49: (right) Early cupboard *in situ* in Room 18**
