MAWSON HOUSE, 4 FENTON STREET, LANCASTER, LANCASHIRE

Archaeological Building Recording

Client:
Woolerton Dodwell Associates
Planning Ap. Ref: 08/00410/CU

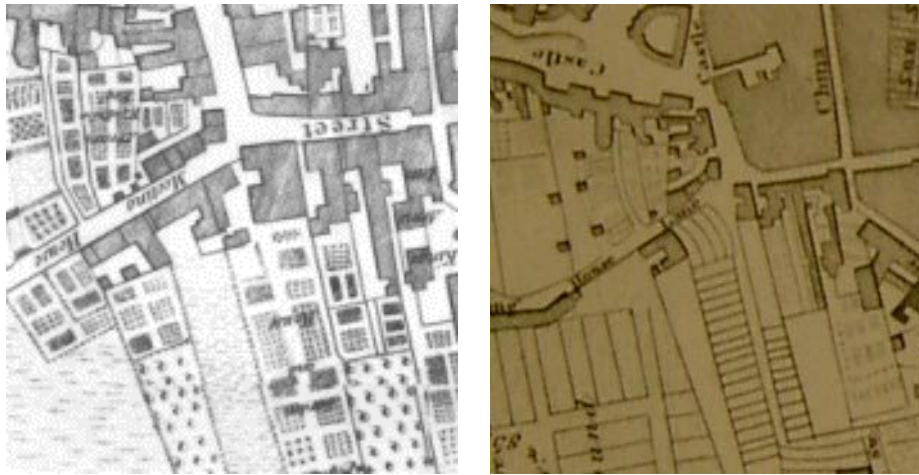
Plate 2: (left) Mackreth's map of 1778

3.4.2 **Mackreth's map of 1778:** this map shows that area has not yet been developed and is apparently part of gardens and open fields (Plate 2).

3.4.4 **Clark's map of 1807:** this map is taken from a history of Lancaster and shows that the land south of Meetinghouse Lane has now been cleared for development, with Fenton Street and building plots marked out, although none are occupied (Plate 3). The second edition of Clark's book, published in 1811, also has a map, but it is apparently the same as that used in 1807.

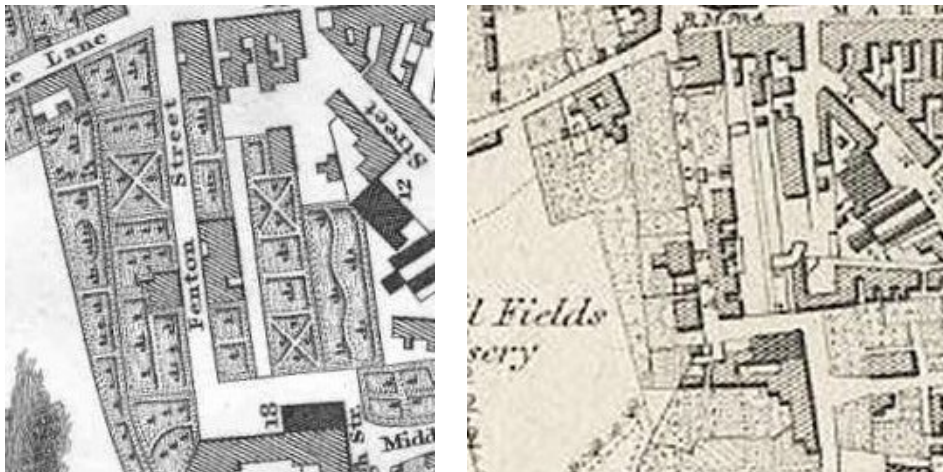
Plate 4: (left) Atkinson's map of 1824**Plate 5: (right) Ordnance Survey map of 1848**

3.4.5 **Atkinson's map of 1824:** this map is taken from Baines's directory of Lancashire (Baines 1824) and shows Fenton Street with a building in what appears to be the location of Nos. 4 and 6, with the rear outshut on No. 4 evident. Curiously, this would mean that the house described as being in Plot 11, approximately the site of the former Friends' Hall (now the Masjid An-Noor Mosque) is not shown despite being recorded in 1823 (see *Section 3.2.3*). It may not be coincidental that an insurance policy was amongst the documents relating to this property, perhaps indicating that the building had been destroyed by 1824. There are very few other buildings on the street apart from a large structure on the opposite side of the road (Plate 4). Approximately the same information is also shown on Binns's map of Lancaster from 1821.

3.4.6 **Ordnance Survey, 1848:** this map shows that Fenton Street is by this time well established with a row of properties on the east side of the street. Nos. 4 and 6 are still evident and have the same plan, albeit somewhat stylised (Plate 5). To the south is what appears to be smaller building and then a much larger structure apparently corresponding to the present No. 10.

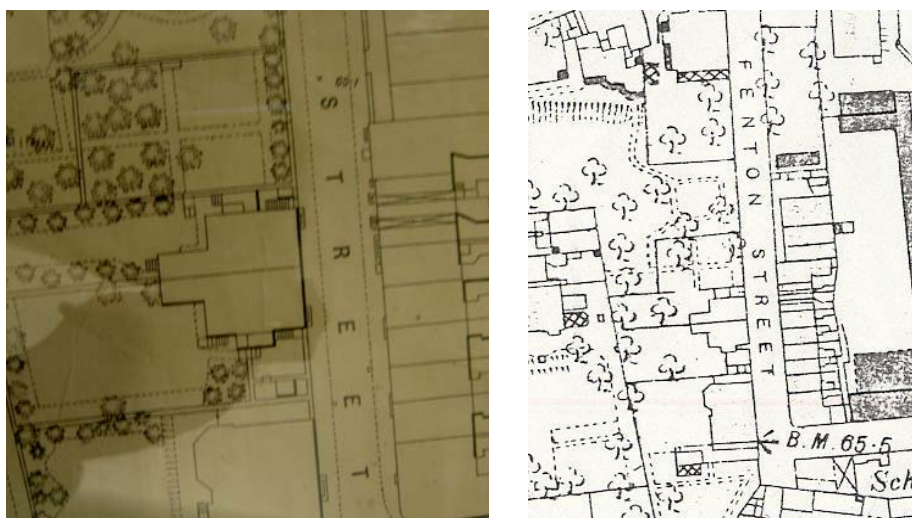
Plate 6: (left) Ordnance Survey map of 1892

3.4.7 **Ordnance Survey, 1892-1893:** these show the site and properties very clearly and is readily comparable to the present mapping (Plate 6: (left) Ordnance Survey map of 1892

Plate 7 and Plate 7; compare with Figure 1). The main part of No. 4 is evident as are the extension to the west and the extension to the north. The latter appears to be attached to part of a walled garden.

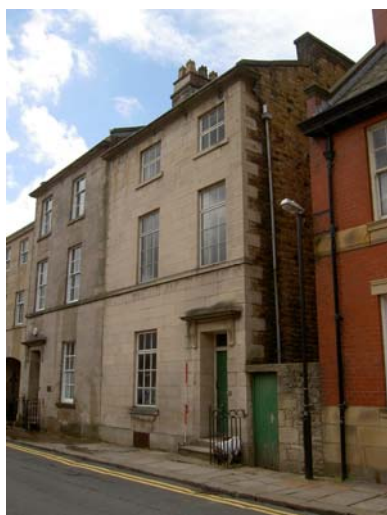
Plate 11: (left) East external elevation

4.2.1 **East elevation:** this forms the front of the building, facing onto Fenton Street (Plate 11). There is a plinth along the base of the wall with cellar lights visible, covered by a grill. The main entrance to the building, giving access to the ground floor, is located on the north side of the east elevation. The doorway for the main entrance has a moulded entablature on two scrolled, fluted corbels. The front door has six panels, which are bevel-raised and fielded, with beaded moulding. The doorway is up two stairs from the level of the street but there is a lower stair at the level of the pavement. The mid step has a roll-moulded top. The steps still have the original railings on the north side, which have quite a plain, square section, with pointed finials. Only the scars are visible for the railing on the south side of the steps; the actual railing is loose in the basement. An original boot scraper is present on the south side of the steps. There is a single window with a stone sill and 12-light modern casements to the south of the main entrance on the ground floor.

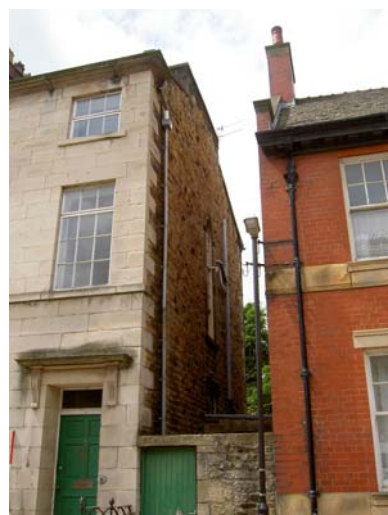
Plate 12: (right) North external elevation

4.2.4 **North elevation:** this covers three floors and the basement (Plate 12). There is a small basement-level window on the east side of the north elevation with a square, stone surround. The window is made of two square sections which are covered by iron bars. There is a basement level door approximately centrally located on the north elevation with a square stone surround with some evident rebuild on the south side. The first and second floors share a stair window with a rounded-top keystone and square surround. The shared window has 15-light casements with interlinked lights above. The lower part of the window is a sliding sash. The lower, ground floor window of the building is partially blocked by the extension to the north elevation. The end of the guttering and stone entablature to the front of the building is visible to the east side of the north elevation. The chimney has a stone capping.

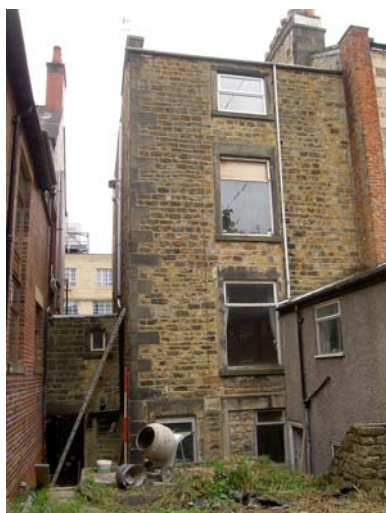
Plate 13: (left) West external elevation

4.2.5 The extension to the north elevation is built over the ground and basement levels and obscures parts of the original building (Plate 13). The roof of the extension is flat. The roof sits on top of two more small corbels built into the wall to the north and another supporting doorway on the east side. The east side of the extension has a large stone lintel spanning between Mawson House and its neighbour to the north. A small doorway is formed below this extension which at the time of this survey was filled with soil. It is suggested that this may have been used as a toilet. The north wall of this small room is built using hand-made brick, forming an open passageway which allows access through to the rear. Stone steps with a simple iron railing on the north side lead from the basement level up the side of the house, onto Fenton Street. The extension is possibly contemporary with, or perhaps slightly later than, the building to the north and incorporates the corbels built into the south wall of the northern building. The extension blocks a window in the south elevation of the building to the north. It appears that the building to the north has also at some stage been extended to the west.

4.2.6 **West elevation:** there is a brick chimney attached on the south side of the west elevation which extends over three floors and the basement. The chimney is built from hand-made mid red-orange bricks. Most of the south side of the elevation is covered (from basement-level to the lower part of the ground floor) by a monopitch outshut with a rendered finish and modern French doors. The outshut is built over

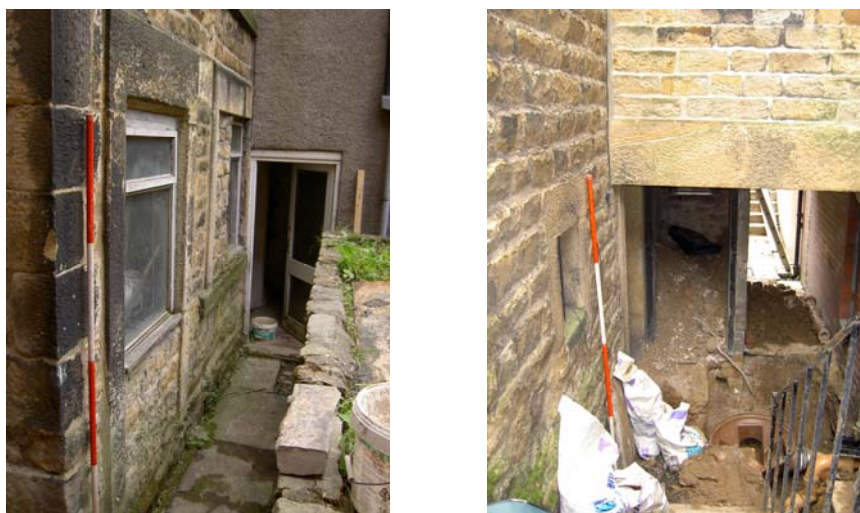
Plate 15: (left) Blocked door and window, west external elevation

4.2.7 The north side of the west elevation has a rougher, stone build with dressed quoins. There is one window on each of the second, first, and ground floors with two-light modern casements with square, stone surrounds. The basement has a former doorway on the north side with a square, stone surround. This former doorway has been replaced with a window with two-light casements and part-filled with stone. Next to this former door is what originally would have been a large window which has also now been partially blocked with stone to leave a two-light window with a hinged casement (Plate 15).

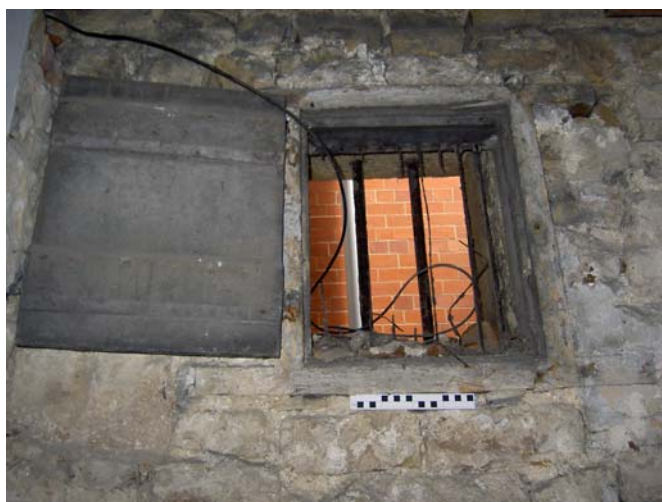
Plate 17: (left) Basement Room 2, window and shutter

4.3.3 Room 2: this room forms an L-shaped corridor linking Room 1 to the stairs. The room has a red and black diagonally-set quarry tile floor which has been partially removed. The north elevation has exposed stone and a doorway on the west side with a timber lintel and a modern, single-panel door with an overlight. There are rebuild lines up either side of the doorway which suggests it is a later insertion. There is a small aperture (covered by two iron bars on the outside and a mesh on the inside) to the east of the original door frame, with a timber shutter with chamfered battens and simple strap hinges (Plate 17). The east elevation is built from hand-made bricks in a fairly random bond that butt against the return wall to the west. Each brick measures 22cm by 7cm by 10cm and is a dark, reddish-orange colour. The construction of the doorway at this end of the room is stone, which is the same as in Room 1. The west end of the room is plastered. There is a small space with plain plastered walls at the south end of the room, below the stairs. There are some timber shelves on scrolled brackets attached to each of the walls and stone slabs below on masonry bases with rounded edges. The stairs are made of stone (Plate 18) and are against a well-dressed stone doorway to the west side of the south elevation. This doorway has a modern surround. The south wall returns to the plain stone build of the west elevation. There is a doorway through to Room 3 on the north side which has a stone lintel and a modern door with panel insert.

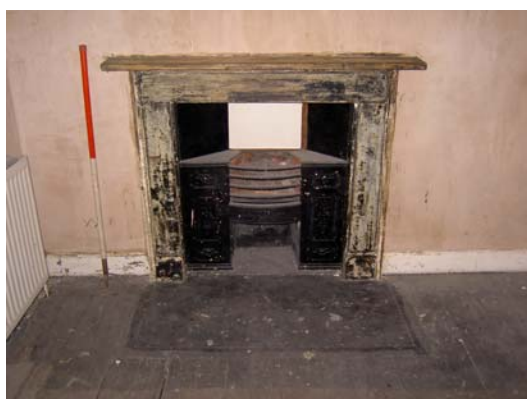
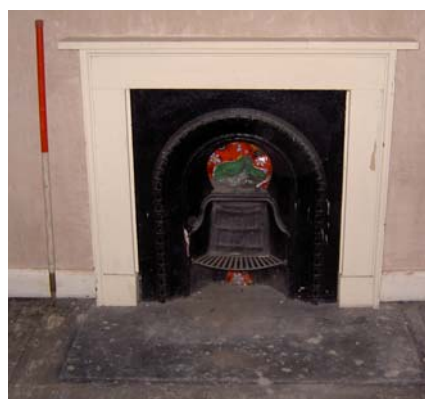
Plate 27: (left) Second floor Room 1, fireplace**Plate 28: (right) Second floor Room 5, fireplace**

4.6.2 **Room 1:** this room has wide floorboards and a plastered ceiling with what appears to be a modern applied cornice with flowers and heraldic emblems. The walls are finished with plaster and paint, with ovolo-moulded skirting. The north elevation is plain. The skirting boards of the north elevation do not quite match the east side, which shows that this wall is a later insertion and not part of the original structure. The east elevation has a window with a modern six-light hinged casement but the ovolo-moulded panelling and surround is badly damaged. East of centre on the south elevation is a fireplace with a hearthstone and a timber lintel with stone surround (Plate 27). The fireplace has an ovolo-moulded edge and an original hob grate with floral panels and Greek key design. There is early, probably hand-made red brick, brickwork at the back of the fireplace. There is a doorway on the north side of the west elevation with an ogee-moulded surround and a six-panel door with ovolo-moulded decoration.

4.6.6 **Room 5:** Room 5 has wide floorboards and a plaster ceiling and a modern cornice decoration which is the same as the rest of the second floor. All of the walls have been plastered and have beaded skirting. The north elevation is plain. The east elevation has a doorway north of the centre, with ovolo-moulded surround and a six-panel door. The south elevation has a central fireplace and hearth with a timber mantle and a stone surround and an applied ovolo-moulded timber edge (Plate 28). There is an iron insert with acanthus leaf and beaded decoration with a grate back with a square and circular pattern. The flue is filled with paper, including a piece of the Sunday Times, dated 2nd October 1988. The west elevation has a central window with splayed jambs to the floor, with ovolo-moulded panelling and a modern two-light hinged UPVC window. The end of the truss projects through the roof.

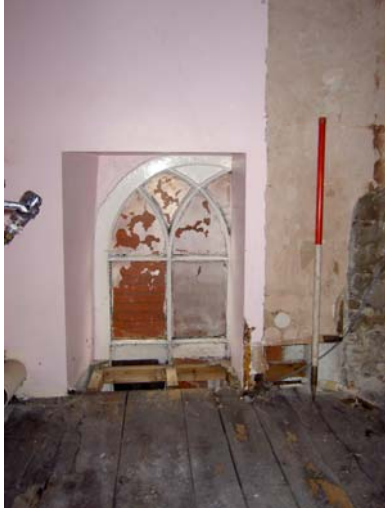
Plate 29: (left) Second floor Room 4 window

4.6.5 **Room 4:** Room 4 is a small, added bathroom and is essentially an extension of Room 3. It has the same wide and narrow floorboards (some of which may have been replaced) as in Room 3 and the walls and ceiling are plastered. There is original skirting throughout. There is an access hatch from this room to the roof space. At the top of the north elevation is a round-headed stair-light with interlinked, pointed arch panels and six lights, but this feature is partly covered by the inserted partition on the east side (Plate 29). The east elevation is a brick-built partition wall made from hand-made bricks of a mid red-orange colour, each measuring 23cm by 7cm by 11cm. The east elevation has the same skirting as Room 3. The south elevation is a partition wall with a low cut skirting, possibly cut off from the original. There is also a doorway with a plain surround. There are coat hooks on ovolo-moulded battens attached to the west elevation and later shelves and the scars for a toilet and pipes were visible.

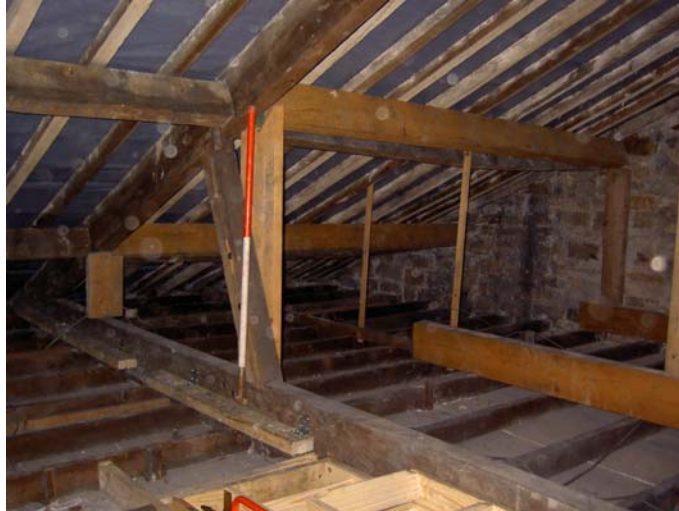
Plate 30: (right) East end of truss in roof space

4.7.1 There is a single truss north of the centre of a simple tie beam type (Plate 30; Fig 5), with angled braces, notched at the junction of principals (east on top of west).
