77-79 DUKE STREET, BARROW-IN-FURNESS, CUMBRIA

Archaeological Building Recording

Client: Barrow Borough Council
Planning Ap. Ref: B10/2007/1109

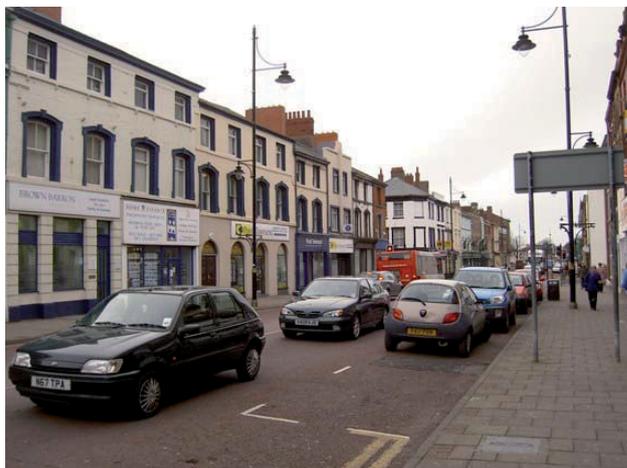
Plate 1: General view along Duke Street from the east showing the block containing Nos. 77-79

1.2.1 Duke Street is in the centre of the modern town of Barrow-in-Furness, a short distance north-west of the town hall, and is one of the streets laid out in a grid pattern as part of the planned development of Barrow that took place in the late 19th century. It still forms one of the main thoroughfares and is largely occupied by shops, offices, and other businesses. The properties are situated on the south-west side of Duke Street (Plate 1), and No. 79 extends around the corner with St Vincent Street (Fig 1). To the rear (south-west) is a back street originally known as Back Duke Street but now part of Clifford Street.

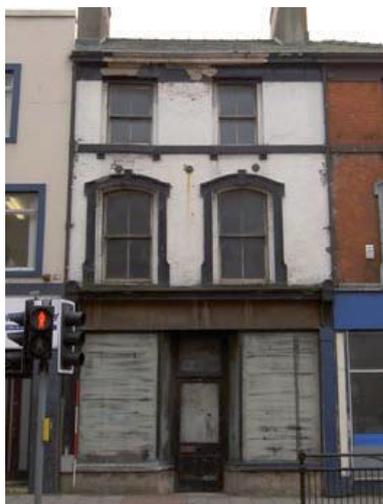
Plate 20: (left) North-east elevation

4.2.1 **North-east elevation (Fig 2):** the front elevation of No. 77 appears to butt No. 75 to the east (although this is probably because the façade of No. 75 has been remodelled) and is three storeys in height, and to the west is No. 79 (Plate 20). The elevation is built of red brick, possibly machine made, laid in the Flemish bond, and has been finished with white paint. The shop front appears to be original with moulded entablature supported by decorative corbels. The pillar on the east side is possibly original but the west pillar has been boxed with timber and painted. The recessed entrance is positioned centrally with original door and single light above. The surround is astragal moulded with an ogee moulded two-panel door with large single light. The door has an enamelled plate with the number '77' on the top batten and a brass plate below the light labelled 'Langdale (Drapers) Ltd. Registered Office'. The large single lights take up the remainder of the elevation returning on each side of the doorway. The moulded sills are also original, but the low walls below them have been finished with cement.

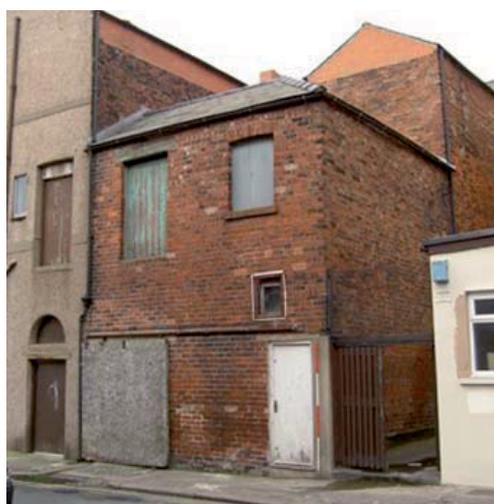
Plate 21: (right) South-west elevation

4.2.3 **South-west elevation (Fig 3):** the elevation to the lower section to the rear of the building (Plate 21) has a large doorway with concrete lintel on the west side, above which is a metal rail that extends to the east side of the elevation. This rail holds a sliding door made from tongue and groove planks strengthened by a thick chipboard panel. At the east end is a doorway with modern tongue and groove door and plain surround, the east jamb of which has been finished with cement. Above and slightly to the west of this doorway is a small single-light window with a red sandstone lintel fitted with a wire grill. The first floor has a loading doorway with a chamfered timber lintel and thin stone sill and there is a boarded window on the east side with a flattened arch and limestone sill. The roof is hipped and laid with slate and has ceramic ridge tiles. Behind the roof is the gable for the main building which is plain although the gable under the roof has been recently rebuilt. Within the enclosed yard area situated above the ground floor, which could not be fully accessed, the wall has been entirely rebuilt, with new windows included that utilise concrete lintels, on the first and second floors.

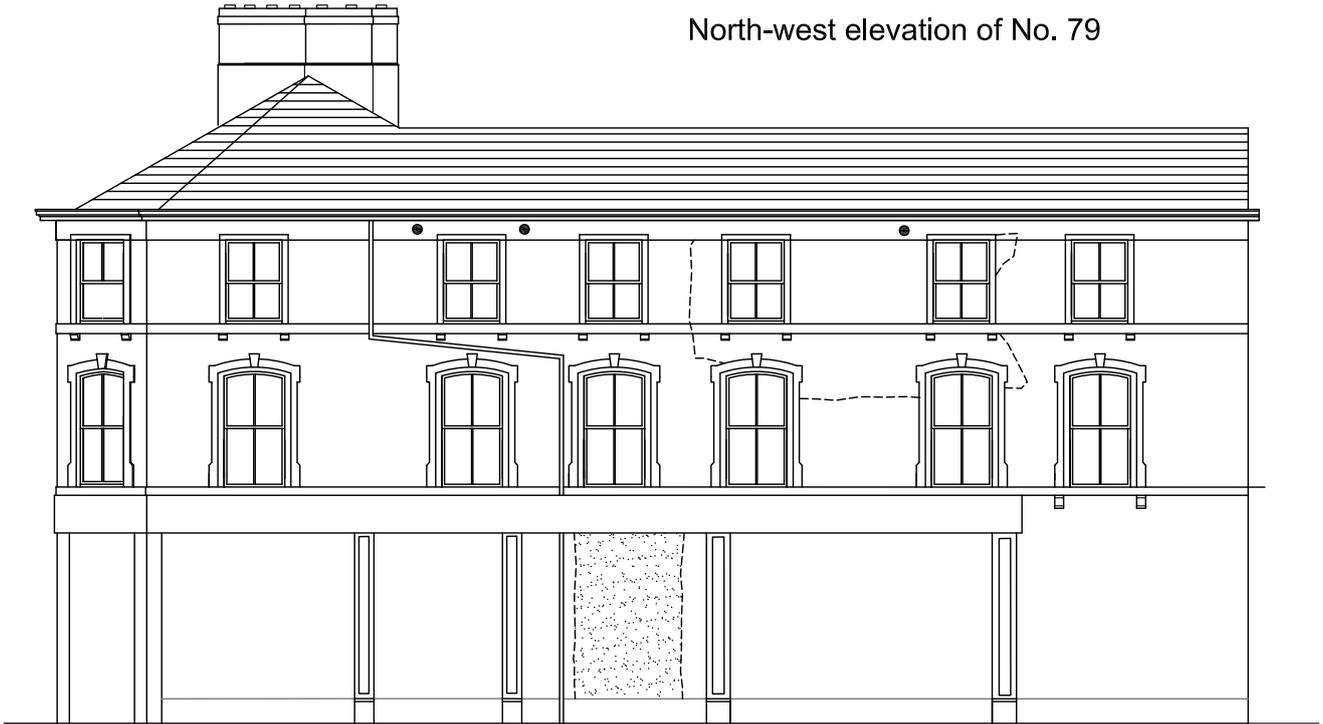
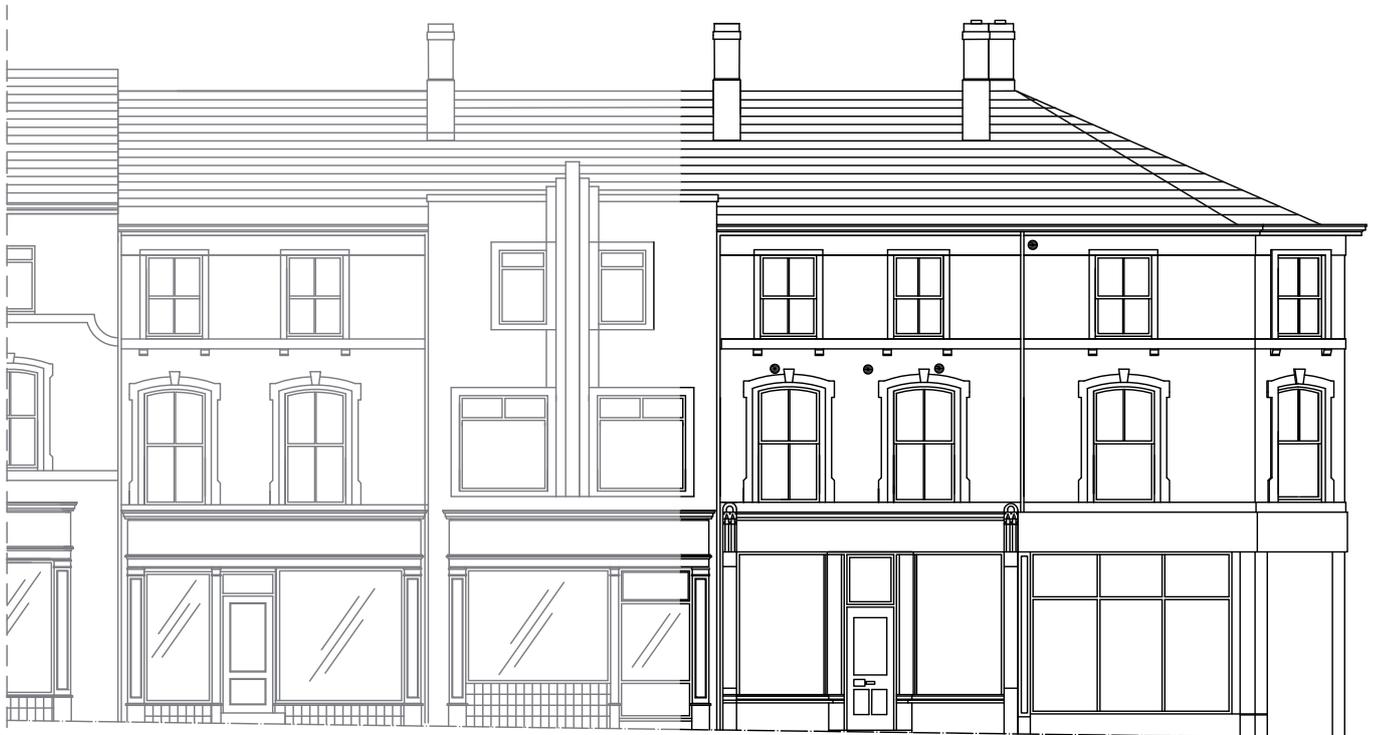
North-east elevation of Nos. 77 and 79

4.4.1 **North-east elevation (Fig 2):** this continues the same build and arrangement of windows as that of No. 77, although the brickwork is not painted, and is also three storeys in height (Plate 40). The north-west end of the elevation is angled at 45° to the south-west. On the ground floor the recessed entrance is situated within this corner. The pilasters on either side of the entrance and at the south-east end of the elevation are modern and undecorated, with the one at the south-east end covering a cast-iron down pipe. The elevation between the entrance and south-east end is taken up by a large six-light window with smaller lights at the top. This window is supported by a low wall finished with concrete render and paint.

4.4.2 North-west elevation (Fig 2): this elevation has the same build and the window arrangement is the same as the north elevation but with six windows each on the first and second floors, although the first floor window at the south end of the elevation has scrolled corbels (Plate 41). Between the shop front windows at the north-east and south-west ends there is evidence of a former doorway, which has been blocked with brick. Below the entablature in the sandstone coping there are three round tie-rod plates situated in the middle of the elevation.

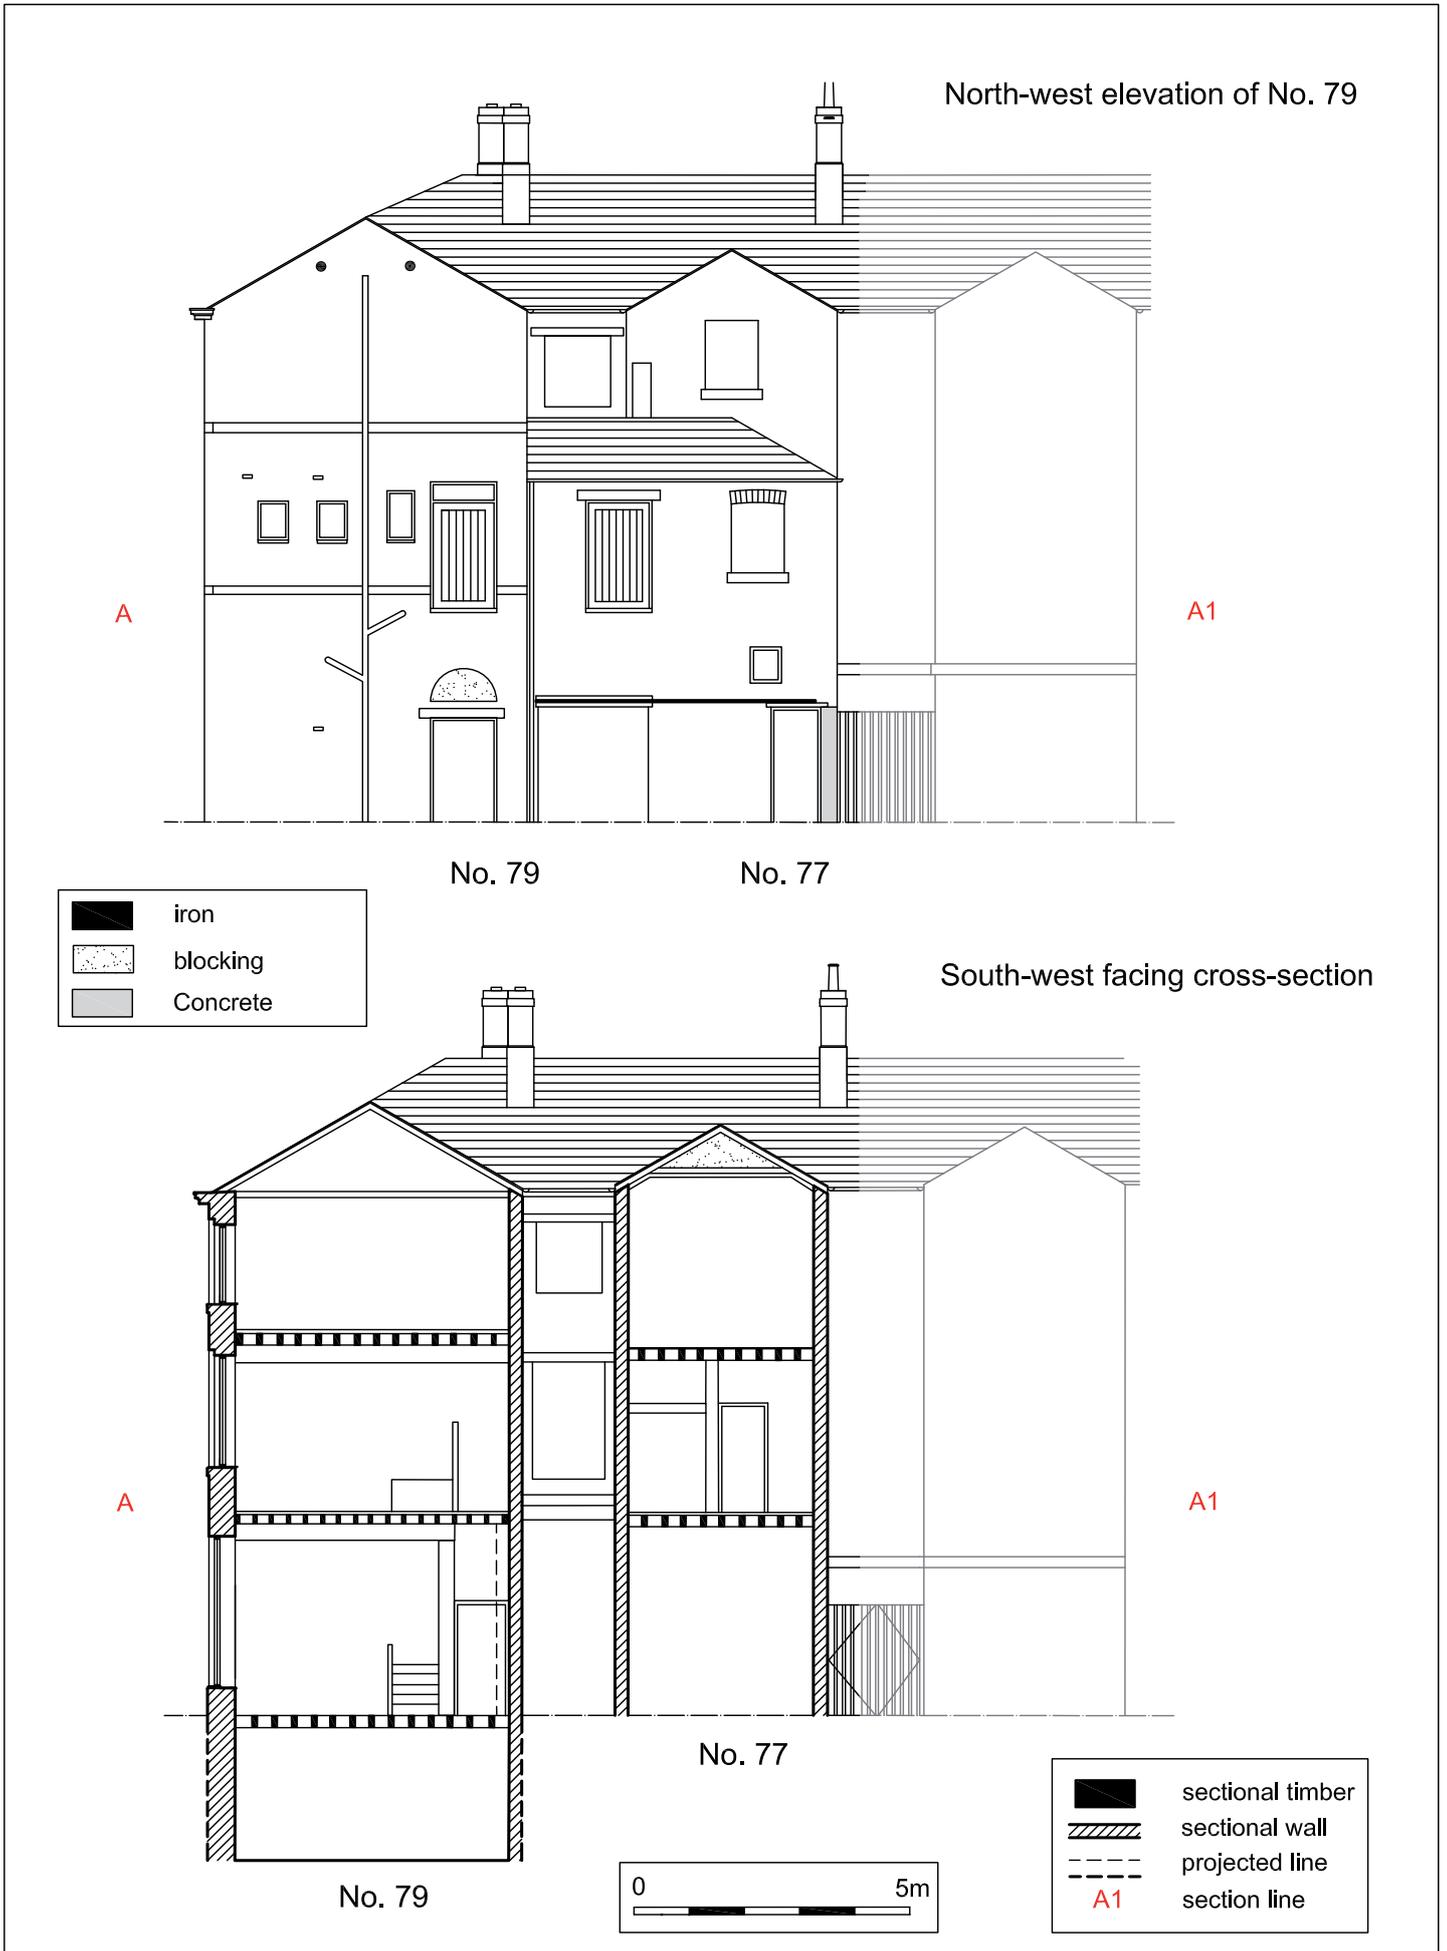
Figure 3: South-west elevation and cross-section

4.4.3 South-west elevation (Fig 3): this elevation forms the rear gable and is finished with pebbledash (Plate 42). On the south-east side the ground floor has a doorway with semicircular light with a much eroded yellow sandstone lintel and a modern surround and door. The first floor has a concrete sill band which continues the line of the sandstone one on the north-west elevation. Three small single light windows with tiled sills are situated above the sill band with a loading doorway with stone sill to the south-east, which intersects the sill band. The door is early, possibly original, and constructed of tongue and groove boards. Between the windows and the second floor sill band are two ceramic ventilation grills. The second floor sill band is concrete and also continues on from the sill band on the north-west elevation. There are two round tie-rod plates at the top of the gable, which are either side of a cast-iron drain pipe that runs down the centre of the elevation.

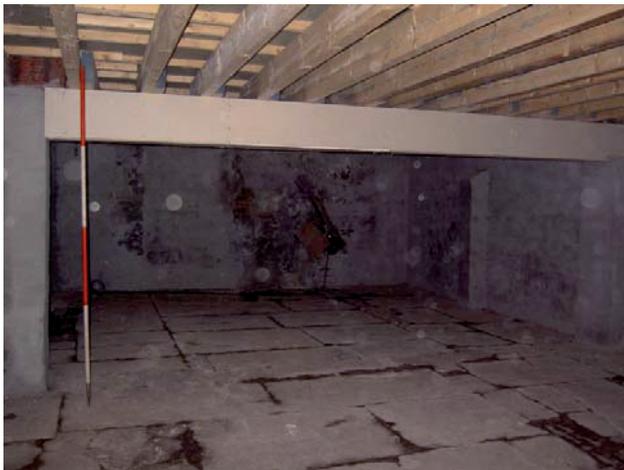
Plate 22: (left) Basement, north end showing flag floor

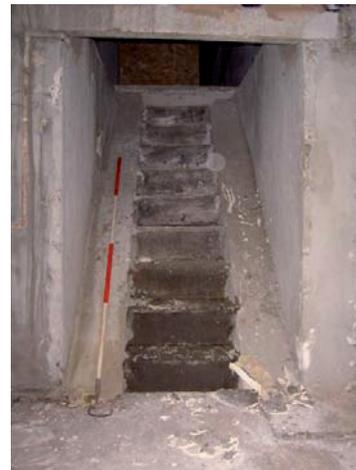
Plate 23: (right) Basement, south-west end showing steps

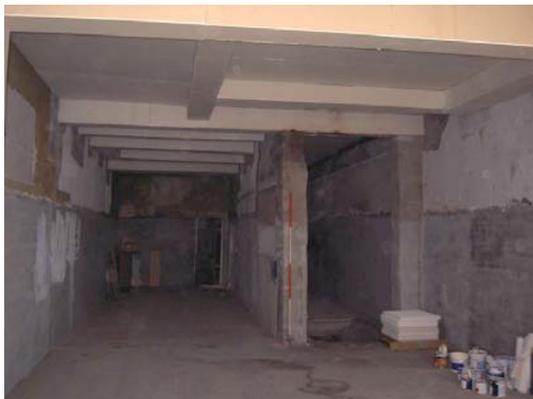
Plate 24: (left) Ground floor Room 1, south-west end

4.3.2 **Ground floor, Room 1:** the floor comprises chipboard at the north-east end and is concrete at the south-west end. There is access to the basement on the west side towards the south end, via stone steps with sloping concrete edges. The ceiling is supported by various steel girders on uprights at the north-east end, housed within plasterboard boxing. A wall separates the basement stairs from the east side of the south-west end of the room creating a corridor (Plate 24). There is a doorway at the

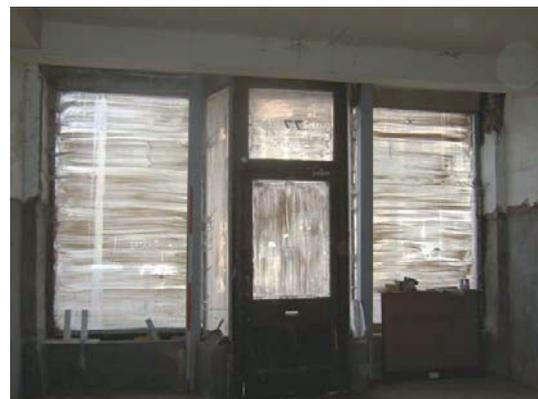
Plate 25: (right) Ground floor Room 1, north-east elevation

south-west end of this wall, and this corridor is open at the north-east end. All the elevations are finished with cement to a height of c1.8m with the remainder being plaster. The north-east elevation is the shop front, which has been heavily modified with concrete (Plate 25). There is an original recessed doorway in the centre with square cast-iron columns on either side. Above the door is a large single-pane light, and the door itself has a large single-pane light with two small panels below. The windows on either side of the doorway, and in the recess, are single-pane lights the full height of the elevation from 0.5m above the floor. There are no features of note on the north-west elevation. The south-west elevation is plastered with some areas of brick exposed. A doorway is situated off-centre to the east with a step down into Room 2. The surround is missing, and the door is an early four-panel type with ogee moulding. There is an open access leading to the corridor to the basement to the west. The south-east elevation has the original plaster remaining, which has been scored to give an ashlar block effect finish.

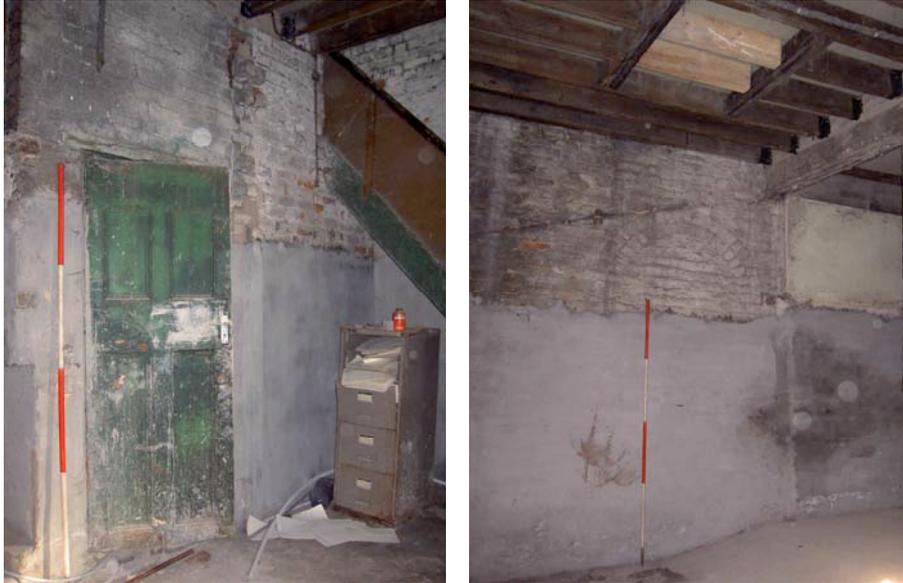
height (Plate 27). The south-west elevation has a large doorway on the west side with a large concrete lintel. The door is constructed of timber tongue and groove battens. To the east is a buttress (which originally formed part of the partition wall) with another doorway at the east end which has a plain surround with a tongue and groove door, above which is a small single-light window. The south-east elevation has no features except for the head of the stairs it supports in the north-east corner.

Plate 26: (right) early door in north-east elevation, Room 2

Plate 27: (left) blocked round-headed aperture in north-west elevation, Room 2

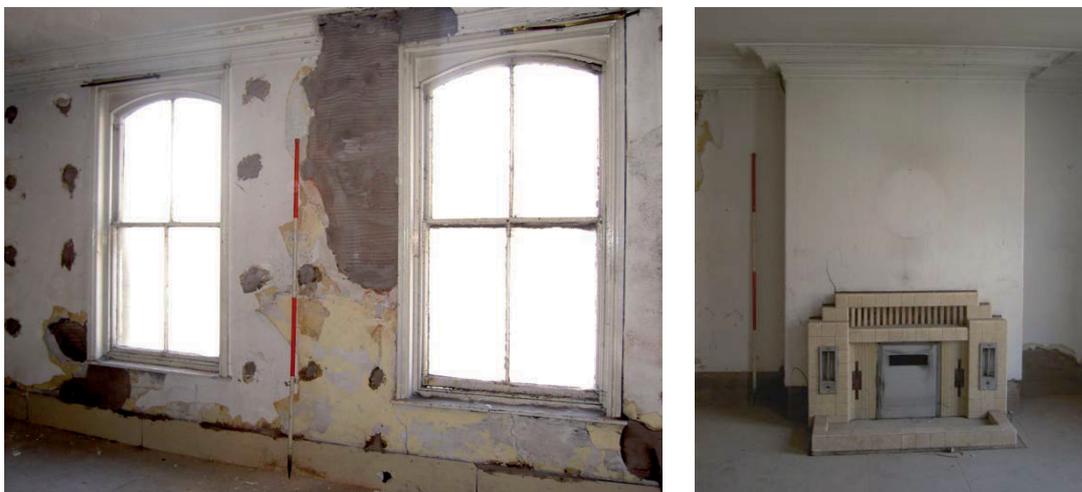
4.3.4 **First floor, Room 1:** the floor to this room has been replaced with chipboard. The ceiling is plastered with an elaborate cavetto and roll-moulded cornice on all sides except for part of the south-west. The walls are finished with plaster except for the areas repaired with cement. The base of the plaster above the floor indicates that it had originally accommodated a high skirting board. In the north-east elevation there are two sash windows, each with four lights, the casements having rounded head and ogee moulded surrounds (Plate 28). The north-west elevation has a chimney breast located centrally with a c1940s tiled fireplace and hearth (Plate 29). The south-west elevation has been heavily rebuilt with a doorway on the east side, the surround and door missing. The south-east elevation has no notable features.

Plate 28: (right) First floor, Room 1, north-east elevation

Plate 29: (left) First floor, Room 1 fireplace, north-west elevation

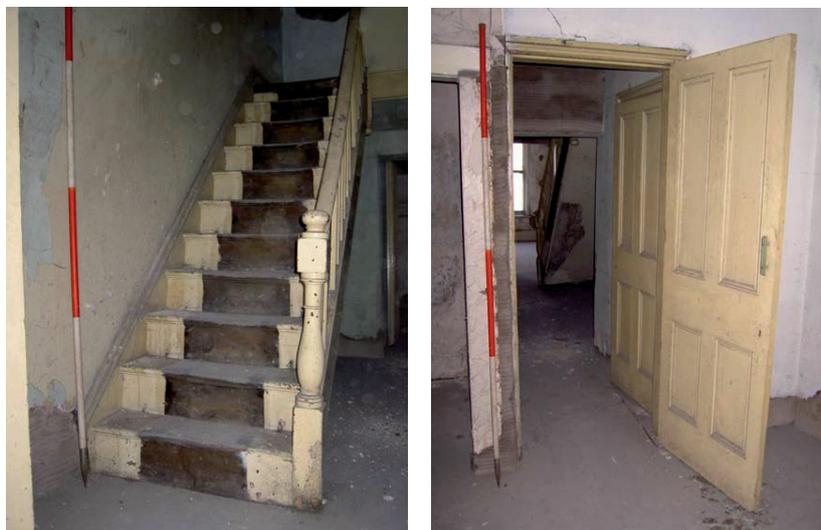
4.3.6 **First floor, Room 3:** this room forms a short hall with a staircase to the second floor (Plate 30). The floor has been replaced with chipboard and the ceilings are plastered. The walls have been plastered with cement repairs. There is a doorway in the north-east elevation on the west side. The north-west elevation has a doorway with an original four-panel ogee moulded door, though the surround is missing. Situated in the south corner under the landing is a cupboard with an original ogee moulded four-panel door. In the south-west elevation adjacent to the cupboard is a doorway with an original ogee moulded four-panel door and surround. The timber staircase and banister with roll moulded skirting board is original and is positioned against the south-east elevation.

Plate 30: (left) First floor, Room 3 stairs against south-east elevation

Plate 31: (right) First floor, Room 4, original doors of Room 2 and 4

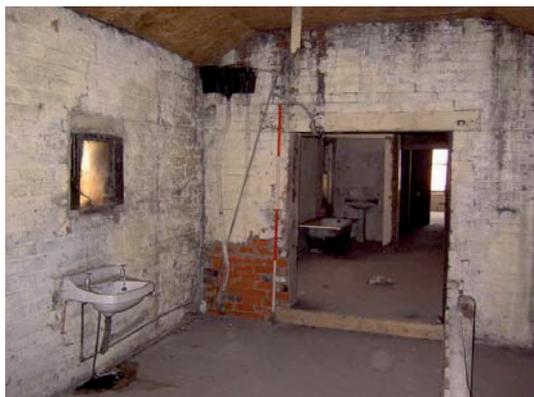
32). On the west side of the door is a water cistern. The north-west elevation has a small single-light window with beaded surround, below which is a hand basin, and returns to the north-west at the south-west end. The south-west elevation has a wide loading doorway with timber lintel on the west side (Plate 33). The door is constructed of chamfered tongue and groove boards and stop-chamfered battens and held by strap hinges with heart-shaped ends. Above the doorway is a timber beam running from the wall and across to the north-east elevation. There is an iron eye on the underside of the beam approximately 1m from the south elevation, and this beam may have originally extended through the south-west elevation and had a hoist on the external side. There is a stairwell down to the ground floor adjacent to the south-east elevation which has a basic timber handrail along the west and south sides.

Plate 32: (left) First floor, Room 5, north-east and north-west elevations

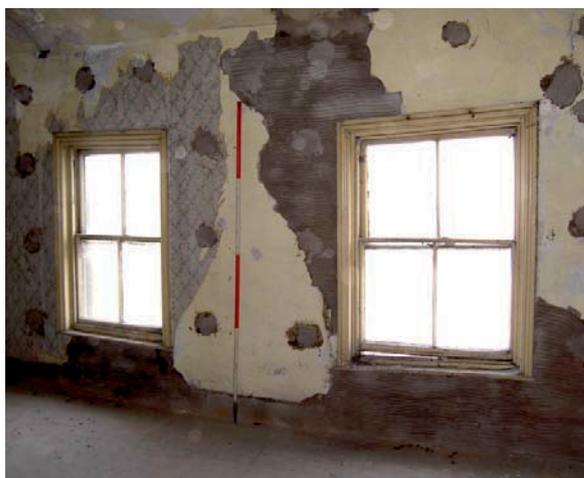
4.3.9 **Second floor, Room 1:** this room has a modern chipboard floor and original lath and plaster ceiling with repairs around the edges. The walls have been finished plaster and cement, and there are remnants of paint and wallpaper. The north-east elevation has two windows; each with four-light sash casements with ogee moulded surrounds (Plate 34). The north-west elevation has a centrally positioned chimney breast, the south side of which angles to the top south corner of the elevation. The fireplace and hearth have been removed, but the beaded skirting board remains (Plate 35). The south elevation has a doorway on the east side with only part of the original ogee surround surviving. There are no features on the east elevation.

Plate 34: (left) Second floor, Room 1, north-east elevation

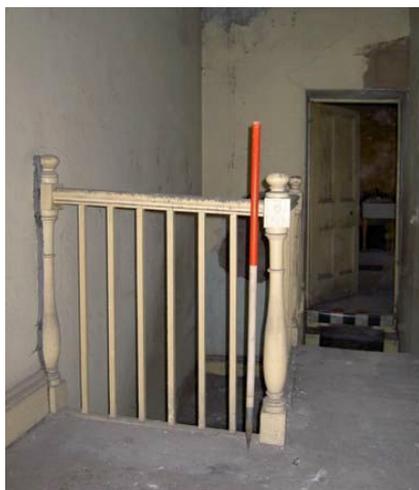
4.3.10 **Second floor, Room 2:** this room forms the hall and includes the staircase from the first floor. The floor is laid with timber boards, and the stairwell is in the south corner (Plate 36). The north-east elevation has a doorway on the east side. At the south-west end of the room between the stairwell and north-west elevation there are stairs down to a landing with stairs returning down to the ground floor on the south-east side and up to a doorway into Room 4 on the south-west. The handrail is supported by posts with rounded finials and square blocks and square spindles, the ogee moulded skirting survives on all four walls. The ceiling has the original lath and plaster finish with repairs in the south-east corner and slopes with the eaves at the south-west end. The north-east elevation has a doorway on the east side with an ogee moulded surround. The north-west elevation has a doorway positioned centrally which has its original ogee moulding. The doorway in the south-west elevation is situated on the east side and has its original ogee moulding, and two steps lead up to it from the landing. The south-east elevation has no features of note.

Plate 36: (left) Second floor, Room 2 with stairs against the south-east elevation

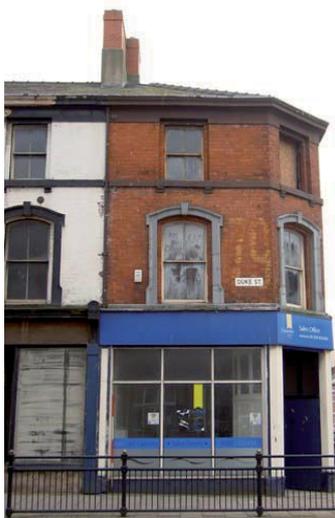
Plate 40: (left) North-east external elevation

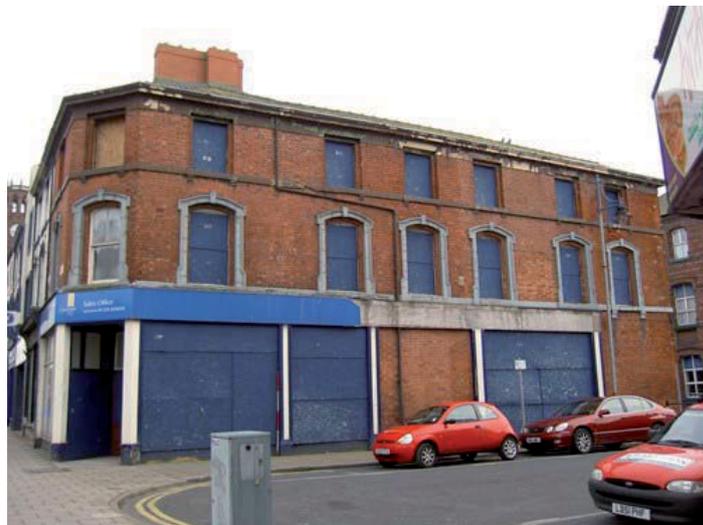
Plate 41: (right) North-west external elevation

the elevation has the casement missing. A brick chimney with short pots is situated at the north-west end of the building, and is possibly a recent replacement. The slate roof, which is a continuation of the roof of No. 77, is hipped at the north-west corner and has ceramic bonnet ridge tiles.

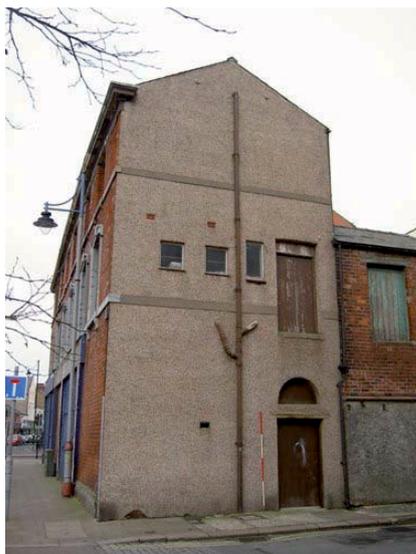
Plate 42: No.79, south-west external elevation

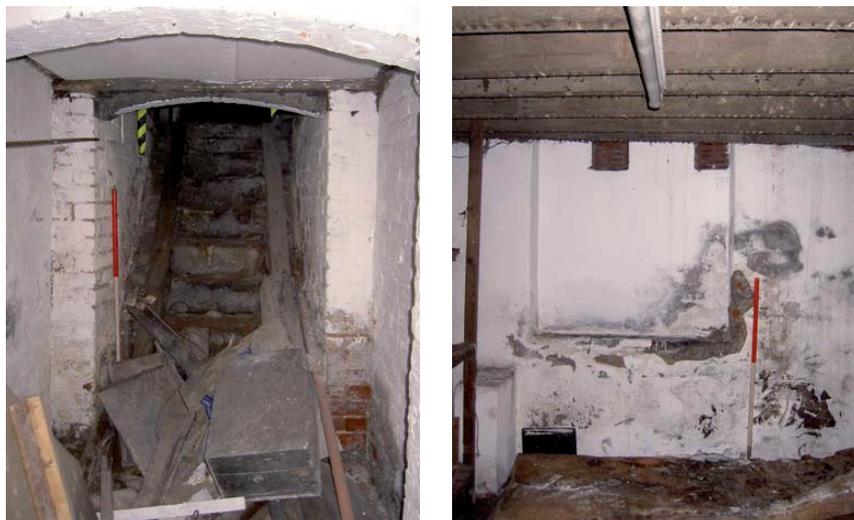
west elevation has exposed brick on the north side. The south-west elevation has shelves attached with a round arched door on the east side which leads to the stairs (Plate 43). The east elevation has two buttresses supporting beams.

Plate 43: (left) Basement, Room 1, south-west elevation and stairway

Plate 44: (right) Basement, Room 3, blocked aperture in north-west elevation

4.5.3 Basement, Room 3: the floor to this room is part stone flag and part concrete. The ceiling is missing with exposed joists. The walls have been rendered and painted. The north-east elevation has a chimney breast and shelving and the west elevation has a blocked aperture with timber lintel and sill leaving a deep alcove. The south-east elevation also supports shelving, and in the south-west corner are two brick supports beneath the shelving. A doorway with timber lintel is at the east end of the south-west elevation, there is also a post supporting a beam for the floor above at the opposite end. The north-west elevation is plain, except for a blocked aperture, which presumably accessed a cellar light in the pavement outside, that has left a shallow alcove (Plate 44).

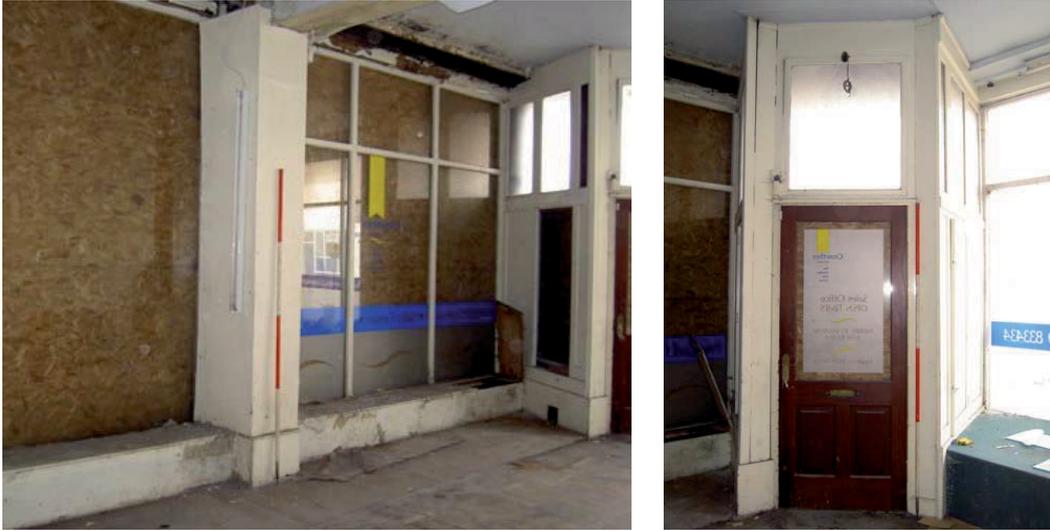
(Plate 45); the one to the north is modern with six lights and the one to the south has a single light. The return in between forms a column supporting the ceiling beam. The panelling continues on the south jamb and there is a wide shelf/sill in each window.

Plate 45: (left) Ground floor, Room 1, north-west elevation

Plate 46: (right) Ground floor, Room 1, recessed doorway in north corner

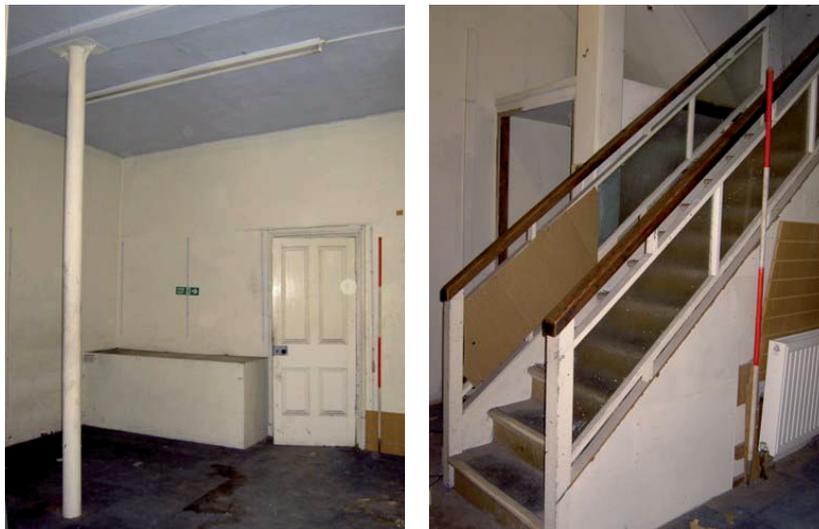
4.5.5 The south-west elevation is a modern stud partition (which is raised slightly as it is situated where the floor slopes up slightly). The doorway on the west side has a modern ogee-moulded surround and modern four-panelled door. At the east end of the stud wall is a return forming a column, within which a recess has been made to house early Bakelite light switches. The skirting is modern with an ogee moulding. The south-east elevation has panelling at the north end which corresponds with the raised display area of the east window in the south elevation. There are two early iron radiators attached and a modern low chamfered skirting board.

Plate 47: (right) Ground floor, Room 2, south-west elevation and column in foreground

Plate 48: (left) Ground floor, Room 2, staircase

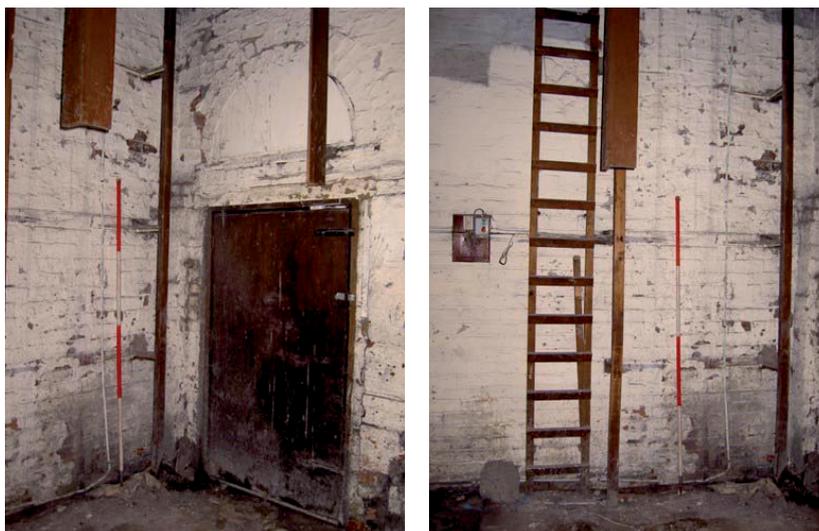
4.5.7 Ground floor, Room 3: this room has the original stone flag floor, raised in the small room situated to the north-west. Basement access is via stone steps in the north-east corner, with timber runners along the edges. The ceiling is open in the south-east corner to accommodate a lift shaft, while the remainder is finished with plasterboard. There is a brick dividing wall on the west side lower than the main wall which is topped with double bull-nosed bricks at the south-west end and a doorway with a flattened arch at the north-east end. On the north-west side of the ceiling is a single beam running north-east/south-west, which rests on a short brick wall. All the walls have been roughly whitewashed. The north-east elevation is on two levels with an apparent butt joint with the walling to the south-east. This part is also brick but supported by a timber beam. North-east of this is walling constructed from timber boards held by battens forming a raised area over the entrance to the basement, which has a flat brick arch. The north-west elevation proper is painted and has a ventilation grill. There is a partition wall which runs parallel to it and is 1.5m in height. Within the area formed by this is a small kitchen with modern units, while a small part of the south corner is inaccessible. This also covers the west side of the south-west elevation, beside which is a small hole in the wall, probably for ventilation. Further to the east is a doorway with brick columns either side with stepped tops. Above this is a blocked round-headed window (Plate 49). The east elevation has exposed brickwork with attached battens for the elevator at the east end. There is a blocked round-headed window and a fixed timber ladder on the north side (Plate 50).

Plate 49: (right) Ground floor, Room 3, doorway and timber tracks of elevator shaft

Plate 50: (left) Ground floor, Room 3, south-east elevation and ladder to first floor

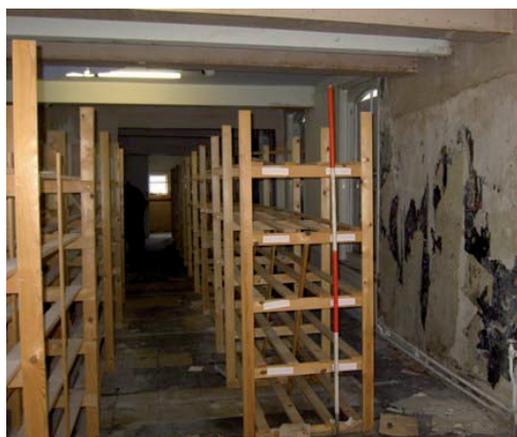
Plate 51: (left) First floor, Room 1, general shot from north-east end showing shelving

plaster. All the walls are also finished with plaster and paint or wallpaper, of which one of the earliest layers was black and patterned with flowers; this was apparently the first layer on top of original yellow distemper. The floor space is taken up with modern timber shelving (Plate 51) The north-east elevation has two three-light sash windows with ogee moulded surrounds and thin sills (Plate 52). The tops of the windows have a shallow arch and roll-mouldings. The north-west elevation has four windows similar to those in the north-east elevation, with the one at the south end having a modern surround. There is a slight return at the south end of the elevation. The south-west elevation has a wide doorway on the west side which is half the width of the wall. There are no features on the south-east elevation.

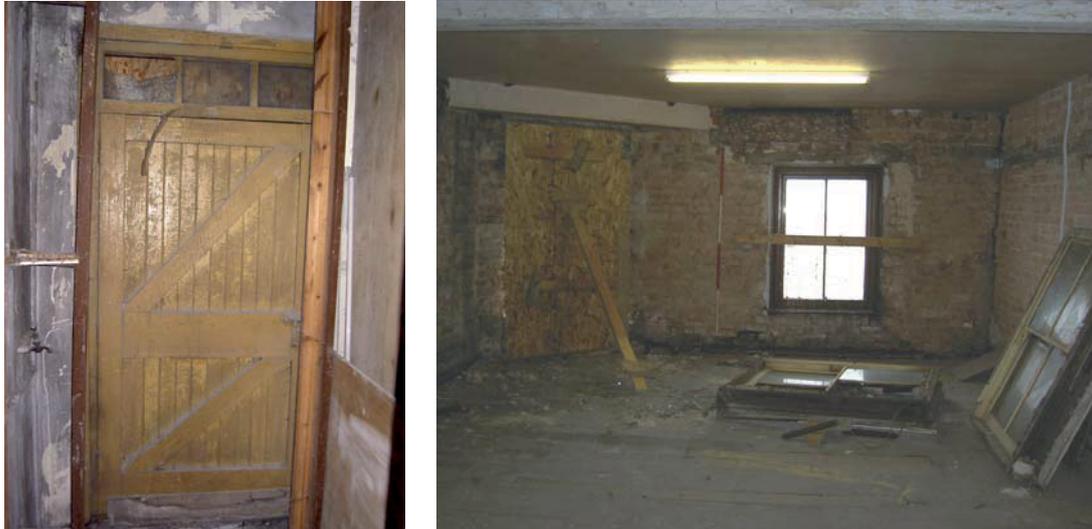
4.5.10 Second floor, Room 1: this room's floor is laid with original but badly damaged timber floorboards. The ceiling is modern plaster with two beams running north-west/south-east, one of which is plastered and rests on concrete pads at either end. The other beam is constructed from two timbers bolted together and whitewashed. The walls are exposed and constructed with mid-red machine made brick, mostly laid in stretcher bond. The tops of the north-east and north-west walls have large sandstone blocks, roughly dressed, situated just below the ceiling. There are roll-moulded skirting boards *in situ* on the north-west, and part of the south-east elevations. The north-east elevation has two windows, with one being in the angled north-west corner (Plate 54). The windows are four-light sash windows with roll-moulded and beaded surrounds, both with machine-cut timber lintels. Attached to the wall at floor level is a long iron strap, L-shaped in section, attached between the wall and the floor joists (Plate 55). The north-west elevation is plain except for two windows with timber lintels but without their casements. The south-west elevation is

modern, constructed from concrete block, and plastered. There is a door on the west side. The south-east elevation has a doorway on the south side, very roughly blocked with brick and with a thin timber lintel (Plate 56). A chimney breast is situated in the middle with modern finish and blocked opening, and in the floor in front of it there is a void for the hearthstone. At the north end of the wall are modern steel ties linking the north-east and south-east walls, which are not well keyed in to each other.

Plate 53: (left) First floor, Room 2, loading doorway in south-east elevation

Plate 54: (right) Second floor, Room 1, general shot of north-east end

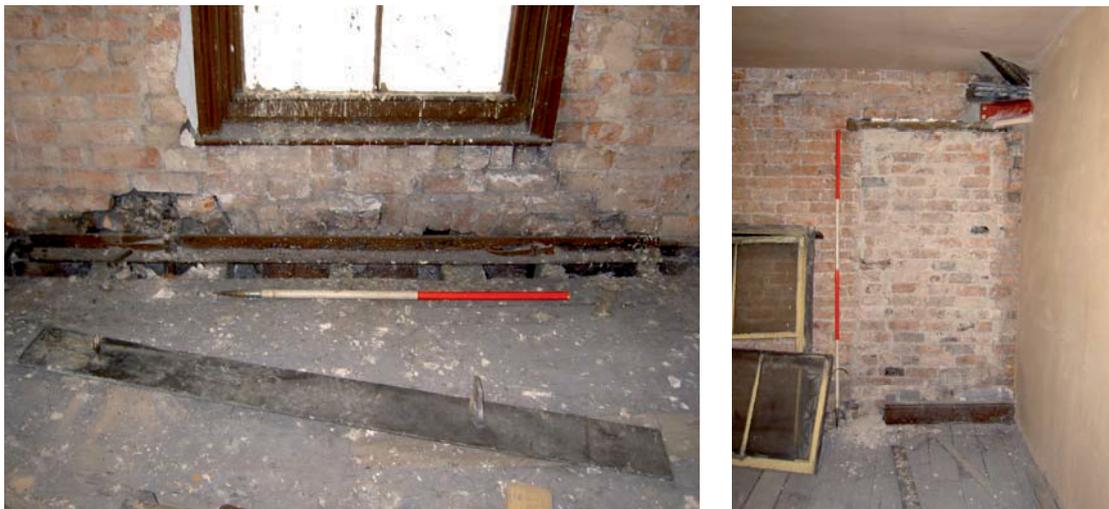
Plate 55: (left) First floor, Room 1, iron strap attached below window in north-east elevation

Plate 56: (right) First floor, Room 1, blocked doorway, south side of south-east elevation

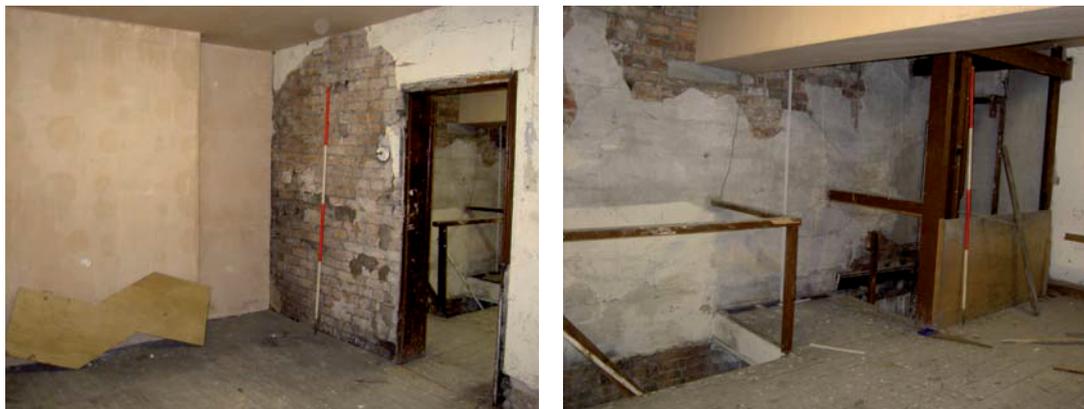
north-west elevation has a window which has had a large part of the wall around it, and to the south, rebuilt with modern brick. The window has a concrete lintel with the sandstone block forming the back of the moulded cornice remaining above. The south-east elevation is a red brick partition constructed in a fairly random bond. There is a doorway east of the centre that may have been a later insertion. There is no door but some surround with ogee moulding has survived, with a gas lighting tap situated to the east (Plate 57). On the east elevation there is plaster on the south side and the chimney breast with the remainder exposed red brick. There is the remains of a roll-moulded skirting board which continues into Room 1/1a.

Plate 57: (left) Second floor, Room 2, south corner

Plate 58: (right) Second floor, Room 3, south-east elevation showing stairs and elevator shaft
