OLD CHAPEL BETWEEN 14 AND 16 MARSH STREET, BARROW-IN-FURNESS, CUMBRIA

Archaeological Building Recording

Client: RS Properties Ltd
Planning Ap. Ref. 142/2005/0722
NGR: 320634 468901

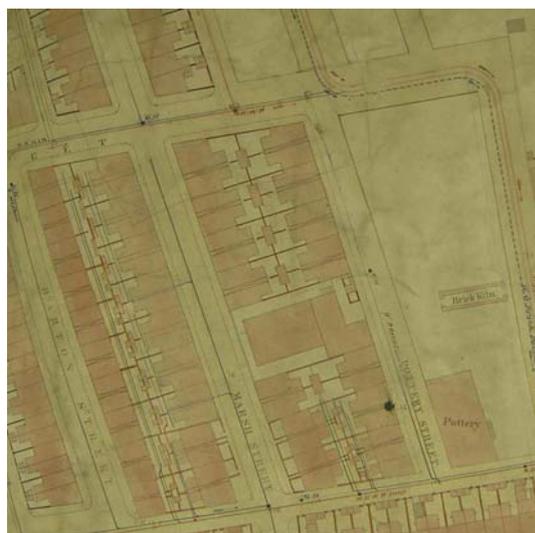
Plate 2: (right) map of c1873, apparently a later edition (Ordnance Survey c1873b)

3.3.2 **Ordnance Survey c1873:** the first of these maps shows Marsh Street not yet developed with only four terraced houses and no chapel (Plate 1). What must be a later edition, although curiously apparently surveyed in the same year, shows the chapel as built and Marsh Street developed up to Lumley Street and beyond. The chapel is the large building situated between Marsh Street and Pottery Street (Plate 2). A pottery is shown on the opposite side of Pottery Street on both maps.

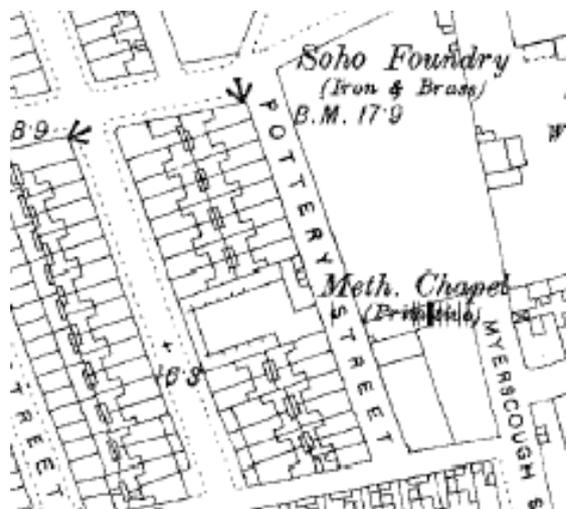
Plate 4: (left) Ordnance Survey map of 1893

3.3.4 **Ordnance Survey Map of 1893:** over the next 20 years there is little evident change although the chapel is shown with projecting buttresses all around it by this date, unlike on the previous maps (Plate 4).

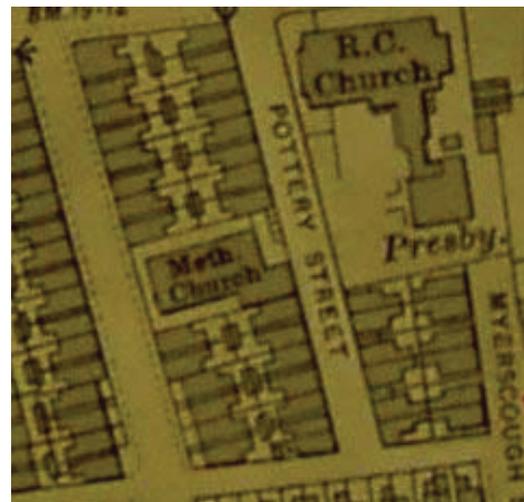
Plate 5: (right) Ordnance Survey map of 1933

3.3.5 **Ordnance Survey Map of 1933:** again, little change has evidently occurred to the chapel, although it is referred to as a church rather than a chapel, but the surrounding landscape has been significantly altered (Plate 5). The pottery has evidently been demolished and replaced with a row of houses and a Roman Catholic Church has been built to the north of this.

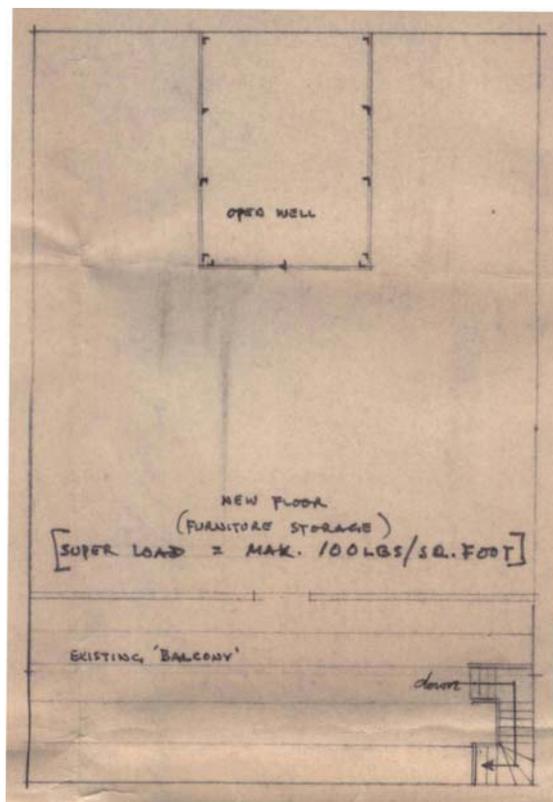
Plate 6: Proposed plan for a new first floor from a planning application of 1977 (Oxley 1977)

3.4.1 **Introduction:** the details of a single planning application from 1977 were available (Plate 6). These indicate that the building was used as a furniture store at this time, and relate to the installation of a proposed first floor (Oxley 1977). It appears that these plans were not carried out.

5.2.1 The chapel building has seen few alterations during its lifetime, most of which probably occurred after the chapel ceased to function as a place of worship. The concrete floor in the schoolroom is one of the obvious changes, probably to replace a rotten timber floor, though the date at which this was added is unknown. The internal furnishings such as the pews, pulpit and organ were probably removed when the church was closed, possibly to be donated to other churches. The platform in the west gallery and the *ad hoc* stud walled water-closet in Room 4 were probably added when the chapel was used for furniture storage. The large doorway in the east elevation of Room 3 also was probably knocked through at this time, and doors either side blocked. The windows that have been blocked were probably also altered at this time, presumably because they were no longer necessary and in order to increase security. The four holes knocked into the east elevation of Room 3 may have been in preparation for the new floor as proposed in the 1977 planning application (Plate 6), which appears to have never been carried out.

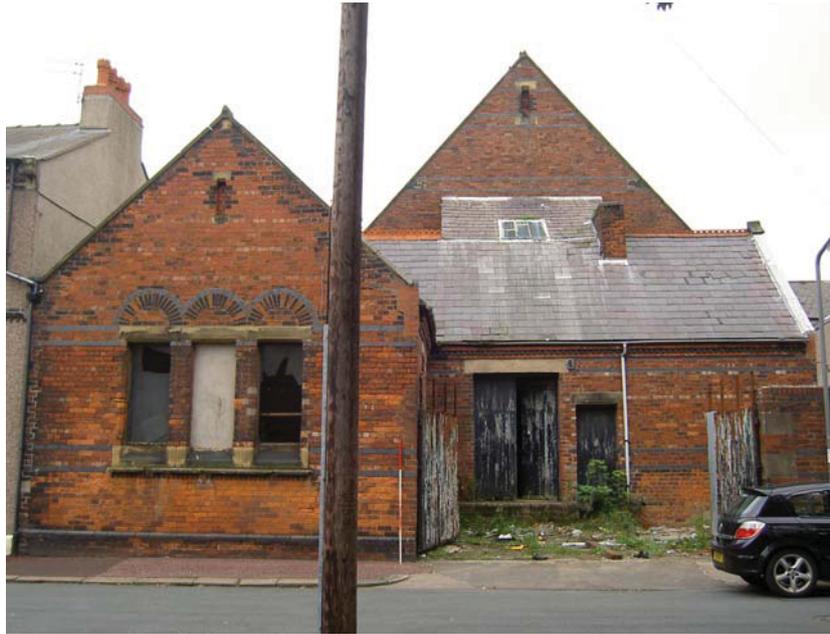
Plate 7: East elevation from Pottery Street

4.2.1 **East elevation:** this elevation forms the rear of the building, facing onto Pottery Street (Plate 7) and consists of the rear walls of the schoolroom and vestry, and the rear gable end of the meeting hall. The south end of the elevation is the gable end of the schoolroom which has three centrally situated rectangular windows. These windows are separated by stop-chamfered brick columns, which support the chamfered yellow sandstone lintels. The large sills are also yellow sandstone, the tops sloping down from the window. Above the lintels are decorative round arches of brick. Two pairs of decorative string courses, of blue brick, run the length of the elevation at the height of the window sills and lintels, the top course following the curves of the decorative pointed arches. The base of the wall has a slight plinth topped with a course of chamfered blue brick.

4.2.2 The gable end of the meeting hall is coped with sandstone slabs and sandstone crested ridge tiles. Immediately below the apex of the roof is a narrow slot with a sandstone lintel and sill. Three pairs of string courses of blue brick decorate this part of the elevation.

4.2.3 The north side of the elevation forms the rear wall of the vestry and entrance into the schoolroom, which has a wide doorway set above a loading platform of brick and concrete. This doorway, which has a plain yellow sandstone lintel, has a set of timber ledge and batten doors within a timber frame. Adjacent to these double-doors on the north side is a single doorway set at the same height accessed by stone steps. Within this doorway is a timber batten and ledge door within a timber frame. Between the roof line and the window lintels is a string course of blue brick in a dog-tooth pattern.

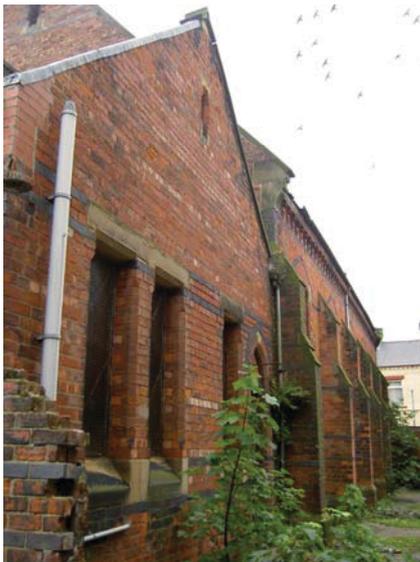
Plate 8: (left) North elevation

4.2.4 **North elevation:** this elevation forms the side of the meeting hall, with the gable of the vestry and side of the schoolroom at the east end (Fig 2). The elevation of the church hall is supported by six brick built buttresses, which are evenly spread along the wall with one at each corner. These are stepped with chamfered sandstone coping at the top and above the centre. Centrally positioned between each of the buttresses is a tall rectangular window with sandstone lintel and sill. The tops of the windows are decorated with a pointed arch of red and yellow sandstone lined with a string course of blue bricks. The sides of the windows are moulded and contain a recessed window frame of 18 leaded lights. These consist of three large lights with a border of smaller red rectangular and square lights. The top two courses of the wall project the width of a single brick and are supported by decorative brick corbels closely spaced with a string course of blue bricks below, which support the guttering.

4.2.5 The east end of the elevation, the gable end of the vestry, has a truncated brick wall butting at right-angles from the east end. At the west end of the gable is an arched doorway (Plate 8). The brick jambs have been chamfered and curve inwards to form a pointed arch, the apex of which has a sandstone keystone. The space within is plain brick above a yellow sandstone lintel. The door itself is a timber batten and ledge within a timber frame. Adjacent to the east side of the door is a rectangular window with stop-chamfered jambs, and sandstone stop-chamfered lintel and sloping sill. At the east end of the elevation are two more rectangular windows separated by a brick column with the sides stop-chamfered. This column supports the sandstone lintels. The window frames are timber with single lights. The wall base and decorative string courses continue round from the east elevation. In the east end corner of the elevation below ground level is a doorway to the basement accessed via a flight of steps alongside the elevation. This doorway has a sandstone lintel with timber frame and a batten and ledge door. The west side of the gable is coped with sandstone slabs and a sandstone crested ridge, while the east side has been covered with lead sheeting. Below the apex of the gable is a narrow slot with stop-chamfered jambs and sandstone lintel and sill.

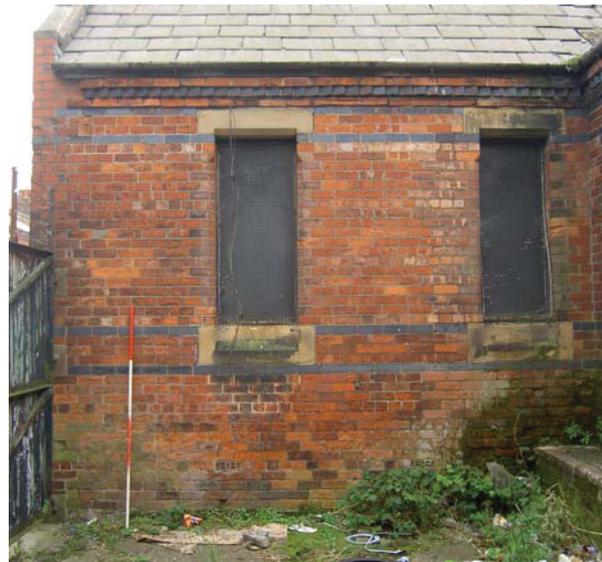
Plate 9: (right) North elevation of schoolroom

4.2.6 The north elevation of the schoolroom (Plate 9) has two tall rectangular blocked windows. One window is situated at the west end and the other just off centre to the east. They have stop-chamfered yellow sandstone lintels and sloping sandstone sills, and the jambs are also stop-chamfered. Between the roof line and the window lintels is a string course of blue brick in a dog-tooth pattern.

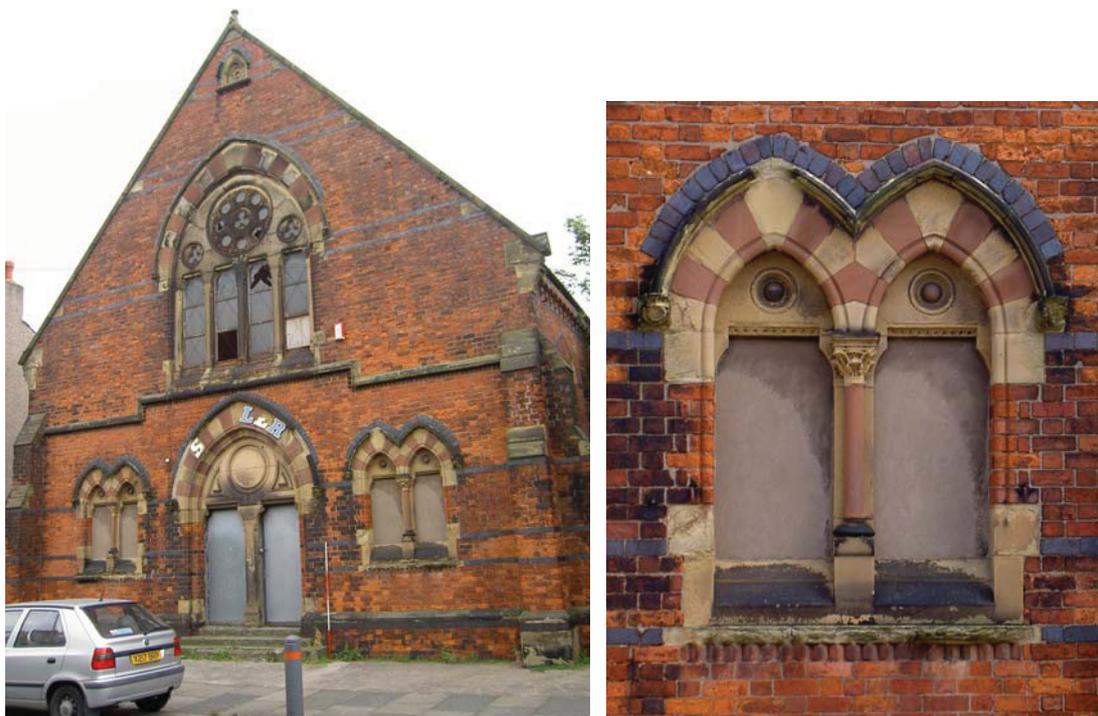
Plate 10: (left) West elevation

4.2.7 **West elevation:** this elevation is the front of the building (Plate 10; Fig 2). At each corner is a buttress similar to those on the north elevation. Running across the lower half of the elevation are three string courses of blue brick (continuing from the north elevation). In the upper half within the gable are three pairs of string courses of blue brick. The two entrance doors are situated centrally within a large decorative archway. The geometric arch is constructed of yellow and red alternating sandstone with a roll-moulded edge within which is a large circular motif of yellow sandstone. There is a moulded sandstone drip-hood over the arch with decorative corbels. Skirting the top of the drip-hood is a string course of blue bricks. Below the arch are the two entrance doors separated by a column. The column between the doors is carved from yellow sandstone with the corners stop-chamfered. The top of the column is splayed to the sides and carved with a crocket to give the appearance of a Corinthian capital. The lintel of each doorway has been decorated with a string of small pointed arches. The doors are reached by three steps, which are stone but have been repaired with concrete. Above the doorway plastic letters 'S...' and '...LER...' (presumably originally spelling 'STOLLERS') are attached to the arch.

4.2.8 On each side of the arch is a pair of arched windows separated by a column (Plate 11). The style of each window is similar to the central arch, but with a pointed arch and a recessed orb of yellow sandstone within the apex of each one. The arch is constructed from alternating red and yellow stone with a roll-moulded edge, above which is a moulded stone drip-hood on decorative corbels, above which is a further decorative band of blue brick. The column supporting the arches is cylindrical with a Corinthian style capital carved with crockets. The windows, which have been blocked and skimmed with cement, have a sloping sandstone sill below which is a narrower projecting sill, also of yellow sandstone, both of which have suffered severe erosion. Below this sill is a string of bricks in a dogtooth pattern.

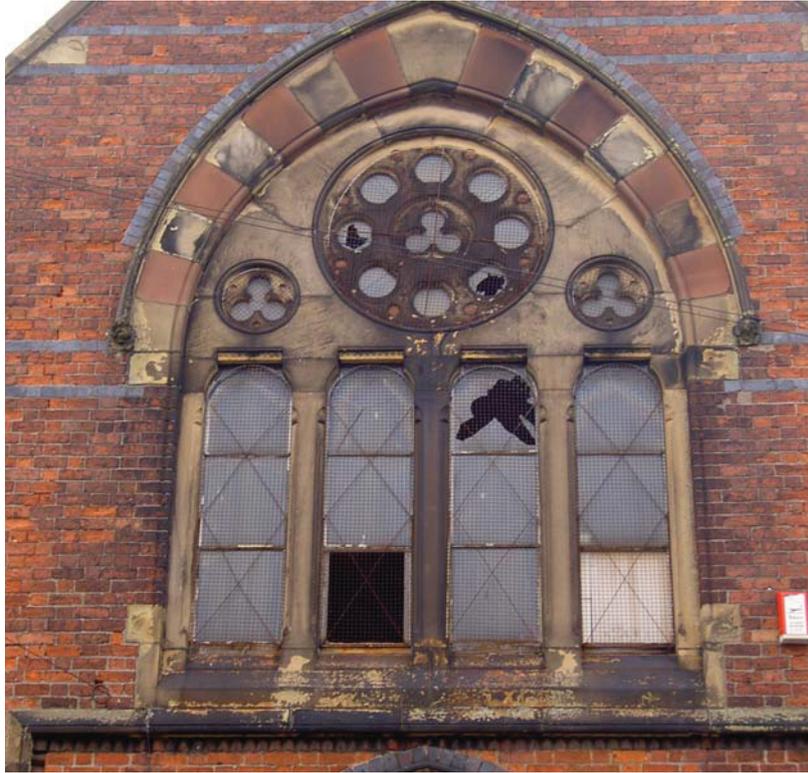
Plate 12: Main window on west elevation

4.2.9 Immediately above the archway is a string course of sandstone which steps down slightly on either side and forms the sill of a large geometric arched window in the centre. This window (Plate 11) comprises four rectangular apertures above which is an arch containing a central light in the shape of a trefoil surrounded by eight circular lights, on either side are two further trefoils, all of which are glazed. Like the central arch below, the arch is constructed from alternating red and yellow stone with a roll-moulded edge above which is a moulded sandstone drip hood on moulded corbels, above which is a further band of blue bricks. The window jambs and lintels are in the same style as the doorways below, with each window having three lights within a timber frame. Situated just below the apex of the gables is a small circular light within a sandstone arch with sill and drip mould seated on a moulded corbels. The top of the gable is laid with sandstone coping slabs, the base of which has a moulded sandstone corbel. At the apex is a crested ridge of sandstone.

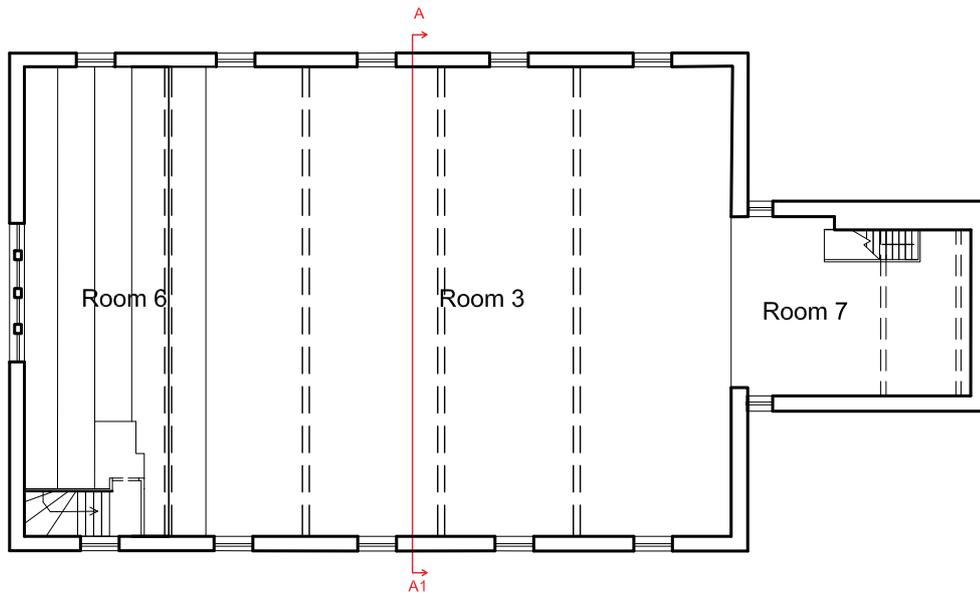
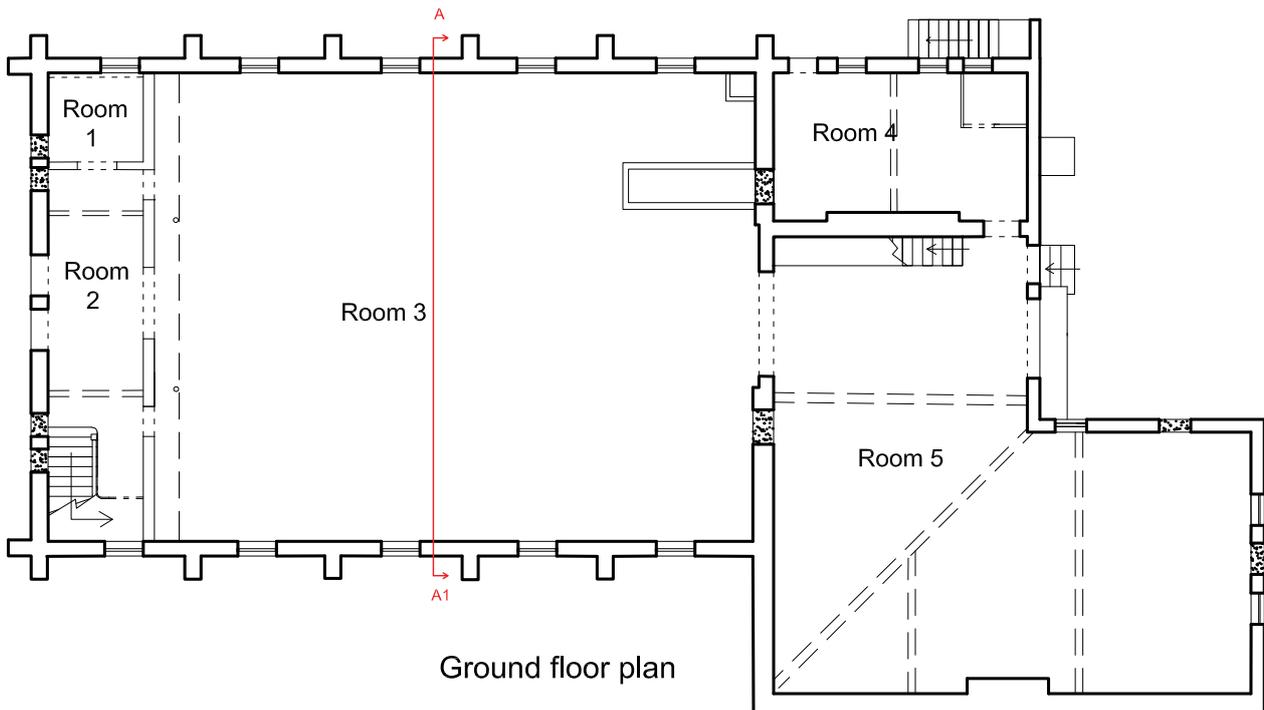
Figure 3: Ground floor and galley plans

4.3.1 There are four rooms and two galleries within the building, although a basement was also present but not accessible due to the entrances being choked with rubble. Room 1 is the cloakroom, Room 2 is the vestibule, Room 3 is the church hall, Room 4 is an ante room, perhaps the vestry, and Room 5 is the schoolroom (Fig 3).

4.4.1 The first floor consists of the galleries which are situated at the west and east ends of the meeting hall. Room 6 is the west gallery and Room 7 is the east gallery (Fig 3).

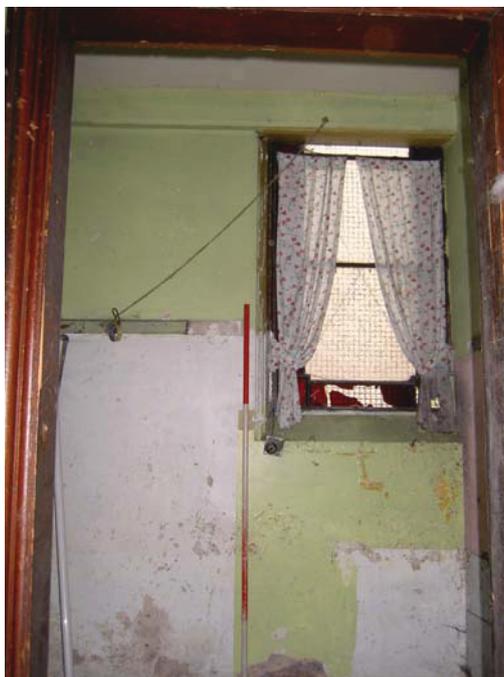
Plate 13: North elevation of cloakroom (Room 1)

4.3.2 **Room 1:** this is room is very small, probably a cloakroom, in the north-west corner of the building accessed via the vestibule (Room 2). The east elevation is painted and wallpapered and a scar from a coat rack is visible. The north elevation has a window on the east side that extends higher than the ceiling (Plate 13). The timber frame has a sloping sill and the jamb is moulded on the west side. There are two cast-iron vents at the base of the wall, and there is an exposed beam set into the wall below the ceiling running east/west which forms part of the structure supporting the floor of the gallery above. The west elevation has been plastered and painted and there is a blocked window on the south side; a scar from a coat rack is visible running between the window and the north corner. The south elevation is lath and plaster and wallpapered and has a coat rack attached. There is a central doorway with a moulded timber surround. The floor is made from timber planks running in an east/west direction and the ceiling is plastered and painted.

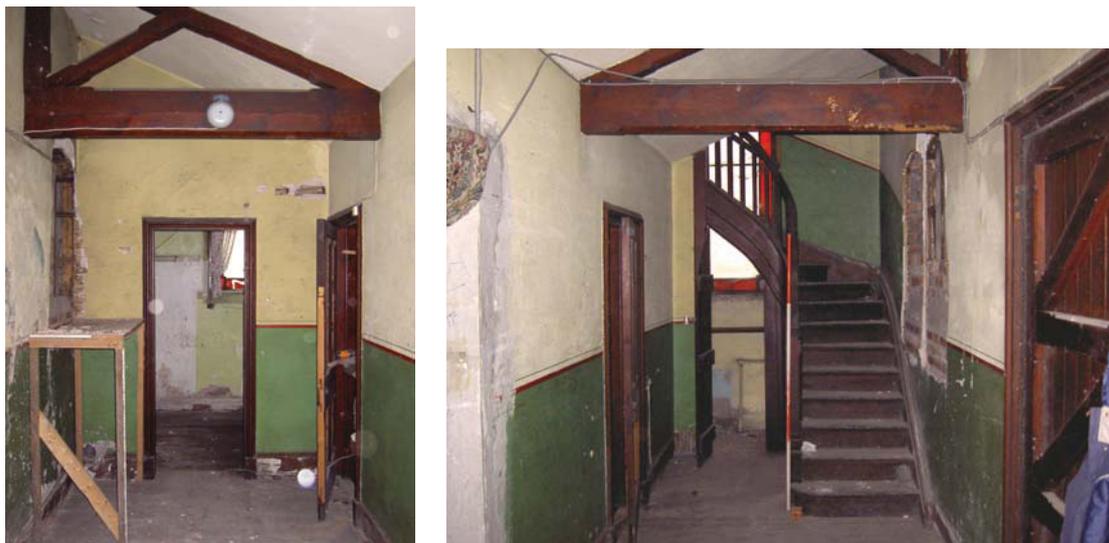
Plate 14: (left) North elevation of vestibule (Room 2)

4.3.3 **Room 2:** this narrow room is the vestibule and runs north/south at the east end of the building. The east elevation has a centrally placed wide doorway into the meeting hall (Room 3). The walls are plastered and painted and another doorway is situated between the wide doorway and north corner. The door frame has a moulded timber frame with a four panel door. The panels are made of tongue and groove battens set at an angle. The frame has been stop-chamfered on the sides facing the panels. A doorway is also present on the south side fitted with a similar door and frame.

4.3.4 The north elevation (Plate 14) is a lath and plaster stud wall with a central doorway and moulded door frame. The west elevation is plastered and painted and the two entrance doorways situated centrally have moulded timber frames with braced batten and ledge timber doors. There are two low arched windows on the south side and one on the north side, all of which are blocked. Also at the south end are the stairs (Plate 15) to the west gallery (Room 6). The stairs rise up to the south corner and return to the east along the south elevation.

4.3.5 The south elevation has a large window that extends beyond ceiling height, of which the top half of the staircase to the gallery passes in front, rising from west to east. The staircase has a square chamfered newel post with plain chamfered balusters and a moulded banister. The underside of the stairs is battened and there is a batten and ledge door to the space beneath. The floor is made from timber with the planks running east/west. The ceiling slopes down from the west, due to the stepped gallery (Room 6) above, and supported by two timber half-trusses. These have a king post strut against the west wall and a raking brace supporting the rafter; all of the timber has stop-chamfered edges (Plate 14).

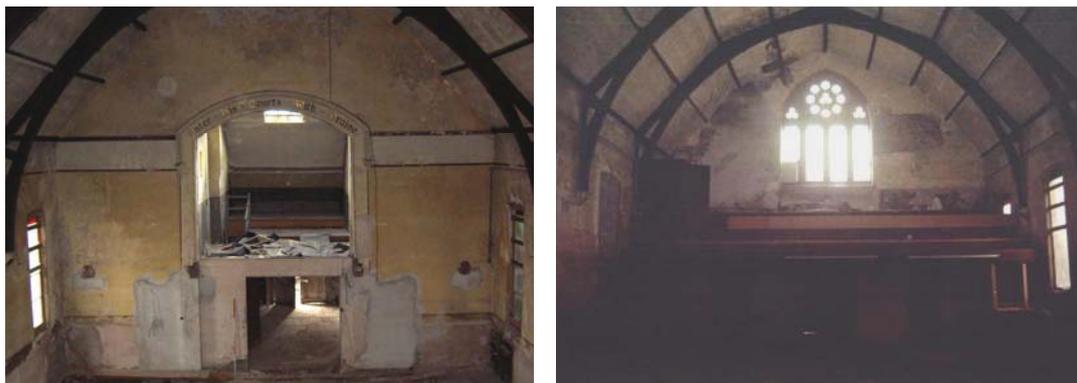
Plate 16: (left) East elevation of the meeting hall (Room 3) with east gallery

4.3.6 **Room 3:** this room is the meeting hall. Situated centrally in the east elevation is a very wide and high shallow-arched opening (Plate 16). The wall below this arch has been knocked through to create a large doorway, slightly off-centre. On the ground floor, either side of the arch, are two blocked doors. The top half is open to the east gallery (Room 7). At the height of the gallery floor there are four roughly knocked out holes in the wall, evenly spaced. The top half of the opening is the east gallery (Room 7) which has a moulded archway with the inscription 'Enter His Courts With Praise' inscribed in black with gold capitals. The wall is plastered and painted. The north elevation is also plastered and painted, with some repair to the plaster. There are four rectangular windows evenly spaced; three are leaded with 18 lights while the fourth (at the west end) has a single light. Approximately half way up the walls there are three corbels, each spaced between the windows, which support the roof trusses (Plate 18). The west elevation supports the west gallery (Room 6), above which is the large central window at the front of the church (Plate 17). The south elevation is similar to the north elevation, although the two windows at the west end have been blocked. In the east corner is a remnant of the early timber panelling (Plate 19). The ceiling is mansard shaped, plastered and painted white. The braced arched trusses supporting the roof are visible as are the purlins, and have been painted black (Fig 4). On either side of the ridge purling situated centrally between the trusses are square vents. The timber floor has been recently removed. In the north east corner of the room is a backfilled stairway down to the basement under Room 4 (Plate 20).

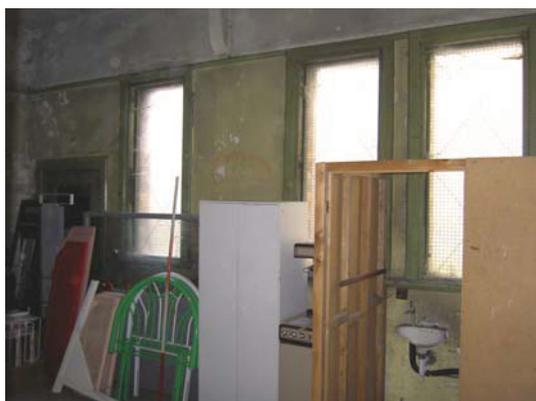
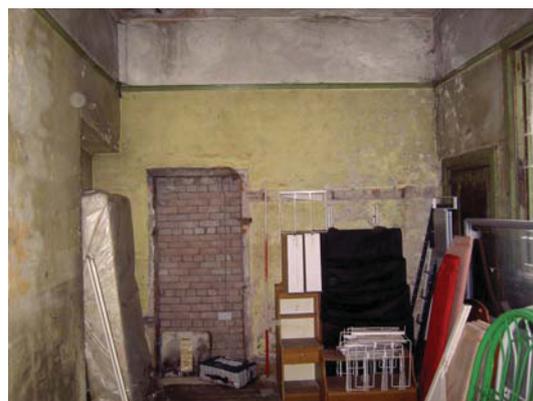
Plate 21: (left) North elevation of Room 4

4.3.7 **Room 4:** this room is situated in the north-east corner of the building to the rear of the building, and probably formed the vestry or equivalent. All four elevations are plastered and painted with a picture rail set at the height of the top of the windows. The skirting boards are plain painted timber on all the elevations except the south, which has a cement skirting.

4.3.8 The east elevation has a small stud wall cubicle in the north corner within which is a toilet and hand basin. The north elevation is plastered and painted. At the west end of the elevation is a doorway with moulded timber frame and batten and ledge door. The three windows in the elevation have single lights within a timber frame (Plate 21). The west elevation has a blocked doorway and a scar between the doorway and the north corner was probably for a coat rail (Plate 22).

4.3.9 The south elevation has a shallow recess at the west end, the top of which slopes upwards to the east. At the east end of the elevation is a doorway with plain timber surround giving access to Room 5. The ceiling is painted lath and plaster with a chamfered beam running north/south. On either side of the beam against the south

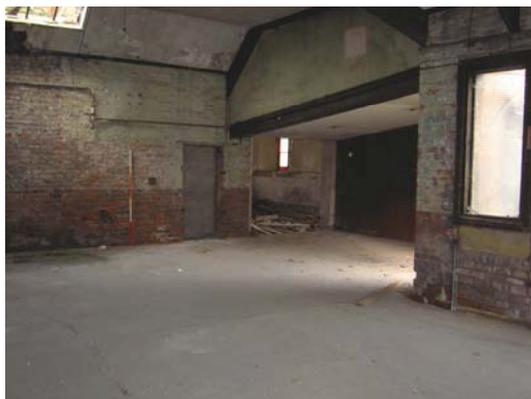
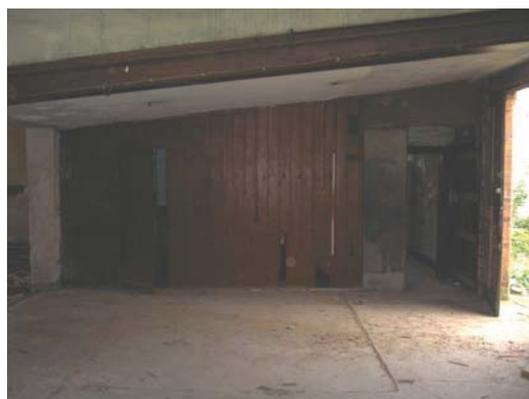
Plate 23: (left) The schoolroom (Room 5) from the south-east

4.3.10 **Room 5:** this room (Plate 23) is situated at the east end of the building and can be accessed from Pottery Street. It probably originally formed a schoolroom. The east elevation is not plastered but the top two thirds are painted. At the south end, situated in the centre, are three rectangular windows with single lights within a timber frame, except the middle window which is blocked. The sills are yellow sandstone and lintels are timber. The wall returns to the west, in which are two rectangular windows similar to those previously described. The wall returns again where there is a large doorway with timber double doors and frame. Adjacent is another doorway with a timber batten and ledge door and frame.

4.3.11 The north elevation has a doorway at the east end giving access to Room 4. The rest of the elevation is obscured by the staircase to the east gallery (Plate 24). The timber staircase rises from east to west and is enclosed within timber planking, the space below the stairs acting as cupboard space with a door at the west end. The west elevation has a large opening at the north end into Room 3 with a blocked doorway on its south side. At the south end of the elevation is a doorway with a timber batten and ledge door and frame. The walls are without plaster and partially painted.

4.3.12 The south elevation is also not plastered and partially painted and has a shallow chimney breast with blocked fireplace situated centrally. The ceiling over the main area of the schoolroom is high, with the edges on the south, east, and west sides sloping and constructed of lath and plaster. A chamfered timber beam runs diagonally from the south-west corner, from which two other beams run in a north/south direction. These beams are secured to the exposed ends of roof trusses. On the west slope of the ceiling is a large timber framed four-light skylight. The ceiling at the north end of Room 5 is approximately two meters lower and supported by a chamfered timber beam running east/west from the corner of the return of the east elevation. The wall above the beam is painted lath and plaster. The ceiling is also of lath and plaster and the floor is concrete.

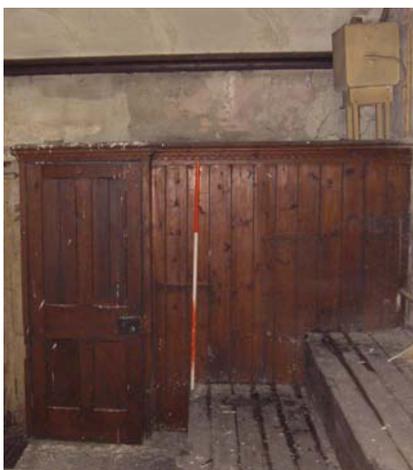
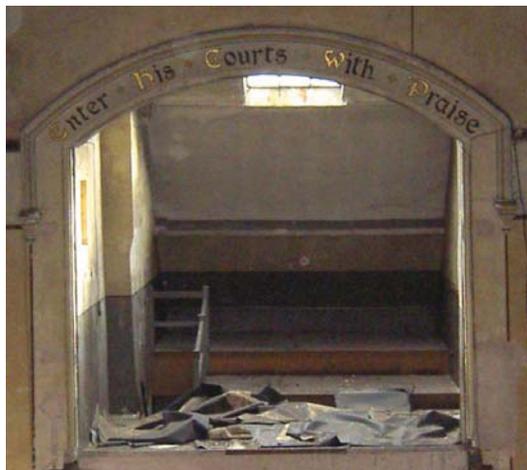
Plate 25: (left) The enclosed staircase at the south end of the west gallery (Room 6)

4.4.2 **Room 6:** this area is the west gallery, which is accessed via a staircase from the vestibule (Room 2). The gallery is directly above the vestibule with the floor projecting approximately two meters into the upper part of the church hall (Room 3). This part of the floor is supported by two plain cast-iron columns with timber capitals. The floor is constructed from timber boards and tiered, stepping down from the west elevation. The middle tier has been raised to that of the preceding tier with a platform constructed of chipboard. The east side of the gallery is open to the meeting hall (Room 3). At the south end of the gallery is the staircase, which is enclosed; its walls and ceiling are constructed of timber boarding (Plate 25).

4.4.3 **Room 7:** this room (Plate 26) is the east gallery situated at the east end of the church hall above the north end of the schoolroom (Room 5) and was where the organ was housed. The east elevation is formed by the ceiling, which comprises lath and plaster. The ceiling follows the roof, which slopes down from the centre of the ceiling to the top of a plain timber skirting board. From the apex of the roof the ceiling slopes down to the west elevation, which is open with a shallow arch with a moulded

edge. There are small scars on the edges of the opening and the archway indicating that there was some type of railing previously installed. The north elevation is plastered and painted with the staircase from the schoolroom (Room 5) entering at floor level, around which is a plain timber railing. A small single light in a timber frame is set high at the west end of the elevation. The south elevation is plastered and painted, with a small light situated high at the west end of the elevation. The floor is tiered and of timber construction with the planks laid north to south. There are three tiers, each of which is fairly wide and shallow.
