18-22 WOOLPACK YARD, KENDAL, CUMBRIA

Archaeological Building Recording

Client:
Maple Grove Developments Ltd

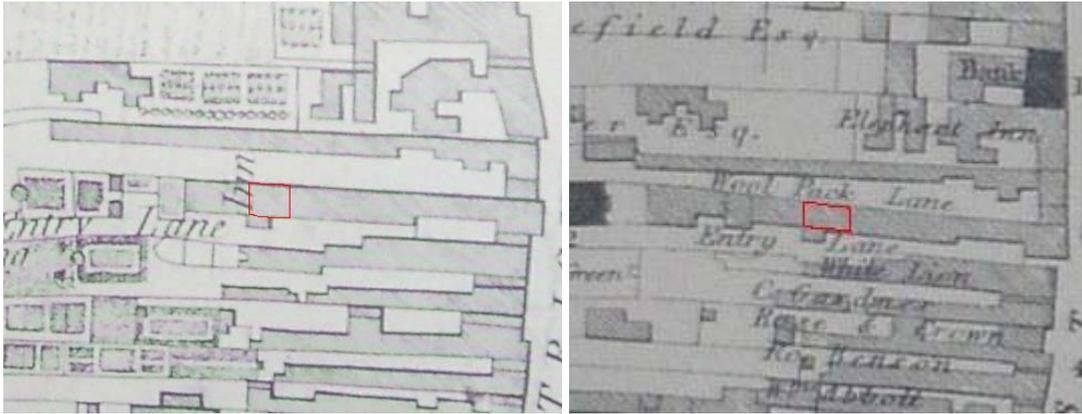
3.2.1 **Todd's map of 1787:** this map (Plate 1) shows a row of buildings containing 18-22 running east/west between Woolpack Yard to the north and Entry Lane to the south. Cottages 18-22 are situated just west of the building marked as an inn. There is a small projecting structure, perhaps an outshut, on the south side of the west end of the buildings.

3.2.2 **Wood's map of 1833:** this map (Plate 2) shows the same row of properties in similar detail. It is evident that the area has changed very little, although some buildings do appear to have been added to the west.

Plate 1: (left) Todd's map of 1787

Plate 2: (right) Wood's map of 1833

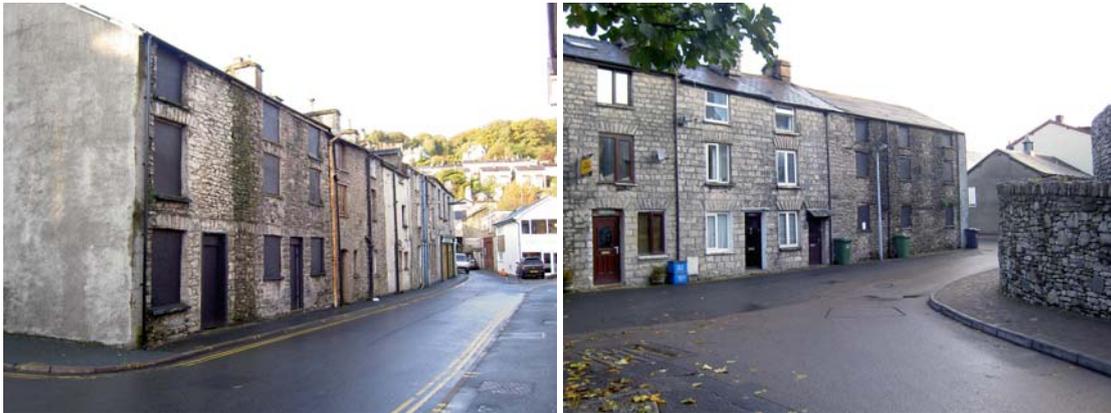
4.1.1 The building is rectangular, orientated east/west and three storeys tall, the front facing north onto Woolpack Yard and the rear facing south onto Entry Lane (Plate 8 and Plate 9). The buildings comprise a row of three cottages numbered 18, 20, and 22 (although, curiously they are labelled 9, 11, and 13 on the current Ordnance Survey mapping; see Figure 1). The external walls are constructed from limestone rubble while the internal walls are brick. The roof is battened and felted but the slates are no longer extant. Internally the ground floor has been concreted and the rooms have been partitioned with timber and lath and plaster or plasterboard. All the doorways have modern timber architraves, although no internal doors remain. The building is split into three cottages, which are separated by brick partition walls. The partition wall between No. 18 and No. 20 is constructed of a single-skin brick wall. The partition wall between No. 20 and No. 22 is of a much sturdier construction but also brick. The north end of this wall is 0.5m thick before returning to a width of 0.25m for the remaining part. All windows have a single-light modern timber casement and a painted timber sill unless otherwise stated. The elevations are shown in Figure 2 and the plans in Figure 3.

Plate 8: (left) West end of Woolpack Yard

Plate 9: (right) Rear of cottages from Entry Lane

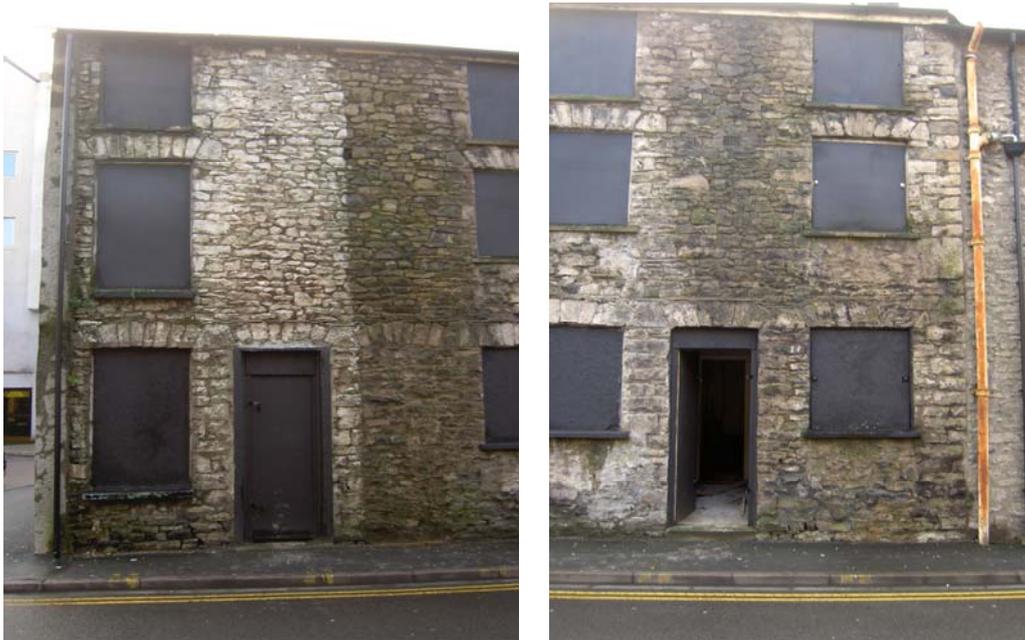
4.2.1 *North elevation:* (Figure 2, Plate 10 and

Plate 11) the ground floor of the elevation has three windows and three doorways, one of which is blocked. The windows are rectangular in shape, although two have been altered with the sills being raised approximately 0.5m. The window at the east end is unaltered and retains its original stone sill; the other two having been replaced with concrete sills. Of the three doorways the middle one is blocked using limestone rubble. The remaining doorways have a stone doorstep and timber doorframes with recently boarded timber doors. The first and second floor windows are situated directly above the ground floor windows, with the second floor windows being shorter; their lintels flush with the roof line. The first floor windows have also been altered in a similar fashion to those on the ground floor, although the east end window is unaltered. The ground floor and first floor windows and the doorways have flat-based shallow arches of stone with a slate string course directly above. This string course runs the length of the cottages and probably acted as a drip course.

Plate 10 (left) West side of north elevation of cottages

Plate 11 (right) East side of north elevation of cottages

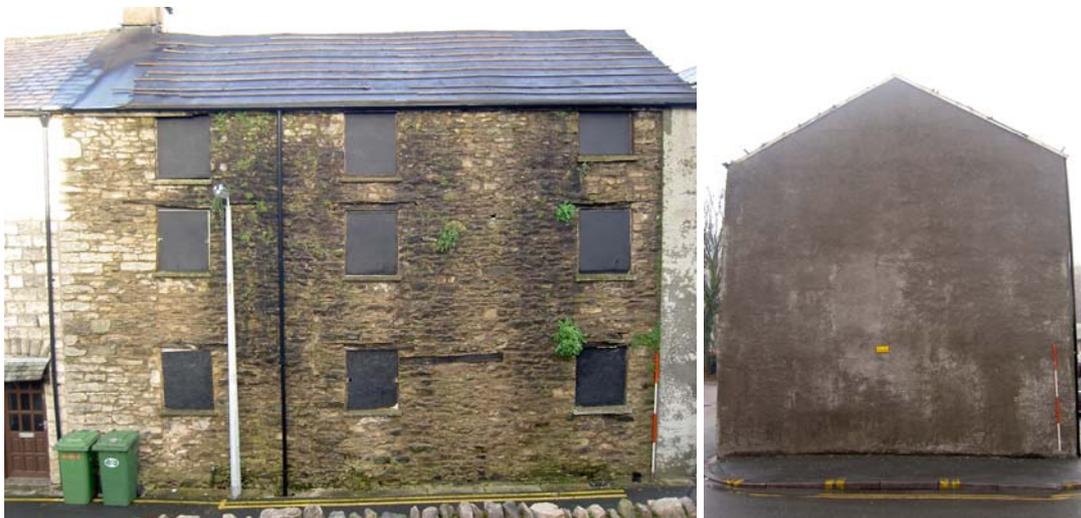
4.2.2 **South elevation:** (Fig 2, Plate 12) this elevation also has nine windows although these are shorter than those on the north elevation. There is one doorway situated at the east end between two windows on the ground floor, which has been blocked with limestone rubble. All the windows and the doorway have exposed timber lintels, which are irregular in length. The windows at the east end of the building retain their original stone sills while the other sills have been replaced with concrete.

Plate 12: (left) South external elevation of cottages

Plate 13: (right) East external elevation

4.2.3 **East elevation:** this is the gable end of the cottages. It has a modern concrete render and is otherwise plain (Plate 13).

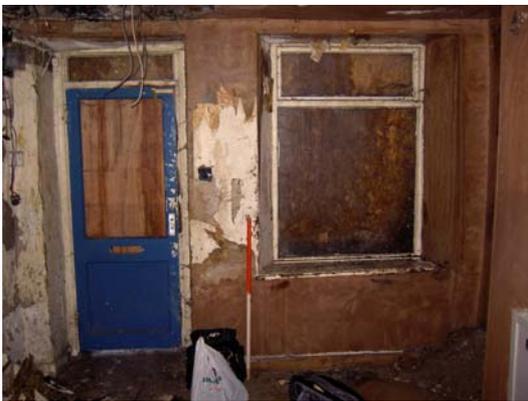
4.3.2 **Room 1:** this room is situated in the north-east corner of the ground floor. The north elevation (Plate 14) has an external doorway with over-light accessing Woolpack Yard on the west side and a window with splayed jambs and timber sill on the east side. The external door is constructed of modern timber with a single light. The wall is plastered and has a modern skirting board. The south elevation (

Plate 14: (left) North elevation of Room 1

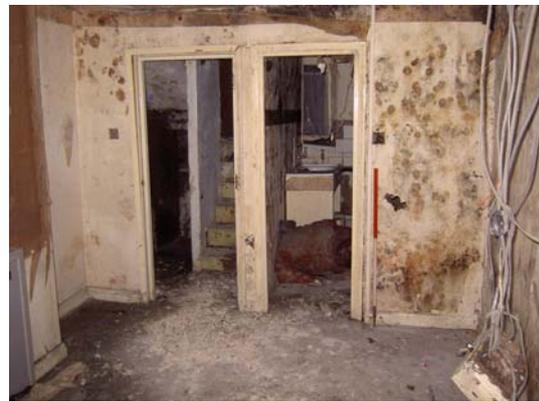
Plate 15) is a timber and plasterboard partition wall with two doorways, one leading to the stairway on the east, the other, on the west side, to the kitchen. The east elevation has a centrally situated chimney breast with a tiled fireplace and mantelpiece of mid-20th century type (Plate 16). The west elevation is the partition wall to No. 20, and is plastered, with a beaded skirting board.

Plate 15: (right) South elevation of Room 1

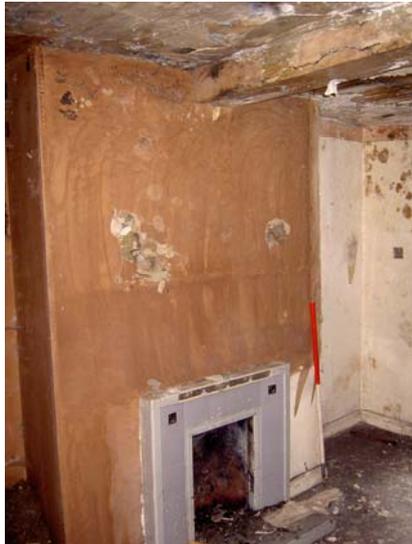
Plate 16: (left) East elevation of Room 1

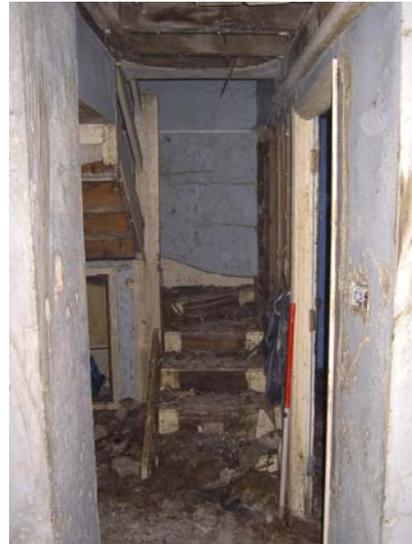
Plate 17). At the west end is a doorway to Room 7. The west elevation is plastered and painted with a doorway to Room 6 at the south end. The stairwell is constructed of timber and is painted. There is a plain newel on the turn and a plain timber handrail, a plain timber batten runs in parallel between the string and handrail. This is repeated on the first floor.

Plate 17: (right) Staircase in Room 6

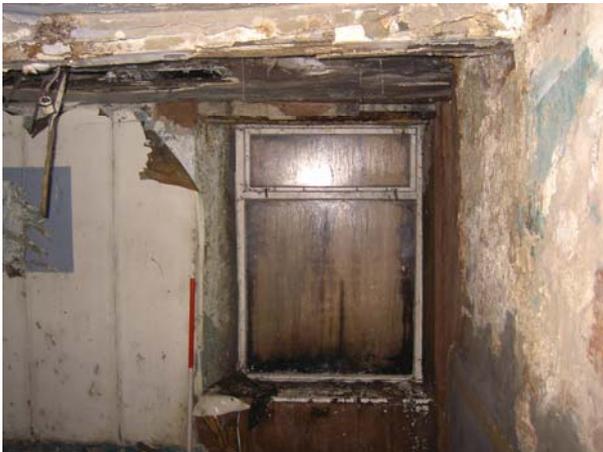
4.4.2 **Room 8:** this room is situated in the north-east corner of the building and is the main bedroom of No. 18. The north elevation (Plate 18) is an external wall, and is finished with plaster and wallpaper. At the east end is a window, the west jamb of which is splayed, that has been fitted with a modern two-light timber casement frame. The east elevation is plastered and painted and a chimney breast is centrally situated, its fireplace blocked. The south elevation is a timber and lath and plaster stud wall with a doorway to the staircase (Room 9) at the east end. The west elevation is the brick partition wall to No. 20, which is plastered and painted.

Plate 18: (left) Window in north elevation of Room 8

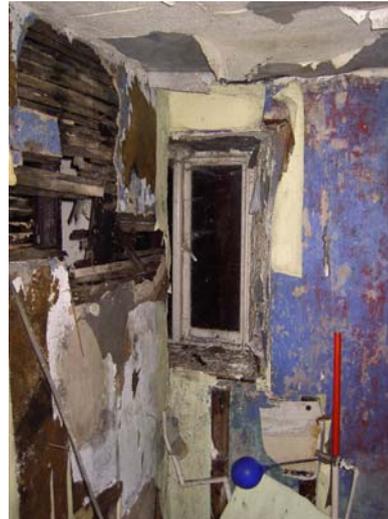
Plate 19: (right) South-east corner of Room 10

4.4.4 **Room 10:** this room is situated at the south end of the building and the fixtures indicate it was used as a water closet. The north and west elevations are timber stud walls with lath and plaster, the north elevation having a doorway to Room 8. The west elevation is the brick partition wall to No. 20, which is plastered. The south elevation (

Plate 19) is an external wall with a window at the east end, which extends past the east elevation into the next room (Room 9).

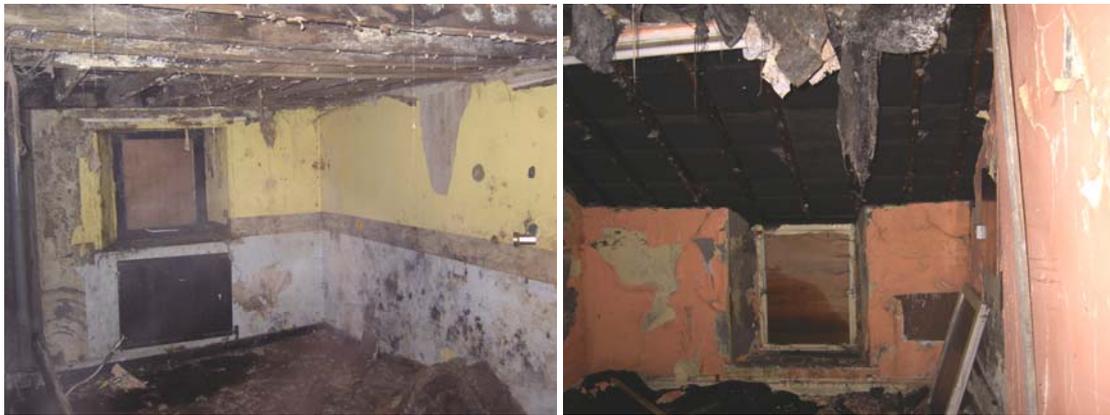
4.4.7 **Room 13:** this large room covers the majority of the first floor of No. 22. The north elevation is a stud wall with a doorway to Room 14. The east elevation, which is plastered and wallpapered, is the partition wall to No. 22. The west elevation is an external wall and also plastered and wallpapered (Plate 20). There is also a centrally fixed radiator and a pair of wall lights. The south elevation is an external wall, plastered and wallpapered, with a window with splayed jambs and a radiator underneath. In the south-east corner of the room are a pair of taps and a small area of tiles with a mirror. All the walls have chamfered modern skirting board.

Plate 20: (left) South and west elevation of Room 13

Plate 21: (right) South elevation of Room 17

4.5.3 **Room 17:** this is the main room on the second floor of No. 20. The east and west elevations are the brick partition walls. Both elevations are plastered and wallpapered. The west elevation has a scar from a fitted wardrobe in the return of the wall as well as a small area of tiling, mirror, and pipe work for a wash basin. Centrally positioned is a two panel radiator. The east elevation has a doorway to Room 19. Between the doorway and the end of the wall are two wall-lights and at the east end is a wash basin. The south elevation (Plate 21) is plastered and painted and has a centrally situated window with splayed jambs. All the elevations have modern chamfered timber skirting boards. The ceiling is no longer extant revealing the roof timbers (Plate 21).

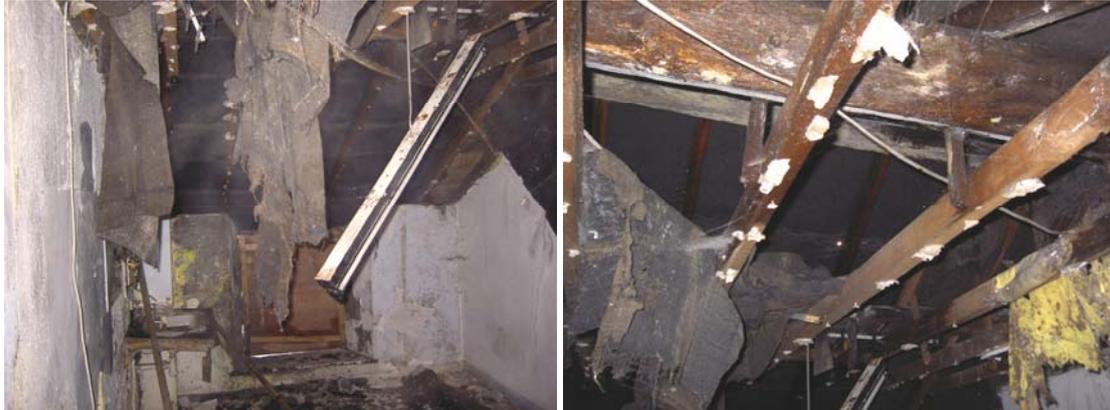
4.5.4 **Room 18:** this room (Plate 22) takes up the whole second floor of No. 22 and is accessed from the landing (Room 16). The elevations are plastered and painted except for the east elevation which is wallpapered. There is also a pair of wall lights attached to the east elevation and a small tiled area and mirror at the east end. All elevations have a chamfered timber skirting board. The north elevation has a window at the west end with east jamb splayed and no window frame. Part of the wall has been coated with a cement render and the north-east corner has been boxed in. The south elevation has a centrally placed window with splayed jambs but the window frame is no longer extant. The ceiling is no longer extant revealing the roof timbers and remnants of insulating material (Plate 23). A fluorescent light fitting hangs from the ceiling.

Plate 22: (left) South elevation of Room 18

Plate 23: (right) Roof timbers in Room 18
