# 'CORN MILL BARN', NEWLAND, ULVERSTON, CUMBRIA

Archaeological Building Recording  
and Watching Brief

Client: Paul Glass  
Planning ref.: SL/2008/0260  
NGR: SD 30010 79650

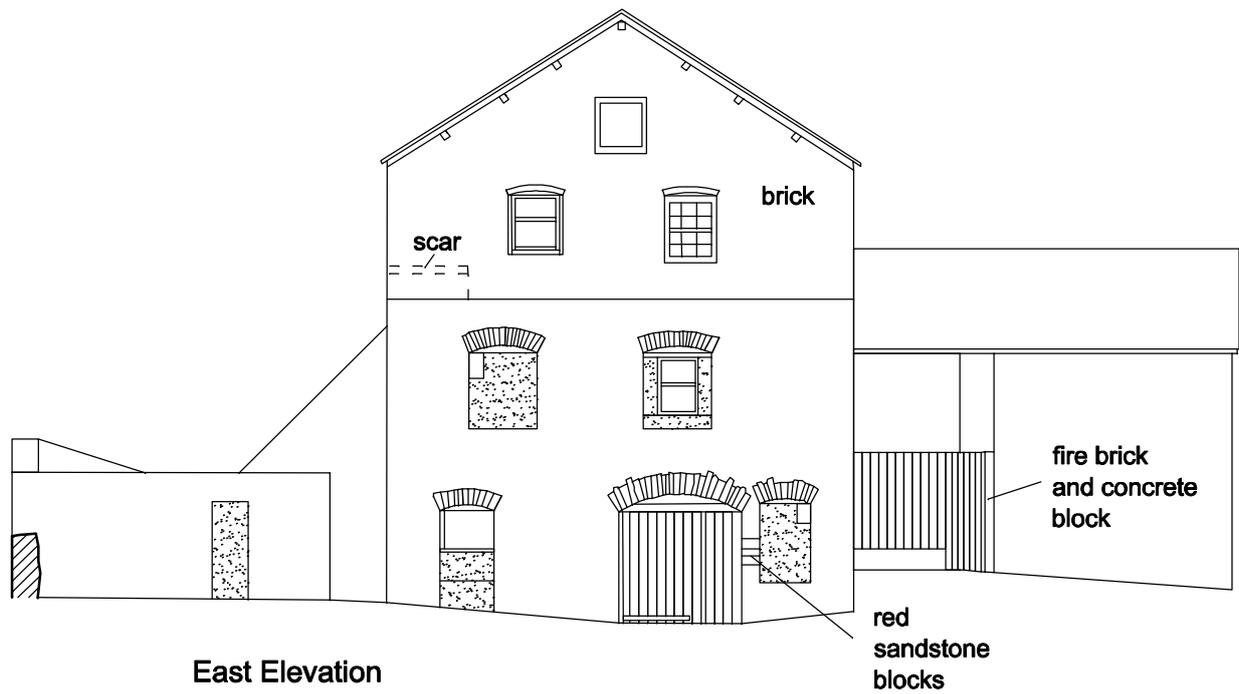
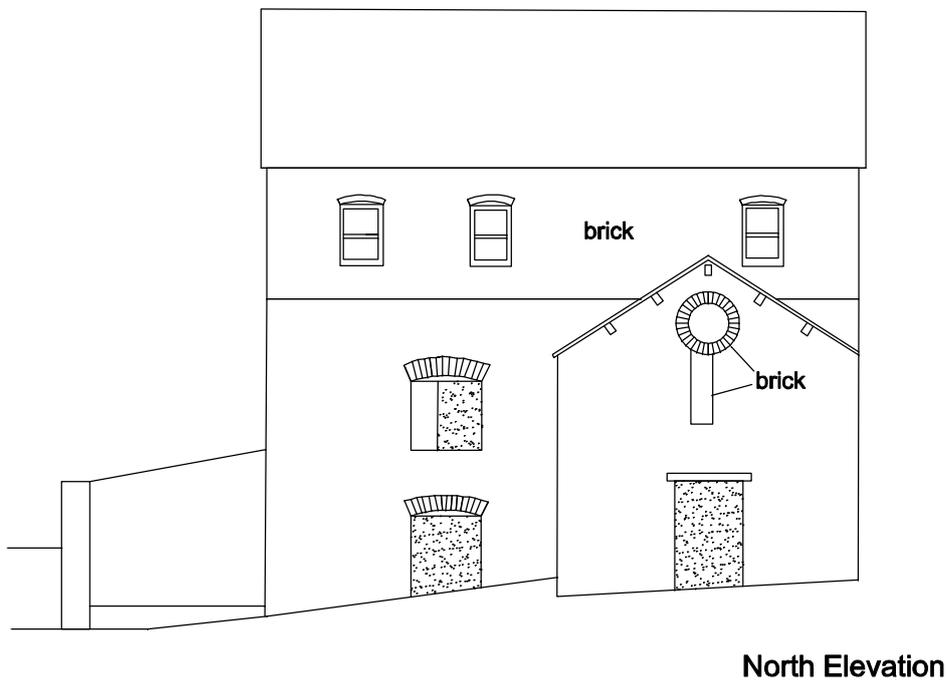
Figure 2: External elevations, north and east

4.2.2 The north elevation of the north extension is of very rough coursed slate and has been heavily repaired. A central door with timber lintel has been blocked with slate. At first floor level there is a tall narrow area filled with handmade mid-orange brick, which marks the position of a flue. At the top, within the apex of the gable, is a circular opening of handmade brick.

**4.2.3 East external elevation (Figure 2; Plate 10):** north of centre on the ground level is a large doorway with a round arched top with edge-set stones and timber lintel below. The doorway is flanked by a window and a smaller door in a similar style. The window to the north is blocked by stone and some brick, and the initials 'TJA' are scratched into a quoin. The door to the south is blocked at the lower half with some furnace lining brick, with the top half remaining as a window with a slate sill and brick in the south jamb. At first floor level are two shallow arched windows. The south window is blocked with sub-rounded stones and mortar, with a small aperture left in the top left hand corner. The northern window has a timber lintel and a slate sill. This window has been narrowed on either side with a column of brick. The second floor has two windows with shallow arches and large timber lintel behind. The south window has a modern two-light timber frame casement and the north window a 12-light sliding sash; neither window has a sill. In the centre of apex of the roof above these windows is a third window with a single-light timber frame. There is a row of headers above the timber lintel and a large slate sill. A mortar and slate scar from the south elevation extends into this elevation approximately 1.5m. There is also minor repair and re-pointing around the windows.

**4.2.4** The east elevation of the north extension is of random rough cut slate with occasional red brick fragments. At the south end is a double width door above which is an opening which has been blocked with fibre-glass corrugated sheeting which extends to the roof. A column of mainly furnace brick forms the north door jamb which supports a wooden lintel.

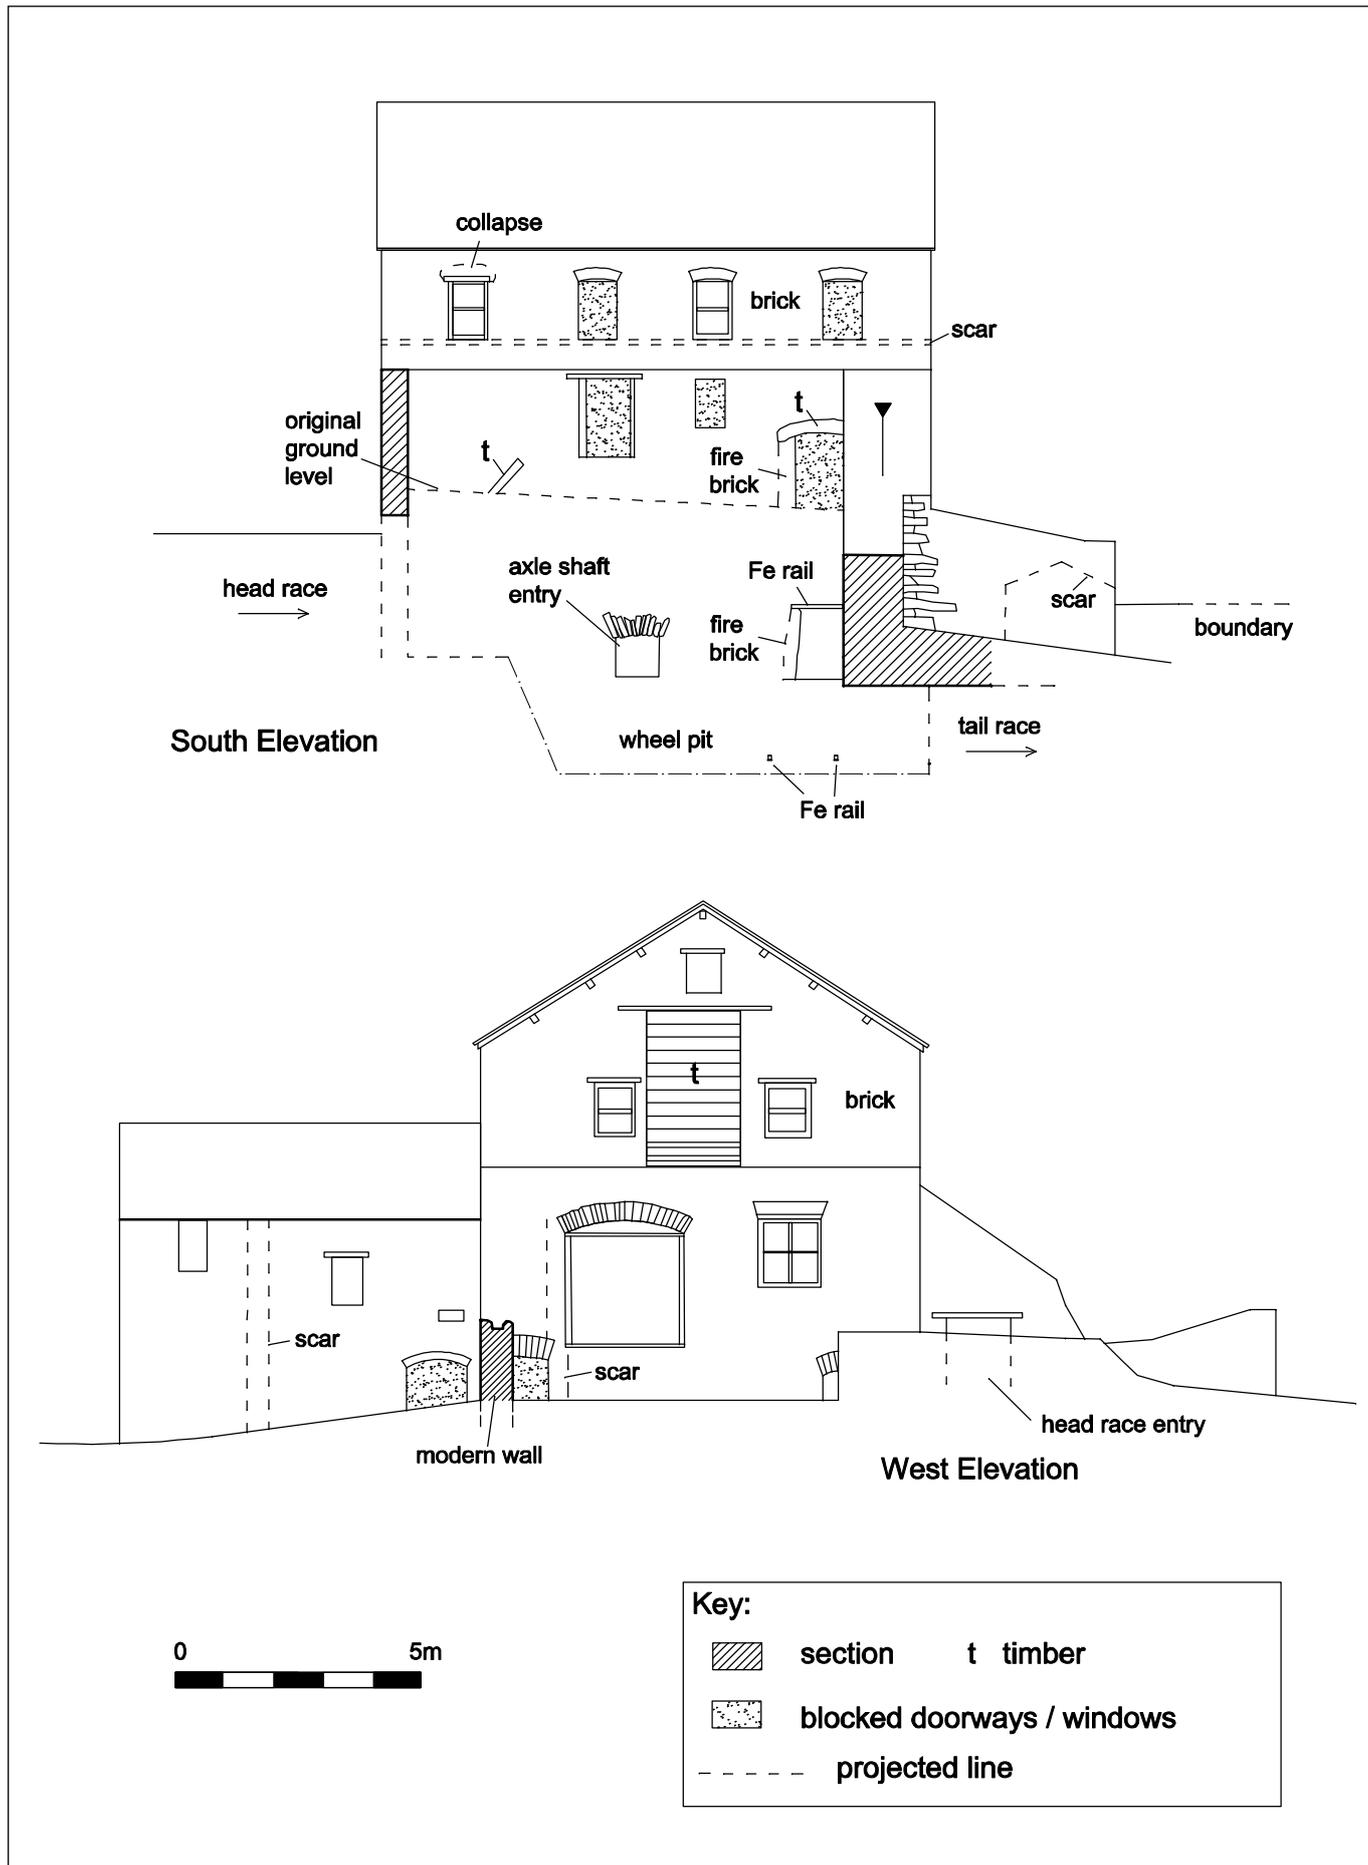
Figure 3: External elevations, south and west

4.2.5 **South external elevation (Figure 3; Plate 11):** on the east side, at first floor level, a substantial angled buttress extends to the south. Adjacent to this is a blocked window with a timber lintel; the west jamb of this has been repaired, and the entire window has been blocked with furnace brick. To the west, slightly off centre, is a window with timber lintel and jambs, which has been blocked with handmade brick. The second floor has four windows, evenly spaced along the elevation, all of which have shallow brick arches and timber lintels. The second and fourth windows from the west are blocked with stone and handmade brick. The first and third windows have two-light timber frames. A scar formed by two rows of slate, probably denoting the position of an attached roof, is present at the sill level of the top floor windows. The entire wall is in poor bad condition, with various cracks and obvious movement.

4.2.6 **West external elevation (Figure 3; Plate 14):** at ground level there is a single aperture on either side, each with a voussoir stone arch: the northern one is completely blocked and has a later wall built over part of it (Plate 13), while the southern one is partially blocked by what is presumably the wall retaining the side of the head race (Plate 12). To the south of this the fragmentary remains of the adjoining wall contain a blocked aperture, presumably originally to provide access between the head race and the wheel pit, which has an iron girder for a lintel. At first floor level, north of centre, is a large arched aperture measuring 2m high by 2m wide, with a large timber sill and lintel. The scar of a former wall is present against the north jamb of this aperture. Set high to the south of centre is a four-light timber frame window, with timber lintel and slate sill. At second floor level, is a centrally-situated large loading doorway measuring approximately 3m in height by 2m in width. It has a concrete lintel and sill, and timber jambs. There is a window on each side of this doorway and one above in the apex of the roof. The north window has a two-light timber frame, with a concrete outer lintel and timber inner lintel. The south window has a two-light timber frame, with an iron rail as a lintel. The top window has a single-light frame, timber jambs, and a slate lintel. There is an aperture between the sill of this window and the lintel of the doorway below, which likely once held a hoist beam. The brickwork around the door and windows has been heavily repaired.

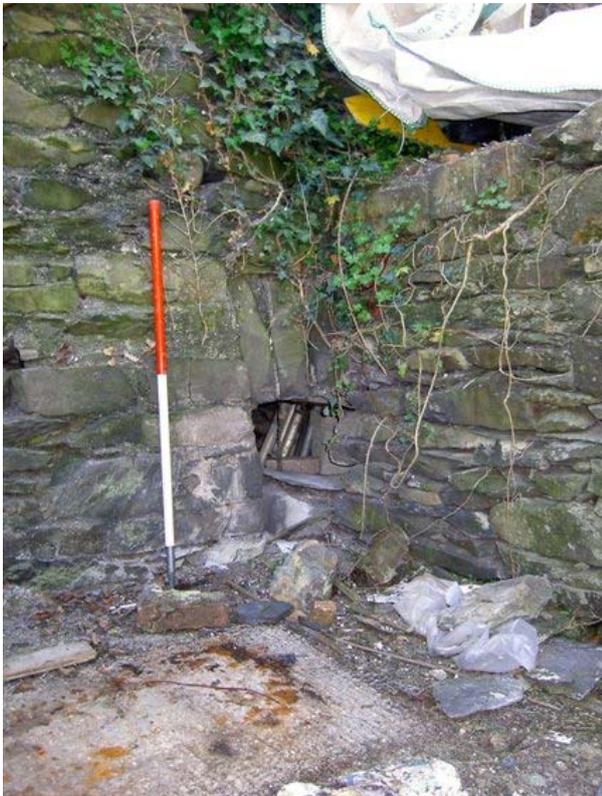
**Plate 12: (left) southern partially-blocked ground-level aperture in the west elevation**

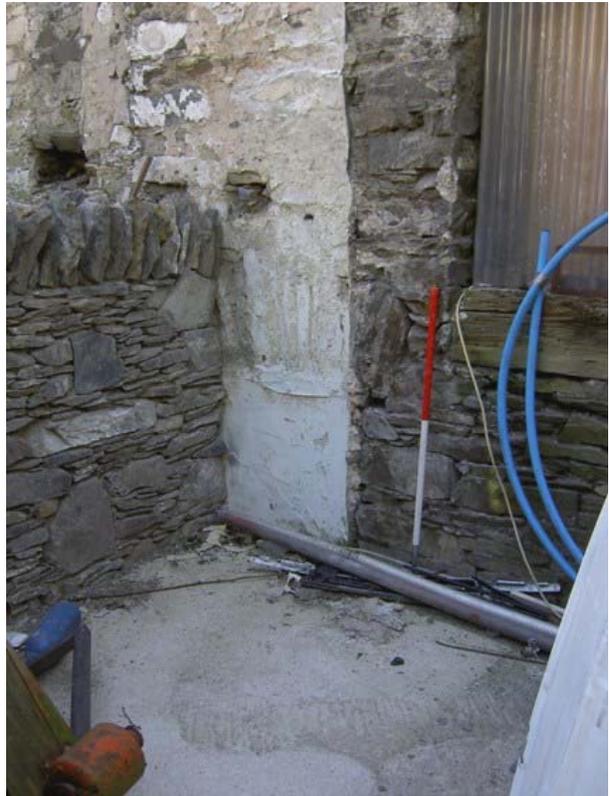
**Plate 13: (right) northern blocked ground-level aperture in the west elevation**

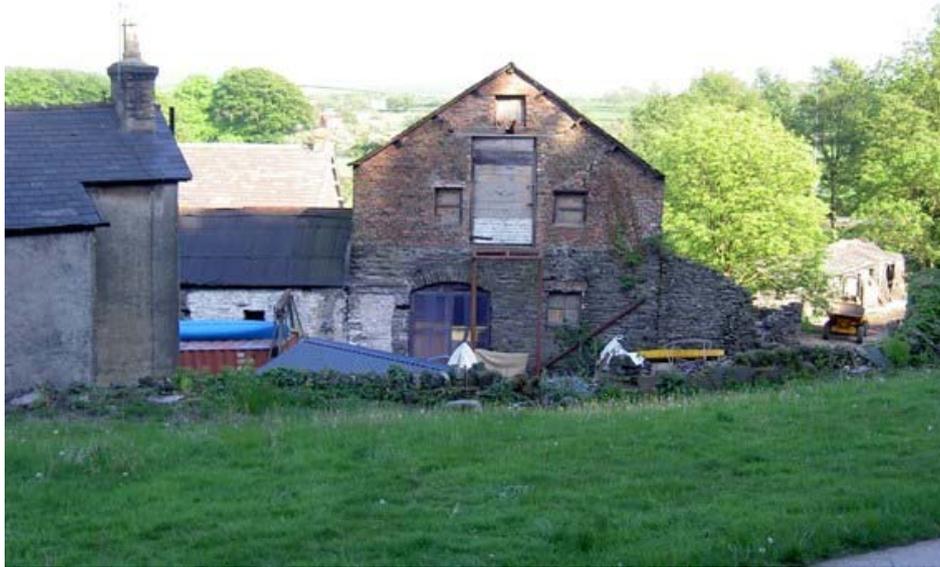
4.2.7 There is a small window opening under the roof line at the north end of the west elevation of the north extension. Slightly off centre to the south is a window opening with a timber lintel. There are scars of a non-extant wall at the south end of the elevation, to the south side of the small window. There is a narrow aperture at mid height on the south end of the elevation, and a blocked doorway is evident on the west side, although this has been largely obscured by a thick covering of whitewash that has been applied across the elevation.

Plate 14: West external elevation

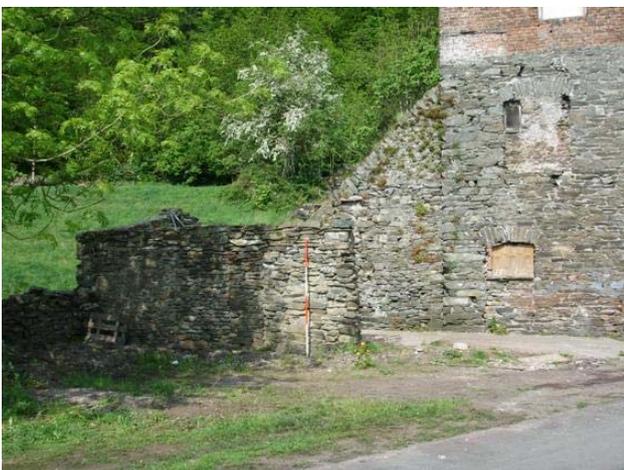
4.2.8 **South-east outshut – elevations (Figure 2 and 3):** the east elevation is constructed of rough courses with slate strings, furnace bricks, handmade bricks and large sub-rounded stones (Plate 15). Just off centre to the north is a blocked narrow doorway. The south elevation is a randomly constructed wall, built using slate, large pieces of which have been used for quoins. The top slopes from west to east, possibly denoting the original roofline. A mortar scar indicates the position of a non-extant outshut (Plate 16). The west elevation extends from the buttress projection, south from the mill. It is constructed from roughly coursed slate and sub-rounded stones with large irregular quoins.

Plate 15: (left) East elevation of south-east outshut

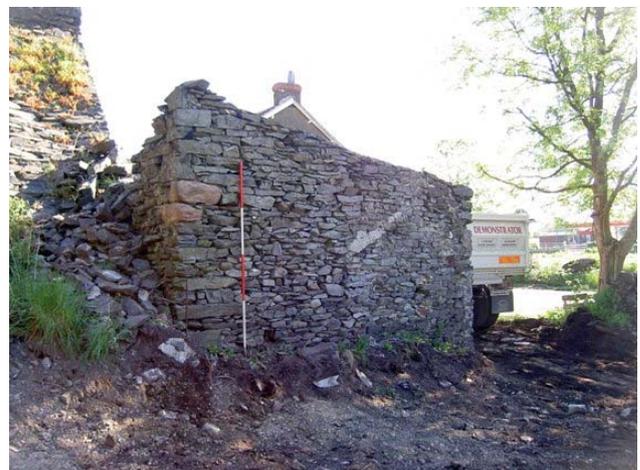
Plate 16: (right) South elevation of south-east outshut

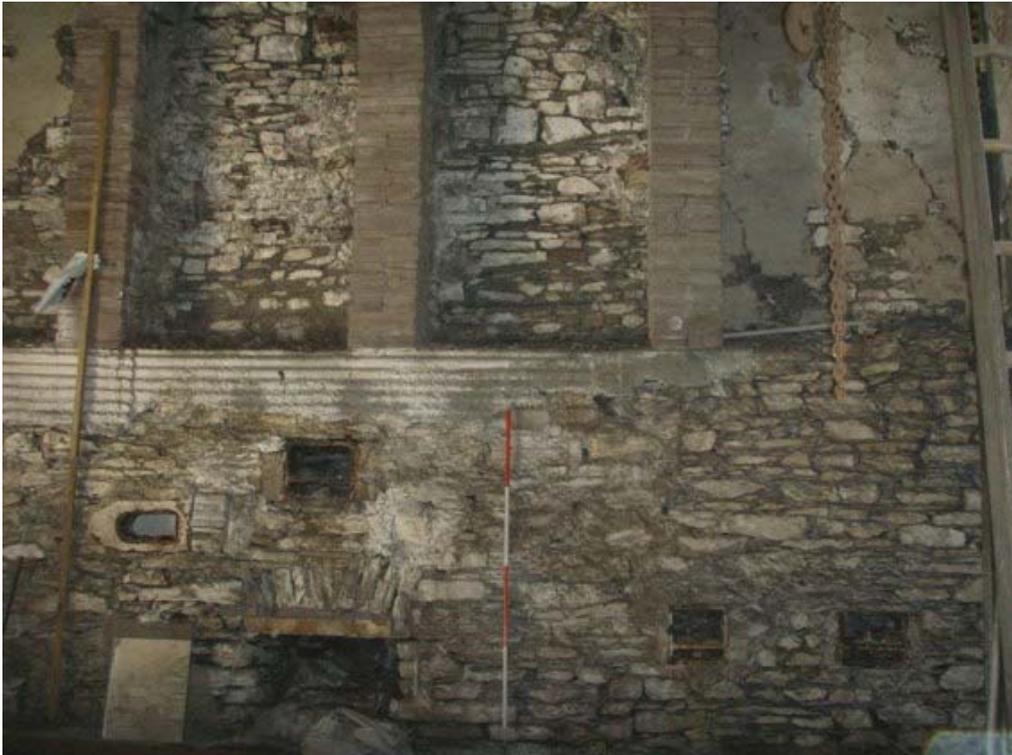
**Plate 17: South internal elevation of the mill showing bearing boxes, aperture for the axle shaft, and tilt hammer head at ground floor level, and inserted concrete supports on the first floor**

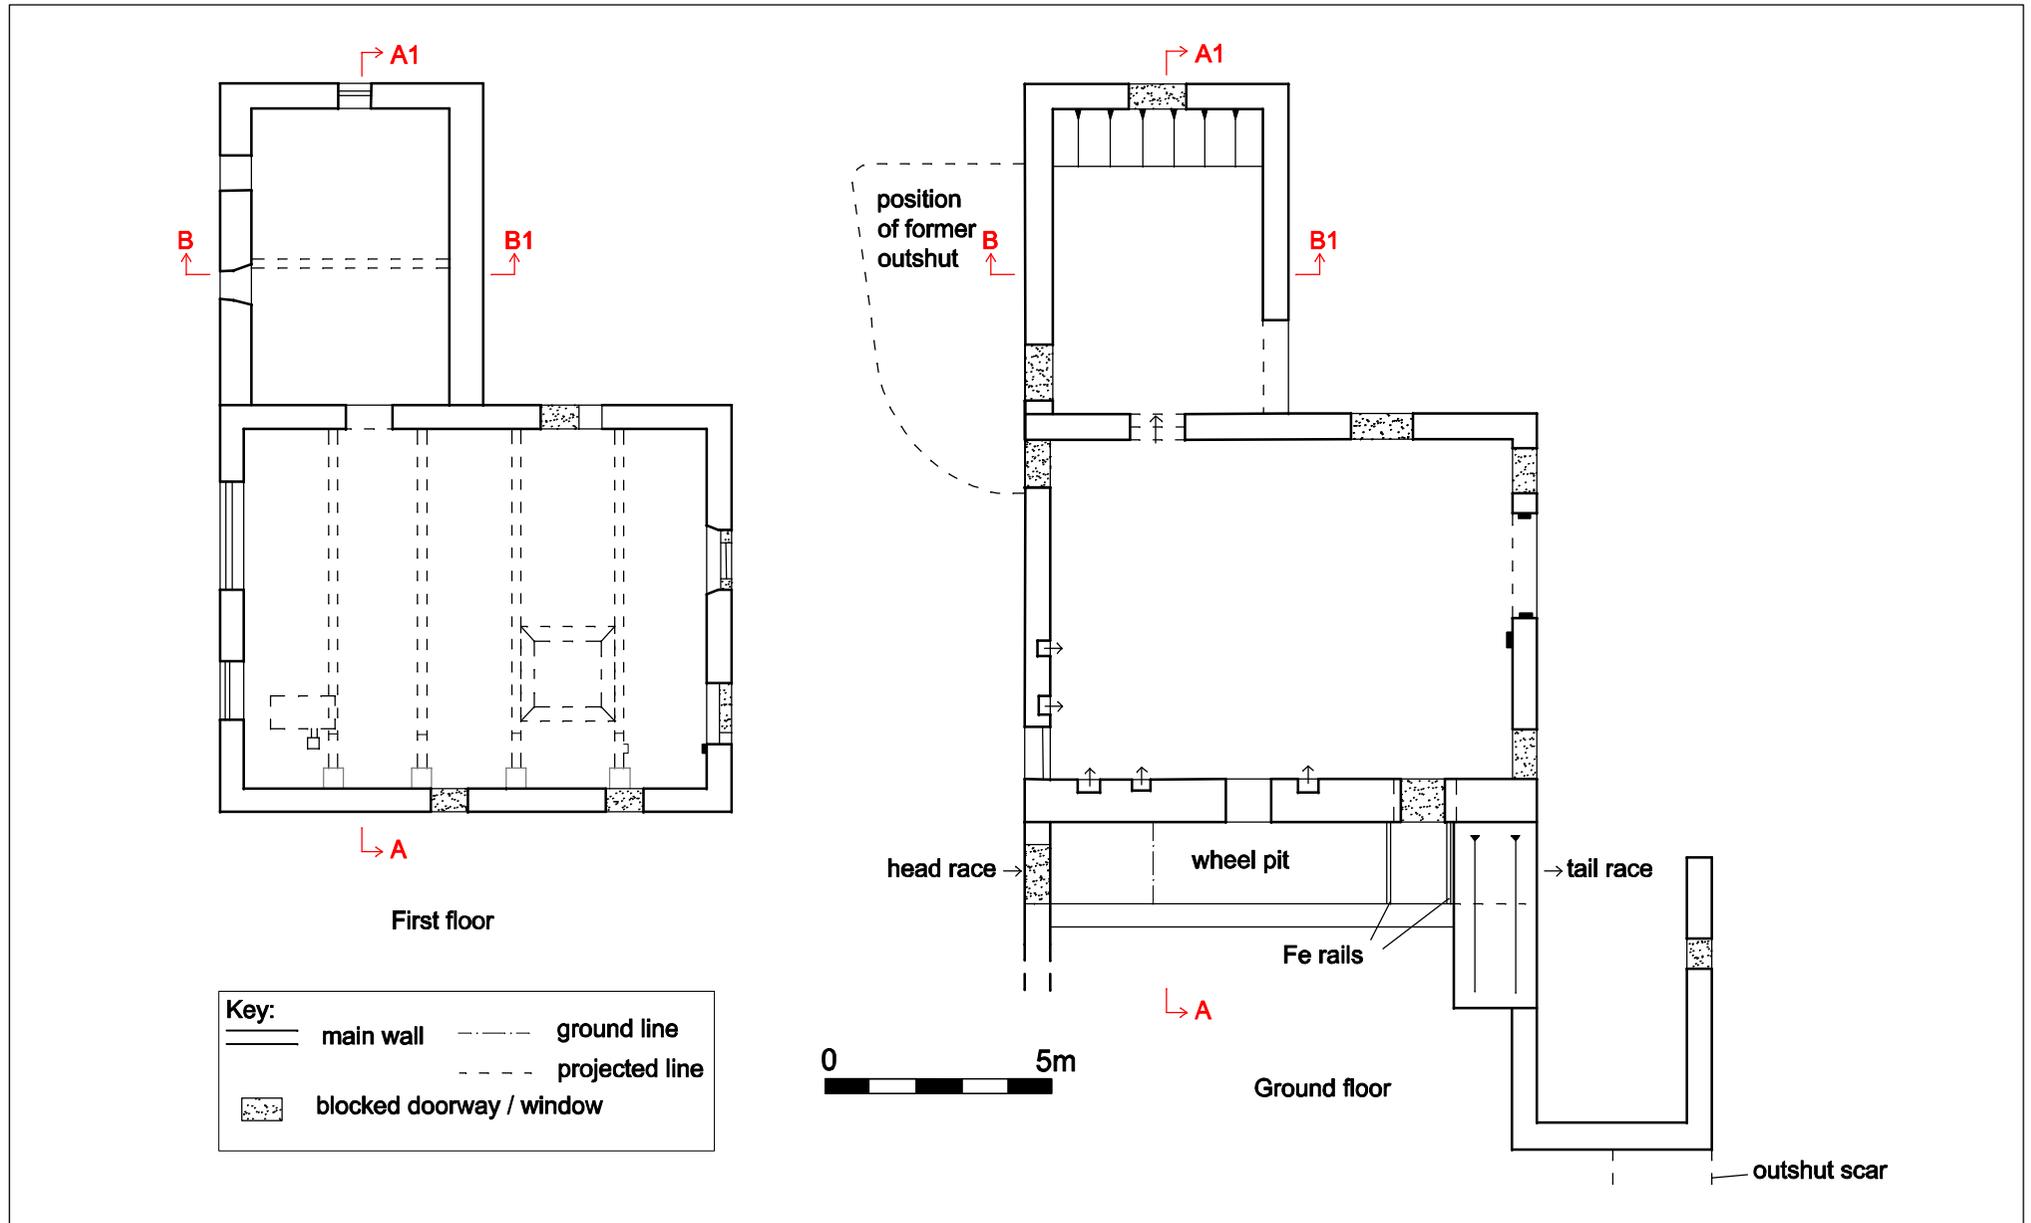
Figure 4: Ground and first floor plans

4.3.2 **First floor – mill (Figure 4):** the north elevation has a half-blocked window on the east side with a rough timber lintel. On the west side there is a doorway with a sawn timber frame and a rough lintel (Plate 19), below which is a sawn-off beam for the first floor level. The beam is hand finished with joist slots. In the east elevation there is a window above the large ground level doorway, which is set in a much larger recess. Another window to the south has also been blocked and is also set in a larger recess. A timber lintel runs the length of the elevation, attached which is a timber block with slot which matches an opposing block attached to a joist. The south elevation is thinner than the ground floor and has four concrete block buttresses supporting the beams of the floor above. Two blocked apertures are visible, one with firebrick and brick in the jambs, which may once have been a door. Some large timbers are built into the wall below the ceiling. The west elevation has a large door on the north side, with a rough timber lintel. A plank and batten door covers the south half of the doorway, whilst the north half is covered by plywood. The sawn off end of floor joists for the original floor remain to the south of the door. The entire first floor has been whitewashed and has some patchy plaster remaining. The ceiling is supported by four beams running north/south. These are all slightly stop-chamfered with additional supports added at the south end, which now rest on concrete pillars, bolted to the beams. There is a hopper in the south-west corner comprising a rectangular box with attached gearing and a pulley on the south side (Plate 20). To the south-east is a large pyramid shaped boxed structure, which forms a funnel situated between two beams. There is an access hatch to the second floor on the west side.

4.3.5 **Northern extension (Figure 4):** the north elevation has a central doorway with lintel, and is now blocked. A sloping wall approximately 1.7m high is built across the length of the wall. A slot above the doorway, a probable flue, is now also blocked. Above this is a square window with a timber lintel and a sill though which the flue is cut (Plate 25). The east elevation has a large double doorway with a single ledge and brace door on the south side. In the south elevation is a central doorway with timber lintel on the ground floor. Above and off centre is another doorway with a timber lintel and frame. Joist slots are suited below this door and along the length of the wall (Plate 27). The west elevation has an off-centre window opening at mid-height, with a timber lintel. There is a small window opening at roof height towards the north end of the elevation and a further small square aperture to the north of this small window, which is blocked externally. At the south end of the elevation there is a low doorway, which has been blocked with stone and has a rough timber lintel, apparently a re-used axle bearing (Plate 26). The roof structure comprises two hand-finished purlins per pitch and a diagonally-set ridge purlin of similar type (Plate 28), all of which overlap at a single truss (Figure 6); this consists of a basic tie-beam form with a single collar, and all of the timber is again hand-finished.

4.3.6 **South-east extension (Figure 4):** the east elevation of the outshut is of the same construction as the external elevation and has been re-pointed in places. The south and west elevations both have remnants of mortar and whitewash remaining (Plate 29).

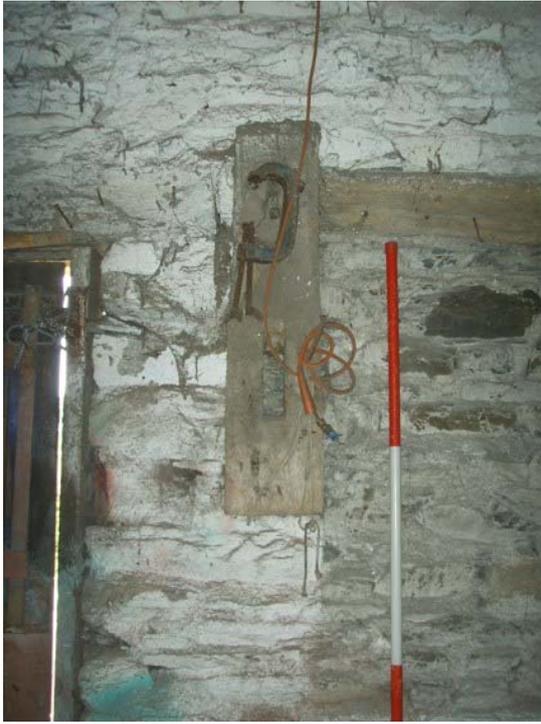
Plate 18: (left) Timber block, perhaps a bearing, attached to the south side of the east elevation

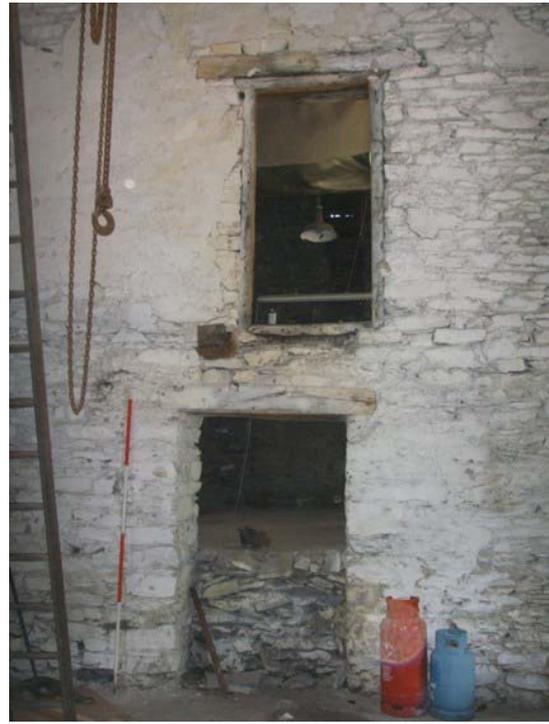
Plate 19: (right) Pair of doorways linking the main part of the mill to the extension to the north

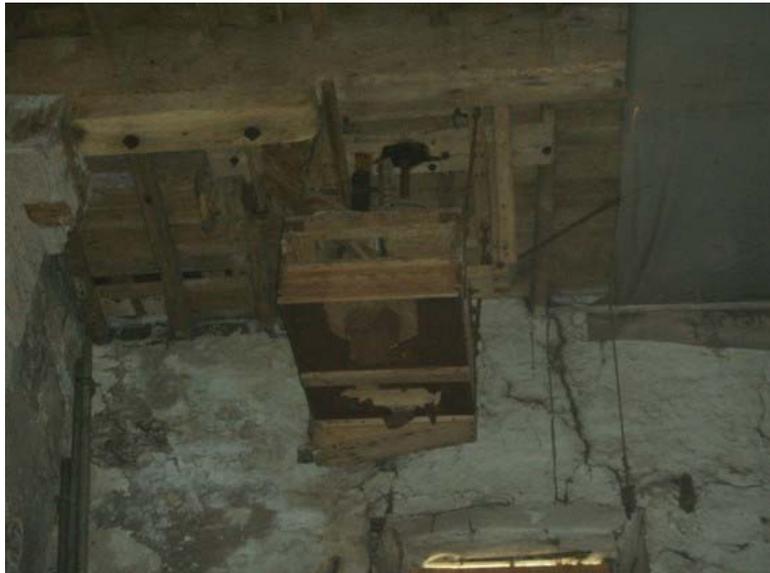
**Plate 20: Timber box or hopper attached to first floor ceiling/second floor joists**

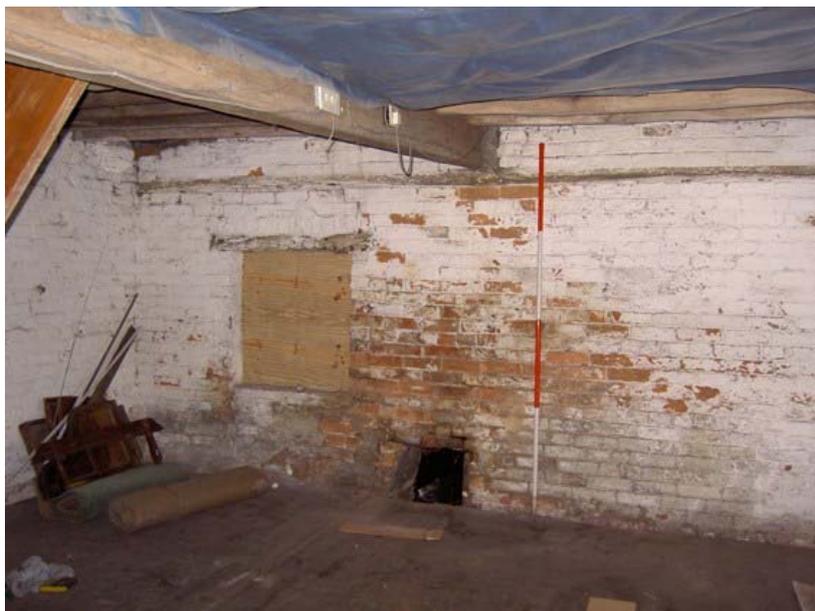
**Plate 21: North elevation of second floor showing brick walling and chute at floor level into the north extension**

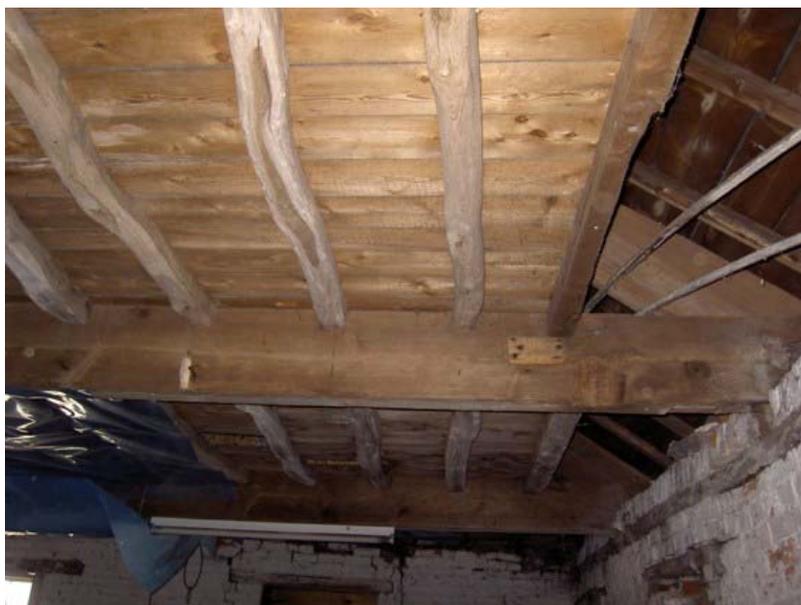
**Plate 22: Typical beam and joists supporting floorboards on second floor. Note gouge in right side of beam**

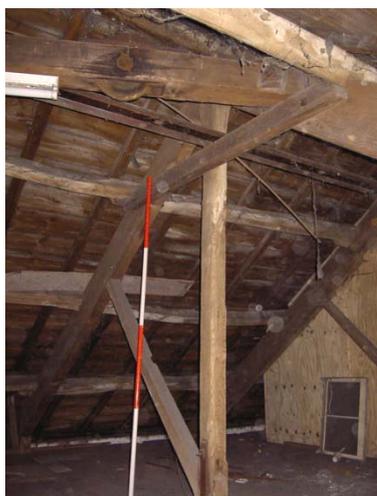
4.3.4 **Attic Floor – mill (Figure 5):** there is no north or south elevation as such; however, a room has been created at the east end by the addition of modern partitions, which are finished with wallpaper. The east elevation is also finished with wallpaper and has one window with a modern uPVC casement with a single light. The west elevation is built from brick and is slightly thinner than the floor below. There is a small aperture with a timber lintel. The attic is effectively divided into two parts by the modern partition walls at the east end. The floor is boards, and covered by carpet in the room to the east. The roof structure is supported by three king post trusses, each with only a single angled strut left, tapered at the top to meet the principals and squared at the base to meet the braces (Figure 6; Plates 23 and 24). Iron straps are attached between the king post and the beam below, and the west and centre trusses have a collar bolted to them. The joints are otherwise fixed with very narrow timber pegs. All the timber is neatly sawn, slightly chamfered, and hand finished and there is an additional narrow beam running between the east and central collars with a pulley wheel housed in the centre (Plate 23). There are three purlins per pitch, overlapping at the trusses, and one diagonally-set, more irregular ridge-purlin. Some empty slots for missing timbers remain in the principals. Each truss appears to have carpenter's marks at the junction between the braces and the principals. On the centre truss, marks "II" and "I" have been chiselled into the timber on the north and south sides, respectively. The east truss bears crescent shaped ")))" marks on the north side. The marks on the west truss are unclear.

**Plate 23: (left) Part of a truss on the attic floor showing pulley wheel incorporated into beam**

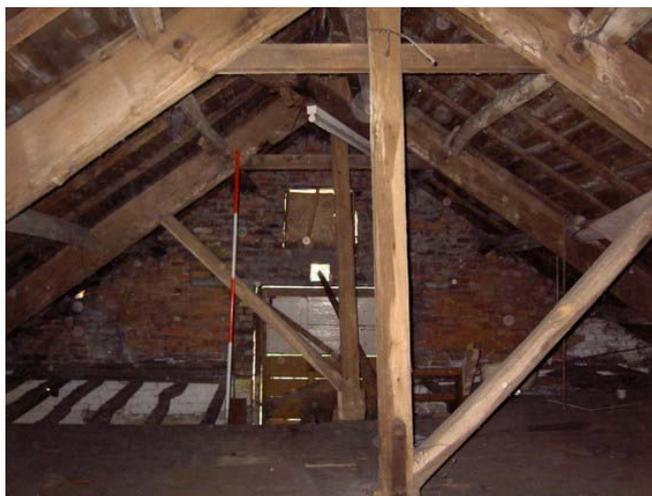
**Plate 24: (right) Trusses on the attic floor**

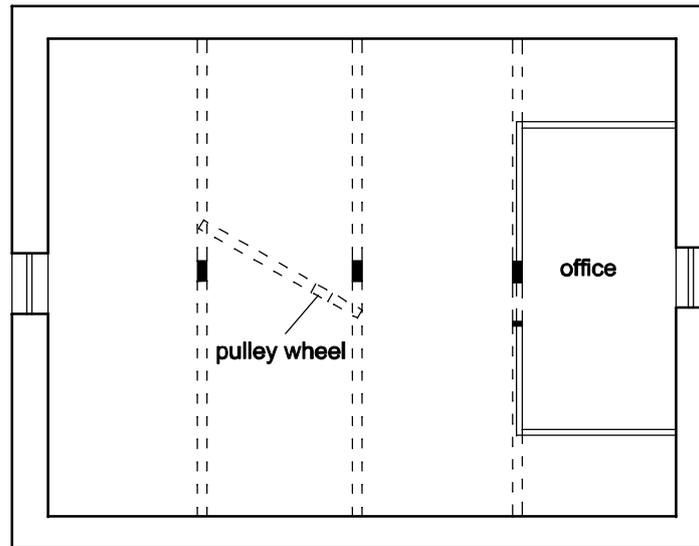
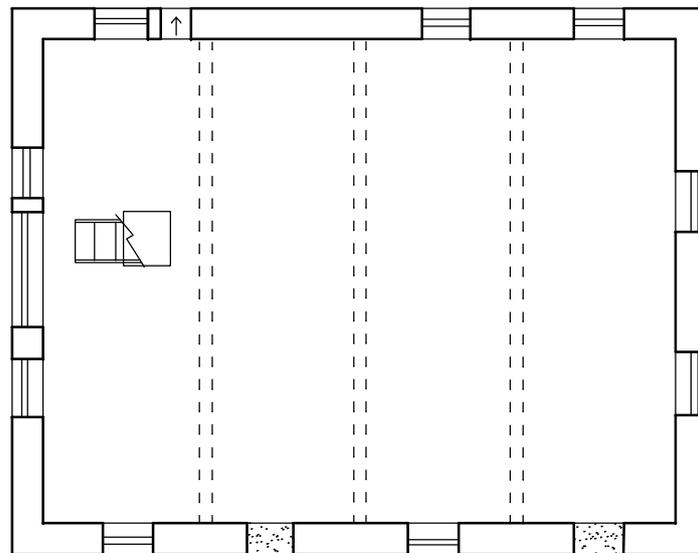
4.3.3 **Second floor – mill (Figure 5):** the north elevation has three windows, all with timber lintels and modern two-light casements. The window on the west side has a re-used lintel and a row of headers above and there is a small hatch at floor level providing access into the extension to the north via a short chute (Plate 21). The east elevation has two windows with hand finished timber lintels. There is a row of headers over the north window. The south elevation has four windows with timber lintels, two of which are blocked. The entire south elevation is severely cracked. In the west elevation there are two windows with timber lintels; there are headers over the south window. There is a large central door with a concrete lintel, which is filled by boards. All of the walls are built from brick and are whitewashed. The floor is boards covered with linoleum. The original ceiling remains, which provides the floor for the attic level above. Three stop-chamfered timber beams run north/south across the room and are built into the north and south walls and supported by large rails on these two elevations. On one of these has a large gouge in its south end, presumably caused by the action of machinery or ropes rubbing against it. The joists are very irregular and hand finished (Plate 22). On the west side are modern timber stairs, leading to a hatch into the attic level.

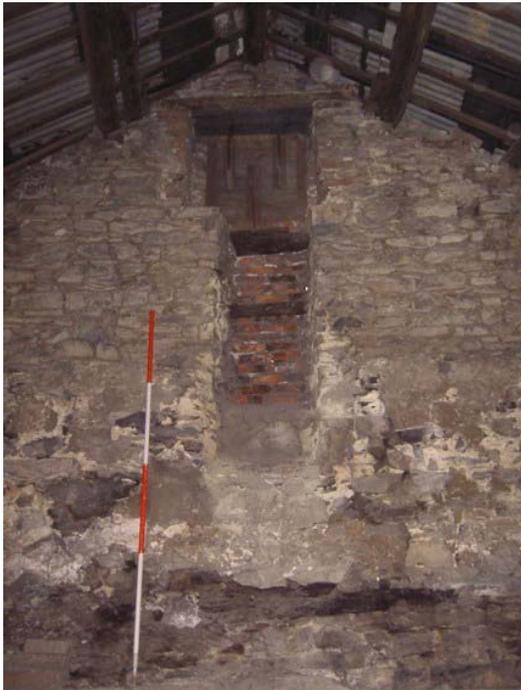
Plate 25: (left) Remains of flue in north end of northern extension

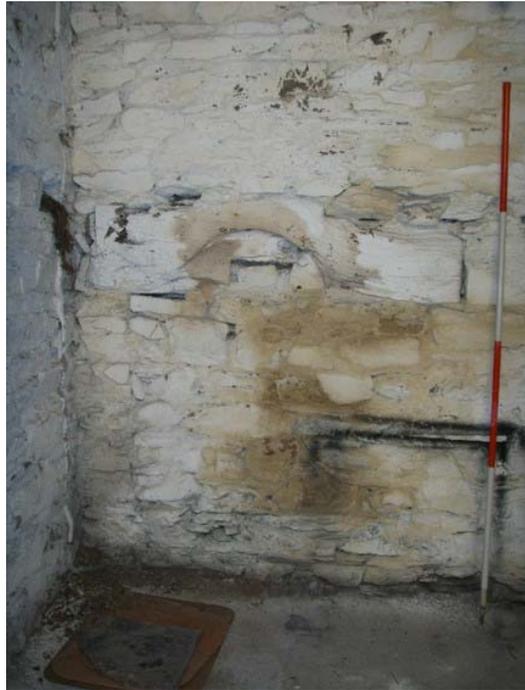
Plate 26: (right) Blocked doorway on south side of west elevation with possible axle bearing re-used as a lintel

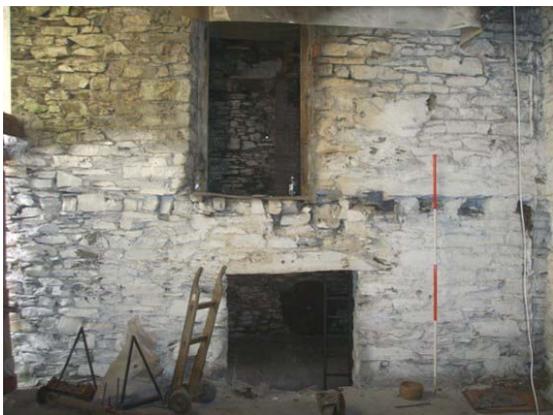
Plate 27: (left) South elevation of northern extension showing doorways and empty joist slots for first floor

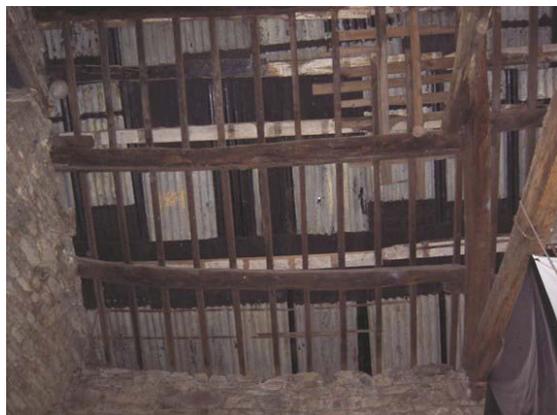
Plate 28: (right) Roof structure of northern extension

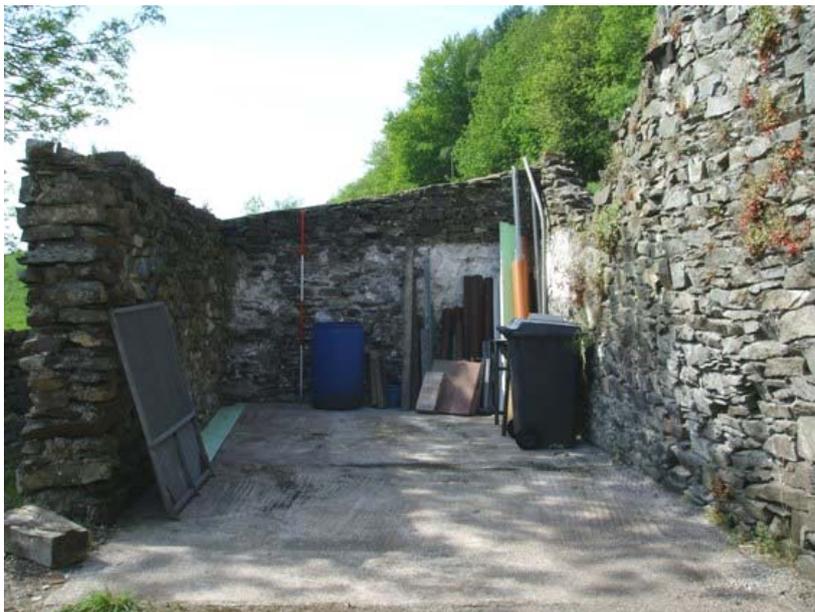
Plate 29: Interior of south-eastern outshut

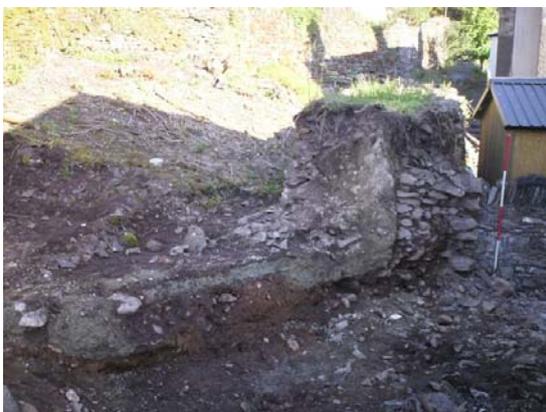
5.2.1 **Area A/B - head race:** the head race leading to the mill runs in a northwest to southeast direction through Area A; Area B is where the mill race has been backfilled. The section through the mill race (Section 1) revealed it was constructed of dry stone walls and lined with clay and was approximately 2m wide where it meets the mill. Due to the mill race running along ground sloping to the east, the east side wall was nearly double the thickness of the west side wall, 2.2m and 1.2m respectively. The sides of the mill race are each constructed of two dry stone walls, the outer walls, **103** and **107**, of each side were constructed first. A thick clay lining, **106**, was applied to the inner sides of the wall, 0.8m thick on the east side and 0.5m on the west side. At the base of the wall the clay lining was approximately 0.4m in depth, acting as a footing for the inner walls, and the lining on the floor of the mill race was fairly thin, between 0.1m and 0.15m in depth. Beneath this central area there was a thin deposit, little more than a centimetre thick, comprising mainly charcoal, **110**, from which a small sample was taken (see *Section 5.4*). The inner walls, **101** and **108**, were then constructed with any spaces within the wall sides being filled with stone rubble, **104** (Plate 30, Figure 8). The depth of the mill race at this point was 1.5m with the east wall being 2.3m high, the east wall was no longer extant. The opposing north facing section reveals that where the mill-race entered the mill it had been truncated and back filled with re-deposited topsoil and building rubble, **109**, and a short culvert, no longer than 3m in length, has been constructed from stone and reused furnace lining bricks (Plate 31) to turn the water away from the mill.

Plate 30: (left) South-facing section of the mill race (Section 1)

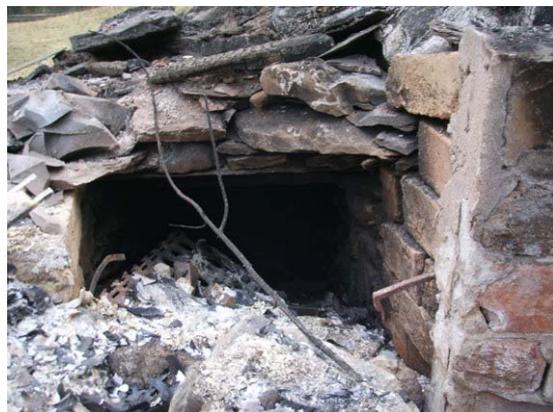
Plate 31: (right) Modern culvert at the south end of the head race

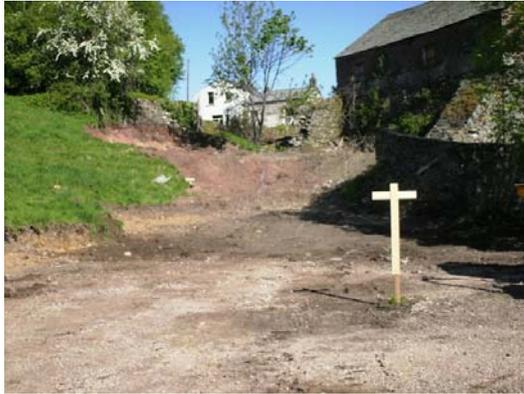
5.2.2 **Area D:** This area is approximately 34m by 22m and is fairly level at the south end but slopes steeply upwards from the middle to the north end and to the west. The topsoil consists of greyish-black friable sandy clay, approximately 0.1m in depth, although immediately beneath the turf on the north-east side, adjacent to the field boundary, was an area of hard standing, comprising 75% gravels and patches of blast furnace slag. This extended to the south-east in front of the long narrow building situated alongside the road. The subsoil was moderately stony, firm reddish-brown sandy clay, approximately 0.15m-0.2m thick and is adjacent to the mill on the northeast side. At the north end the ground was taken down by approximately 1.5m. Deposits of gravel and stone stained by iron ore were found on the west side of the area, below the east boundary wall of Rose Cottage (Plate 32 and Plate 33).

**Plate 32: (left) General view of Areas D and E looking north**

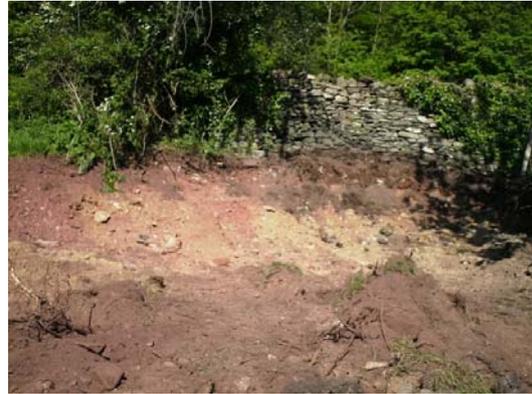
**Plate 33: (right) West side of Area D showing deposits of gravel stained by iron ore**

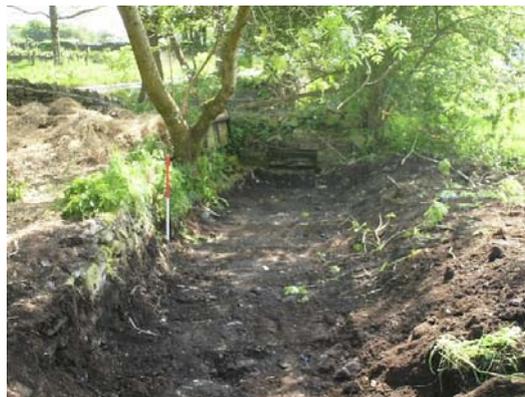
5.2.3 **Area E:** This area, approximately 19m by 24m, is south of Area D (Plate 32) and fairly level on the east side sloping slightly upwards to the west. The topsoil, which was only 0.1m in depth, was stripped, and the ground levelled to a maximum depth of 1.5m at the base of the slope on the west side. Towards the north east side of the area the topsoil was very gravelly which was due to sand and gravel being laid down at the field entrance due to water-logging. No features were found within this area. In the south-east corner of this area, a slightly deeper channel was excavated to expose the ditch alongside the road, which presumably originally linked to the tail race from the mill (Plate 34). Within this area the top of a stone culvert was exposed, which comprised slate slabs resting on upright edging stones. This was only exposed to a depth of 0.4m, and the whole structure was found to be 1m wide.

**Plate 34: Channel containing culvert alongside east boundary**

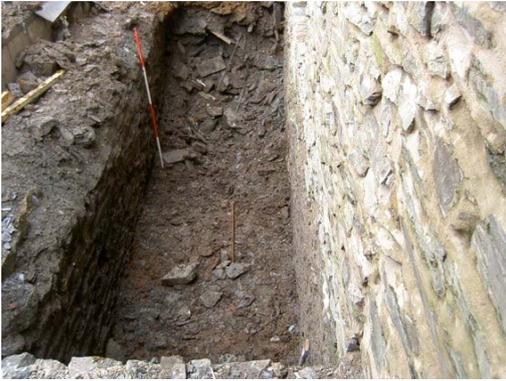
5.2.4 **Area C - the wheel pit:** the wheel pit is situated on the south side of the corn mill and had been backfilled to raise the ground to the height of the mill race, leaving the original ground level sloping down steeply southwards from the mill. The ground works involved the removal of the made up ground above the wheel pit down to the level of the footings of the south wall. The backfill within the wheel pit largely comprised building rubble and re-deposited topsoil, with inclusions of mid 20<sup>th</sup> century domestic waste including a dismantled automobile and was essentially the same as the material filling the head race (**109**). The removal of the backfill revealed a shallow arched opening in the east buttress which exited to

**Plate 35: (left) Excavated wheel pit, looking west**

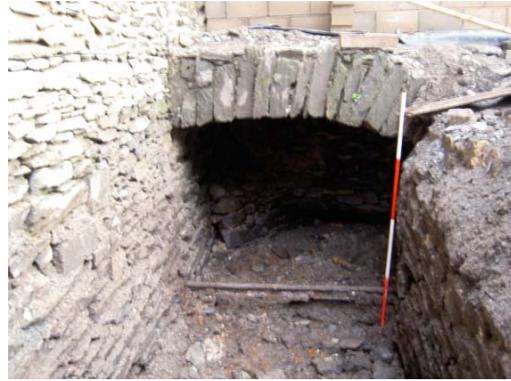
the tail race running to the south-east. In the south elevation of the mill a blocked doorway was revealed at the east end with an iron rail acting as a lintel and the west jamb constructed mainly of large furnace bricks. A square opening was revealed just west of centre of the south elevation, which was also blocked.

**Plate 36: (right) Arched entrance of the tail race**
