# 'CORN MILL BARN', NEWLAND, ULVERSTON, CUMBRIA

Archaeological Building Recording  
and Watching Brief

Client: Paul Glass  
Planning ref.: SL/2008/0260  
NGR: SD 30010 79650

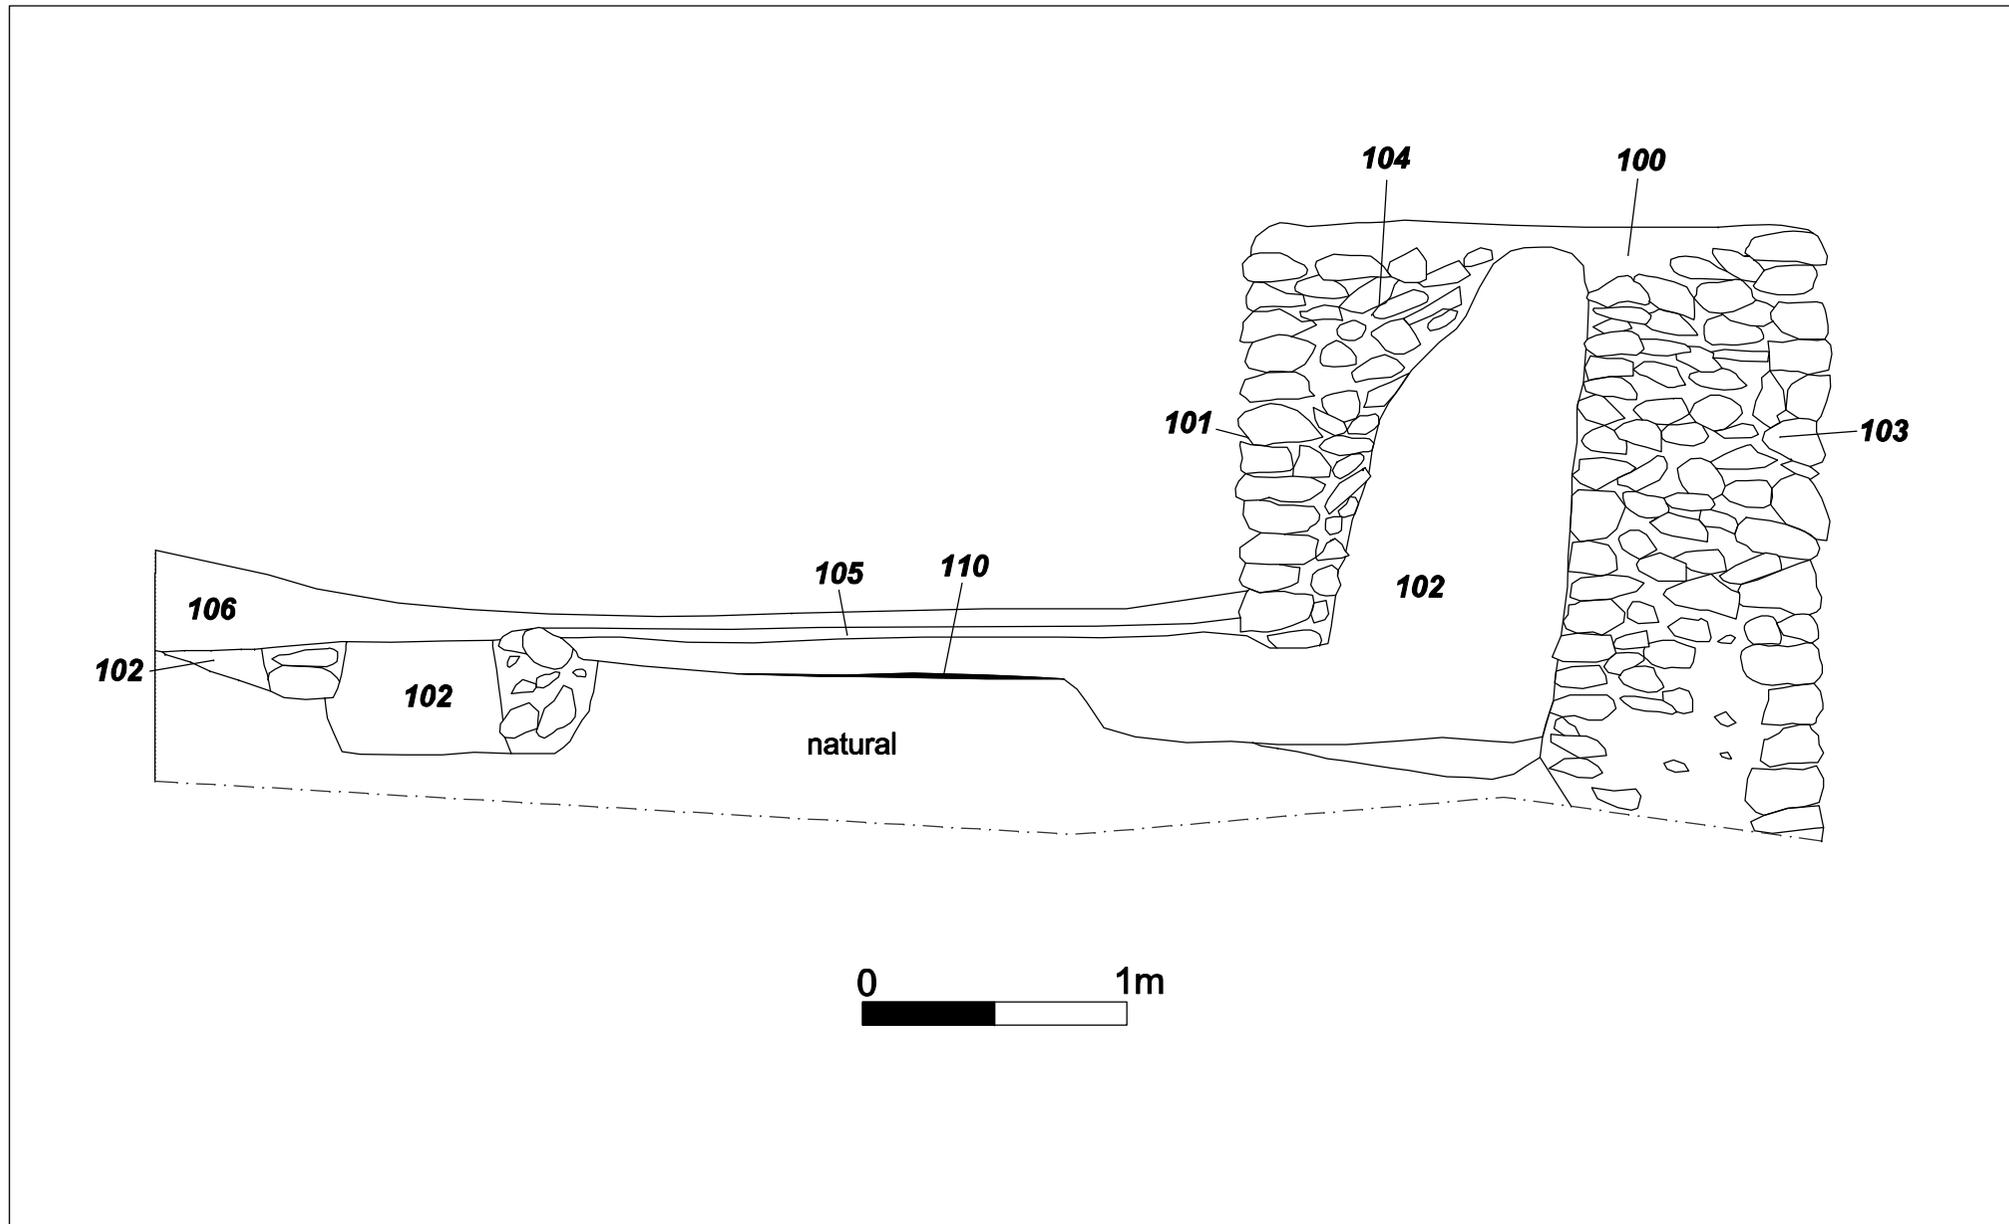
Figure 8: South-facing section through head race

5.2.1 **Area A/B - head race:** the head race leading to the mill runs in a northwest to southeast direction through Area A; Area B is where the mill race has been backfilled. The section through the mill race (Section 1) revealed it was constructed of dry stone walls and lined with clay and was approximately 2m wide where it meets the mill. Due to the mill race running along ground sloping to the east, the east side wall was nearly double the thickness of the west side wall, 2.2m and 1.2m respectively. The sides of the mill race are each constructed of two dry stone walls, the outer walls, **103** and **107**, of each side were constructed first. A thick clay lining, **106**, was applied to the inner sides of the wall, 0.8m thick on the east side and 0.5m on the west side. At the base of the wall the clay lining was approximately 0.4m in depth, acting as a footing for the inner walls, and the lining on the floor of the mill race was fairly thin, between 0.1m and 0.15m in depth. Beneath this central area there was a thin deposit, little more than a centimetre thick, comprising mainly charcoal, **110**, from which a small sample was taken (see *Section 5.4*). The inner walls, **101** and **108**, were then constructed with any spaces within the wall sides being filled with stone rubble, **104** (Plate 30, Figure 8). The depth of the mill race at this point was 1.5m with the east wall being 2.3m high, the east wall was no longer extant. The opposing north facing section reveals that where the mill-race entered the mill it had been truncated and back filled with re-deposited topsoil and building rubble, **109**, and a short culvert, no longer than 3m in length, has been constructed from stone and reused furnace lining bricks (Plate 31) to turn the water away from the mill.

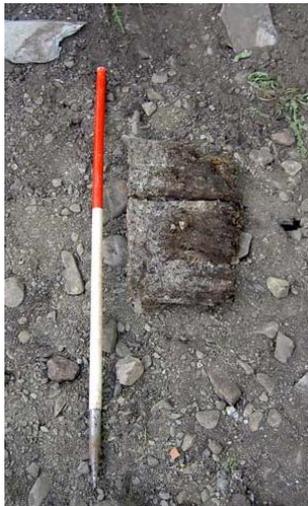
5.3.3 **Timber:** a single timber and iron object was recovered from the upper fill of the mill race. This took the form of a single iron shaft, to which were attached perpendicularly the remains of three timber boards (Plate 37). It was approximately 0.5m long by 0.3m wide and may have formed part of a sluice gate, an element of the mill machinery or similar.

**Plate 37: (left) Timber and iron object recovered from the fill of the mill race**

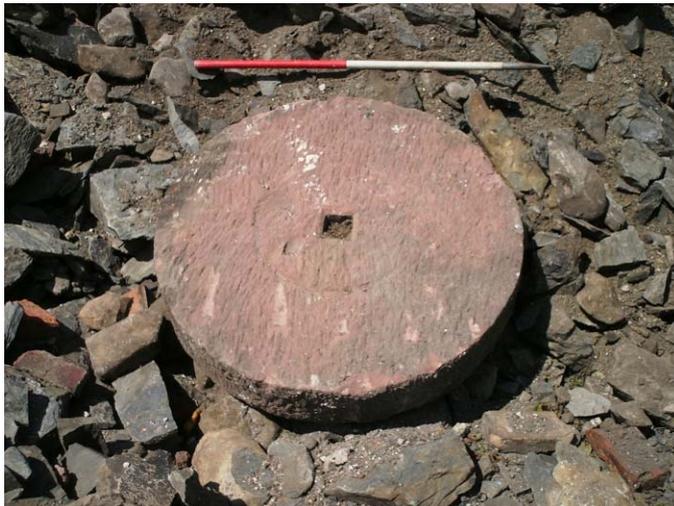
**Plate 38: (right) Red sandstone disc recovered from beneath the floor of the northern extension**

5.3.4 **Stone:** a large disc of neatly dressed stone was recovered from the rubble beneath the floor of the northern extension (Plate 38). This was formed from a single large piece of red sandstone, measured 0.98m in diameter and 0.18m in thickness. The centre hole was 0.08m square and chamfered with a small notch adjacent to one corner. The striations from the chisel-work were between 0.03 – 0.05cm in length and ran in the same direction. The edge was similarly marked, chiselled from side to side. Although perhaps large enough to have been a mill stone the type of material suggests that it was not. It may, however, have formed part of the machinery associated with the wheel, such as the bedstone (see Watts 2002, 12 for an example image). Four fragments of mill stone have been identified, however, which were recovered from the fill of the wheel pit. One of these was relatively non-descript, with just the spindle hole to identify it (Plate 41), but the other three had chased rynds visible. In two cases the associated bolt holes with iron bolts were clearly evident. The two with iron bolts had very straight rynds

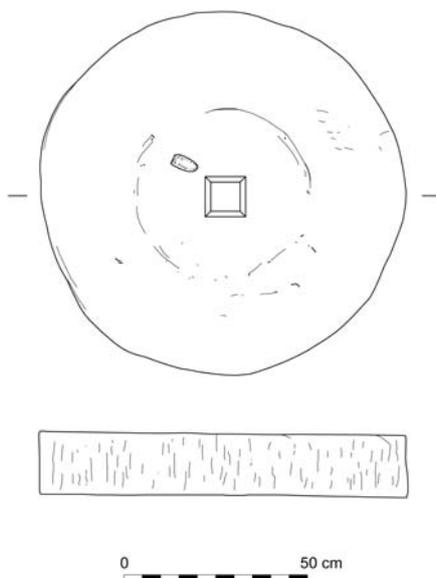
**Plate 39: Illustration of the sandstone disc**

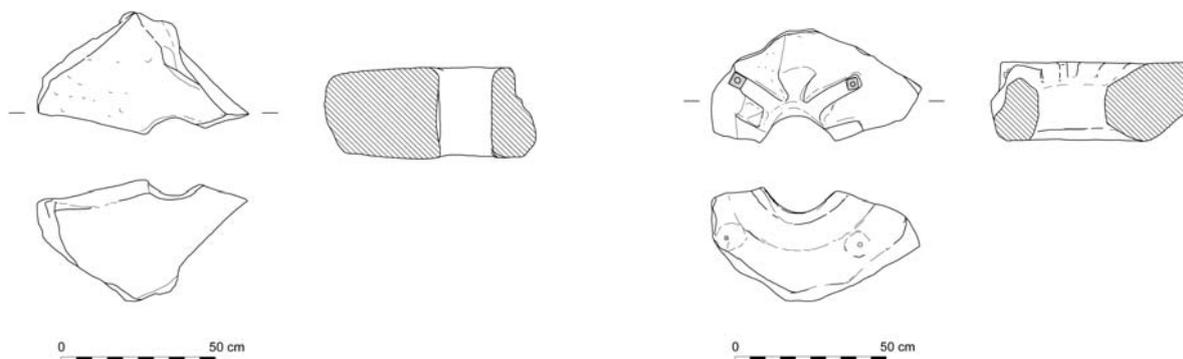
forming a regular x-shape across the spindle hole, and are probably post-medieval in date (see for example Watts 2002, plate 24; Plate 42 and 43). The other has more curved rynds, no sign of bolts, and a slight collar on the opposing side, and is perhaps more likely to be medieval in date (*op cit*, 102; Plate 43).

**Plate 40: (left) Millstone 1**

**Plate 41: (right) Millstone 2**

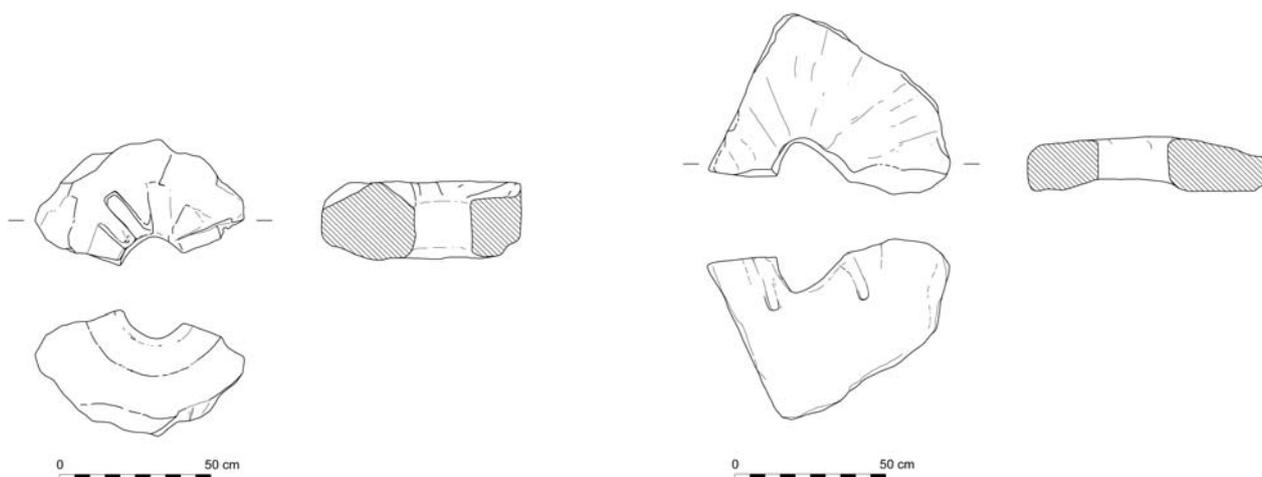
**Plate 42: (left) Millstone 3**

**Plate 43: (right) Millstone 4**

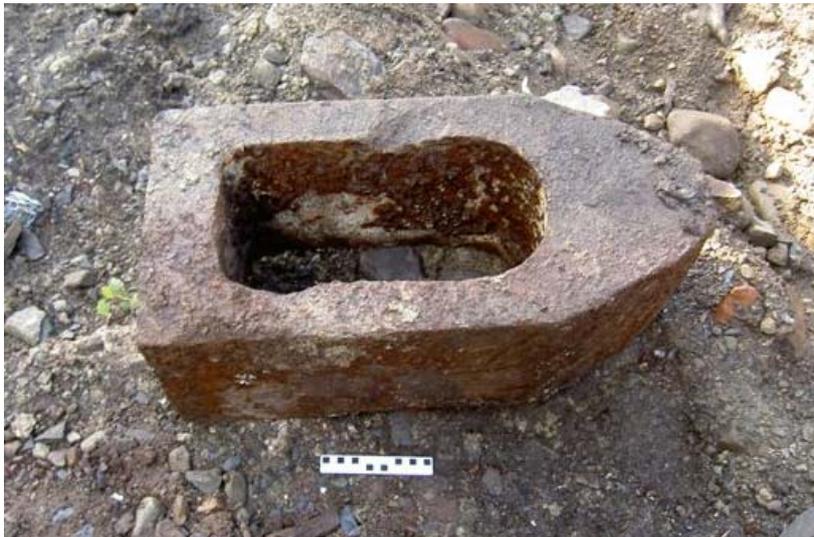
forge added in 1783 (see *Section 3.3.1* above). Iron hammer heads of almost identical form are recorded as being cast at the Penny Bridge forge in the early 1750s (Berg and Berg 2001, 291; Plate 46), although the equipment used at the Newland forge was said to have come from the Bearpot Works at Seaton (Fell 1908, 218), which were established c1762 (Marshall and Davies-Shiel 1969, 45).

**Plate 44: Iron tilt hammer head as recorded on site**

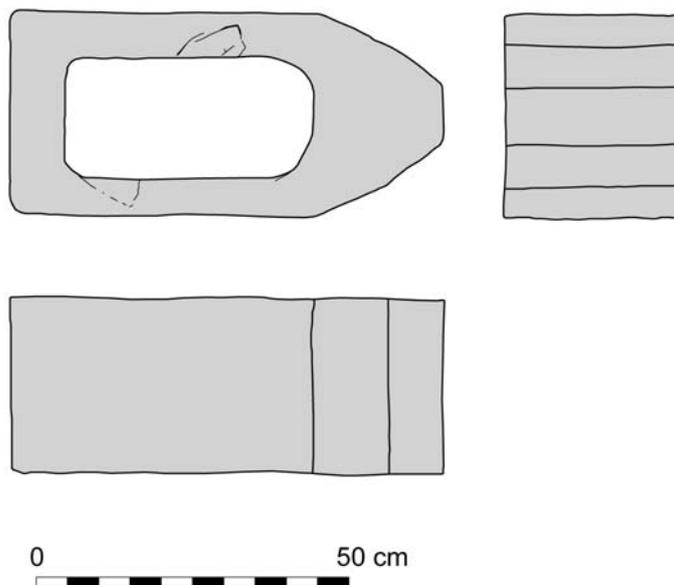
**Plate 45: Illustration of the tilt hammer head**

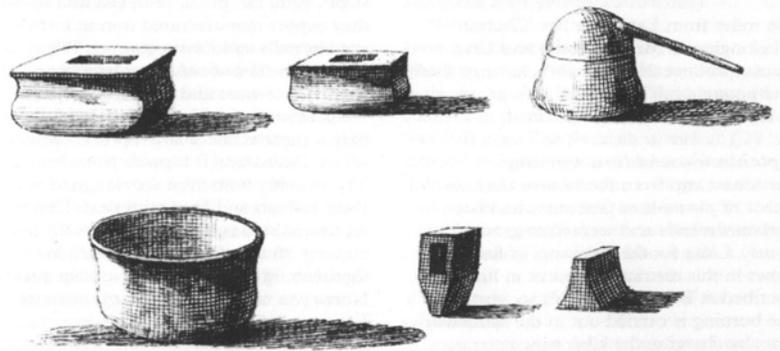
**Plate 46: Iron castings made at Penny Bridge illustrated by RR Angerstein, including what appears to be a tilt hammer head similar to that from Newland (Berg and Berg 2001, 291)**

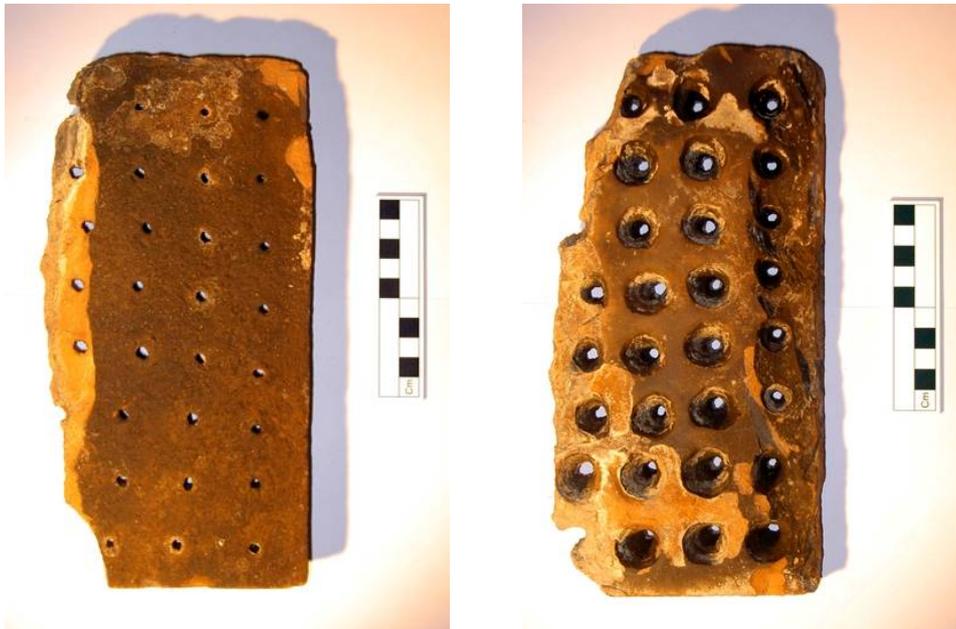
5.3.6 **Ceramic building material:** a single fragment of perforated drying kiln tile was recovered from within the northern extension during the building recording (Plate 47 and Plate 48). The texture of the upper surface suggests that this had been cast in a sand mould, while the crudeness of the perforations indicates that they were made by hand by simply inserting a pointed stick through the original block of clay before firing. Dating such tiles is difficult as so little work has been done on them; although by the later 19<sup>th</sup> century more complex machine-pressed types were becoming common, hand-made varieties such as this date from the 17<sup>th</sup> – 19<sup>th</sup> centuries (Crew 2004, 4).

**Plate 47: (left) Drying kiln tile, upper side**

**Plate 48: (right) Drying kiln tile, lower side**
