KEEPERS COTTAGE, ABBEYSTED, LANCASHIRE

Archaeological Building Recording

Client:
4th Duke of Westminster's
1964 Settlement
Planning Ap. Ref.: 05/00976/LB
NGR: SD 356170 454238

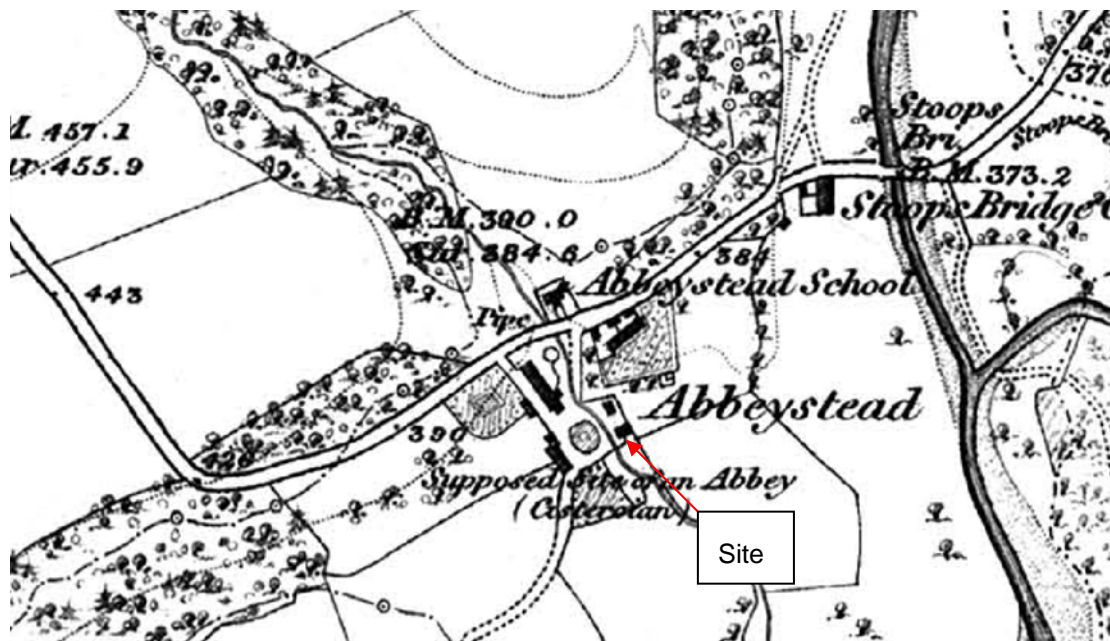
Plate 2: Extract from Ordnance Survey 1847

3.2.2 **Ordnance Survey 1847:** this plan shows that the number of houses in the settlement of Abbeystead has reduced but some of the properties, especially to the west of the stream, appear more grandiose (Plate 2). The school has now been built and the road layout to the west of the village appears to be slightly changed. Keepers Cottage can clearly be seen as the lower east building.

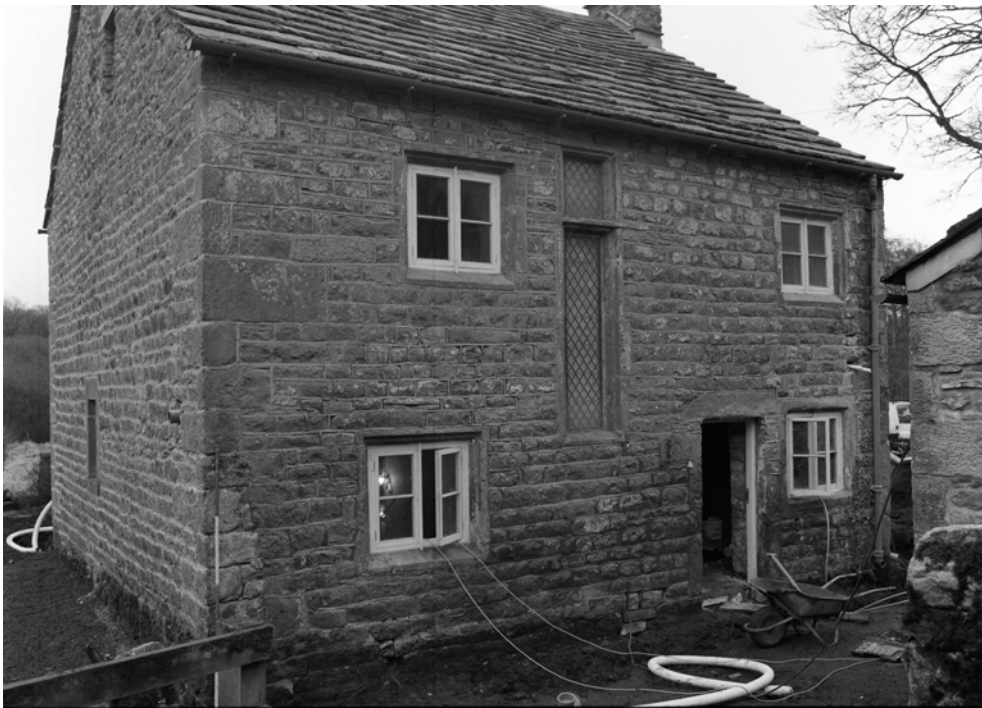
Plate 4: North elevation

4.2.1 **North elevation** (Plate 4, Figure 2): the ground floor incorporated an original doorway that accessed the western of the two rooms; there was a window either side of the doorway. The gritstone window surround at the west end of the elevation was probably re-used from an earlier building; it was plain except for a slight chamfer (which was more pronounced on the sill) and a single, central, diamond shaped stone mullion that had been painted white in keeping with the later six-light timber casements that had been inserted. The doorway was immediately to the east of the window and was finished with roughly dressed and substantial quoins set under a large lintel. The quoins on the west side of the doorway were irregular due to its proximity to the window; this asymmetry appears to be original though and not the result of any later alterations, the door itself was a modern tongue and grooved timber insert. The window at the eastern end of the elevation was a modern white-painted timber insert, which was located within an original rebated stone surround that was at odds with the sill which was chamfered; this arrangement was also common to the two upper windows on this elevation. A wall from the north-west butted the extreme east of the elevation partially obscuring the lower quoins; on the second site visit this wall had been removed revealing a mason's mark (Plate 10). Two metal vent grills were located at the base of the wall to the east of the doorway and were obviously intended to air the eastern of the two ground floor rooms; there was also a cast iron downpipe at the west end of the elevation. Photographs taken before the project was undertaken show that there was a hopper marked 'AC' midway up this downpipe (see Plate 5). The upper part of the elevation had two windows, located roughly above those on the ground floor, between which there was an ornate leaded stair light. The stair light was divided by a transom that was about three quarters of the way up; this stone was dressed on its upper and lower sides to fit with the rebated and chamfered jambs. The listed building information (*Appendix 2*) suggests that these rebated window surrounds are re-used and this may well be the case as they differ from the window surrounds on the south elevation of the property. Certainly the mullioned window appears to pre-date the construction of the house. The stair light was glazed with small diamond shaped panes which were supported at the rear with horizontal braces.

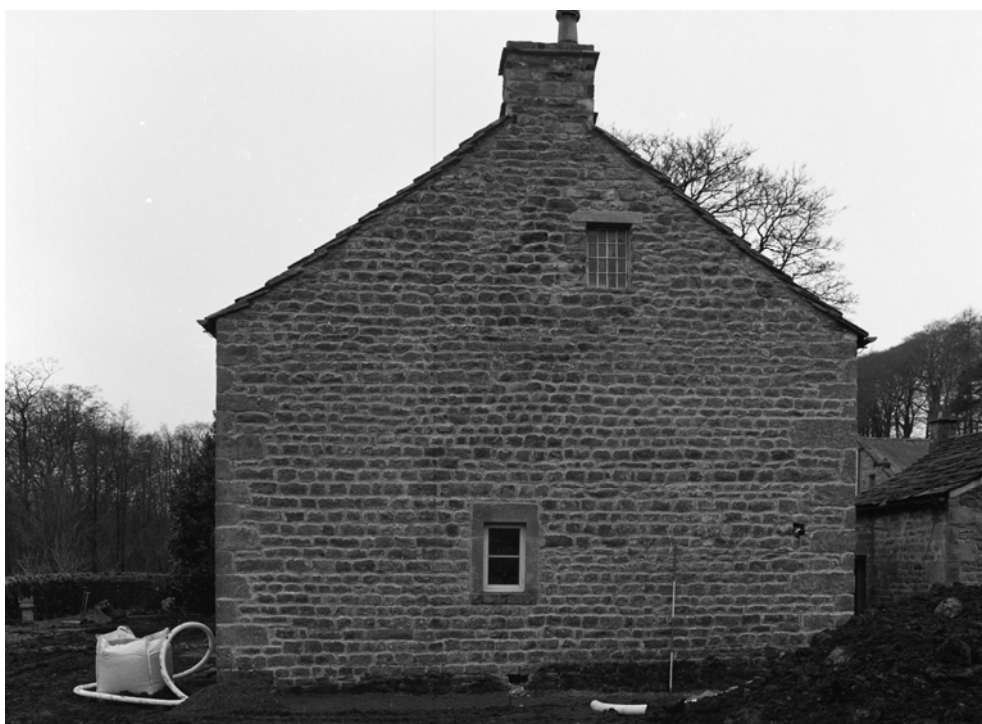
Plate 6: East elevation

4.2.3 **East elevation:** this gable elevation was plain except for a single window on the ground floor and an attic window (Plate 6). The ground floor window had a plain stone surround with a short sill that housed a white-painted two-light timber casement. Below this window there was a metal grill at ground level that covered a wall vent. The attic window appeared to be a later addition, there was no stone surround or quoins and the lintel was fashioned from concrete. A chimney was evident on this elevation on photographs taken by the client prior to the building recording; this had been removed at the time of the recording of the internal features at which time the roof had also been removed. The later external shots were taken after the building had been re-roofed and show the re-built chimney which is a faithful reconstruction of the original.

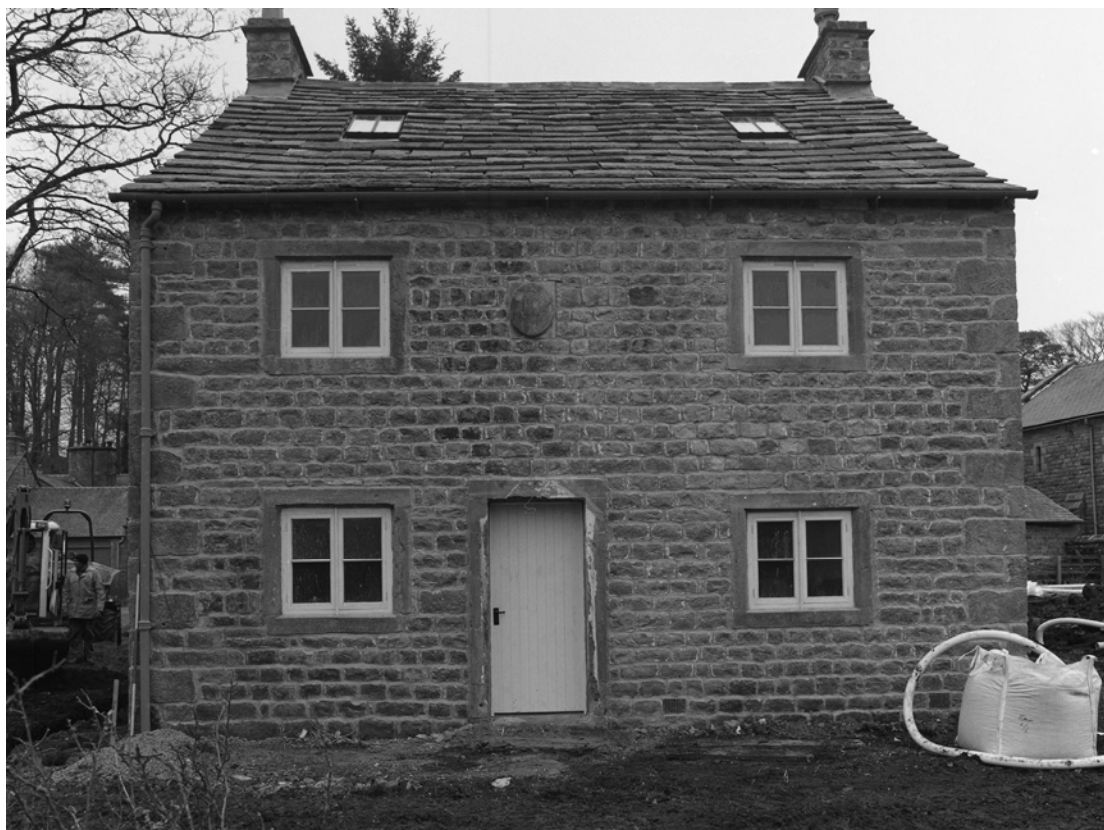
Plate 7: South elevation

4.2.4 South elevation: this elevation formed the front of the house (Plate 7), although having no road access to this side of the property makes it appear more like the rear. The elevation housed two ground floor windows either side of a central door and two upper windows. There was a rectangular datestone above the door, which had a raised oval field that was inscribed with the initials TC and the date 1770 (Plate 9). The window surrounds on this elevation were plainer than those to the rear and just had a slight chamfer. These surrounds housed white painted two-light timber casements on the ground floor and similar four-light casements on the upper floor. A narrow scar ran up the centre of the plain stone door surround which indicated the location of the porch, the door surround on the interior side of the porch appeared to have been whitewashed. The porch is evident on the first edition 1: 2500 Ordnance Survey map of the site (Plate 3) and is also shown in photographs that were taken prior to the building recording. The photographs from the client show a broken stone slab running part the way up the west side of the door; the scar suggests that the porch had a gabled roof. The listed building information (*Appendix 2*) also confirms that the porch was open and gabled. An iron downpipe ran down the west side of this elevation.

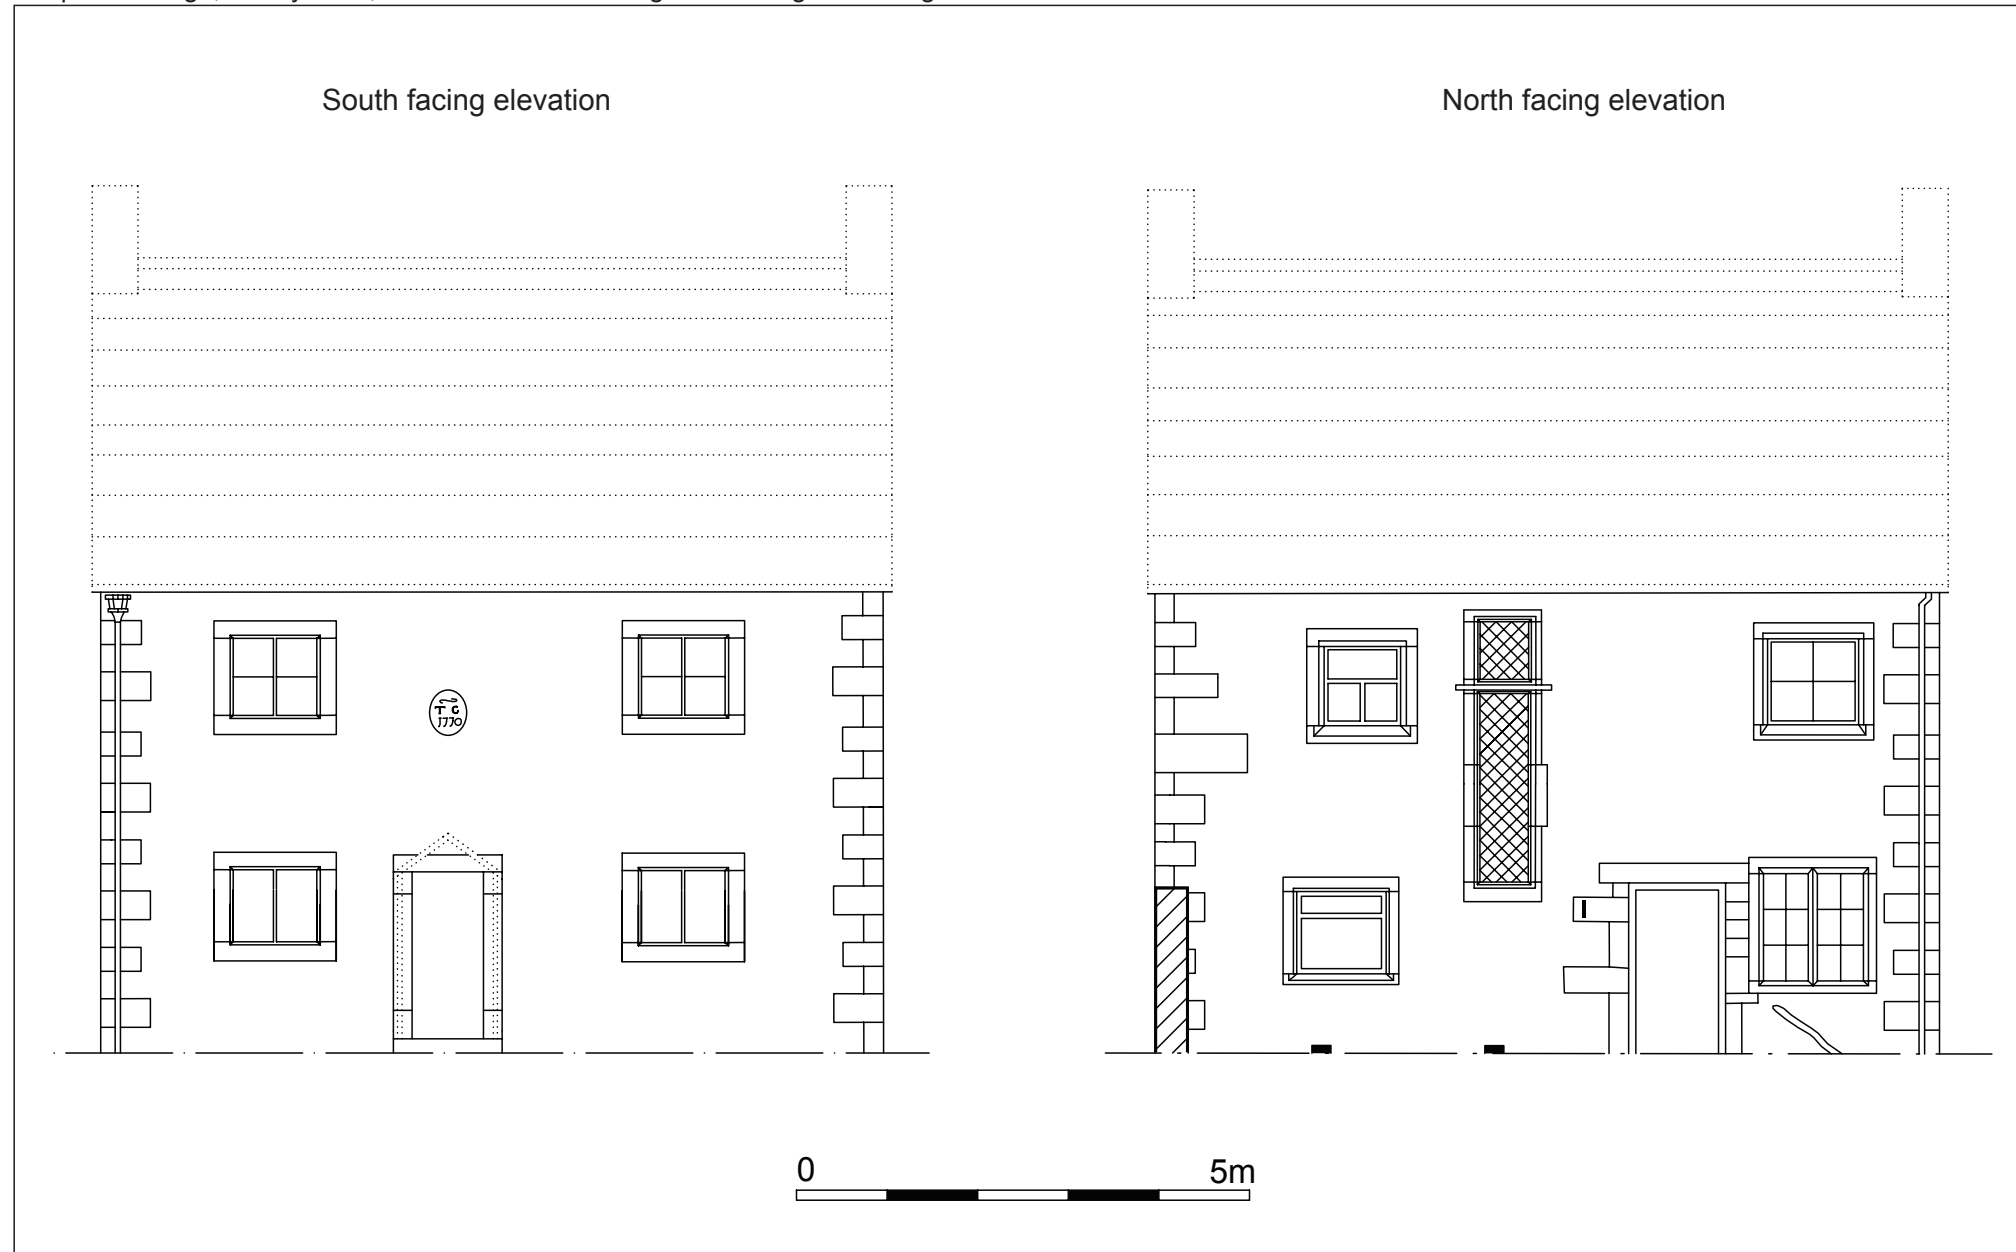
Figure 2: Front and rear elevations

- **Drawings**: drawings were produced by hand-annotating 'as existing' illustrations of the buildings supplied by the client (see *Figure 2* and *Figure 3*). These were:

- i. 'as existing' ground, first and second floor plans at 1:50;
 - ii. 'as existing' front and rear elevations at 1:50;
 - iii. in addition, a cross-section was produced at a scale of 1: 50.

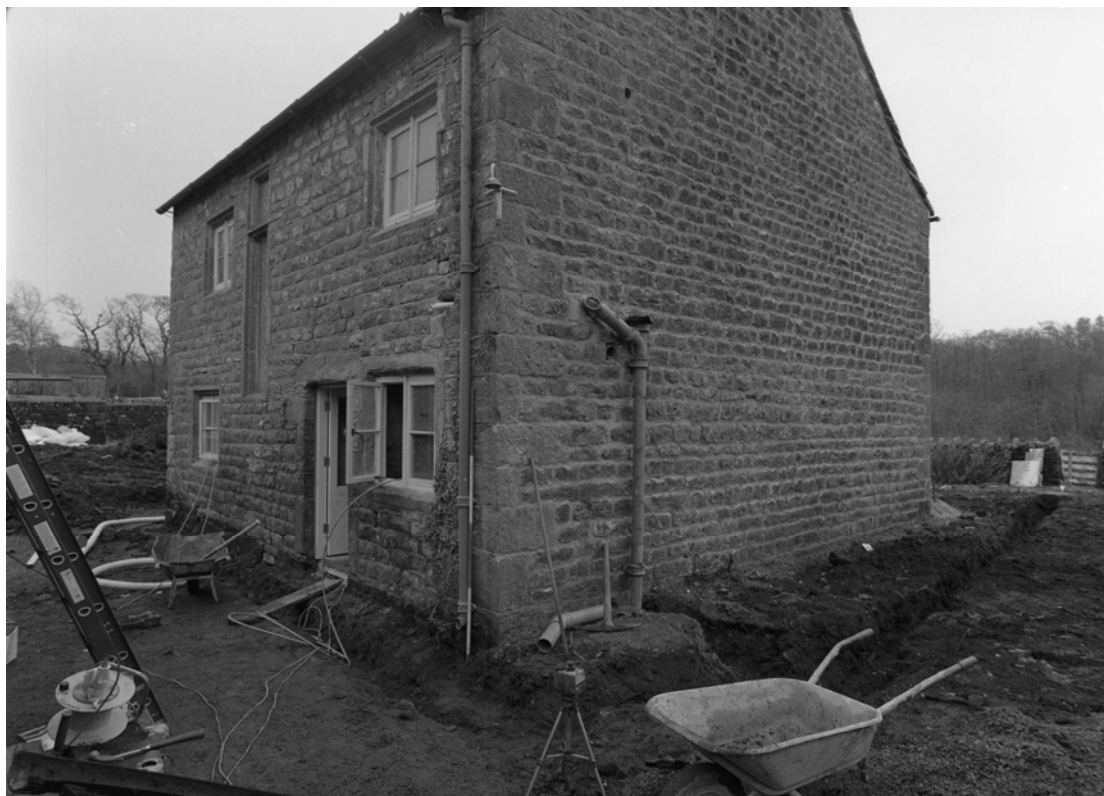
Plate 8: North and west elevations

4.2.4 **West elevation:** this gabled elevation was entirely plain except for an iron downpipe that exited the upper and central parts of the north side of this elevation (Plate 8). A chimney was evident on this elevation on photographs taken by the client prior to the building recording; this chimney had been removed at the time of the recording of the internal features at which time the roof had also been removed. The later external shots were taken after the building had been re-roofed and show the re-built chimney which is a faithful reconstruction of the original.

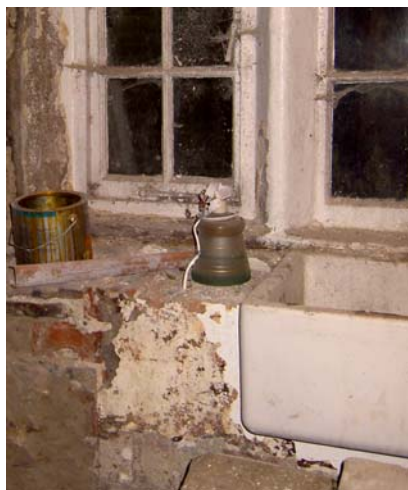
Plate 11: (left) Kitchen window showing mullion and sink

4.3.2 The north elevation housed an original mullioned window at the west end, the diamond shaped mullion separated two white painted, timber, six-light casements which had stays and latches typical of the early-mid 20th century. The window had splayed jambs and the width of the wall permitted a shelf below the lights, which housed a relatively modern ceramic Belfast sink (Plate 11). The shelf to the west of the sink had been re-built in red brick which suggests a larger sink was originally located in this area. To the east of the window was the only back entrance to the property, it had a modern tongue and grooved timber door with rear bracing under an original roughly squared oak lintel.

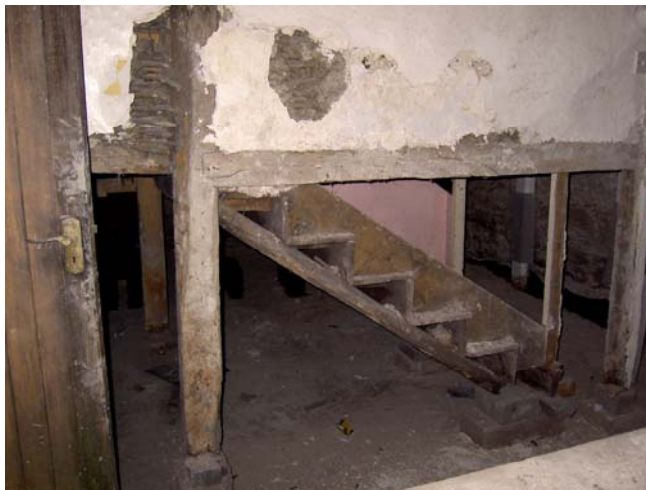
Plate 12: (right) Stairway partition in kitchen

4.3.3 The east elevation comprised a stud partition; the main frame was constructed from two oak posts that were keyed into the overhead beam and the flooring, which was probably originally gritstone flags. At least one horizontal timber joined these vertical posts and was keyed into the north elevation; these main timbers were roughly squared oak. The horizontal timber originally sat upon a low stone wall which had been removed to facilitate the lifting of the original flooring, the partition above the wall was filled with wattle and daub which had been plastered over (Plate 12). A modern horizontal green painted timber was affixed to the plastered area of the partition and had numerous coat hooks attached. There was a doorway at the south end of this elevation which was formed by the vertical post of the partition and the stone wall of the south elevation.

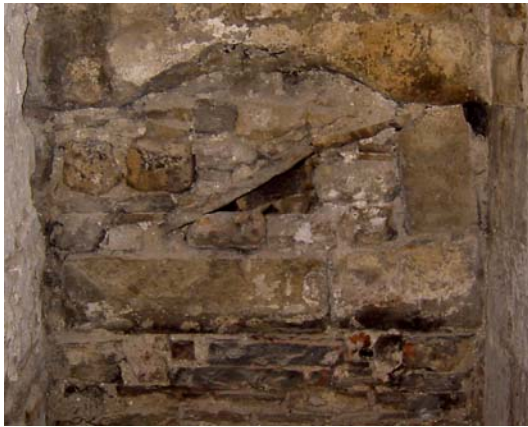
Plate 13: (left) Blocked up bread oven in kitchen

4.3.5 The west elevation housed a wide original chimney breast that was located centrally and constructed from a series of ashlar blocks that supported a tall thin stone lintel, which in turn supported a moulded pediment (Plate 14). The fireplace opening was over 1m wide and 0.50m deep and it seems likely that this was used as the cooking area. The flue of the fireplace was built into the main wall of the house and had recently been blocked up. Adjacent to the chimney breast, to the south, a bread oven had been constructed in the wall; this consisted of a large stone lintel with an arched underside and vertical pillars at each end that were seated on horizontal ashlar gritstone blocks (Plate 13). The aperture had been blocked but would have measured 1m in width by 0.40m in height; its depth was probably 0.30m. The socket in the southern elevation of the room may have been used to place a timber to secure the door of the oven.

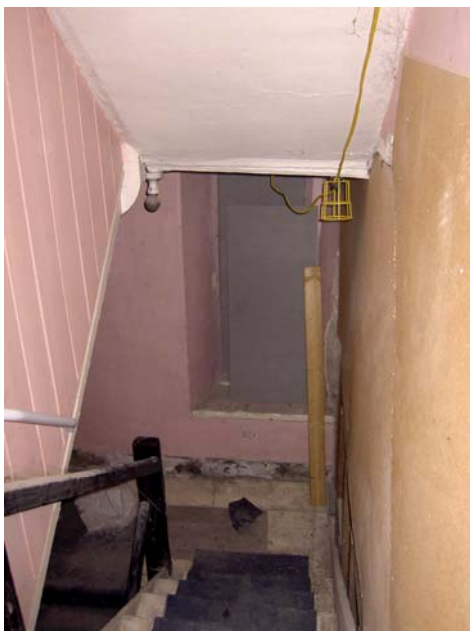
Plate 15: (left) View down stairs from first floor with boarded stairlight visible

4.3.6 Room 2 - stairs, ground floor rear: this room number designates the stairwell which separated Rooms 1 and 3. The stairway construction utilised the northern of the two vertical members of the stud partitions in Rooms 1 and 3; these were braced horizontally forming the basis for the mid-floor landing of the stairs. A pair of roughly finished oak timbers formed the strings that rose from the floor to the horizontal timber; horizontally and vertically set planks were then braced to the strings to form the treads and risers (Plate 12). Narrow vertical boards that were painted pink separated the lower steps and the upper steps up to the newel at the landing (Plate 16). The base of the tall and narrow stair light was located just over the mid-floor landing; it had a white-painted thin timber board sill and splayed jambs (Plate 15). Elements of the staircase appeared to have been replaced, but the basic design and location were undoubtedly original. The underside of the upper half of the staircase housed a yellow-painted timber door surround which indicates that this area was enclosed for storage; within this stair cupboard all the timber was white-painted.

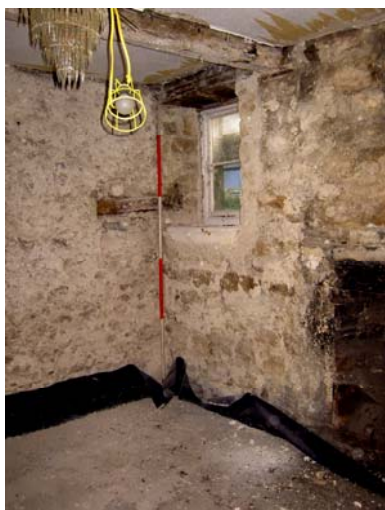
Plate 17: (left) Parlour showing fireplace and window in east elevation

4.3.12 The east elevation housed a small window at the north end with a white painted two light casement and a white painted timber sill. The lintel was square cut oak and the jambs were splayed (Plate 17). Midway along the elevation there was a small fireplace under a stone lintel; the interior had been lined with a variety of frogged and unfrogged red bricks. The main fittings of the fireplace had been removed leaving a flue that was built into the external wall.

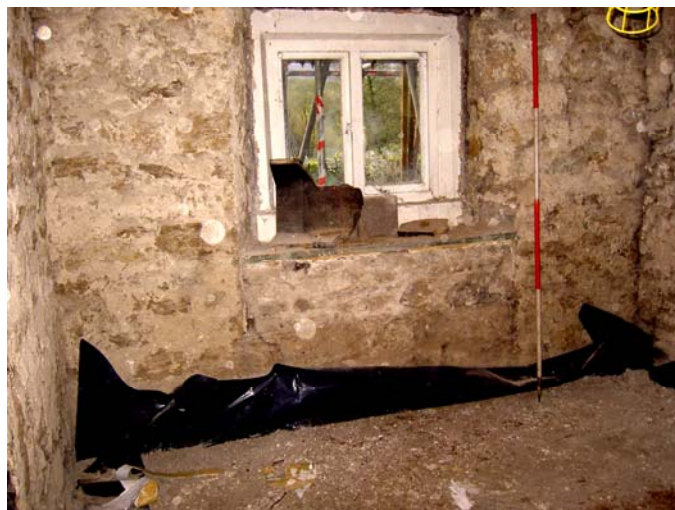
Plate 18: (right) Window in south elevation of parlour with filled window seat

4.3.13 The south elevation was plain except for a large window in the centre of the elevation. Once again the window had splayed jambs and a modern white-painted timber two-light casement, a shelf below and an original oak lintel. The shelf was originally a window seat that had been built back up to the base of the stone surround and capped with a timber board (Plate 18).

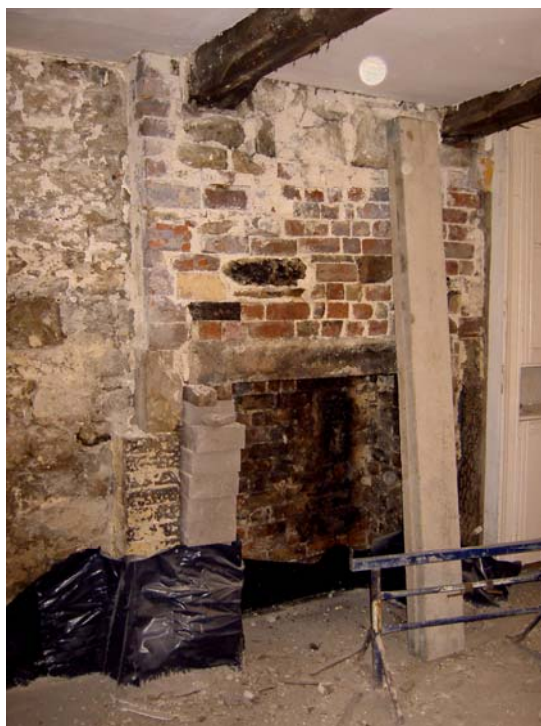
Plate 19: (left) Inserted chimney breast in the living room, ground floor

4.3.18 The west elevation housed a centrally located chimney breast which was added or at least re-built. The chimney breast was constructed from a mixture of brick types, as well as gritstone rubble and two apparent stone lintels. It seems possible that originally this fireplace mirrored that in Room 4 with the flue built into the main wall, and that at a later date it was expanded and brick lined to create more heat. Certainly some of the frogged bricks incorporated would post-date the construction of the house and the stonework of the breast appears to have been built around the two beams (see Plate 19). A cupboard had been fitted adjacent to the north side of the chimney breast, which was painted white with panelled doors above and below a shelf. It would seem likely that this was added into the space that was created by the construction of the chimney breast which in itself may have been built to accommodate a range. This type of arrangement would be typical of the 19th or early 20th century.

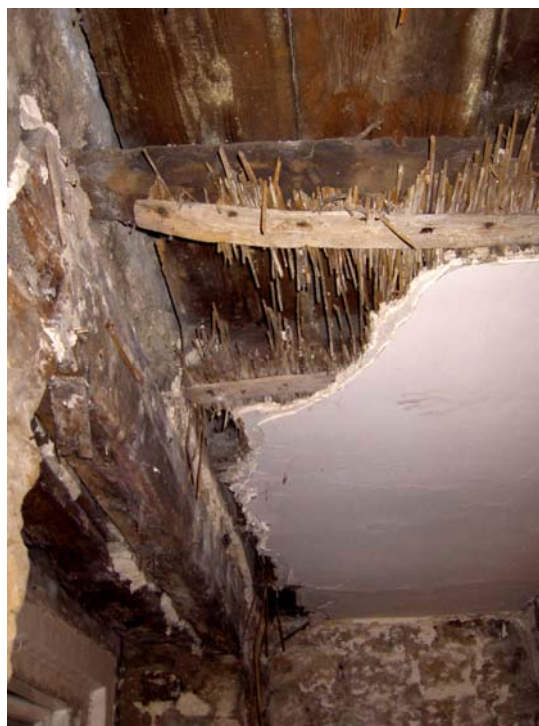
Plate 20: (right) Phases of ceiling insulation evident in living room

4.3.15 **Room 5 – living room, ground floor front:** this room was accessed from the front door and had a south facing window, a large fireplace, and a fitted cupboard. As with Room 4, two beams ran east/west across the room, both of which were fashioned from oak and were hand finished and chamfered. Damage to the ceiling plaster revealed rushes were affixed to the above floor joists by battens and laths (Plate 20); above the rushes there was a thick deposit of organic insulation. The original flooring had been removed and a concrete base had recently been laid.

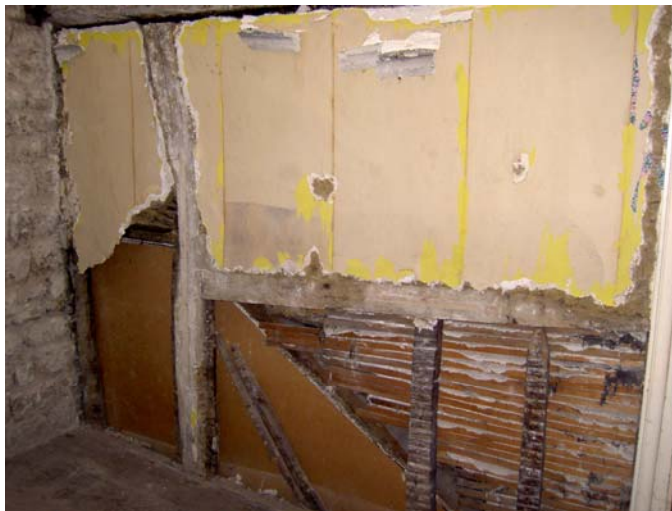
Plate 21: (left) Stud partition in Room 6

4.3.21 The east elevation consisted of a stud partition with a doorway at the south end (Plate 21). This stairwell partition was identical to that of the floor below (Section 4.3.3) except that it was continuous to the floor, lacking the stone wall base. Between the two vertical posts that were jointed into the western roof truss there was a central, horizontal bracing timber; the area below this was filled with lath and plaster and not the wattle and daub that filled the remaining regions of the partition. The partition had been covered in modern plasterboard, but where this had been removed in places; the daub containing straw was clearly visible beneath. The doorframe was finished in white painted modern timber and the small area of partition over the doorway was constructed from tongue and grooved boards.

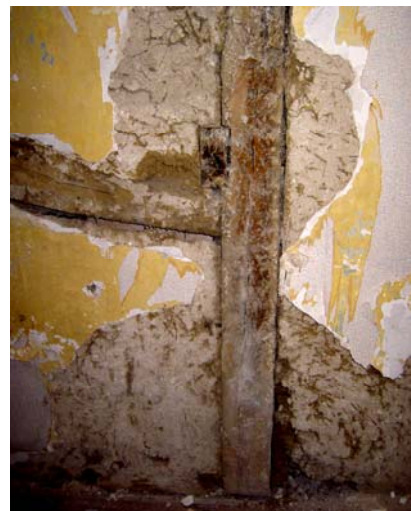
Plate 22: (right) Partition in Room 8

4.3.25 **Room 8 – bedroom, first floor rear:** this room was essentially a mirror image of Room 6 (Section 4.3.19-4.3.23) except that the mud and stud partition was entirely original, as was the plaster covering it, which contained straw and hair (see Plate 22). The window in the north elevation contained a modern three light casement with a top hung ventilator under an original oak lintel which had a

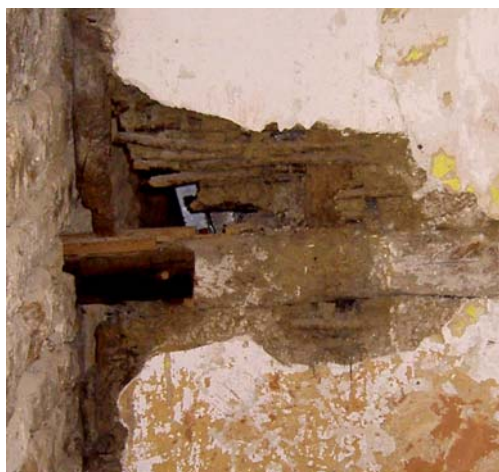
Plate 23: (left) Detail of 'mud and stud' in Room 10/9

4.3.26 Rooms 9/10 – bedrooms, first floor front: these front rooms were presumably the master bedrooms, being slightly larger than the rear rooms, having south facing aspects and both benefiting from fires in the rooms below. Each room had a window in the southern elevation, and two north/south oak chamfered beams either side of a third beam that was located over the shared central wattle and daub partition wall. Both rooms had pine floorboards with black staining around the peripheries suggesting that they were once carpeted. The ceilings had been removed to facilitate the insertion of modern softwood joists. The entrances to both rooms were in the north elevation, although both lacked doors but had original oak lintels. The west elevation of Room 9 had a region of heat altered stonework in the centre (Plate 26), indicating the line of the flue in the wall from the fire in the living room below. The eastern beam of this room also had a series of peg holes in its underside; this may be indicative of a former partition in the room or possibly that the timber was re-used from elsewhere. There was a central fireplace in the east elevation of Room 10 with a stone surround with a red brick lining (Plate 25); this was linked to the same flue as the fire in the parlour below. The partition that separated the two rooms was constructed around a central vertical timber that held two separate horizontal timbers which were keyed into the walls at either end (Plate 23 and Plate 24). The horizontal oak timbers were roughly squared and midway up the elevation, vertical staves were fixed into these timbers around which withies were wound before being covered in daub and plastered.

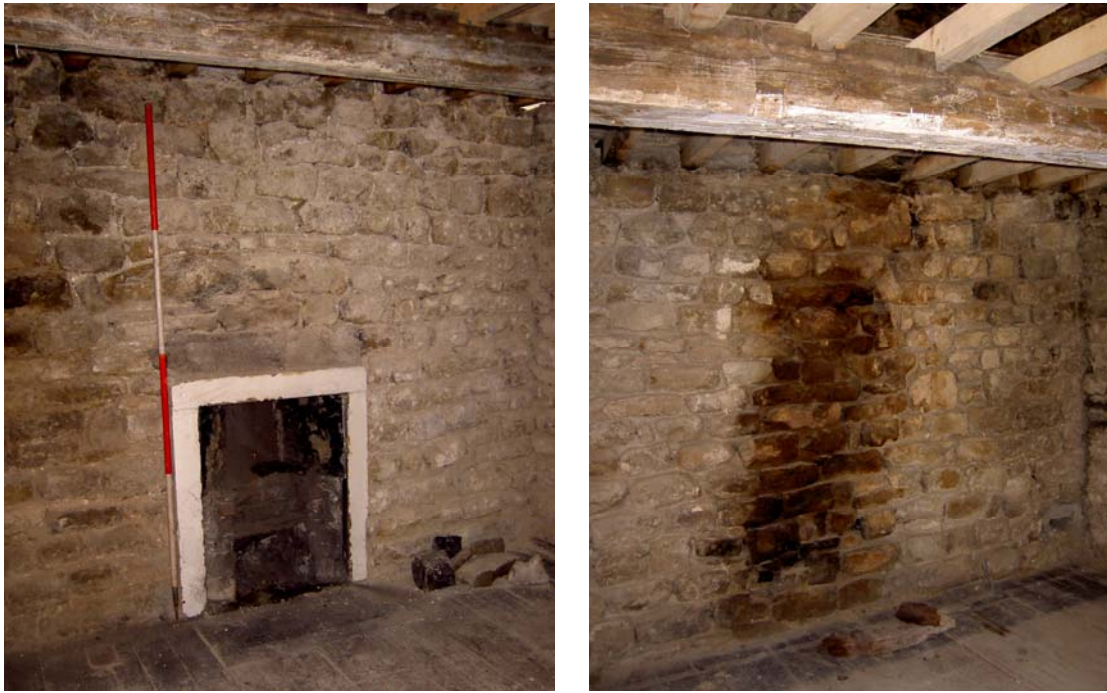
Plate 25: (left) Fireplace in Room 10

Plate 26: (right) Smoke-blackened stonework in Room 9 indicating the line of flue from the fireplace in the living room below

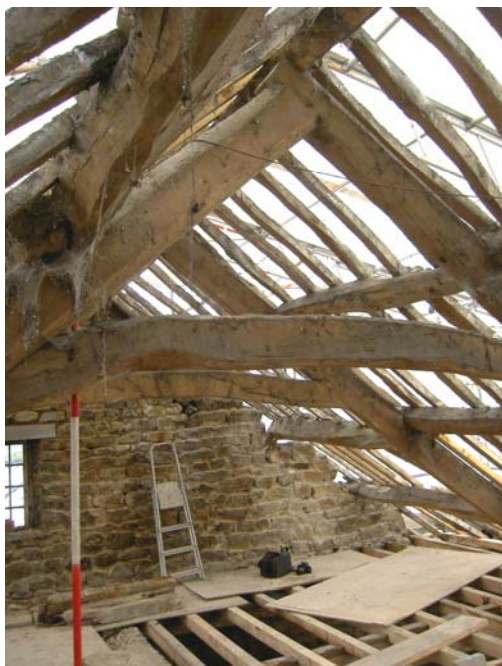
Plate 27: (left) Roof trusses in attic space, from the west

4.3.27 Room 11 – attic, second floor: this room was a single undivided space; there was a small inserted window in the east elevation that held a timber 16-light fixed casement with a stone sill and a concrete lintel. The original roof timbers were in place but they were unclad; the flooring had also been removed. There were two tie beam trusses. The principle rafters were fashioned from sawn and hand finished Baltic red pine; the tie beam and collar, from hand finished oak (Plate 27). Baltic timber marks were present on the east side of the eastern truss at the base of the southern principle (see Plate 30). There were three sets of overlapping heavy oak purlins either side of the ridge purlin; these carried many original heavy oak rafters which were pegged in place (Plate 28). The ridge purlin was comprised of three separate timbers that had pegged scarf joints at the trusses (Plate 29); the north principle held the mortise and overlapped the south on whose tip a tenon was located.
