# FLEET SQUARE GARAGES, LANCASTER, LANCASHIRE

## Archaeological Watching Brief

Client: RP Tyson  
Construction Ltd

Planning Application Ref:  
06/01495/FUL

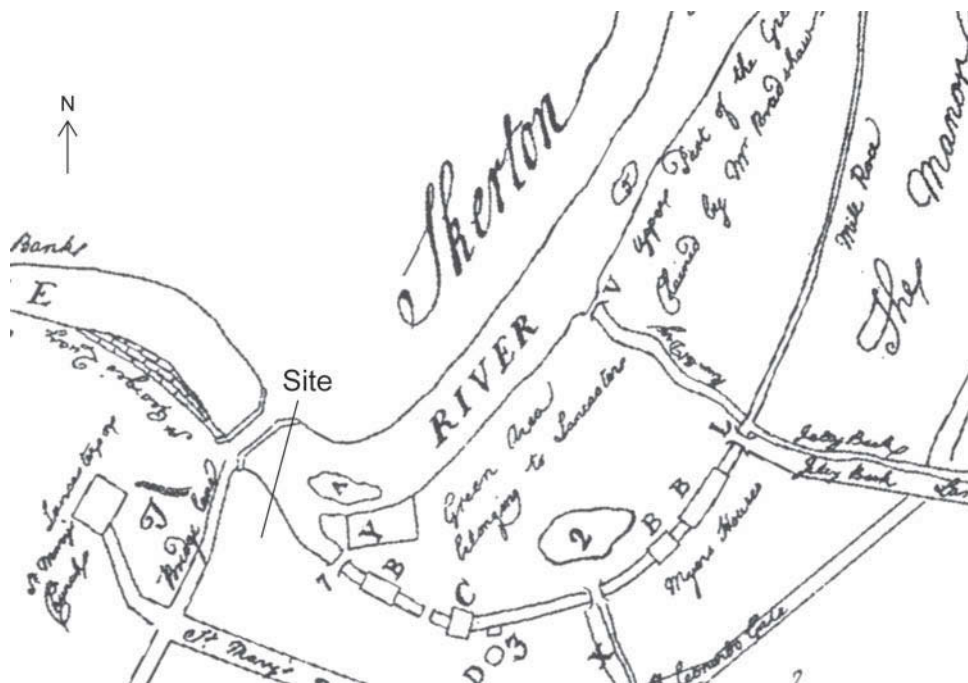
**Plate 3: Extract from a plan of c1754 showing the area of the mill race and the course of the River Lune**

3.2.2 **Map of 1754:** this map, produced as part of a legal dispute regarding the fishing rights on the Lune belonging to William Bradshaw and reproduced by Horsfield (2001, 16). Although not especially detailed it is of interest for its depiction of the River Lune at the time, which seems to have had a number of small islands within in it to the east of the site, and it also shows the line of the mill leat, which was becoming built over by this time.

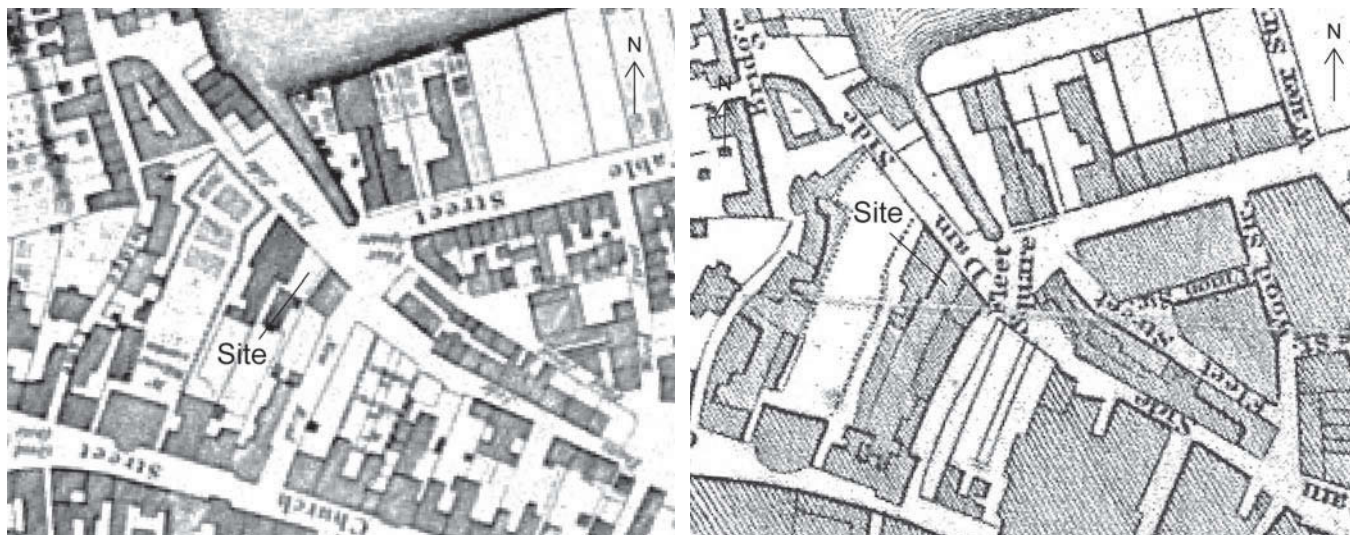
Plate 4: (left) Mackreth's map, 1778

3.2.3 **Mackreth’s map, 1778:** this map shows the early development of the quayside in the 18<sup>th</sup> century and the layout of New Road, joining Church Street and ‘Dam Side’, currently known as Damside

Street (Plate 4). There is a building shown on the corner of the junction of Dam Side and New Road, which is the current location of the Lancaster and District YMCA. The site occupies an area immediately to the north-west of the YMCA which is shown as undeveloped at this time, although there are buildings shown further to the north-west along Dam Side in limited detail.

3.2.4 **Clark's map, 1807:** this map is taken from Clark's (1807) *Historical and Descriptive Account of the Town of Lancaster* and shows a similar arrangement of buildings on the corner of Dam Side and Fleet Square (Plate 5), but again the detail is scant.

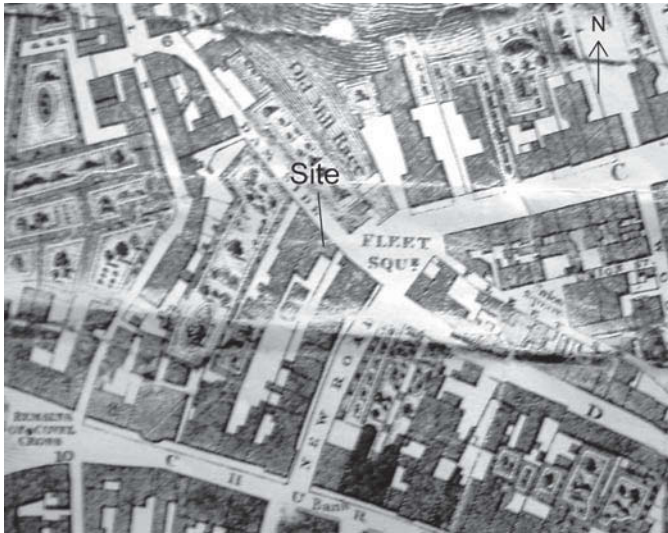
Plate 6: (left) Binns's map, 1821

3.2.5 **Binns' map, 1821:** this map appears to show an L-shaped building in the space to the north-west of what is now the YMCA building on the corner of Dam Side and New Road, and it is more detailed than the earlier maps and shows the adjoining properties more clearly (Plate 6). The passage along the north-west side of the YMCA building is also clearly marked.

3.2.6 **Atkinson's map, 1824:** this map is taken from Baines's (1824) *History, Directory, and Gazetteer of the County Palatine of Lancaster* (Plate 7). There is some discrepancy between this plan and Binns' map in the arrangement of the buildings around Fleet Square; a considerably larger gap is shown on Atkinson's map, where there is just a narrow passage between the YMCA building and the L-shaped building to the north-west on Binns' map (*cf.* Plate 6).

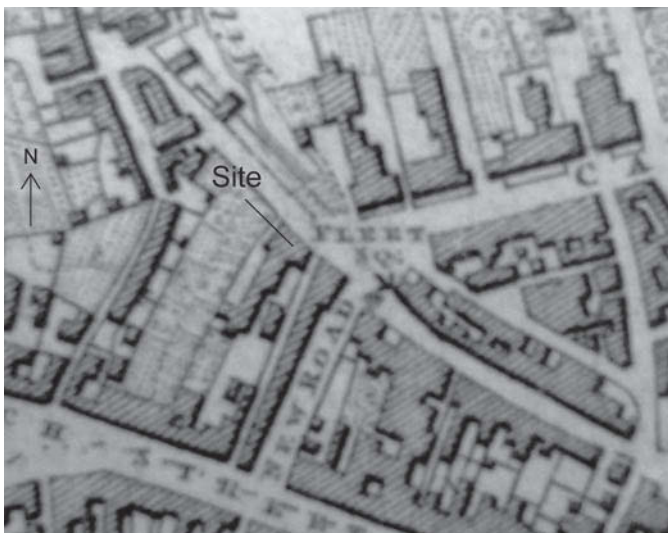
Plate 8: (left) Ordnance Survey map, 1848

3.2.7 **Ordnance Survey, 1848:** this map shows limited detail of the buildings around Fleet Square, but again shows an L-shaped building on the site and the passage to the south-east (Plate 8).

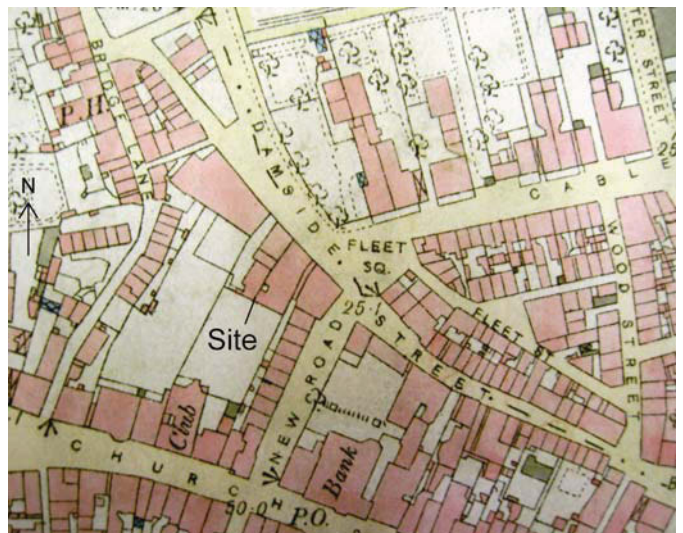
Plate 9: (right) Ordnance Survey map, 1893

3.2.8 **Ordnance Survey, 1893:** this map is considerably clearer than the preceding ones due to the scale at which it was produced, and shows the footprint of the structures on Damside Street. Further development has taken place along Damside Street to the north-west of the site. The site itself has been filled, and the arrangement of the buildings is much changed. Those to the north-west of what is now the YMCA building, which at the time was Pye's warehouse, seem to have formed part of the overall complex, which included additional warehousing and a garage, perhaps initially for housing horse-drawn wagons (Greenlane Archaeology 2008) (Plate 9).

3.2.11 **Ordnance Survey, 1913:** this map shows a similar arrangement of buildings as the earlier edition of the Ordnance Survey (cf. Plate 9), although some more infilling of the space behind the garages has occurred, especially in the south-west corner of the site (Plate 12). The eastern building is labelled '22'.

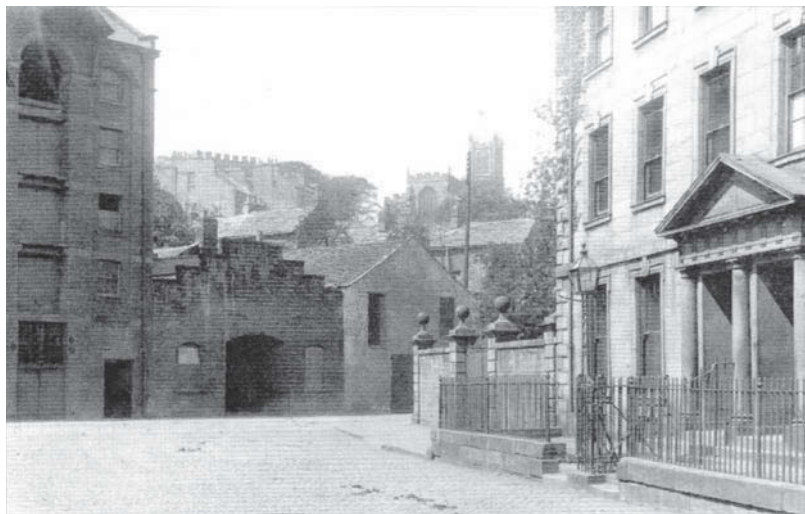
Plate 11: (left) Photograph, 1912

3.2.10 **Photograph, 1912:** this photograph shows the view across Fleet Square from the west end of Cable Street towards Lancaster Castle. The garages which occupied the current site are visible in the centre of the photograph, with the castle behind (Plate 11; after Hayes 2000, 26).

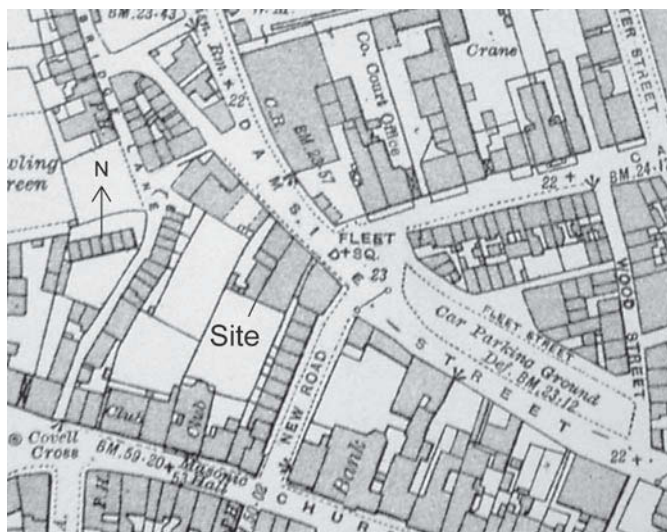
Plate 13: (right) Ordnance Survey map, 1938

3.2.13 **Ordnance Survey, 1938:** this map records the demolition carried out under the Corporation Clearance Scheme in the 1930s of the buildings near Fleet Square (Bathgate and Pye 1997, 9; Plate 13).

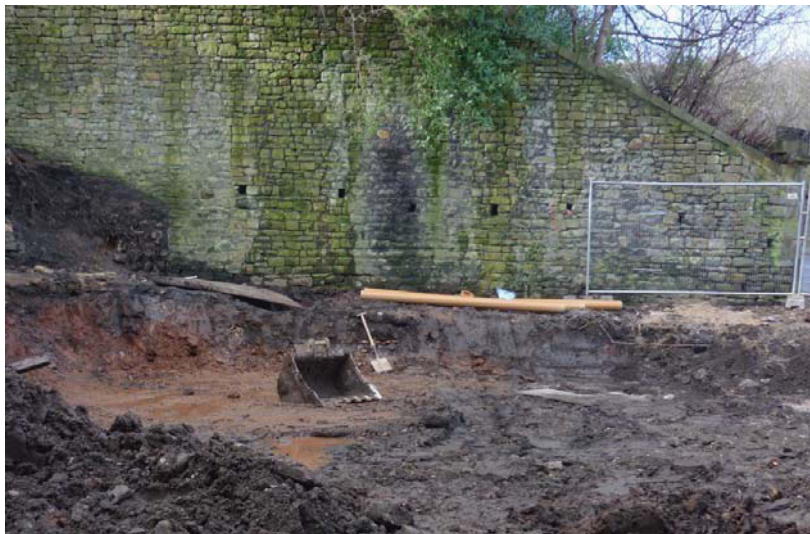
Plate 14: Open area excavated towards the north-west side of the site

4.2.1 **Phase 1:** initially, a large open-area of the site (approximately 130m<sup>2</sup>) was exposed by machine along the north-west side of the site, approximately 2.8m away from the walls (Plate 14; see Figure 4). This revealed a distinct edge, possibly of a curvi-linear feature (**12**), formed by a dark greyish-brown deposit (**10**), below the level of the overburden and demolition rubble (**11**), which was clearly discernible against the soft reddy-brown clay natural (**13**). This dark greyish-brown deposit (**10**) was visible on a north-west/south-east alignment across the centre of the site and seemed to shelve downwards towards the street front to the north, and the upper part was clearly somewhat disturbed as it contained some mortar fragments, ceramic pipe, and brick and stone building rubble as well as fragments of transitional pottery (late medieval or early post-medieval) immediately below layer **11**.

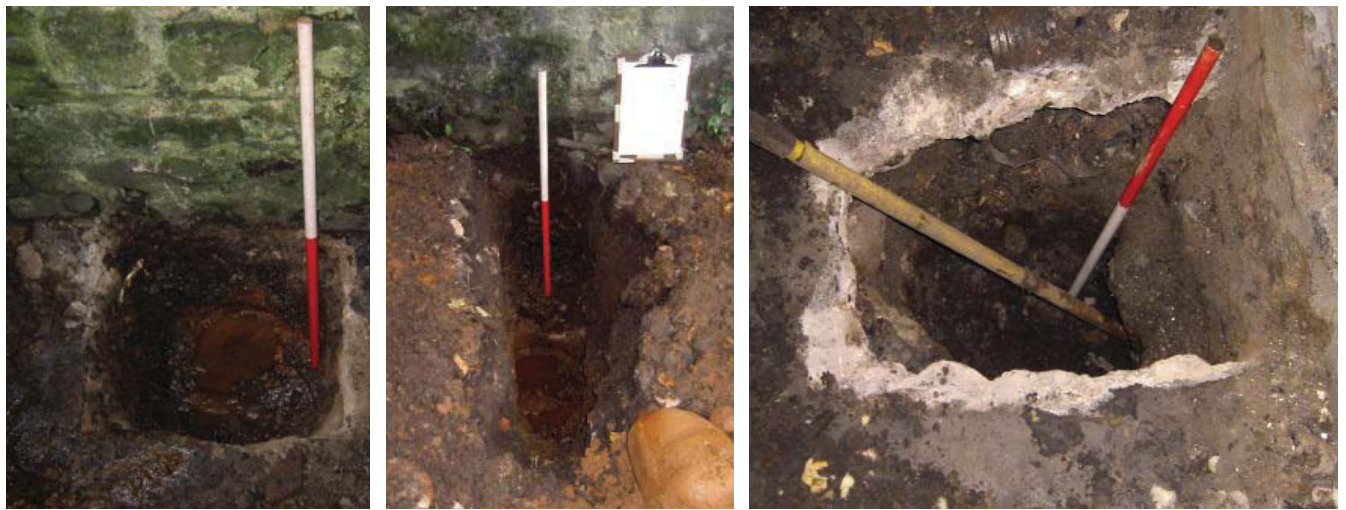
Figure 3: Test pits

4.1.2 **Test pit 2:** this pit was located against the north-west face of the yard wall at the extreme north-west of the site (see Figure 3). The pit measured 0.50m by 1.00m and revealed the footings of this wall to be 0.70m deep. Excavation stopped at a depth of 1.00m and natural pinkish-yellow clayey-sand was encountered at 0.50m at the south-east end of the pit where it was not truncated by the cut for the wall foundation. Between the yard cobbles which extended to a depth of 0.20m and the natural at 0.50m a mid-dark brown clayey-silt was encountered which incorporated some sand and occasional gravels. It was not possible to accurately characterise the small region of this deposit that was undisturbed by the cut for the wall footings in this dark and narrow pit.

Test Pit 1 - facing south-west

Test Pit 2 - facing north-west

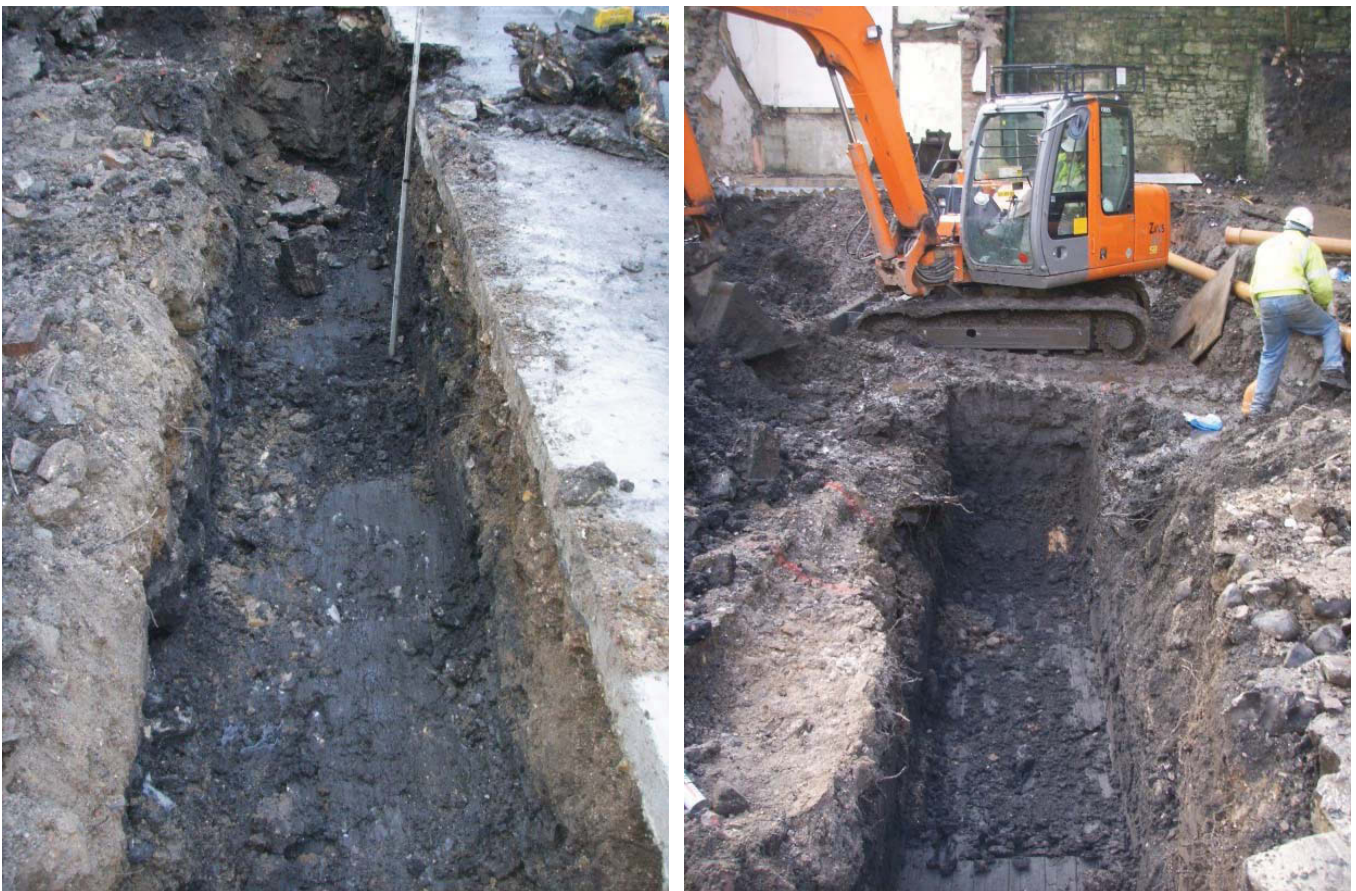
4.2.3 **Trench A:** the overburden/demolition rubble (**11**) below the concrete slab was approximately 0.75m thick above a waterlogged black silt deposit (**10**), which was initially excavated to a depth of 1.45m (Plate 15). The depth of the trench was later re-dug and reduced to a depth of 1.8m, revealing a continuation of context **10** to this level, and a piece of curved and worked stone was recovered at approximately this depth (see *Appendix 3* and *Section 4.3.2*; see also Figure 6). This blackish deposit was thought to be a continuation of the dark-greyish brown deposit observed in the open area excavation of Phase 1; it had a different colouration due to the lack of mixing of the deposit with the overlying demolition rubble at this level.

4.2.4 **Trench B:** the overburden (**11**) was 0.6m thick at the north end of the trench but petered out towards the south (Plate 16). It overlay a black silty deposit (**10**), which was encountered to the maximum depth of the trench, which was originally excavated to a maximum depth of 1.3m and then increased to 1.6m. Context **10** appeared to be more sterile towards the rear of the site.

Plate 15 (left): Context 10 exposed in Trench A, looking west

Plate 16 (right): Trench B, looking south-west

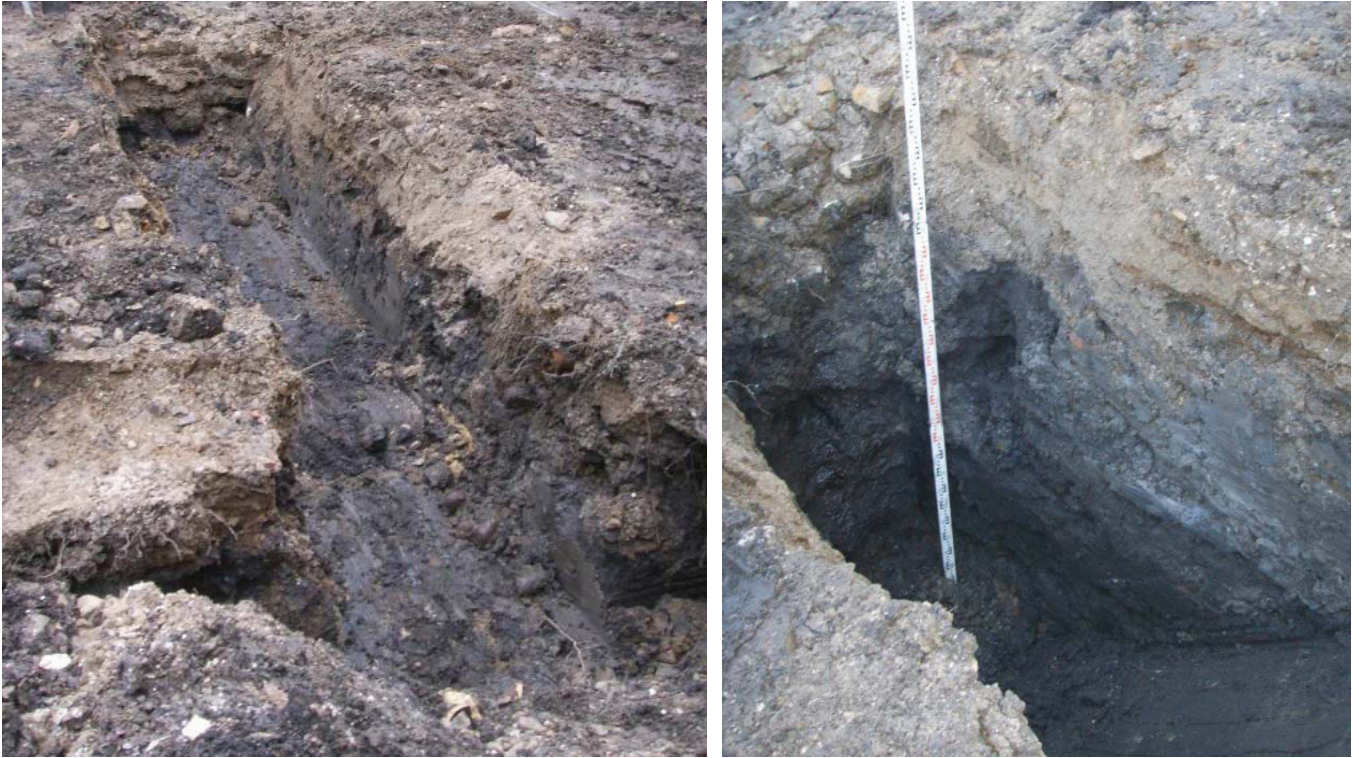
4.2.5 **Trench C:** the west end of the trench was dug to a depth of 1.25m where context **11** was observed to be 0.6m thick on top of context **10** (Plate 17). An area extending 2.8m from the east end of the trench was excavated to a depth of 2.7m. Context **10** continued to this depth and it was observed that the upper part was more clayey (Plate 18). Some sandy looking yellowish-grey clay was observed at this depth which appeared to be underlying context **10**, but it was not possible to investigate this deposit due to the depth of excavation.

**Plate 17 (left): General view of Trench C from the north-west**

**Plate 18 (right): North-east facing section at the east end of Trench C**

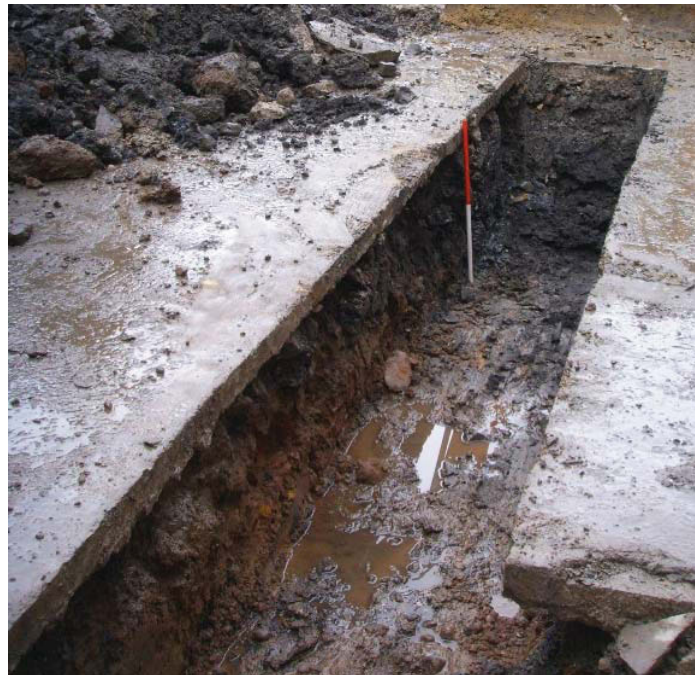
4.2.6 **Trench D:** this trench was excavated to a depth of approximately 1.0m and revealed similar deposits to those that were encountered in Trenches A to C (Plate 19). Rubble (**11**) was exposed below the concrete, which lay on top of the orange clay natural. A blackish silt deposit, probably the same as context **10**, was encountered towards the north end of the trench and appeared to follow the same alignment as context **12**, which is thought to be a palaeochannel, presumably the earlier course of the River Lune.

**Plate 19: North end of Trench D, viewed from the south**

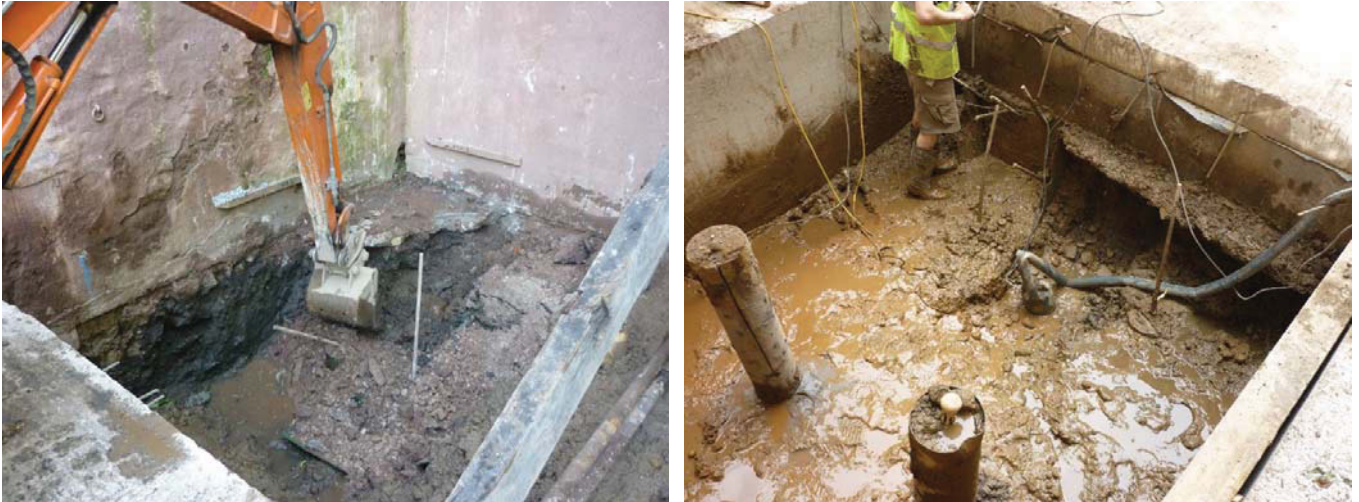
4.2.8 **Phase 3:** the final phase of the on-site work involved the supervision of trenching along the south-west wall (Figure 5). The remnants of the concrete floor and some stone flags, which were above a demolition deposit that contained frogged 'LUNESDALE' bricks, was also removed from this corner, and various water pipes were observed running along and parallel to the back wall below the floor (Plate 20). The trenching was carried out piecemeal, with shuttering and concrete being laid after each section had been excavated (Plate 21). The trench along the south-west edge of the site was excavated in sections and was overall between 3.3m and 3.6m from the wall. Unfortunately, the far south-east corner of the site filled with water as soon as it was excavated, so this section of the watching brief was reduced to examination of the spoil for finds until the area could be adequately drained.

**Plate 20 (left): Removal of the remaining floor in the south-east corner of the site**

**Plate 21 (right): Working shot, concrete having been laid either side**

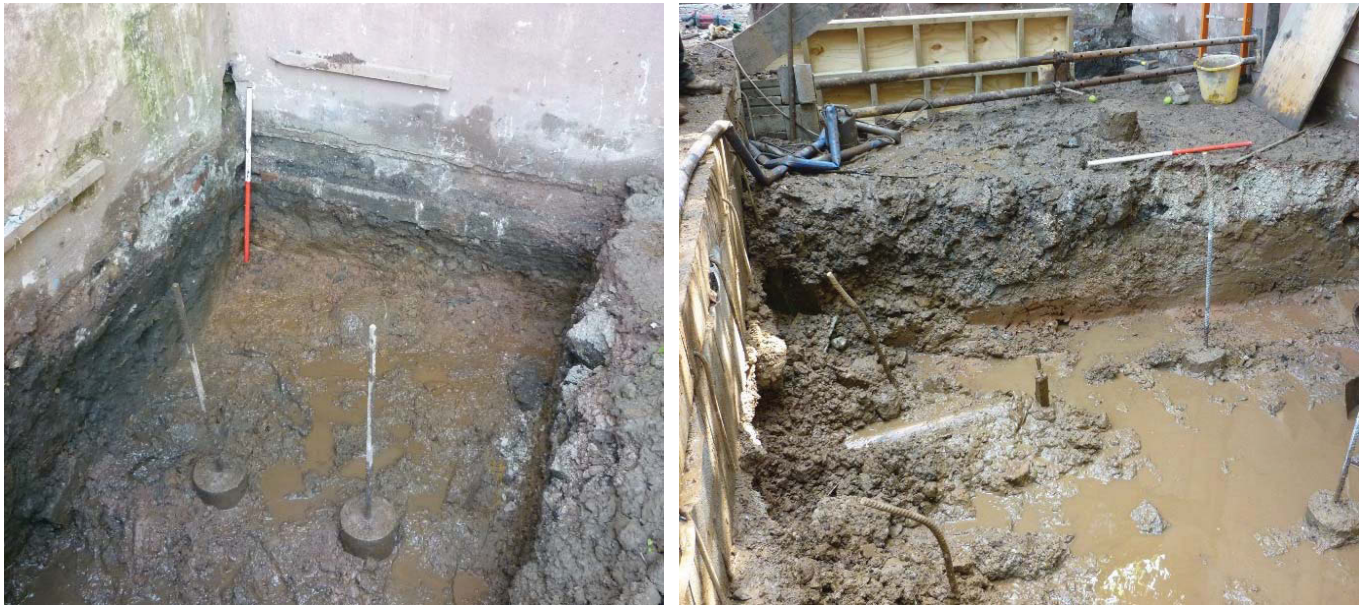
4.2.9 The south-west wall appeared to overly a layer of overburden with red brick and gravel, which was above a similar blackish clayey-silt deposit to context **10**. This black clayey-silt deposit, context **14**, apparently the fill of distinct feature (**15**) different to the palaeochannel (**12**), had some large limestone and sandstone blocks in its upper part, some of which appeared to have been worked and had similar proportions to the worked piece, which was recovered from Trench A, and had presumably been laid to make the ground suitable for construction, although there was no apparent structure or a cut for a foundation wall. This blackish clayey-silt deposit extended as far as the south-east corner of the site and was observed to continue to the maximum depth of excavation against the south-east wall with a maximum thickness of approximately 0.5m (Plate 22). This deposit continued 5.8m to the north-west (Plate 23) and appeared to follow a similar alignment to the edge created by context **10**; it had a similar consistency, colour and organic content, but was encountered much further to the south. It did not extend into the south end of Trench D.

**Plate 22 (left): South-east corner of the site post-excavation**

**Plate 23 (right): Continuation of context 14 in the trench section**

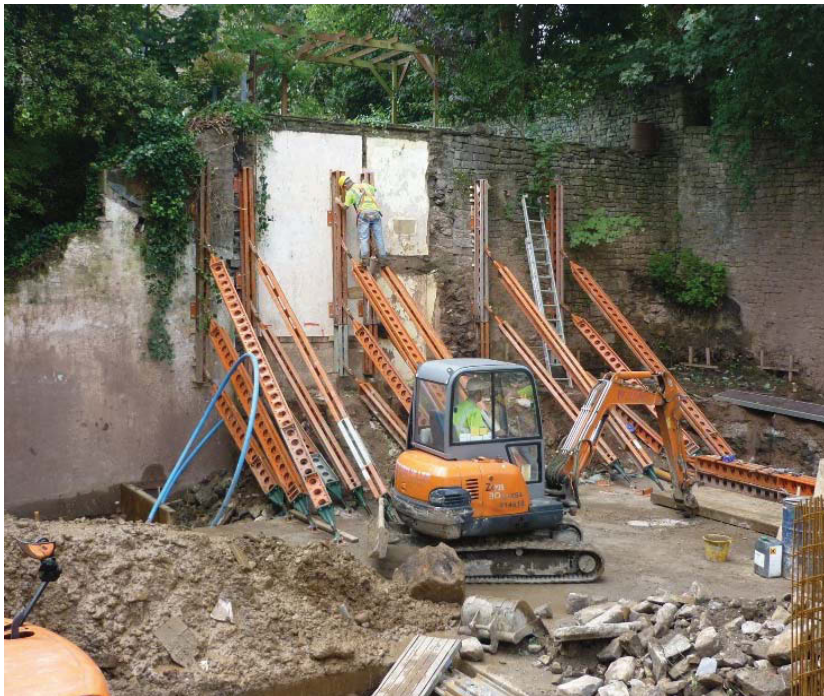
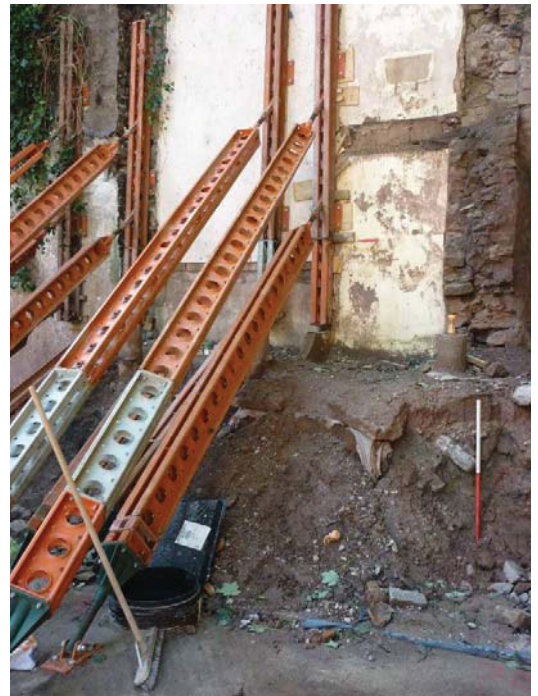
4.2.10 The retaining wall around the south side of the site had to be carefully propped further to the north before any excavation could be carried out (see Plate 24 and Plate 25). Various levelling deposits (**17** and **18**) and fill deposits (**19**) of cuts for water pipes and/or drains were recorded within the confines of the structure to the north and west side of the site, above the red clay natural (**13**) (Plate 26), which were observed to continue along the north-west side of the site towards the road (Plate 27). The natural appeared to change to yellow-brown sand in the south-west corner of the site at a depth of approximately 2.5m. A similar deposit was also observed in Trench C.

**Plate 24 (left): Propping of the south-west wall**

**Plate 25 (right): Detail of the props against the south-west wall**

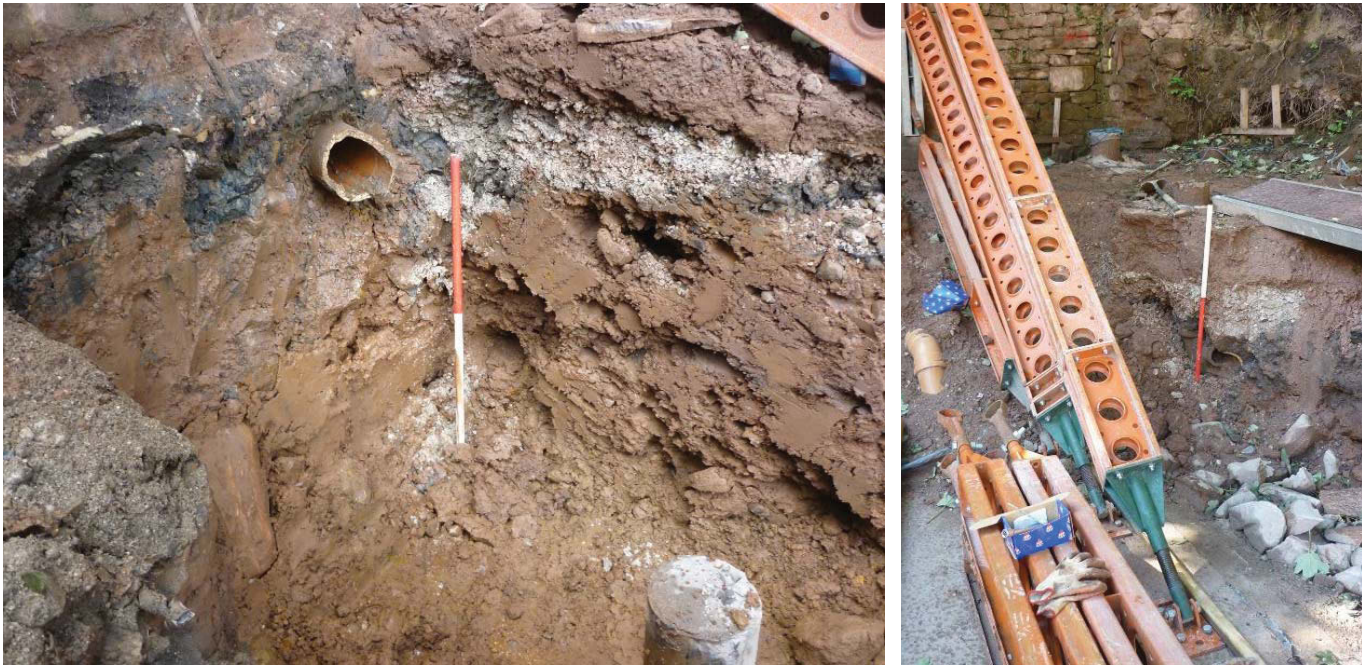
**Plate 26 (left): Deposits within the structural remains against the south-west wall**

**Plate 27 (right): Continuation of deposits along the wall to the north-west**

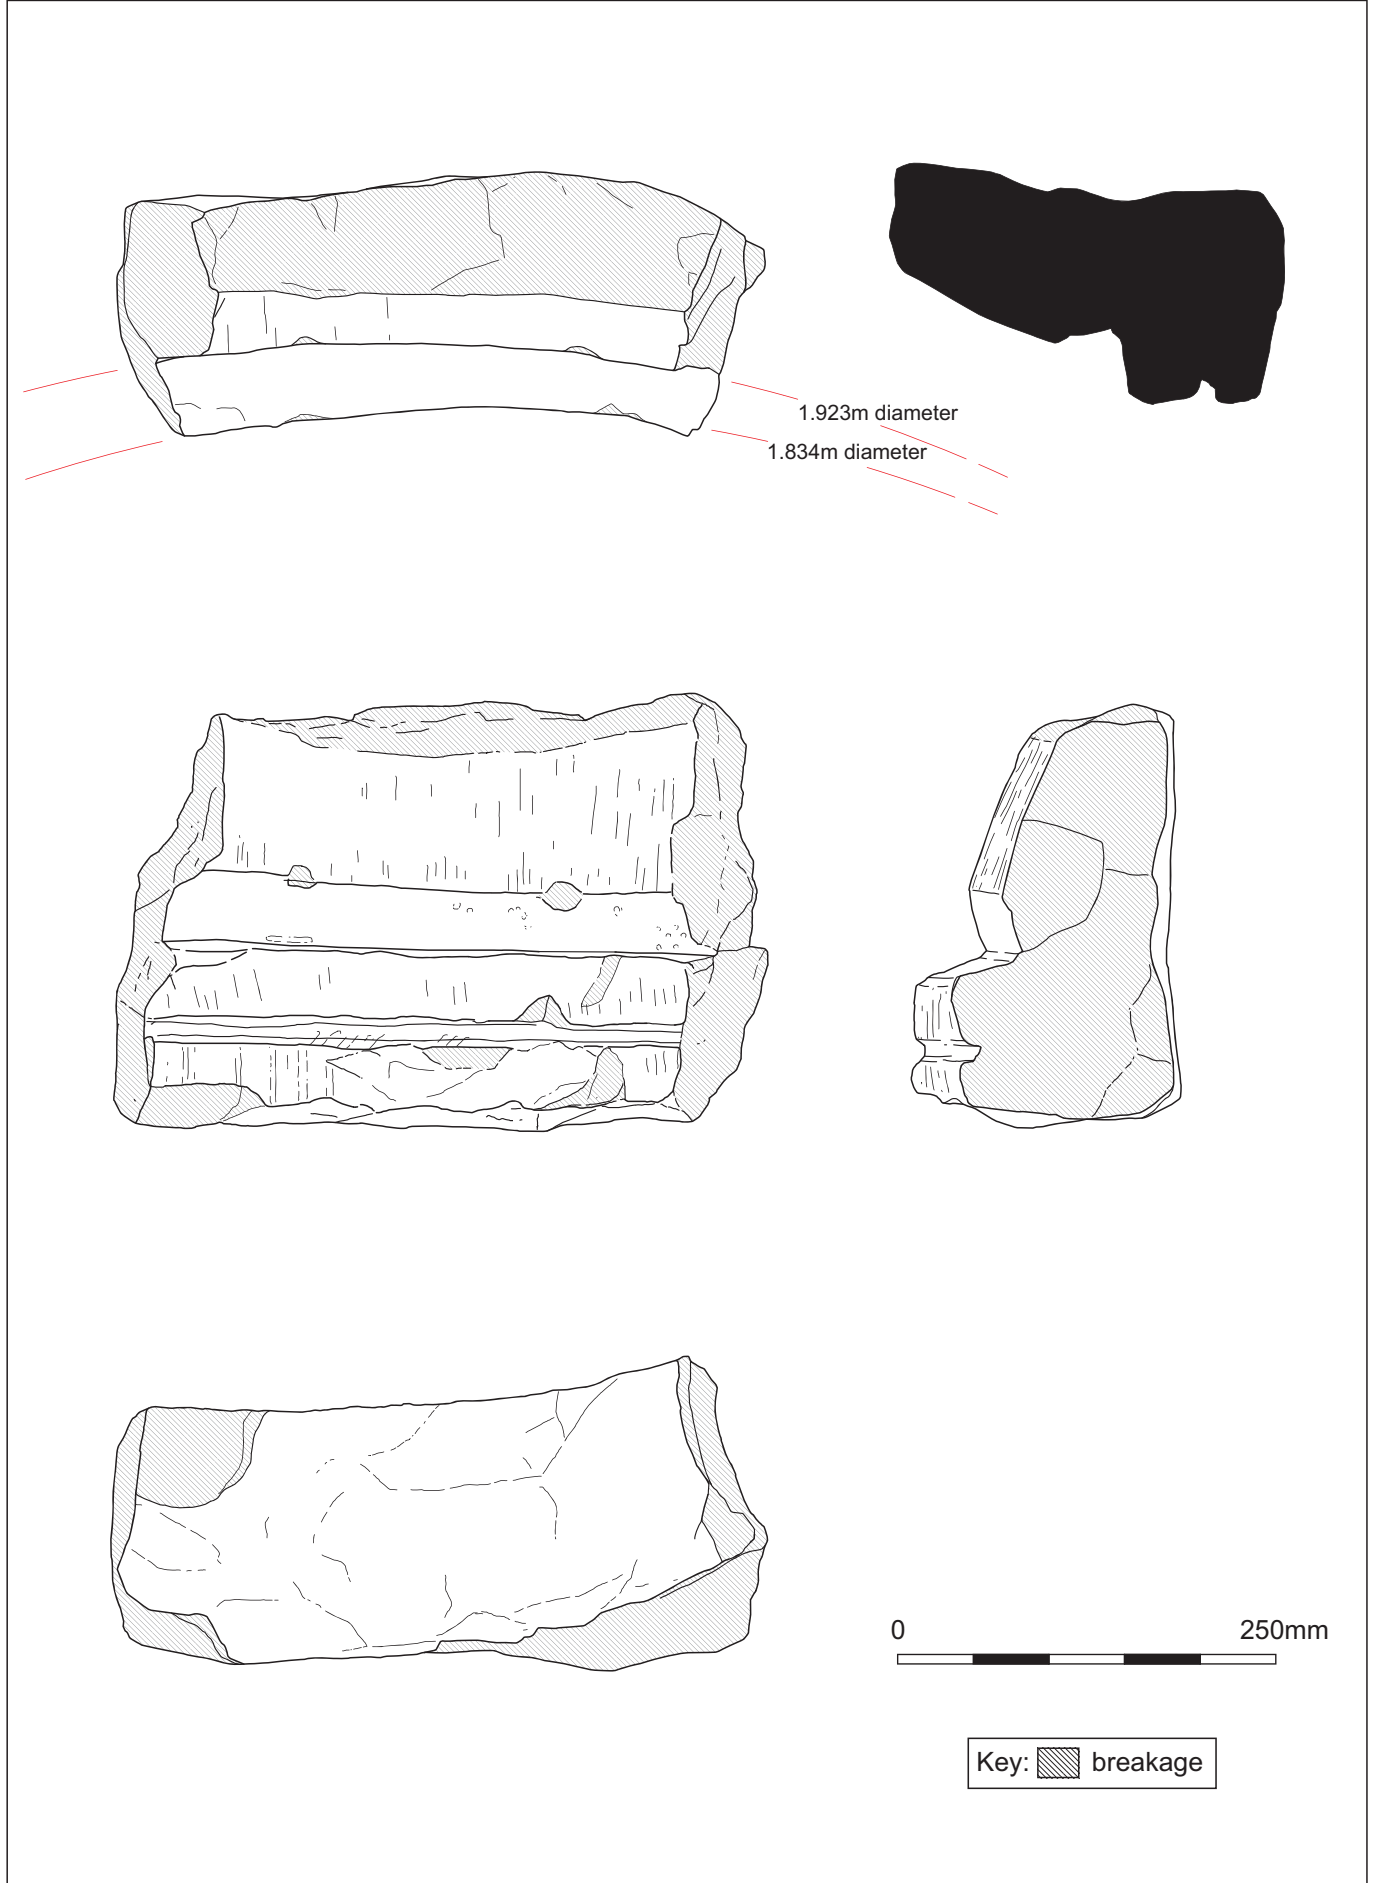
Figure 6: Section of window voussoir recovered from context 10

A large piece of a window arch, which probably housed a leaded light, was recovered from the palaeochannel, but estimates for its date range from the 12<sup>th</sup> to the 17<sup>th</sup> century and its origins cannot be determined. Some late medieval pottery was recovered from this deposit, with a broad date range from the 15<sup>th</sup> to the 17<sup>th</sup> century, but other finds from this deposit were more consistently 17<sup>th</sup> to 18<sup>th</sup> century in date, after which time the area was known to have been built on as part of the quayside. That there was activity on site nearer to the earlier date suggested for this piece of stonework was evidenced by some abraded fragments of pottery, with a late 13<sup>th</sup> to 14<sup>th</sup> century date, but these were recovered from an overlying deposit and thus residual; the majority of the finds which were recovered from the overlying deposits related to activities on the site after this time, and dated from the 18<sup>th</sup>, 19<sup>th</sup>, and 20<sup>th</sup> centuries.

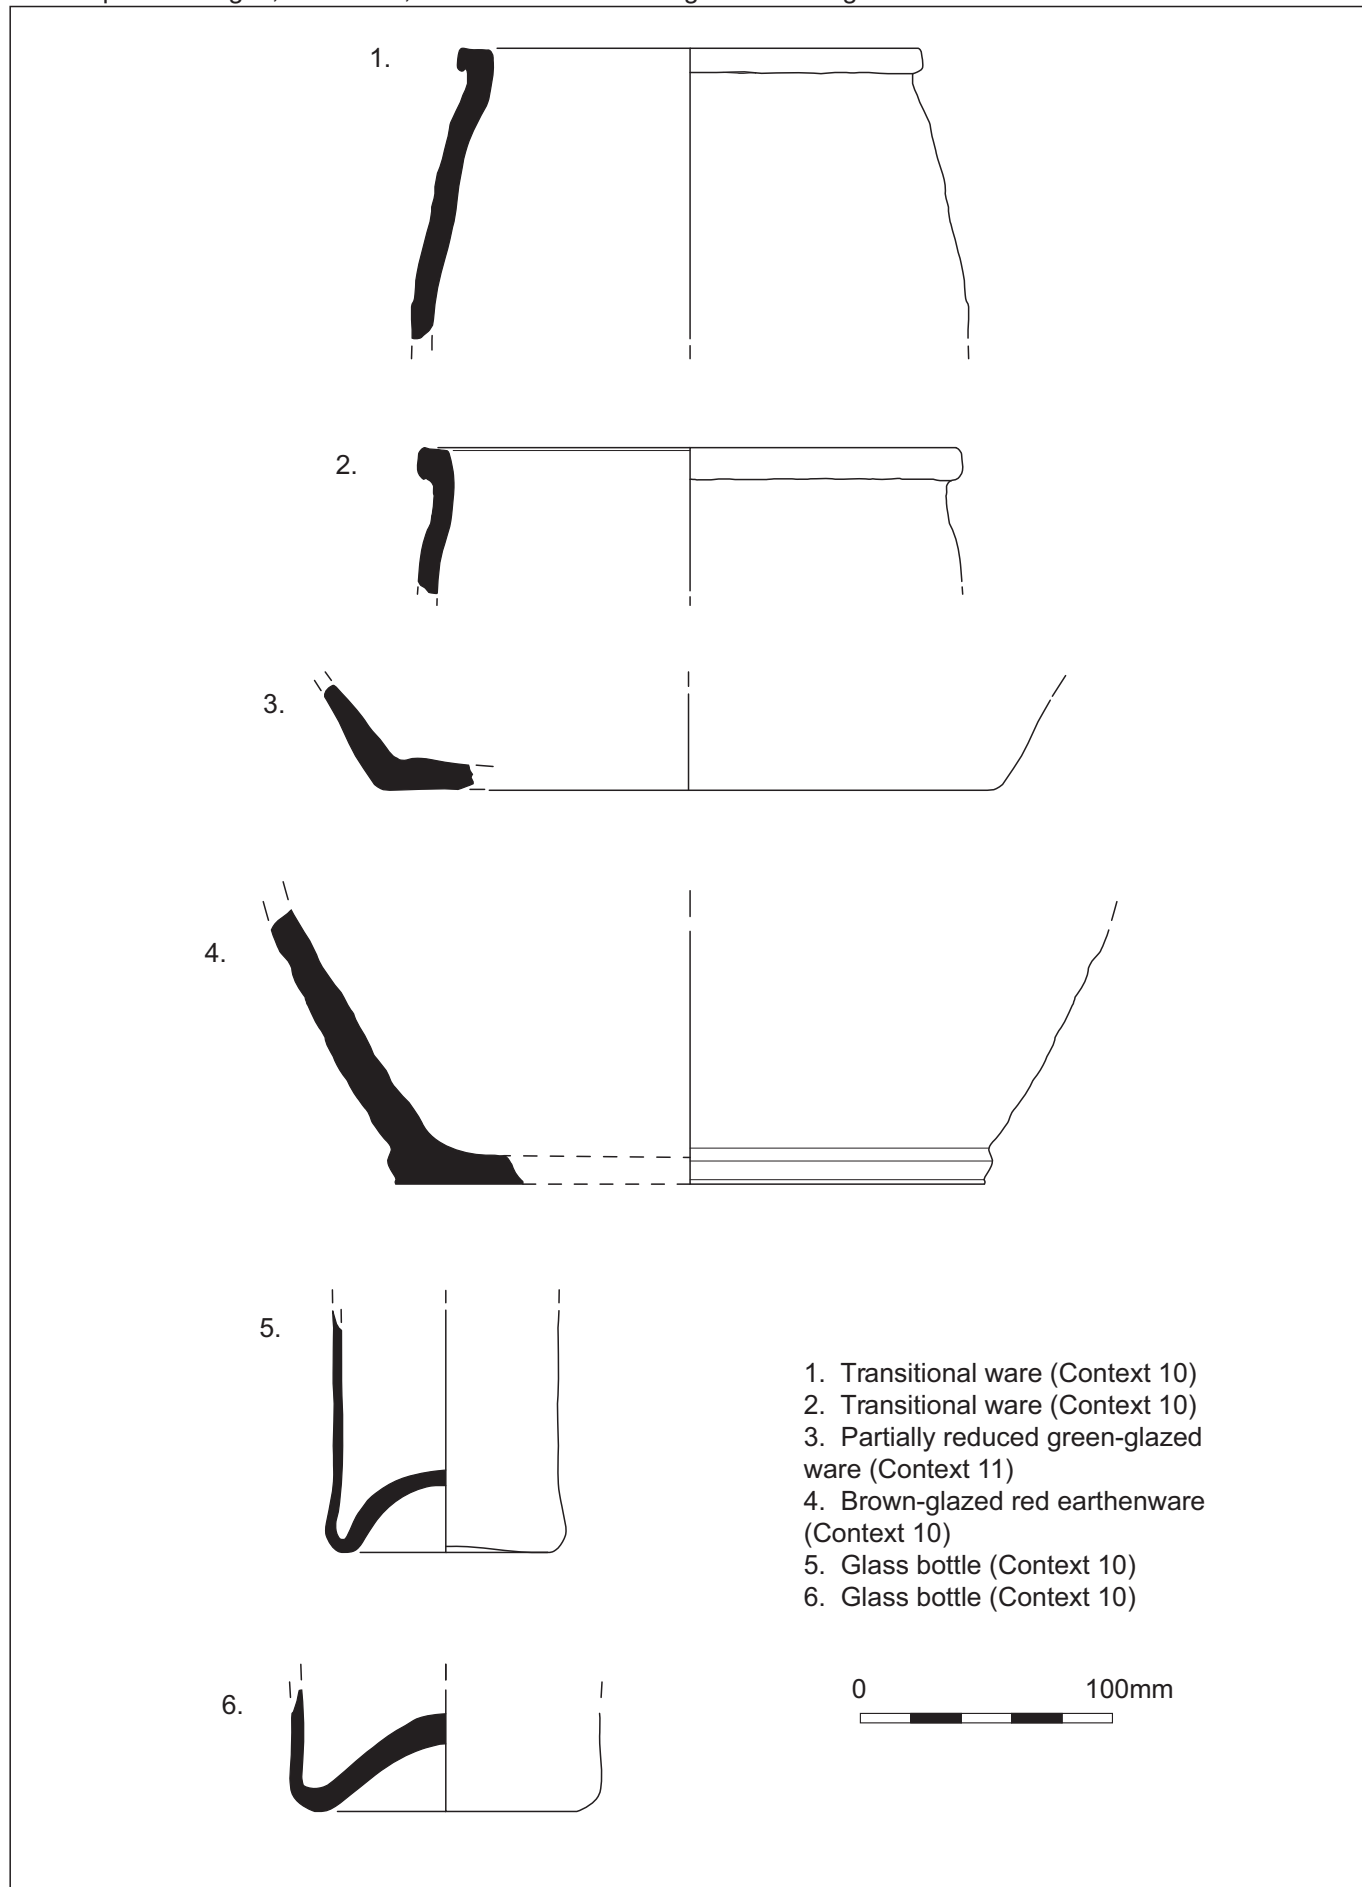
Figure 7: Selection of pottery and glass finds
