NEWLAND FURNACE GARAGE, NEWLAND, ULVERSTON, CUMBRIA

Archaeological Building Recording
and Watching Brief

Client: Trustees of the Newland
Estate
Planning ref.: SL/2008/0451
NGR: SD 29970 79730

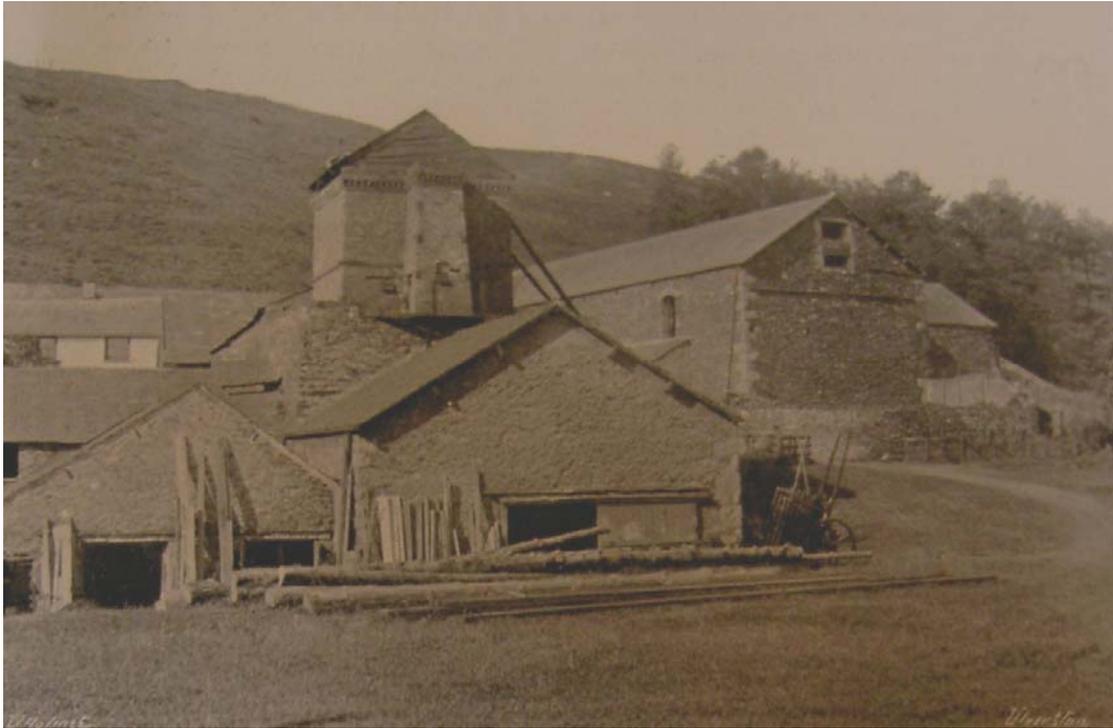
Plate 1: Newland Furnace c1897 shortly after its closure with the garage in the foreground (Anon 1897)

7.1.2 At some point before 1897 (Plate 1) the roof was raised by some 1.5m. The former roof line is visible on the interior elevations and the timber wall plates are still *in situ* on the exterior. There are also remnants of cement where the roof was sealed against the east elevation of the furnace. When the furnace was closed down the history of the building becomes uncertain, though it is thought to have been used by Thomas Thompson as a joiner's shop (Goodall 2001, 8). After 1971 the lower floor of the building was backfilled with rubble and a concrete floor was laid down to make use of the building as a garage (Helme 2002, 70; it has also been suggested that this was done in 1968 (Stan Bould pers comm.)). Presumably at this time the doorway in the east elevation was partially blocked and a window inserted. The doorway on the north elevation shows evidence of being widened as the east jamb has been finished with firebricks while the opposite side looks unfinished. Also, a large window was opened above the doorway to allow more light into the building. At some time in the past the slate on the west half of the roof has been replaced with corrugated iron.

7.2.2 The subsequent enlargement of the building by raising the roof height is of uncertain date, but evidently occurred before the mid 1890s as it is shown in the photograph published in 1897 (Plate 1). It is conceivable that this alteration was made after the building became occupied by a joiner and wheelwright after the furnace closed down.

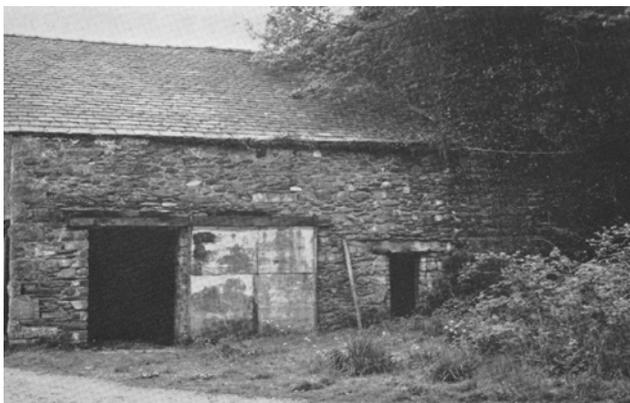
Plate 2: (left) North elevation, c1971 (Marshall and Davies-Shiel 1971, 80)

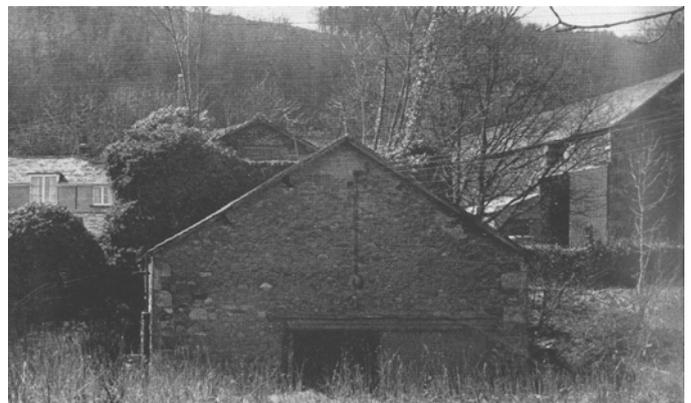
Plate 3: (right) East elevation, c1969 (Marshall and Davies-Shiel 1969, 18)

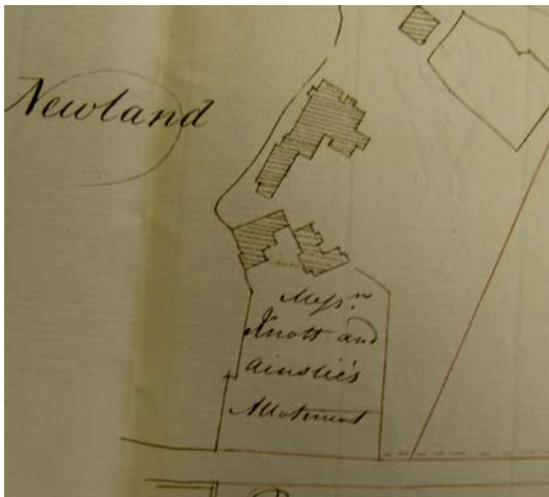
3.2.1 **Plan of c1804:** this undated plan is on paper water marked 1804 (Plate 4; CRO(B) BD/BUC/49/Bundle 1/16 c1804) and is apparently the earliest detailed depiction of the furnace and its associated structures. It shows the furnace, cottages, corn mill, and associated buildings. It is not apparent whether the garage is present at this time as the plan is not quite detailed enough to show it, but there does appear to be a building on its location.

Plate 4 (left) Extract from c1804 plan

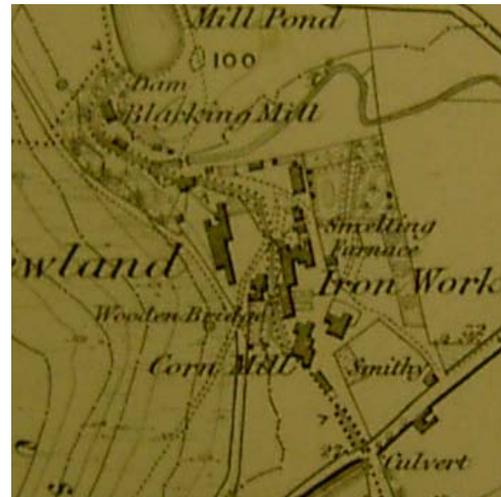
3.2.2 **Ordnance Survey 1851:** this plan (Plate 5) clearly labels the 'Iron Works', and specifically the 'Smelting Furnace', but is not quite detailed enough to show whether the garage exists. Again, however, there appears to be a structure on the site.

Plate 5: (right) Extract from 1851 Ordnance Survey

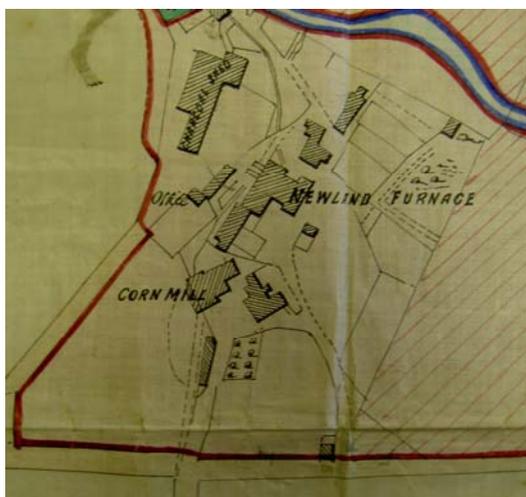
3.2.3 **Mid-19th-century plan:** this detailed undated plan (Plate 6; CRO(B) BD/BUC/40/Bundle 2/58 n.d.) is very similar to the earlier Ordnance Survey map and labels the office and charcoal shed. The furnace buildings appear unchanged, and, although it is not clear, the garage would seem to be present.

Plate 6: (left): Extract from mid-19th-century plan

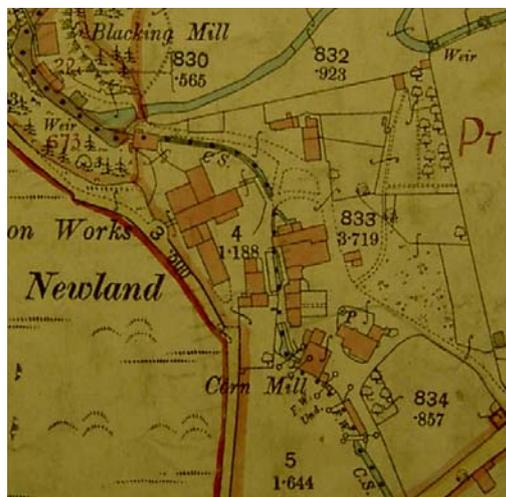
3.2.4 **Ordnance Survey 1890:** this slightly more detailed map (Plate 7) shows a slightly different outline to the layout in 1851. The garage building is shown quite clearly on this map, although the internal divisions do not seem to tally with the actual plan of the site. There is also clearly a structure immediately to the south side of the garage.

Plate 7: (right): Extract from 1890 Ordnance Survey

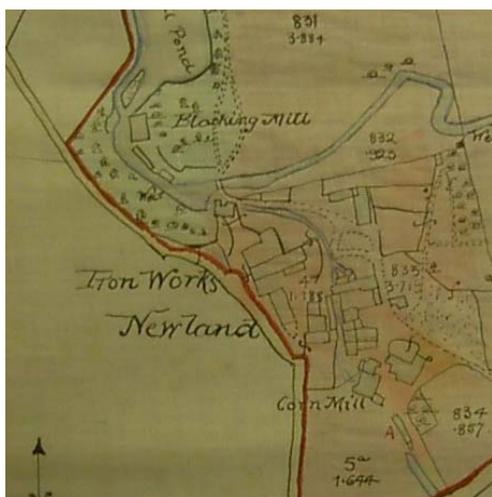
3.2.5 **Indenture Plan 1904:** this plan (Plate 8) has probably been hand drawn from the earlier 1890 Ordnance Survey map and shows the buildings to be unchanged from that date (CRO(B) BD/BUC/43/Bundle8/22 1904).

Plate 8: (left) Extract from 1904 indenture plan

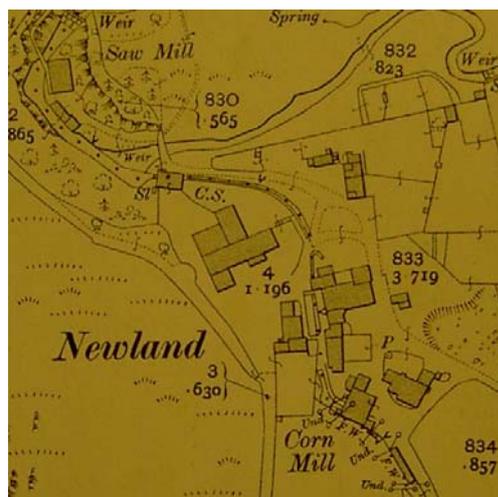
3.2.6 **Ordnance Survey 1913:** this map (Plate 9) gives a very clear picture of the arrangement of the furnace buildings, especially as the internal divisions appear more accurate than the map of 1890. The general layout of the buildings seems largely unchanged, however, although it is noticeable that the furnace, to the west of the garage, is not filled in, probably due to it being a ruin.

Plate 9: (right) Extract from 1913 Ordnance Survey

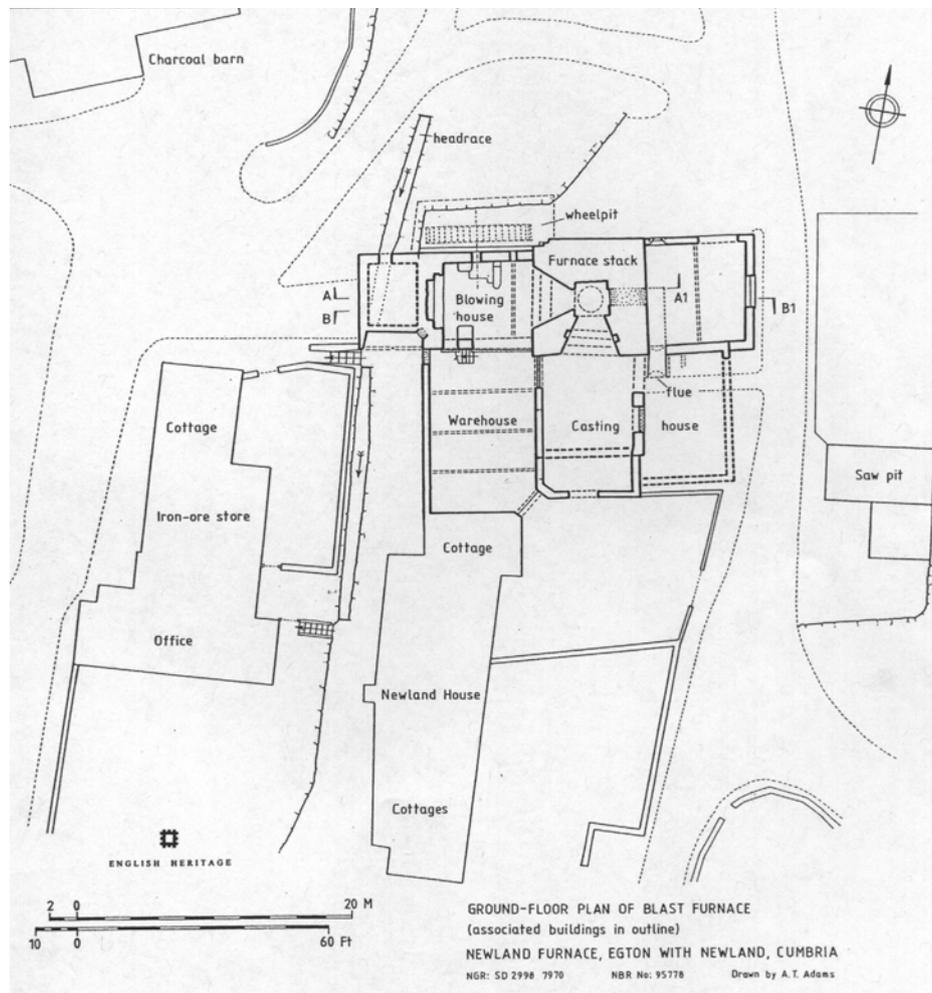
Plate 10: Plan of the furnace and associated structures including the garage, to the east of the furnace stack (after Goodall 2001, figure 4)

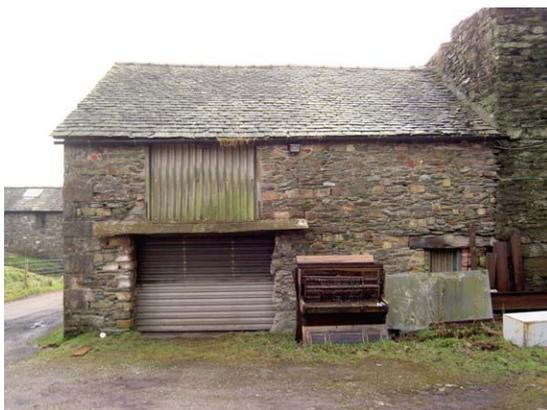
5.2.1 **North External elevation:** this elevation is of a mortared rubble construction mainly of limestone and firebrick with some slate (Plate 11). The east end has large rectangular quoins of limestone while the west butts the furnace. There is a wide doorway towards the east end with another wide albeit slightly smaller opening above, which extends to the roof. There is a timber lintel separating the doorway from the opening above, along which is a drip hood of timber planks with a skin of iron sheeting. The east jamb has quoins of firebricks and the west jamb is poorly finished and irregular. The opening above has a timber lintel and jambs. Both openings have been blocked with corrugated plastic sheeting. At the west end is a doorway which has been narrowed with brick jambs, a timber frame, and a heavy timber lintel, and it too has been blocked with corrugated plastic sheeting. There is a rafter end exposed midway along the elevation.

Plate 11: (left) North external elevation

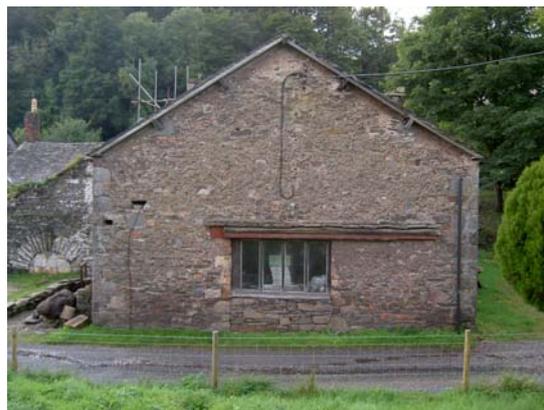
Plate 12: (right) East external elevation

5.2.2 **East External elevation:** this elevation is the gable end of the building and is constructed of mortared stone rubble which consists of a mix of re-used sandstone, limestone, house bricks, fire bricks and slate (Plate 12). The wall appears to have been rendered with a coarse gravelly mortar. Both ends of the elevation are set with large rectangular limestone quoins. Situated centrally is a wide doorway, which has been converted into a window, the space below having been blocked with firebricks, sandstone and slate. The window itself is timber-framed with four tall vertical lights, above which is a timber lintel which extends to the north end of the elevation. Affixed to the lintel is a timber hood which probably covered a rail for a missing sliding door. Immediately above this is a drip hood of roofing slate. At the south end of the elevation at a height of approximately 2.5m are two small rectangular apertures, possibly acting as vents or for access.

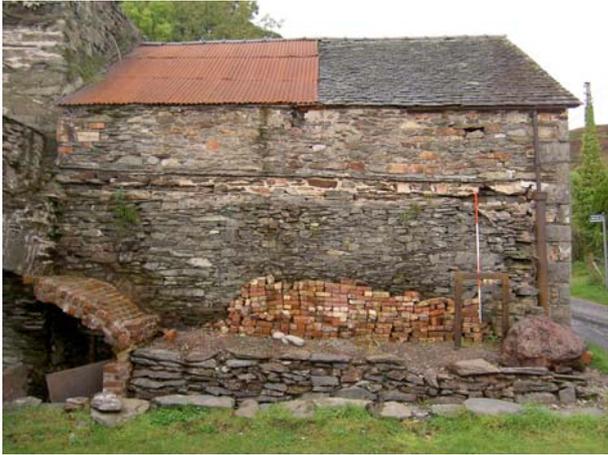
Plate 13: (left) South external elevation

5.2.3 **South External elevation:** the lower two-thirds of this elevation (Plate 13) are constructed of coursed slate with the upper third being constructed of mortared stone rubble at a later date. This rubble is similar to that on the north and west elevations. Two timber lintels are exposed at each end of the elevation within this rubble running along the top of the slate section; the one at the west end being 2.5m long, and the other being 3.5m long. Approximately 0.3m above the slate section is a course of roof slate, possibly a drip course, running the length of the elevation. The west end of the elevation butts the furnace wall and the east end is keyed to the north elevation with large limestone quoins. Set amongst the quoins are two small grindstones, 0.3m in diameter, made of a yellow gritstone (Plate 14). At the west end of the elevation, below ground floor level, a half-arched flue of red bricks extends to a height of 1m at right-angles to the wall. This half-arched flue contains a rectangular aperture with a timber lintel (Plate 15), which is blocked with loose rubble. At the east end of the elevation are the remnants of a slate wall, keyed in just behind the quoins, which is 0.7m in length and approximately 2m in height. There is a small rectangular aperture in the top east corner of the elevation and an exposed rafter end situated midway along the roof line. A cast-iron gutter runs the length of the roof line to a cast-iron drainpipe at the east end.

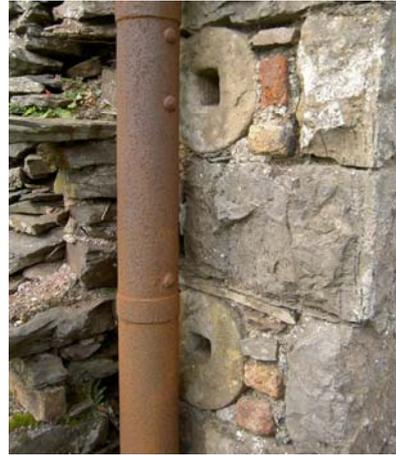
Plate 14: (right) Grindstones set in south external elevation

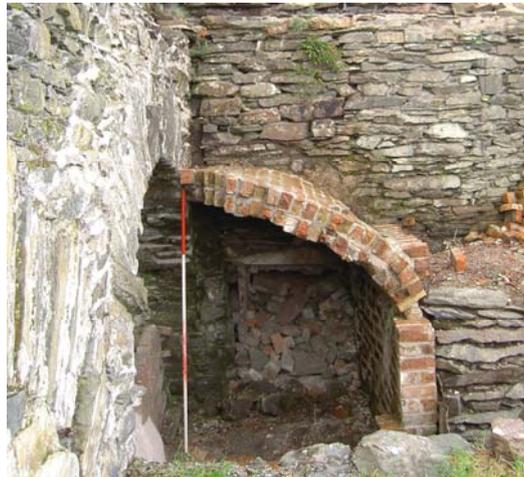
Plate 15: Flue at west end of south external elevation

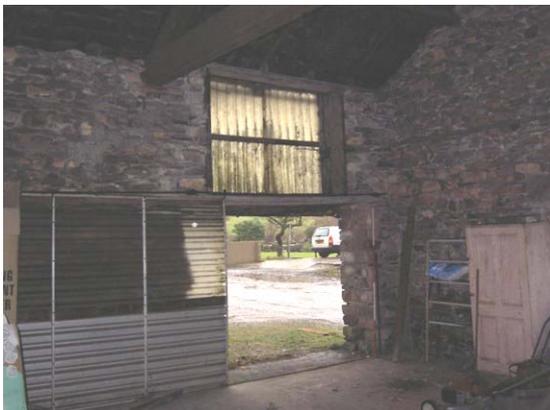
5.3.2 **North elevation:** this elevation (Plate 16) is constructed of stone rubble and mortar with firebrick inclusions. It butts against the north end of the west elevation of the furnace. At the east end is a large doorway; the east jamb is constructed from large firebricks. It has a relatively modern siding door comprising a metal-frame with transparent corrugated plastic. At the west end of the elevation is a window with a shallow brick arch, blocked with transparent corrugated plastic. Directly above the doorway is a large window extending from the top of the doorway to the roofline. The window frame is made from scaffolding boards and the light is transparent corrugated plastic. It is possible to see evidence of an earlier, lower roof in the stonework, running just above the height of the doorway.

Plate 16: (left) North internal elevation

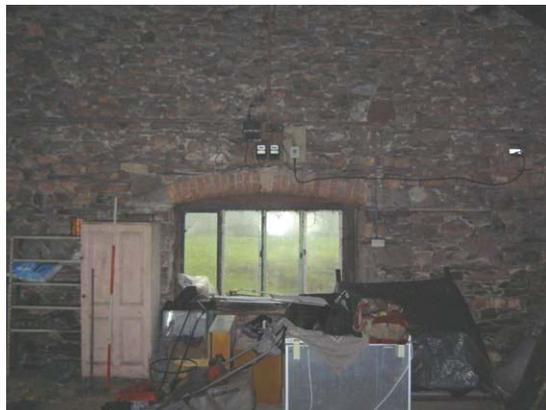
Plate 17: (right) East internal elevation

5.3.3 **East elevation:** the east elevation (Plate 17) is also constructed of stone rubble and mortar although with a higher amount of firebrick inclusions. A large window with a timber sill has been inserted where there was previously a doorway with a shallow brick arch; firebricks have been used to block the doorway below the window. The original roof line consists mainly of firebricks and can be seen just above the window.

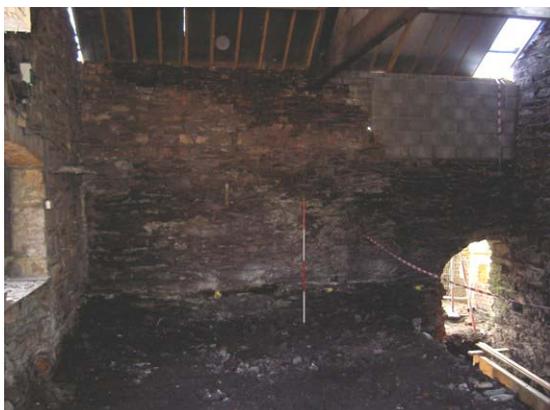
5.3.4 **South elevation:** this elevation (Plate 18) is of the same construction as the north elevation and butts against the south end of the east elevation of the furnace. At the west end, towards the base of the elevation, is a brick lined half-arched opening which is flush against the west elevation. This opening extends down below the level of the floor. A slight change in the stonework reveals the original roofline of the elevation.

Plate 18: (left) South internal elevation

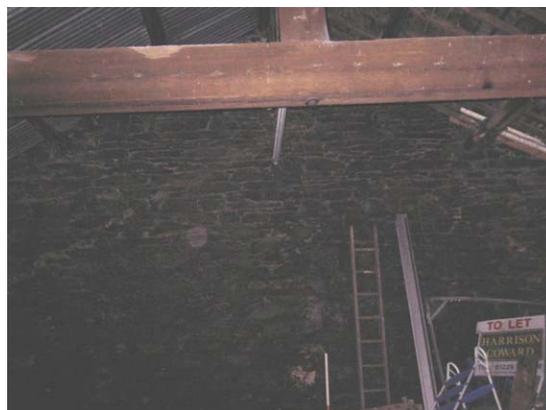
5.3.5 **West elevation:** the west elevation of the garage (Plate 19) comprises the east elevation of the furnace. This wall is constructed of medium sized roughly cut limestone. Centrally positioned at the base of the wall is a brick lined flue, which exits from the furnace. This flue also extends below the level of the floor and only a small amount of the top is visible.

Plate 19: (right) West internal elevation showing east wall of furnace

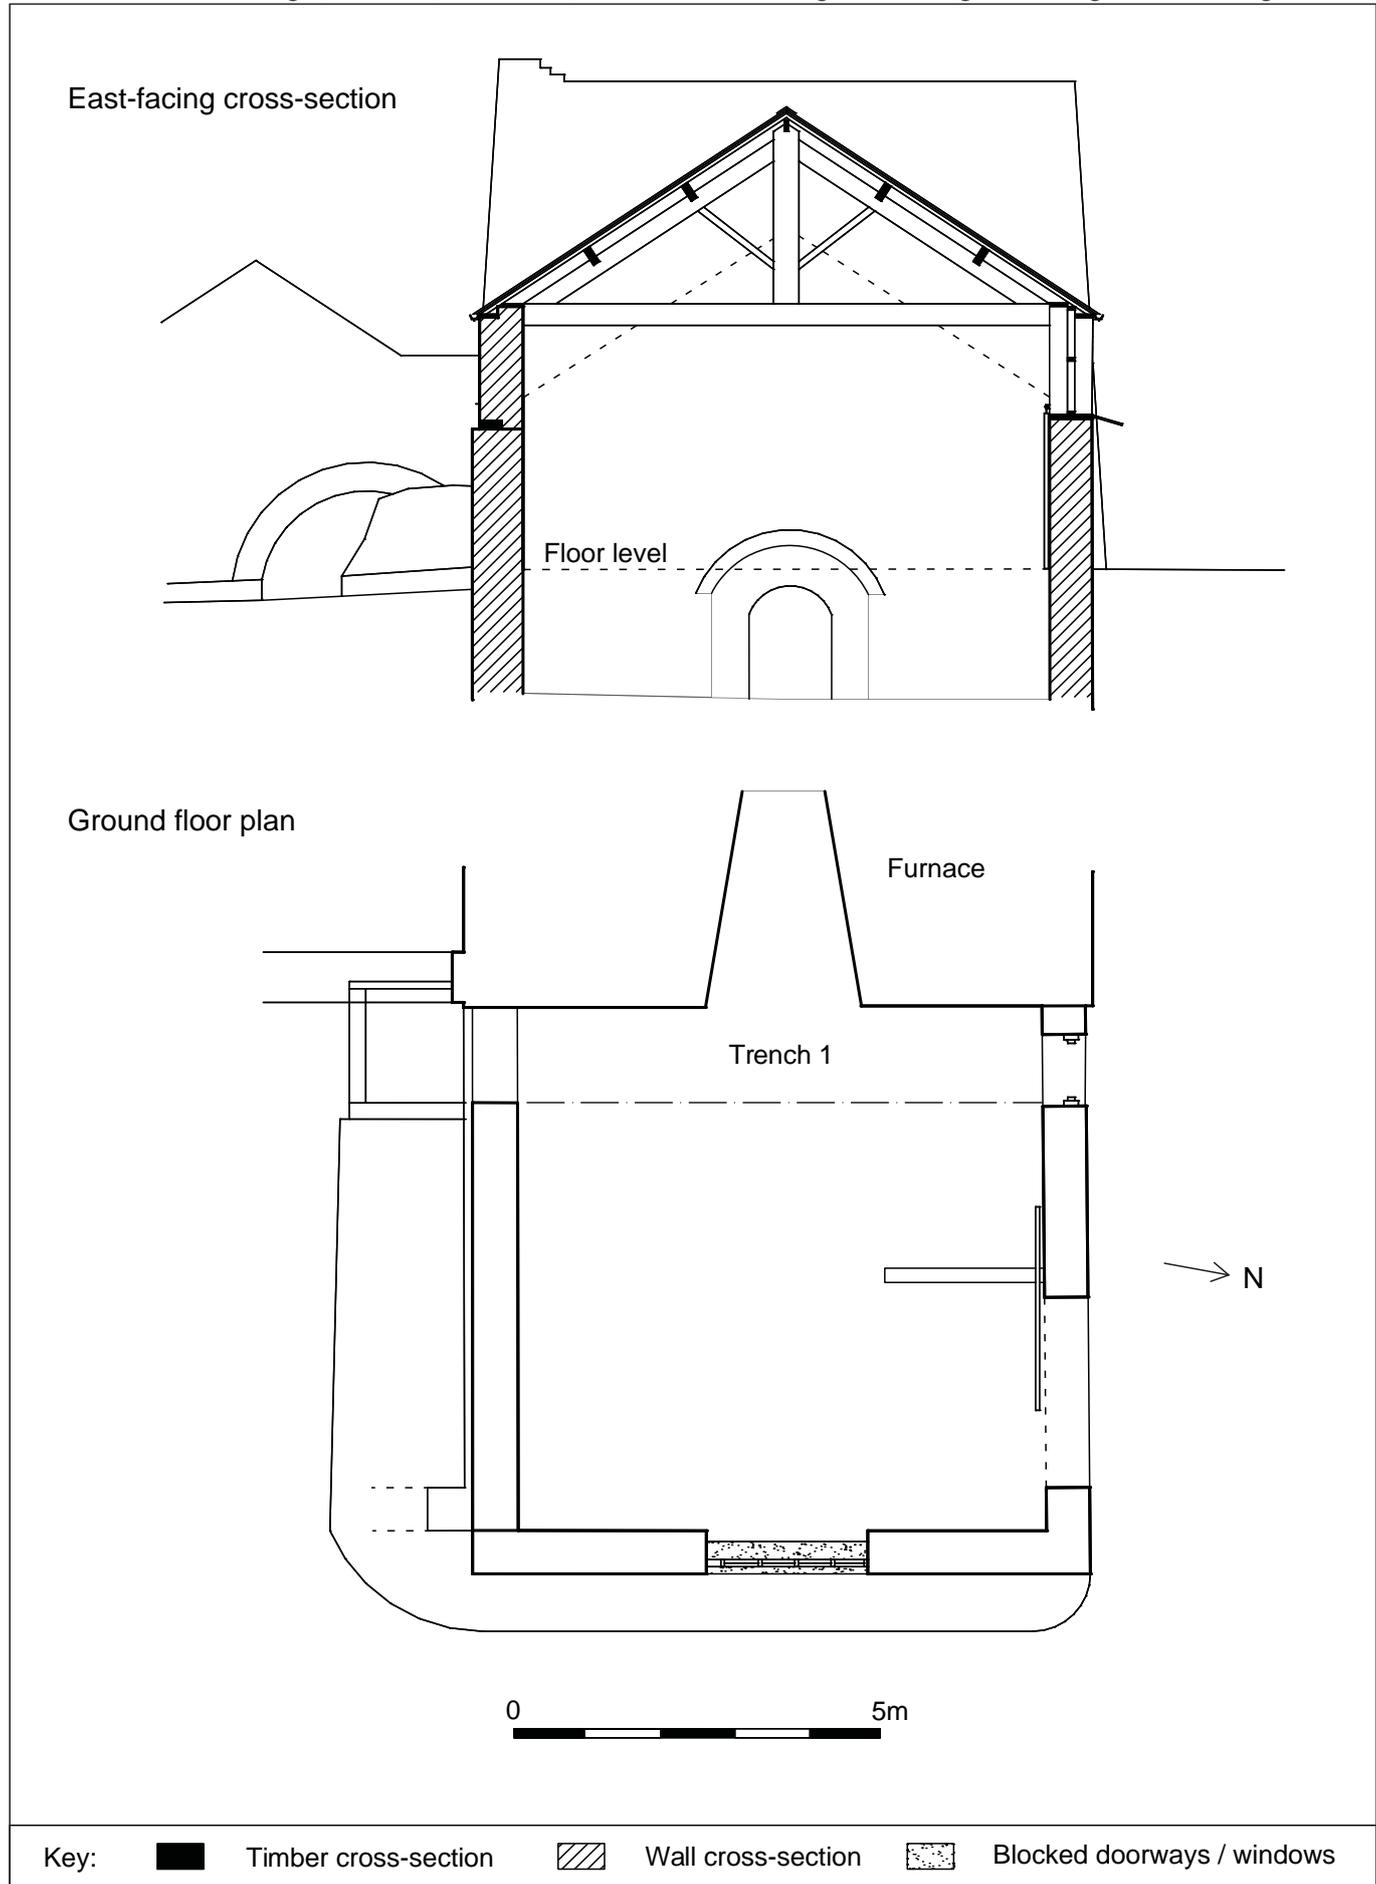
5.3.1 **Introduction:** the garage is a single room building mainly constructed of stone rubble, fire bricks, and mortar. The floor is concrete and slopes slightly to the west to allow drainage through the flue in the south-west corner. The roof structure comprises a single truss with three purlins supporting a mixture of slate and corrugated iron sheets (Figure 3).

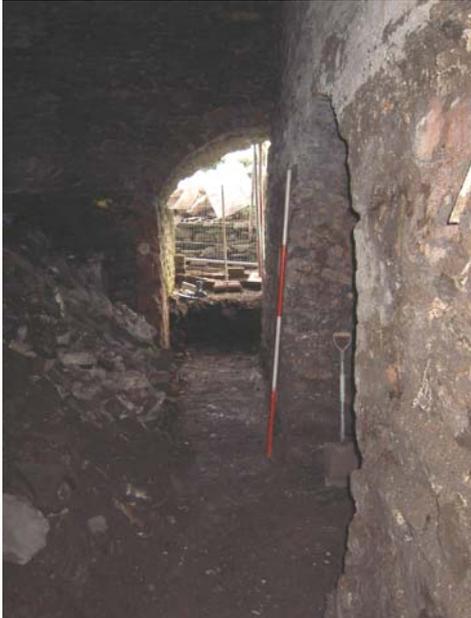
Plate 20: (left) South end of Trench 1

6.1.2 **Trench 1:** this trench (Plate 20, Plate 21) was excavated to the depth of the original floor, which was 1.8m below the existing floor level (Figure 4). The original floor sloped slightly upwards from the centre of the room towards the south elevation and was composed of red brick apart from an area in front and inside of the flue, which was concrete. The entrance of the flue (Plate 22) had a brick arch and its lining was also of red brick with a yellow string course at the base of the arch. The entrance at the west end of the flue was smaller than the east end by 0.43m in width and 0.55m in height. The floor of the flue was level.

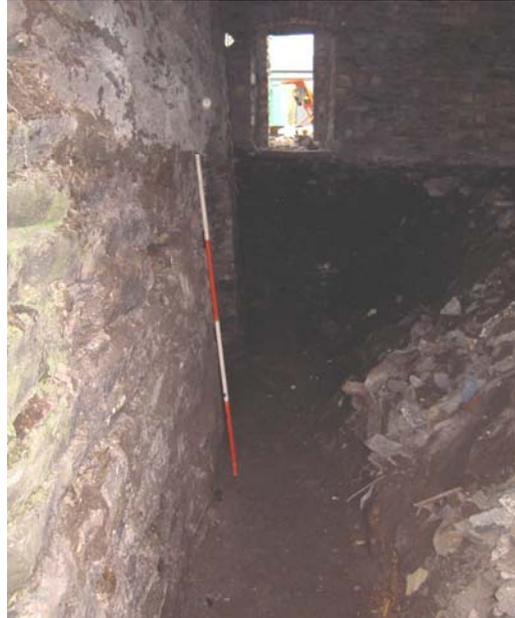
Plate 21: (right) North end of Trench 1

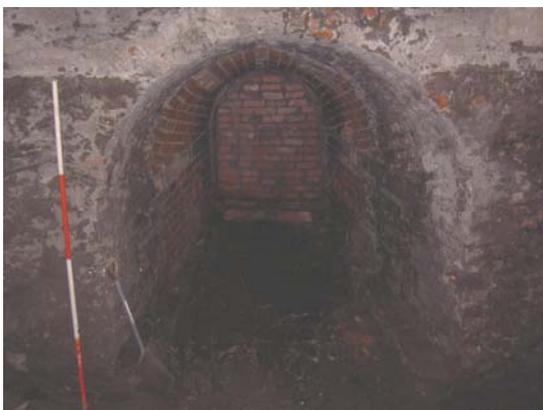
Plate 22: (left) Flue in north elevation

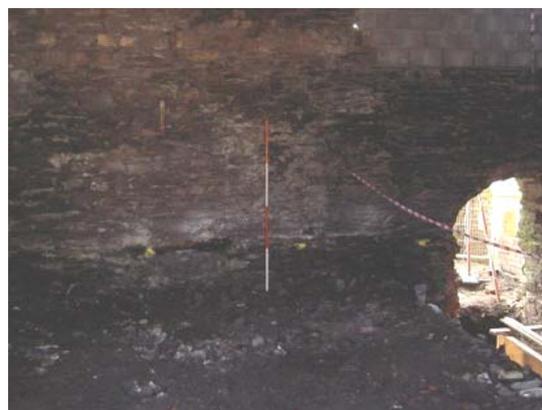
Plate 23: (right) Rubble backfill of floor

6.1.3 **Removal of the floor:** the concrete surface of the floor was removed and the rubble below excavated to a depth of 0.4m (Plate 23). Removal of the concrete revealed a timber 2.2m in length inserted lengthways into the north elevation (Plate 24). This timber, which was, approximately 0.2m in thickness, was attached to other timbers embedded in the rubble. A length of timber and a small slot at the same height were also revealed just below floor level in the south elevation.

7.1.3 Removal of the make-up layer of rubble below the concrete floor confirms that the original floor level was considerably lower, although this was evident within the flue that passed through the south elevation of the building. There is no evidence to show that there were any intermediate floors within the building; the timber protruding from the west elevation may have been a platform or some form of support. There was no scarring visible on the east elevation of the furnace to show how the flue was constructed between it and the flue aperture on the south elevation. Unfortunately the make-up layer of the floor was not pulled back far enough from the furnace wall to reveal any possible remnants of flue structure. The lack of keying between the brickwork of the flue and the south elevation suggests that the building was built at a later date to the flue.

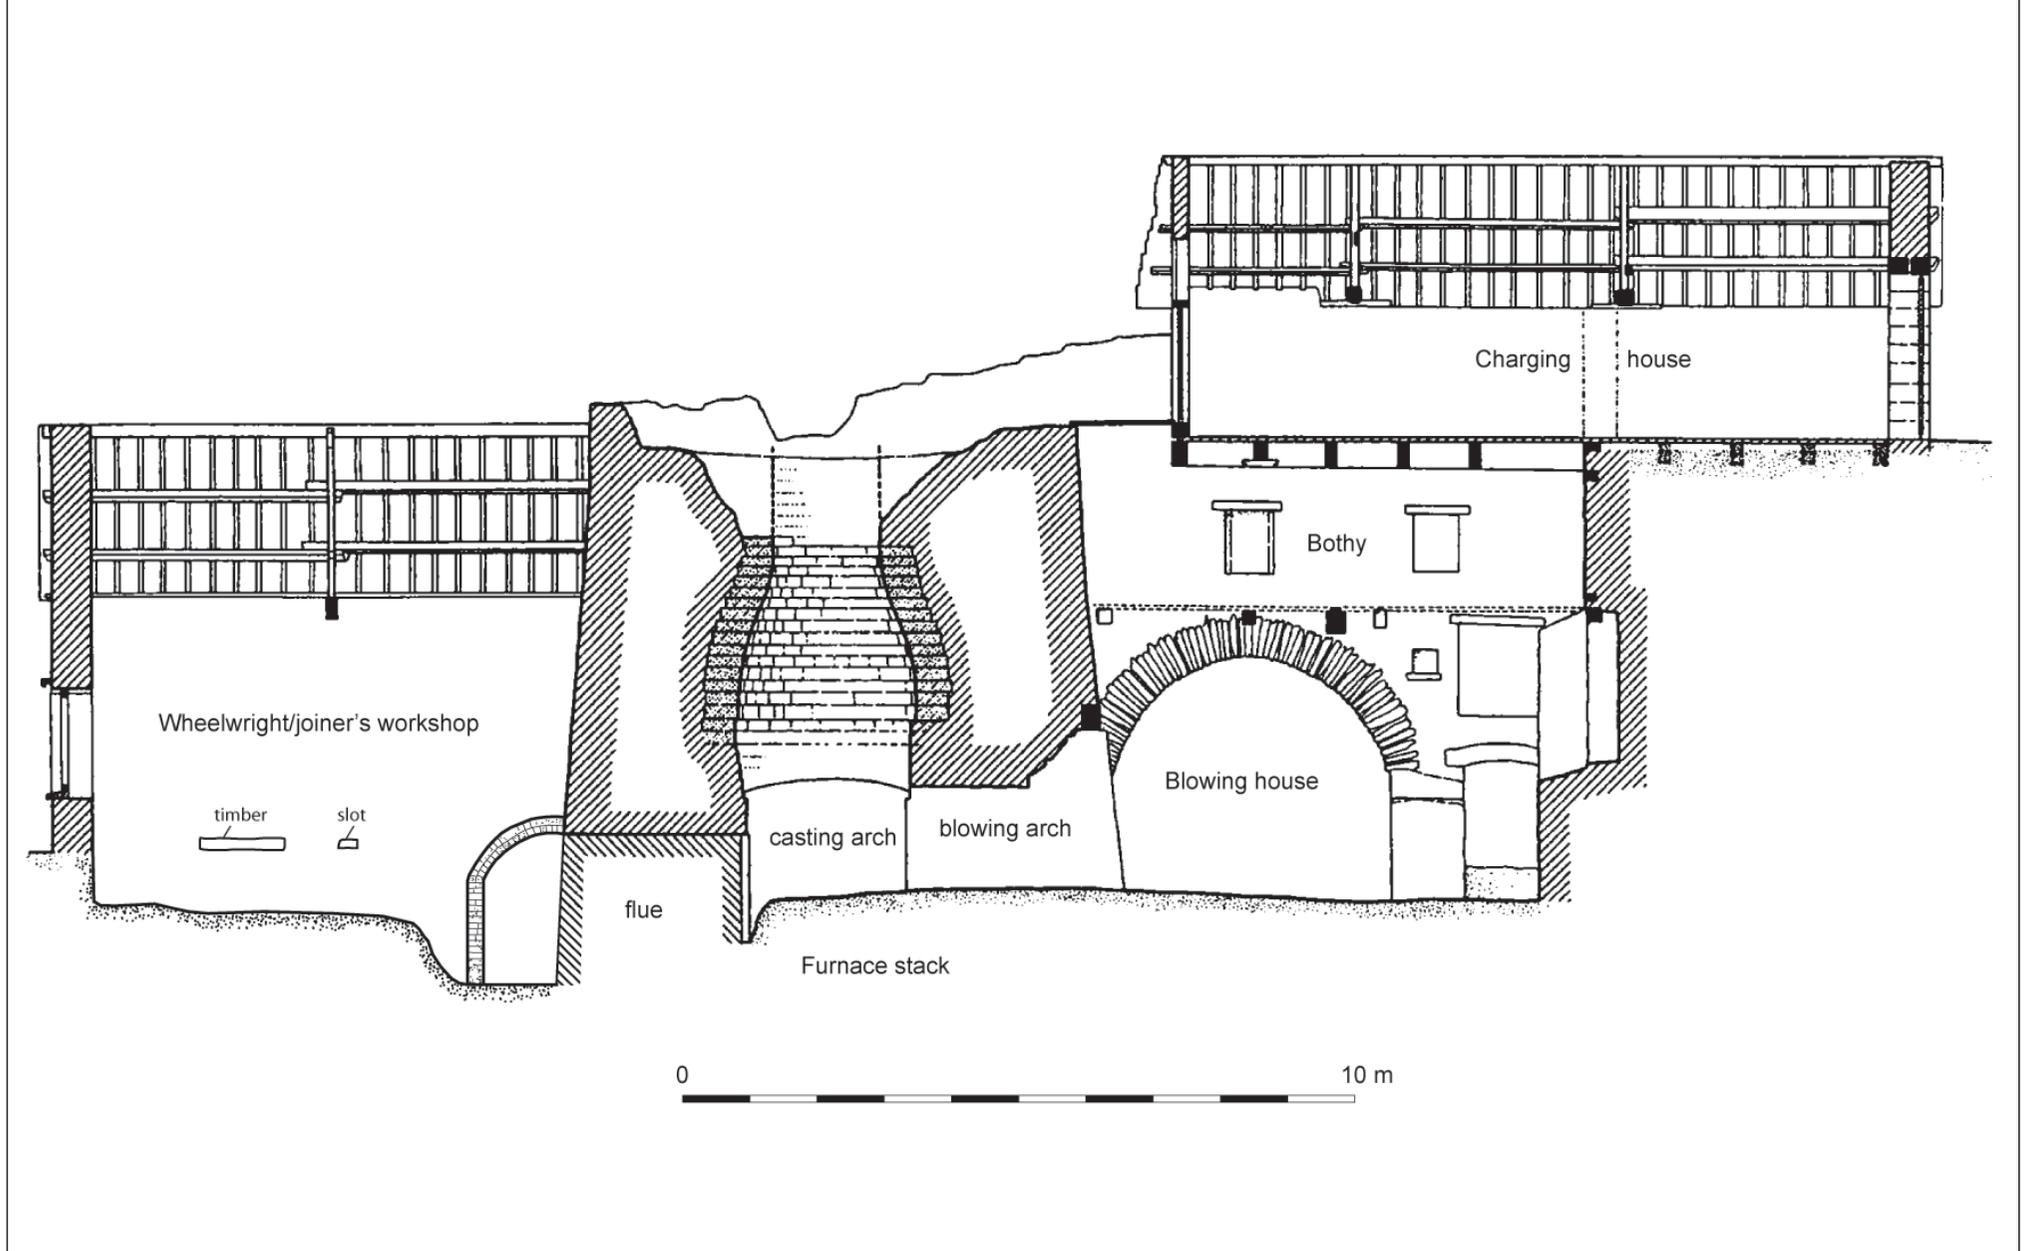
Figure 4: Long section through the furnace and 'garage' (labelled 'Wheelwright/joiner's workshop'), showing features identified during the watching brief (after Goodall 2001, figure 5)

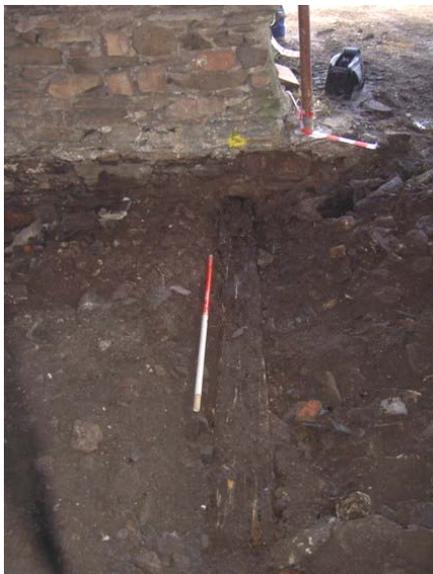
Plate 24: Timber extending from north elevation
