BARN AT NATLAND HALL FARM, NATLAND, KENDAL, CUMBRIA

Archaeological Building Recording

Client: Mr and Mrs Bennett
NGR SD 51937 89245

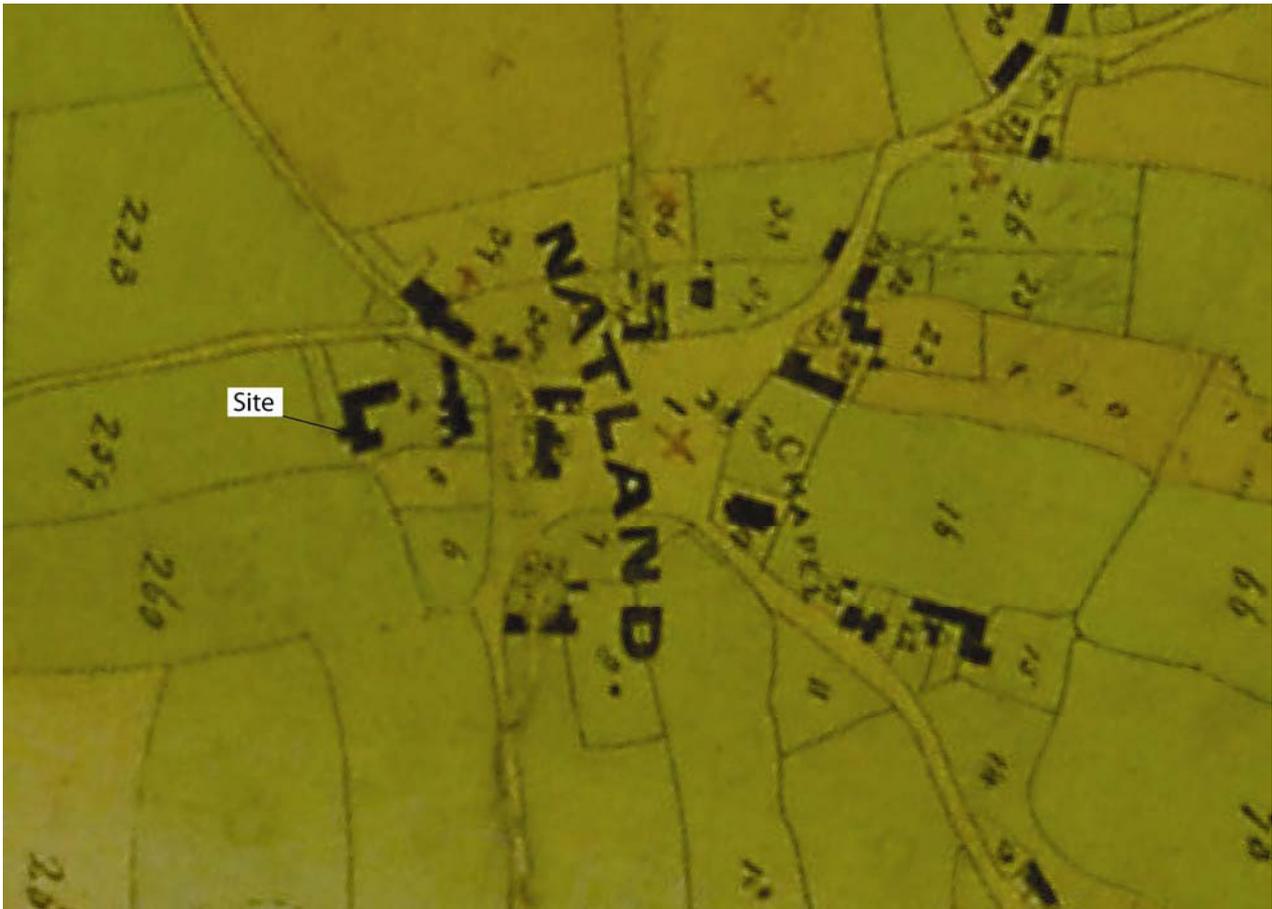
Plate 1: Corn rent map, c1836

3.2.2 **Corn rent map c1836** (Plate 1): this is the earliest map found depicting the barn at Natland Hall Farm, and it shows the basic L-shape of the original barn structure with small additions to the east and west of the south wing (CRO(K) WQ/R/C/12 c1836).

5.1.3 **Phase 2 - early 19th century:** this phase is represented by the additions evident on the corn rent map (Plate 1) which include an addition to the south-east corner of Room 1b and another addition to the west side. The addition on the west side has left no trace and was presumably demolished to make way for the addition of Room 5 in the second half of the 19th century. It is probable that this addition was a single storey as it seems to roughly correspond to a point in the western elevation of the barn (Room 1b) where there is a higher level window. A square slot in the wall just to the north of this window also suggests the possibility that an overhead axel horse gin was situated against this side of the building; the 1863 Ordnance Survey plan (Plate 2) shows an external circular feature in this area that could be a gin ring. The pedestrian doorway in this elevation was perhaps blocked at this time and replaced with a window through which the horses could be observed (see Plate 21). It is possible that the addition of a wagon door to the south became necessary for the delivery of crops to feed the horse powered threshing machine, which would account for the two wagon doorways on the same elevation. The more northerly doorway, which must be original, would have allowed a through draft for the earlier hand threshing. The outshut on the east side (Room 6) had clearly been added to the original barn as it made obsolete two of the slot vents in the east external elevation of Room 1b. In addition, the butting of this outshut against the east quoins of the barn (Room 1b) can be seen on the southernmost elevation. It seems probable that this addition (Room 6) was a stable, its addition still leaving access to the main barn through either or both of the wagon doorways on the east elevation.

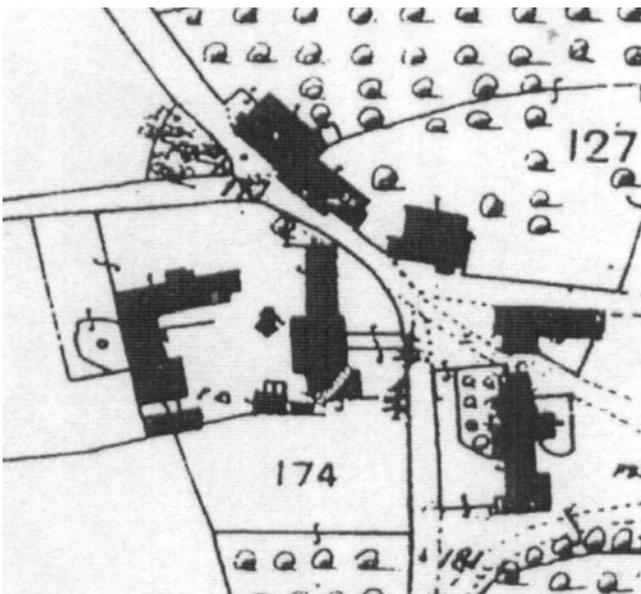
Plate 2: (left) Ordnance Survey map, 1863

3.2.3 **Ordnance Survey 1863:** this first edition Ordnance Survey (Plate 2) shows the building in good detail, the addition to the west side of the south wing appears to have been removed by this date. Adjacent to the south end is a smaller building that no longer exists.

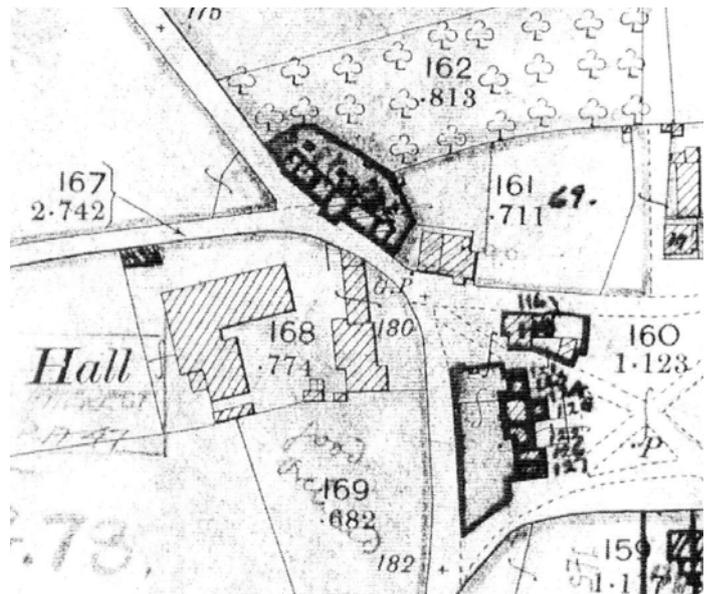
Plate 3: (right) Ordnance Survey map, 1898

3.2.4 **Ordnance Survey 1898:** this Ordnance Survey (Plate 3) shows that the barn has been widened on the east, west and north sides.

5.1.4 **Phase 3 -late 19th century:** the extension to the north of the barn (Room 3) and the shippon on the west side of the barn (Room 5) had both been completed by 1898 (Plate 3). Rooms 2, 8 and 4 were also completed in this phase, which also sees the addition of the second stable on the east side of Room 1b. This phase is significant as it shows a shift from arable to dairy farming at the site, which is in keeping with the general trend at this time when urban populations were rapidly increasing. It seems likely that the barn was re-roofed, as illustrated by the ceramic bonnet tiles covering most of the apex.

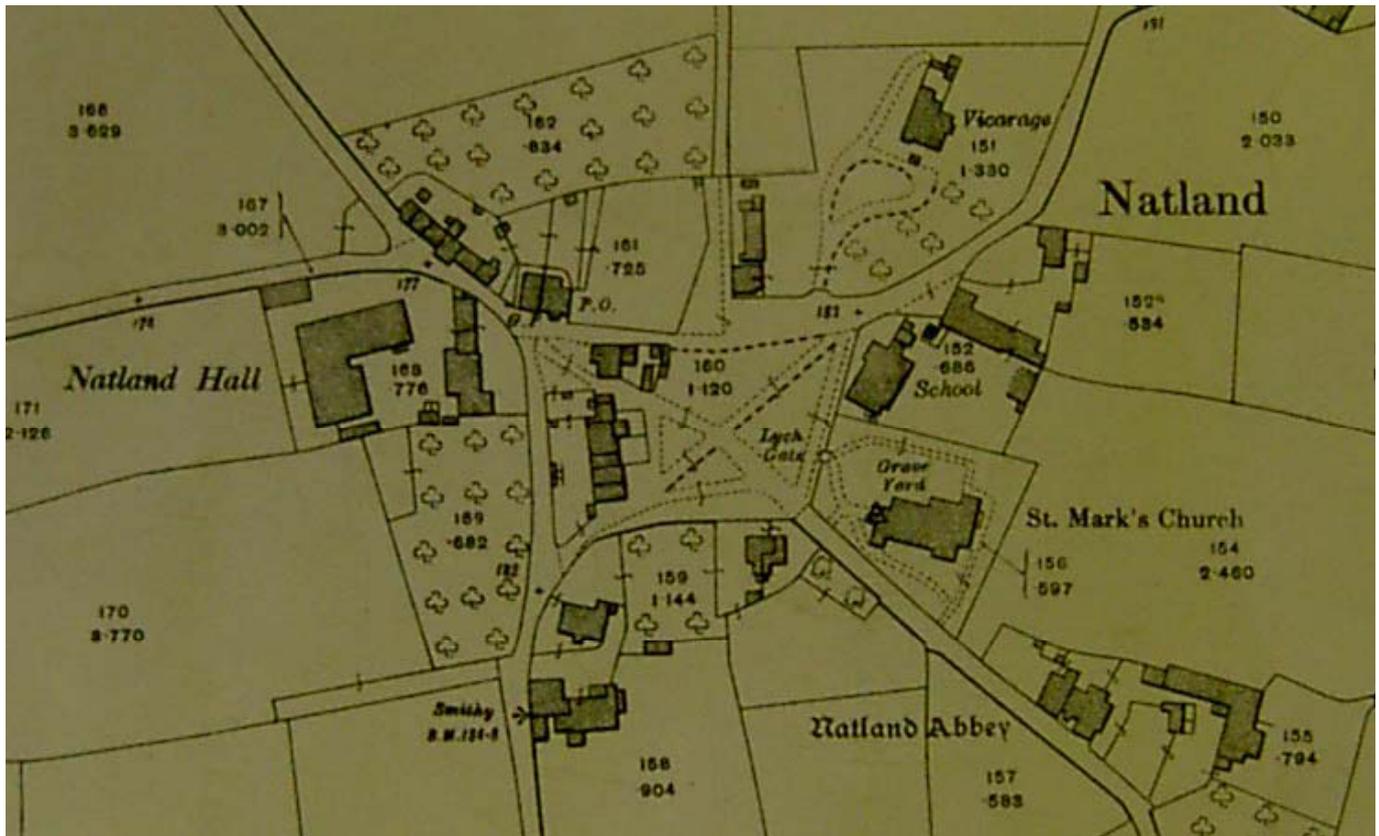
Plate 4: Ordnance Survey map 1912

3.2.5 **Ordnance Survey 1912:** this map (Plate 4) shows that the barn has reached its current size and shape by this time; the steps leading to the hayloft at the east end are now visible for the first time. The small building south of the main barn is still evident at this time.

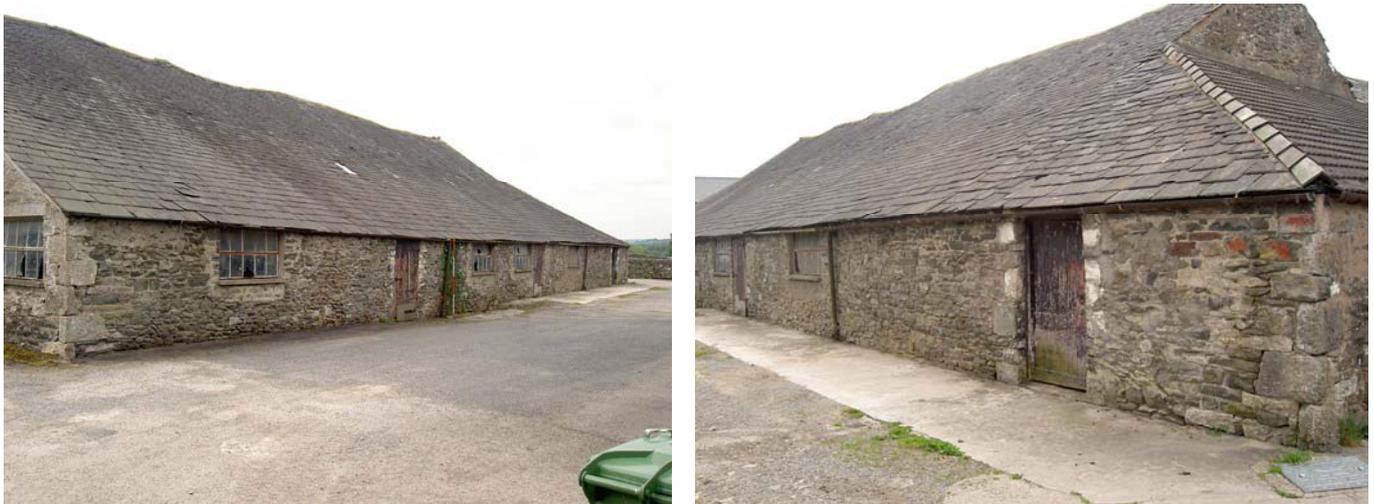
4.2.1 **North elevation:** this elevation was formed from Rooms 3 and 4 (Figure 2), which appear to have been added to the north side of the original barn (Room 1a) at the same time. There were two skylights in the roof over Room 3, and the guttering was iron except for a short length of plastic at the east end of the elevation. There were four 10-light metal casemented windows, the upper row of five lights hinged inwards (Plate 5). All the windows related to Room 3 and had been replaced or inserted, and there was evident re-build around the jambs and below the concrete sills. This elevation housed three timber doors, one to Room 4 and two to Room 3. The east and west doorways were quoined (Plate 6), the central doorway was not, and had probably been inserted at a later date.

Plate 5: (left) North elevation, east end

Plate 6: (right) North elevation, west end

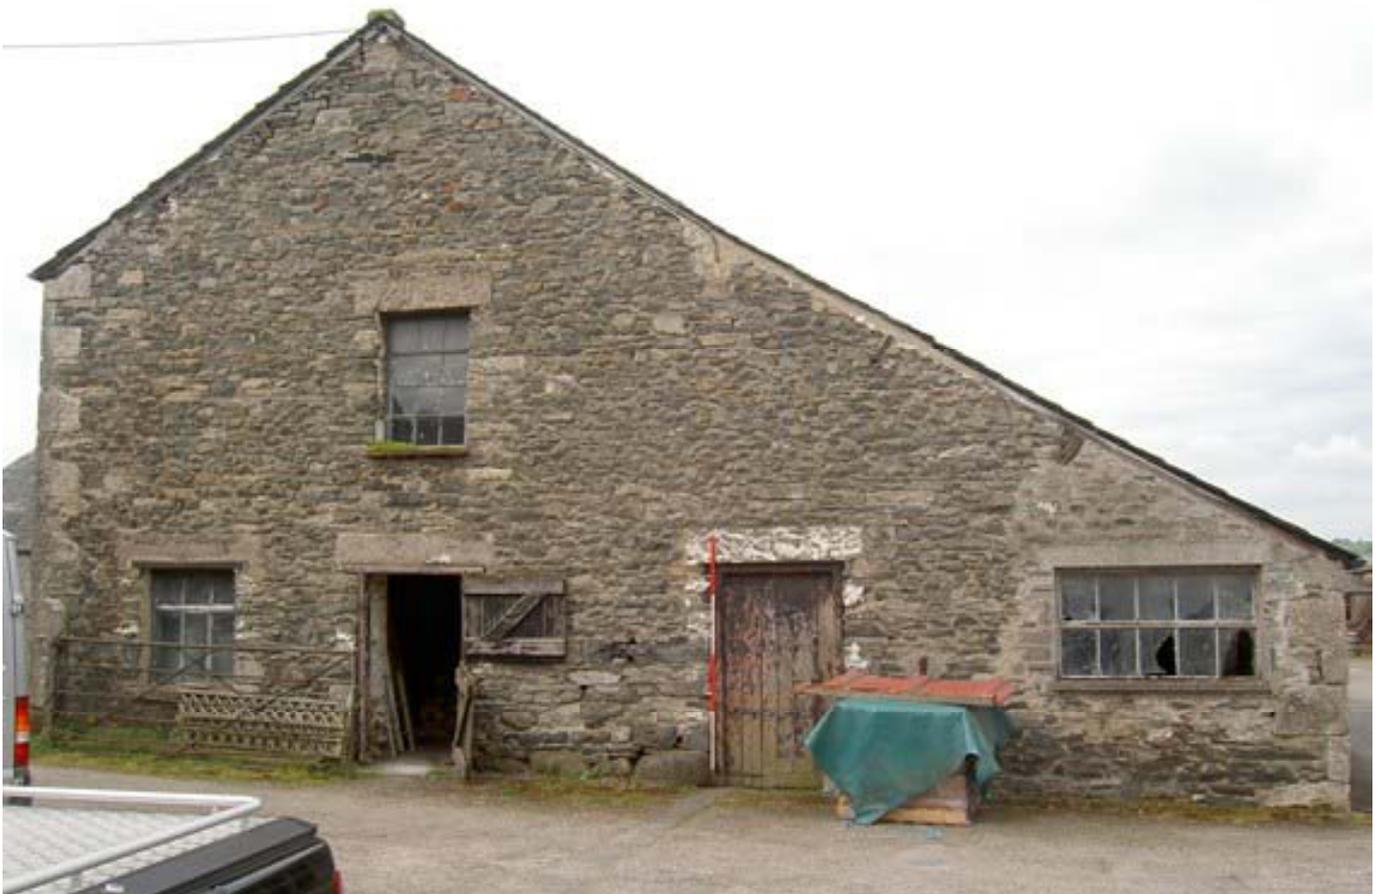
Plate 7: East elevation (north part)

4.2.2 East elevation (north part): this elevation comprised two parts (Figure 2): the gable end formed by apparently contemporary outshuts (Rooms 2, 8 and 3) to the north (Plate 7), and a section of the main barn (Room 1b) and two further outshuts (Rooms 6 and 7) to the south (Plates 8 and 9). Room 3 had a window at the north end that had either been inserted or modified with the same appearance as those described for the north elevation (see *Section 4.2.1*). The doorway to Room 3 was located at the south end of the room; its rough quoining along with the grey sandstone lintel had once been whitewashed. The gable end formed by Room 2 and Room 8 had a central doorway and a window to the south; the surrounds of these apertures had once been whitewashed unlike the upper window, which was centrally located. The doorway was similar to that described for Room 3, however, the lintel sat upon a thin piece of timber that also formed the upper part of the doorframe, which housed a stable door. The ground floor window to Room 2 had a substantial grey sandstone lintel and a harder yellow sandstone sill; its jambs were un-quoined and had been rendered with cement. The window frame was white painted timber with a row of three square lights in the top hung ventilator over a row of three taller lights in the fixed casement below. The upper window (to Room 8) was similar to the lower window, but had rudimentary quoining and a 12-light casement.

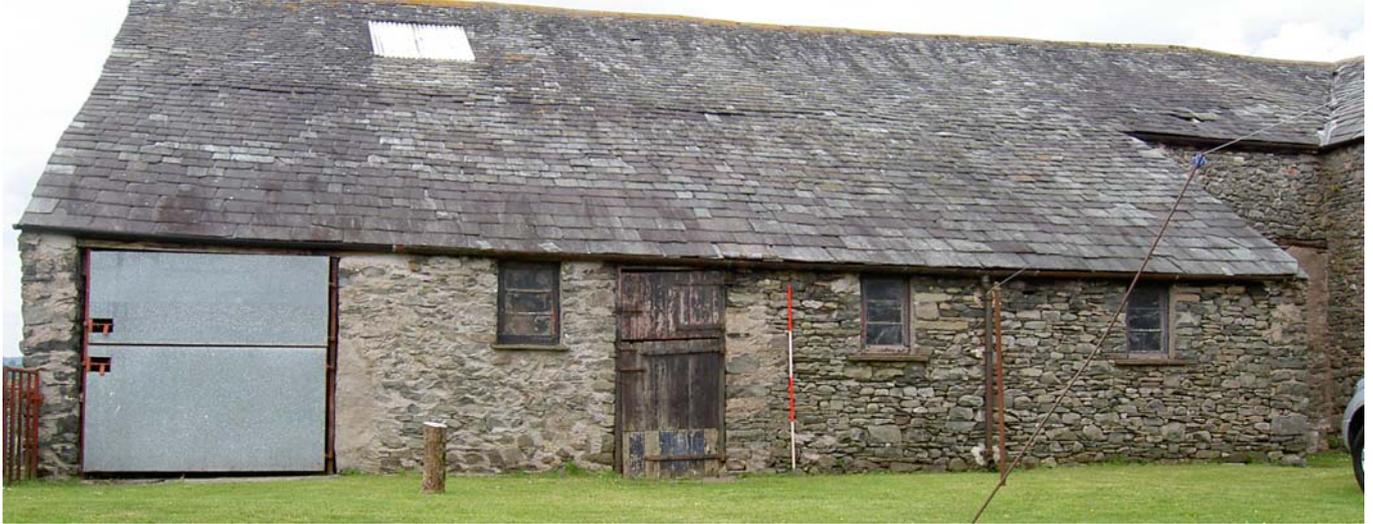
Plate 8: East elevation (south part)

4.2.3 East elevation (south part): in this area the original barn (Room 1b) had largely been obscured by two outshuts (Rooms 6 and 7). The outshut at the south end (Room 6) had a double width doorway that had possibly been inserted or enlarged (Plate 8); this housed a modern steel panel stable-type door that was hung on a metal frame. There was a conventional timber stable door at the north end of this room. Between the doorways there was a small window with splayed jambs, a sandstone lintel and three lights arranged vertically in a fixed timber casement. The stonework of this outshut was roughly rendered, which distinguished it from all the other elevations. The east elevation of the second outshut (Room 7) appeared to have been added between the existing north wall of Room 6 and a pre-existing east/west wall to the north (see Plates 8 and 9). This elevation housed two windows identical to that of the adjoining outshut (Room 7). The small region of the original barn (Room 1b) that was visible just to

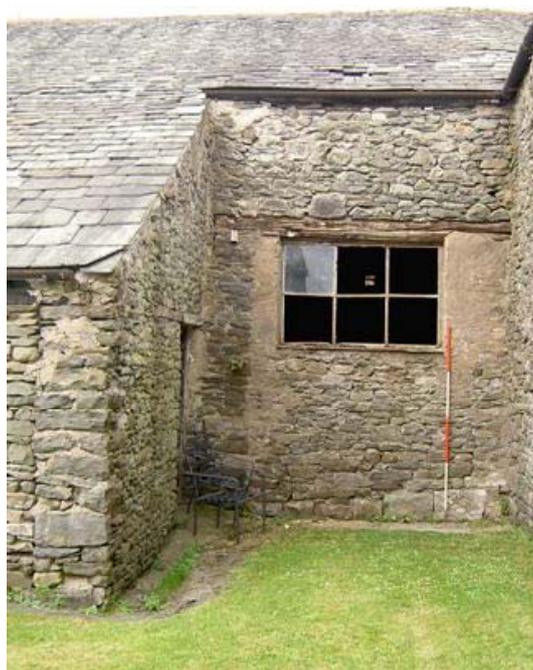
Plate 9: East elevation (central)

the north of the outshuts (Rooms 6 and 7) largely comprised a blocked wagon door into which a window had been inserted (Plate 9). The original oak lintel was still in place and it bore the scars of previous use. A line of cement render indicated the southern extent of the former doorway and its northern extent was flush with the southern elevation of the main barn (Room 1a). The inserted window had six-lights arranged three-over-three in a fixed timber casement.

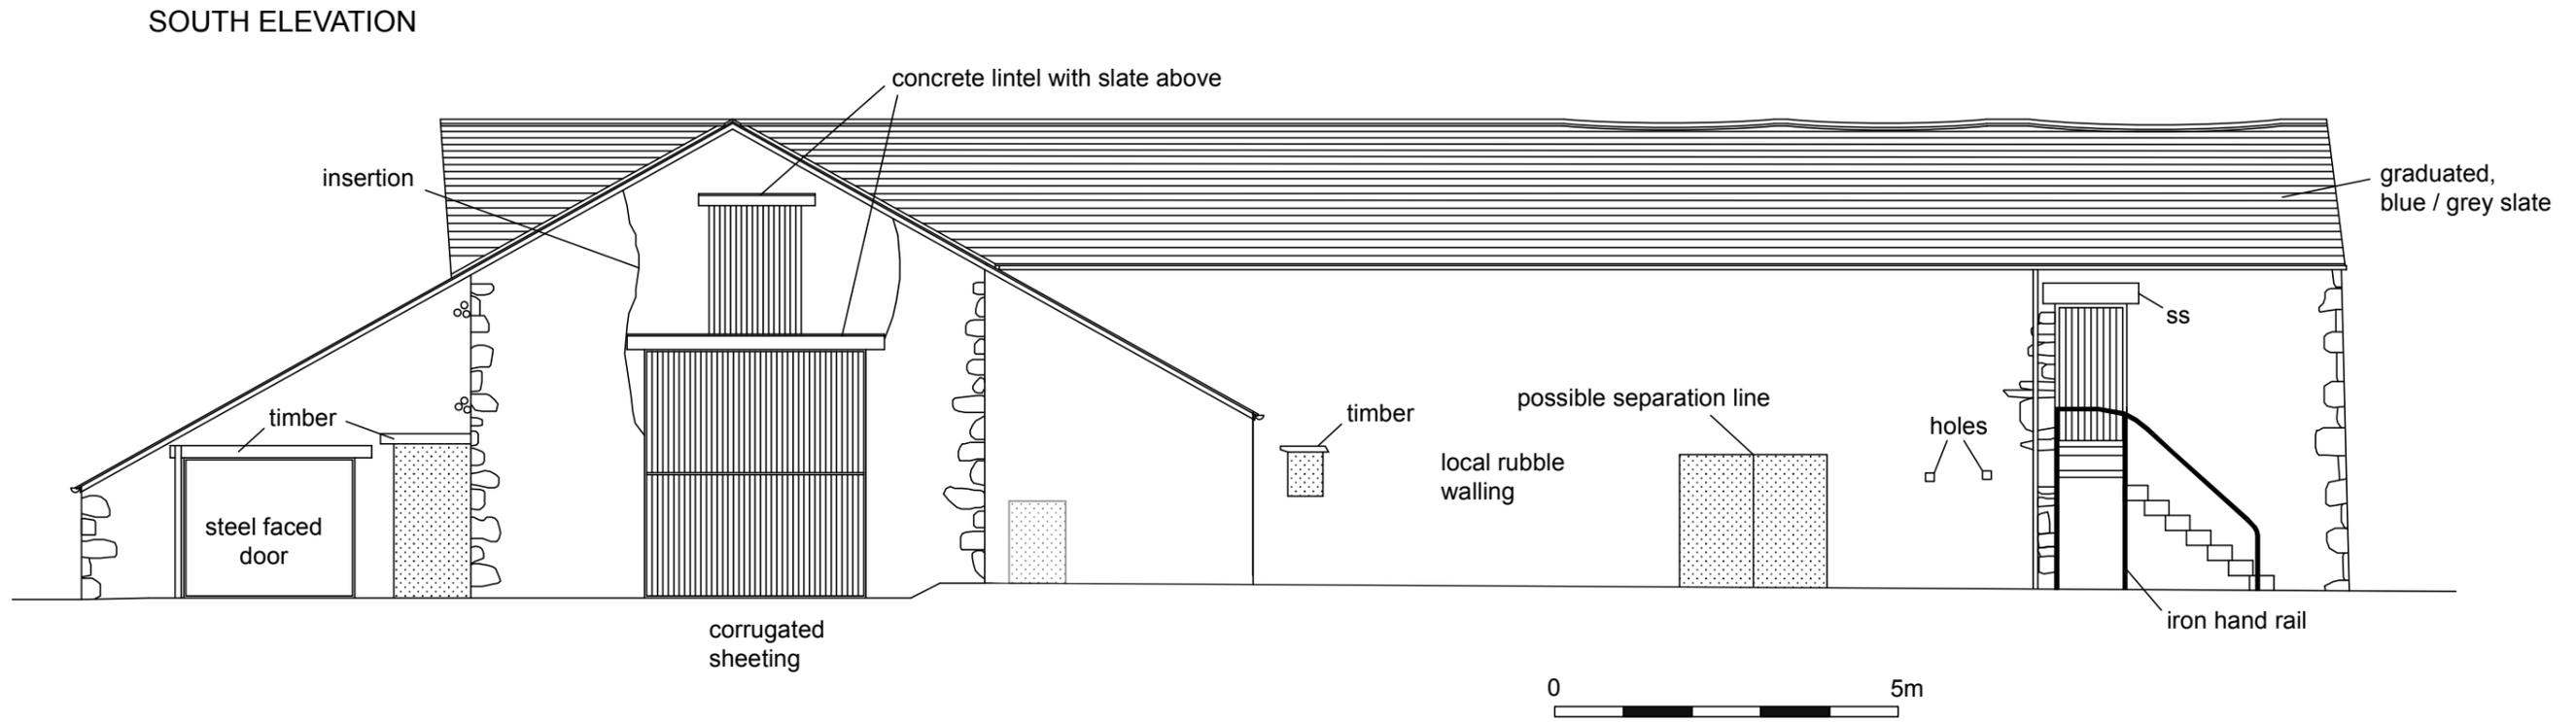
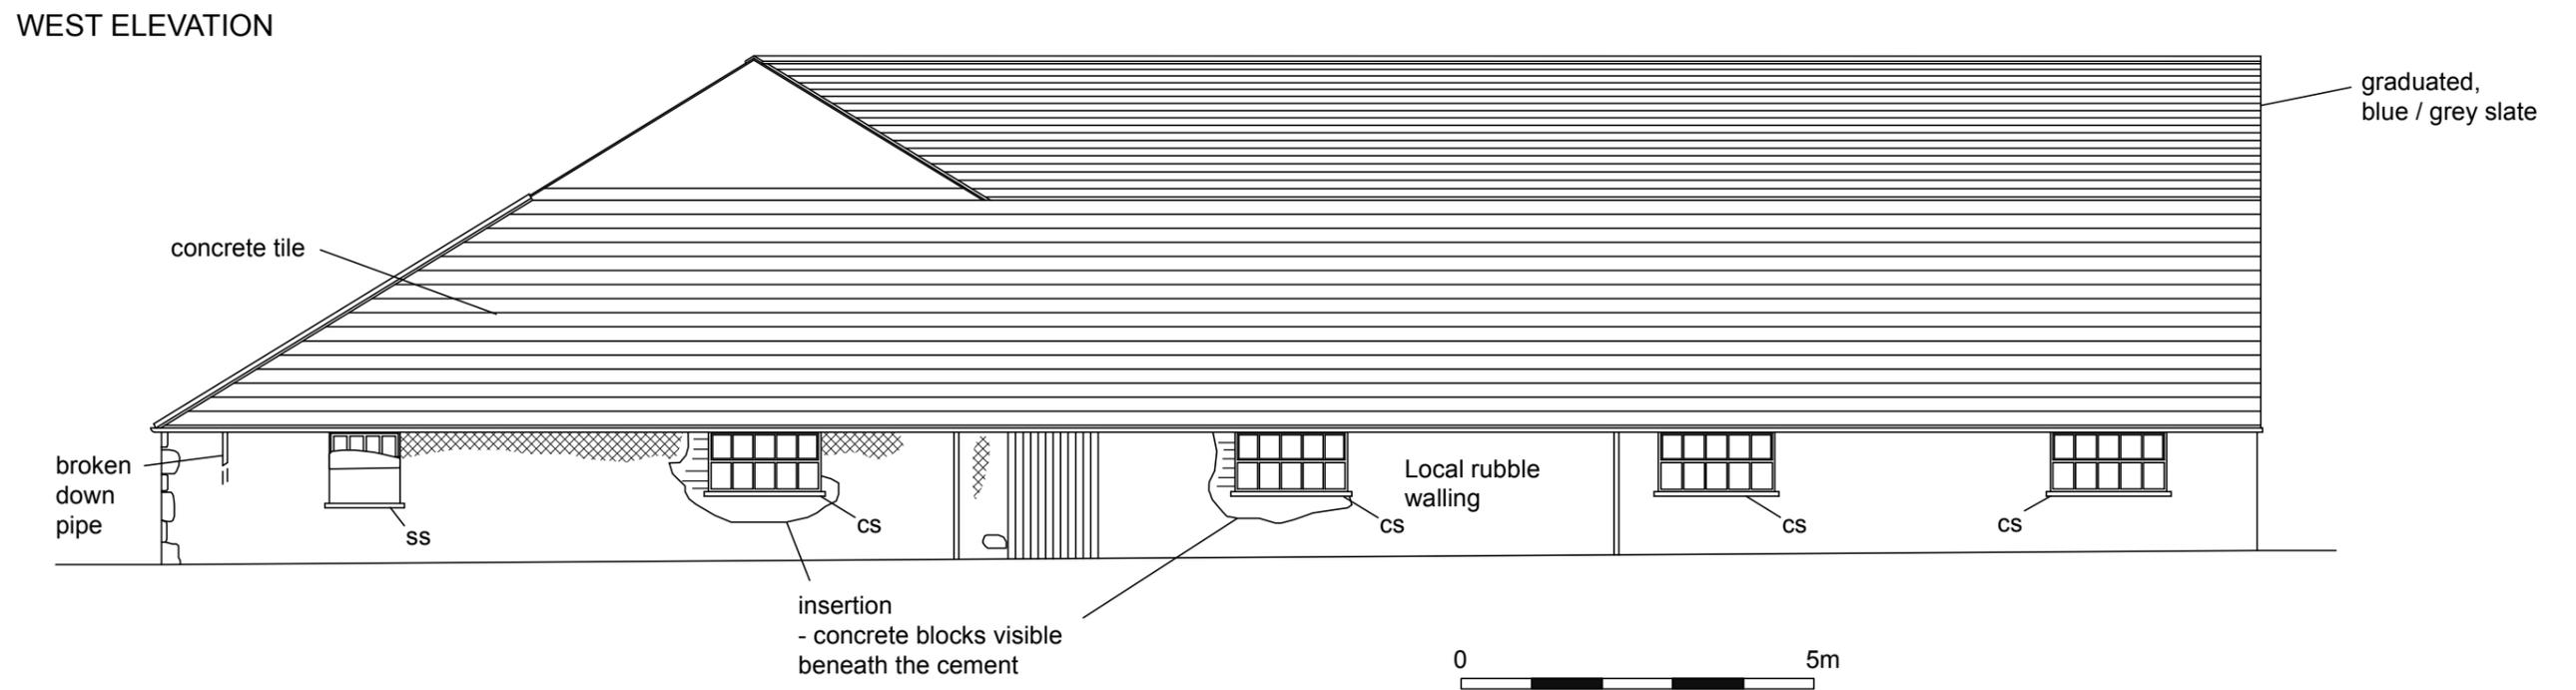
Figure 3: South and west external elevations

4.2.4 **South elevation (west gable):** this elevation was formed by two overlapping parts (see Figure 3), the most westerly part comprising the gable end of the barn (Room 1b) flanked by two outshuts to the west and east (Rooms 5 and 6 respectively). At the west end of the elevation the original extent of the earlier central barn (Room 1b) was clearly evident by its quoins, which were butted against by the outshuts (Plate 10). The outshut to the west (Room 5) comprised a double width wagon door with a blocked pedestrian entrance to the east. The pedestrian doorway had an external timber lintel under a slate drip course; the west jambs of this doorway were quoined suggesting it was an original feature. The ceramic pipes incorporated into the wall over this doorway would suggest that it was purpose built as a shippon. The wagon doorway had a modern metal sheet door under an oak lintel. The barn (Room 1b) had a huge wagon door located centrally below a large upper aperture; both these apertures appeared to have been inserted below concrete lintels and were closed with corrugated galvanised iron sheets. The south elevation of the outshut to the west (Room 6) was plain; this would appear to have been a stable and was one of the first additions to the original L-shaped barn (it is present on the corn rent map of c1836 (Plate 1)).

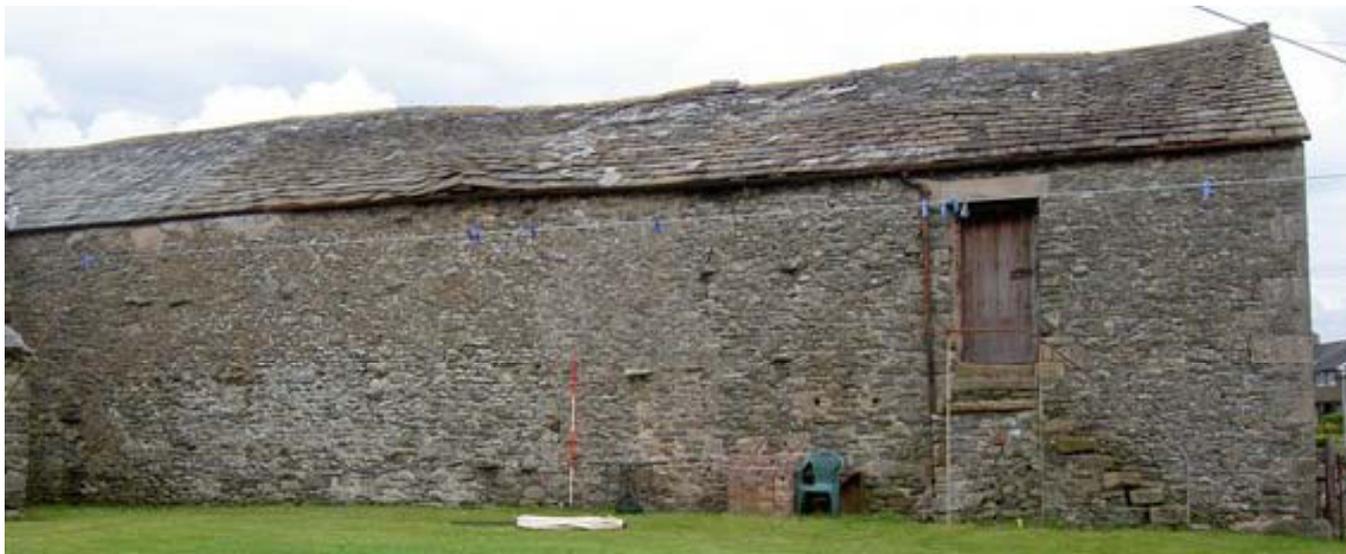
Plate 11: South external elevation of Rooms 1a, 2 and 8

4.2.5 **South elevation (east part):** this comprised the southern elevation of the main barn (Room 1a) and outshut (Rooms 2 and 8). The southern elevation of the barn contained three blocked apertures, but was otherwise plain except for two or three rough rows of projecting through-stones. The blocked pedestrian door at the west end lacked a lintel and had quoins on the west side but not on the east. The second blocked aperture was a window located some 3m further to the east; the window was small and square and the timber lintel was still evident. Further east still there was a blocked double doorway. This was located in an area of the elevation that appeared to have been re-pointed and possibly repaired, and it was noticeable that the roof in this area was badly damaged. (The west side of this doorway is visible

to the left of the scale in Plate 11 and the east side is to the left of the brick stack). It would appear that the blocking was carried out in two phases, with the eastern part of the doorway blocked at a later date than the west. The addition of the outshut (Rooms 2 and 8) is marked by the west jamb of the doorway and the steps that led to the hayloft (Room 8). Rudimentary quoining was evident at the east end of the barn, and this could also be seen behind the steps and in the doorway to the hayloft (Room 8). The southern elevation of the stables (Room 2) was plain except for the addition of the stone steps leading to the upper floor (Room 8). The doorway to the upper floor (Room 8) had a yellow sandstone step and a greyish sandstone lintel; the door was constructed from timber planks and was probably not contemporary with the addition of this extension, which the map regression suggests occurred in the second half of the 19th century (see *Section 5.1*).

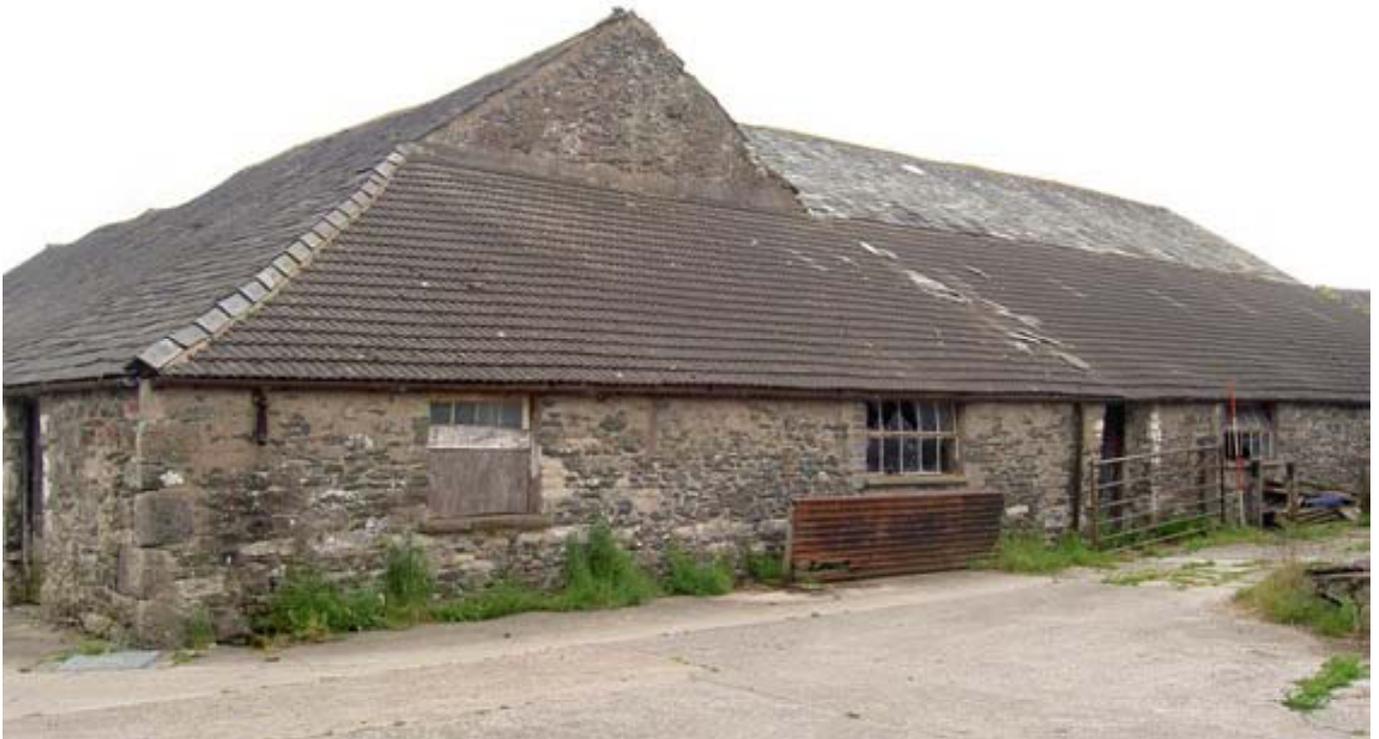
Plate 12: North end of the west elevation

4.2.6 **West elevation:** this elevation was formed by Rooms 3 and 5, which were both clad in concrete tiles rather than slate, and a small plain section of the gable end of the main barn (Room 1a) was also visible at the north end of the elevation (see Figure 3 and Plates 12 and 13). The window to Room 3 at the north end was partially blocked by timber board with just a single row of four lights visible; the window had a sandstone sill and was roughly quoined. The remaining features on this elevation all belonged to Room 5 and comprised four 10-light windows as per the north elevation (see *Section 4.2.1*), which had been inserted/widened in the same way, and a single doorway with the remains of whitewash around the un-quoined jambs.

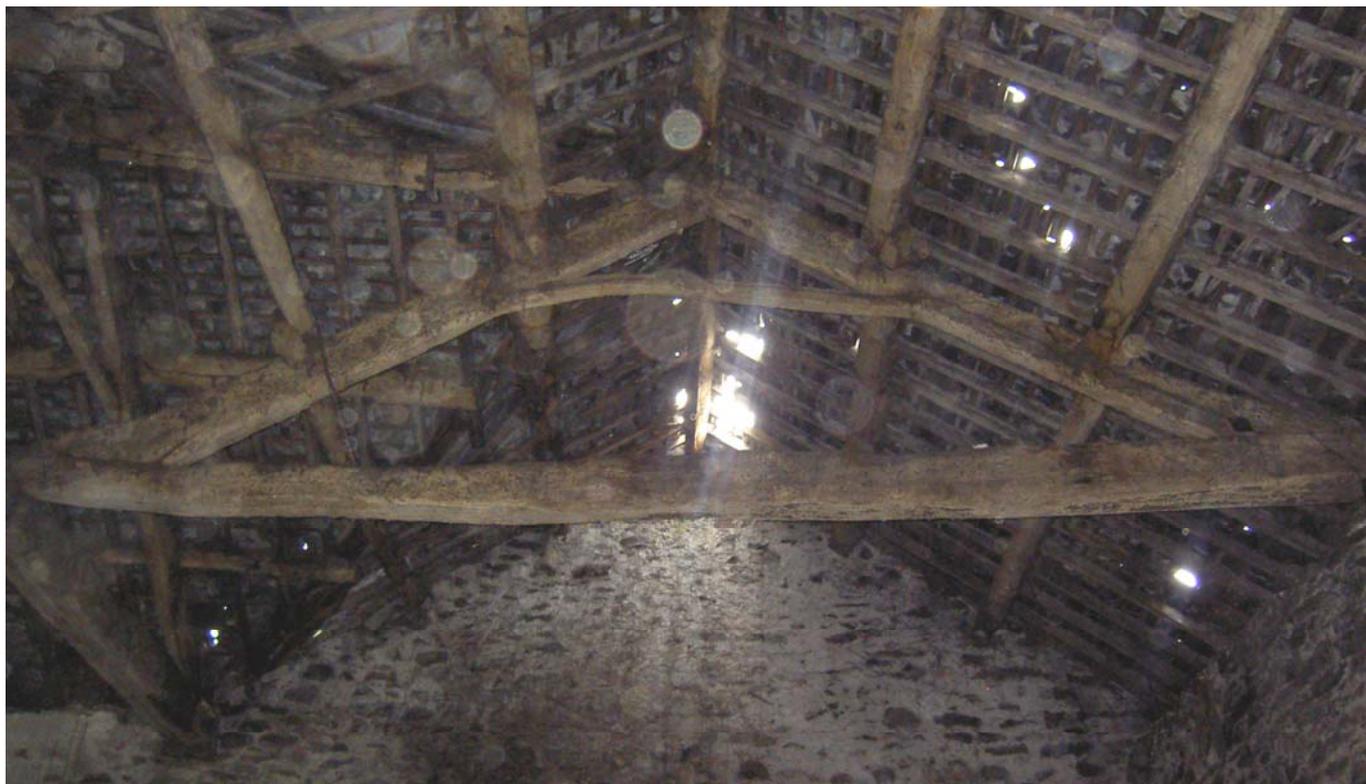
Plate 14: West truss, Room 1a

4.3.1 **Room 1a:** this room formed the east/west wing of the original open-plan barn; the north/south and east/west elements of the original barn were contemporary and the separation of the L-shaped building into two parts (Rooms 1a and 1b) is for descriptive purposes. The floor of the barn showed evidence of being cobbled but was largely buried under muck and straw. The interior space is open to the rafters and has six north/south trusses. Only the three western trusses retained their upper collar (Plate 14); the others had slots where the collar had previously been (Plate 16). There were two large purlins per pitch that were lap jointed at the trusses where they were probably pegged together. The timbers did not appear to have been re-used and all of them were hand finished oak. The rafters and battens by contrast appeared to have been replaced by modern square cut softwood timbers. At the east end of the roof there was some evidence of plaster on the underside of the slates.

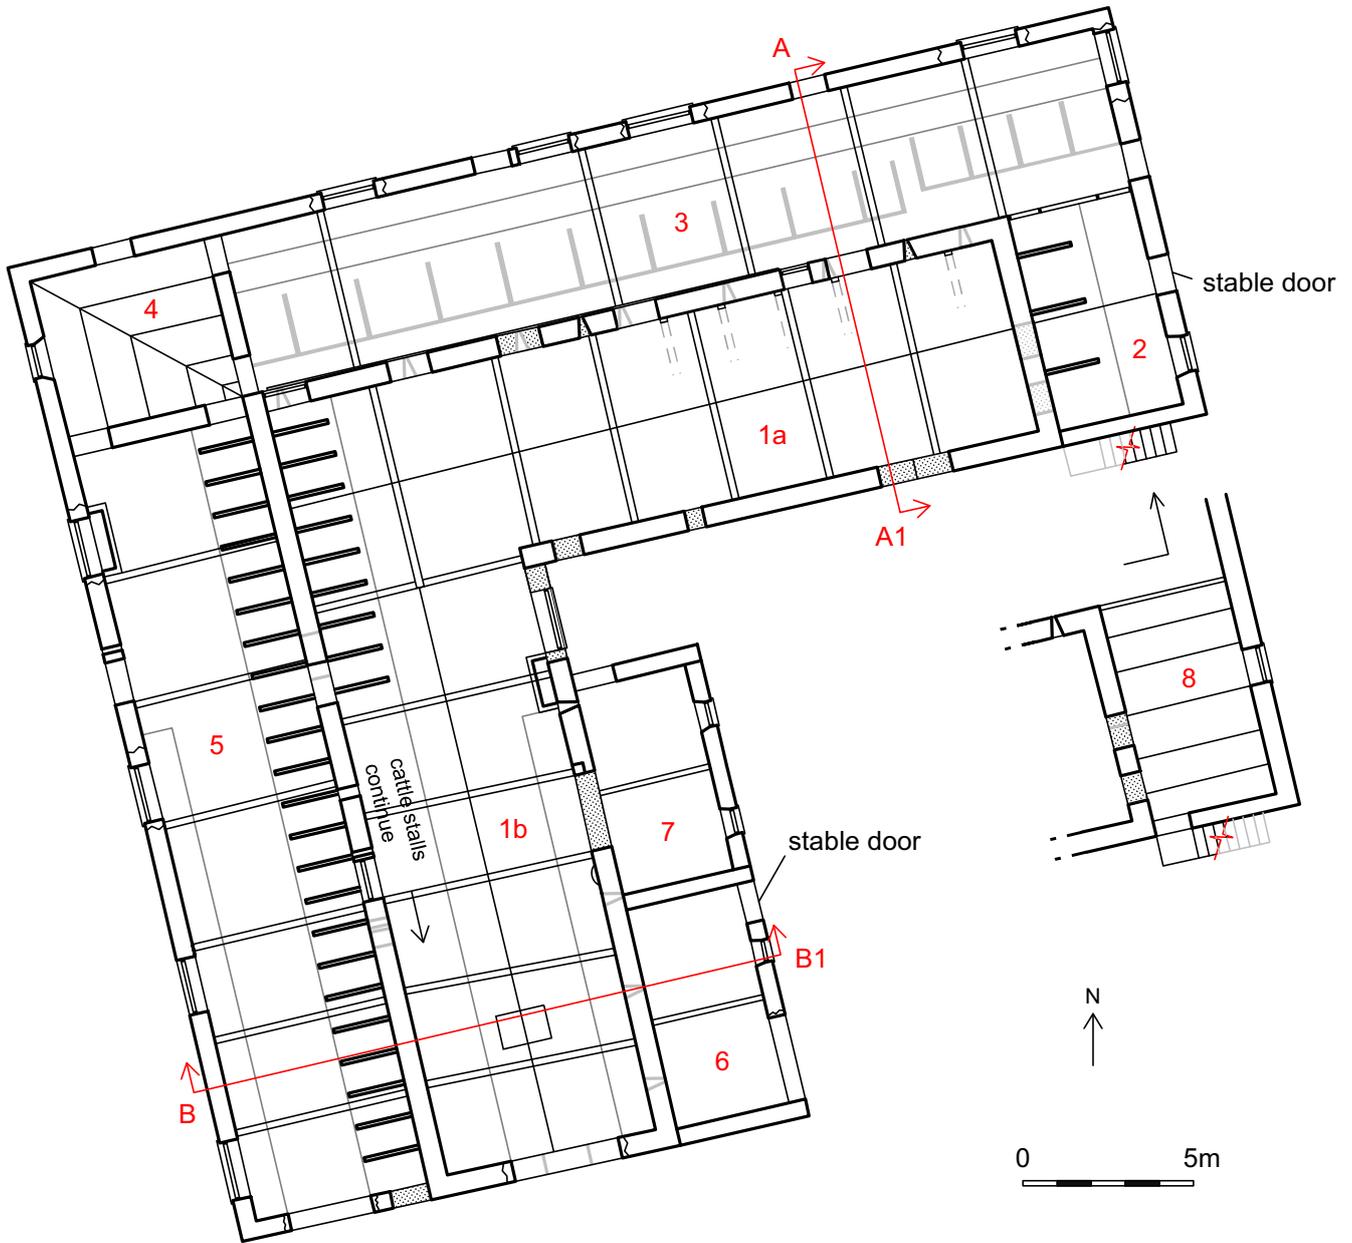
Figure 4: Floor plan

Key:					
	overhead features		blocked feature	2	room numbers
	concrete plinth		blocked features on the upper floor		relict timbers of the half-loft
	concrete stalls		features on the upper floor		indicative of iron cattle stalls

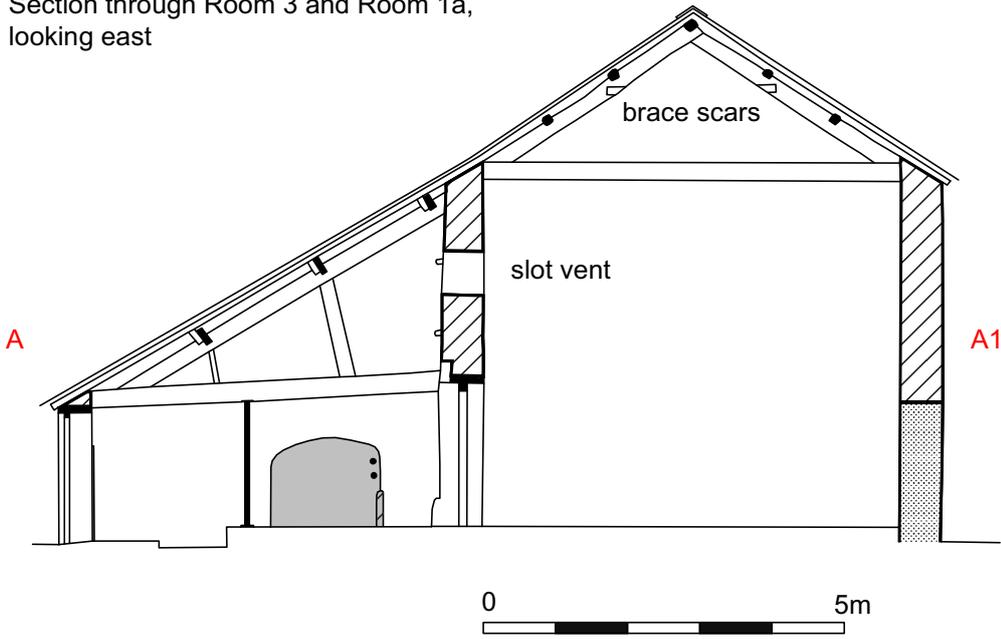
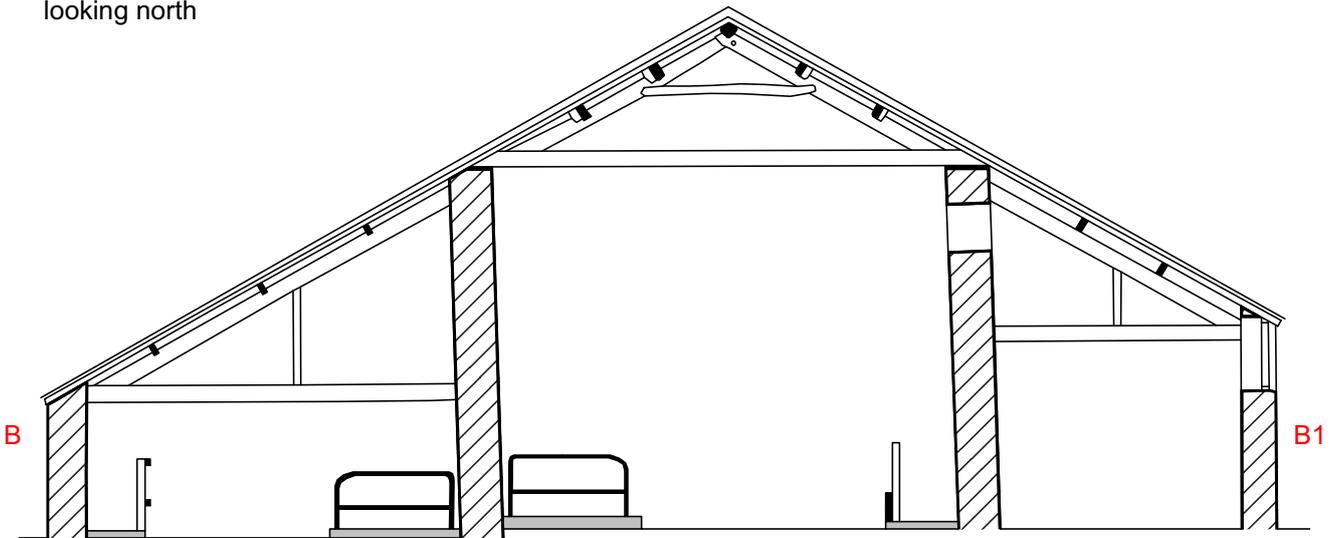
Figure 5: Cross-sections

Section through Room 3 and Room 1a, looking east

Section through Room 5, Room 1b, and Room 6, looking north

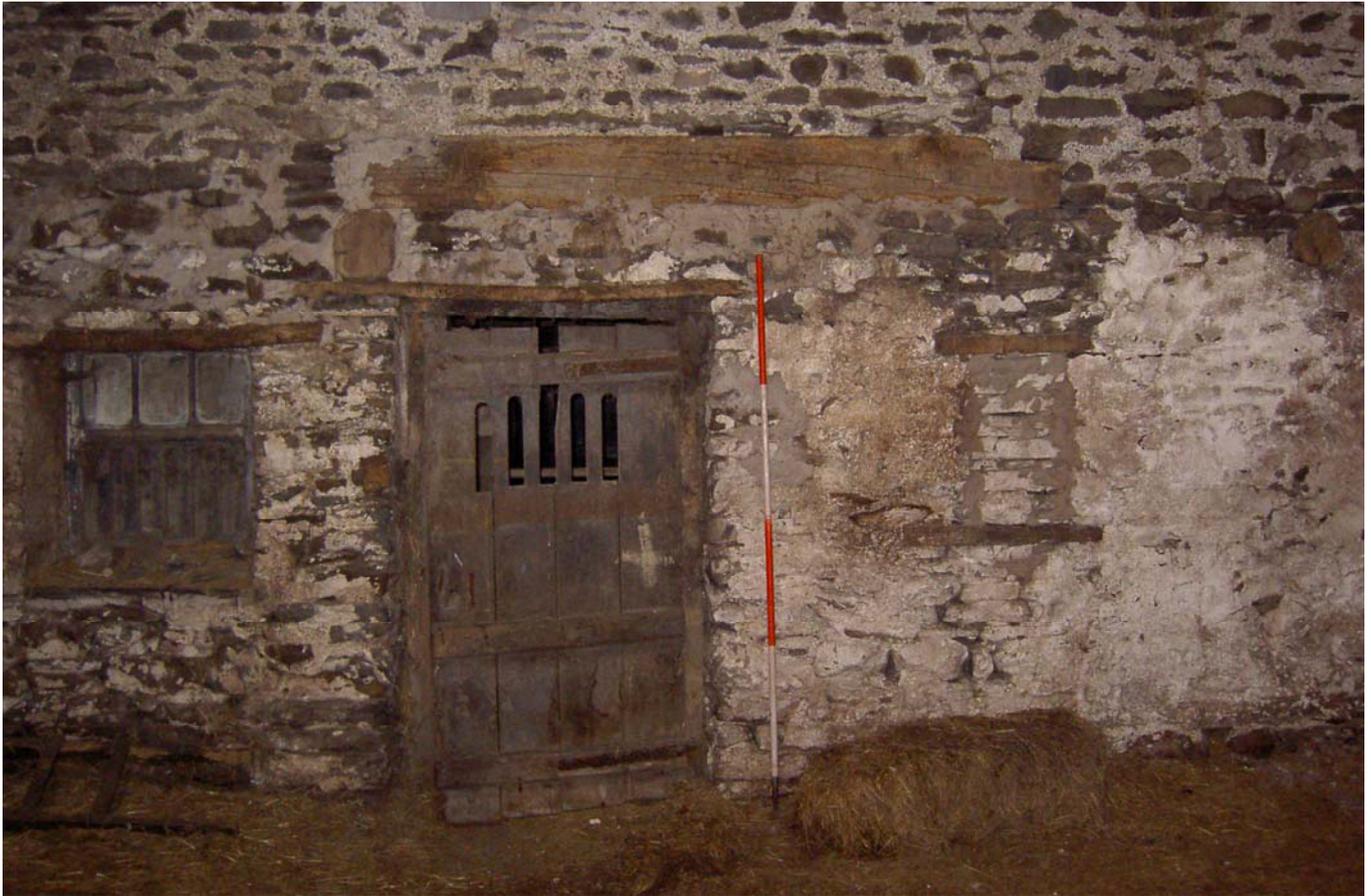
4.3.2 **North elevation:** this elevation appeared to have had five doors, two of which had been blocked up. The two doors towards the east end of the elevation were situated under roughly squared hand-finished oak lintels that appeared to be original, although the jambs were not particularly well quoined. The central blocked doorway was topped by a neater, square cut oak lintel which was below end set oak timbers sawn flush with the walls. There was a similar doorway further to the west which had some cement render around the aperture. The westernmost doorway had been half blocked to form a window, which was more modern, with an oak lintel and cement render over the sill. The window itself had three-over-three lights and the upper section hinged in the same way as those found on the exterior elevations of Rooms 3 and 5. There were two large timbers above door height that were built into the wall; one over the east door (Plate 15) and the other over the next door to the east. These timbers both sat over one of the five beams (now sawn off) that would have formed a half-loft at the east end of the building: there was no evidence to suggest that these extended right across to the south elevation. There was a square window between the two easternmost doorways, which appeared to have been original (Plate 15). The window had three square lights over a timber board and a thin roughly hand-squared oak lintel, with the slate sill forming a recess. There was a row of seven winnowing slots on the upper floor and two blocked slots visible on the ground floor; one central and the other near the east end (Plate 15). All of the winnowing slots had squared oak lintels.

Plate 15: East end of north elevation, Room 1a, note sawn floor joist timbers for half loft

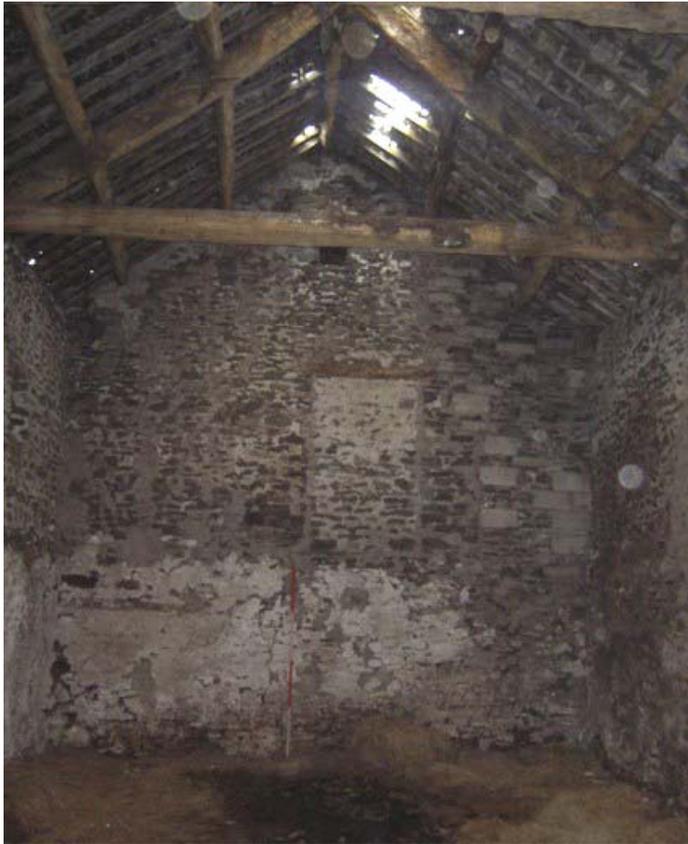
4.3.3 **East elevation:** this gable end (Plate 16) housed an owl hole under the roof apex, below which was a blocked pitching door with an oak lintel. This pitching door would have related to the half loft (whose sawn floor joists can be seen in Plate 15) and the wall below this level had been whitewashed. To the south of the pitching door a number of concrete blocks indicate the location of another blocked doorway which was narrower than the pitching door (Plate 16).

Plate 16: (left) East elevation, Room 1a

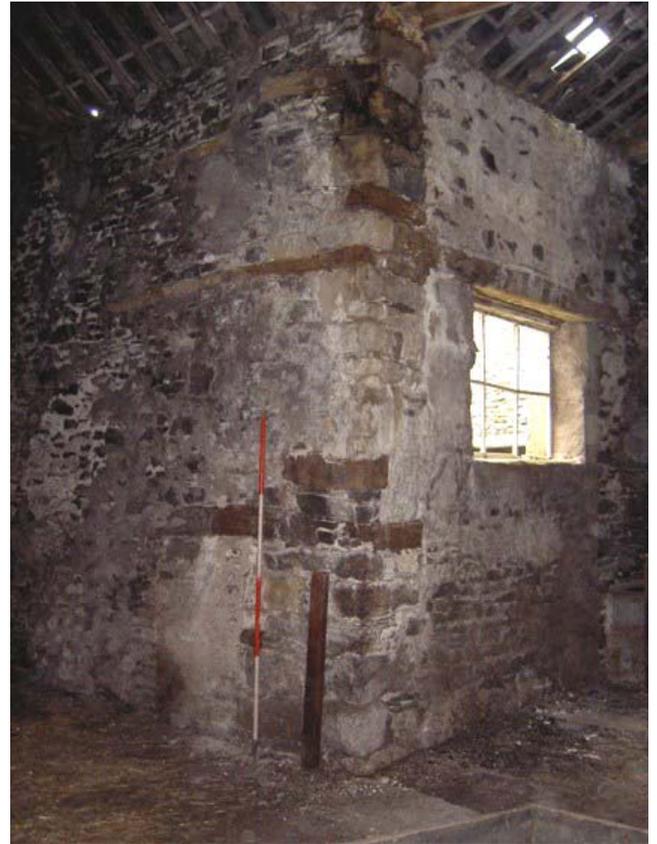
4.3.4 **South elevation:** this elevation was very plain, and the only blocked aperture visible internally was the small blocked door, 1.35m by 0.8m, at the west end of the elevation which sat under a roughly squared oak lintel (Plate 17). A blocked double doorway near the east end was evident from the outside, as was a blocked window in the centre (see *Section 4.2.5*).

Plate 17: (right) Blocked door in south elevation, Room 1a

4.3.8 **East elevation:** there was a blocked cart door at the junction with the south elevation of Room 1a (Plate 17) and a window had been incorporated into the upper part of the blocking. The roughly squared oak lintel sat over a six-light fixed timber casement. To the south of this door was one of a series of four upper and lower winnowing slots with oak lintels. Further to the east there was a lower square aperture with an oak lintel that was on the north side of a second, slightly lower, blocked cart door under an original square-cut oak lintel (see Plate 19). Over the cart door there were two small blocked square vent slots, also under oak lintels; the addition of Room 7 sometime between 1897 and 1912 (see *Section 5.1*) would have made these features obsolete. The first set of the three pairs of vents/slots to the south of the door were blocked, the others were not. Between the lower vent and the blocked door there was a semi-circular projecting stone which looked purposeful. The rest of the elevation was plain except for the two remaining pairs of winnowing slots. There was an unusual oak lintel over one of the lower slots, which had a deep a recess in the middle with many holes. This would appear to be a re-used rail from an early stud partition wall (Plate 20).
