BARN AT NATLAND HALL FARM, NATLAND, KENDAL, CUMBRIA

Archaeological Building Recording

Client: Mr and Mrs Bennett
NGR SD 51937 89245

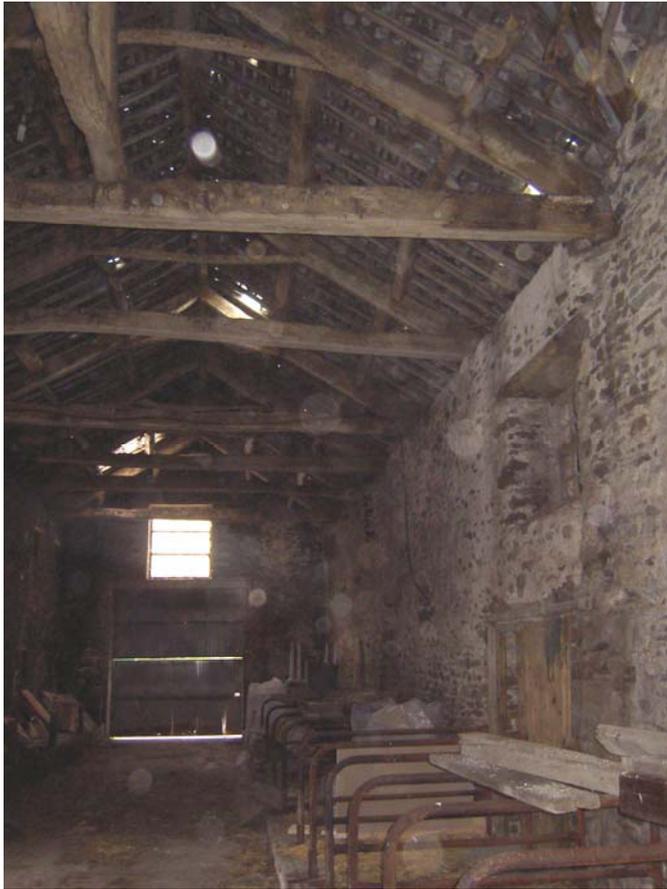
4.3.6 **Room 1b**: this is the south-west section of the original L-shaped barn. The floor was concreted and had a raised plinth with iron cattle stalls on the west side of the room (Plate 18). There was a timber plank and post feeding trough built against the east elevation that had a water trough at the north end (Plate 19). The six trusses ran perpendicular to those of Room 1a, but were otherwise identical (see *Section 4.3.1*). The tie beam of the northernmost truss supported the west truss of Room 1a (Plate 18).

Plate 18: (left) west elevation of Room 1b, looking south

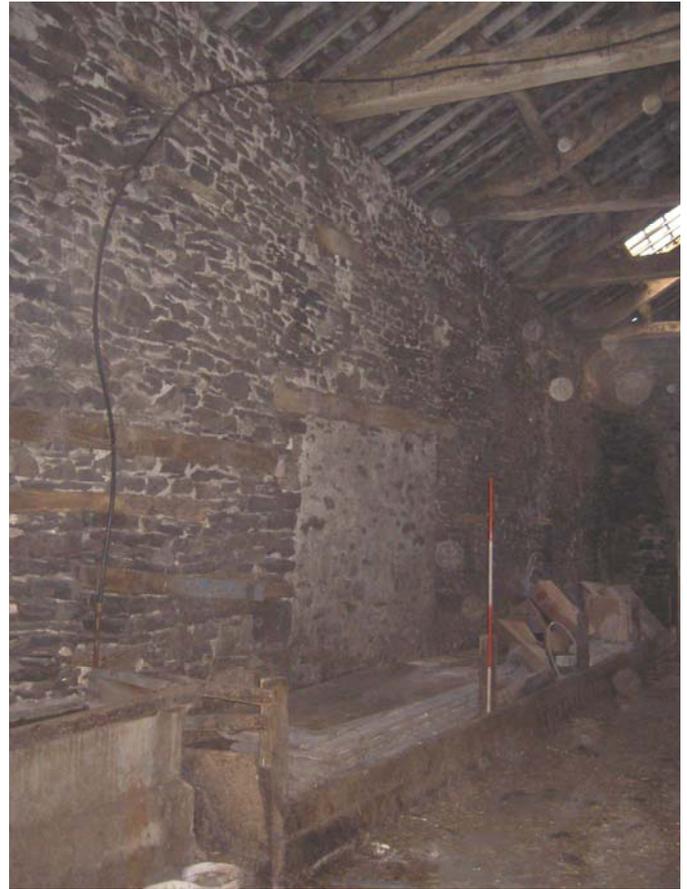
Plate 19: (right) east elevation of Room 1b, looking south

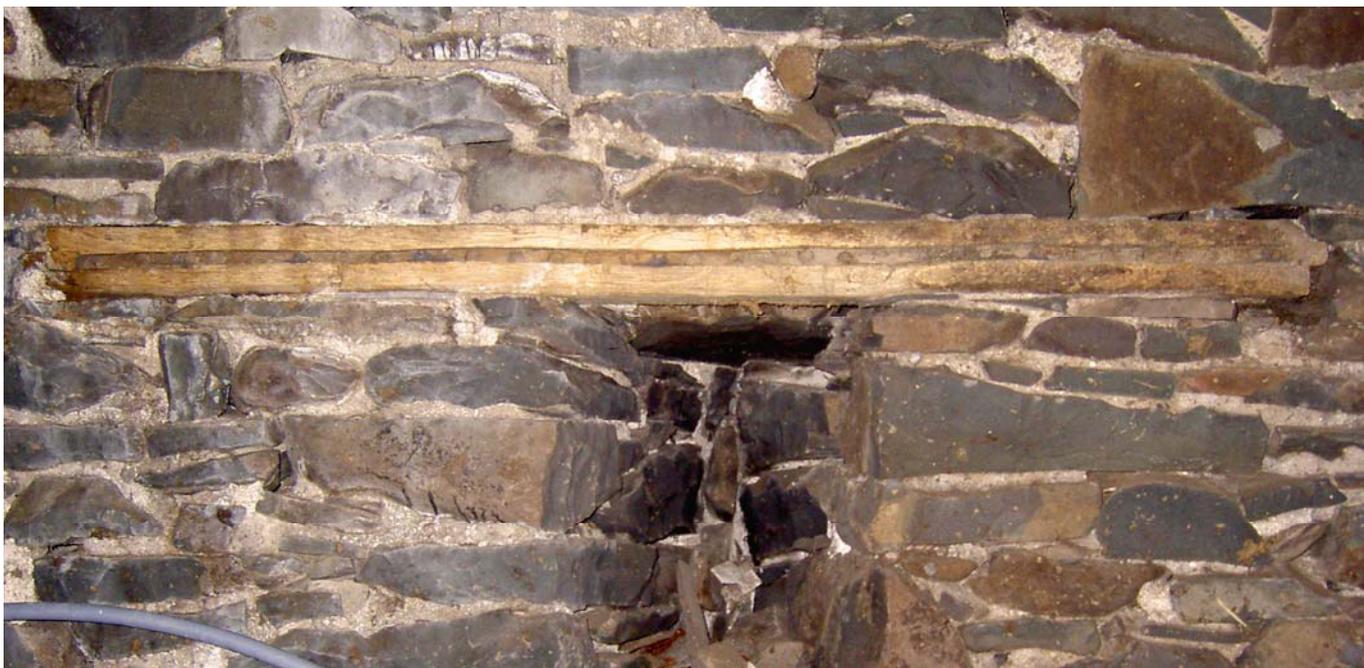
4.3.8 **East elevation:** there was a blocked cart door at the junction with the south elevation of Room 1a (Plate 17) and a window had been incorporated into the upper part of the blocking. The roughly squared oak lintel sat over a six-light fixed timber casement. To the south of this door was one of a series of four upper and lower winnowing slots with oak lintels. Further to the east there was a lower square aperture with an oak lintel that was on the north side of a second, slightly lower, blocked cart door under an original square-cut oak lintel (see Plate 19). Over the cart door there were two small blocked square vent slots, also under oak lintels; the addition of Room 7 sometime between 1897 and 1912 (see *Section 5.1*) would have made these features obsolete. The first set of the three pairs of vents/slots to the south of the door were blocked, the others were not. Between the lower vent and the blocked door there was a semi-circular projecting stone which looked purposeful. The rest of the elevation was plain except for the two remaining pairs of winnowing slots. There was an unusual oak lintel over one of the lower slots, which had a deep a recess in the middle with many holes. This would appear to be a re-used rail from an early stud partition wall (Plate 20).

Plate 20: Re-used partition rail over slot vent, east elevation of Room 1b

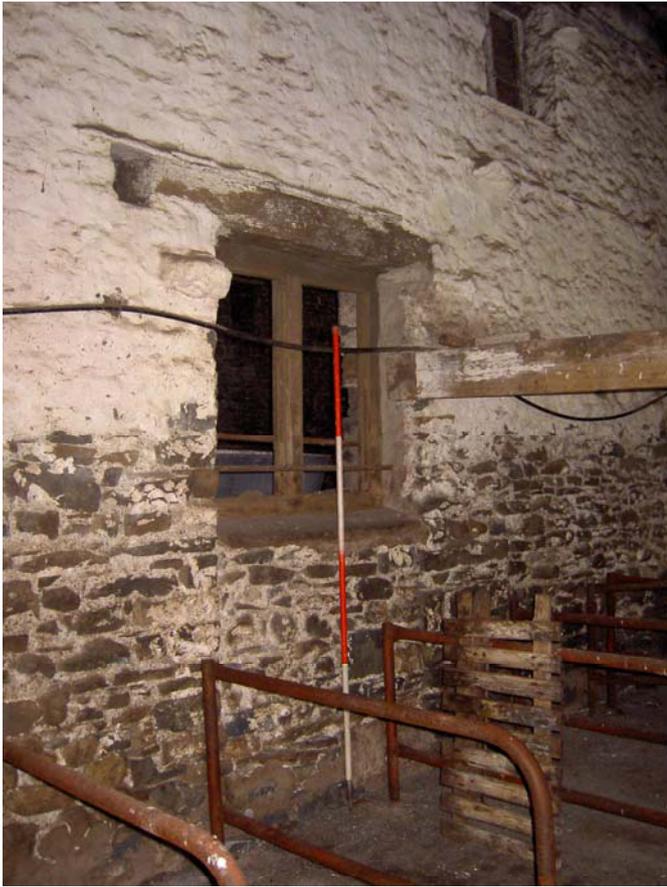
4.3.10 **West elevation:** there was a roughly central, partially blocked doorway, which housed a window at head height (Plate 21). This window appeared to be quite recent and had a timber casement that probably held two lights. Two metal bars spanned the lower part of the jambs. Just to the south there was an upper square window under an original oak lintel, situated below the wall plate (Plate 21). To the south of the lower central window there were four timber lintels built into the wall at the same height as the lower winnowing slots on the opposing elevation; there were no associated slots on this side, however, and it appeared there never had been. There were also other timbers more randomly built into the wall in this area. Immediately to the north of the lintel of the central blocked doorway was a small square slot under a square cut oak lintel, and north of the blocked door there was a small window slot with a stone lintel. Towards the north of the elevation there was a sliding door, made from timber boards, with a timber lintel. Above this door and slightly to the north there was a 20-light fixed timber casement window which was no longer glazed (Plate 22).

Plate 21: (left) Blocked door in the centre of the west elevation of Room 1b, viewed from Room 5

4.3.20 **East elevation:** this elevation represented the original exterior of the barn (Room 1b; see *Section 4.3.10*; Plates 21 and 22), and the plinth visible on the north side of the barn (Room 1a) continued around and down the full length of this elevation. There were three windows and two doorways on this elevation, one of the doorways had been converted to a window (Plate 21). There was a slight return in the upper part of the wall (Plate 27) to the north of the northernmost window, approximately in line with

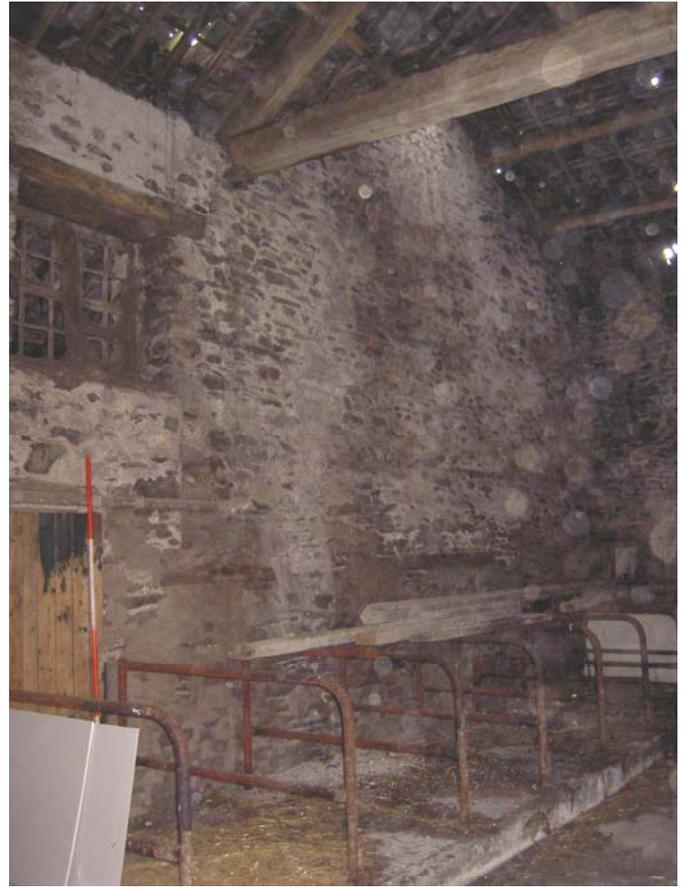
Plate 22: (right) Sliding door and window towards the north end of the west elevation, Room 1b

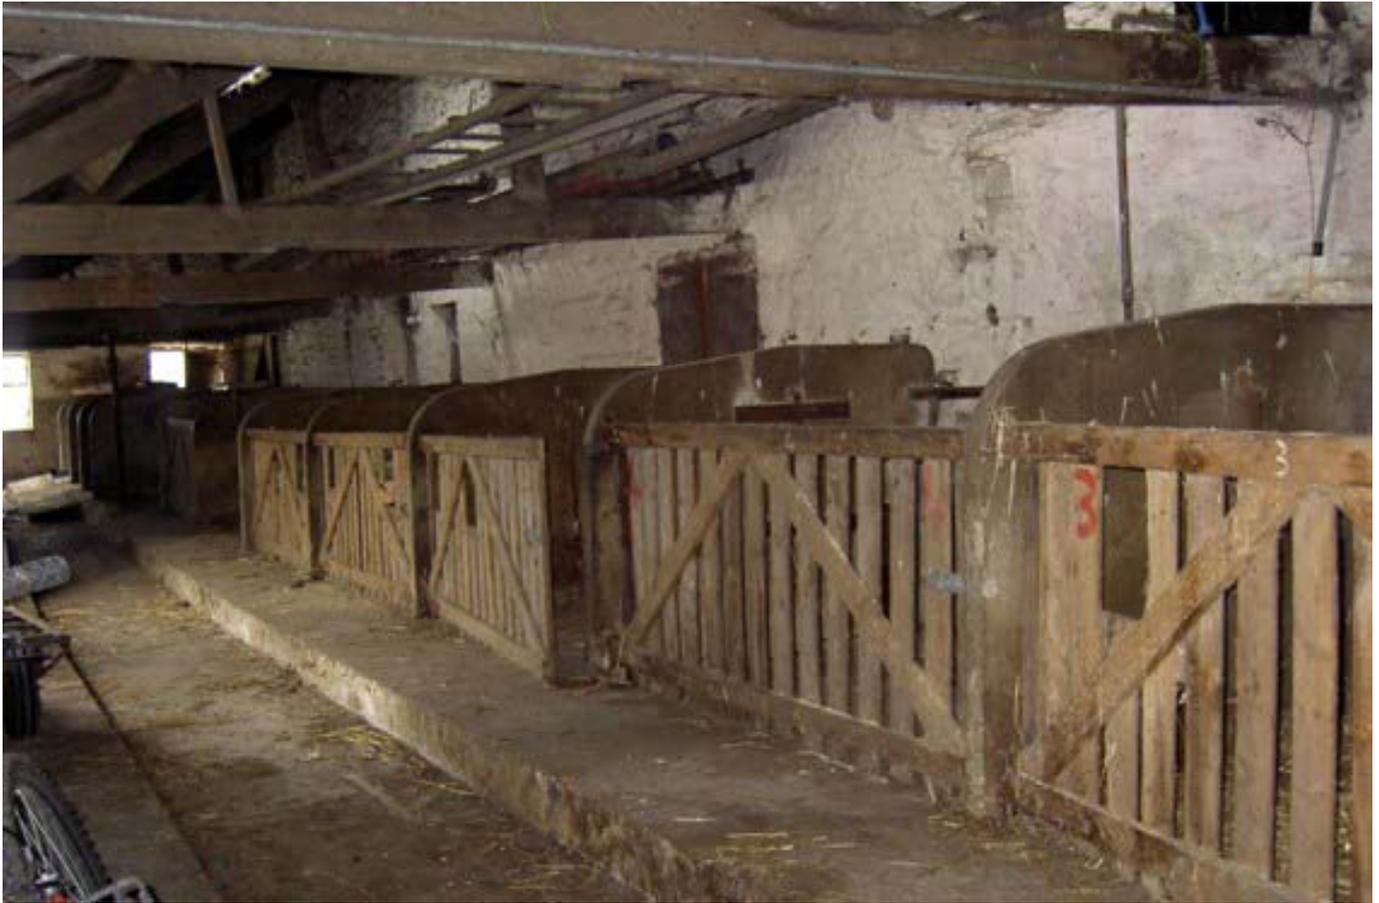
Plate 23: Room 3 from the west

4.3.12 **Room 3:** this outshut was probably contemporary with Room 2 and Room 8 and between them they obscured the north and east aspects of the original barn (Rooms 1a/1b). This area was entirely given over to cattle stalls which indicated it functioned as a cow house (Plate 23). The floor was concrete, with a feeding passage running along the south side (against the north exterior of the original barn, Room 1a) and stalls and a dung channel to the north. The stalls were made from cast concrete and iron bars and some had wooden gates. There were six half trusses across the room, all identical, with two slightly off-vertical braces between the tie beam and principle rafter. All the timber was relatively modern machine-sawn softwood.

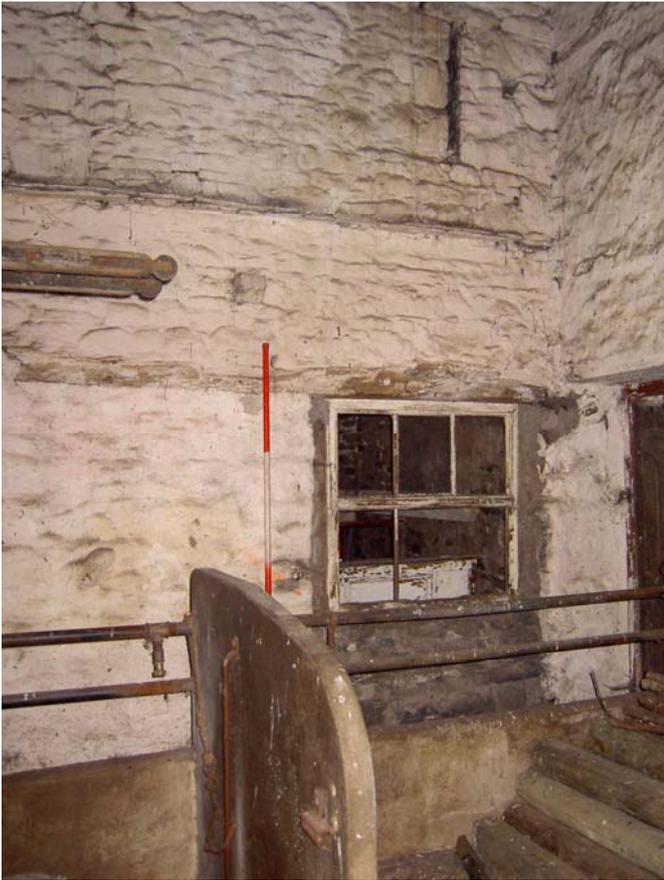
4.3.15 **South elevation:** this elevation was two-storeys high, and largely comprised the external wall of the original barn (Room 1a). At the east end of this elevation a timber partition has been added separating Room 3 from Room 2. The exterior of the original barn had been entirely whitewashed up to the wall top, this part of the elevation housed seven upper and two lower slot vents, five doorways (of which two had been blocked, see Plate 24) and two windows (see *Section 4.3.2* for further details). A drip course began just to the west of the eastern door of the original barn (Room 1a), and ran westwards to the end of the elevation. A stone plinth, which jutted out approximately 0.10m from the wall, ran along the length of the wall at a height of 0.35m from the base. The eastern doorway had a stone arch above, suggesting that it used to be the main pedestrian entranceway to the barn, before the outshut (Room 3) was added (Plate 25).

Plate 24: (left) Blocked doorway under a drip course at the west end of the south elevation, Room 3

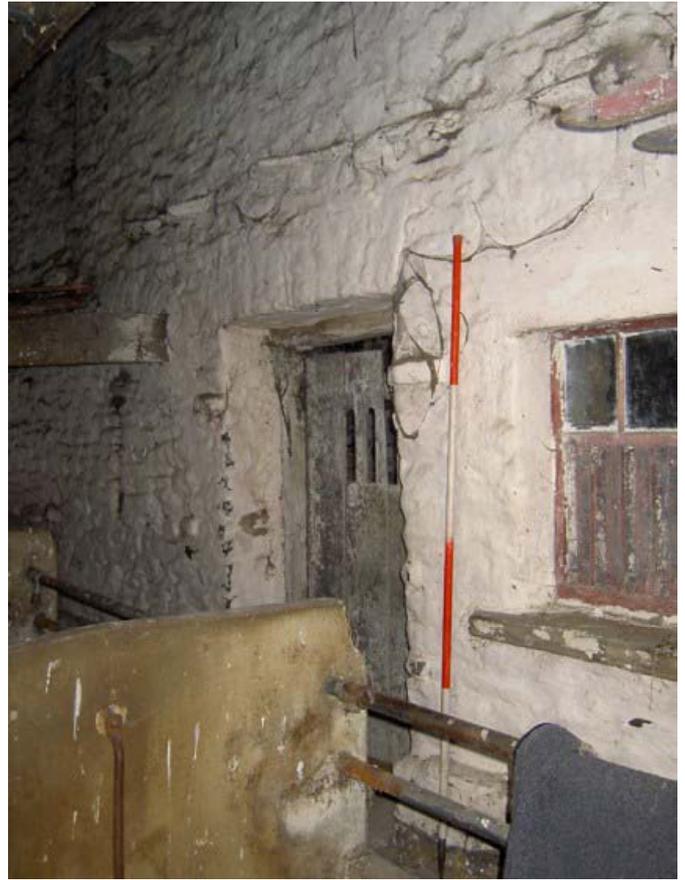
Plate 25: (right) Eastern doorway of the original barn (Room 1a), the only doorway with a stone arch

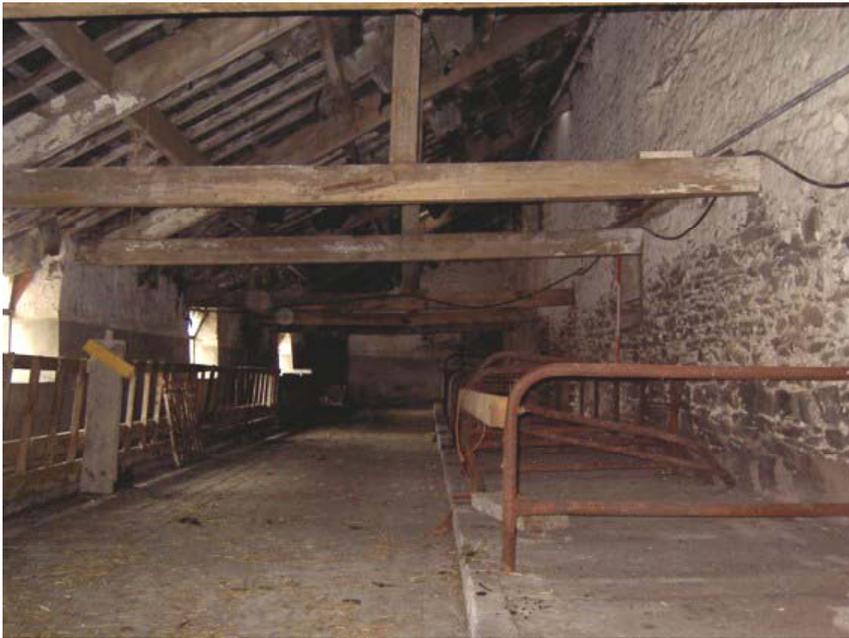
4.3.18 **Room 5:** this shippon ran south from Room 4 and in turn obscured the exterior west elevation of the original barn (Room 1b). The roof timbers, windows, and doors were identical to those of Room 3, except that the trusses had a single vertical strut (Plate 26). The floor was concrete and the walls were cement rendered on the lower north and west elevations. The stall arrangements were a mirror image of those found in the adjacent barn (Room 1b), with iron bar stall partitions on a raised plinth on the east side and a plank and post feeding trough on the west side with a drinking trough at its north end.

Plate 26: (left) Room 5, viewed from the south

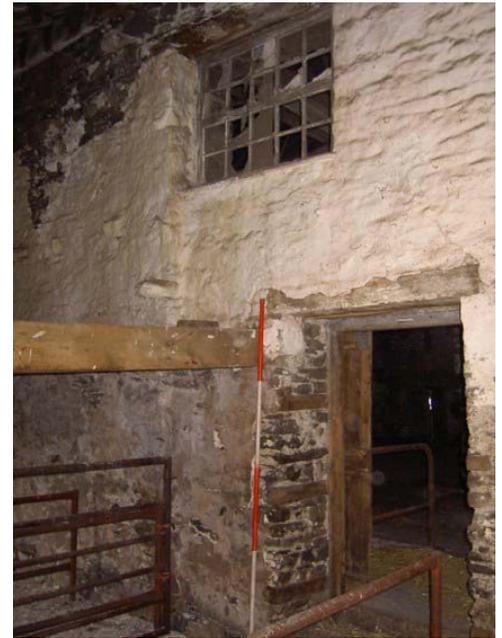
the south elevation of Room 1a, but there was no real evidence to suggest that this could help resolve whether Rooms 1a/1b were contemporary or not.

Plate 27: (right) Slight return in the wall, east elevation, Room 5

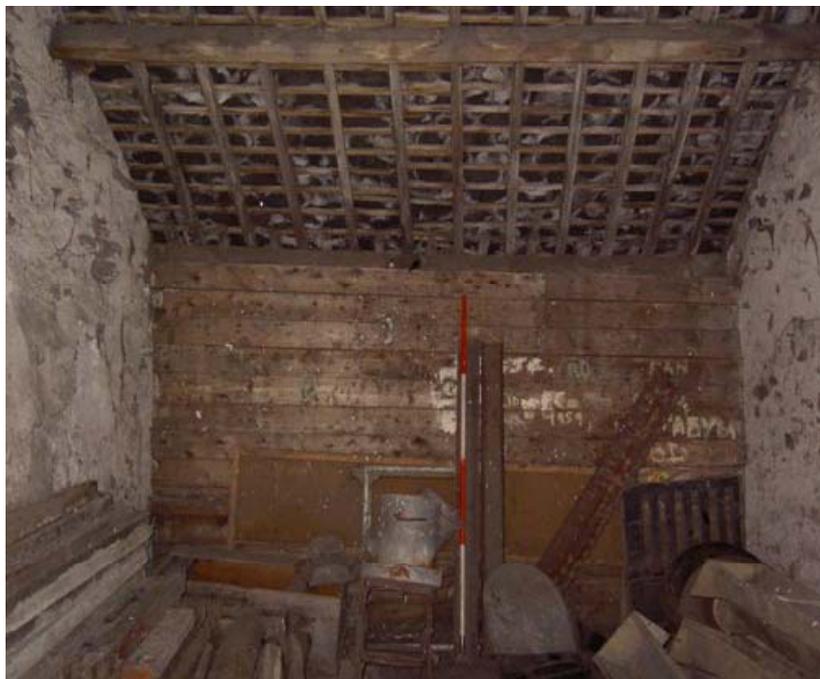
partition wall between Rooms 2 and 3 (Plate 28). The east elevation was plastered stone. There was a 12-light timber casement, with a square cut timber sill and lintel, centrally located on the east elevation. The top three panes of the window appear to hinge inwards and the jambs were splayed. The entrance to the room was up a flight of stone steps and through a door in the south elevation; this had a plain square cut wood frame under an oak lintel. There was a blocked doorway in the south side of the west elevation; this corresponds with that of the upper east elevation of Room 1a (Plate 29). The pitching door of Room 1a was not really evident on this elevation, but the owl hole at a higher level was.

Plate 28: (left) Room 8 north elevation, upper section of the timber partition wall

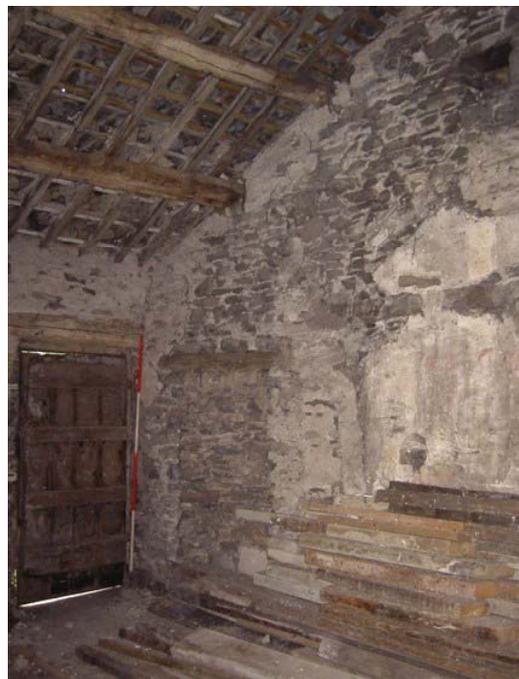
Plate 29: (right) East interior elevation of Room 8/upper section of the external east elevation of Room 1a

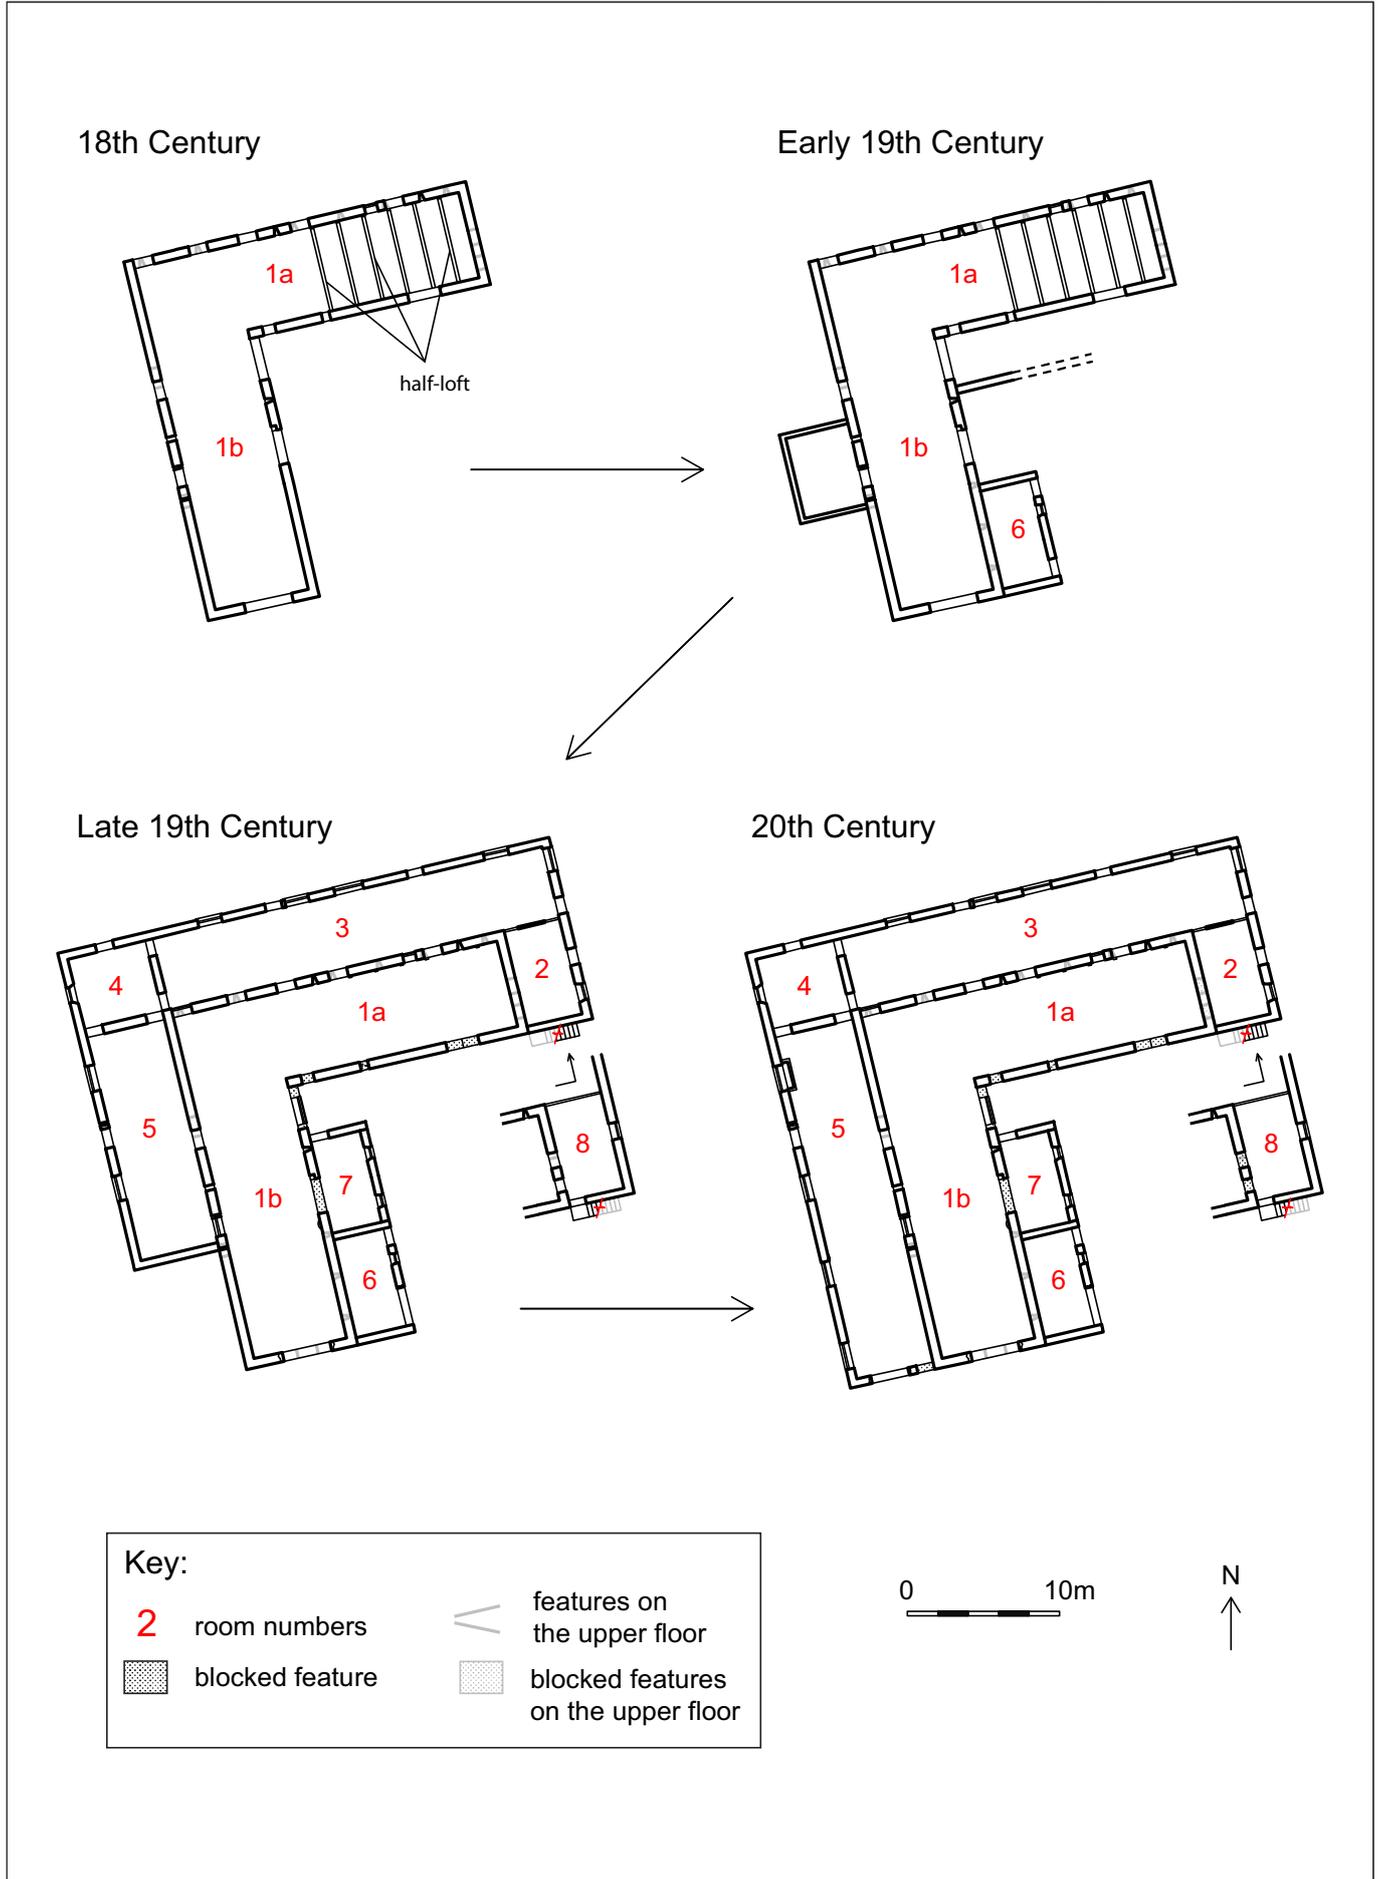
Figure 6: Phase plan

5.1.1 **Introduction:** a total of five phases of development were identified within the building, as outlined below and illustrated in Figure 6.

5.1.2 **Phase 1 - 18th century:** the earliest phase of construction at the site was clearly the erection of a large 'L'-shaped barn formed by Rooms 1a and 1b. This barn was clearly present on the c1836 corn rent map (Plate 1) by which time it had acquired additions to the east and west sides of the south wing. There were suggestions that that this barn may have been built in two phases; the western gable end roof construction at the corner of the L-shape of the barn seems unusual, as does the slight kink evident in the exterior west wall of Room 1a/b (see *Section 4.3.20*; Plate 27). Despite these factors, the similarity of the roof timbers and the lack of conclusive evidence in the walls suggest that Barns 1a and 1b were contemporary. At this stage the barn would appear to have had a purely crop processing function, with a pitching door onto a half loft at the east end and the threshing area in the south wing between the wagon doorways.

5.1.3 **Phase 2 - early 19th century:** this phase is represented by the additions evident on the corn rent map (Plate 1) which include an addition to the south-east corner of Room 1b and another addition to the west side. The addition on the west side has left no trace and was presumably demolished to make way for the addition of Room 5 in the second half of the 19th century. It is probable that this addition was a single storey as it seems to roughly correspond to a point in the western elevation of the barn (Room 1b) where there is a higher level window. A square slot in the wall just to the north of this window also suggests the possibility that an overhead axel horse gin was situated against this side of the building; the 1863 Ordnance Survey plan (Plate 2) shows an external circular feature in this area that could be a gin ring. The pedestrian doorway in this elevation was perhaps blocked at this time and replaced with a window through which the horses could be observed (see Plate 21). It is possible that the addition of a wagon door to the south became necessary for the delivery of crops to feed the horse powered threshing machine, which would account for the two wagon doorways on the same elevation. The more northerly doorway, which must be original, would have allowed a through draft for the earlier hand threshing. The outshut on the east side (Room 6) had clearly been added to the original barn as it made obsolete two of the slot vents in the east external elevation of Room 1b. In addition, the butting of this outshut against the east quoins of the barn (Room 1b) can be seen on the southernmost elevation. It seems probable that this addition (Room 6) was a stable, its addition still leaving access to the main barn through either or both of the wagon doorways on the east elevation.

5.1.4 **Phase 3 -late 19th century:** the extension to the north of the barn (Room 3) and the shippon on the west side of the barn (Room 5) had both been completed by 1898 (Plate 3). Rooms 2, 8 and 4 were also completed in this phase, which also sees the addition of the second stable on the east side of Room 1b. This phase is significant as it shows a shift from arable to dairy farming at the site, which is in keeping with the general trend at this time when urban populations were rapidly increasing. It seems likely that the barn was re-roofed, as illustrated by the ceramic bonnet tiles covering most of the apex.

5.1.5 **Phase 4 -early 20th century:** this latest stage of development sees the completion of the western shippon, at which point the building reached its present size.

5.1.6 **Phase 5 – 20th century:** this phase comprises various cosmetic modifications including those to the windows of the shippons (Rooms 3 and 5), and the various widened doorways with metal sheet doors and skylights.
