# PARKHOUSE FARMHOUSE, PARKHOUSE ROAD, BARROW-IN-FURNESS, CUMBRIA

Archaeological Building Recording

Client: Dr and Mrs Mardel  
NGR: SD 22365 71042  
© Greenlane Archaeology Ltd  
July 2009

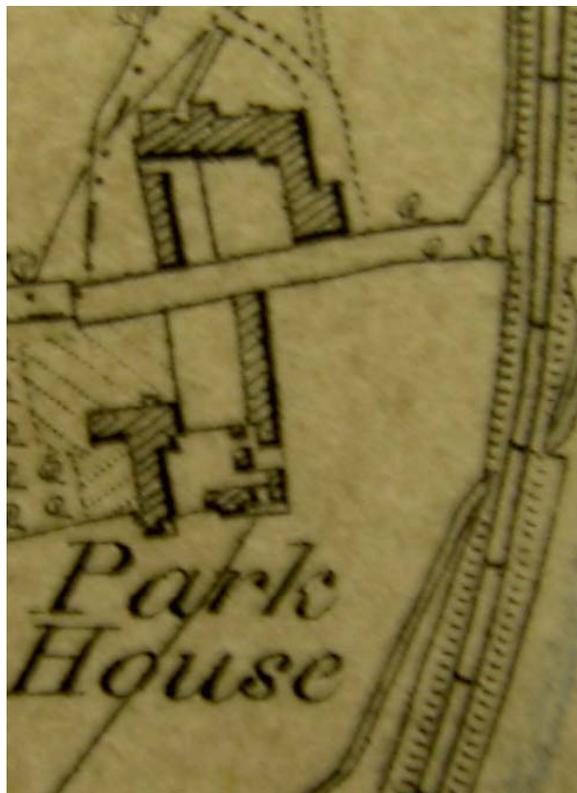
Plate 1: Ordnance Survey map, 1851

3.3.4 **Ordnance Survey 1851** (Plate 1): this map shows 'Park House' on the north and south sides of a track; on the north side of the track is a complex of buildings on the north, east and west sides of a courtyard, and on the south side are two long buildings orientated north-south, and five smaller buildings in the south-east. A mill race appears to enter the buildings surrounding the courtyard from the north. Parkhouse Farmhouse is situated in the south-west corner of the farm complex. The map shows the barn was in existence at this time and a smaller outshut was attached to its south side.

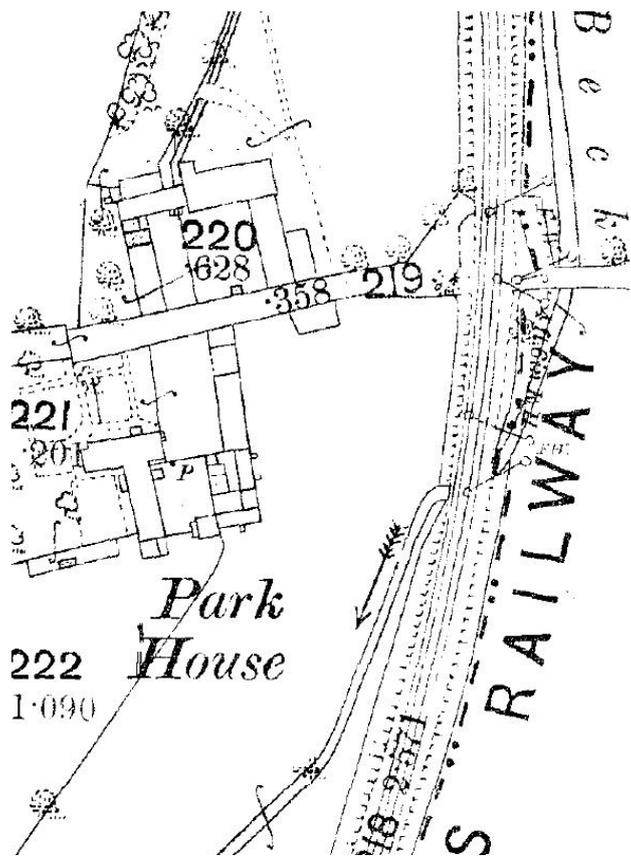
Plate 2: Ordnance Survey map, 1891

3.3.5 **Ordnance Survey 1891** (Plate 2): this is at a larger scale than the previous map, and shows a lot more detail. The barn with its outshut can be clearly seen at the south end of the farmhouse.

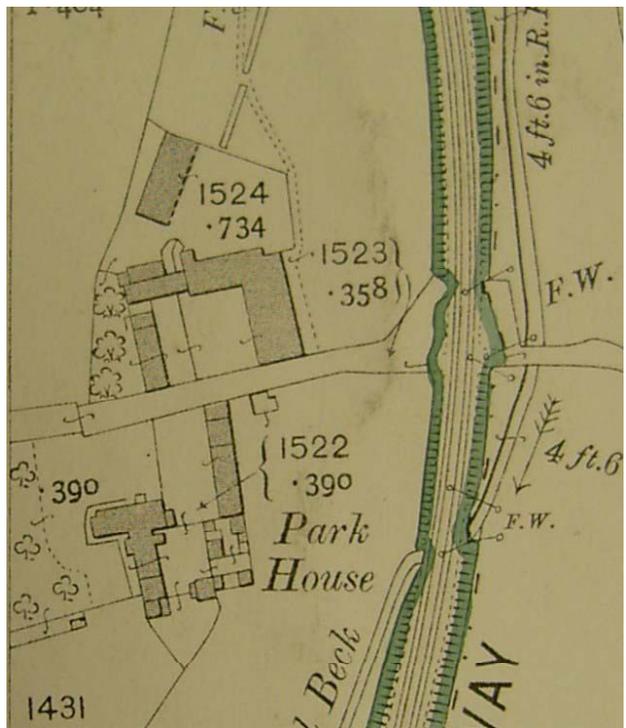
Plate 3: Ordnance Survey map, 1913

3.3.6 **Ordnance Survey 1913** (Plate 3): this map also shows the barn and the outshut clearly. Little has changed since the previous map.

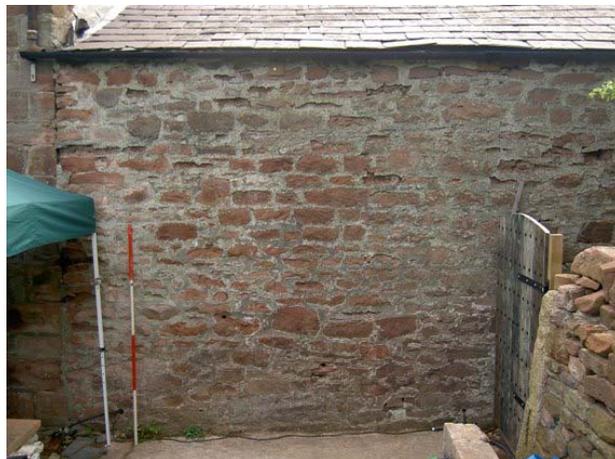
Plate 4: West elevation

4.3.1 **West elevation:** This elevation (Plate 4) has few features, although it has been coarsely re-pointed at some point. There is a clear butt joint between this building and the farmhouse to the north.

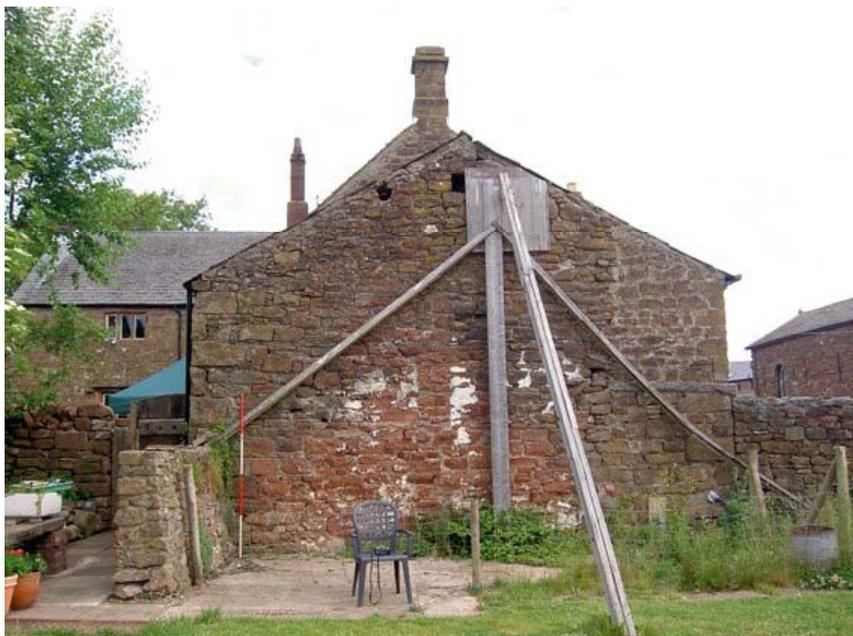
Plate 5 (left): South elevation

4.3.2 **South elevation:** this is the gable end of the building (Plate 5). It is constructed from a mixture of sandstone blocks of varying quality and some sandstone rubble with occasional pieces of slate. The east side has been rebuilt above two meters where there is a 1.6m long concrete lintel (Plate 6), and the sandstone blocks used in this section are of better quality than the remainder of the wall. At a height of approximately 2.5m is a thin course of slate extending from this repair to the east end of the elevation. Just below the apex of the roof is a small rectangular aperture, probably an owl-hole. There is a sandstone wall extending southwards some 3m from the west end of the elevation. The elevation is being supported by a temporary timber buttress due to the wall bulging out just below and to the east of the owl-hole. The cleaner red sandstone of the lower half of the wall indicates the previous existence of a small outshut butting this elevation.

5.2.1 There appears to have been little alteration to the structure since it was built, although there was evidently an outshut attached to the south elevation, which is no longer extant. The barn was most likely built at a later date than the farmhouse as it butts against it. The barn is also of a different construction, comprised of coarser stonework, and is not to the same standard as the farm house, which has regular cut masonry. The position of the outshut that was attached to the barn can be seen quite clearly by the reddish sandstone off-centre to the west side of the south elevation (see *Section 4.3.2*; Plate 5), which suggests that it was removed fairly recently.

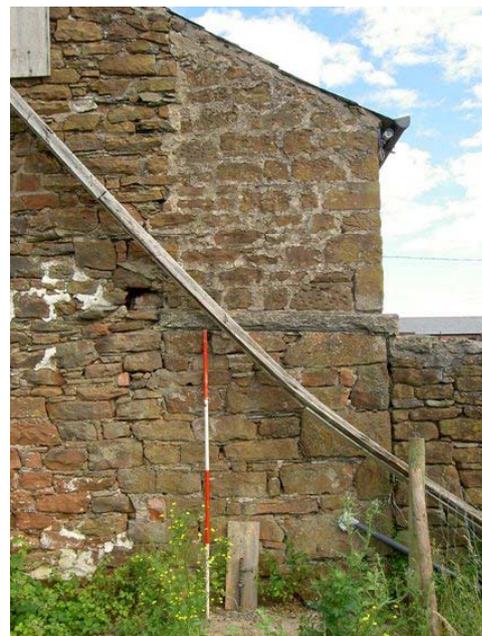
Plate 6 (right): Rebuild on the south elevation

5.2.2 The rebuilding of the south east corner of the barn was probably due to the installation of the concrete beam immediately below this work and two metres above ground level. This beam appears truncated, so may have originally extended out from the wall; it was perhaps associated with the outshut though not part of the original structure. The sandstone blocks used for this rebuild were probably imported from another building as, although of a similar material, they are of a different cut; they may have been re-used from Furness Abbey, something that evidently happened a great deal during the construction of the neighbouring farm buildings (Greenlane Archaeology 2006).

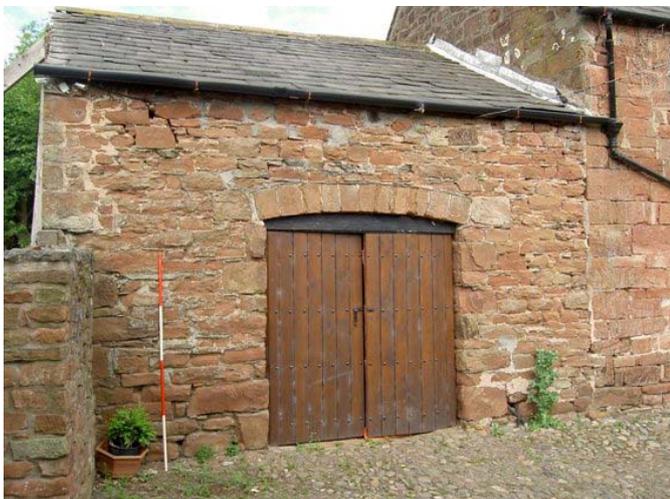
Plate 7 (left): East elevation

4.3.3 **East elevation:** this elevation (Plate 7) has a large central doorway with timber double doors hung directly from the jambs. The doorway has a shallow arch constructed of sandstone blocks approximately 0.3m high by 0.25m wide (Plate 8), above which is a layer of slate, probably originally a drip course. The door jambs are constructed of larger sandstone blocks, and there is also a threshold of large sandstone blocks. There is a sandstone wall butting the south end of the elevation and extending to the east. There is a clear butt joint between this elevation and the farmhouse to the north.

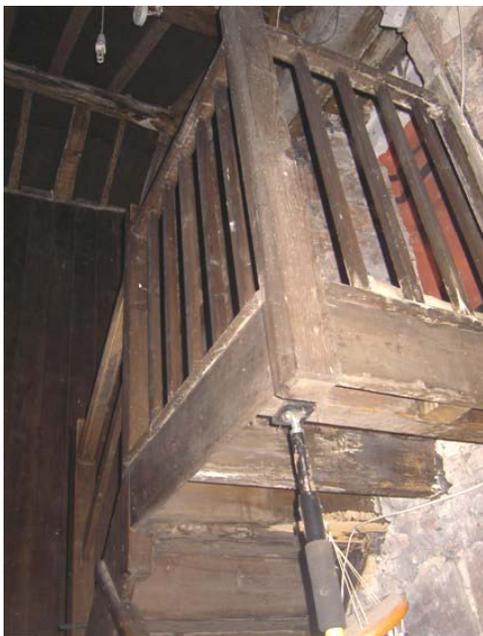
4.4.1 **North elevation:** this elevation is the south wall of the farm house to which the barn is attached. This wall is constructed of fine cut red sandstone blocks of a uniform height and width. There is an enclosed plain timber staircase (Plate 9) against it on the east side giving access to a doorway on the first floor to the farm house. The staircase is enclosed by timber stud and planking, which extends to the roof (Plate 10) and is accessed by a doorway on the ground floor at the east end. The staircase is a relatively plain timber construction with square posts, spindles, and hand rail.

Plate 9 (left): Stud and timber wall of enclosed staircase on the north elevation

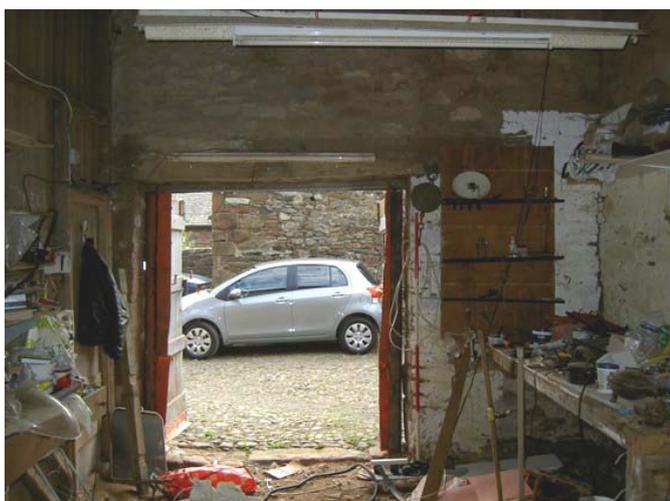
Plate 11 (left): East elevation

4.4.2 **East elevation:** this elevation (Plate 11 and Plate 12) has no features except the main doorway which has a large timber lintel (over 3.5m long by 0.3m deep and 0.25m thick). Notches cut on the underside suggest this is a re-used beam of some sort. This elevation has also been partly painted white and re-pointed. The double doors are of a timber plank and ledge construction and hung directly to the door jambs; there is a timber panel between the doors and the doorway arch.

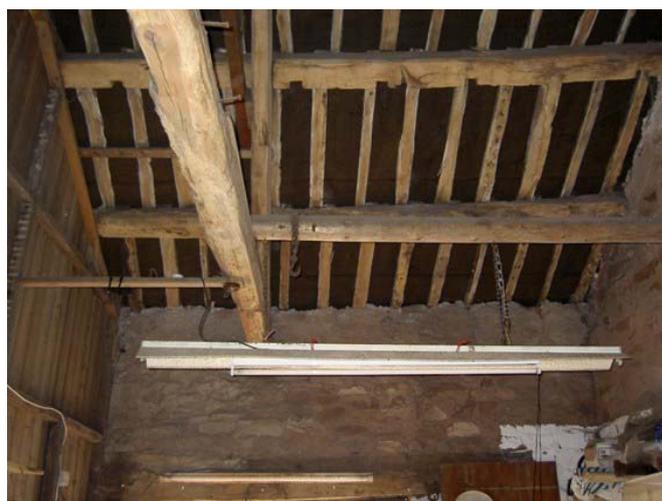
Plate 12 (right): East elevations and roof timbers

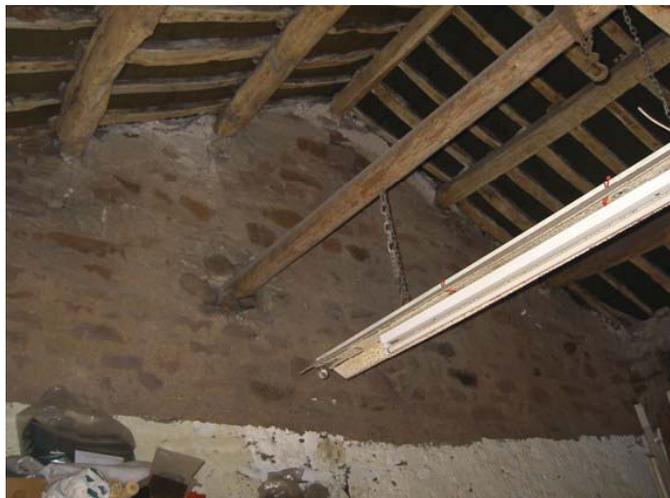
4.4.3 **South elevation:** apart from the owl-hole already mentioned, this elevation (Plate 13) is featureless except for a small recess (0.2m x 0.15m) at a height of 1.5m on the west side. The lower half of the elevation has been painted white, while the remainder has been heavily re-pointed (Plate 14). A beam has been inserted into the wall, which runs north/south across the room, the opposite end resting on the truss.

Plate 13 (left): Gable of south elevation

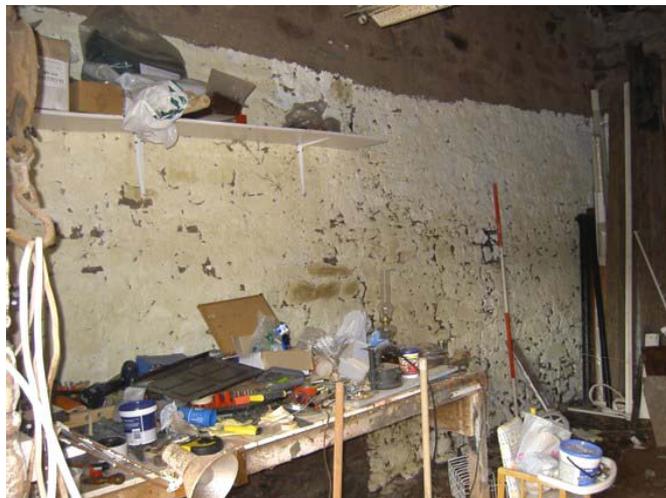
Plate 14 (right): Lower half of south elevation

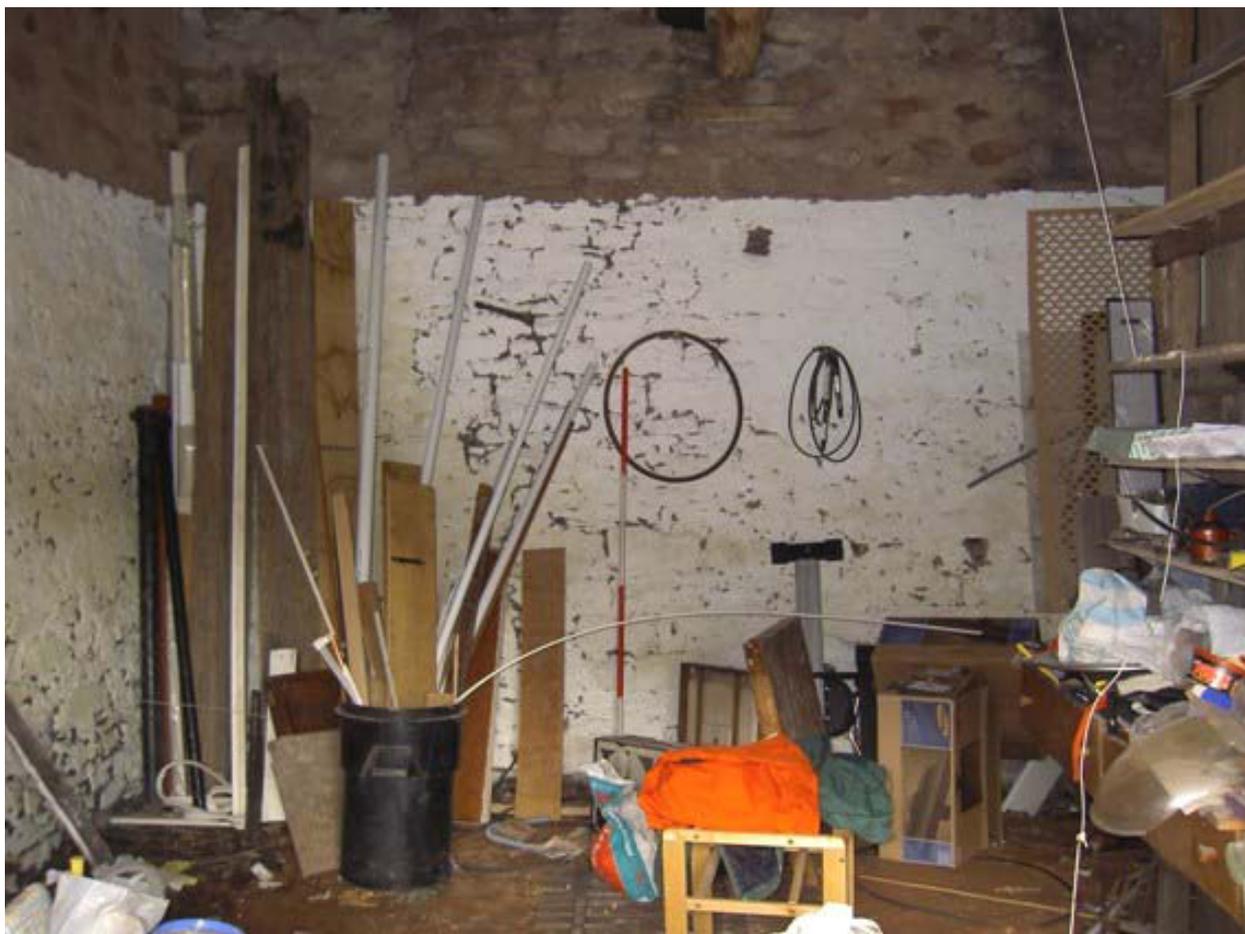
Plate 15: West elevation

4.4.4 **West elevation:** this elevation (Plate 15) is similar in appearance to the south elevation although there is a small recess (0.1m x 0.1m) situated centrally, at a height of approximately 2.5m.

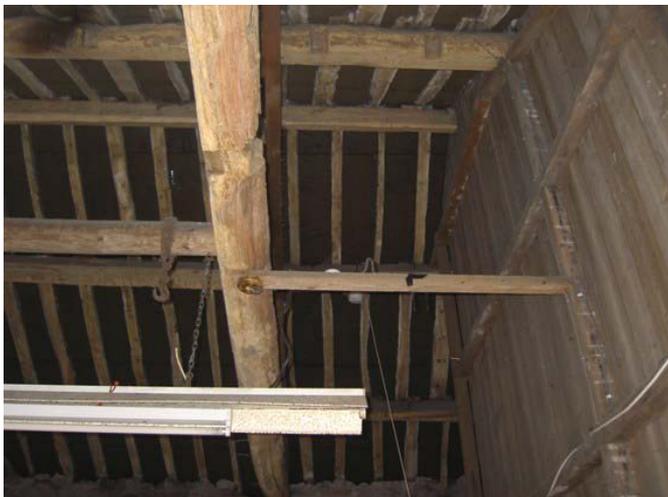
4.2.2 The roof has a centrally situated truss and A-frame supporting a ridge purlin with two purlins either side. The main truss is irregular, suffering from woodworm, and has been repaired at the east end. The principal rafters have been chamfered on the lower edges and have an empty slot, probably for the original cross member; the west rafter had a carpenter's mark in the form of the Roman numerals 'III'.

4.4.5 **Roof.** the roof (Plate 16) has a centrally situated tie beam truss supporting a ridge purlin with two purlins either side. The tie beam is hand-finished, irregular, and suffering from woodworm, and has been repaired at the east end. The principal rafters have been chamfered on the lower edges and have an empty slot, probably for the original collar. The west principal rafter has a carpenter's mark 'III' chiselled into it and a modern piece of timber has been attached on the opposite side to replace the missing collar. A further horizontal beam has been installed, which rests on the tie beam of the truss at the south end and is fixed into the gable wall at the north end. It supports a chain with a hook and a light fitting. The slates are supported by rafters and have roofing felt beneath.

**Plate 16 (left): Main truss and purlins**

5.2.3 The re-used timber present in the roof is possibly from an earlier building, made use of during the original construction, or used at a later date to replace timbers, possibly affected by woodworm, of which there is evidence in the main truss. The re-use of timber is known to have been commonplace from at least the 17<sup>th</sup> century (Tyson 2000, 41).

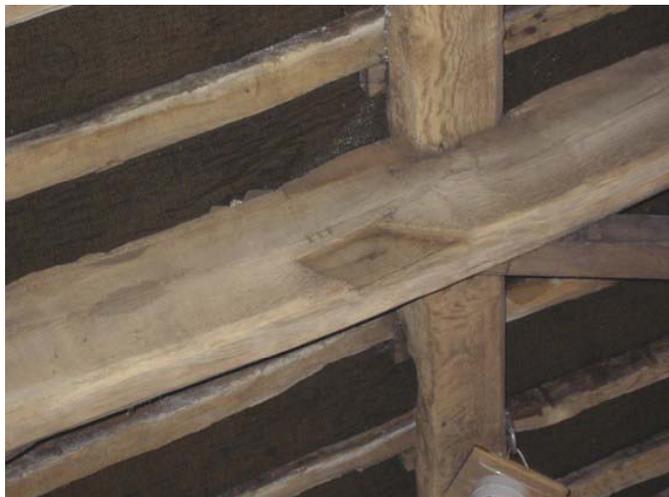
**Plate 17 (right): West principal rafter showing empty slot and carpenter's mark**
