# FORMER AUCTION MART, LIGHTBURN ROAD/BROGDEN STREET, ULVERSTON, CUMBRIA

## Archaeological Building Recording

Client: Modlar Ltd

Planning ref.: SL/2009/0911

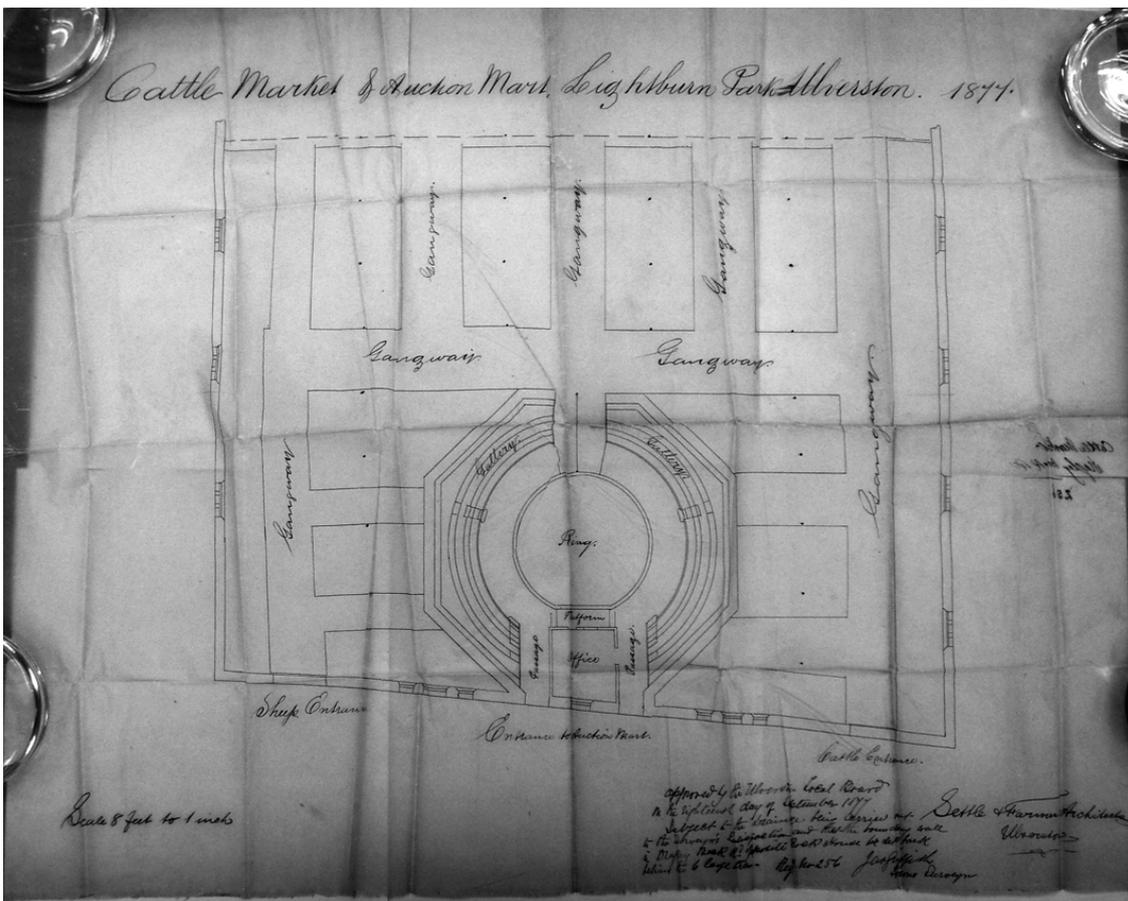
Plate 4: Plan of the Cattle Market and Auction Mart, Lightburn Road, Ulverston, 1877

3.3.5 **Plans for cattle market and auction mart, Lightburn Park, Ulverston, 1877:** detailed plans of the cattle market and auction market were produced by Settle and Farmer Architects, Ulverston, in 1877, including the cross-section and elevations facing to Lightburn Road and Dragley Beck Road (CRO(B) BSUD/U/23 1877; CRO(B) BSUD/U/256 1877). It is recorded on the plan, in a note written by the Town Surveyor at the time, James Griffiths, that these were 'approved by the Ulverston Local Board on the eighteenth day of September 1877 Subject to the drainage being carried out to the surveyors satisfaction and that the boundary wall in Dragley Beck R<sup>d</sup> opposite Rock House be set back behind the 6 large trees' (Plate 4). The elevation to Lightburn Road (the north elevation) is symmetrical (Plate 5); the entrance to the sheep auction ring is to the left and a similar entrance is shown for the cattle to the right. The windows and doors are quoined and the roofline has ornate stonework. There are four large mullion windows shown on the east elevation to Dragley Beck Road (now Victoria Road). The roof structure above the auction ring is shown in considerable detail in cross-section, as are the tiered galleries surrounding the ring (Plate 6). A small section of the longitudinal section was also produced (Plate 7).

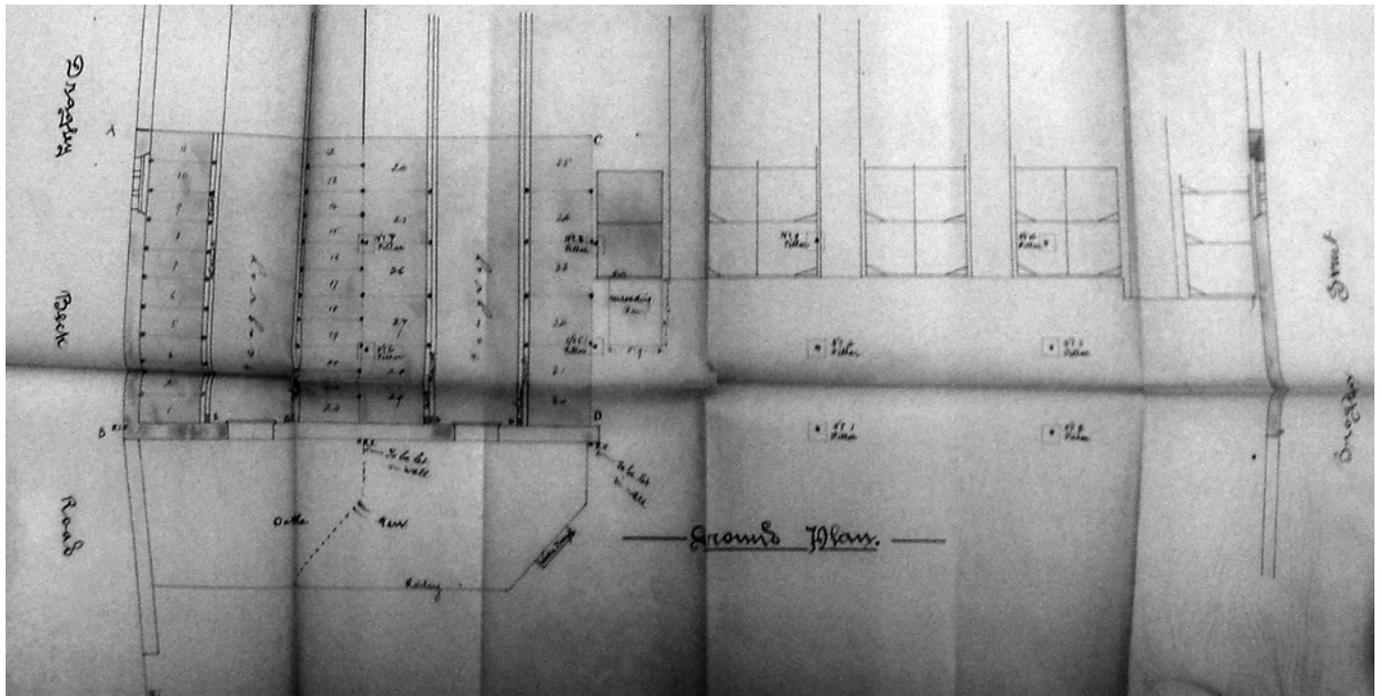
Plate 9: Plan of alterations to Auction Mart, 1889

3.3.6 **Alterations to the Auction Mart, 1889:** proposals were submitted for alterations to the south-west end of the Auction Mart in 1889, although the architect's name is not given (CRO(B) BSUD/U/655 1889). Although these proposals were for further cattle sheds along Dragley Beck Road (now Victoria Road), which is outside the current survey area, the south end of the sheep auction ring is also shown (to the right hand side on Plate 9). It is also interesting to note that the structural details relating to the columns and principal rafters (Plate 10) are identical to those which were recorded during the on site survey in Room 4 (see Section 4.4.6).

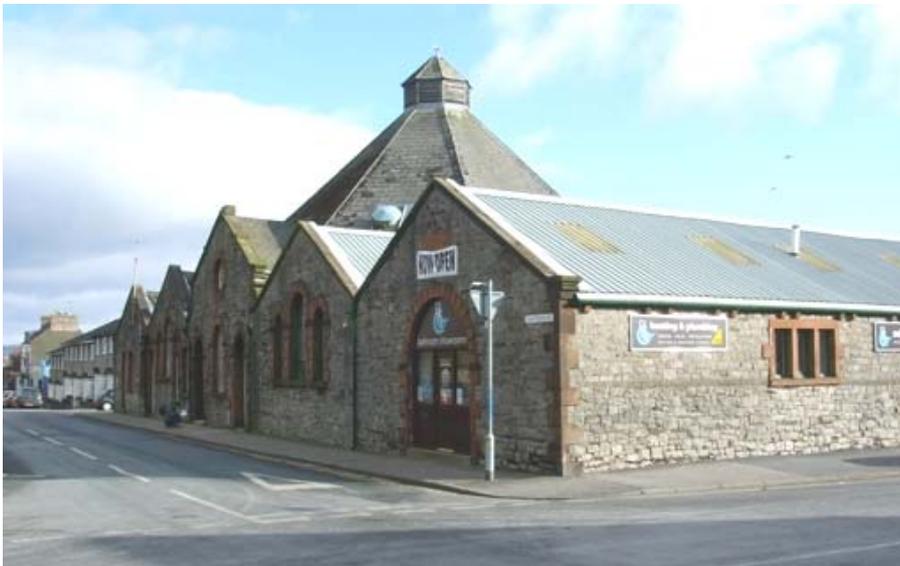
**Plate 24: General view of the Auction Mart from Victoria Road**

4.2.1 The majority of the building was rock-faced with limestone in rough courses with pieces of slate used as levelling (Plate 24). The quoins and door and window surrounds were neatly dressed red sandstone. The doors appeared to be original, where visible, but the windows were mostly boarded up. The roof was a mix of asbestos sheets with plastic skylights and slate. Slate was used extensively on the octagonal section and on the west end of the building. The raised octagonal roof had a slatted timber louvre on top, skylights and additional vents. The front elevation had more decorative detail than those to side and rear (Figure 2). The building is approximately orientated north/south, with the front facing north onto Lightburn Road, the east facing onto Brogden Street, and the south towards a neighbouring garage.

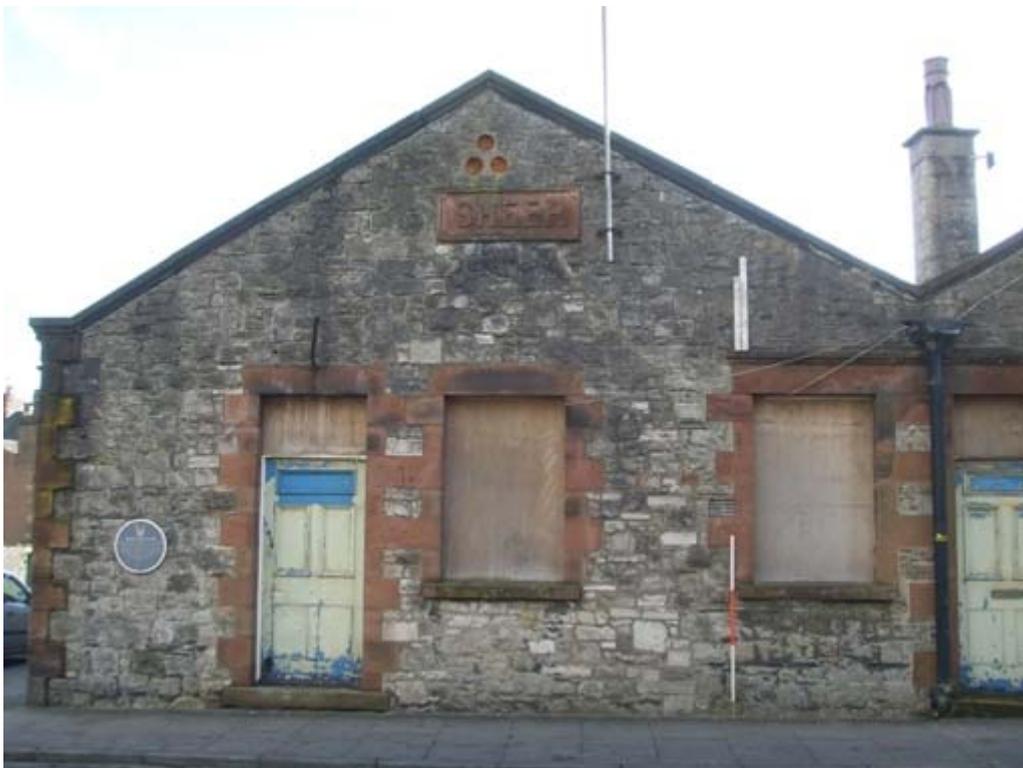
**Plate 25: West end of the north external elevation**

4.3.1 **North elevation:** the building had five gables along its length from Brogden Street to Victoria Road (Plate 24) but the current site comprised only the three western parts (see Figure 2). The east part was gabled with coping along the ridge and kneelers, and there were quoins at the east end of the elevation (Plate 25). Below the gable was a stone sign labelled "SHEEP.", and three inserted ceramic pipes. There was a plaque attached to the wall midway between the quoins and the doorway, to the west end of the elevation (Plate 23). The doorway was at ground floor level and had neat quoins flush with the wall and the original five panel moulded door. There were two windows to the west of this, again with flush quoins and lintel. The entire area around the west door and window was rebuilt, incorporating a much finer grey-brown mortar and pieces of re-used neatly dressed stone and marble. The west window was below a moulded entablature that continued over a door to the west (below the second gable), but the windows were otherwise the same. The lintel and quoins of this window connect together with those of the door to the west. There was an iron vent next to the quoins on the east side of this window, marked "R<sup>D</sup> N<sup>O</sup> 444334 COWELL'S SANATORIUM VENTILATOR". This Registered Design Number dates to 1904 (Kolojeski 2004).

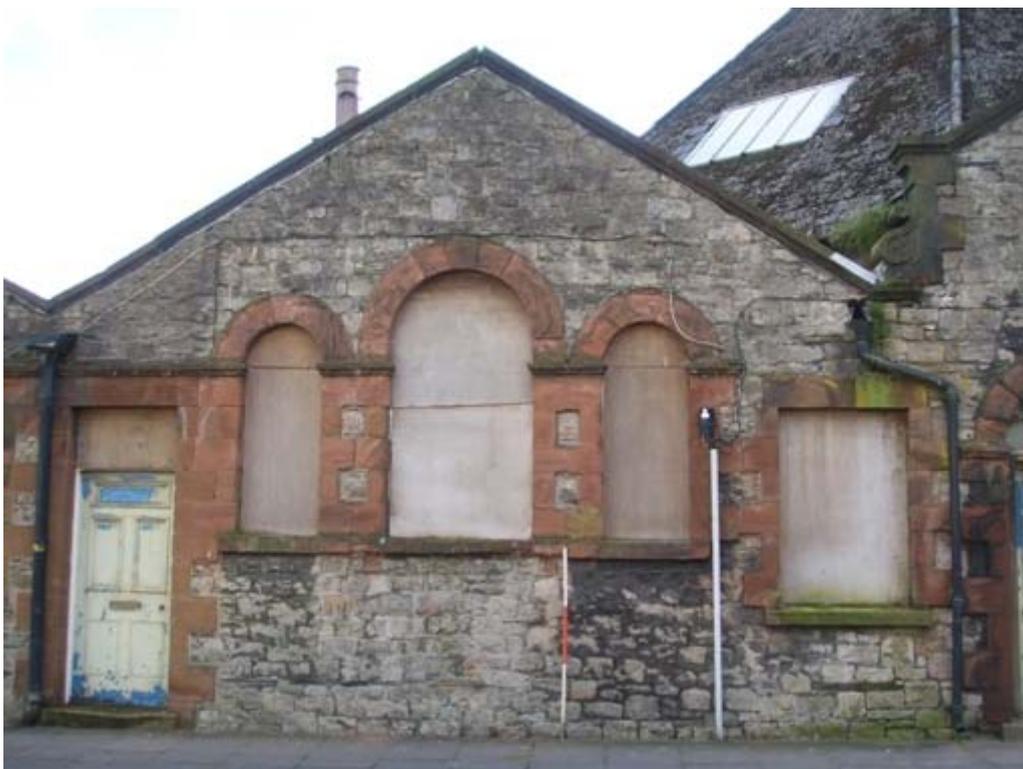
**Plate 26: Central part of the north external elevation**

4.3.2 The central section was another gable with plain coping (Plate 26). There was a doorway on the east side below the entablature, housing what appeared to be an original five-panel moulded door with a boarded light above. The quoins were flush with the wall. There was a three part window to the west of this doorway, across the centre of the gable, with round-headed arches and projecting quoins and a moulded string course. All of the windows were boarded up. There was another window to the west with projecting quoins, lintel, and sill.

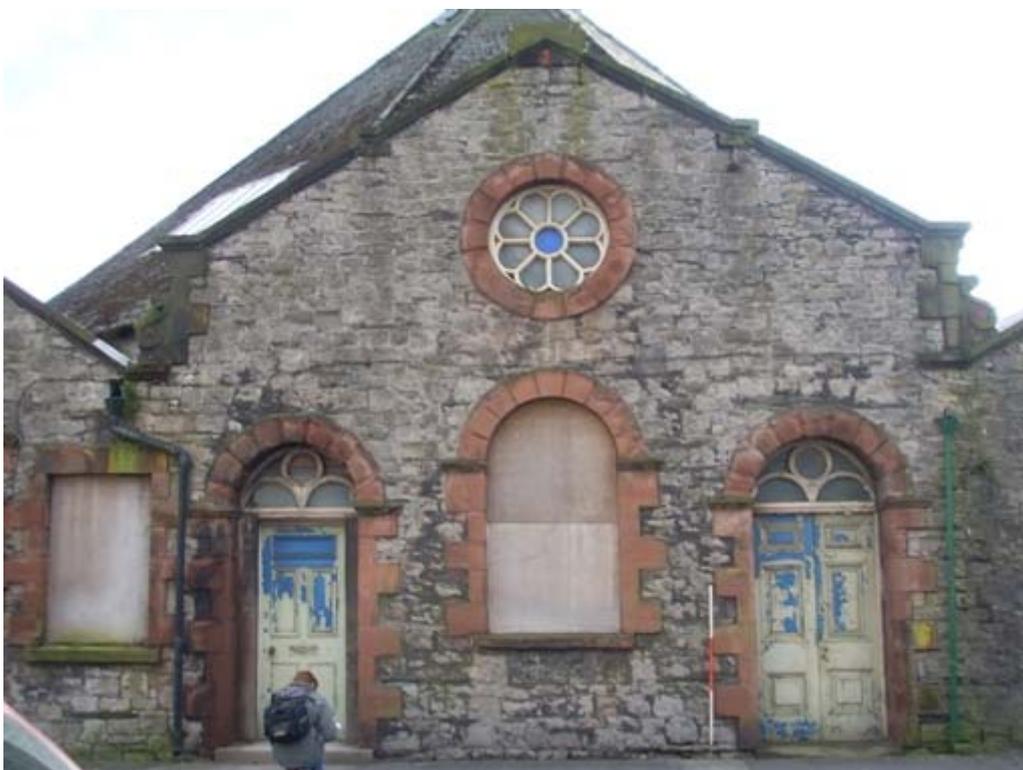
**Plate 27: East end of the north external elevation**

4.3.3 The octagonal roof was above the west end gable. There was a round window below the apex with petal patterned lights and a round centre (Plate 27). The gable had kneelers and scrolls brackets and quoins at the sides and step-in coping and a square block on top. This part of the building had a pair of doorways with projecting quoins and a moulded string course. The doors appeared to be the original five- and six-panel moulded doors, and had round heads with geometric over lights.

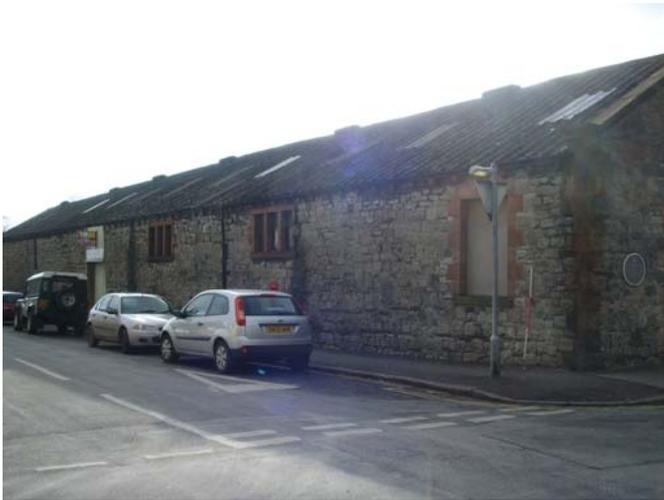
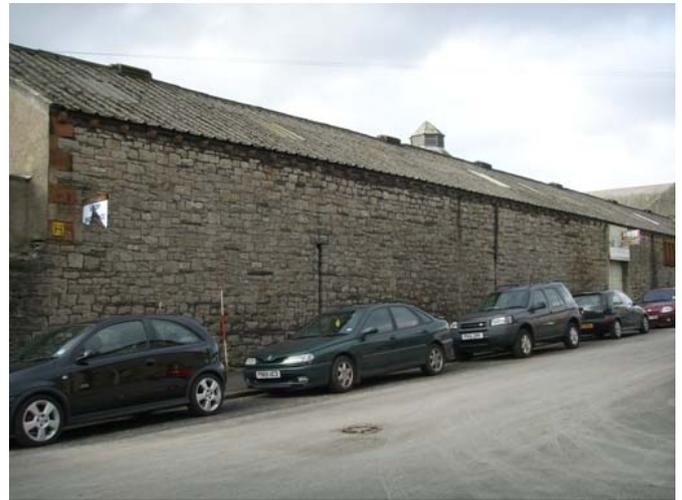
4.3.4 **East elevation:** this elevation was largely plain. There was a row of rounded (quarter circle) corbels below the roof and a mix of plastic and iron rain water goods. Dressed quoins projected from the face of the wall at the north end (Plate 28). Towards the north end of the elevation there was a large window with neat quoins flush with the wall. This window had evidently been inserted; darker and smoother mortar had been used in the re-build, which incorporated different and possibly re-used stone and marble. There were two further small three-light mullion windows, set at a high level, to the south of this door. A post box had been inserted below the northernmost of these two windows. There was a large doorway with a double plank door slightly to the south of centre on this elevation (to the left side on Plate 28 and on the far right on Plate 29). This doorway had a machine cut timber lintel and a tongue and groove plank section above with a sign attached for "Cumbria Crystal". There were two recessed areas in the wall to the south of this doorway for down pipes (Plate 29). Quoins finished the wall at the south end, but modern concrete blocks had also been incorporated. The broken remains of a sign, which once read "SHOP ENTRANCE", were still attached to the south end of the building. The wall continued at a lower level to the south, with a gateway knocked through, and there was a door to steps at the south end. Behind this wall, immediately against it to the east side, there stood a higher wall which had a modern rendered finish.

**Plate 28 (left): North end of the east external elevation**

**Plate 29 (right): South end of the east external elevation**

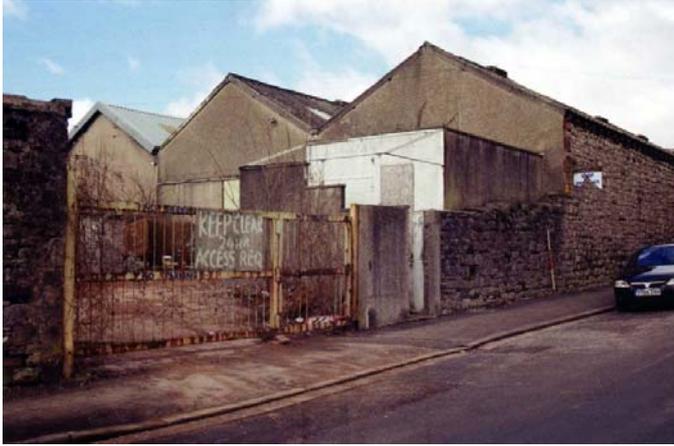
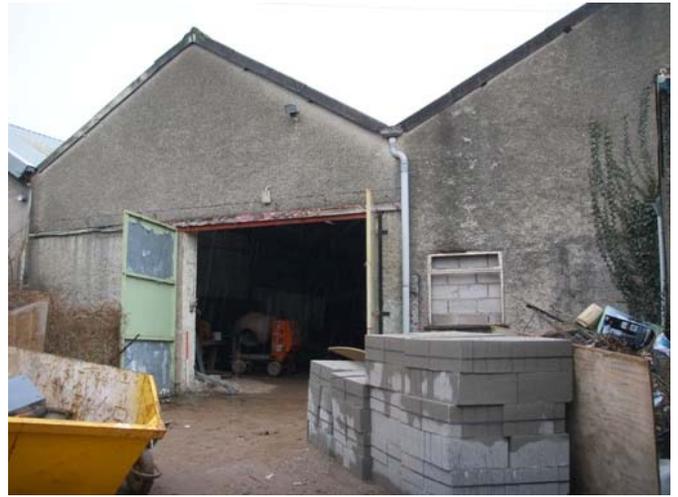
4.3.5 **South elevation:** this elevation was formed by the gable ends of Rooms 4 and 7. A further concrete block extension (forming Room 7a) obscures the lower east end of Room 7 and the east external wall of this small room butts against the boundary wall to the east. There was a large double door which opened into Room 4 and a small blocked window to the east of this below the gable end of Room 7 which had been blocked with modern concrete blocks. The elevation was finished with a modern roughcast render.

**Plate 30 (left): Oblique view of the south external elevation**

**Plate 31 (right): South external elevation**

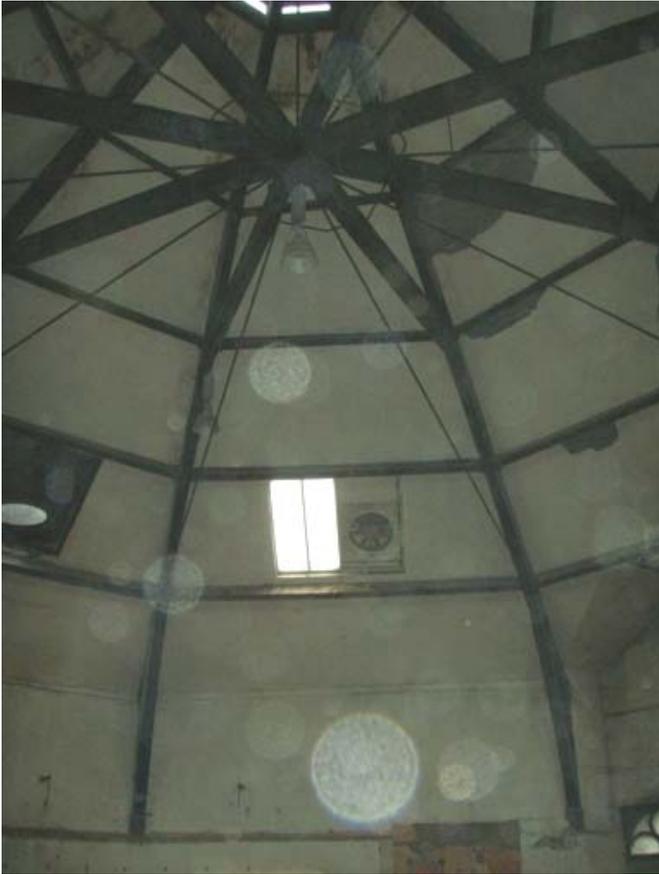
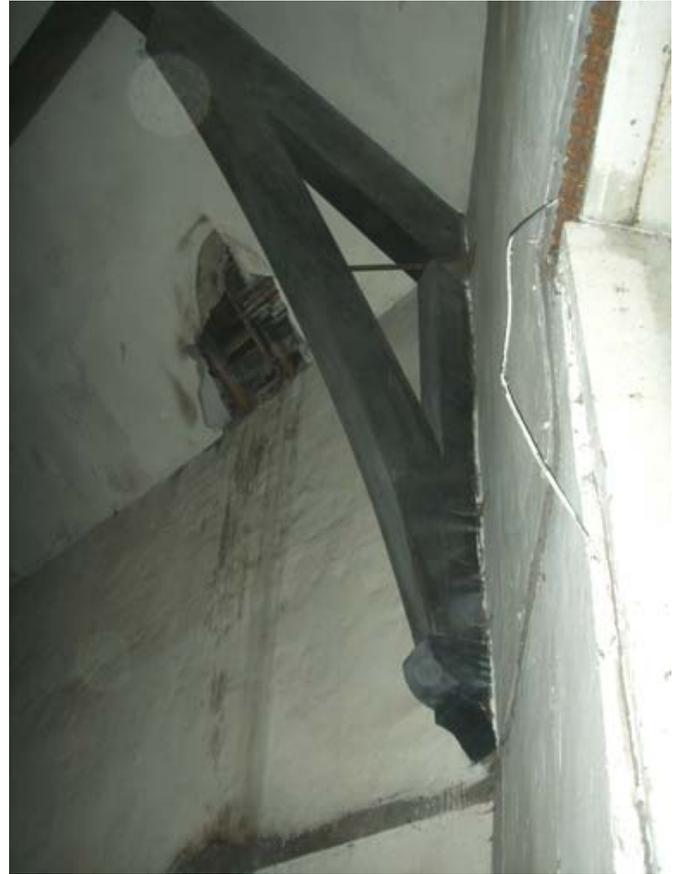
4.4.1 **Room 1:** this formed an octagonal space open to its tall conical roof, which was topped with a louvered lantern. All of the walls were finished with render and painted white, although the timber of the roof structure was painted dark grey (Plate 32). The floor was concrete, with a large rectangular pit across the centre orientated north/south and another large pit against the west elevation covering approximately a third of the floor area: both of these pits had been recently partially filled with rubble. The roof structure was supported by four trusses each comprising a principal rafter supported by an upright post sat on a semi-circular ovolo-moulded corbel projecting from the wall and an angled bracket (Plate 33). The tie beams connected between each half of the truss and met in the centre forming a cone. In addition there were iron tie rods running between the principal rafters and the junction of the tie beams, plus one forming a 'king post' between the junction of the tie beams and the top of the lantern and smaller ones between the principal rafters and the angled bracket (Figure 4). Each pitch of the roof had five purlins and the roof was finished with painted lathe and plaster, with a single large four-light skylight in each side, although at least one of these had been converted to house a metal vent. There were various metal brackets attached to the walls and roof, and scars for other ones that had evidently held pipes and other fittings associated with the former glass works.

**Plate 32 (left): Conical roof structure of Room 1**

**Plate 33 (right): Roof supports, Room 1**

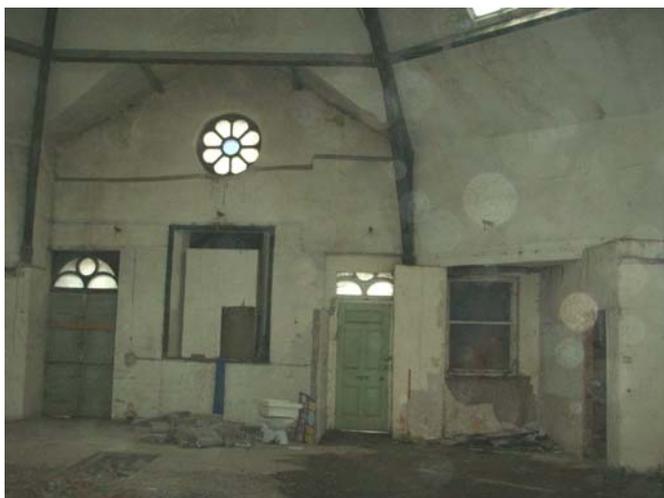
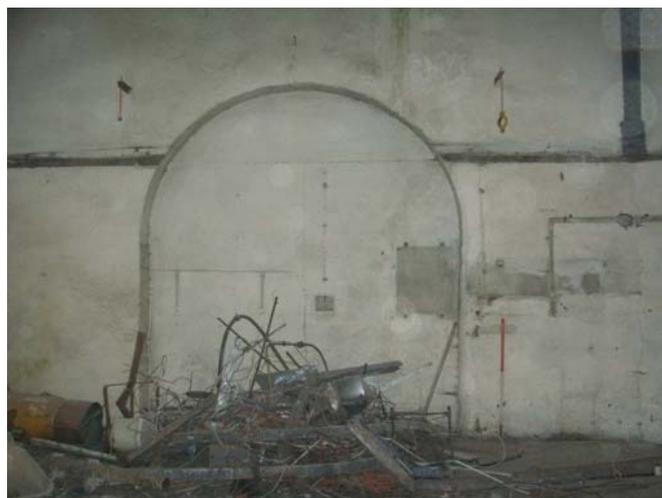
4.4.2 The elevations are largely plain, although the north incorporated the gable forming part of the front elevation and included a pair of pedestrian doorways either side of a window, with a circular window in the apex above (Plate 34); adjacent to the eastern doorway there was a short section of concrete block walling extending into the room. The central window had modern timber boxing over it, and there was a further smaller window to the east. This had evidently been inserted, there were hand-made bricks in the jambs and sill and it had a concrete lintel, and it had a two-light sliding sash casement. In the north-east corner a hand-made brick wall had been added, extending into the room to form the corner of Room 2, supported by iron I-beam lintels. This had originally not extended to the height of the roof, but concrete blocks had recently been added so that it did and it contained a pedestrian door leading to Room 2 with a concrete lintel. The east elevation was otherwise unremarkable, although there was another doorway in the centre, which appeared to be a modern insertion as it had concrete blocks in the jambs and a concrete lintel. There was a large doorway to the south-east, which had been inserted as there were bricks in the jambs and it had iron I-beam lintels. To the south-west there was a large round-headed doorway that had been blocked leaving an alcove (Plate 35).

**Plate 34 (left): North elevation of Room 1**

**Plate 35 (right): Blocked alcove to the south-west, Room 1**

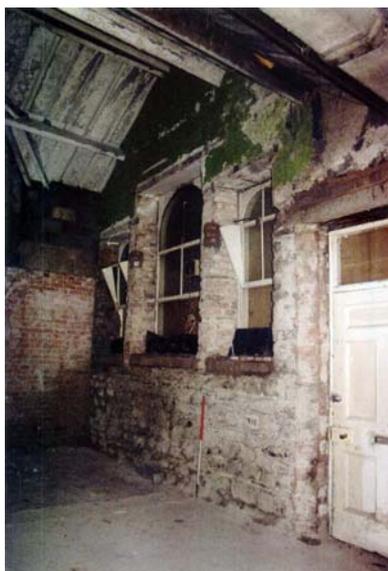
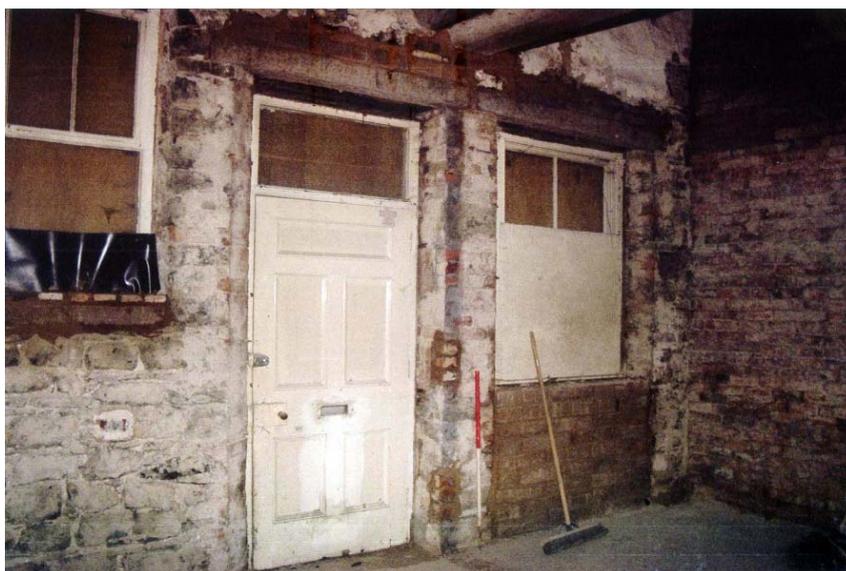
**4.4.3 Room 2:** this room had been extensively altered prior to the building recording taking place, with some internal walls removed, plaster stripped from the walls, and some minor rebuilding around the windows. The floor was timber boards, covered with vinyl with the scars of the former internal walls visible. It was open to the roof, which comprised the exposed underside of corrugated asbestos sheets and the original timber purlins. The north elevation had three grouped windows on the west side (Plate 36); a large central one flanked by two smaller ones, all round-headed and with relatively modern hinged timber casements, timber lintels and red brick forming the splayed central column. There was a doorway to the east with brick jambs, splayed on the west side and incorporating the sandstone visible externally on the east side, and a concrete lintel. There was a window to the east, with splayed brick jambs originally extending to the floor, although the lower part had been filled in, and with a four-light sliding sash casement and concrete lintel (Plate 37). Immediately to the east was a small square hole with a timber lintel, which corresponds to the vent visible externally. The east elevation was brick built; the bricks being machine made and laid in an English Garden wall bond (at a ratio of five rows of stretchers to one row of headers). There was a small, low-level opening in the centre, filled with concrete blocks, which had evidently not continued into the room beyond. To the south of it there was a pedestrian doorway with a timber lintel that has recently been filled with concrete blocks.

**Plate 36 (left): West end of the north elevation of Room 2**

**Plate 37 (right): East end of the north elevation of Room 2**

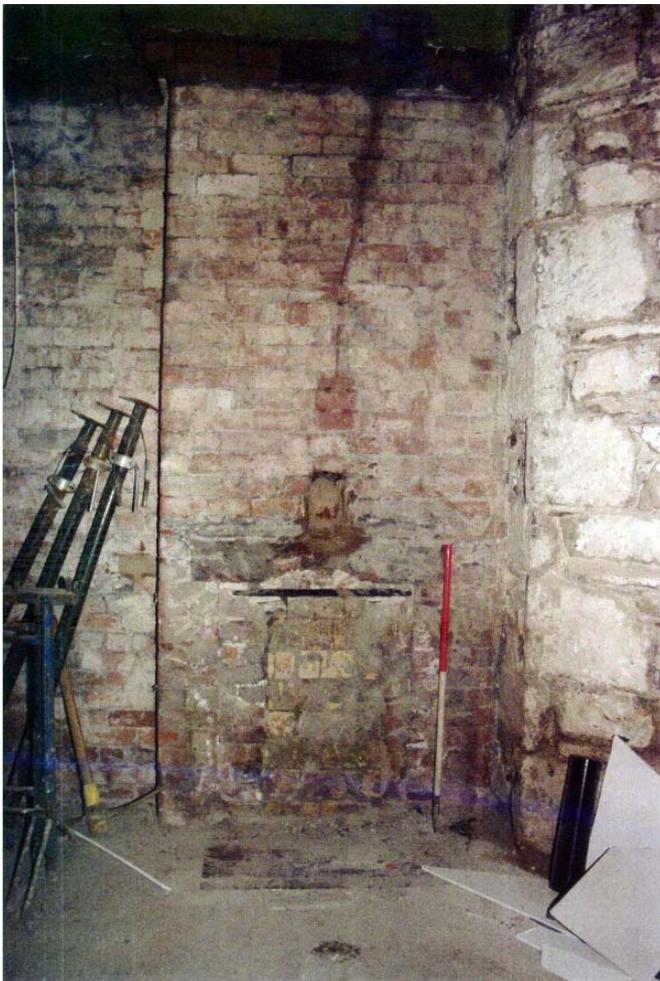
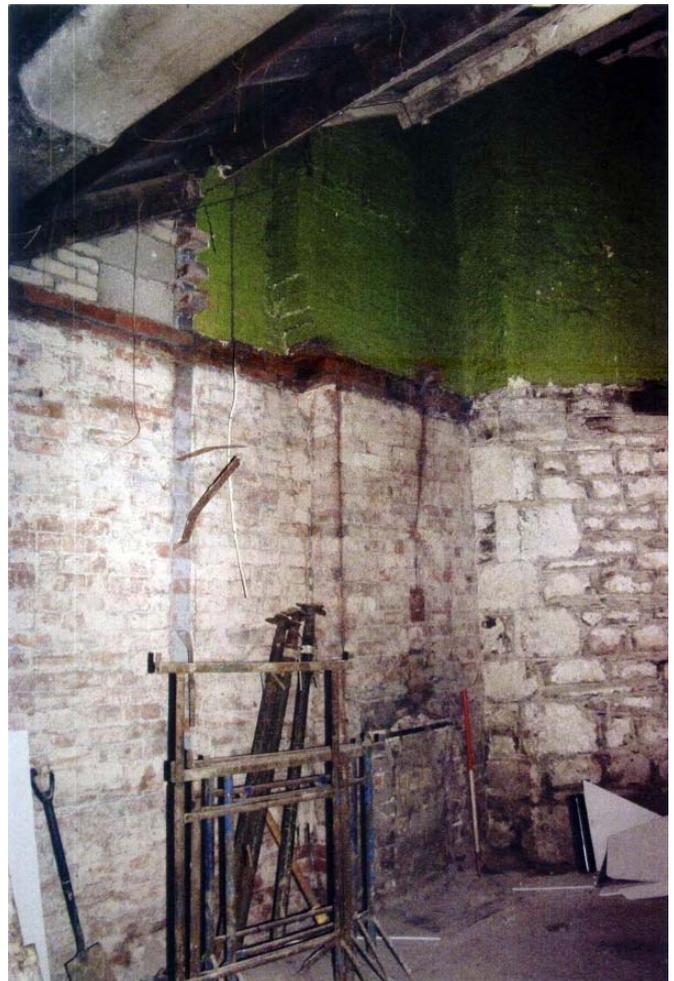
4.4.4 The south elevation had a doorway on its east side that appears to have originally been a window that had been recently enlarged; it also had a timber lintel. The remainder of this elevation was constructed from machine made brick essentially laid in stretcher bond but with occasional irregular headers. It steps out on the west side to form a chimney breast within which was a fireplace blocked with yellow fire bricks and with a sandstone lintel (Plate 38); the floor in front of it was finished with small glazed tiles. The fireplace had evidently been blocked on more than one occasion and a hole had also been knocked into the flue, presumably to accommodate a later stove. The chimney breast was stepped out towards the east making it slightly wider towards the top (Plate 39), and to the east of it there were bricks projecting from the wall (formerly part of the internal wall) marked 'Furness Brick Co'. The west end of the south elevation butted the wall of the octagonal Room 1, which was built from limestone with large neatly dressed quoins. The west elevation was formed by the brick added wall that projects into Room 1 and had a small pedestrian doorway on the south side with a concrete lintel and butted the north and south elevations. The bricks were rougher and more hand made compared to those in the south and east elevations, and laid in stretcher bond forming a wall a single brick thick. The iron I-beams supporting the wall where it had been knocked through into Room 1 were marked 'LANARKSHIRE STEEL COY LTD SCOTLAND 10X6 BRITISH STEEL'.

Plate 38 (left): Fireplace in the south elevation of Room 2

Plate 39 (right): Chimney breast in the south elevation of Room 2

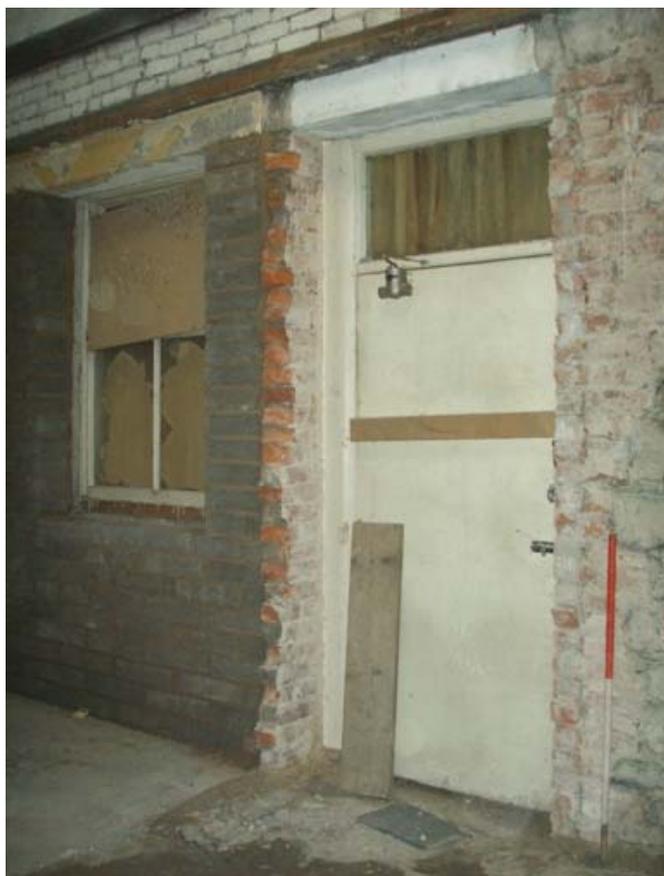
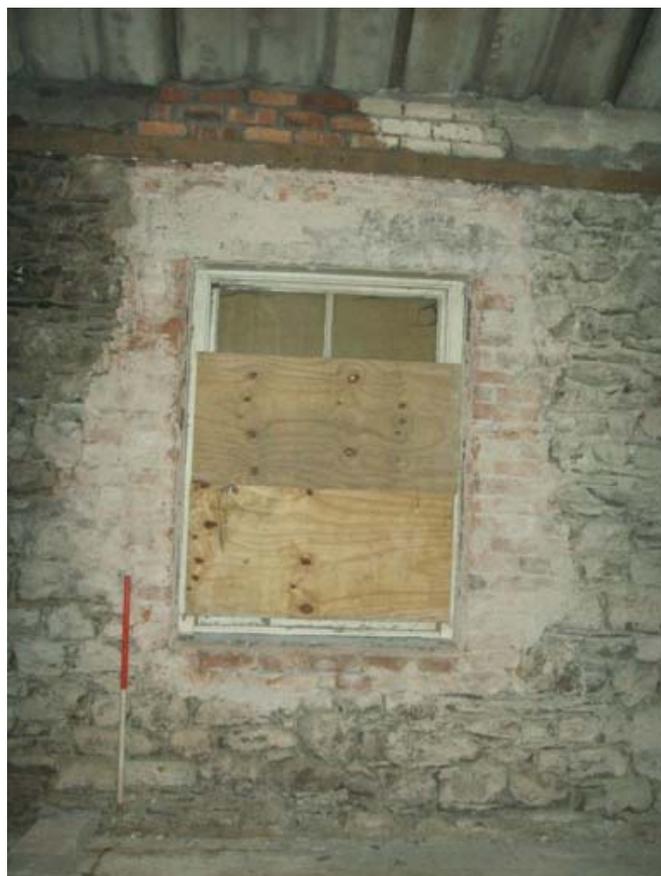
4.4.5 **Room 3:** the east half had a concrete floor while the west was timber boards, the different types of flooring being either side of the scar of a former internal wall. The entire floor was covered by vinyl. The north elevation had a window to the west with a four-light sliding sash casement and modern concrete block infilling around it (Plate 40). There was a doorway to the east with a modern door and single over light; both the doorway and the window have concrete lintels and the east jamb of the doorway was brick, indicating that it was rebuilt. In the north-east corner there was a piece of apparently

re-used pecked yellow sandstone. The east elevation had a large window with a four-light sliding sash casement, which was evidently inserted as it had numerous hand-made bricks in its jambs and a concrete lintel (Plate 41). The south elevation was constructed from rough hand-made brick laid in English garden bond at a ratio of five rows of stretchers to one row of headers. The scar of a partition wall was evident in the centre and there was a doorway on the east side, which was apparently inserted as the jamb was rebuilt and had a timber lintel. The west elevation was also brick, apparently butted by the south elevation but butting against the north. It had a doorway on the south side, which had been recently blocked with concrete blocks and there were two 'alcoves' in it to the north, also filled with concrete blocks. The tops of the west and south elevations had been recently raised with concrete blocks, suggesting that they originally had lower suspended ceilings.

**Plate 40 (left): North elevation of Room 3**

**Plate 41 (right): Window inserted in the east elevation of Room 3**

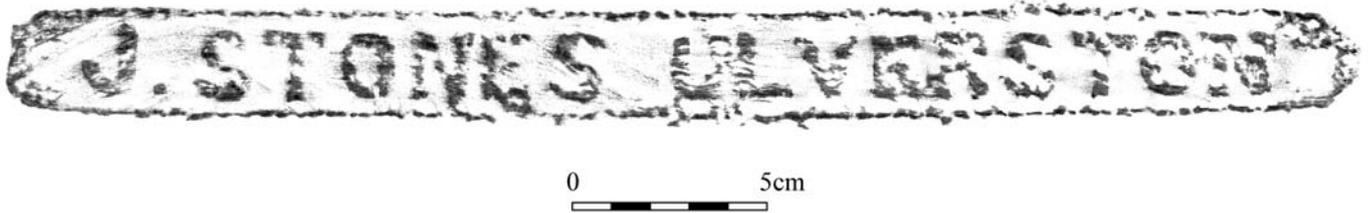
**4.4.6 Room 4:** this formed an awkward space comprising what would originally have been a large open area extending to the south, subsequently sub-divided into smaller rooms and separated from the other half of the original building by modern concrete block walls, but also including an area that was formerly subdivided into small rooms where the walls had been removed and replaced with new concrete block ones. In general the floor was concrete and lower at the north end, although it had been partially removed here, and sloping to the south. The roof was a complex structure with two sections each with its own truss spanning two bays meeting at a cast iron column – this arrangement undoubtedly continued to the west into the separate part of the building, where it was supported by another row of cast iron columns. Each truss comprised a pair of principal rafters and a collar with an iron tie rod running from the base of each principal to a junction plate before connecting to a vertical tie rod joined to a metal bracket linking the top of the two principals and effectively forming a king post. There were three purlins per pitch. The columns were all similar in style, but with some variation: typically they had a flanged top attached to which were two metal plates housing the ends of the tie beams. The four most northerly examples were marked 'J. STONES ULVERSTON' (Plate 42), while the rest had no evident mark (Plate 43). One was evidently quite different to the rest and appeared to be much more modern, while two

**Plate 42: Rubbing taken of the maker's mark found on the four most northerly metal columns in Room 4**

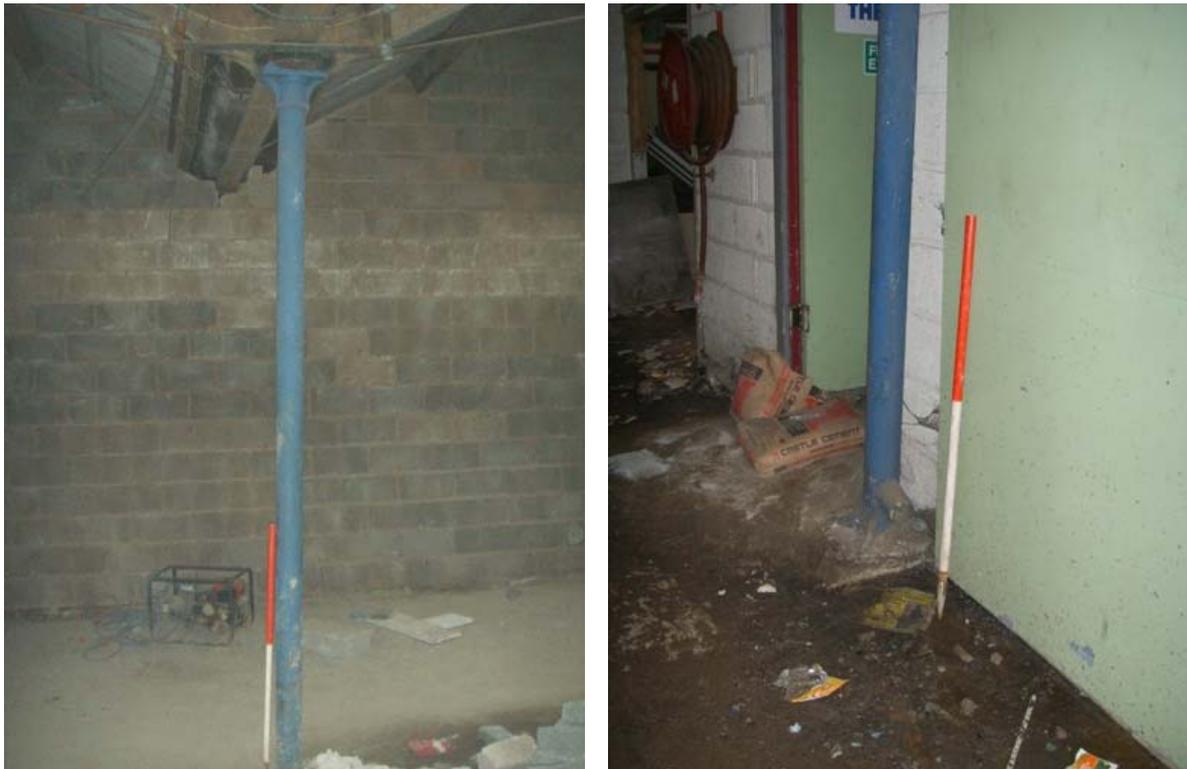
incorporated pipes projecting from the base suggesting that they were connected to the rainwater drainage system (Plate 44). At the north end the roof structure was slightly different in that there was only one truss spanning a single bay with a half truss supported by an upright post sat on a semi-circular corbel against the wall forming the octagonal Room 1.

**Plate 43 (left): Detail of typical J. Stones marked iron column**

**Plate 44 (right): Detail of column base showing incorporated pipe**

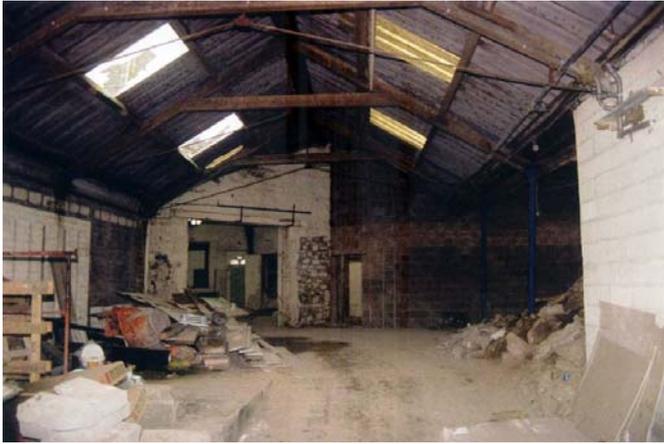
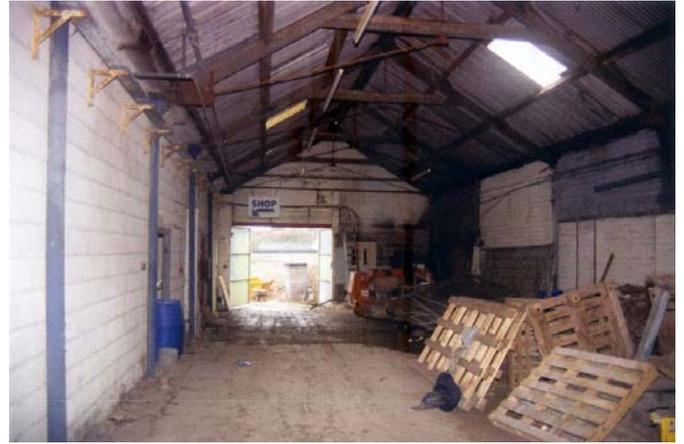
4.4.7 The north elevation comprised a brick wall forming the south elevation of Room 3 and Room 2 (Plate 45). The west side comprised machine made brick laid in stretcher bond, which was extended to the east by rougher hand-made brick, all of which had been recently modified and raised in height. The west elevation was constructed of limestone at the north end and comprised the main east and south-east wall of Room 1, before returning to the west further south, where the large inserted door was situated, and continuing as an inserted concrete block wall. This wall ran along the line of the second row of cast iron columns supporting the roof, which were actually incorporated into the wall. The scars of recently removed modern concrete block walls were evident in the south-west corner, and the south elevation was a relatively modern concrete block construction forming a gable (Plate 46). The original trusses extended as far as the wall and there was a large doorway with an iron I-beam lintel incorporated into the wall. The east elevation at the south end was also constructed from concrete blocks, running along the line of columns. The wall had four doorways providing access to the rooms to the east (Rooms 5-8), and it returned at the north end to the east where it butted the original east elevation, which was relatively plain apart from two three-light windows with sloping sills.

Plate 45 (left): North end of Room 4

Plate 46 (right): South end of Room 4

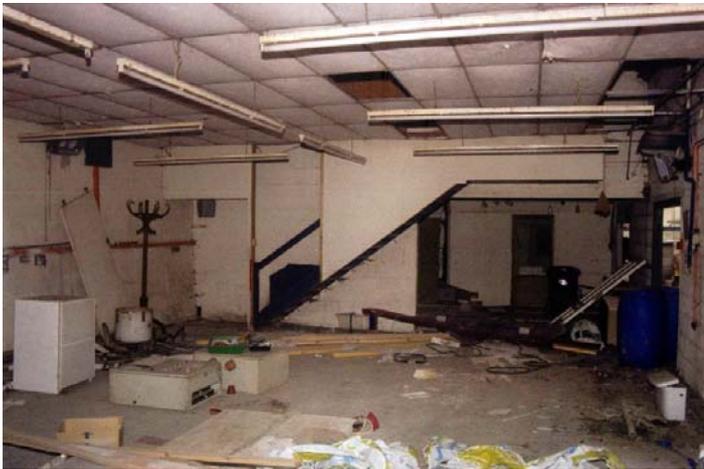
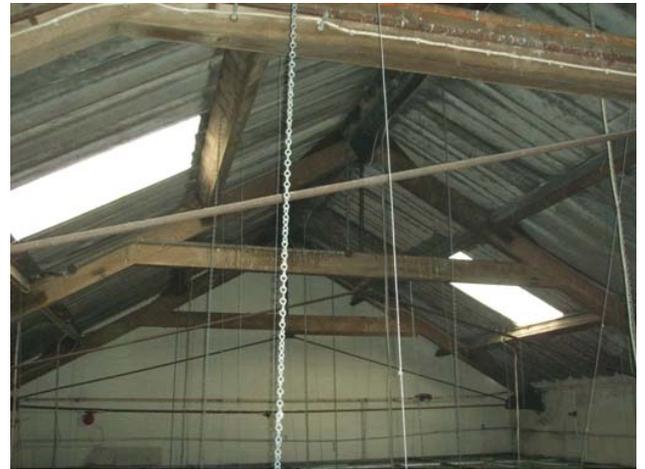
4.4.9 **Room 6:** this too had an entirely modern finish (Plate 47), with a concrete floor and suspended polystyrene ceiling with the original trusses above (Plate 48). The walls were all finished with modern plaster and paint with modern electrical fittings throughout. There was a doorway to the north and two large doorways to the west, while the partition wall to the south had been removed leaving the room open to Room 6a. The staircase leading to the first floor (Rooms 9 and 10) was situated on the east side of the south elevation.

Plate 47 (left): Room 6/6a

Plate 48 (right): Original trusses above Room 6
