**HISTORIC BUILDING SURVEY:
OUTBUILDINGS AT LODGE FARM, SKENDLEBY, LINCOLNSHIRE**

Planning Application: Pre-application
NGR: TF 4325 7073
Oasis Reference: allenarc1-108884
AAL Site Code: SKLF 11
Global Accession Number: LCNCC: 2011.359

Report prepared for
Scorer and Hawkins,
on behalf of Mr Guest

By
Allen Archaeology Limited
Report Number 2011059

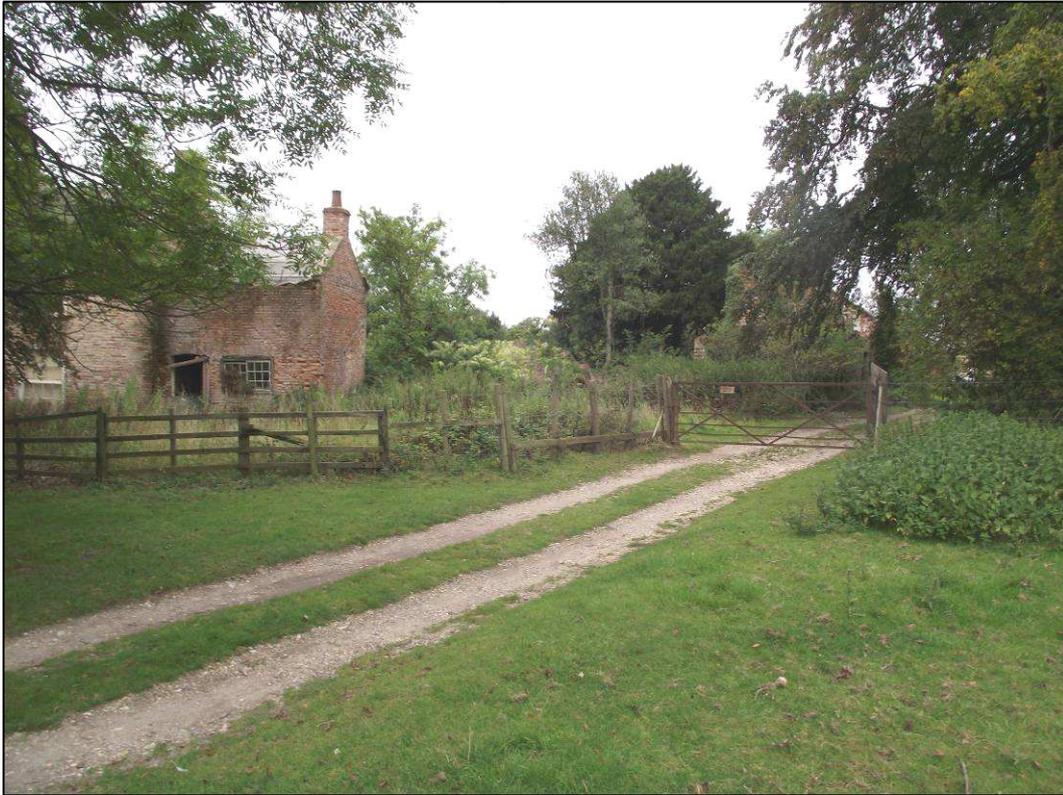
Plate 1 (Shot 4): General view of the site showing Lodge Farm House to the left and its outbuildings to the right, looking west-north-west

- 6.1 To differentiate between the individual outbuildings, each structure has been given an identification letter (A – K), with A being the outbuilding closest to the house (Plate 1).
- 6.2 Very little remained of outbuilding A and it was heavily overgrown at the time of survey with no possibility of detailed survey. It appears to have been built using an English Garden Wall Bond (Plate 2).
- 6.3 The adjacent dovecote, B was in a poor state of repair with no remaining north-east elevation or roof. The remaining elevations are again in English Garden Wall Bond. It appears to have been a two storey structure and was probably used as a store on the ground floor, as the nesting holes are restricted to the upper part of the south-west elevation. Protruding brickwork towards the top of the elevation forms a number of perching ledges (Plate 3).

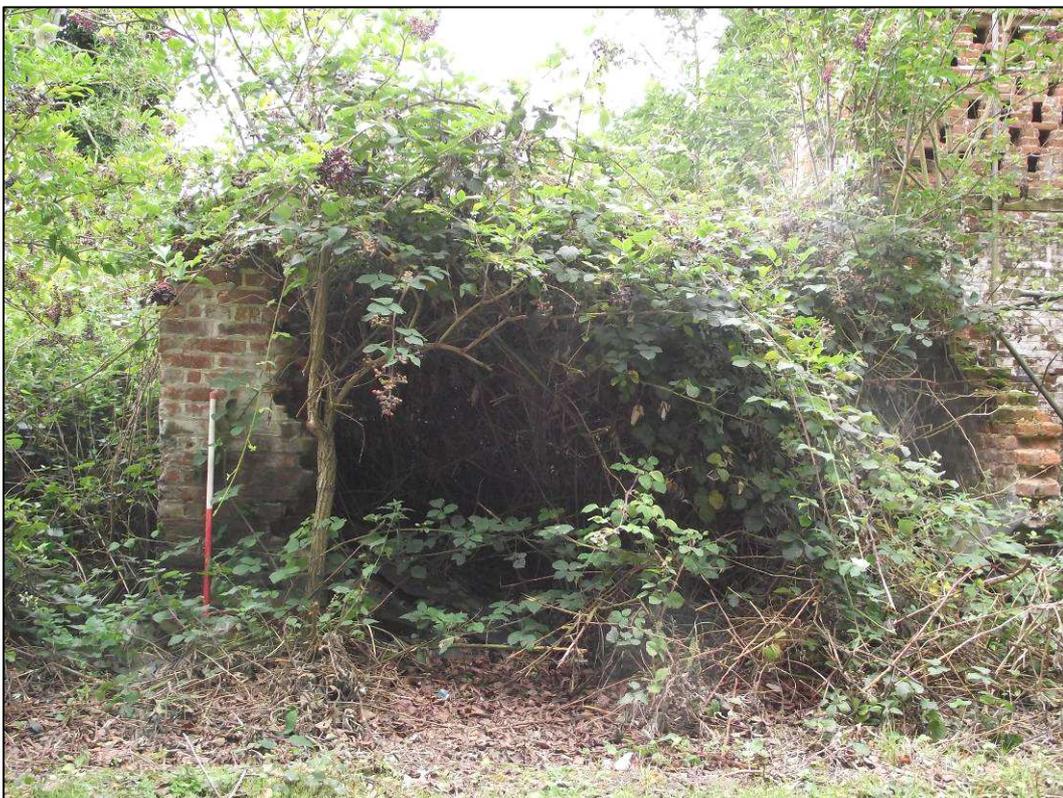
Plate 2 (Shot 8): Remains of overgrown outbuilding A, looking south-west

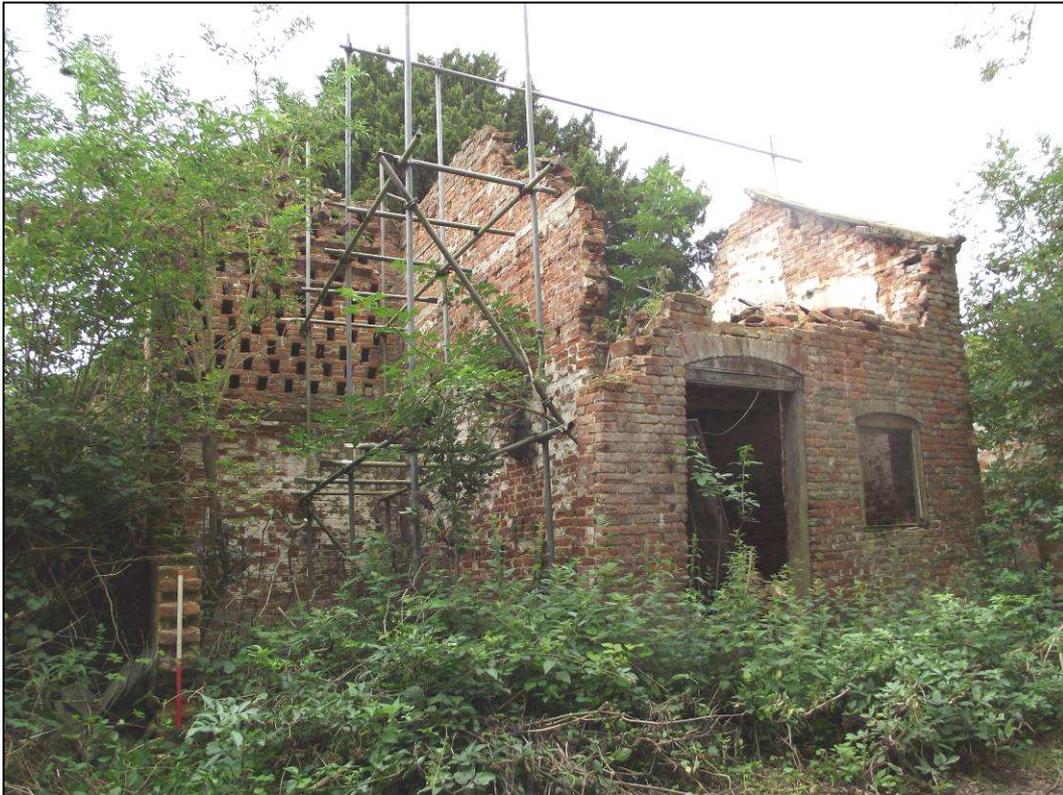
Plate 3 (Shot 9): North-west elevation of dovecote B and outbuilding C, looking south-west, showing nesting holes and perching ledges

- 7.2 Some evidence for the function of the buildings was apparent. For example, the square recesses in the upper portion of outbuilding B clearly indicate its use as a dovecote. This is a typical development of the late 18th/early 19th century, when dovecotes were commonly built on an upper storey of a building rather than as a freestanding structure with nesting holes running the full height of the building. This change was a result of the introduction of the brown rat to England in the mid 18th century, which was larger and more voracious than the native black rat and was capable of climbing the walls of the dovecotes (<http://www.mccannhistoricbuildings.co.uk/truthaboutdovecotes/>).

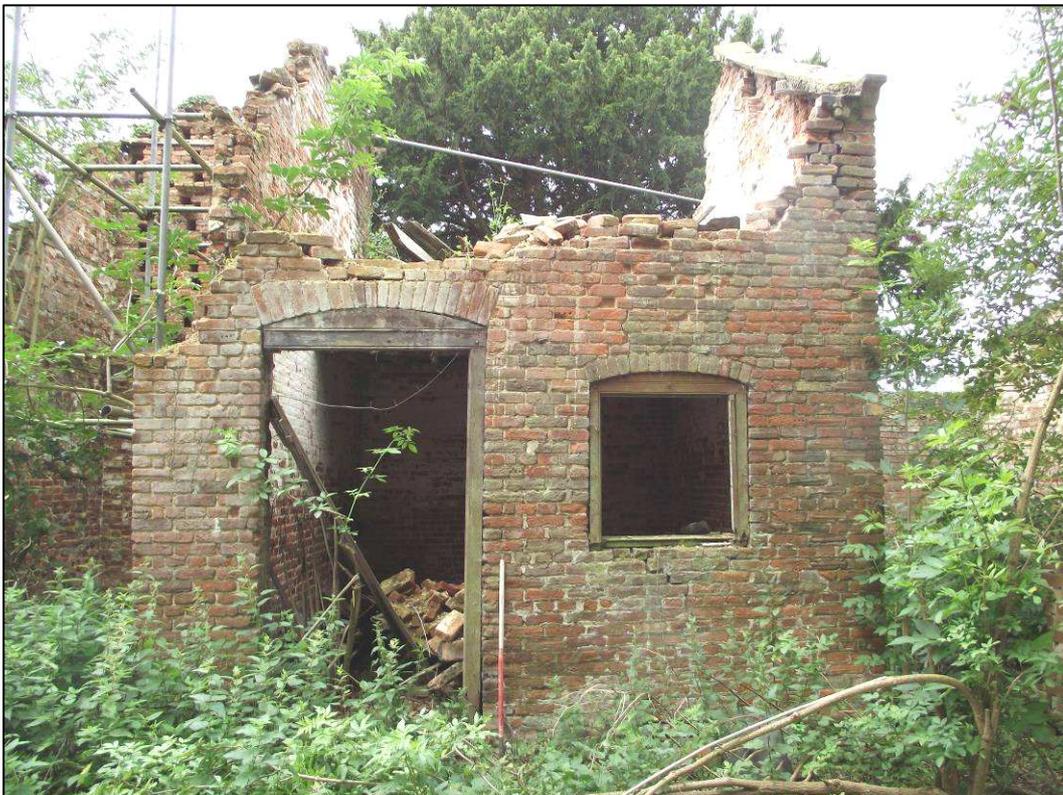
Plate 4 (Shot 12): North-west elevation of outbuilding C, looking south-west

- 6.4 The majority of outbuilding C is standing, although the roof has collapsed. The profile of the surviving walls indicates it was a double pitched gabled roof however. The north-east elevation has a doorway with a wooden frame (the door is present but has been taken off its hinges) and a cambered rubbed brick arch. There is also a square window with a wooden frame with a segmental arch of brick headers laid side on (Plate 4). The interior has partially been painted white and apart from a hole in the south-east corner, the planked first floor is still intact (Plate 5).

- 7.3 The adjacent two storey building C, clearly had an upper hayloft, as indicated by a blocked pitching hole, and as such may have served as a stables. Until the beginning of the 19th century this was common practice, reflecting the importance of the horse in the hierarchy of farm animals, as it provided insulation and made feeding easier, by dropping the hay through a hatch into the stable below. However, the procedure was gradually abandoned during the 19th century as the heat and moisture from the animals also resulted in rapidly rotting floor boards of the hayloft above (Wade-Martins 1991). In this instance there was no evidence for any hatches in the surviving floor, suggesting it is a replacement of the original, marking a modification of the building's function in line with the changing conventions of agricultural practice.

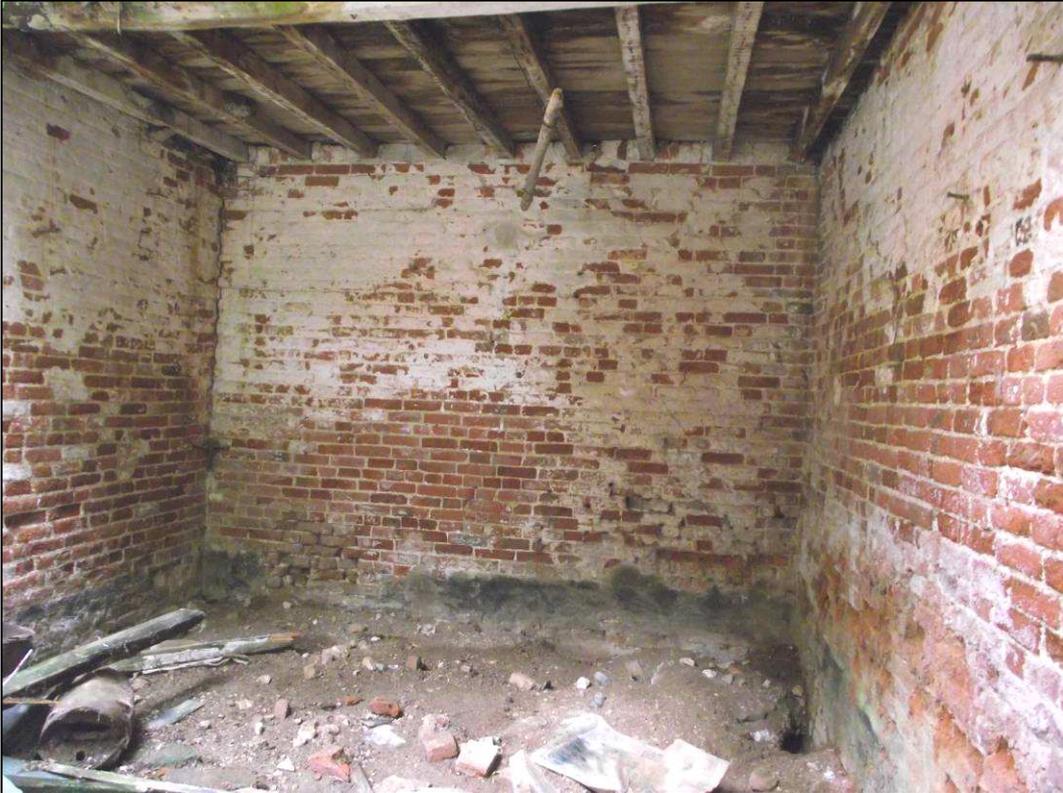
Plate 5 (Shot 13): Interior of outbuilding C, looking south-west

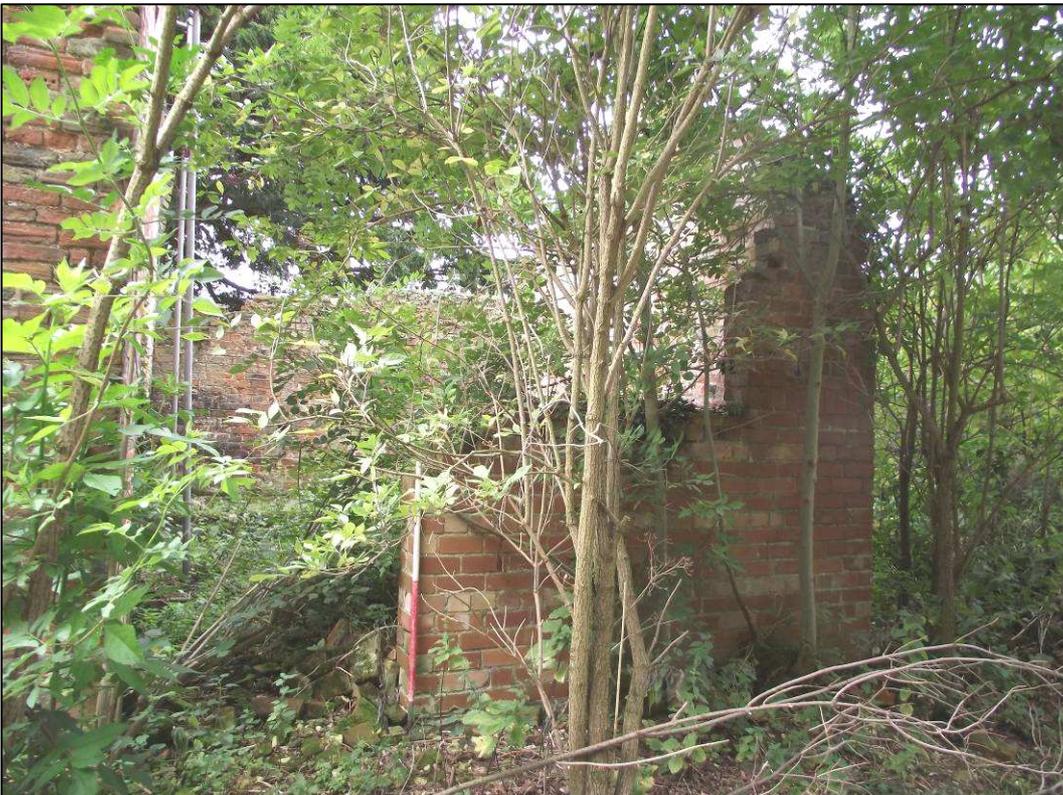
Plate 6 (Shot 15): Repaired north-west elevation of Milk Parlour D, looking south-west

- 6.5 The north-west elevation of the outbuilding D has recently been repaired but not to its full original height. The remaining walls are partially intact and the roof is missing. There is an overgrown concrete feeding trough along the south-west elevation, suggesting the building served as an animal shelter/feeding shed (Plates 6 and 7). The south-east elevation show scarring of two roofs, one double pitched and a lower single pitched roof. The upper double pitched roof appears to a later addition as the gable shows the roof scar cutting across a bricked up possible former pitching hole (Plate 8).

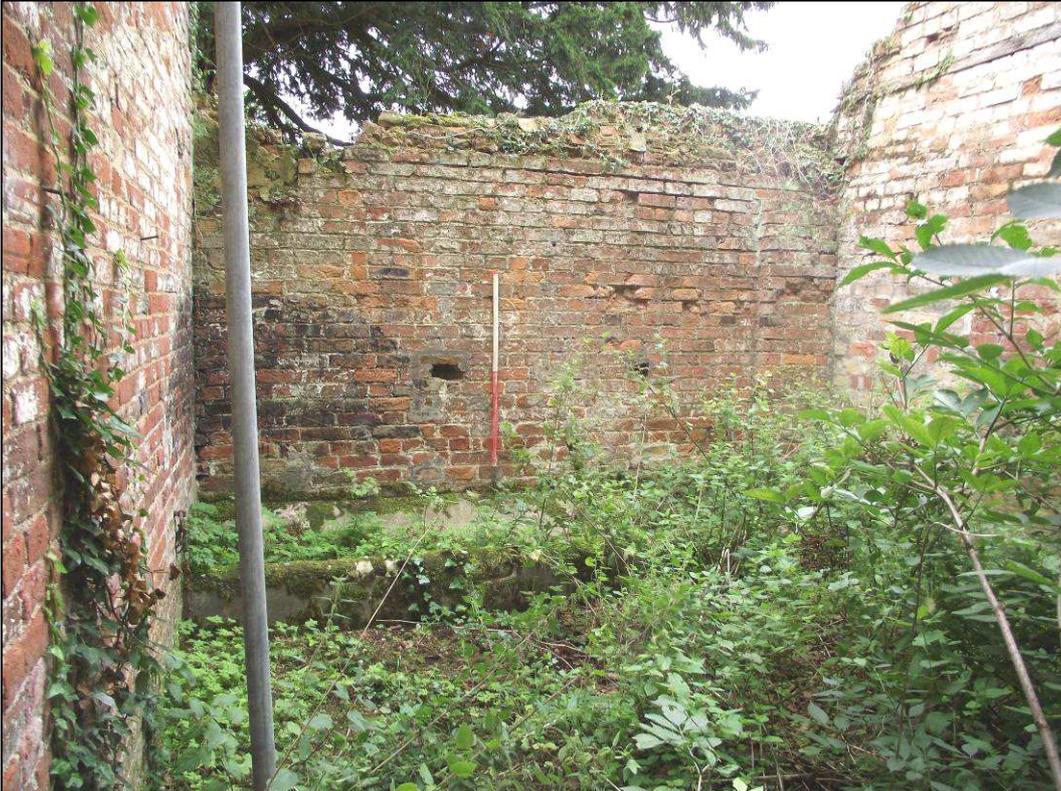
Plate 7 (Shot 16): Interior view of Milk Parlour D, looking south-west. Concrete feeding trough visible amid the overgrowth

- 7.4 Adjacent to C, was a small outbuilding D, with a feeding trough present, suggesting it was a animal shelter or feeding shed. The only other building to which a function could be assigned was the probable cart shed, I, which appears to have been open fronted on the north-east elevation to allow easy access to the adjacent track.

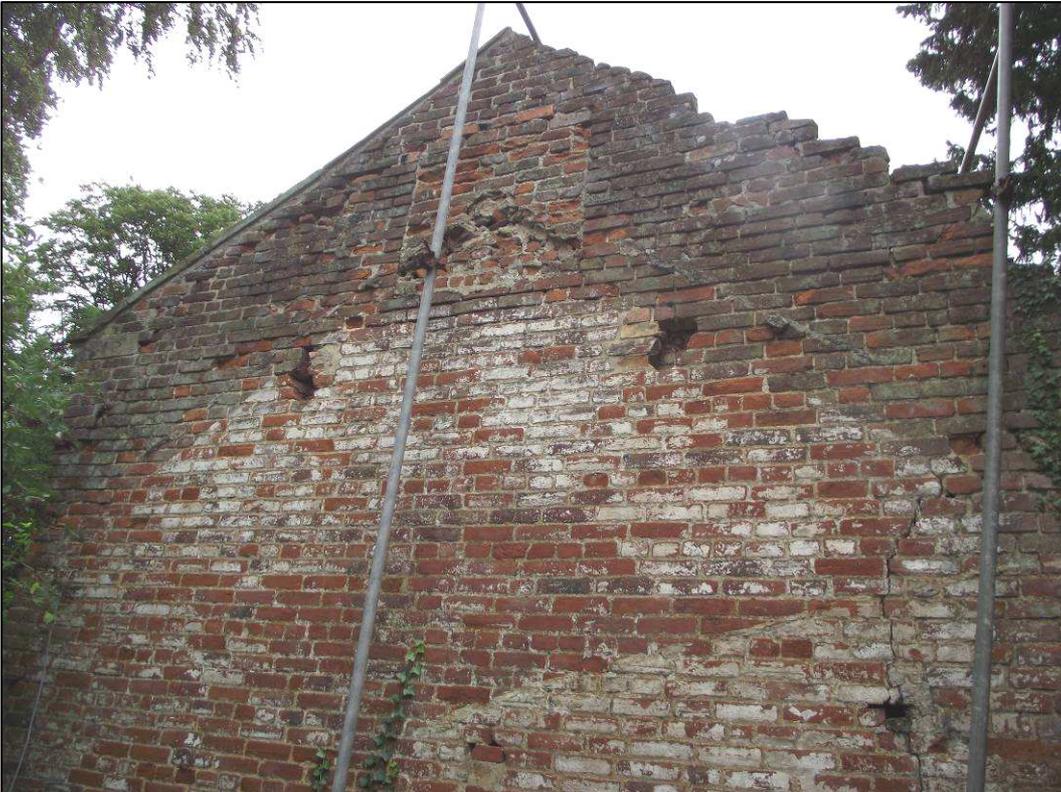
Plate 8 (Shot 19): South-east elevation of Milk Parlour D, looking south-east

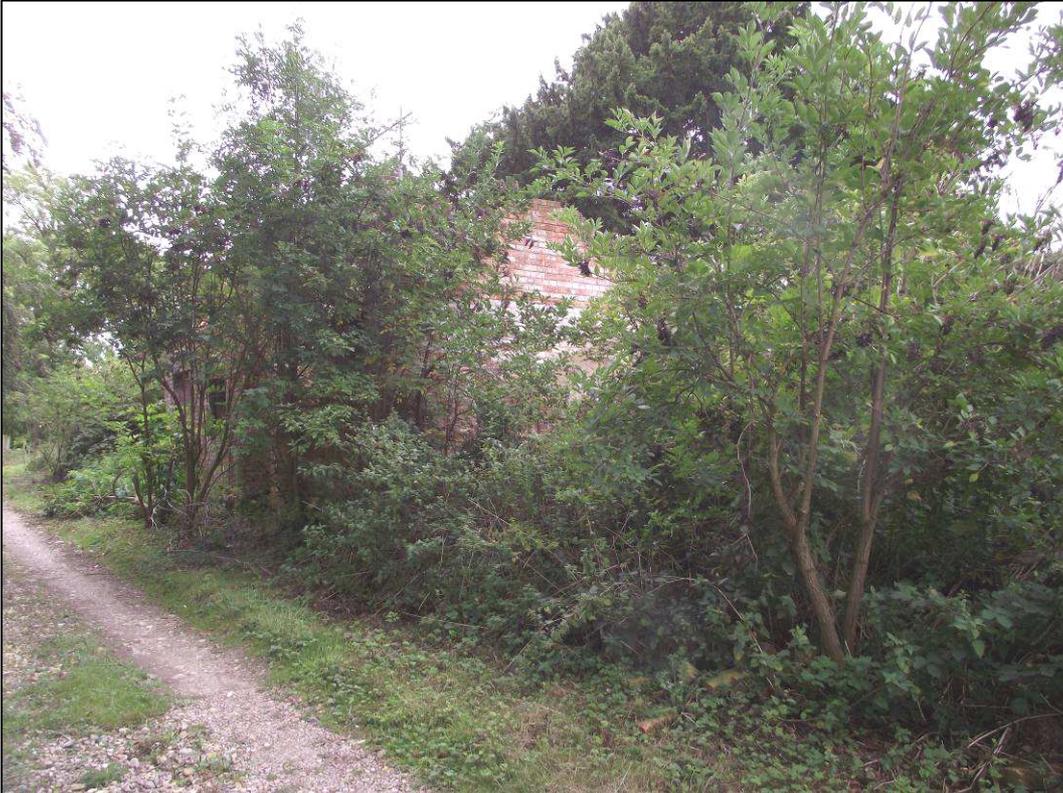
Plate 9 (Shot 23): Overgrown outbuildings E and F, looking south

- 6.6 Outbuildings E and F were very overgrown and largely derelict and as such no features of note were recorded (Plate 9).
- 6.7 Adjacent to the north-west were two small outbuildings, G and H (Plate 10). There was probably a doorway in eastern part of the north-east elevation of G, suggested by a surviving brick jamb (Plate 11). There is a single square window opening in the north-east elevation of H, with a wooden frame and brick segmental arch.

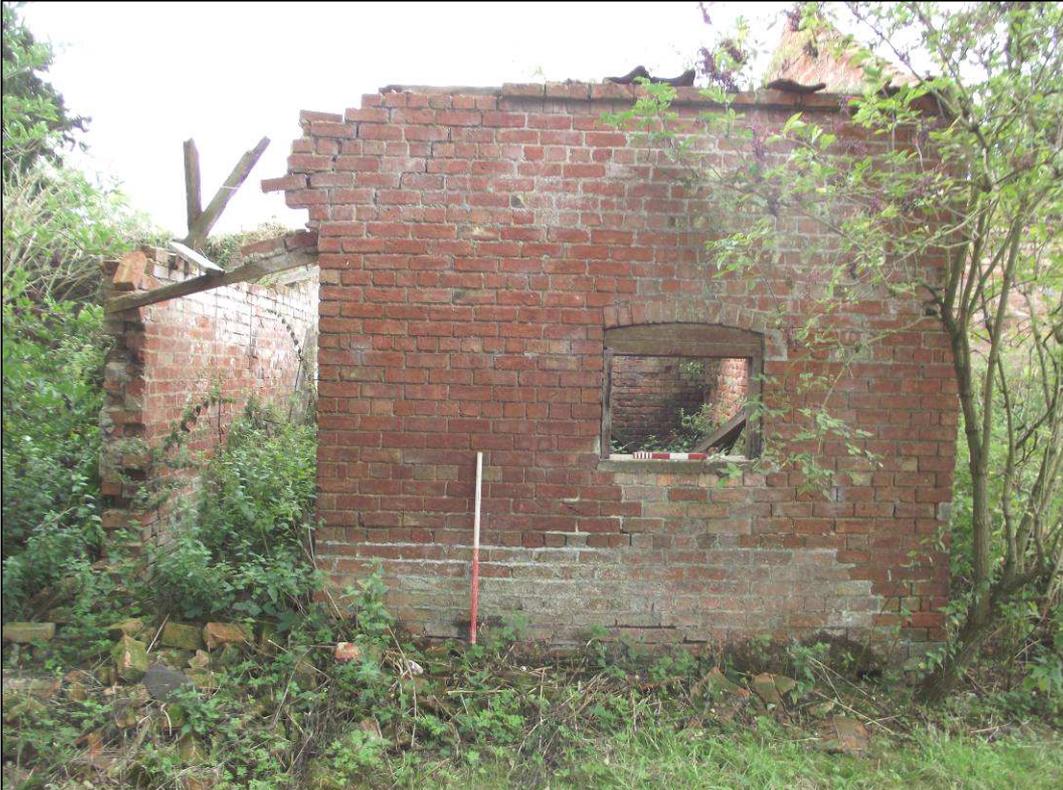
Plate 10 (Shot 24): North-east elevation of outbuildings G and H, looking south-west

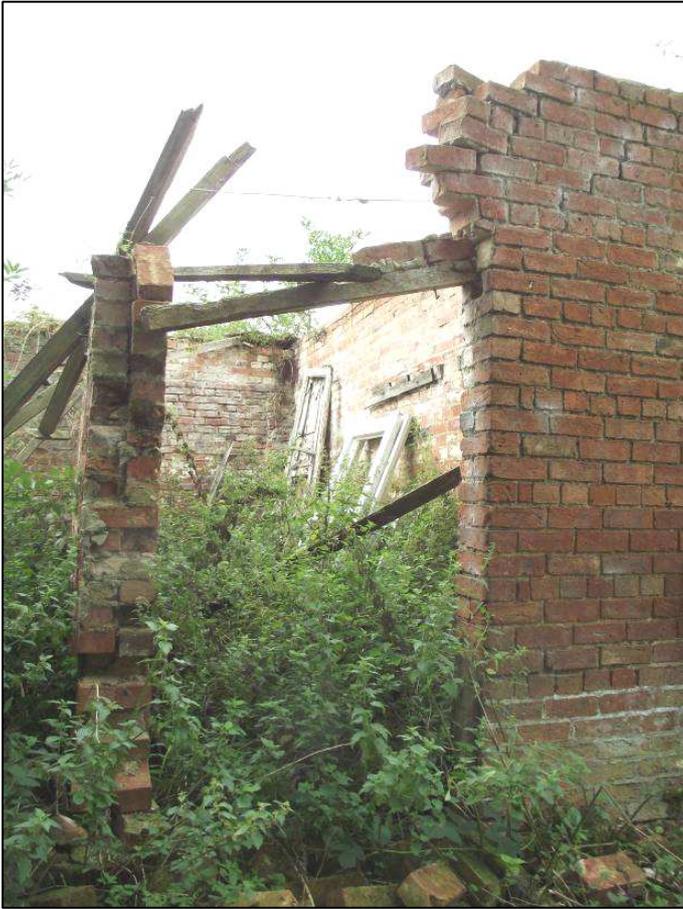
Plate 11 (Shot 25): General view of outbuilding G, looking south-west. Note the surviving brick jamb to the right of the opening indicating a probable former doorway

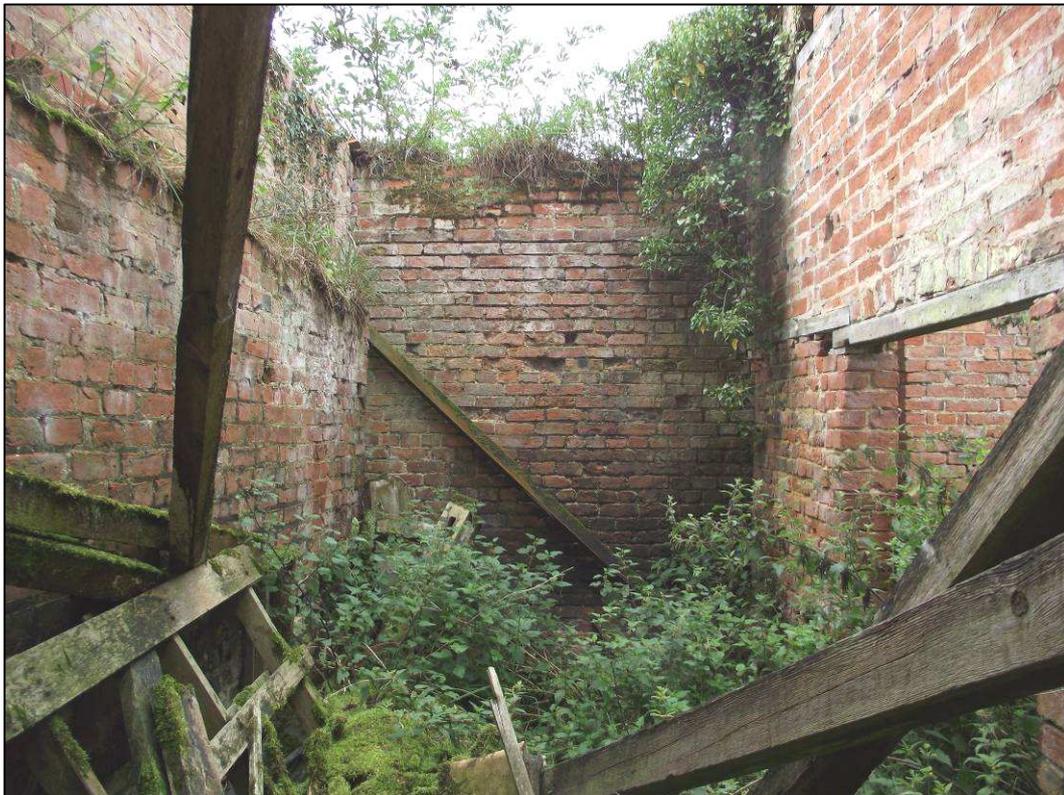
Plate 12 (Shot 26): Overgrown interior of outbuilding H, looking south-west. Note additional brick wall to left of shot with stubs of former floor joists above, and doorway into cart shed I to right of shot

- 6.8 There appears to have been a single brick thickness wall added to the internal south-east elevation of outbuilding H, probably to support a floor added to form a loft space, as indicated by the stubs of former floor joists surviving above this wall (Plate 12).

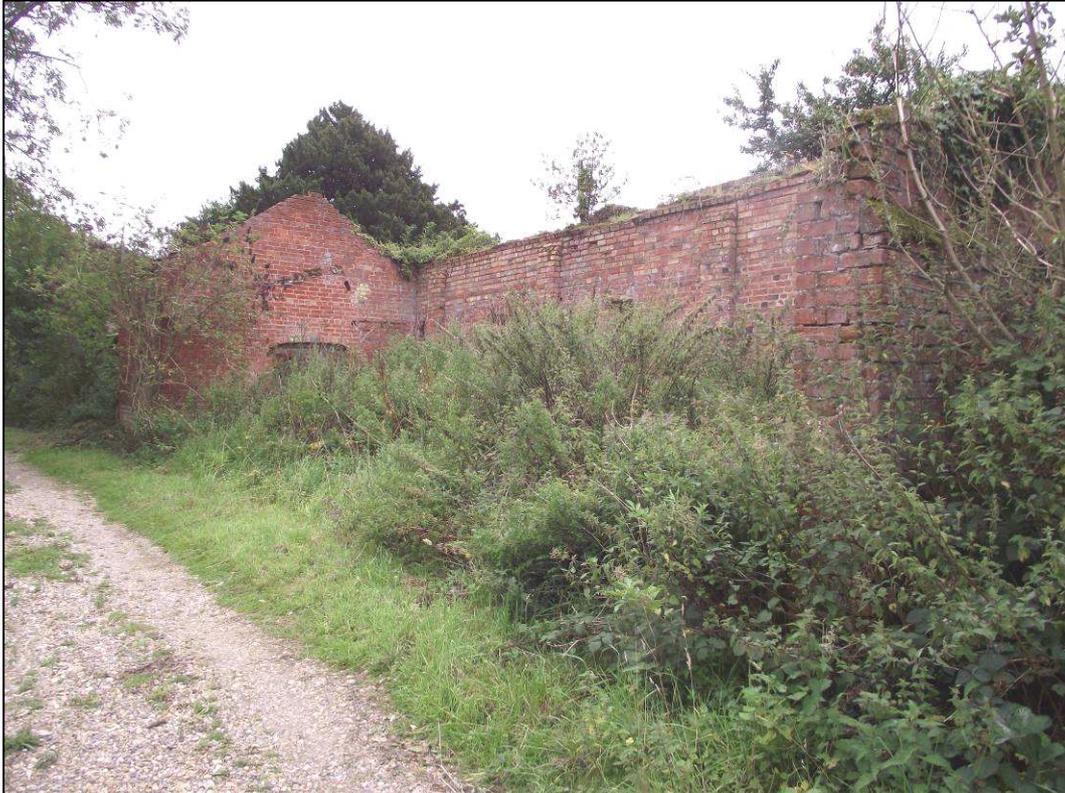
Plate 13 (Shot 33): Cart shed I, looking south, showing roof scar of former mono-pitched roof and brick buttresses

- 6.9 A doorway from H accessed outbuilding I to the north-west, which appears to have been an open fronted building, most likely a cart shed. It had a brick segmental arch which had been partially truncated by the later insertion of a wooden lintel. The roof of the cart shed was missing but a roof scar on the south-east elevation indicated it previously had a mono-pitched roof (Plate 13). Brick buttresses are also visible along the south-west elevation, and there is a small square bricked up window opening in the north-west elevation (Plate 14).

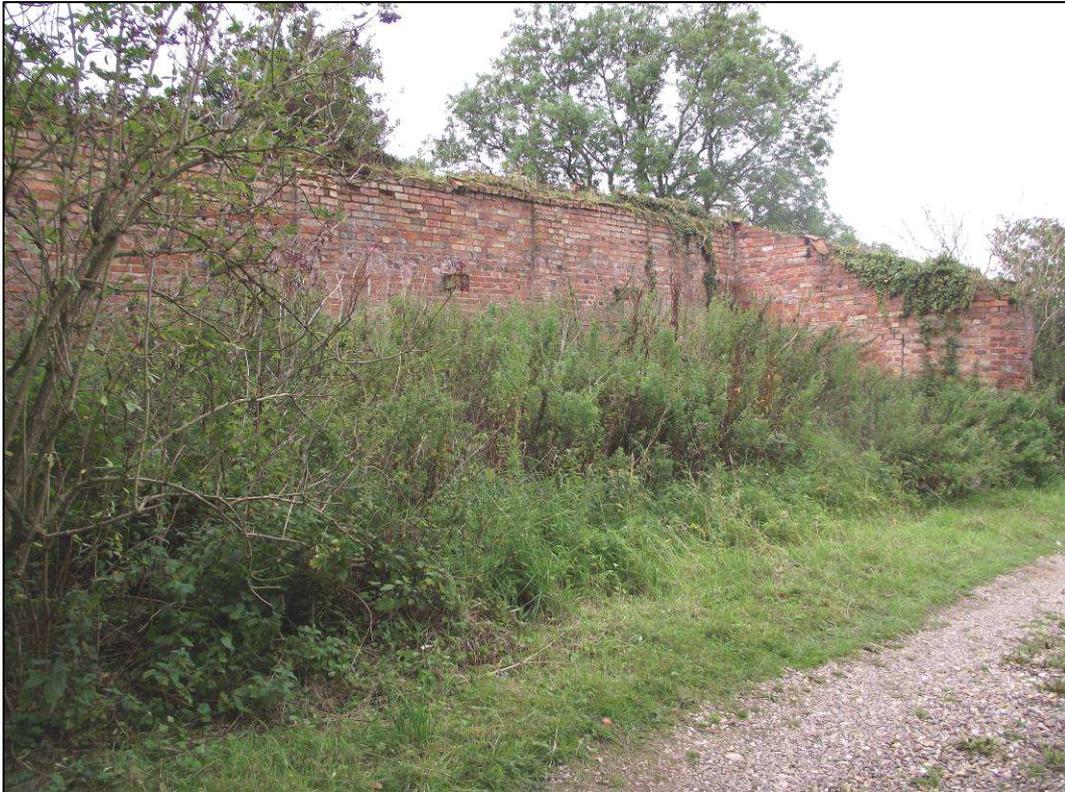
Plate 14 (Shot 32): Cart shed I, looking west. Note blocked window in north-west elevation

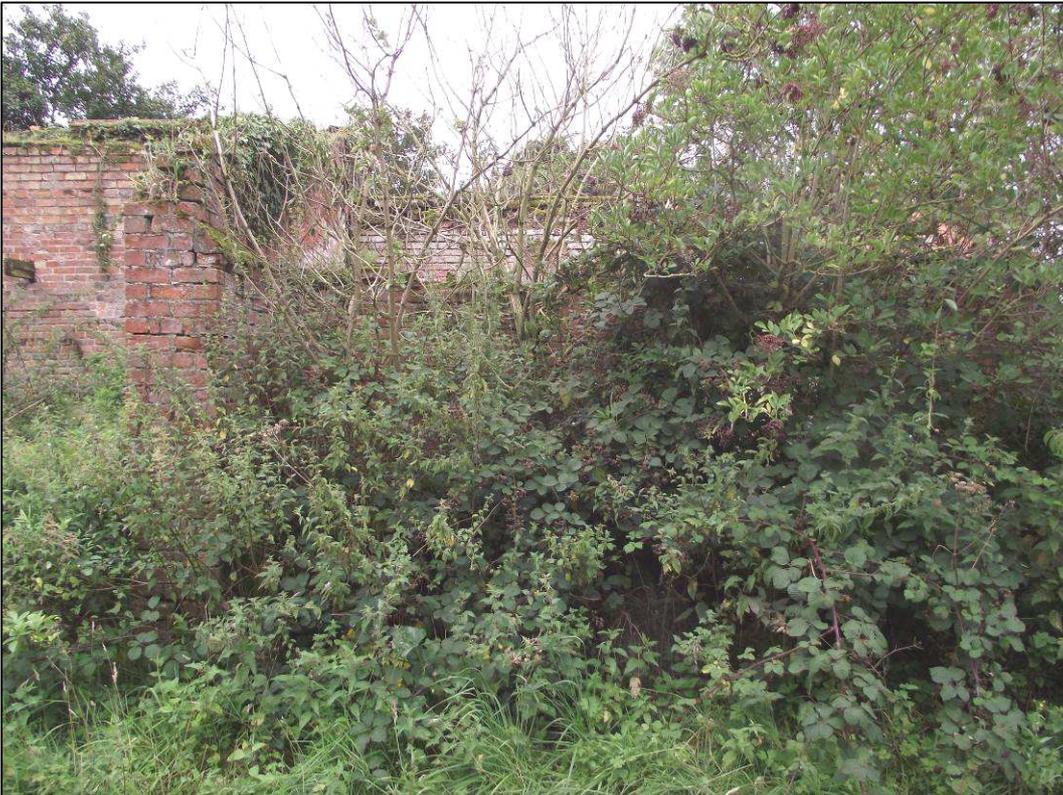
Plate 15 (Shot 34): Outbuilding J, looking south-west

- 6.10 At the north-western end of the range was a small outbuilding J, which was very overgrown, although a small portion of its mono-pitched roof with ceramic pantiles did remain in-situ (Plate 15). To the south-west, this was abutted by another small outbuilding, K, which was almost completely demolished to ground level, except for a section of brick boundary wall forming the north-west elevation (Plate 16).

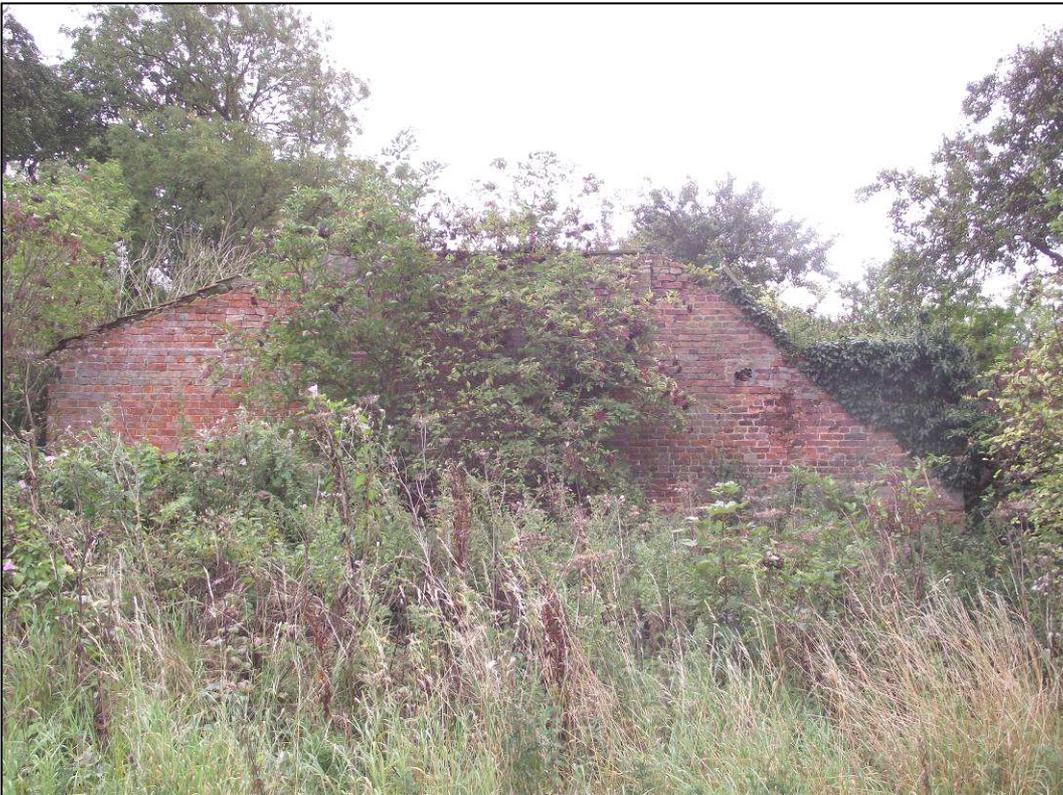
Plate 16 (Shot 37): North-west elevation of outbuildings J (to left), and K (to right), looking south-east

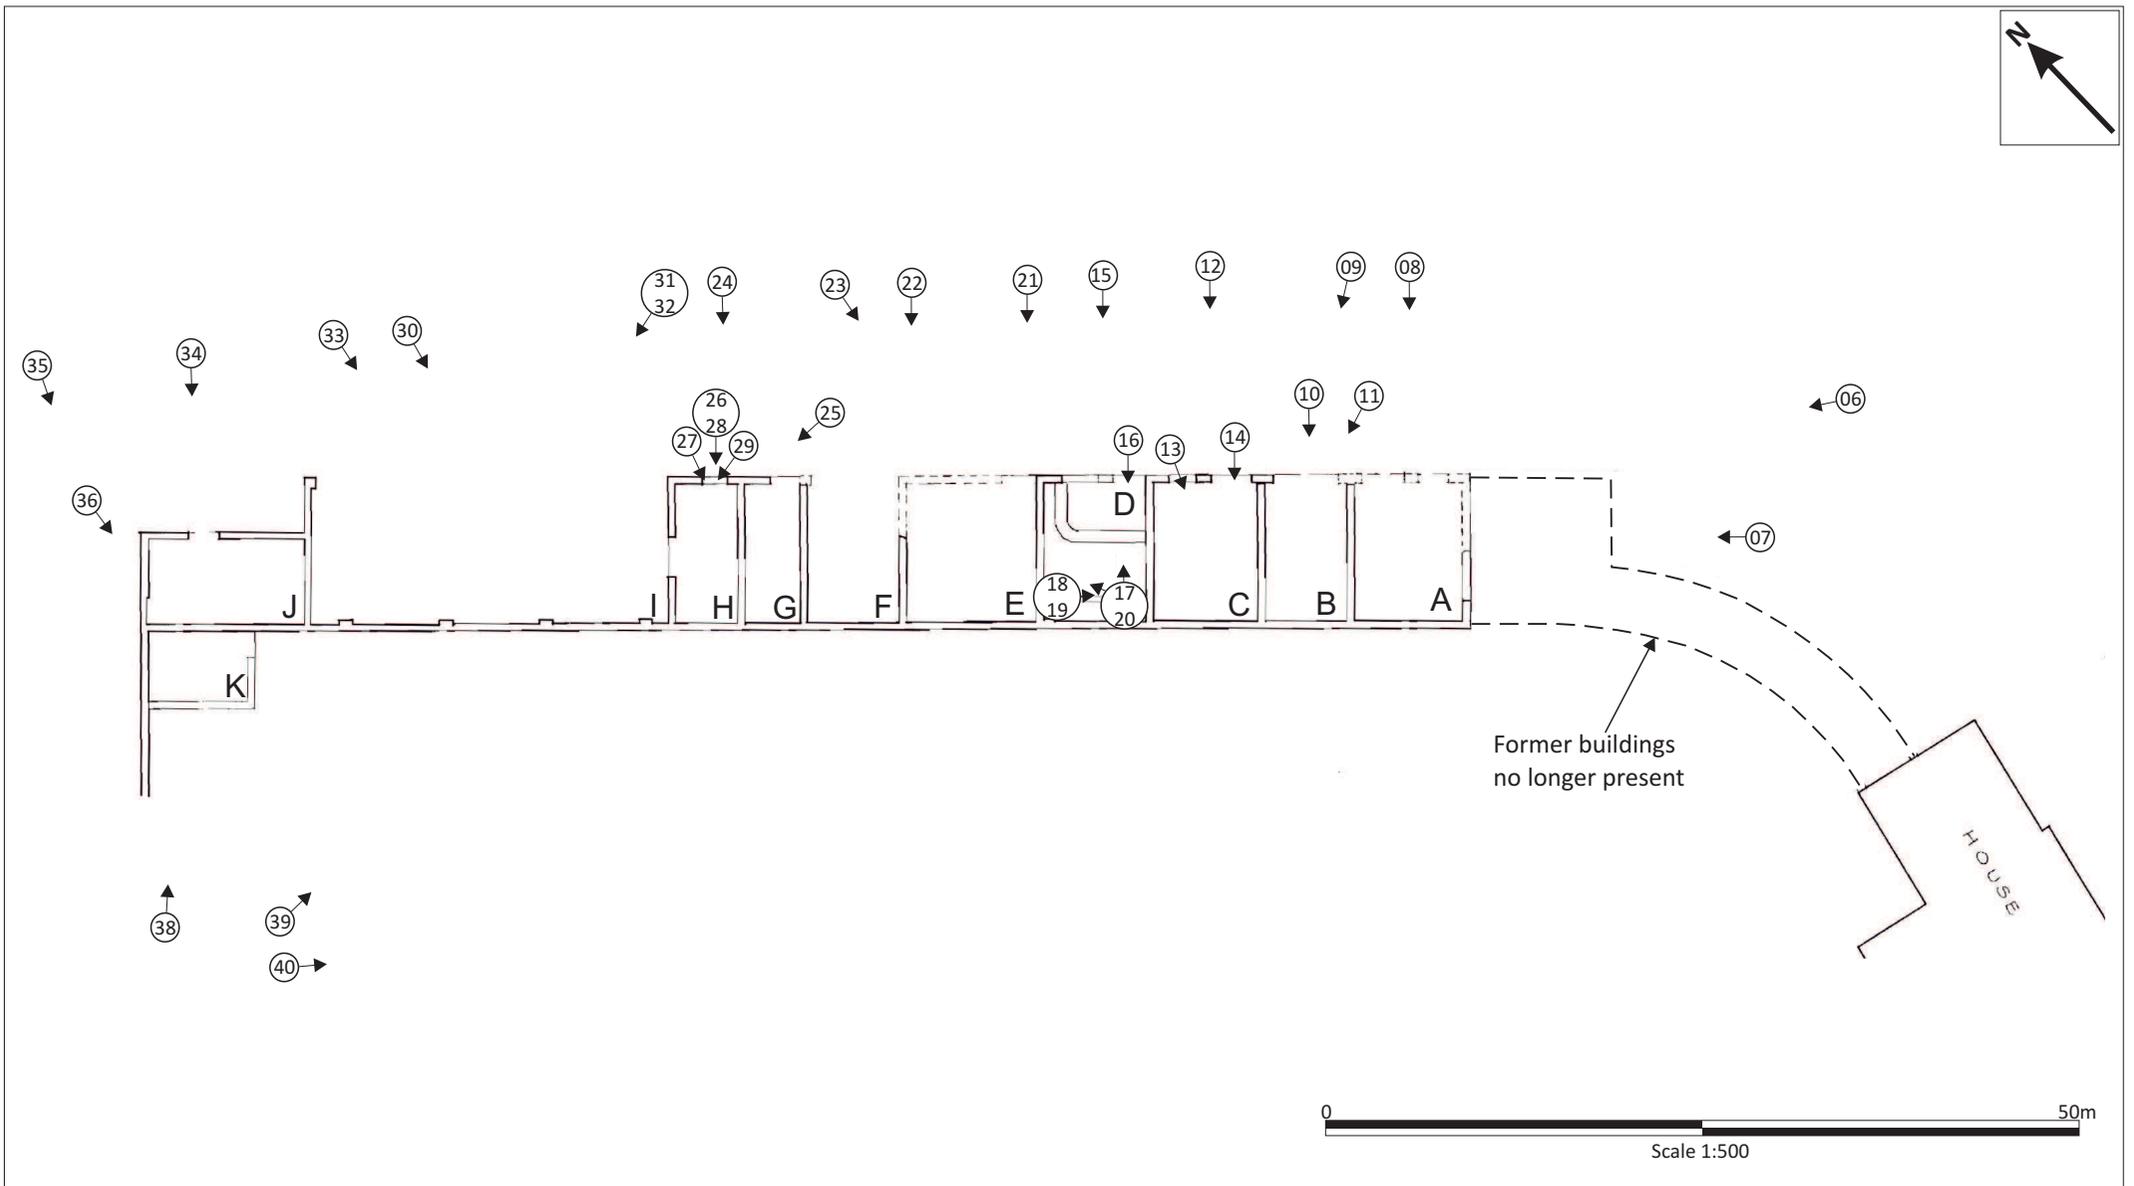
Figure 3: Plan of outbuildings A-K at scale 1:500. Numbered arrows indicate location and orientation of detail shots. General area shots located on Figure 2

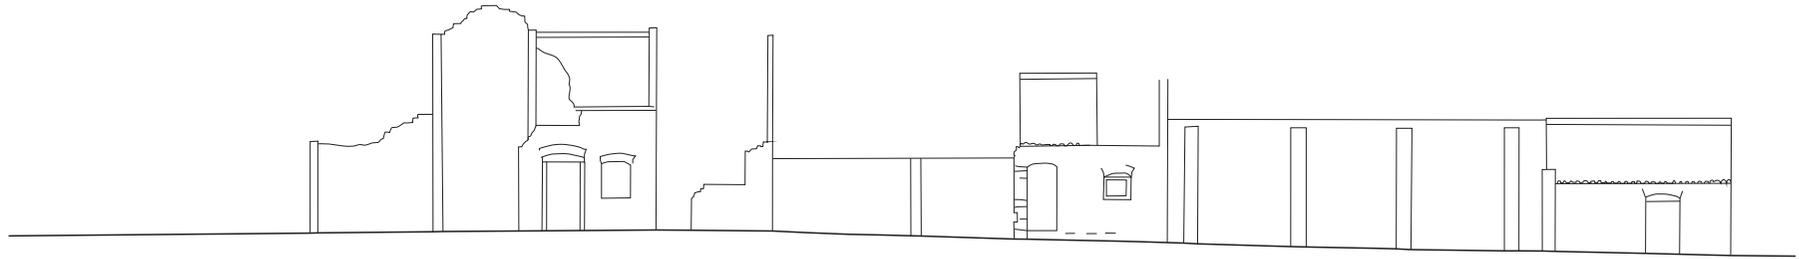
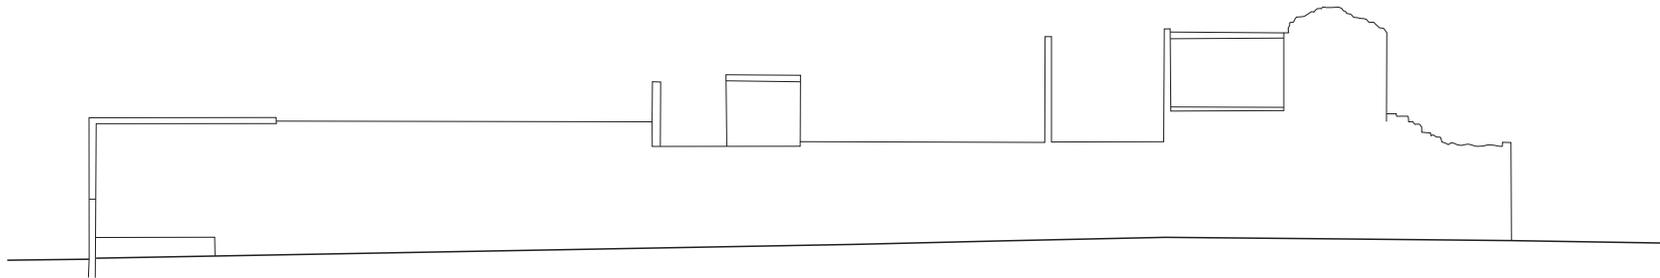
Figure 4: Elevations of outbuildings at scale 1:250

North-East Elevation

South-West Elevation

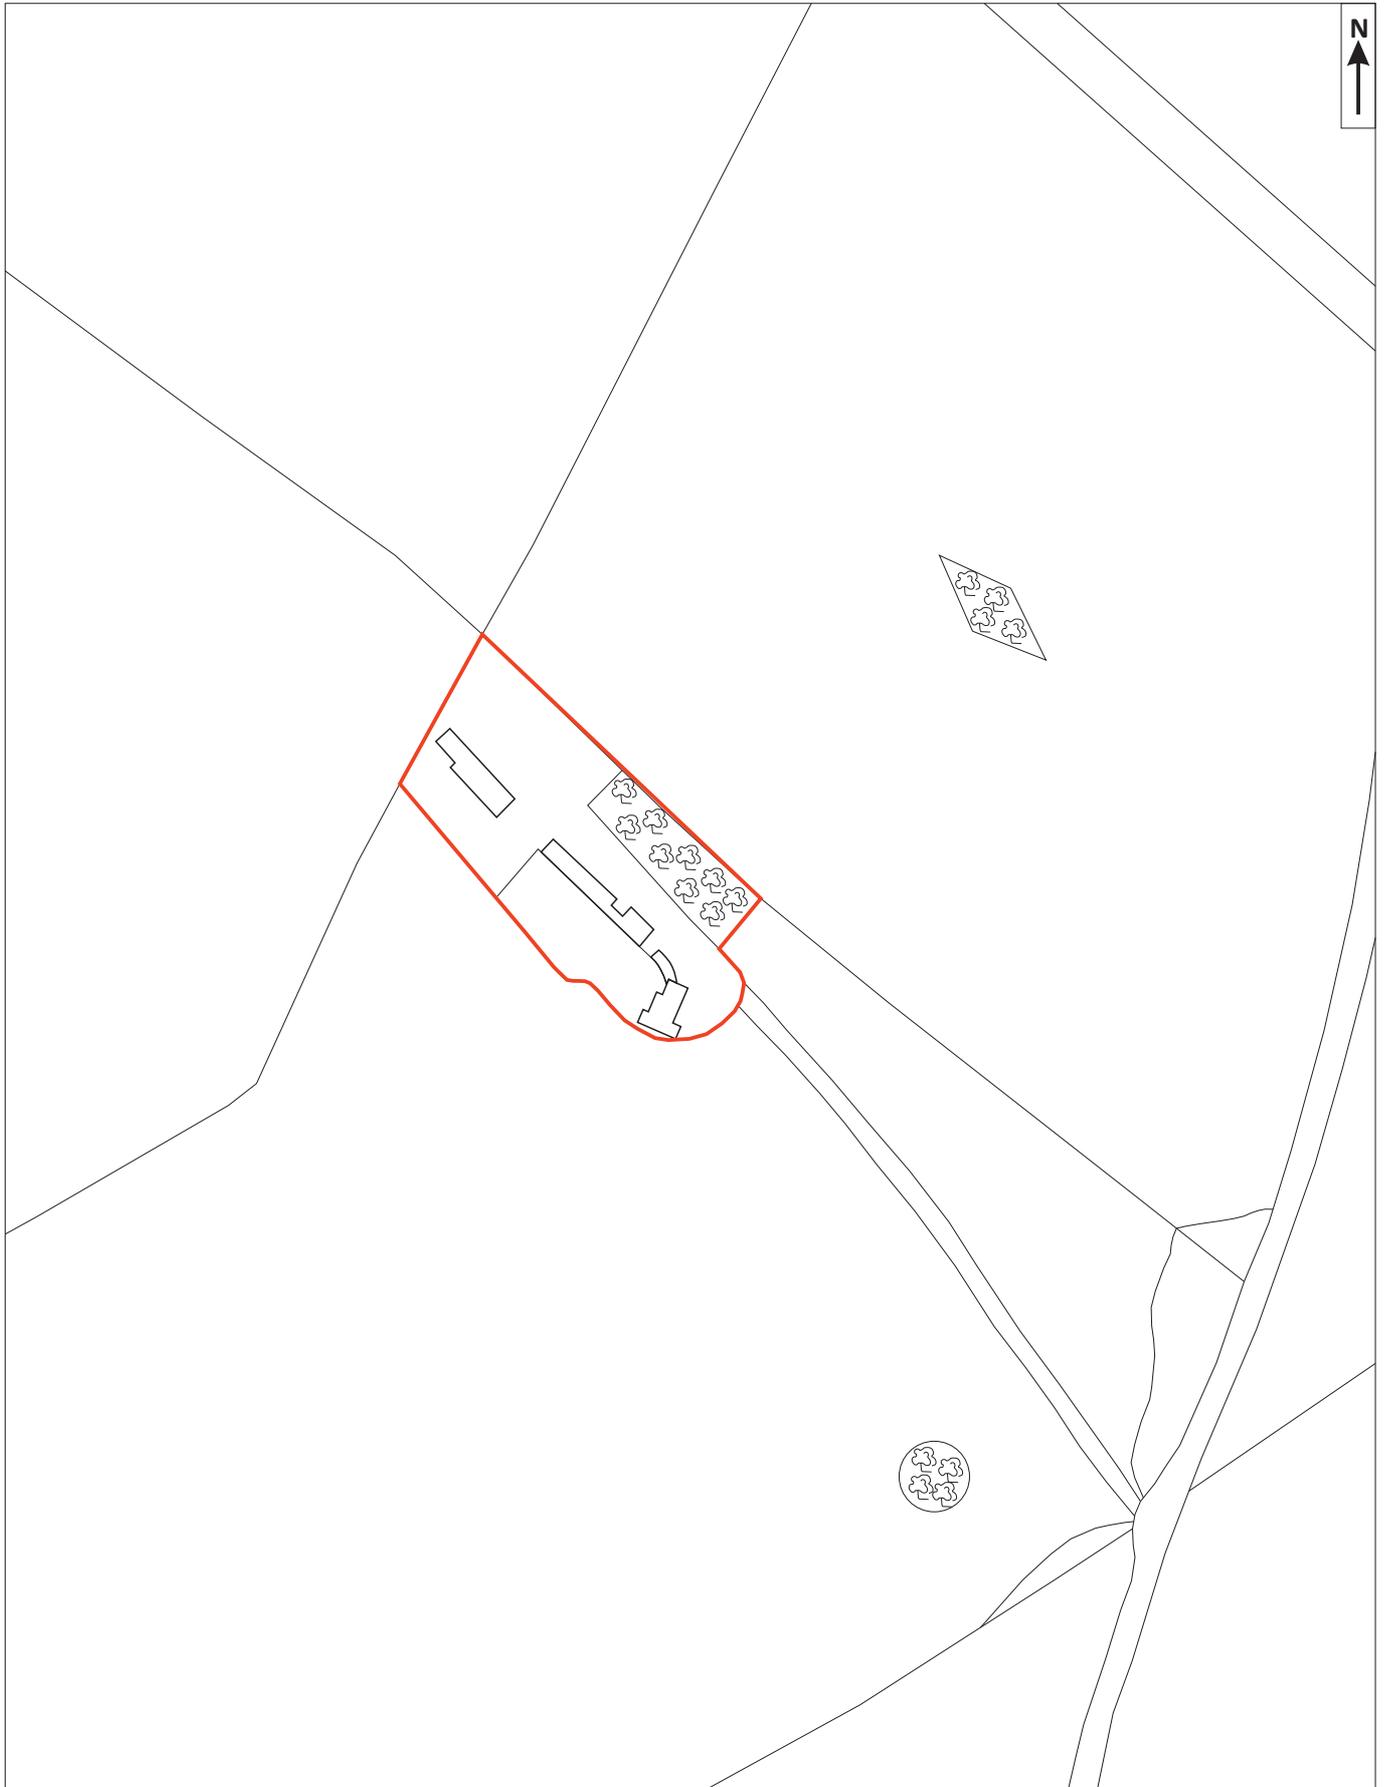
Figure 5: Extract from 1838 survey of the parish of Skendleby at scale 1:2,500, with Lodge Farm outlined in red

- 7.7 Historic map evidence indicates that Lodge Farm House and its attendant outbuildings were present from at least 1838 (Figure 5). The map shows the curved 'smokery' building was present at this stage, with a linking wall running to the main block of outbuildings. There was a slightly larger block at the south-west end of the range with a very small adjacent block. By the
