**HISTORIC BUILDING SURVEY:
OUTBUILDINGS AT LODGE FARM, SKENDLEBY, LINCOLNSHIRE**

Planning Application: Pre-application
NGR: TF 4325 7073
Oasis Reference: allenarc1-108884
AAL Site Code: SKLF 11
Global Accession Number: LCNCC: 2011.359

Report prepared for
Scorer and Hawkins,
on behalf of Mr Guest

By
Allen Archaeology Limited
Report Number 2011059

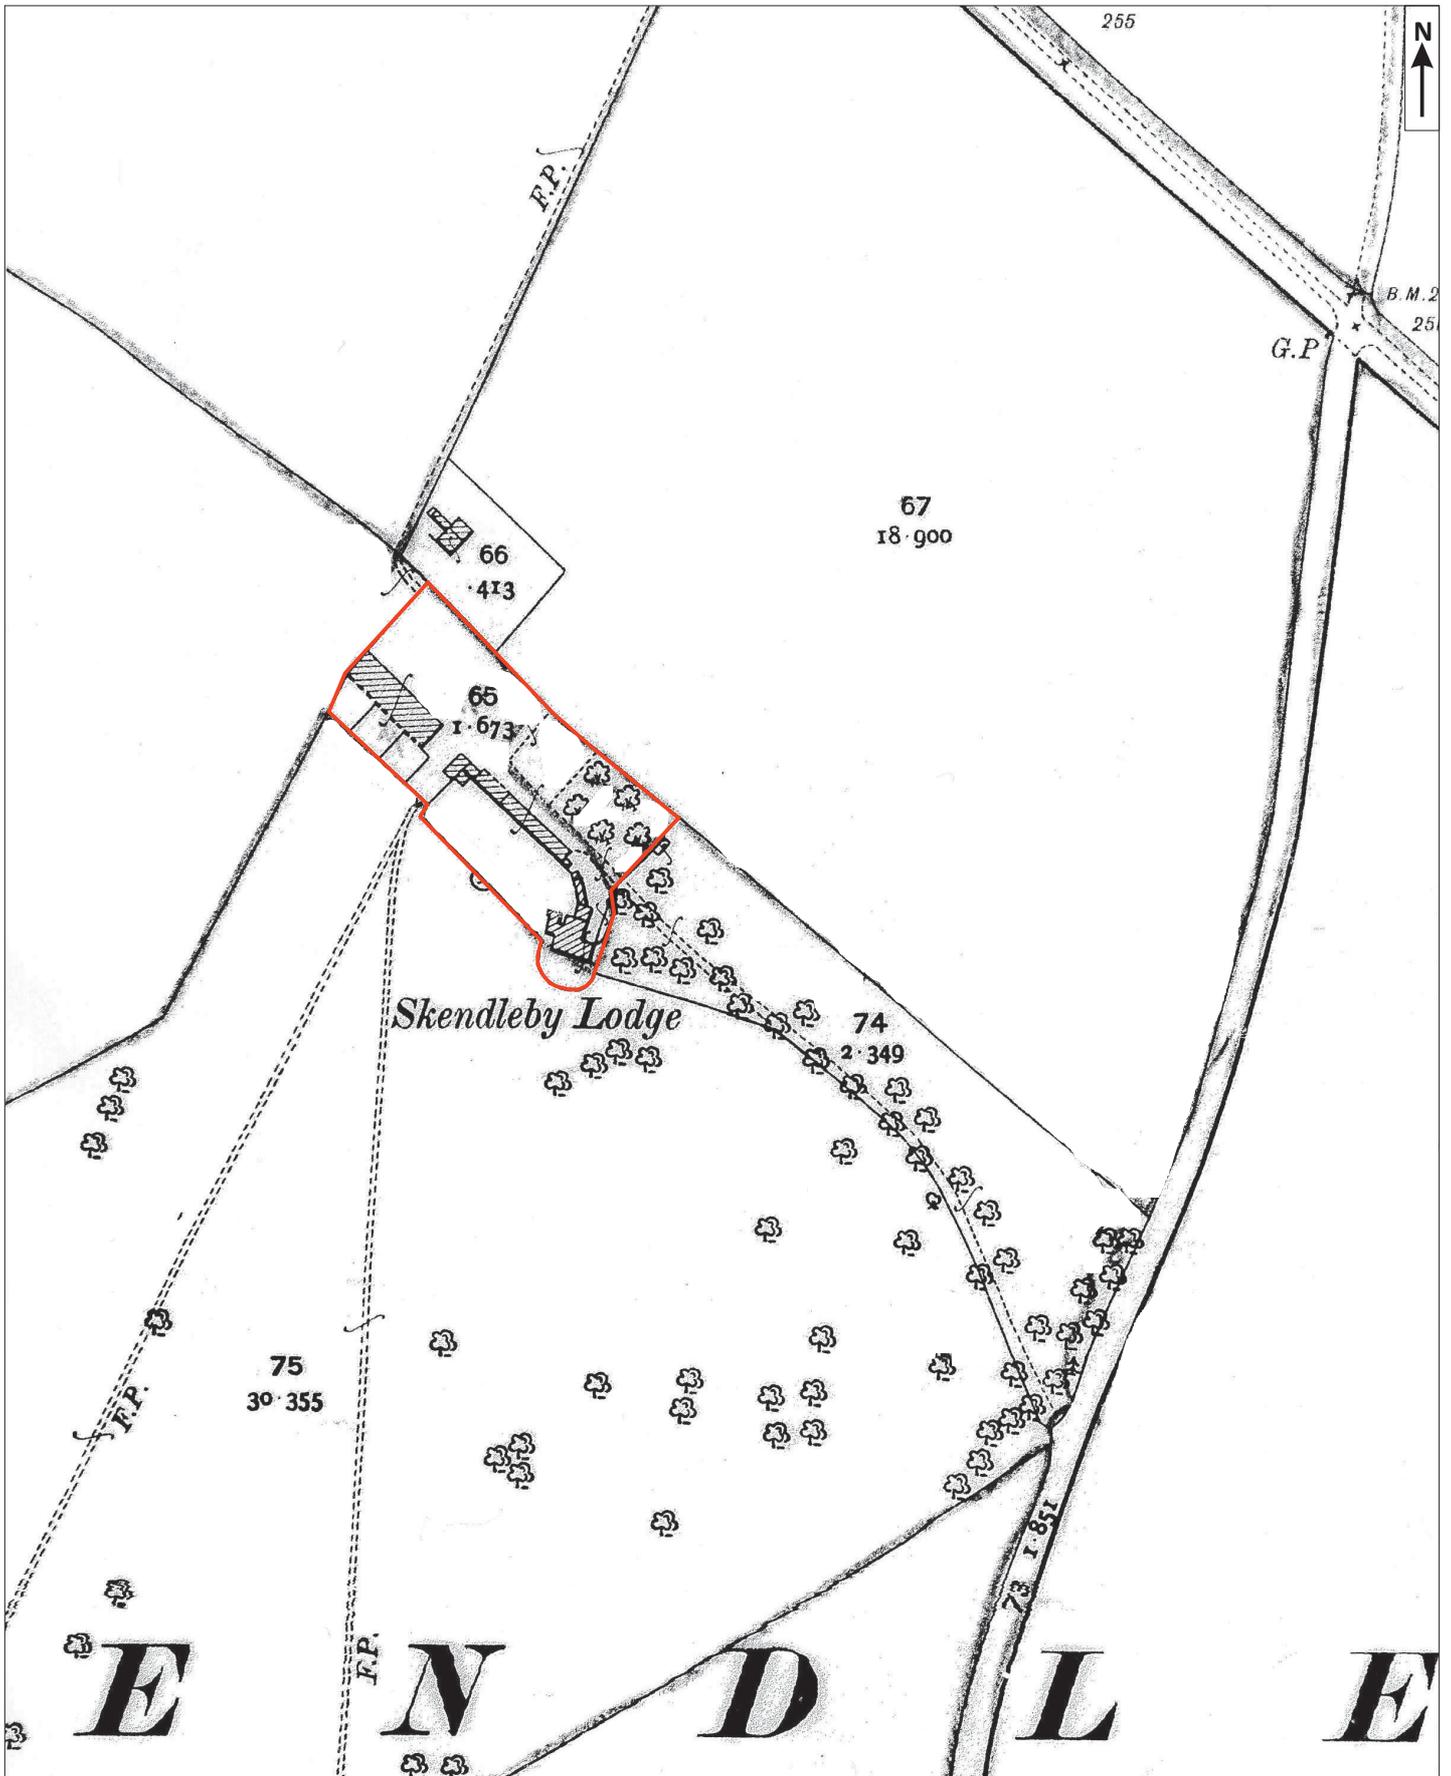
Figure 6: Extract from 1906 Second Edition Ordnance Survey map at scale 1:2,500, with Lodge Farm outlined in red

time of the 1906 Ordnance Survey map (Figure 6), the layout was much closer to the present form, with a range of buildings of generally equal width, except for a small block at the south-east end of the range, which is no longer extant. There was also another building shown attached to the two small outbuildings J and K.
