**ARCHAEOLOGICAL WATCHING BRIEF REPORT:**  
**MONITORING OF GEOTECHNICAL TEST PITS AT**  
**SPRING MEADOW, BELTON HOUSE, GRANTHAM,**  
**LINCOLNSHIRE**

Planning Reference: Pre-Planning  
NGR: SK 92757 39207  
AAA Site Code: BESM 08  
OASIS Reference: allenarc1-52682

AAA Report Number 2008/065

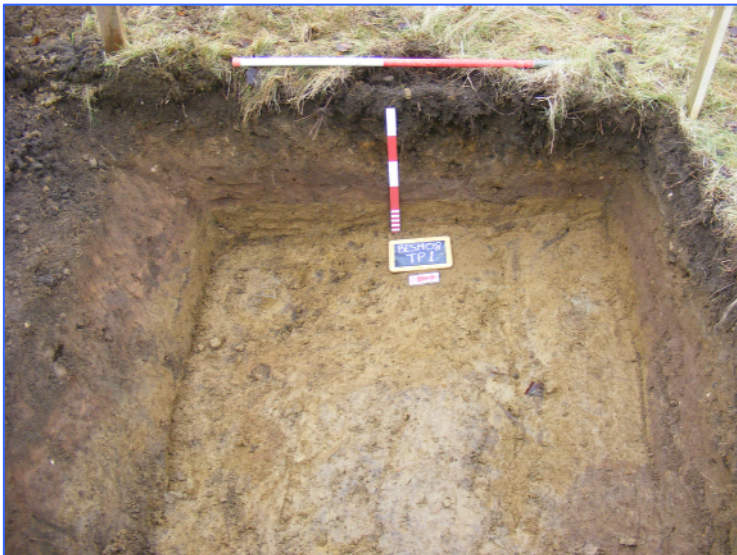
**Plate 2:** Test Pit 1, east facing section, looking west

- 6.1.1 Test Pit 1 was located along the line of the proposed car park track, in an area that the geophysical survey showed varied responses indicative of possible modern ferrous detritus in the topsoil, as well as possible ridge and furrow (Hibbitt and Allen 2008). Test Pit 1 was centred on NGR SK 92791 39301.
- 6.1.2 The uppermost deposit was a 0.2m deep topsoil horizon, 100, comprising dark brown clayey sand, with occasional rounded gravel. It sealed a layer of redeposited natural with frequent limestone fragments, 103, which was approximately 0.15m deep. Below 103 was a c.0.15m

deep layer of reddish brown clayey sand, 101. Both deposits appear to be deliberately dumped deposits, although their precise function is unclear. They may have been dumped to raise and level this part of the field to limit flooding, or represent dumps of material associated with an episode of development of the estate.

- 6.1.3 At the base of the test pit was naturally-formed light yellowish brown clayey sand, 102 that was 0.24m deep and extended below the limit of excavation. Augering of this deposit showed it to continue for another 0.38m, sealing a 0.44m thick deposit of compact grey clay with occasional small sub-angular gravel, 104. Below this the auger sample revealed another 0.1m thick layer of coarse orange/brown sand, 105, that overlay a further 0.3m of compact grey clay, 106, that extended below the limits of the auger sample. Layers 102, 104, 105 and 106 are all likely to reflect waterborne deposition, with the same layers being deposited by high energy flood events, while the clay layers represent deposition by slow-moving or standing water.

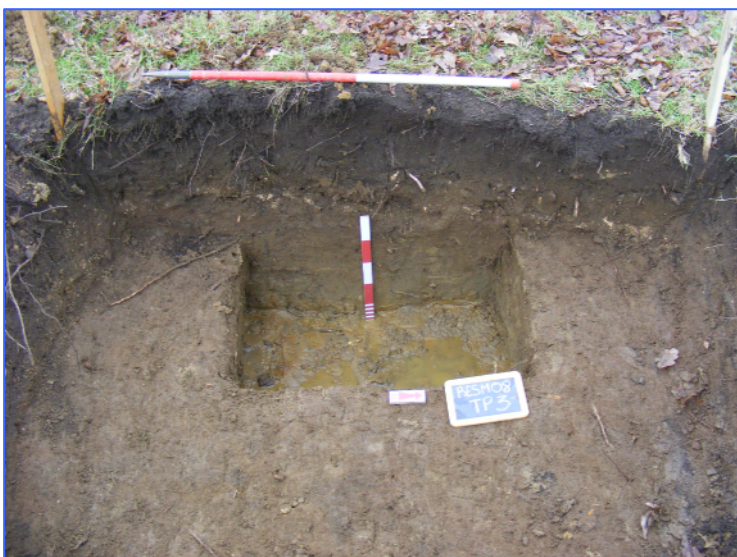
**Plate 3:** Test Pit 3, east facing section, looking west

- 6.3.2 Topsoil 300 was a c.0.3m deep friable, dark brown clayey sand with rare inclusions of stone pebbles. It sealed 301, dark brown clay sand with frequent roots and rare sandstone pebbles, which overlay a thin lens of dark brown sand with frequent small sub-angular stone rubble, 302. Beneath 302 was 303, a c.0.25m deep layer that was identical in composition to 301 above. It is possible that layers 301 and 302 represent dumps of material associated with the laying out of roads and other nearby park land features, sealing a former undated soil that is represented by 303.

- 6.3.3 Following machine excavation, it was unclear whether deposit 303 was a layer or the fill of an archaeological feature, so a slot was hand excavated against the west edge of the test pit to ascertain this and to determine the stratigraphic sequence. The slot identified 303 as a layer that extended a further 0.25m below the machine-excavated trench. This sealed a probable natural alluvial sequence, comprising a 0.26m deep layer of coarse brown/grey sand 304, over an orange/brown sand 305 that extended below the limit of the hand dug slot. Augering at the base of the slot suggested that deposit 303 continued for some depth, but the material was too wet and loose to stay in the auger.
