# HELMSHORE MILLS TEXTILE MUSEUM, HELMSHORE, LANCASHIRE

## Archaeological Evaluation

**Oxford Archaeology North**

November 2006

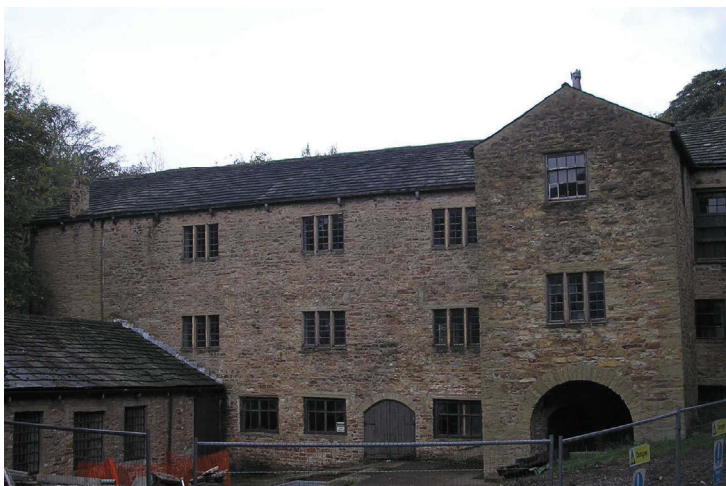
Plate 1: The south-facing elevation of Higher Mill

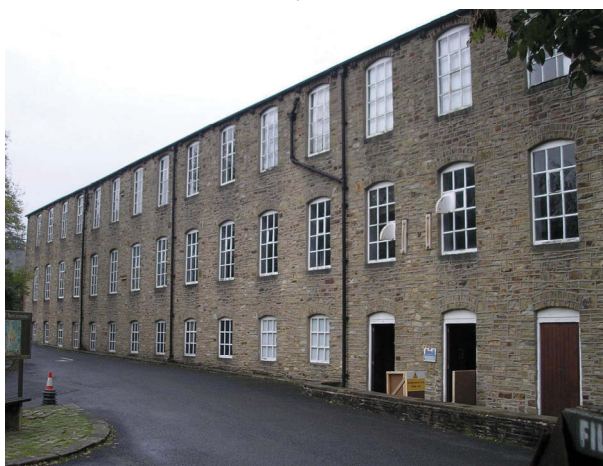
Plate 2: South-west-facing elevation of Whitaker's Mill

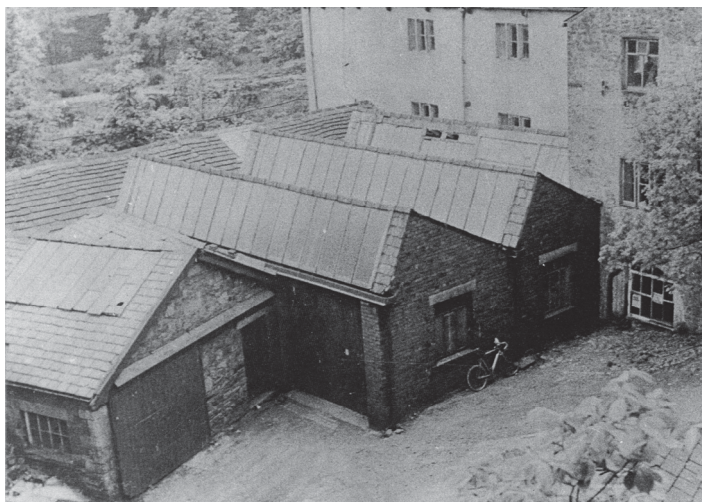
*Plate 3: The boiler house (on the left) prior to demolition*

- 3.2.13 It is uncertain precisely when the boiler house was erected, although it is likely to have been during the early 20<sup>th</sup> century, and was probably contemporary with a single-storey extension linking the two mills (Plate 3). The erection of these buildings necessitated the demolition of a detached rectangular building, which is depicted on Ordnance Survey mapping published in 1891 (Plate 4). During its operational life, the boiler house contained a single Cornish-type boiler, which had been manufactured by Yates and Thoms, a Blackburn-based firm, and was installed around 1911. Boilers of this type typically measured 16ft by 6ft, which is consistent with the dimensions of the boiler house. The boiler, however, was not connected with the mill's steam-power plant, but was intended to generate the steam for heating the working floors in the mill.

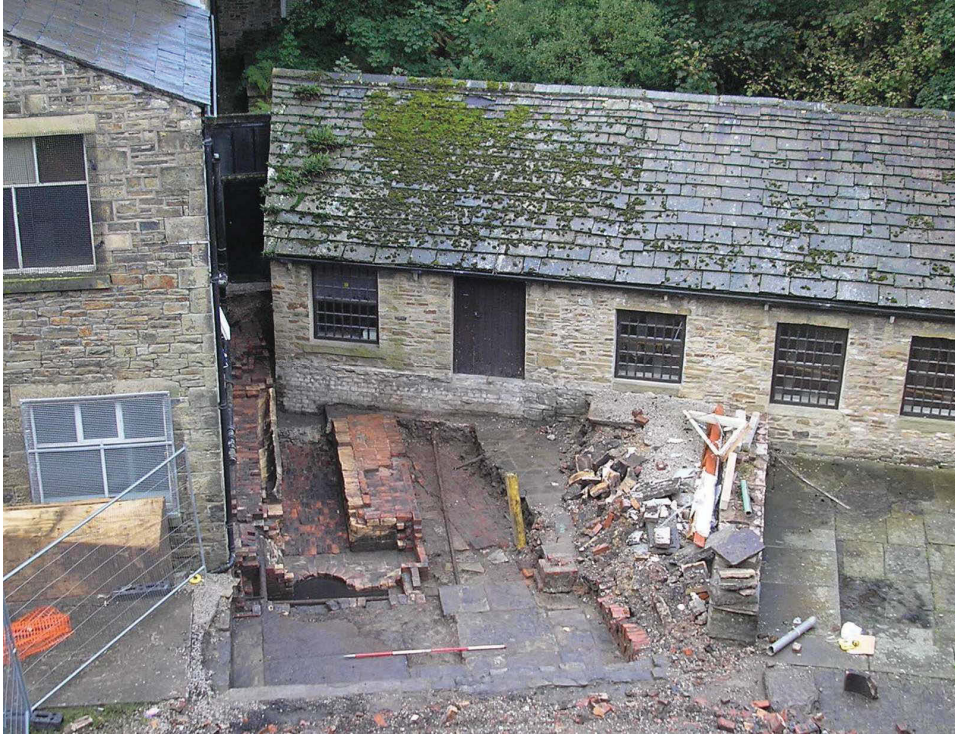
Plate 5: General view of the excavated boiler house, looking west

- 4.1.1 The entire footprint of the proposed new building was uncovered, exposing three phases of archaeological activity (Plate 5). Phase 1 represented the construction of a stone arch that may be contemporary with the construction of the tail race from Higher Mill sometime during the late 18th century. Phase 2 comprised the construction of the rectangular building as shown on the 1891 OS map (Plate 4). The remains were exposed along the northern part of the excavated area, within the footprint of the former boiler house. Phase 3 represents the construction and use of the boiler house. Additional remains pertaining to this phase include the insertion of a stone drain placed along the foundation of the eastern wall of the link building. The drain overlaid a stone block that may have been part of the retaining wall for the stone arch. Phase 4 pertains to the abandonment and demolition of the building in the 1960s, and the subsequent construction of the link building extension.

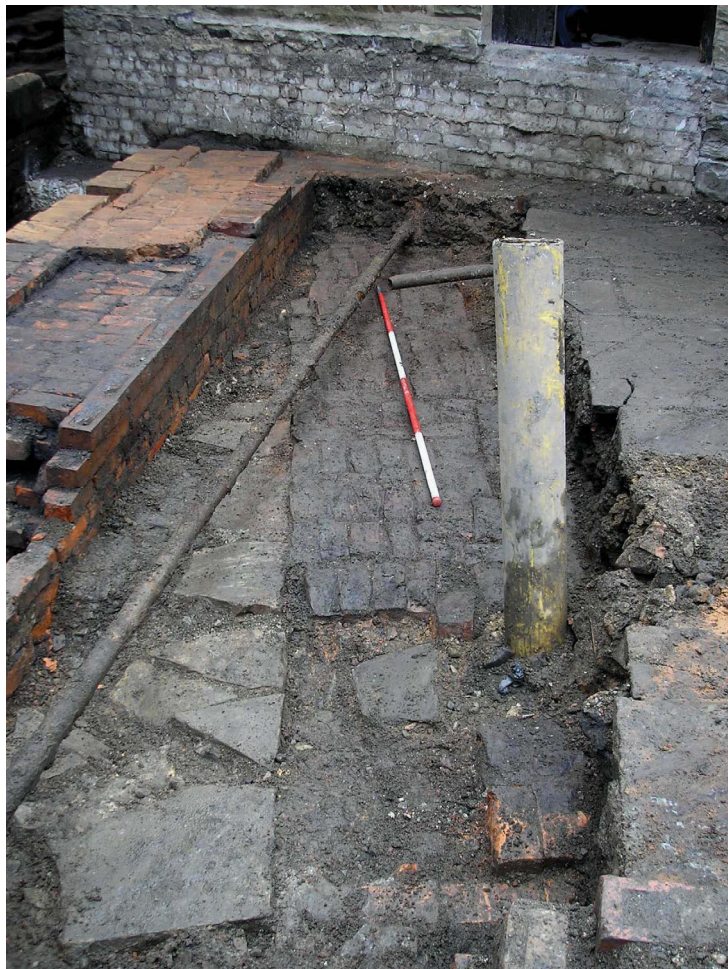
Plate 6: Wall *105* and brick surface *100* looking west

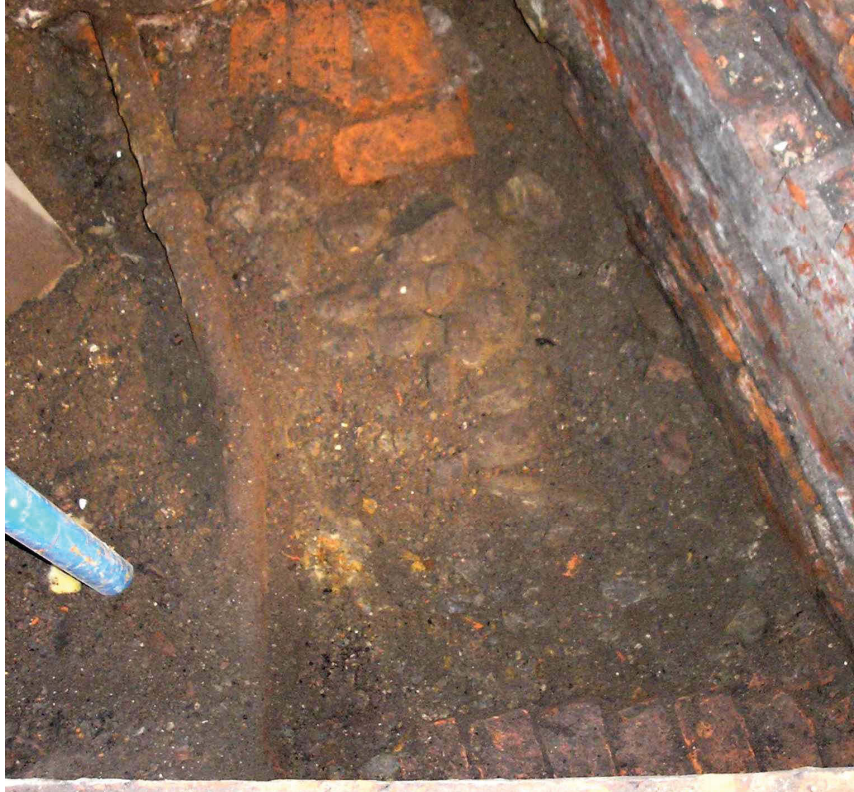
Plate 7: Cobble surface *103* at the western end of surface *100*, looking east

- 4.2.5 A spread of cobbles were observed across the line of the wall, representing an uneven and poorly-sorted surface (**103**) measuring 0.50m by 0.30m. The cobbles (Plate 7) possibly represented the remains of a threshold into the original building, although this could not be ascertained with confidence.

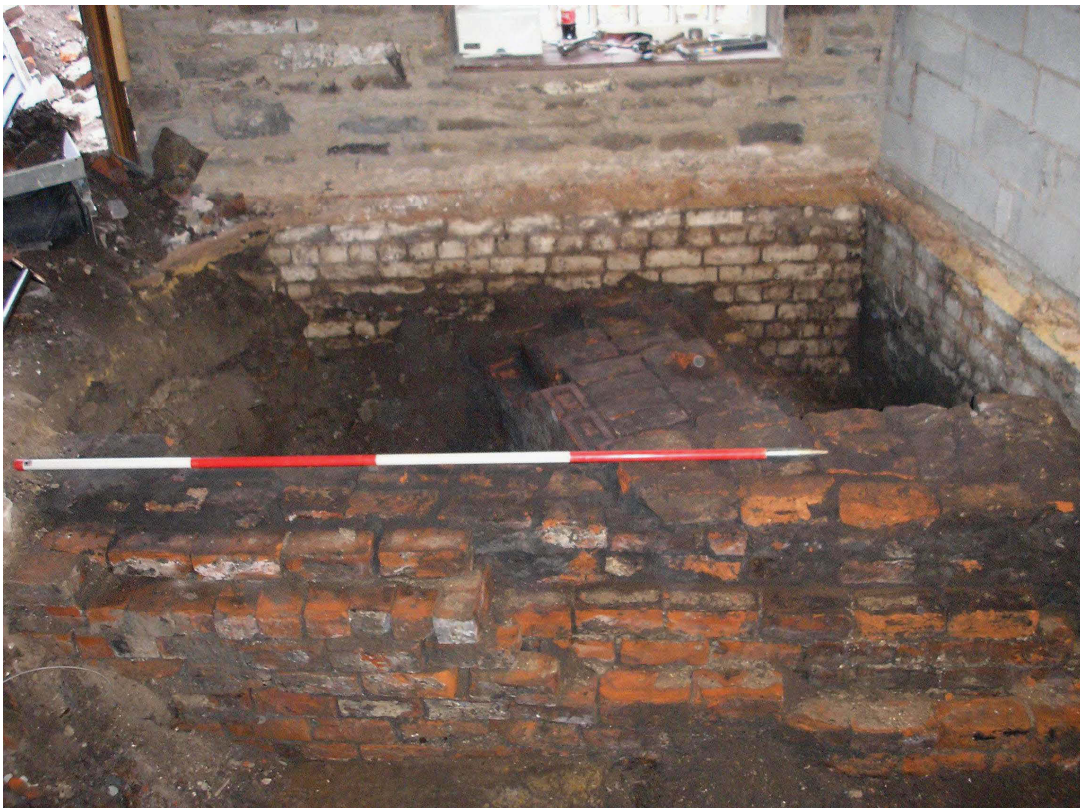
Plate 8: Western wall (*114*) of the boiler room

- 4.3.3 The western wall of the boiler room (114) was exposed at a distance of 1.60m west from the eastern wall of the link building between the two mills. Wall 114 measured 0.65m wide, and followed a north-east/south-west alignment for a distance of 4m (Plate 8). It comprised 11 courses of locally-manufactured, machine-made Accrington and Clatton bricks laid in an English Garden bond, with traces of lime wash along the eastern face. The wall was originally three brick strings wide, but at some point two brick skins had been added along the east and west face, widening the wall to five brick thick in width. The wall survived to a maximum depth of 0.76m below the 1980s concrete foundation of the link building extension.

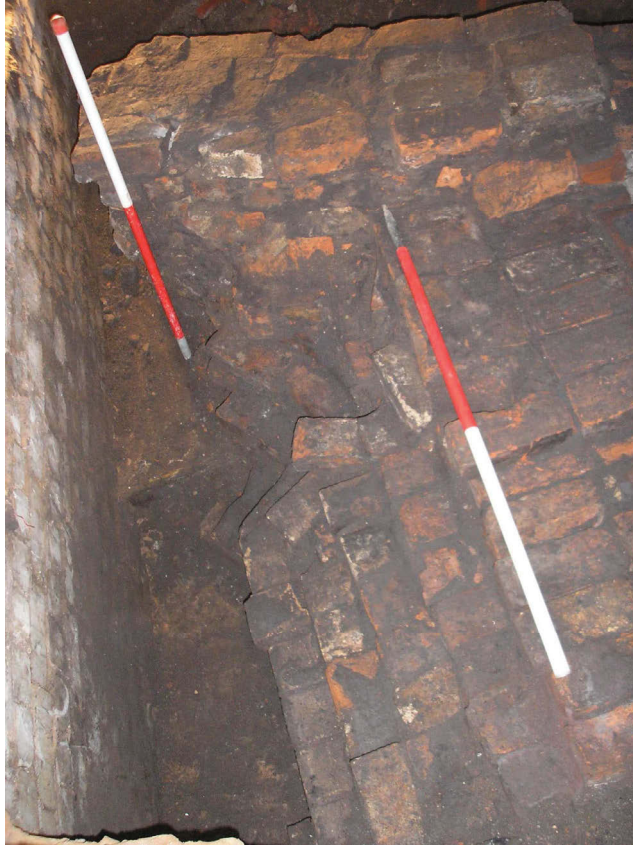
Plate 9: Western end of boiler seating wall *101* within the link building extension

- 4.3.4 A substantial east/west-aligned wall (101), measuring 6m long by 1.10m wide, was bonded to the eastern face of wall 114, representing a seating for the boiler. Wall 101 was lined along its southern edge by refractory bricks, with a further five skins of mould-thrown bricks across its breadth, that was in turn bordered by a single skin of Accrington bricks along its northern edge, and a stepped foundation along the south-west corner within the link building extension. The wall survived to a height of 0.60m, comprising seven courses above the ash pit floor (107), and 11 courses in height within the link building. The western end of the wall curved sharply to the south, forming the terminal end of the ash pit (Plate 9), although the construction of the link building during the 1980s obliterated much of the remains in this area.

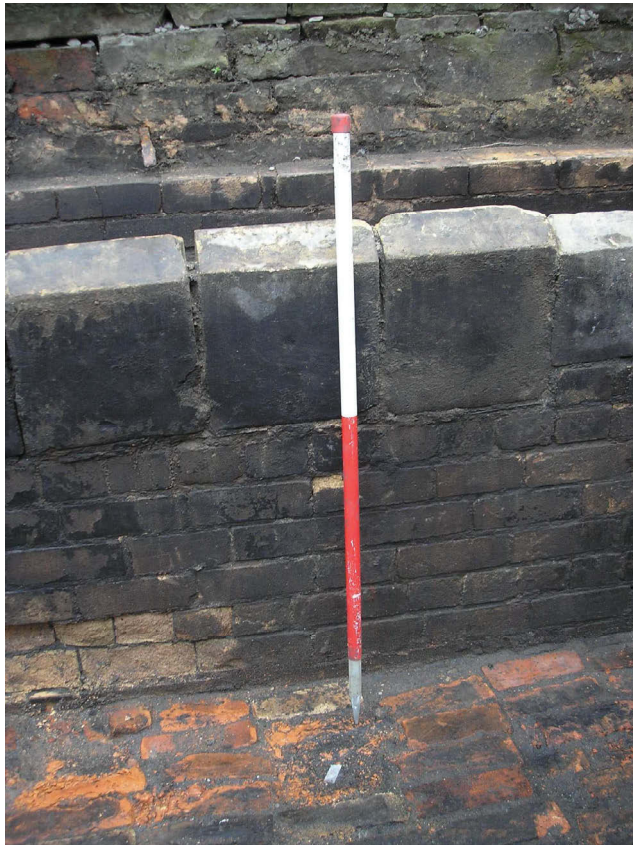
Plate 10: Refractory brick wall below boiler mounts lining the ash pit *107*

- 4.3.5 A series of nine boiler mounting blocks survived *in situ* on top of the second seating wall, which also formed the southern edge of the ash pit floor. Each mount measured 0.40m in height by 0.30m wide, and were constructed of refractory material. The underlying boiler seating wall was similarly constructed of refractory bricks, and survived to a height of eight courses (Plate 10). No mounts survived along the northern edge of the ash pit on top of wall 101. The floor of the ash pit comprised nine strings of well-laid mould-thrown bricks, laid in Stretcher bond. The floor was overlaid by abundant fuel waste and frequent large fragments of boiler mounts, which had presumably been discarded into the pit after the boiler was removed.

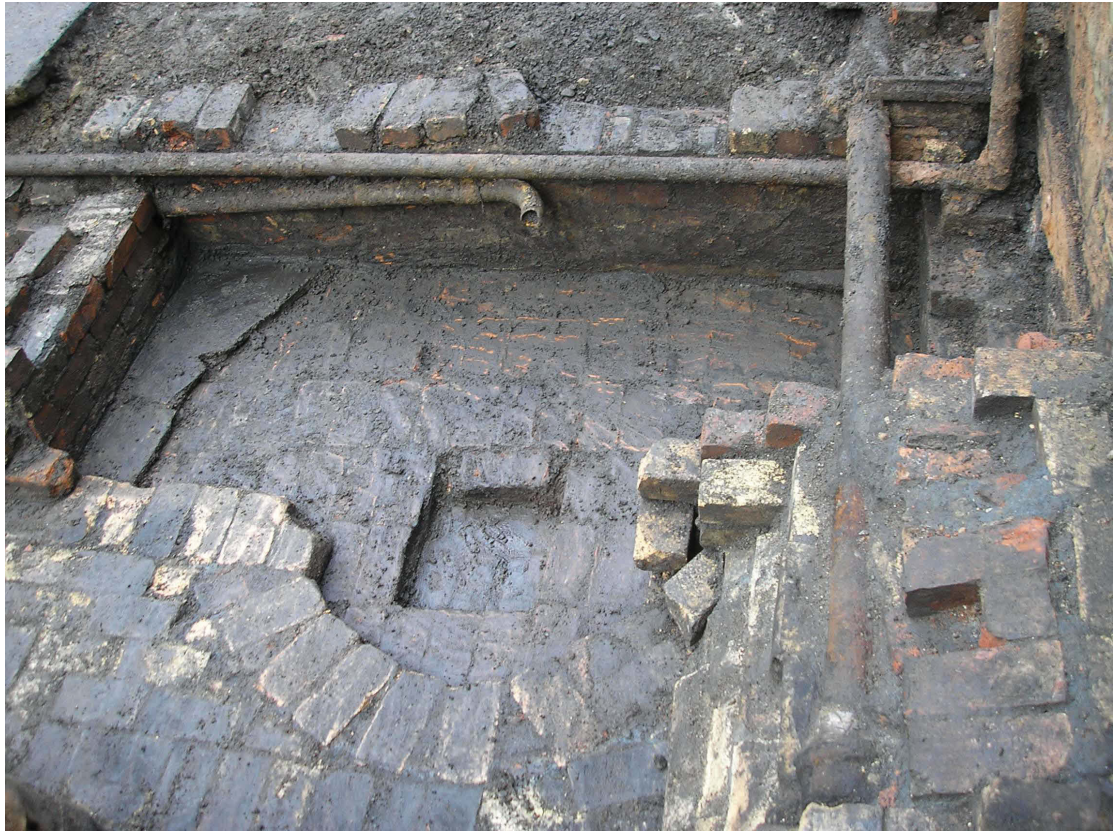
Plate 11: Flame-end *106* of the boiler foundation

- 4.3.6 The eastern end of wall 101 was butted by a single skin wide wall (109) that partitioned the south-east corner of the room. The wall was exposed for a distance of 1.70m, doglegging slightly at the eastern section where it butted a north/south-aligned wall (111) bordering the coal store area. This partitioned section represented the flame-end (106) of the boiler, which comprised an almost entirely fire-brick split level surface with a small 0.40m long, by 0.30m wide and 0.15m deep rake-out pit surrounded by a two-string arch forming the coal feed area (Plate 11). The boiler pit was surrounded by a confluence of

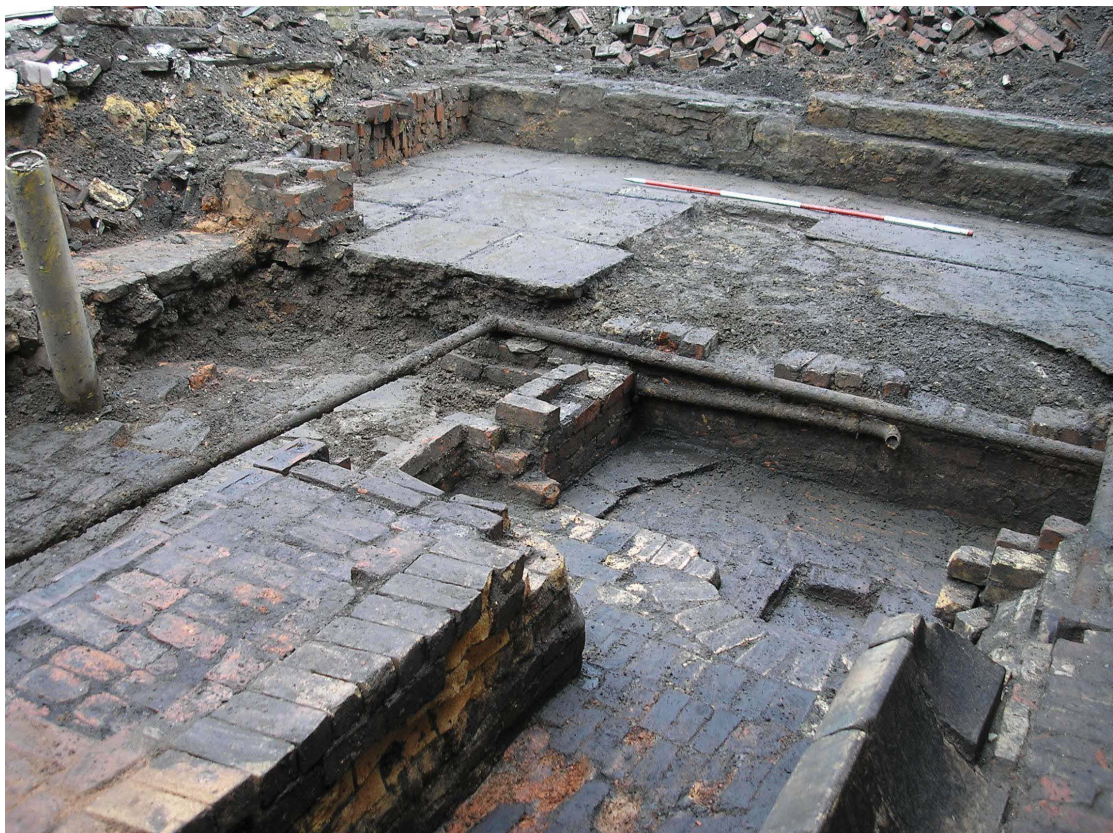
Plate 12: Coal store *112* and wall *113* at the eastern end of the boiler foundation

- 4.3.7 The flagged surface in the coal store (*112*) area of the room measured 4.40m by 2.70m, bordered by stone wall (*113*) representing the eastern limit of the room (Plate 12). The surface comprised irregularly-sized thin flags, which sealed mixed clay, sand and fuel debris. Two large iron plates were positioned within the southern part of the surface, presumably to provide an easy surface from which to shovel coal into the boiler hopper.

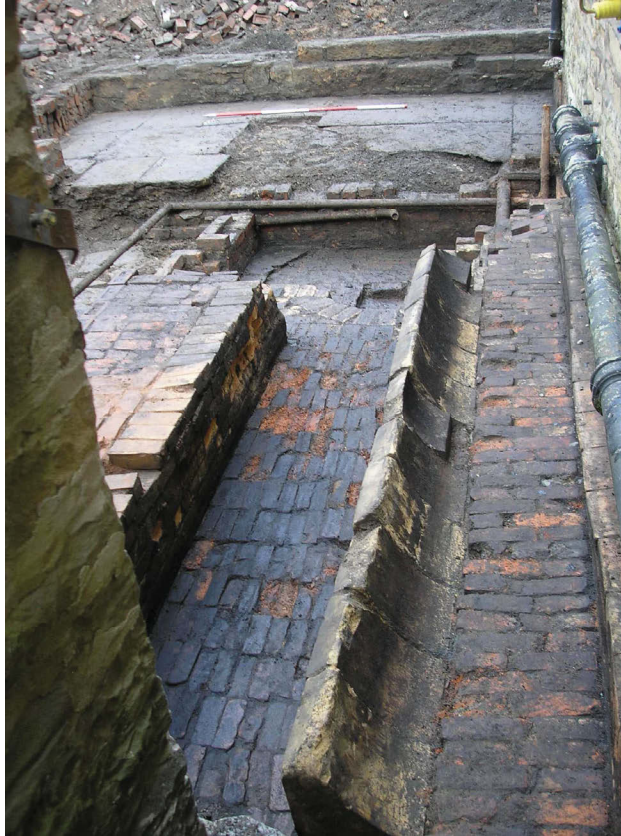
Plate 13: Flue *108*, and ash pit *107*, looking east

- 4.3.8 The flue (*108*) leading from the boilers to the mill chimney was located along the southern part of the boiler room attached to the north wall of Whitaker's Mill, continuing west up the alley that accessed the annexe between the buildings (Plate 13). The flue was lined along the southern edge by a single skin thick refractory brick wall, surviving to a height of 0.35m, which sat above a surface of mould-thrown bricks. The entire flue measured 0.86m overall wide from the fire-brick wall to a line of boiler seating mounts along the northern edge. The heavily-sooted flue floor comprised two stretchers laid side-on bonded with light grey lime-ash rich mortar. The floor at the western end of the flue stepped up to 0.21m in height, and was exposed at a depth of 0.60m below the concrete foundation across the base of the access door. The raised area of the floor sealed the refractory wall lining the ash pit, widening the surface to 1m and four brick strings in thickness. It is possible the bricks in this section were laid after the boiler was removed in order to create a level surface prior to the installation of the flag-stoned alley. The eastern end of the flue was bordered by a 1m wide 45-degree angled ramp representing the upward draught at the flame-end of the boiler. The ramp comprised entirely of refractory brick, which was at least three courses thick, and eight strings wide. An iron water pipe was exposed running east/west below the flue floor for a distance of 1.2m heading west up the alley. It is probable the pipe provided the heated water from the boiler, thus providing heat for rooms inside the mill.

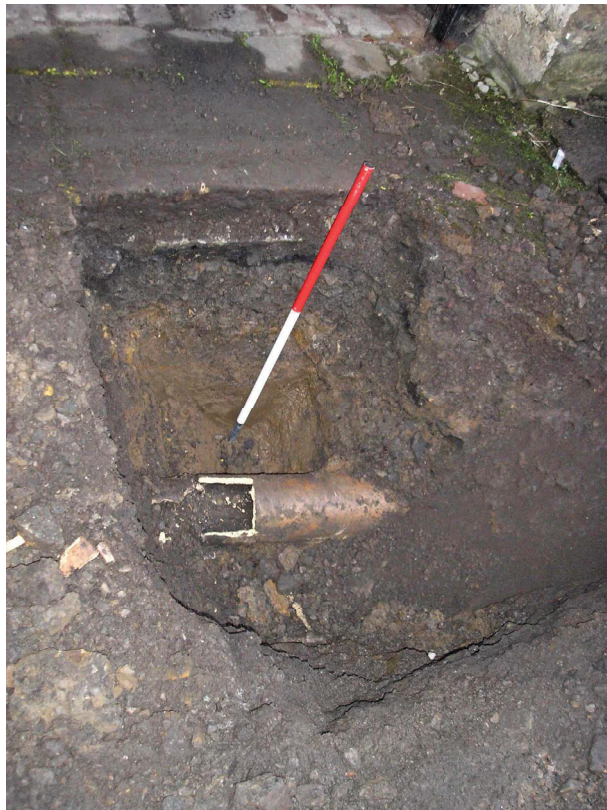
Plate 14: View of pipe in Test Pit 1

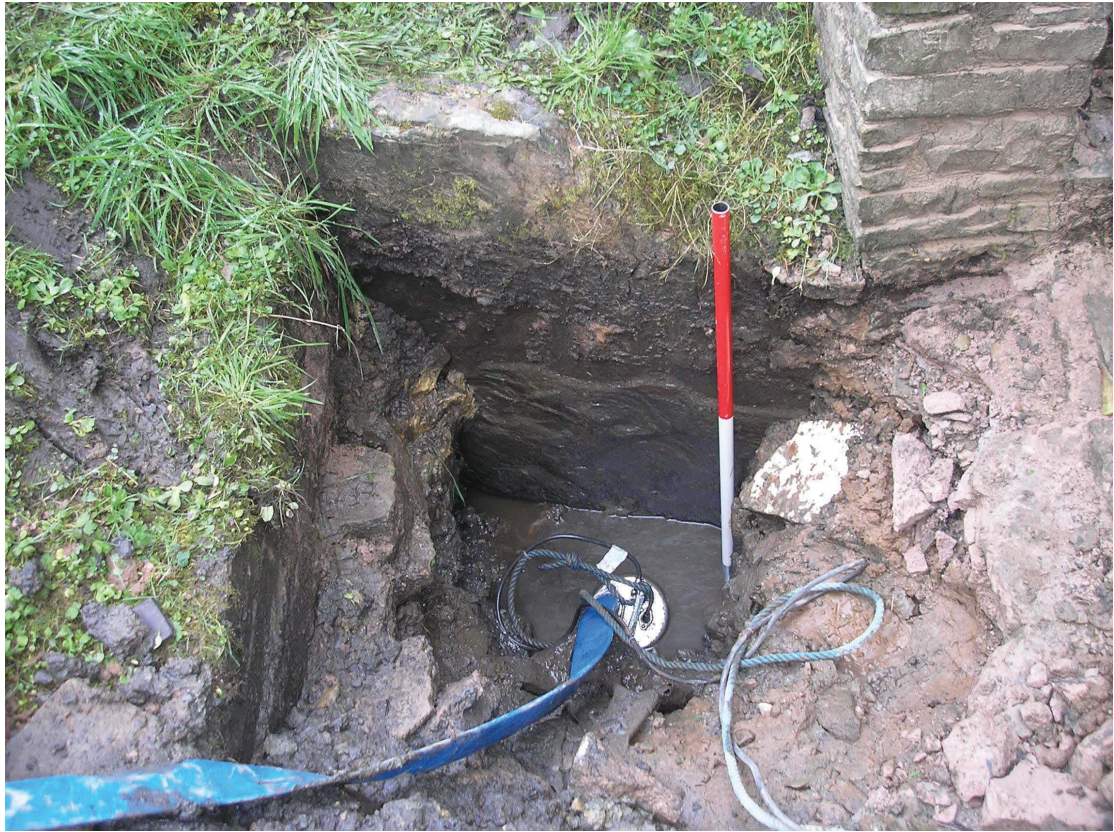
Plate 15: View of the headrace wall in Test Pit 2

wall survived partially across the breadth of the headrace, along the northern edge of the test pit. The wall survived to a depth of 0.40m below the turf bank, and comprised three irregularly-laid stone and brick courses bonded with grey lime mortar. The wall was probably constructed during the 20<sup>th</sup> century as a part of a landscaping exercise, effectively sealing the backfill of the disused headrace. A backfilled deposit, measuring at least 0.60m thick, was encountered below the wall and spread across the test pit. A full depth of the deposit was not observed due to the ingress of water into the pit from the lodge. This hindered further excavation, and precluded an examination of the floor of the headrace.

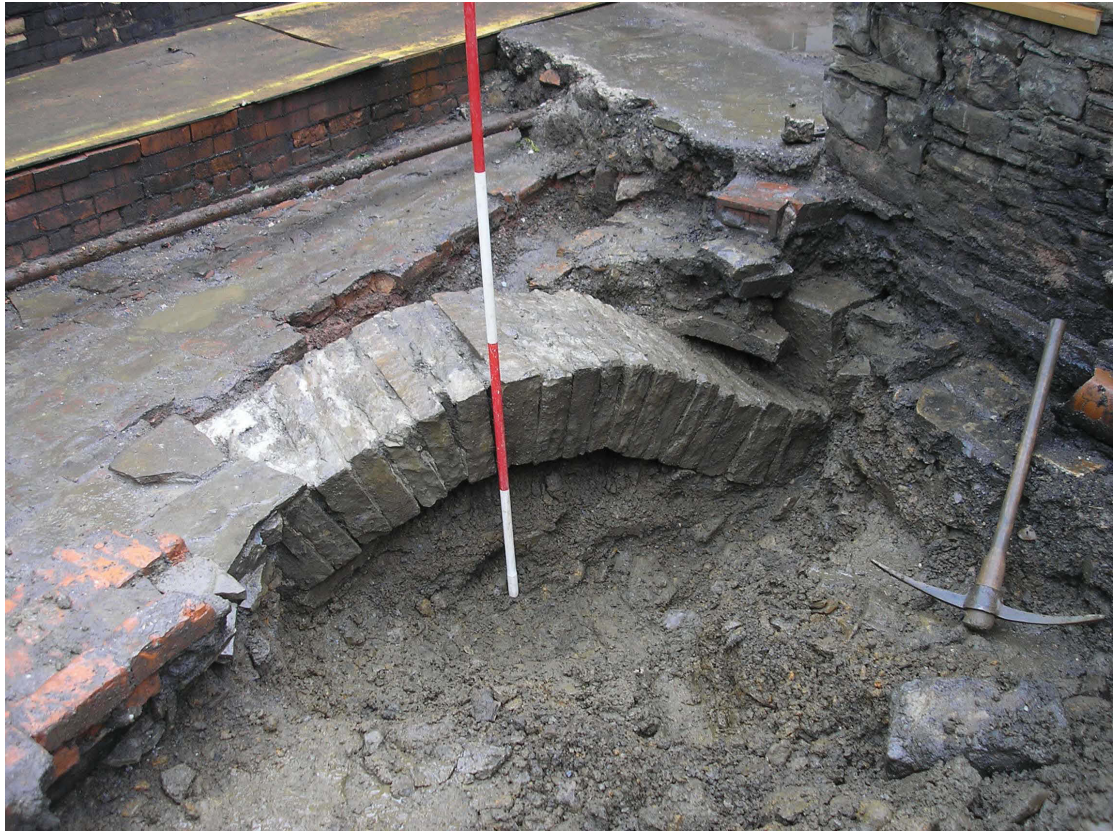
Plate 16: Stone roof arch *01*, looking south

- 4.2.1 The earliest archaeological remains encountered during the evaluation predated the construction of the boiler house in the early 20<sup>th</sup> century. These remains comprised the construction of a stone arch (*I*) aligned east/west across the roof of the original tail race. It measured 2m long by 0.56m wide, and 0.32m deep, and was recorded at a height of 0.42m above the tail race roof (Fig 9) within a hand excavated sondage place beneath the width of the arch. The gap between the top of the tail race roof (*03*) and beneath the arch was filled with firm orange stony clay (*02*). The arch (Plate 16) was constructed

foundation for the flame-end of the boiler, or served as a capping over one of the tail races that is known to run below the boiler house.

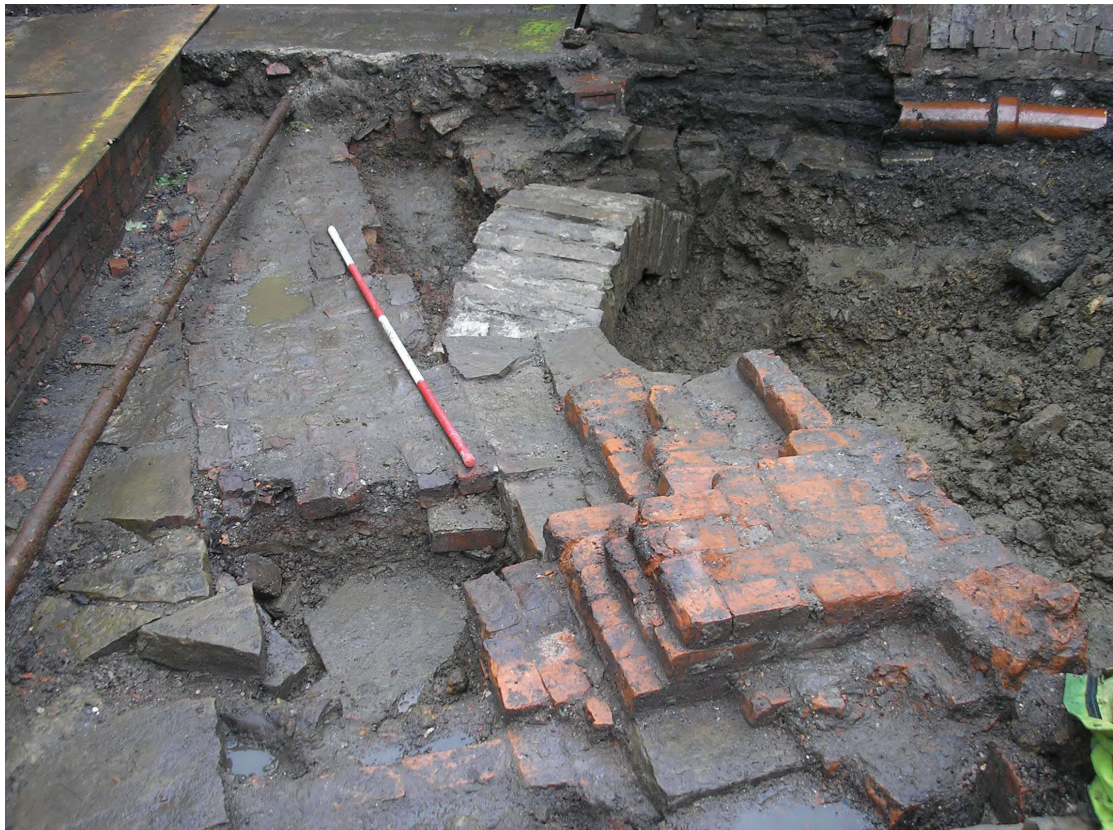
Plate 17: Stone wall foundation *06*, looking south

- 4.2.3 Stone wall foundation **06** comprised a row of four regular sized thin stone blocks each having a thickness measuring 0.10m with two courses visible (Plate 17) over a distance of 1.8m and overall width of 0.45m. Part of the southern end of wall **06** overlaid the eastern end of the stone arch. The blocks were laid flush with the brick surface along a north/south alignment positioned along the surface western edge, similar stones were observed along the eastern edge of the surface that were tentatively described as a 'wall' during the 2006 evaluation. It is therefore probable that each row of stone blocks may have provided the foundation for the seating wall for each side of the boiler (of probable Cornish type-pers.comm. Ian Gibson). The demolition of the building and construction of the later boiler house (*Phase 4 below*), had eradicated each wall at the southern end of the brick surface. However, a row of five north./south aligned small stone blocks (**17**) each measuring 0.20m by 0.10m were retained along a similar height as foundation **06**, butting the south eastern edge of the stone arch. The stones overlaid a very mixed mottled clay, and possibly represented a residue of the southern extent of wall **06**.
