**An Analysis of the Historic Fabric of  
Late 16<sup>th</sup> and early 17<sup>th</sup> Century Buildings  
in Ledbury,  
Herefordshire**

**A Report Prepared for the  
*England's Past For Everyone Project*  
*Herefordshire*  
by  
Duncan James**

**June 2007**

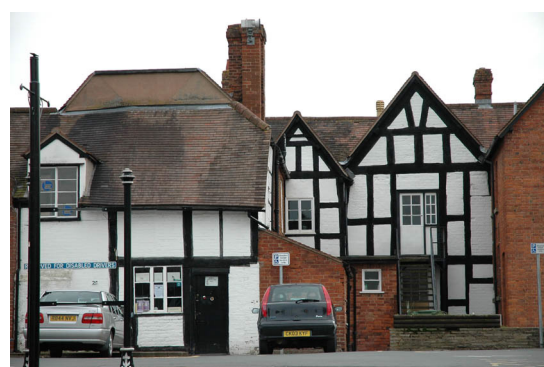
The Master's House – north elevation

This is a late medieval, timber-framed open-hall house with cross wings at each end. Tree-ring dating has shown that it is built from timber that was felled in 1487 and so it would have been erected either in the same year or the following one. [Report forthcoming by Nottingham Tree-Ring Dating Laboratory]. It is a late example of a medieval hall house because in Herefordshire after about 1500 the preference was to build ceiled halls, with chimneystacks rather than an open hearth. [James, D. 2005. p.90] The hall range contains a spere truss, with cusping, at the lower end; a principal truss, with arch bracing to the collar, over the middle of the hall; and a further decorated truss at the upper end. There were also projecting oriels on both sides of the upper end of the hall and at the cross passage – the latter possibly forming porches. Both cross wings are of three bays. The hall roof has two tiers of curved wind braces. [Morriss, R. K. 2002].

The primary structure is now virtually enclosed within 18<sup>th</sup> century and later extensions but the majority of the roof structure survives intact. [Hillaby, J. 2003. pp.107-114]

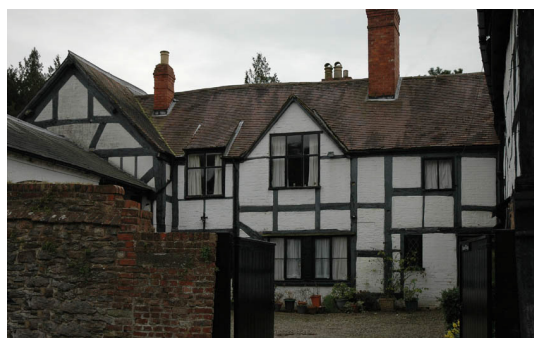
Abbot's Lodge – hall range – north elevation

The principal arch-braced truss over the hall has been replaced by a later tie-beam truss. The three-bay service wing survives, later extended by another three bays, but the upper or solar cross wing has been removed, probably following the first phase of construction of the adjacent Church House (q.v.).

The building is significant in respect of the present study because Church House was built in front, indeed, was a development of, the now lost upper, solar crosswing of Abbot's Lodge, a building which may then have been downgraded to a lower status function until, in the 18<sup>th</sup> century it was remodelled and rose once more in status. The two became separate units of accommodation, probably during the 17<sup>th</sup> century.

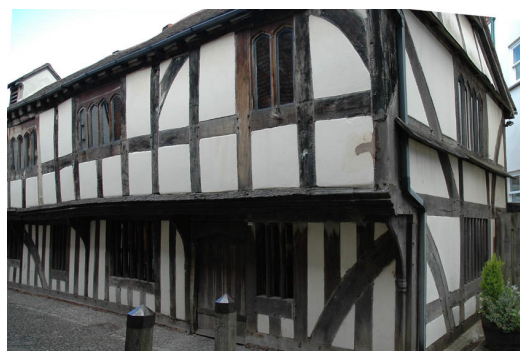
The Old Grammar School looking N.W.

This five-bay, timber framed, two-storey range, laid out on an approximate east-west orientation, is probably of late 15<sup>th</sup> century date. The figures of 1480 –1520 have been suggested. [Wallis, J.D. & Wood, G.C. p.5] It has a deep jetty along the south side. The building, which was restored in 1977/8 near to its original form, clearly had some public function rather than being purely domestic. It has been suggested that it may have been built as a guild hall and only later used as a grammar school [ Wallis, J.D. & Wood, G.C.]

An unusual feature is the smoke bay at the west end, which may have had a service function; that and the position of the offset cross passage tends to support the proposition that the west end bay was the 'low' end of the building and that the east end bay, with its separate entrance, was the high end. This is in contrast to the published view. [v. Wallis, J.D. & Wood, G.C. pp 20-23 (by S.R. Jones) for further details.]

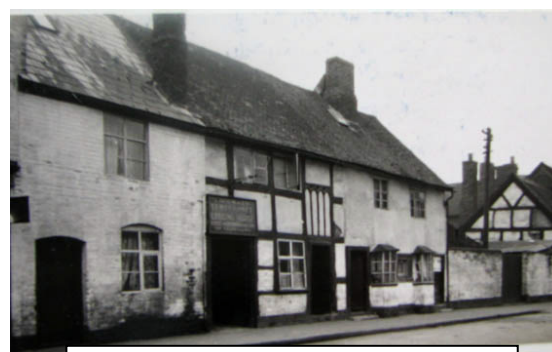
28-32 Bye Street, Ledbury. C. 1930.  
North elevation.

This building was demolished post-1945. From the photograph and ground plan made in the 1930s [RCHM notes. 1930] this appears to have been an axial hall house, laid out on an east west orientation parallel to Bye Street. The foliated-

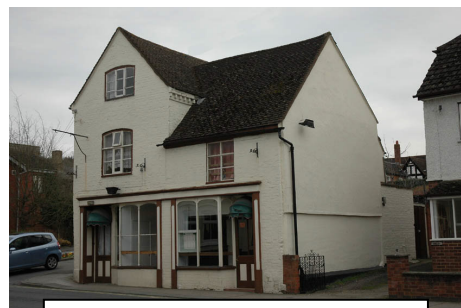
16 Bye Street. North elevation.

This is a small range set parallel to the road with a cross-wing at the east end. It is reported to have a roof of early date. [Wallis, J.D. & Wood, G.C. pp.14-15]. The building has been refaced in brick and a Victorian or later shop front has been fitted. The right hand side of the building can be seen on the left hand side of the photograph above of 28-32 Bye Street.

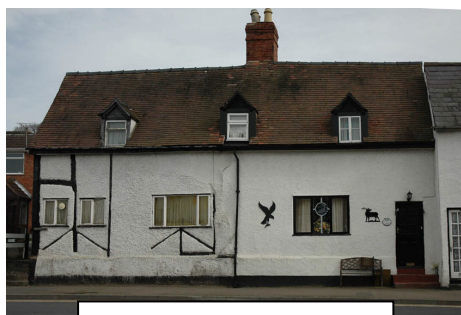
233 & 235 The Homend

In the north gable end wall of this pair of tenements is a pair of steeply pitched cruck blades that are probably of 15<sup>th</sup> century date. It is suggested that they are either re-used material in a later building or relate to a lost building that stood to the north.

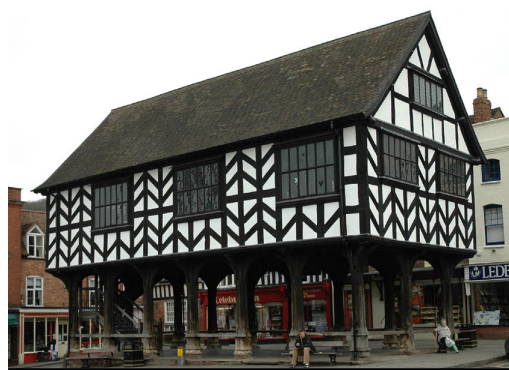
The Market House. South-west elevation.

This is a key central structure in the layout of Ledbury and an important visual symbol of the town but its year of construction has always been something of a puzzle to historians and, as a consequence, a wide range of dates has found its way into print.

There are seven tie-beam roof trusses, four of which have bracing in the form of triangular brackets beneath the high collars and there are short, raking struts from low down on the principal rafters to the tie beams. The central truss was never fitted with triangular brackets below the collar although it does have raking struts. The general impression is of a roof designed to form a clear storage area through the middle of the attic with enough headroom (c.6ft (1.83m)) to make it easy to use. The floor, although the joists and floorboards are missing, was also of substantial construction, almost identical to the layout and dimensions to be found at first floor level.

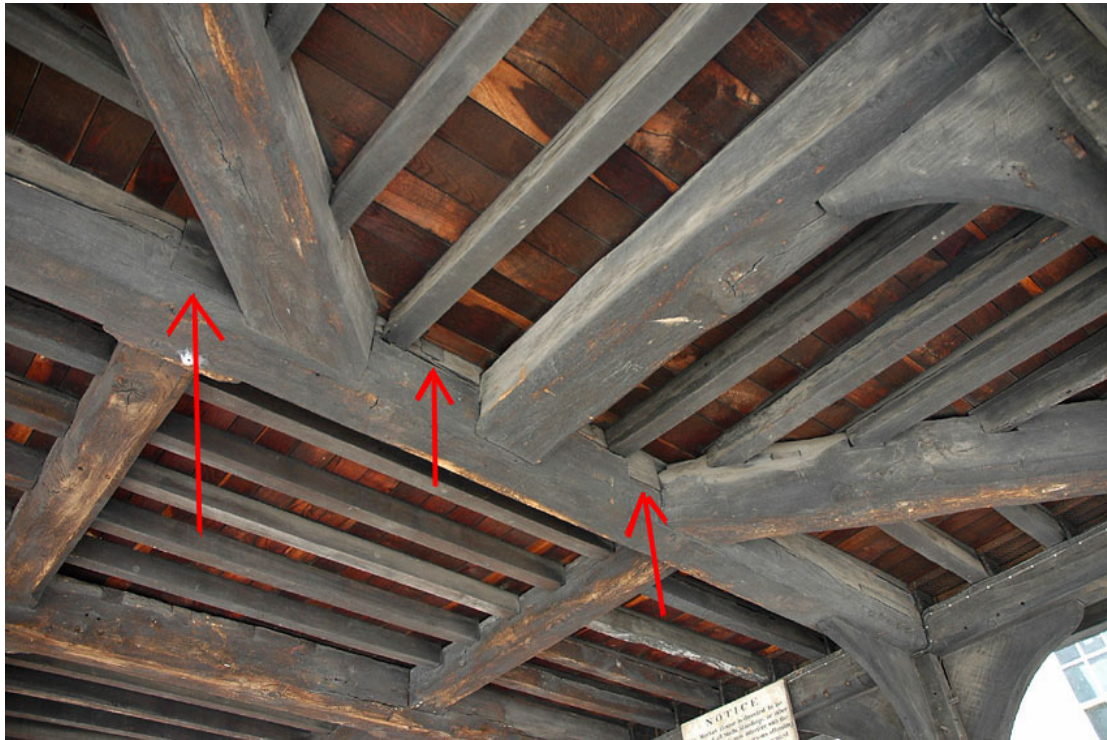
Ledbury Market House.

ends mortised into the transverse beams; to clear the way for this it was necessary to remove the pairs of axial beams at each end and plug the mortices. This meant removing the related columns and replacing them with a single column central to each end, supporting a new, central axial jetty beam. The dragon beams are, as noted in 1939 [TWNFC 1939 p.xxv] not oak but elm, confirmation, if it were needed, that the revised structure is not part of the primary phase. (The use of elm in buildings of the later 17<sup>th</sup> century is also quite common).

These modifications to the end bays also made it necessary to rearrange the floor joists and there are plugged mortices in the transverse beams that indicate their former positions.

The ground-floor ceiling showing inserted dragon beams and plugged beam and joist mortices.

The end jetty needed further support, which accounts for the additional brackets on the south and north faces of the corner posts, one of which, on the south-east corner post, overlays an incised flower – a feature of the primary phase. (There was formerly a similar, partially obscured motif on the south-west post but the present one is a 20<sup>th</sup> century replacement and the decoration was not copied.)

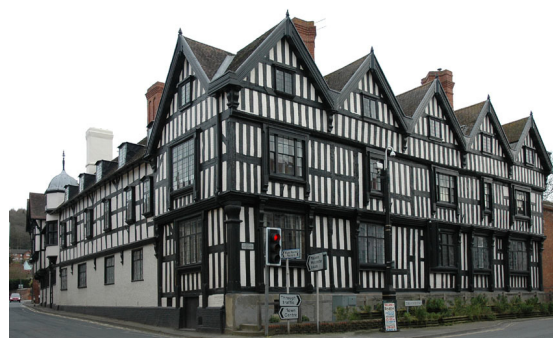
Ledbury Park showing the principal west elevation..

The earliest part of this building, and of principal concern for this report, is the west range laid out on a north-south alignment on the corner of The Southend and Worcester Roads.

A number of factors, including documentary evidence, decoration and an inscription on interior panelling, indicate that the house was built in about 1590 by Edward Skyner.

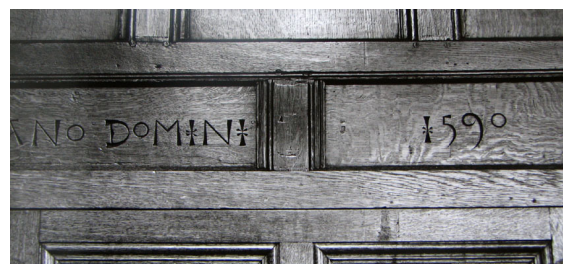
Ledbury Park. Inscription on panelling.

In his paper on the subject J.W.King [King, J.W. 1997, p.104] refers to Robinson for a construction date for Ledbury Park. This is from the line “*The house was built, as a tablet testifies, in 1595,.....*” [Robinson, C. J. 1872. p.167]. It may be that Robinson is quoting, inaccurately, the date on the panelling, or that there really was a tablet with 1595. However, on the assumption that the panelling belongs to the house it is unlikely that it would predate the building itself. Many of the later changes to the building were made after 1688 when the house came into the hands of the Biddulph family. [King, J.W. 1997, p.106]

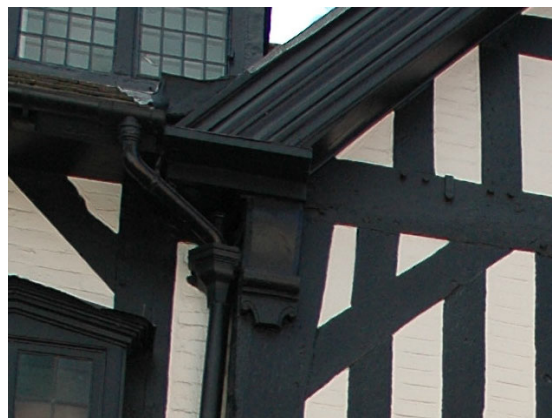
Ledbury Park.  
Primary console on the north end of the west range.

These bold mouldings and consoles on the present façade were probably added in the late 19<sup>th</sup> century and were possibly the work of the architects R.Coad and J.M. Maclaren who carried out the addition to the east end of the north wing and other works. (The design was illustrated in *The British Architect* in the Oct 8<sup>th</sup> issue of 1886).

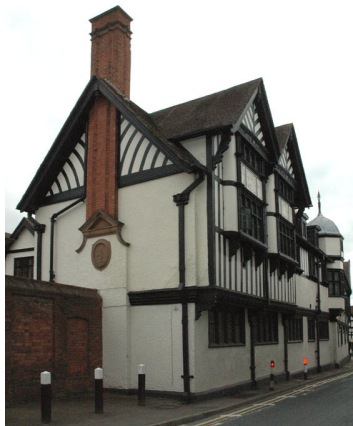
Ledbury Park  
Late 19<sup>th</sup> century additions.

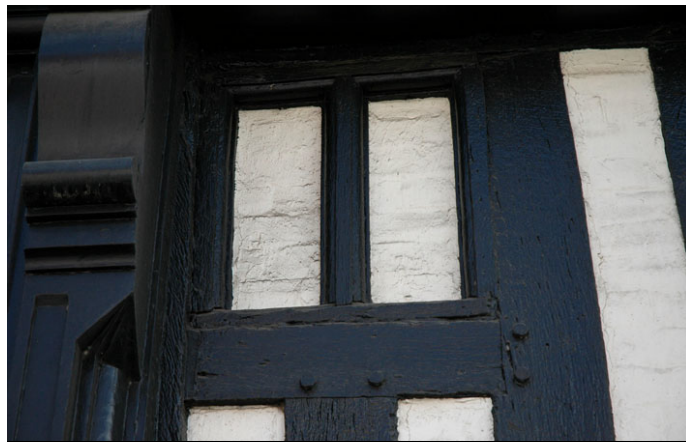
A notable and characteristic Ledbury feature can also be seen alongside the two wide windows at ground and first floor levels on the bay at the south end. Here, on each side of the main windows there are small, two-light blocked windows with ovolo moulded surrounds and mullions.

On the west range the first and attic storeys project slightly and there are bressummers with double ovolo mouldings. The tie beams on the attic gables also project slightly and have single ovolo mouldings. The north end of the range is also jettied at first floor level. These are mouldings that belong comfortably to the probable date of construction (1590) and they are also used on a number of the ceiling beams inside the building. The finest ceiling beam mouldings are in the ground-floor north end panelled room; these have a double ogee and a central roll moulding and run-out stops.

Ledbury Park.  
One of a pair of small side windows on the west front.

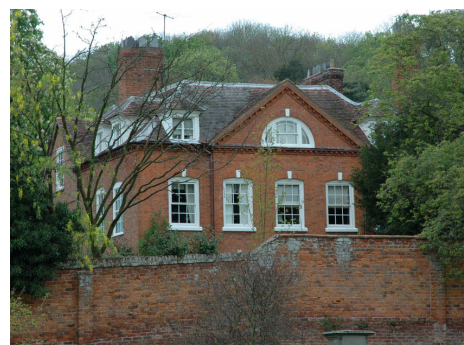
Lower Hall viewed from the churchyard.

This is the site of *Nether Hall*, the house of another portionist attached to the church. What stands today is all of 18<sup>th</sup> century brick although reset carved fragments, possibly of the 15<sup>th</sup> century, in one, formerly external wall were noted in the 1930s.  
[RCHM notes. 1930]

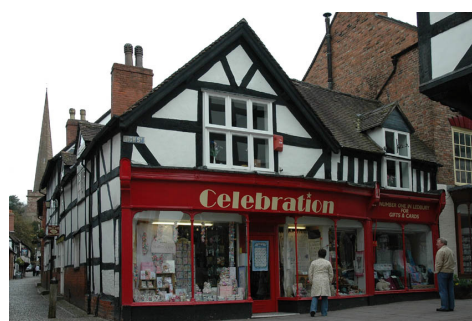
1 High Street. West elevation.

This 16<sup>th</sup> century timber-framed building occupies the corner site at the meeting of High Street with Church Lane. It is of two storeys consisting of a short, close-studded range parallel to High Street and a formerly deeply jettied cross wing at the north end extending back along Church Lane. There is a 17<sup>th</sup> century range, which has been raised in height, abutting the east end of the cross wing.

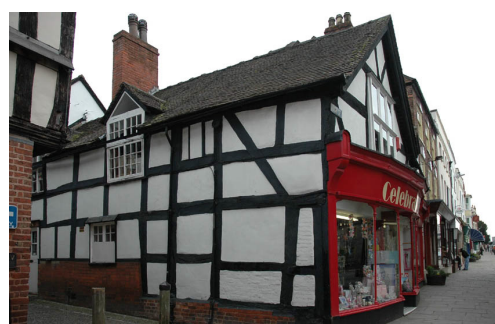
1 High Street. Framing along the north side.

The cross wing has a small, blocked upper window on the north side. In the west gable is a large window that is a later, possibly 18<sup>th</sup> century, insertion made by cutting the tie beam. The present shop front, which embraces the entire ground floor west façade, is probably of early 20<sup>th</sup> century date. It replaced a lower, bow-fronted design, possibly of 18<sup>th</sup> century date.

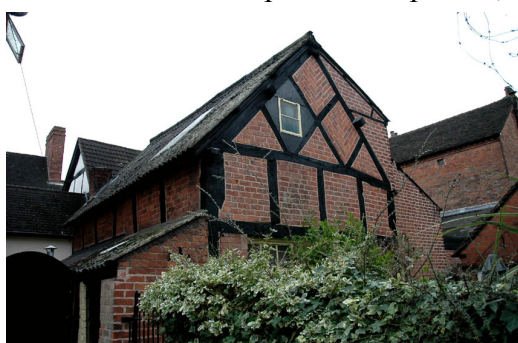
Timber-framed building behind No. 2 High Street.

Also, close to this building, but to the rear of No 2 High Street (listed under the same RCHM number) is a late 16<sup>th</sup> /early 17<sup>th</sup> century timber framed building with lattice work framing in the gable.

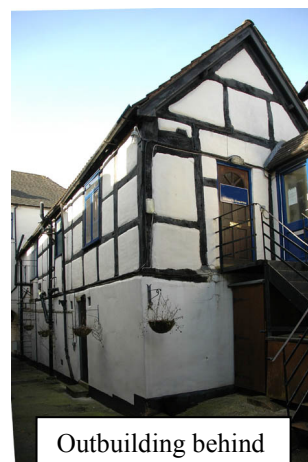
Outbuilding behind  
No. 3 High Street.

Although No. 3 High Street, with its 18<sup>th</sup> century brick front, like others in the row, probably contains timber framing, it is well hidden. However, to the rear there is a two storey timber framed building, of possible 16<sup>th</sup> century date, laid out on an east west alignment that appears to have an underbuilt jetty along the south side.

At first floor level in the east end of the building is a narrow blocked doorway with a doorhead that either led onto an external staircase or shows that the range continued in an easterly direction.

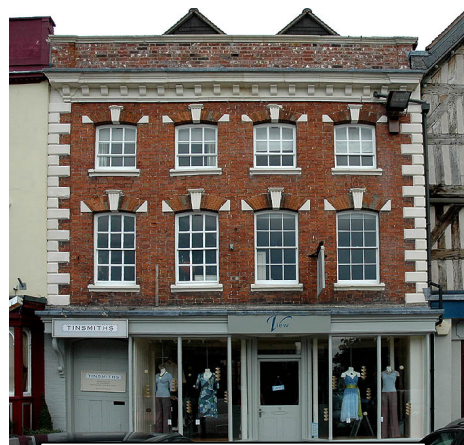
8 High Street. West elevation.

This refacing, in effect underbuilds both first and second floor jetties, increasing the available floor space, especially at street level. The earlier building is indicated by the two gables visible above the parapet. Also, as Hillaby noted, it is possible to see, intruding into the upper part of the first floor windows, the unaltered floor level of the earlier house. [Hillaby 1997. p.94].

The RCHM noted two smaller timber-framed buildings, both “probably of early 17<sup>th</sup> century date”. [RCHM notes 1930].

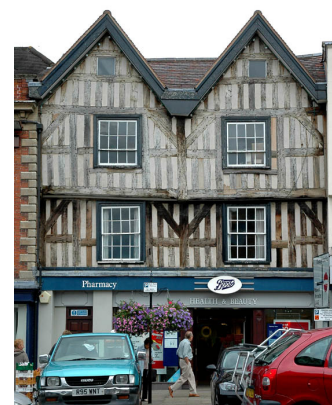
9 High Street. West elevation.

When the RCHM visited the building in 1930 the now exposed timber framing on the front was hidden behind stucco, probably applied when the windows were inserted, possibly in the 19<sup>th</sup> century.

This is either a late 16<sup>th</sup> century, or more likely an early 17<sup>th</sup> century, building of two bays and three storeys with two attic gables on the west front. The top storey is jettied and has an ovolo moulded bressumer in two sections with run-out stops. It is almost certain that the first floor was originally also jettied but it is now underbuilt with a modern shop front

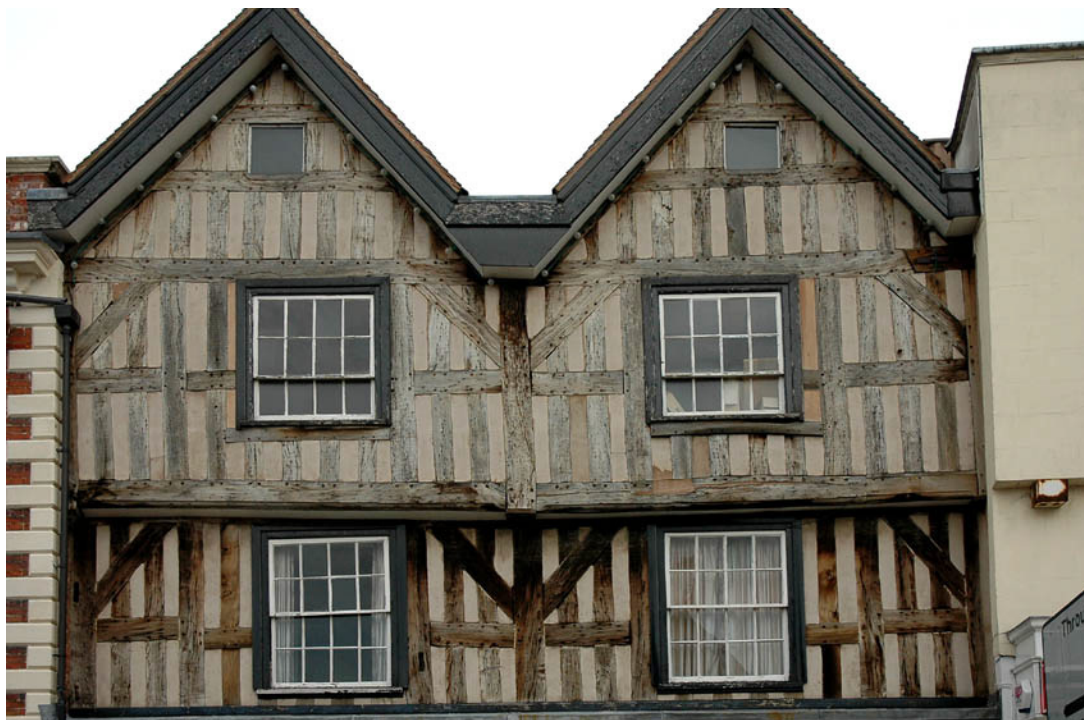
9 High Street. West elevation – 1<sup>st</sup> and 2<sup>nd</sup> floors.

There is close studding on the front and in the gables and diagonal bracing in the corners.

The later sash windows are offset from the original window openings and cut into, and drop below, the primary sill levels.

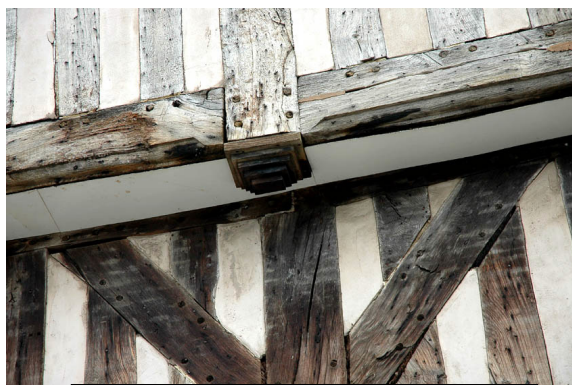
The buildings on each side now partially enclose the corner posts particularly on the upper storey. The central post in the top storey has a modern pendant slightly below bressummer level but whether this is a copy of the original is not known.

9 High Street. West elevation - detail.

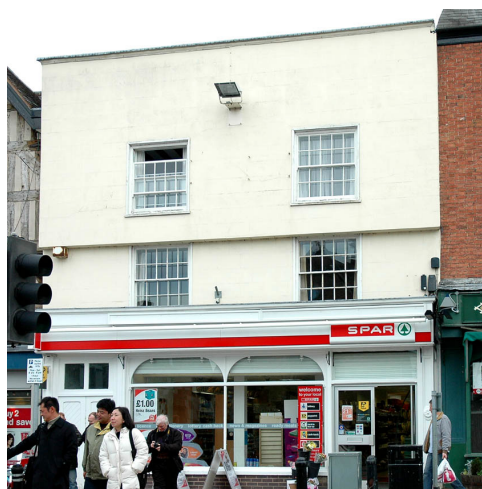
10 High Street. West elevation.

Although the front of the building is plastered, and has large sash windows, this is a three storey timber-framed building laid out on a north-south orientation. The second floor is jettied and it is almost certain that the first floor was jettied before the installation of later shop frontage. There is evidence to suggest that it may also have been jettied on the rear of the building.

RCHM puts the date at early 17<sup>th</sup> century and noted that “*The landing at the top of the staircase has some wall lining of late 16<sup>th</sup> ce. Panelling similar to that in Lord Buddulph’s house and in No. 9 and a moulded cornice (presumably all reset) and a panelled door matching the panelling.*” [RCHM notes. 1930].

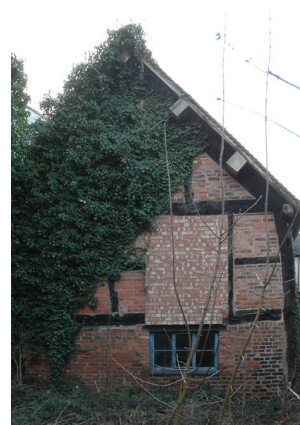
Although there are some aspects of the main part of this building that suggest it may be early, there is one building to the rear that is early 17<sup>th</sup> century. It is a two-storey two-bay timber-framed range with heavy, stop-chamfered ceiling beams.

14 High Street.  
Building in rear garden.

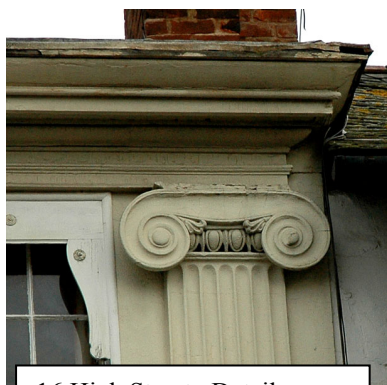
16 High Street. Detail.

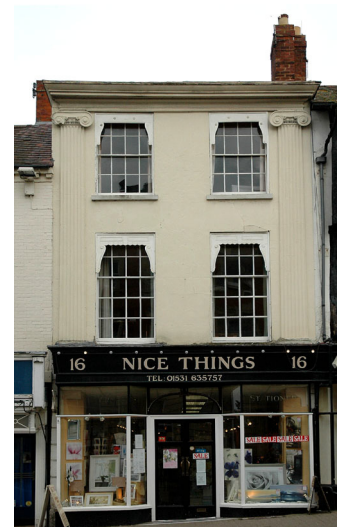
The evidence for the earlier configuration of this building come from the painting of 1820 (see below) which shows it to have been jettied at first and attic floor levels in line with its neighbours, Nos. 17, 18 and 19. This indicates that the present front with its fluted pilasters and Ionic capitals probably belongs to the early 19<sup>th</sup> century and not, as suggested by RCHM, the mid-to-late 18<sup>th</sup> century. [RCHM notes 1930 – under RCHM No. 18]

16 High Street. West elevation.

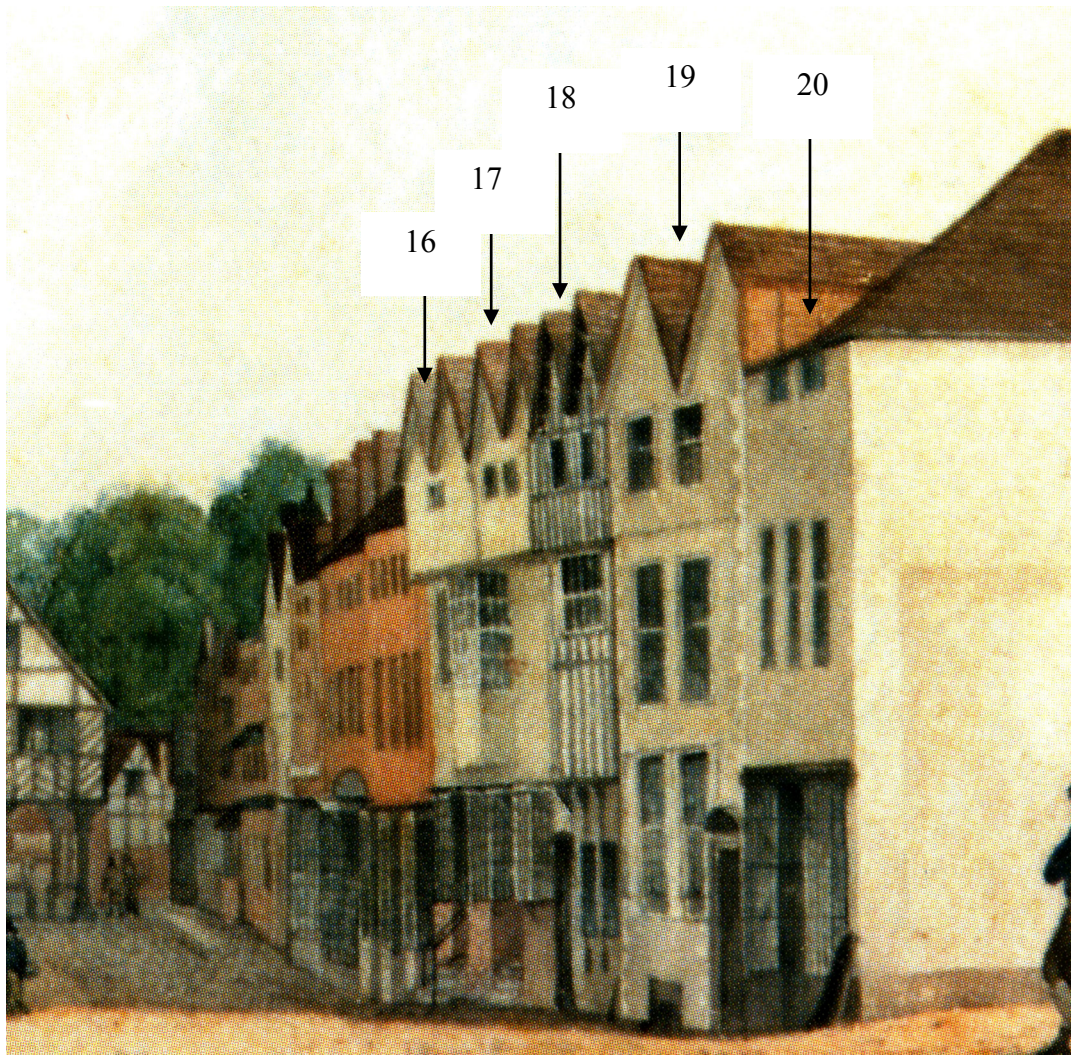
A view of the High Street in 1820 showing numbers 16 to 20. [from Hillaby, J. 1997 – front cover]

This is a 19<sup>th</sup> century refronting or rebuilding of a timber-framed building. The 1820 image (p.25) shows this to have been a building of similar form to others in the High Street with a double gable and probably of late 16<sup>th</sup>/early 17<sup>th</sup> century date.

The 1820 image (p. 25) shows this building refronted but with two gables still in place and a doorway to one side in the same position as at present. It seems highly likely that this building was originally jettied at first and second floors. As a further indicator of the primary date the ceiling beams are recorded as having ovolo mouldings.

This building is considered by RCHM to be fairly early 17<sup>th</sup> century [RCHM notes 1930]. The illustration of 1820 (p. 25) shows the building with a hipped roof and two, oddly low windows under the eaves. This looks very much as if it was part of a remodelling or refronting of the late 18<sup>th</sup> or early 19<sup>th</sup> century. The engraving of 1733 (p. 19) illustrates this corner house showing two attic gables and a window in each. In more recent times the top storey has been raised to insert larger windows.

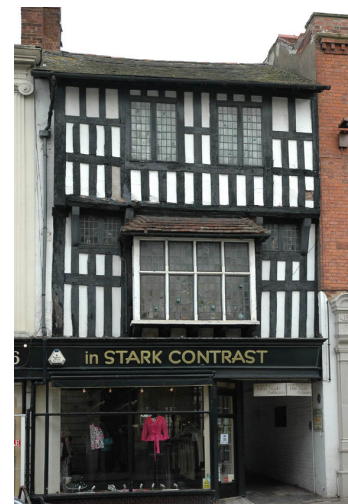
This three storey, timber framed building, which is of late 16<sup>th</sup> century date, has close studding on the front and a jettied top floor. It is almost certain that the first floor was also jettied although it is now underbuilt with a modern shop front. An alleyway passes through the south side of the building but this is probably a later alteration as the ovolo-moulded ceiling beams continue through into the present shop, which suggests that the ground floor was originally arranged as a single room. The building appears to have moved sideways away from the building on the north and ‘into’ the building on the south. The

17 High Street. West elevation.

southern corner post plus, in the case of the top storey one of the narrow vertical panels, have been lost.

Repairs and alterations have been made to the front.

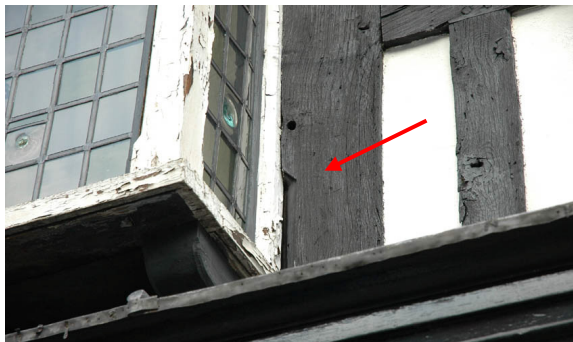
17 High Street. Peg hole and ovolo moulding indicate the position of the original window sill

The later, large, projecting first floor window is the same width as the original but has a much lower sill. And as indicated by the moulded window jambs the primary window did not project.

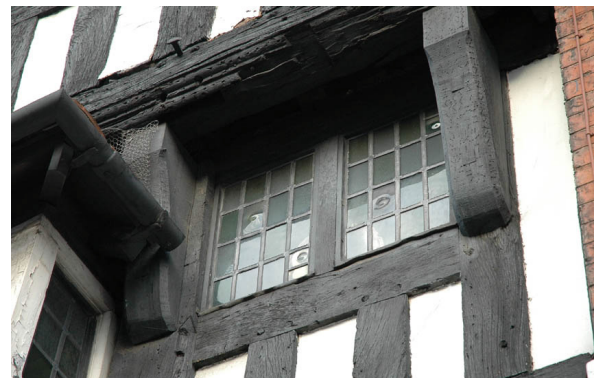
17 High Street. Side window with later brackets under the jetty.

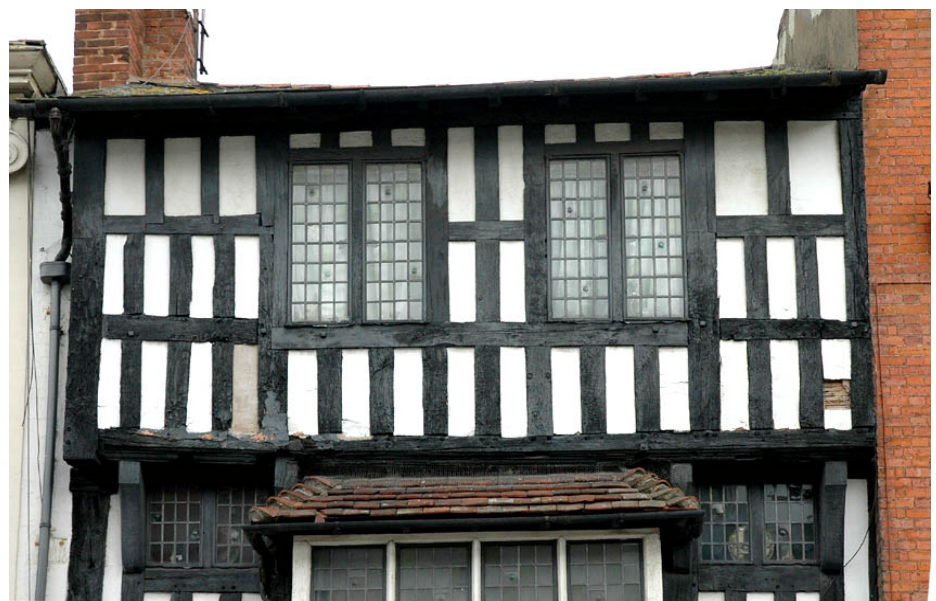
17 High Street. Top storey.

There is a considerable number of new timbers below the eaves but these are replacements for lost material rather than a new construct. What the RCHM inspector J.W.Bloe did suggest is that the range originally “*evidently extended northwards but the next house, No. 16 was rebuilt in mid-to-late 18<sup>th</sup> century*”

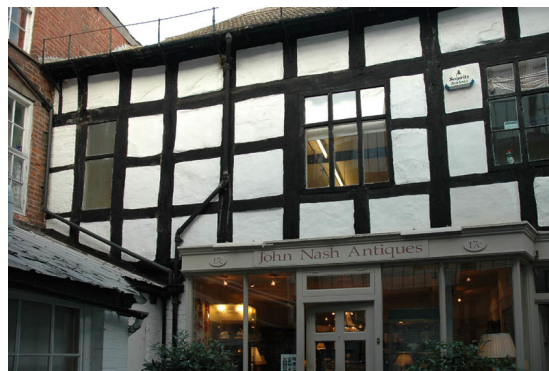
This timber framed range stands on the east side of the yard behind Nos. 17 and 18 High Street. It is probably of late 16<sup>th</sup> century date. It consists of three bays and is two storeys high with an attic storey. The first storey appears to have been jettied along both sides of the building although it is now underbuilt. A section of exposed bressummer on the east side has a double ovolo moulding. Due to the underbuilding only part of the west side bressummer is visible but it appears to have a similar profile. A shaped bracket or console, which has been hewn from the top of the post, (i.e. it is attached) survives beneath the east side bressummer on the south side of the (later) alleyway through the south end of the building, indicating that the jetty was relatively shallow.

17c High Street. West elevation.

The beams on the ground floor and first floor are chamfered, with cut stops. From an RCHM drawing the attic roof has a double tier of trenched purlins. The truss shown has no tie beam but a high collar with vee struts above and long queen posts below forming a door frame. In addition there are raking struts from the principal rafters at lower purlin level that meet the base of the door frame. [RCHM notes 1930].

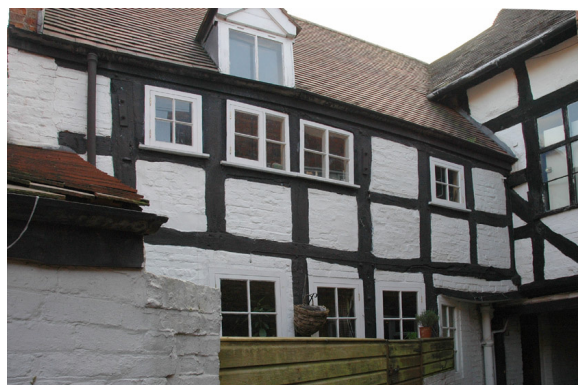
Cottage behind 17 & 18 High Street. North elevation

At the south end of the range a (later) passageway has been created at ground-floor level. Behind the south end of the range is a two-bay, two storey timber-framed cottage that is of 17<sup>th</sup> century date. It abuts the east side of the larger range and has been modified on one corner to clear the route for the later passageway.

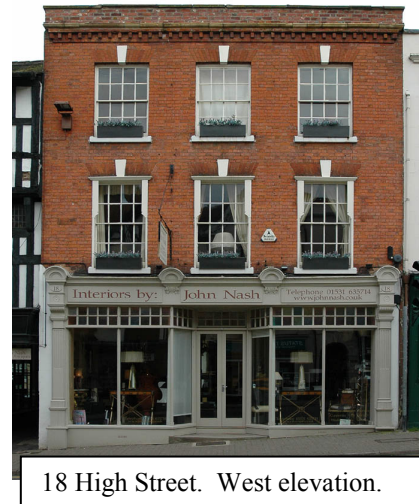
18 High Street. West elevation.

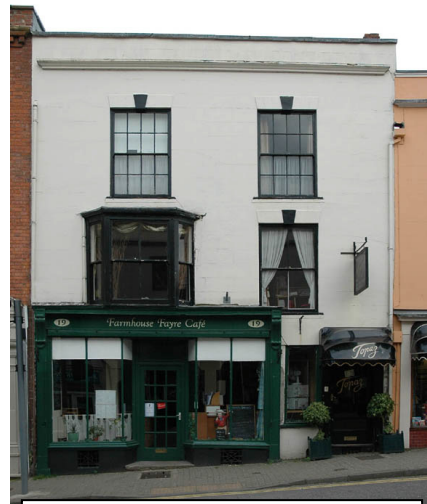
The RCHM considers this to be of early 17<sup>th</sup> century date, timber-framed and of two-storeys heightened by another storey. [RCHM notes 1930]. The refronting appears to be 18<sup>th</sup> century in date with a later shop front and one bay window.

19 High Street. West elevation.

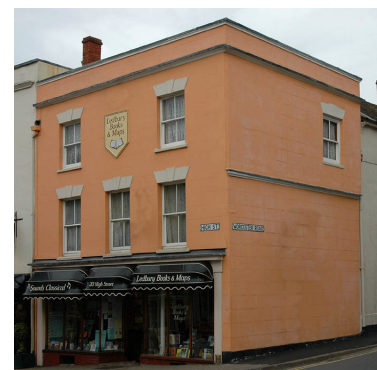
20 High Street. South-west elevation.

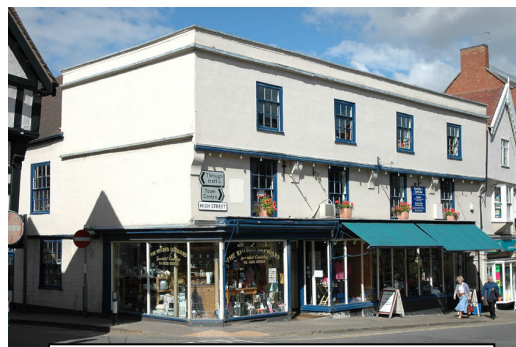
21 High Street. South-east elevation.

It is a substantial timber-framed building that appears to be laid out as four bays parallel with High Street with a lower wing running back along New Street. It is two storeys high with an attic storey. The first and second floors are jettied although the first floor jetty has been underbuilt and a modern shop front inserted.

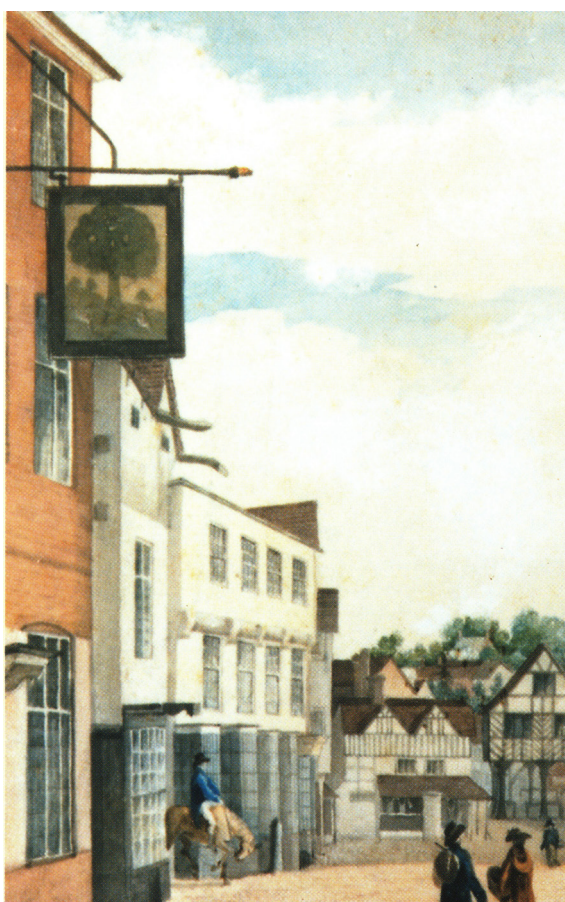
21 High Street. Looking north. c.1820  
[from Hillaby, J. 1997 – front cover].

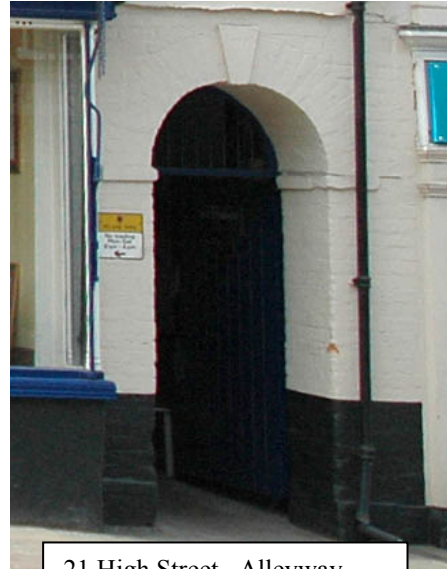
On the line of the alleyway, at the rear of the building, is the site of the former doorway; the post on each side is missing but the doorhead, with ovolo moulding, is still in place.

21 High Street. Alleyway.

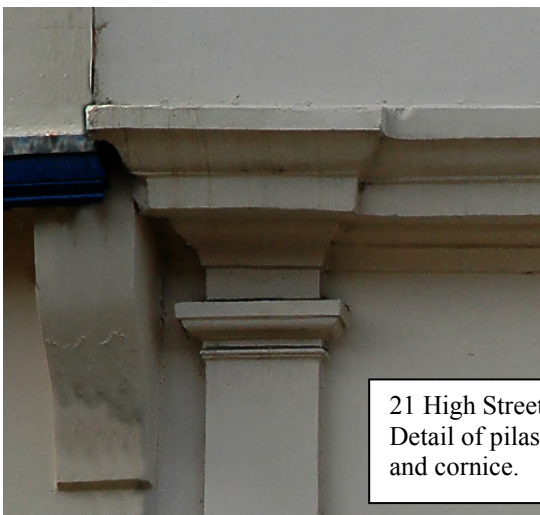
21 High Street.  
Detail of pilaster  
and cornice.

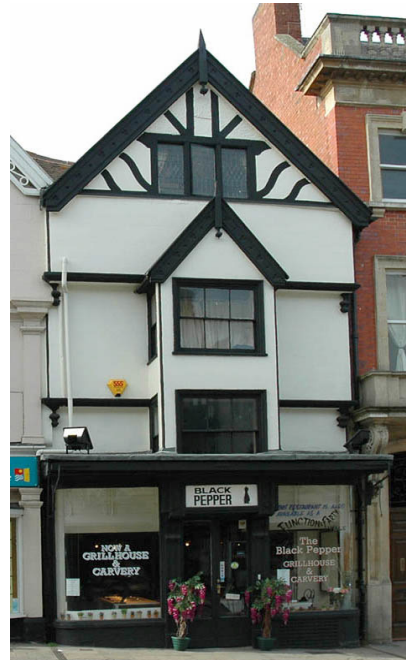
At first and second floor levels there is a projecting window bay with a gabled roof and (later) bargeboards matching those on the attic.

The design of the pendants at the ends of the bressummers suggests a date in the first half of the 17<sup>th</sup> century.

23 High Street. East elevation.

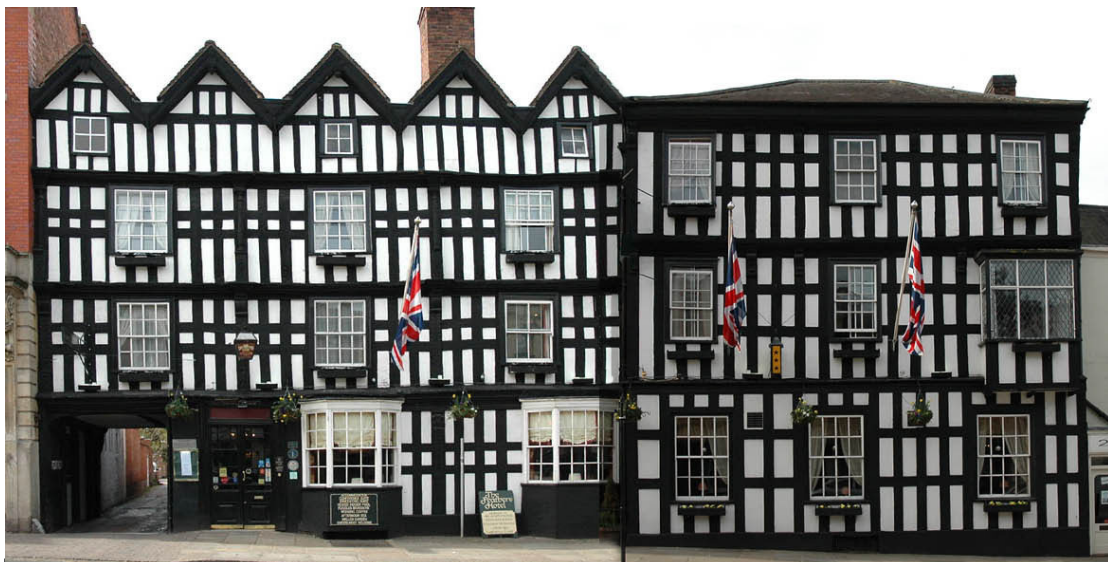
South range.

**The Feathers Hotel.**  
East elevation .

The remarkable feature on The Feathers is the decoration on the principal posts at first and second floor level, which has survived in good condition, probably due to being covered for many years when the front was plastered and pilasters formed over the carved decoration. At the same time a deep moulded cornice was added at bressummer levels. This covering decoration was somewhat similar to that which survives on 22 High street (q.v.).

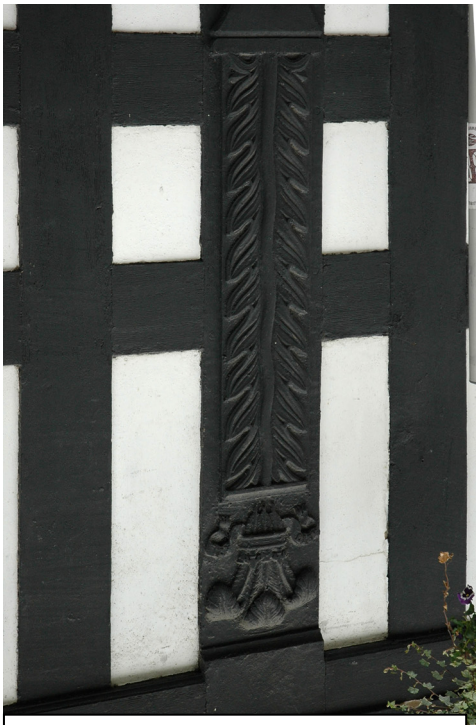
Feathers Hotel – decoration on posts at ground-floor level.

At ground-floor level, between the two later bay windows, is the “feathers” motif on one of the posts

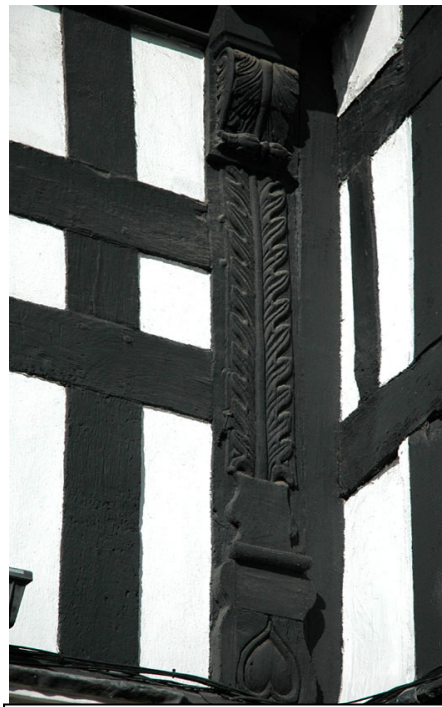
Feathers Hotel – decoration on posts at first-floor level.

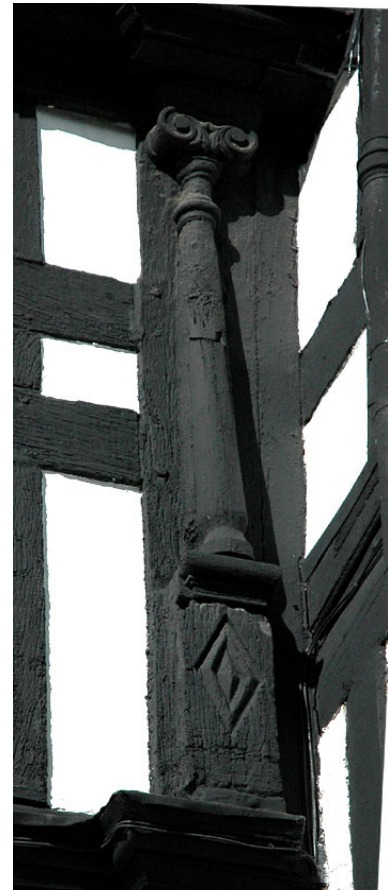
Feathers Hotel – decoration on posts at second-floor level.

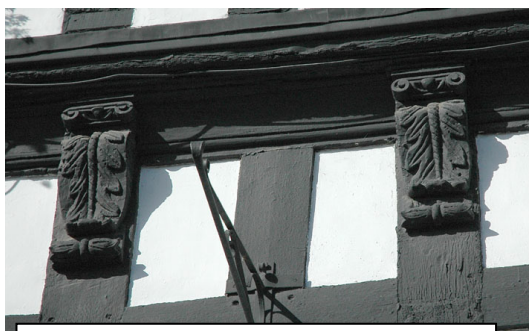
The jetties have consoles that are relatively shallow as they are carved from the posts. There are six at both the second floor bressummer level and under the eaves.

Feathers Hotel – North range.  
Carved consoles under the jetty.

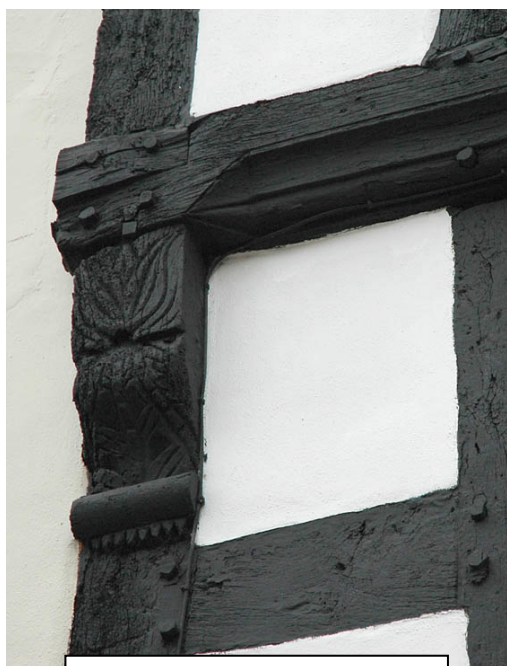
27 High Street – detail of bressummer and console.

The second-floor bressummer has ovolo moulding and the decorated consoles under each end of the shallow jetty are carved from

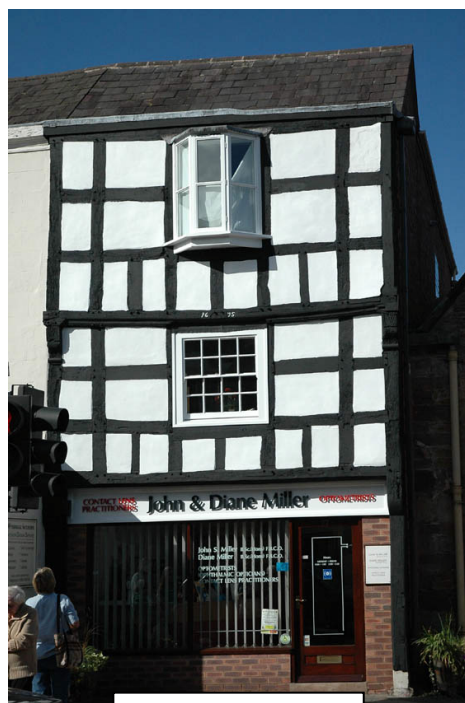
The framing is not typical of Ledbury buildings in that it does not have close studding however, other features are similar to those found elsewhere in the town.

27 High Street.  
East elevation.

the tops of the posts. The middle of this bressummer has a carved date of 1675 and the initial 'H' set within an oval. (The RCHM report this as 1695 but this appears to be a misreading) [RCHM 1932. p.110]. It is possible that these have been added later as the frame, consoles and mouldings suggest a date in the early 17<sup>th</sup> century although the inscription has been cut off along the lower edge and may have been a central feature of the original building. The mouldings on each side appear originally to have had run out stops acknowledging the inscription or possibly a central console. There is evidence that the inscription included two other initials in the lower part.

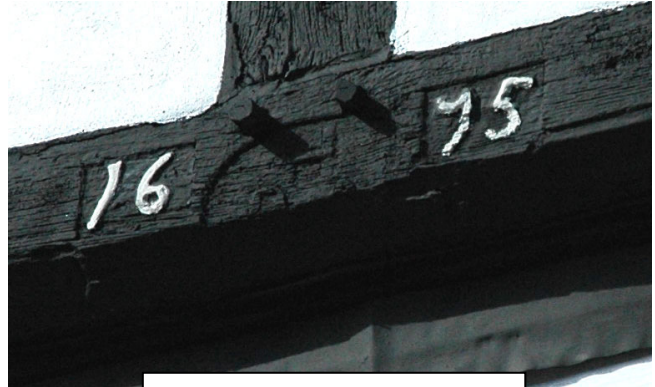
27 High Street – detail of dated inscription.

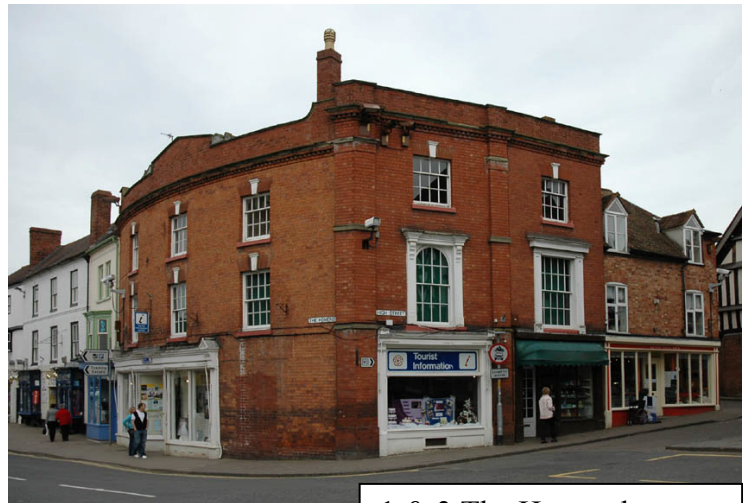
In earlier times what are now Bye Street and Church Street formed the principal cross road with the main north-south route. The site, which is at the lower end of the larger of Ledbury's two triangular market areas, is a clear example of market encroachment that has probably taken place as the New Street- Worcester Road 'Upper Cross' has grown in importance.

1 & 3 The Homend.  
South-west elevation.

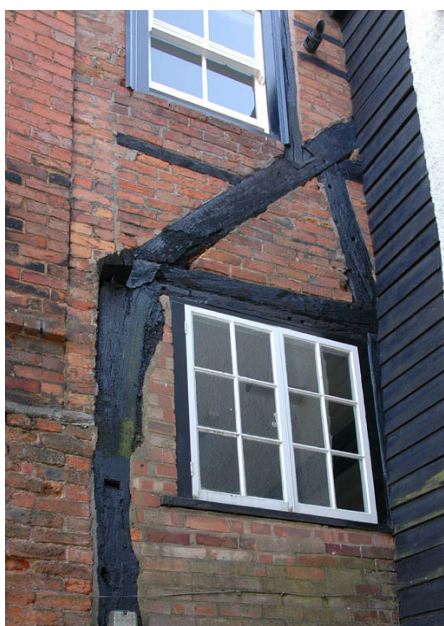
7 The Homend – embedded primary structure.

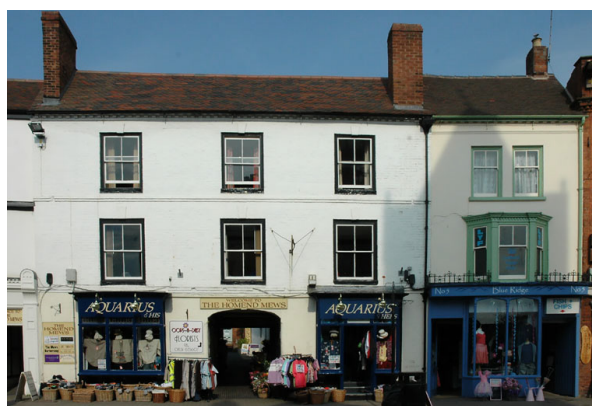
5 & 7 The Homend – west elevation

Apparently, on the evidence of the continuity of the ceiling beams, RCHM states that Nos. 5 and 7 The Homend form one building of mid-17<sup>th</sup> century date. Part of the gable end framing is visible at the north end of the range indicating that it was originally two storeys high rather than the present three. The façade is work of the late 18<sup>th</sup> century, by which time 5 and 7 had become separate buildings. There is a long 18<sup>th</sup> century range to the rear that was used as an assembly room. [Eisel, J. & Shoesmith, R. 2003. 187-196]. RCHM also noted the existence of an ovolo moulded 4-light casement window on the ground floor although this was not seen for the present report.

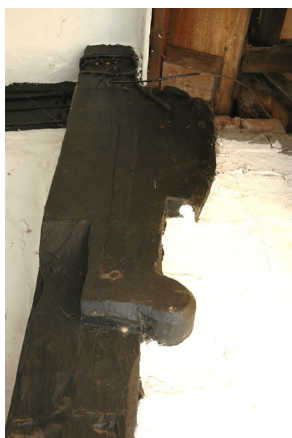
9 The Homend – jetty post & jowelled console.

Useful evidence for the date of this building, which suffered damage from the fire at the adjacent ‘Seven Stars’ in 2001, is to be found in the alleyway at the south end of the building. Here there is a jetty post with an integral, moulded console (i.e. carved from the top of the post) and set back from the present front. The

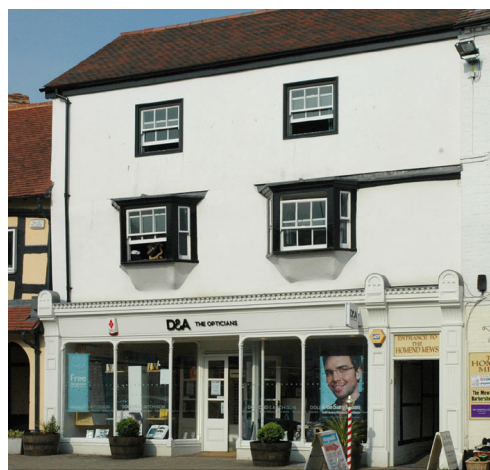
carving has been mutilated but sufficient remains to provide some support for the RCHM statement that this timber-framed building is c.1600 in date. [RCHM 1932. p.110].

9 The Homend – West elevation.

The building was refronted probably in the late 18<sup>th</sup> century. The odd projection above the two later oriel windows at first-floor level suggests that this may have been the former eaves level or possibly is an indication of a second-floor jetty.

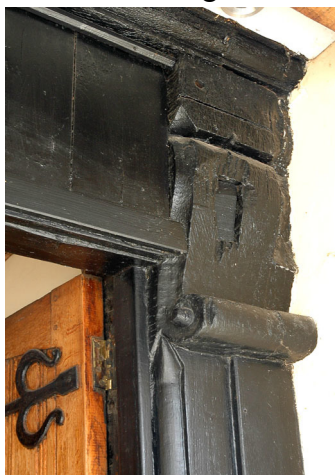
This timber-framed, two-storey, late 16<sup>th</sup> century building suffered a disastrous fire in 2001 and clearly much of the original structure was lost. The framing on the front of the building survived along with the door

Seven Stars Inn.  
Doorframe.

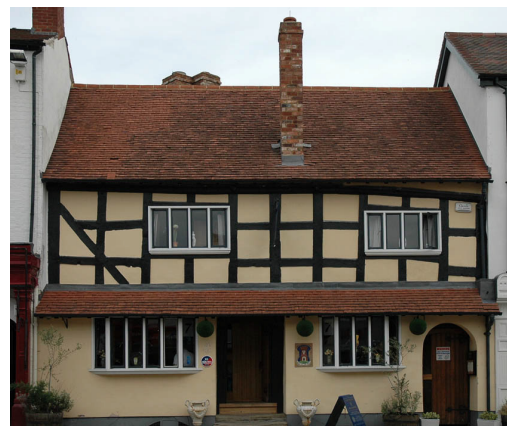
This is a two storey building with a first floor jetty that has been underbuilt and a small pentice created. The bressummer has a simple ovolo moulding as have the jambs of the main doorway. There are voluted brackets at the tops of the doorway jambs although these have been somewhat mutilated

The Seven Stars Inn. West elevation.

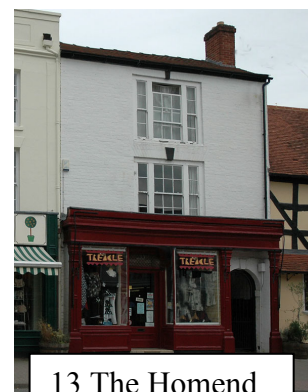
This timber framed, three storey building has been re-faced and re-modelled and a later shop front inserted. RCHM saw some exposed framing and put the date at early 17<sup>th</sup> century.

13 The Homend
