**An Analysis of the Historic Fabric of  
Late 16<sup>th</sup> and early 17<sup>th</sup> Century Buildings  
in Ledbury,  
Herefordshire**

**A Report Prepared for the  
*England's Past For Everyone Project*  
*Herefordshire*  
by  
Duncan James**

**June 2007**

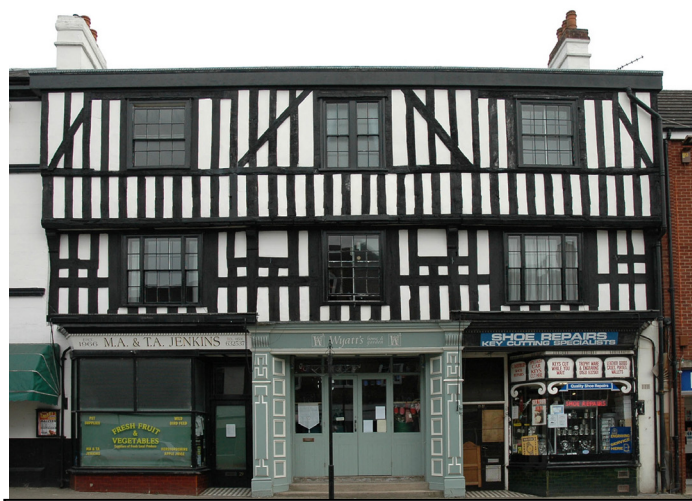
Since it was visited by the RCHM inspector in 1930 this large building has had the 18<sup>th</sup> century stucco removed to reveal the timber framing. Built in about 1600 it is a three bay house laid out on a north-south axis parallel with the street. It has two storeys plus an attic storey that was raised in the 18<sup>th</sup> century to

27 & 29 The Homend – “Cinema House”.

incorporate sash windows. It seems likely that the house was built with three gables in the attic storey and that these were removed when the front (and the back) walls were raised in height. The original layout of the ground floor is uncertain, however, probably by the 18<sup>th</sup> century, there was a central principal doorway in place with a doubled flight of about eight steps leading up from street level. [Hillaby 1997 p.8 shows the house in the centre of the image.] This indicates that the ground floors in the building must have been lowered to their present levels.

The timber framing at first-floor level has close studding and a double row of horizontal rails. The three sash windows have been inserted in the primary window openings although the latter were both wider and had higher sills. On each side of each window there are blocked openings for small secondary windows.

At the top floor level there is close studding below the later sash windows. The rail above this studding is ovolo moulded and projects slightly; it is either the primary wallplate originally at eaves level or it formed the tie beam for a series of three gables. Above the close studding there is framing that relates to the raising of the roof in the 18<sup>th</sup> century.

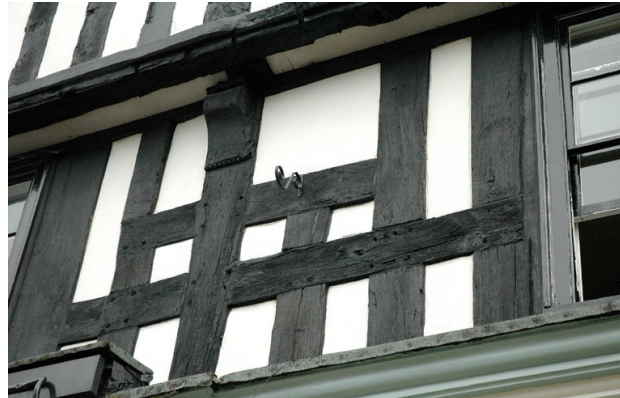
27 & 29 The Homend – “Cinema House”.  
Evidence for two of the small side windows.

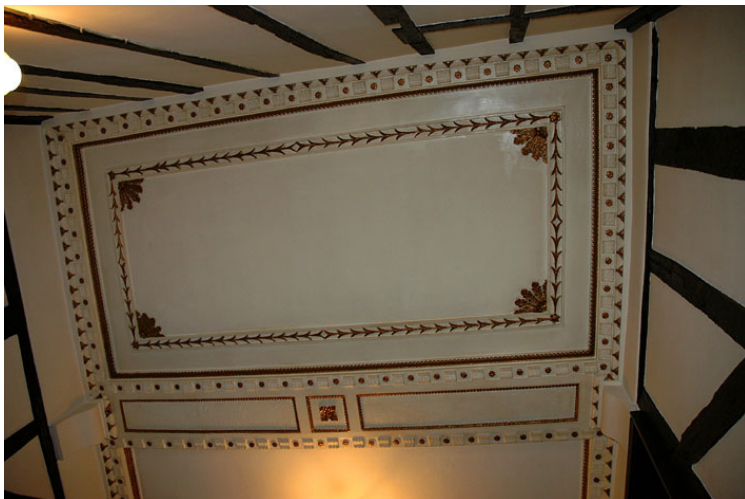
27 & 29 The Homend – “Cinema House”.  
Plaster ceiling above the former staircase.

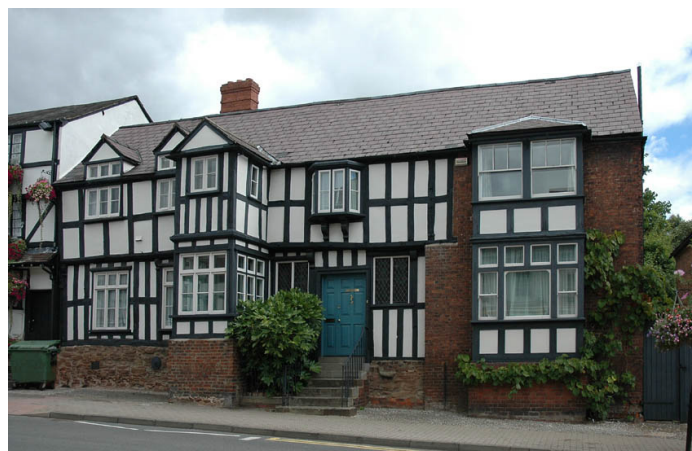
Built in about 1600, this timber-framed, two-storey building is set on a high rubble-stone plinth and laid out on a north-south alignment parallel with the street. It occupies a wide plot that may once have been larger. The south end of the range has been rebuilt in brick, with a two storey bay and to the rear of the north end of the range there is a later wing. On the front of the building is a narrow, two-storey projecting bay set on a high brick plinth.

Abbey House. 37 The Homend – west elevation.

The framing of the range at ground-floor level is in the form of close studding with a single mid-rail whilst at first-floor level the studs, still with a mid rail, are more widely spaced.

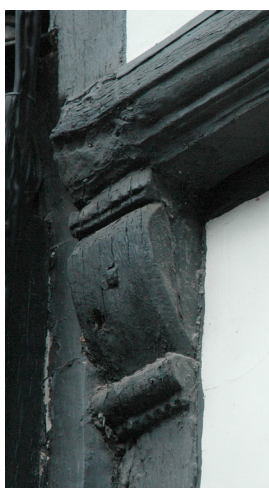
Abbey House.  
Detail of  
jowelled console.

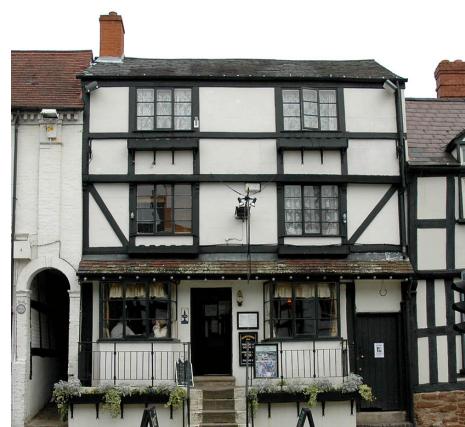
This three-storey timber-framed building is, like the adjacent Abbey House, set on a high plinth. It appears to be two bays long and there is a passageway through the south end. The ceiling beams on the ground floor over the south bay have wide chamfers. In the north bay is a ceiling beam with wide chamfers and stepped stops. A post inside the building between the bays retains evidence that it was a door jamb with provision for a door head. Little of the original framing is exposed although the core of the building is almost certainly 17<sup>th</sup> century in date.

Horseshoe Inn. West elevation

The front has imitation framing and the ground floor has been built out as a shallow pentice.

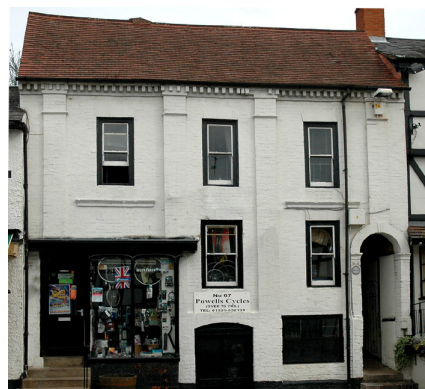
According to RCHM this is a 17<sup>th</sup> century building, probably of two bays, remodelled in the 18<sup>th</sup> century with a new brick front sporting four brick pilasters. [RCHM notes 1930]. It is likely that there was a central front door between the two central pilasters and that this was reached by means of a short flight of stone steps. There is an alleyway through the south end of the building where some of the (later) timber framing can be seen.

67 The Homend – west elevation.

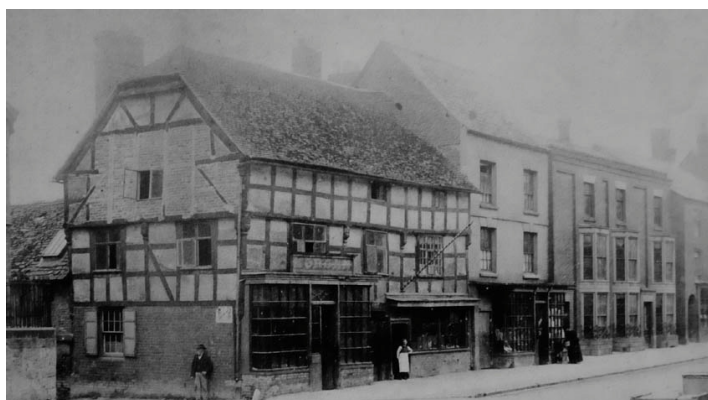
This site is now occupied by the Barrett Browning Memorial Institute (built 1892-6) but the building it replaced, judging from surviving photographs, was a substantial timber-framed structure of two-storeys and attics laid out on an approximate north-south axis parallel to the main road. It had square panelling and was three bays in length.

The building formerly on the site of 2 The Homend.

The end bays were each five panels long and the centre bay just three.

The top (attic) storey also has a shallow jetty on both east and south elevations. It was almost certainly designed for storage of goods, loading and unloading by hoist from wagons drawn up beneath the south end. The form of the end roof truss with its high collar and interrupted tie beam was probably used throughout the roof. (It is similar to those in the roof at No. 21 High Street).

What can be seen in the photograph is that there are shallow consoles under the bressummer to the attic storey and that these are almost certainly carved from the top of the posts. Although it does not have close studding this would befit its role as a working building and one that is recorded as being a tanhouse.

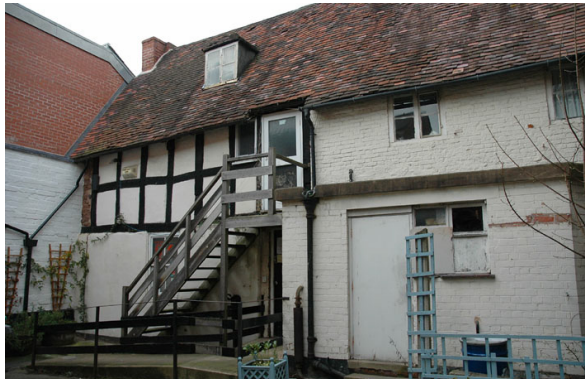
To the rear there is a 17<sup>th</sup> century timber-framed range that is visible from Bye Street. It was noted in 1930 as containing, in the east room, panelling and a fire surround of early 18<sup>th</sup> century date.

Timber-framed range behind 4 The Homend

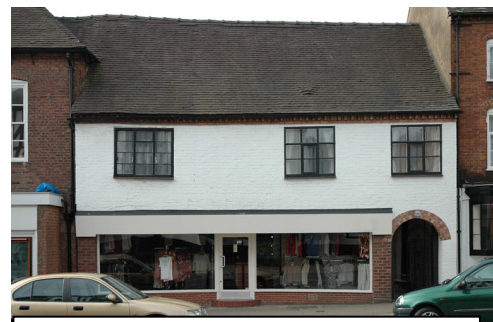
This is an early 17<sup>th</sup> century building that was remodelled in the late 18<sup>th</sup> century. It is of two storeys and originally the first floor projected on a shallow jetty. The consoles under the jetty were cut from the top of the post and the bressummer had a simple ogee moulding. [RCHM notes 1930].

24 The Homend – east elevation.

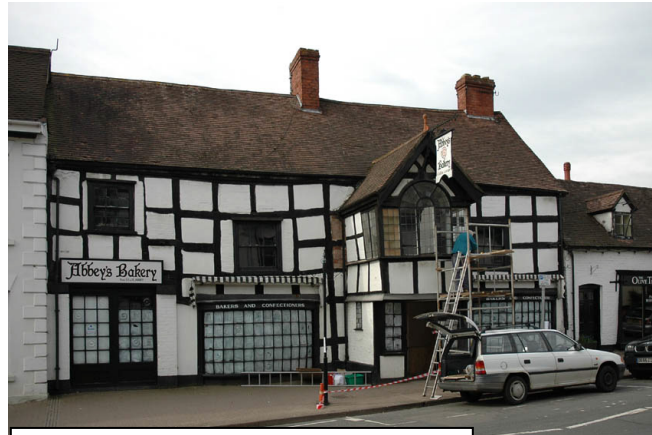
This timber-framed, two-storey house is one of the most prominent in The Homend, principally due to the two-storey, jettied porch that stands well forward of the main front. This feature may be a slightly later addition to what is a relatively plain building with near square panels and a ground floor frontage with modern shop windows (introduced since the 1930s). There was formerly a carriageway through the south end of the building. Some remodelling took place in the 18<sup>th</sup> century when the large window with semicircular head was inserted in the front and sides of the porch.

42 The Homend – East elevation

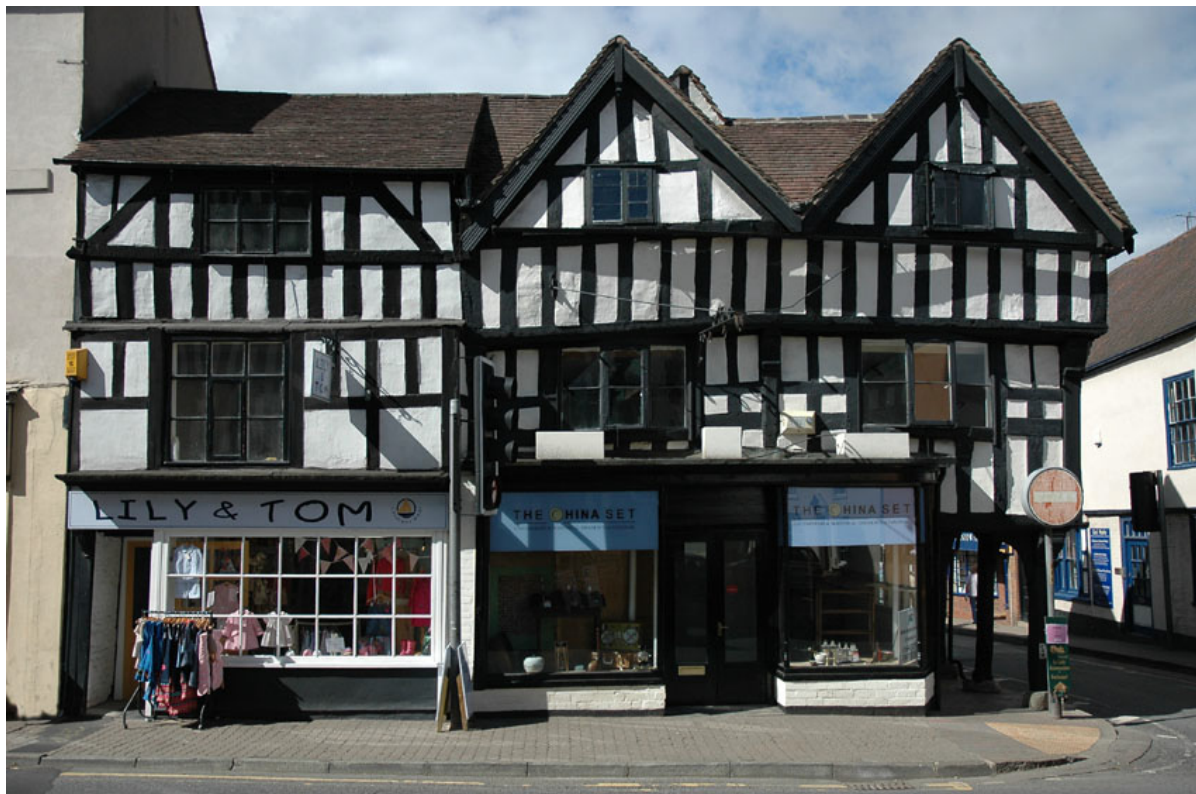
1 & 2 The Southend. E. elev.

This is a three bay, double pile range laid out on a north-south axis with one half of the north bay oversailing the footpath and supported on a row of four posts. It is of two storeys and above that is an attic storey with two gables to the north and two (originally three) to the east. The first and second floors are carried out on jetties to the north and east. There is a dragon beam under the north-east corner of the first floor.

The gable over the southern bay has been removed and the front built forward in timber framing, possibly still with a gable, and this has subsequently been modified by sweeping the roof forward to create a new eaves level at collar height.

The building does perhaps display on one structure all the characteristic features of Ledbury timber framing of c.1600. This is one building where it would be of considerable value to establish a fixed date by tree-ring dating as it would provide a key to so many others in the town.

- a) the consoles, which are cut from the tops of the posts and, where exposed, have ovolo mouldings down the sides.
- b) the consoles along the arcade that are cut from the tops of the columns.
- c) the 'toothed' lower edge on the consoles.
- d) the jetty bressummers which have ovolo mouldings.
- e) the close studding with mid-rail.
- f) the attic gables.
- g) the 'eared' side windows.

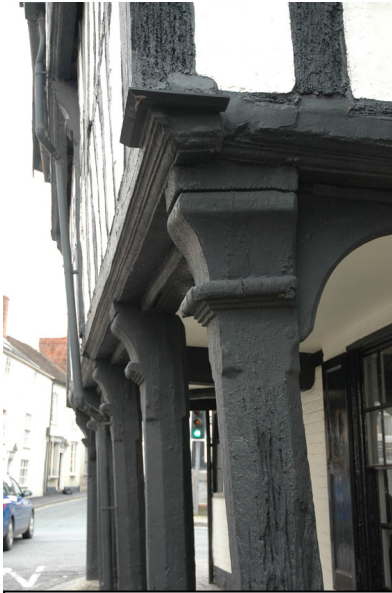
**1 The Southend.  
North side arcade.**

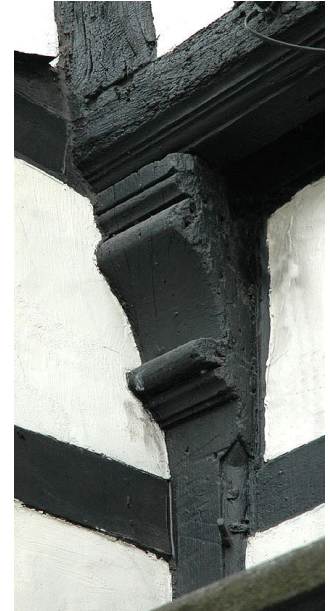
**1 The Southend.  
Console on east elevation**

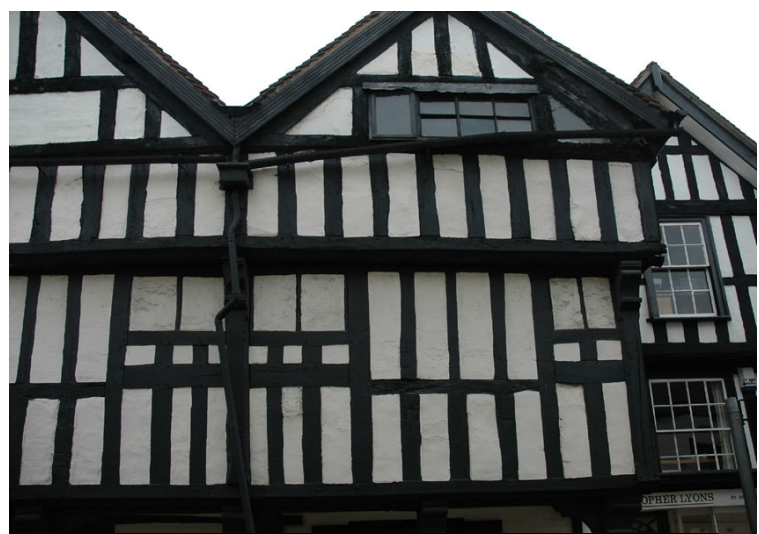
**1 The Southend –blocked windows in north elevation.**

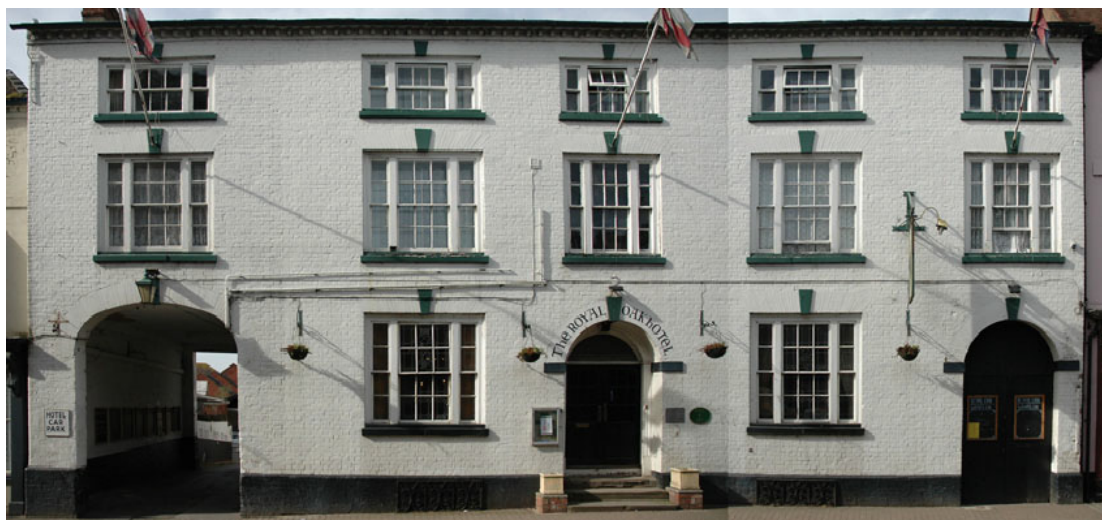
**The Royal Oak Hotel, 5 The Southend.  
East elevation**

The late 18<sup>th</sup> /early 19<sup>th</sup> century brick front on the Royal Oak hides a timber-framed building probably built in the late 16<sup>th</sup> century. It is on an L shaped plan and was a two-storey building possibly with attics. There is a passageway through the south end and a carriageway through the north. Internal decoration, including panelling, suggests a late 16<sup>th</sup> century date. The panelling was identified by RCHM as of the same detail as that dated 1588 in The Master's House and 1590 in Ledbury Park. [RCHM notes 1930].

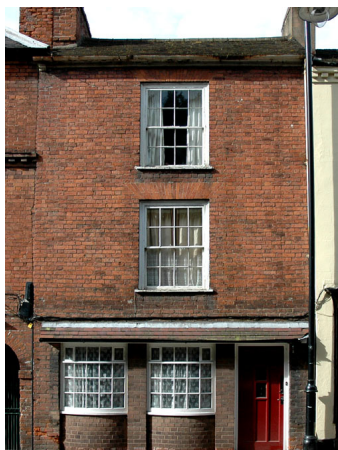
**9 The Southend – east elevation**

This is a narrow site with a timber-framed 17<sup>th</sup> century house that was altered and refronted in the 18<sup>th</sup> century. The 18<sup>th</sup> century shop front has been lost. When the RCHM saw the building there was exposed timber framing at the back. It is possible that there was originally a gable to the front as the house seems to have been aligned on an east-west axis.

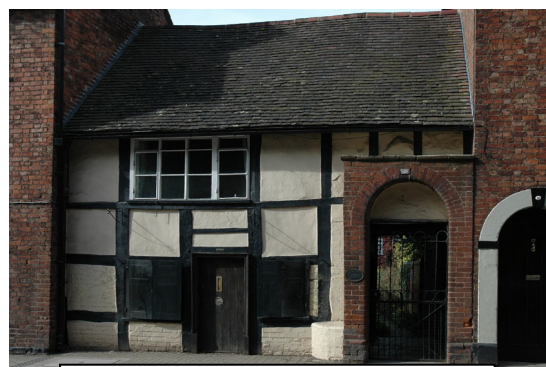
This is an early 17<sup>th</sup> century timber framed building of very modest size. It is just two storeys high and probably two bays long. The ceiling beams in the ground-floor rooms have large stop chamfers. There is a brick arch over the passageway that leads to buildings behind.

19 The Southend – east elevation.

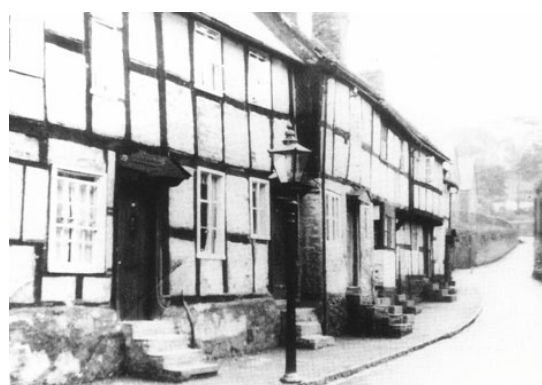
This was a timber-framed row of two storey cottages in Church Street, demolished in comparatively recent times. The oldest were those with the jettied first floor (nos. 25 & 26) which the RCHM put at early 17<sup>th</sup> century. The jetty was carried on posts with shaped brackets at the top. Clearly these were modest houses and probably typical of many in the town, particularly along The Homend, that have been refronted and raised in height.

22-26 Church Street. Looking east

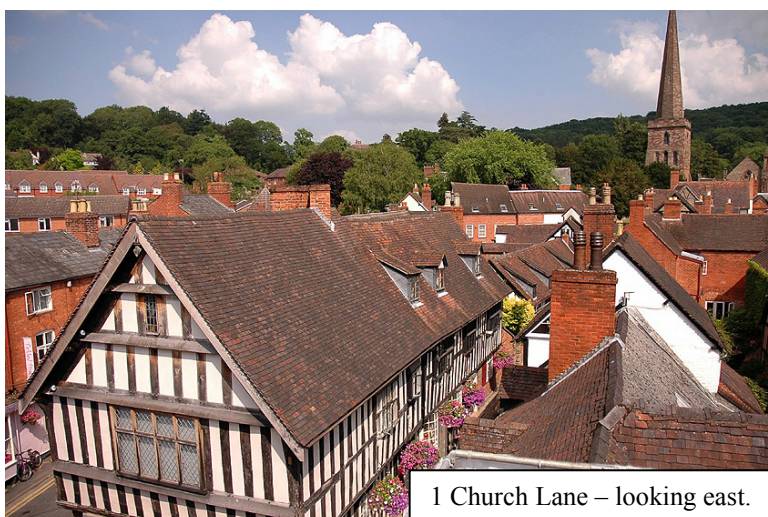
and in so doing utilises the large chimneystack between the two, creating a back-to-back fireplace. The newer building neatly copies the width and jetty and eaves height of the west range but the ridge height is slightly lower. There are also three dormer windows in the south pitch of the roof.

1 Church Lane – looking east.

The date of the east range is indicated by the ovolo moulding on the bressummer and the style of the brackets, under the jetty and the window sills, with their ‘toothed’ decoration in the form of ‘v’ shaped notches. The windows on the south side have ovolo moulded mullions and transomes, and moulded sills.

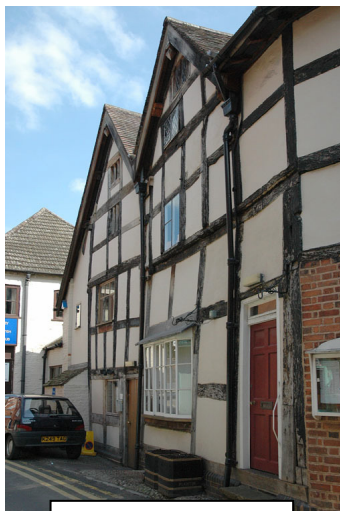
Along the north side of the range is a complex series of two-storey gabled extensions facing on to Church Street.

1 Church Lane.  
Rear of building  
seen from  
Church Street.

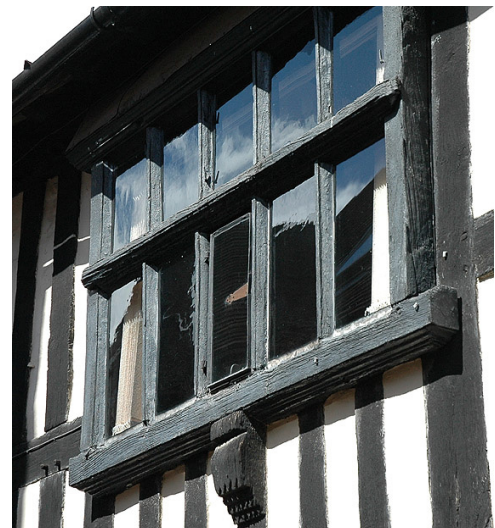
1 Church Lane – window with  
bracket under sill. South side.

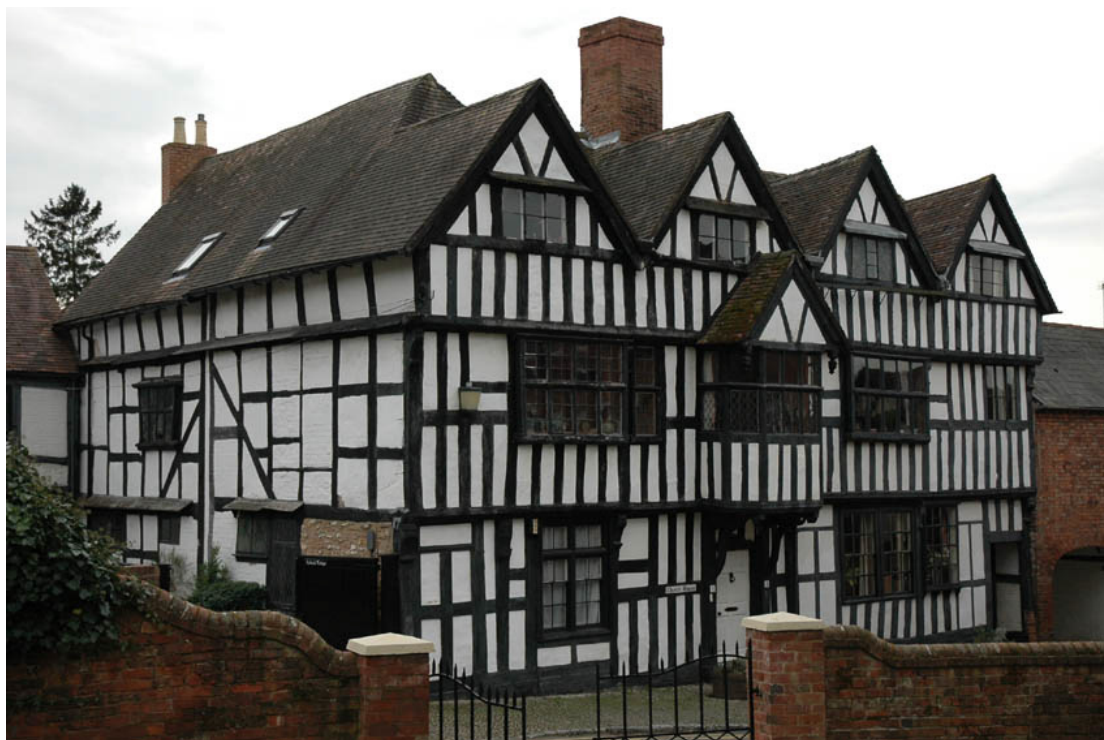
Church House. North-east elevation.

Church House is a remarkably complete, late 16<sup>th</sup> century timber-framed house. It consists of a four-bay range laid out on an approximate east-west axis with a slightly later wing abutting the back of the east end bay. The house has three storeys, the third one being an attic storey with four gables on the north front. There is a first and second floor jetty on the front elevation. The front door, which is positioned off centre below the second gable from the east, has a first floor projecting porch with faceted corners (semi-octagonal) and a gable above. It is supported by large, shaped brackets springing from the door jambs. There is an alleyway through the west end of the building.

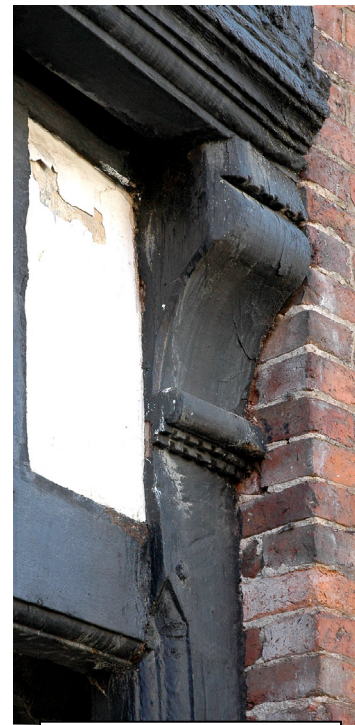
Church House.  
Jowelled console.

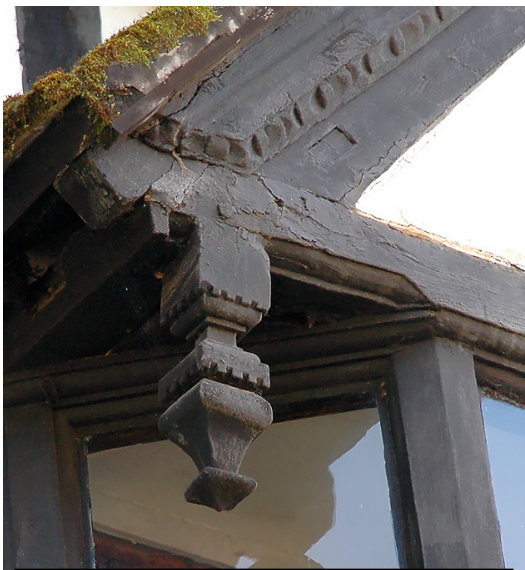
Church House – pendant on porch.

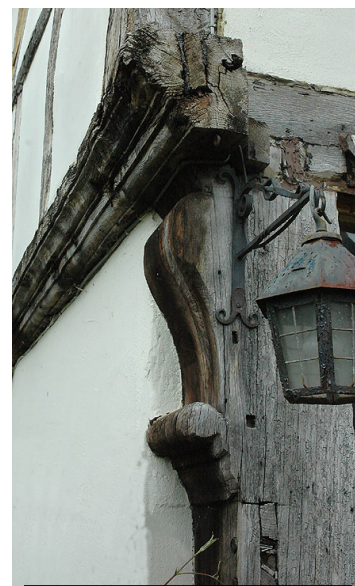
Church House – jowelled  
console on rear wing.

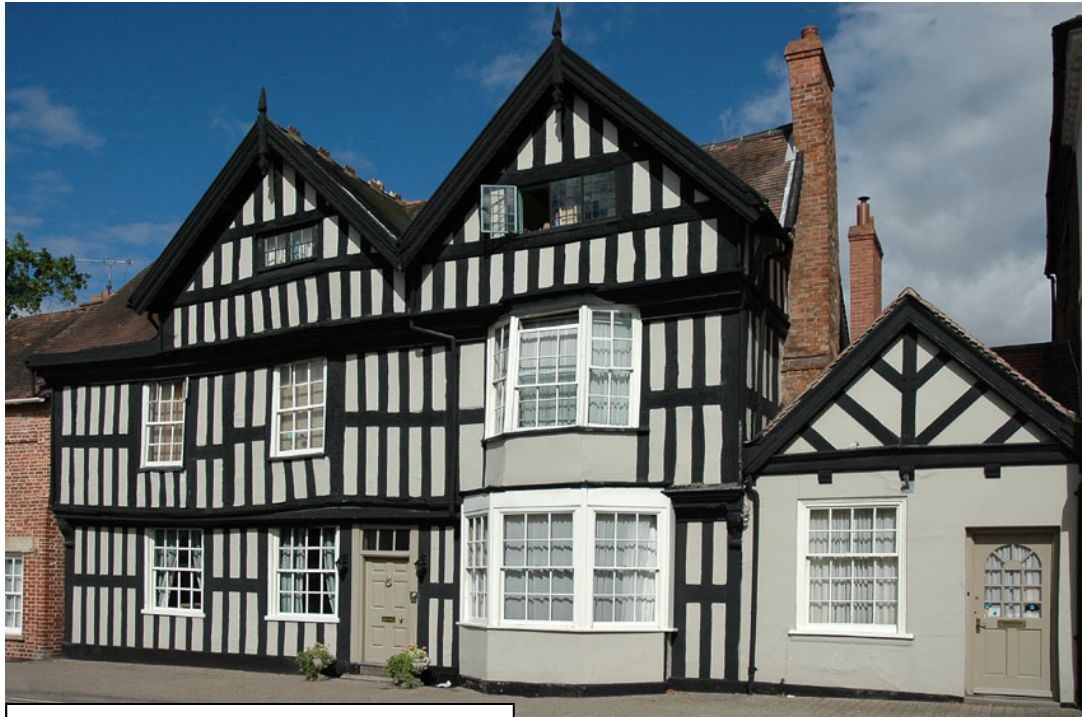
The Steppes. New Street. South elevation.

It was built in about 1600 and is of two storeys with an attic storey and two gables to the south front. The first storey and the gable storey are jettied and have ovolo moulded bressummers with consoles below. The gables are also jettied slightly at tiebeam level and there is an ovolo moulding along the lower edge. The front has close studding and both ground and first floors have a midrail. There is a brick chimneystack at the east gable end of the house, which is possibly a later addition as there is close studding on the east end and the chimney does interfere with this.

There is later coving fitted under the bressummers and a modern bay added to the front. The bargeboards on the gables are 'modern' (i.e. early 20<sup>th</sup> century) and have a pattern that is similar to the Church House bargeboards – which may also be 'modern'.

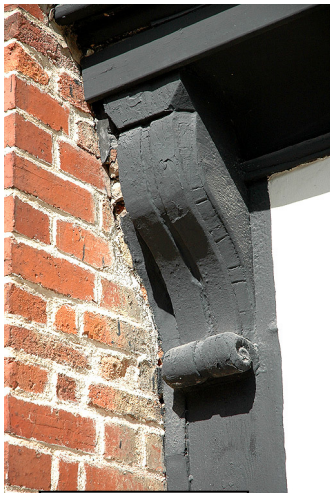
The Steppes.  
Console under  
first-floor jetty.

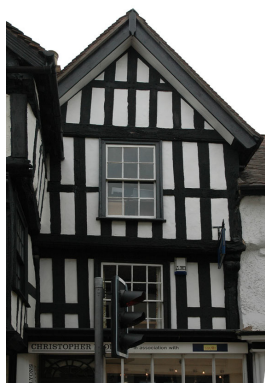
**5.46    2 New Street.** RCHM 83. NGR SO 7111 3756

2 New Street. N. elev.

This three-storey timber-framed house was built in about 1600 and appears to be laid out on a north-south axis with a gable fronting the road. It is jettied at second floor level and almost certainly had a jettied first floor

although this has been underbuilt with a later shop front that is set forward of the front of the building. The gable tie beam is also set slightly forward to create a shallow jetty. There are consoles at each end of the second floor ovolo moulded bressummer although whether they are cut from the top of the posts is not known. The ground floor has chamfered ceiling beams.

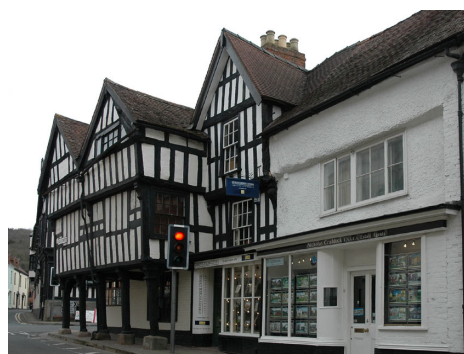
1 The Southend and 2 New Street..

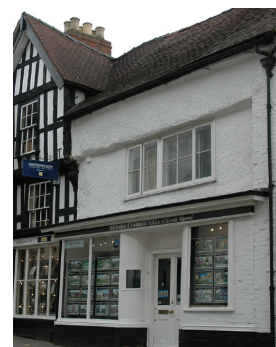
**5.47    4 New Street.** RCHM 84. NGR SO 7110 3756

Built in about 1600 this is a timber-framed building of two storeys with attics. Evidence for a shallow 9inch (c. 23cm) first-floor jetty survives behind the present 19<sup>th</sup> century shop front where there is a double ovolo moulded bressummer and the remains of a console carved from the top of the east-side jetty post. Running down the inner edge of the post is an ovolo moulding. (c.f. similar feature on 17 High St., 1 & 2 The Southend and Church House). The attic storey also has a shallow jetty. The front is hidden by rough-cast.

4 New Street.

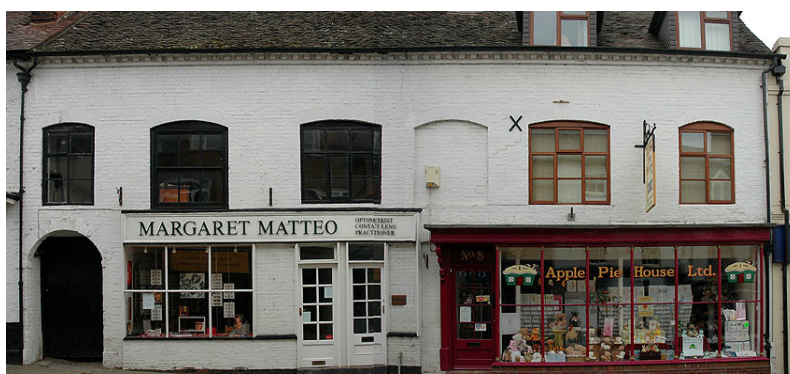
**5.48    6 & 8 New Street.** RCHM 85. NGR SO 7109 3756

6 & 8 New Street. North elevation.

These two shops appear to be of one build and of 17<sup>th</sup> century date. The brick refronting and (probably) roof raising is 18<sup>th</sup> century work. There are stop-chamfered beams in the ceilings on both ground floor and, according to the RCHM, also on the first floor. [RCHM notes 1930].

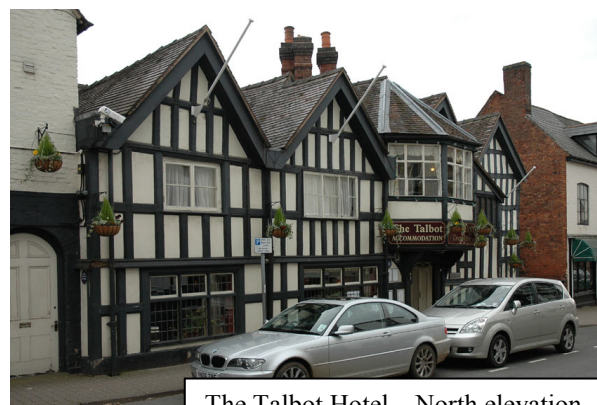
**5.50    The Talbot Hotel.** New Street. RCHM 86. HSM 41922 NGR SO 7106 3754

The first phase of this building probably dates to the late 16<sup>th</sup> century when a two storey, timber-framed range was built parallel to New Street on an east-west axis, with a central chimney stack and back-to-back fireplaces. There were either three or four gables to the front. The timber framing was in the form of close studding on the north front. The ground floor west room is lined with dated panelling (1596) and there is a fire surround and overmantle of the period although the fireplace itself was removed when the base of the stack was cut through to create access.

The Talbot Hotel – North elevation.

In the second phase, early in the 17<sup>th</sup> century, the building was extended forward and refronted, and a large semi-octagonal oriel added over the main entrance. The front doorway is something of a puzzle and may be the original door reset. It has what appears to be a cranked doorhead panel fitted to the top of the door which suggests that it has been removed from an earlier site – possibly when the refronting took place.

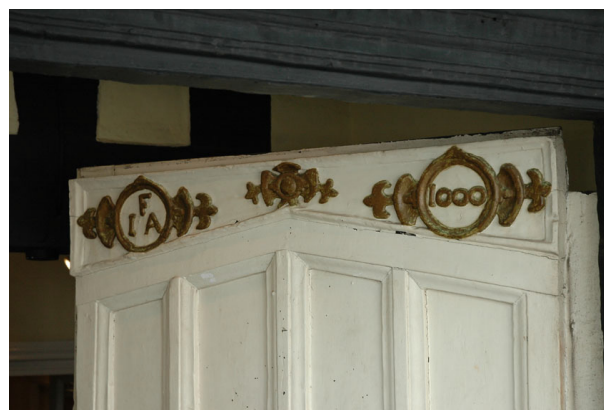
The Talbot Hotel – Inscription over door.

There are the initials F, I, A, on the 'doorhead' and a date that is open to interpretation as it must have been damaged at some time. It now reads '1000' and could be 1600; 1606; or 1608. If it is reset from the primary structure, 1600 may be appropriate. The door jambs are in the form of pilasters and there is strapwork decoration across the top.

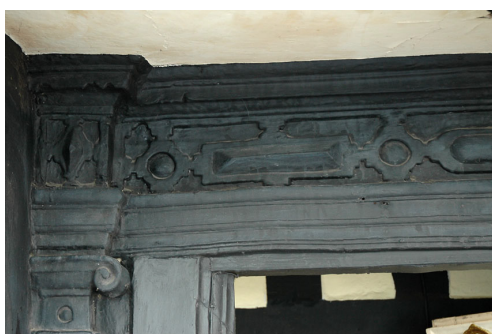
The Talbot Hotel  
Door surround with strapwork decoration.

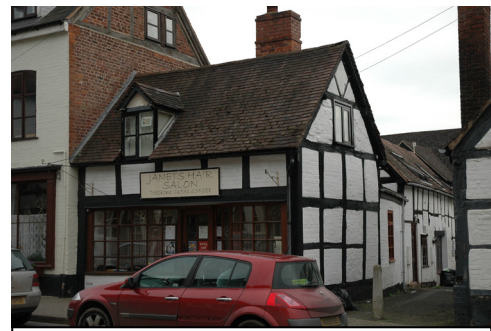
**5.51**     **24 New Street.** RCHM 87,  
NGR SO 7103 3754

This small 17<sup>th</sup> century single storey building with attics is timber framed, with a modern shop front. Behind the building, extending southwards, is a further timber-framed two storey outbuilding.

24 New Street – north elevation

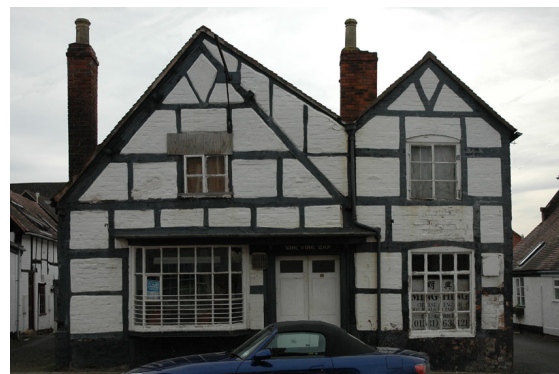
**5.52**     **26 New Street.** (Former Vine Tap Inn) RCHM 88. NGR SO 7102 3753

The two phases of this 17<sup>th</sup> century timber framed building are clearly evident from the front gabled elevations. The wide east range is single storey with attics whilst the narrow west range is of two storeys. They may be contemporary structures. At some point the west side of the roof of the east range has been raised at the eaves to meet the higher eaves level of the west range. There is a later shop front. The RCHM sets the date at mid-17<sup>th</sup> century [RCHM notes 1930].

26 New Street – north elevation

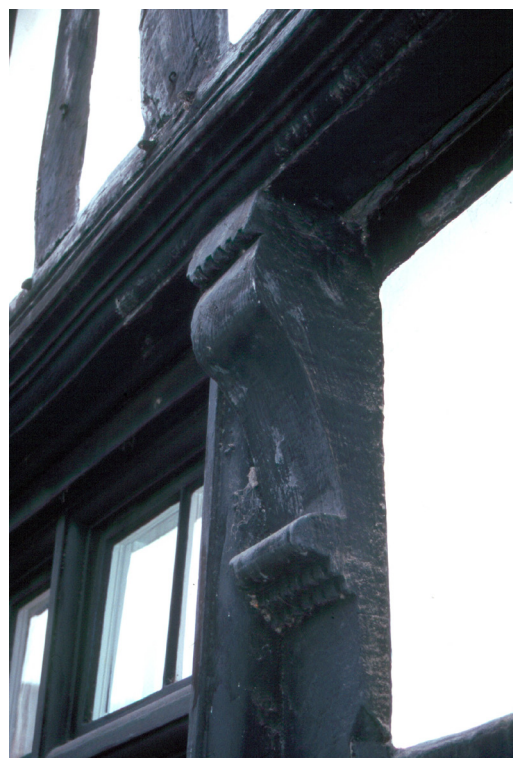
A console shaped from the flared top of the post. Church House, Church Lane.
