Archaeological Desk-Based  
Assessment and Walkover Survey  
Leckie  
Gargunnoch  
Stirlingshire

ST30

**ARCHAEOLOGICAL  
DESK-BASED ASSESSMENT &  
WALKOVER SURVEY  
LECKIE,  
GARGUNNOCK  
STIRLINGSHIRE**

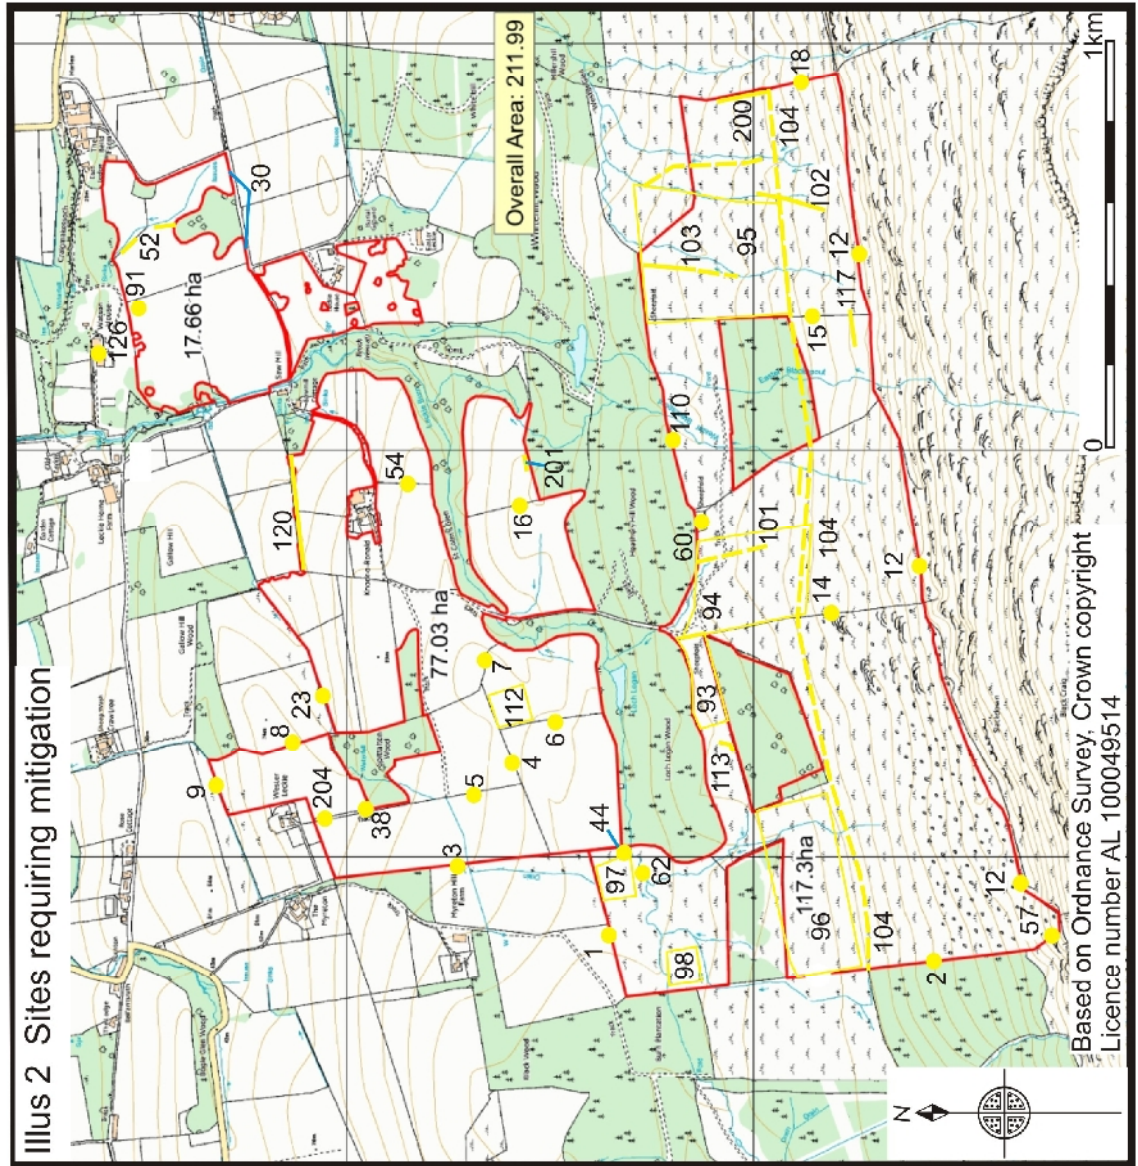
*Illustration 2: Sites requiring mitigation*

1-9, 12, 14-16, 18, 23	Boundaries
30	Boundary/revetment
38	Track
44	Ree
52	Boundary/bank
54	Boundary
60	Sheepfold
62	Bridge
91	Cairn
93-98	Rig and furrow
100, 102-104	Banks
110	Enclosure
112	Rig and furrow
113	Enclosure
117	Boundary
120	Ha-ha
126	Watson House
200, 201	Banks
204	Boundary
