**An Archaeological Survey
of the Town Lade
PERTH**

**AN ARCHAEOLOGICAL
SURVEY OF
THE TOWN LADE
PERTH**

Alder Archaeology Ltd was commissioned by Tulloch NET and PKHT to carry out an archaeological walkover survey and basic desk-based assessment of the Perth's historic lade to give an overview of its cultural heritage. The city lade runs for some 4.5 miles from a weir known as Low's Work on the River Almond by Huntingtower, through Tulloch estate and onwards to Perth city centre where it exits into the River Tay by the Old Tay Bridge. The entire non-culverted length of the lade was surveyed over four days between the 10th and 24th of May 2011. The recent winter flooding had caused damage to the weir at the intake on the River Almond and this meant that upper portions of the lade were dry during the survey. As well as recording the general conditions and alterations to the mills along the lade, the survey identified several new features including earthworks near Ruthvenfield and various clay pits of unknown date below Perth crematorium.

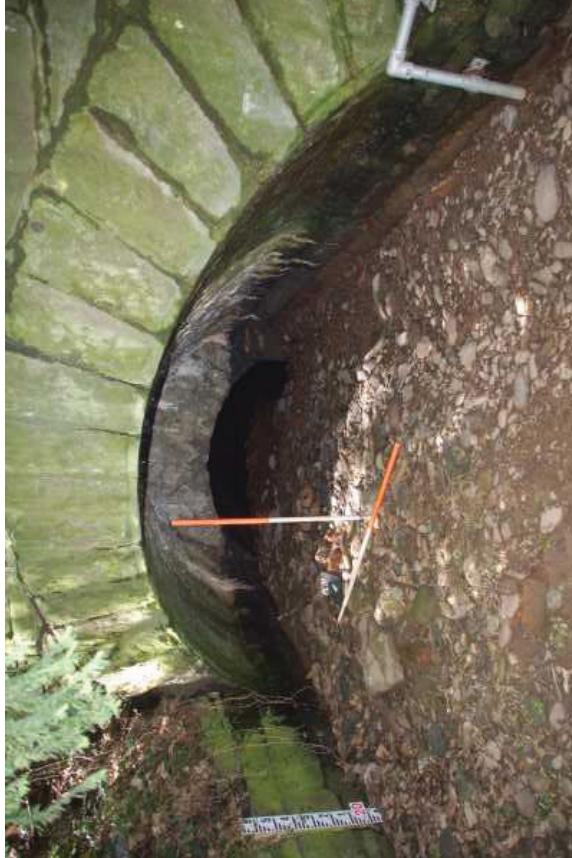
202	Girder bridge near Huntingtower Bleachworks	Bridge	20 th century	-	-	NO 07041	25637
<i>Walkover Description:</i> Two large steel girders and a pipe crossing the lade at a slight angle. The girders are set into brick walls constructed from colliery bricks. Wooden shuttering lies against the sides of the lade below and on either side of the brick walls. The shuttering is for two large concrete plinths (hardly visible) which have been set on either side of the lade to support the girders.

<i>Interpretation:</i> This was the crossing point for a light railway built in the early 20 th century named 'mineral railway' on the OS map. The railway was associated with the nearby Huntingtower Bleachworks mill and would have been used to bring in materials for the bleaching process and export finished products. There was also a line running NW from the factory across the Almond to Pitcairnfield Bleachworks. An isolated concrete and brick pier from this line can still be seen in the River Almond a 200m to the NE of site 202. It is possible that this pier may be demolished by the council in the future as it seems to be causing erosion of the river bank.

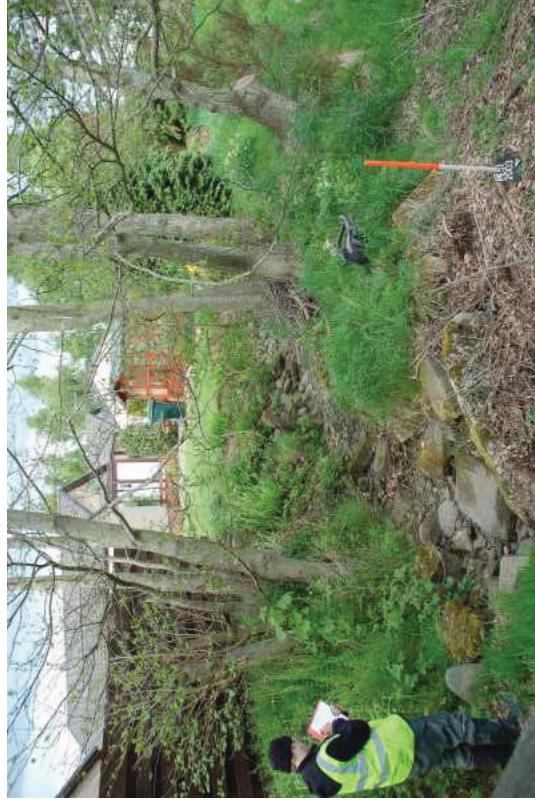
204	Huntingtower Bleachworks Waterwheel Building	Mill	19 th century	MPK 5326	NO02NE 84/0./1	NO 07236	25702
<p><i>Waterwheel Description:</i> The waterwheel building associated with Huntingtower Bleachworks mill. Site comprises a roofless stone-built rectangular building with three arched windows in each of the S, E and W walls. Stonework is of high quality, being constructed from squared sandstone blocks built to level beds. The N wall has been bricked up. W of the mill, the mill lade has been lined with rectangular cast iron panels stiffened with raised flanges, and there is a grille over the entrance to the wheel. A stone-lined overflow channel passes round the S side of the building descending down three steps. Slots for a sluice and winding gear cogs can be seen at the entrance to the overflow channel. A rounded steel bar attached to the cogs and running over the lade to the NW bank shows that the winding mechanism for the sluice was controlled from the factory side.</p> <p>The waterwheel is in situ and is of three-bayed construction, made from bolted cast iron rims supporting wooden paddles, many still surviving. A small squared aperture in the SE wall provides access to the axle of the wheel, presumably to enable easy access for lubrication. At the front of the building, water exited from the waterwheel under a wide low arch. Slates found in the lade to the west of the building suggest the roof had once been slated.</p> <p><i>Interpretation:</i> The style of the building its stonework suggests a mid 19th century date and it is highly likely that the building is the same as that shown over the lade on the 1st edition OS map. The factory building to which the power from the waterwheel was transferred to the N would have been demolished when the site was redeveloped; the bricked up wall probably dates to this period. Such a large waterwheel could have provided a considerable amount of power for industrial processes in the mill during the 19th century.</p> <p><i>Relevant site from DB4: Huntingtower Bleachworks (34)</i></p>

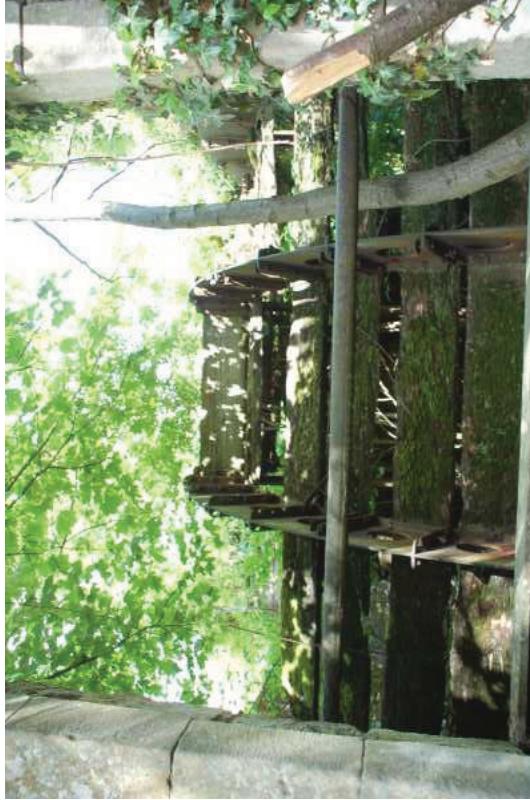
205	Bleachers Way Bridge	Bridge	Late 19 th or early 20 th century	-	-	NO 07270	25679
<p><i>Walkover Description:</i> A heavily re-built and recently re-pointed stone and concrete bridge made from re-used blocks of sandstone, possibly from the Huntingtower Bleachworks factory buildings. The lade runs through a tube made from corrugated iron.</p>							
<p><i>Interpretation:</i> There was a bridge in this location by the late 19th century when a new access road was created for Huntingtower Bleachworks. The current structure however, seems to have been constructed very recently, presumably when the Huntingtower Bleachworks site was redeveloped. There may still be an earlier core behind the modern stonework.</p> <p><i>Relevant site from DBA:</i> Huntingtower Bleachworks (34)</p>

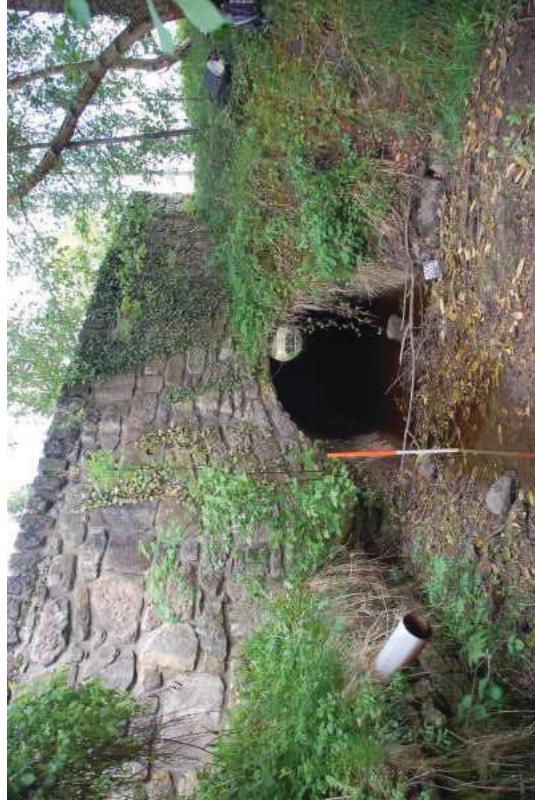
206	Huntingtower Hotel Bridge 1	Bridge	19 th century	-	-	-	NO 07351	25594
<p><i>Walkover Description:</i> A well-built 19th century stone bridge constructed from well squared off blocks of sandstone. The upper half of the walls are finished with bull-faced blocks of sandstone and the lower with smoothed off blocks of sandstone.</p>								
<p><i>Interpretation:</i> The bridge was probably constructed in the early to mid 19th century; its style suggests it was built at the same time as the culvert exit at Huntingtower Bleachworks to the N. In the mid 19th century the bridge was part of the main access route to Huntingtower Bleachworks. However, by the late 19th century, a new road and bridge had been constructed to the NW meaning factory traffic no longer had to pass near the house that was later to become Huntingtower Hotel. In the 20th century this bridge became part of the formal driveway to the house.</p>

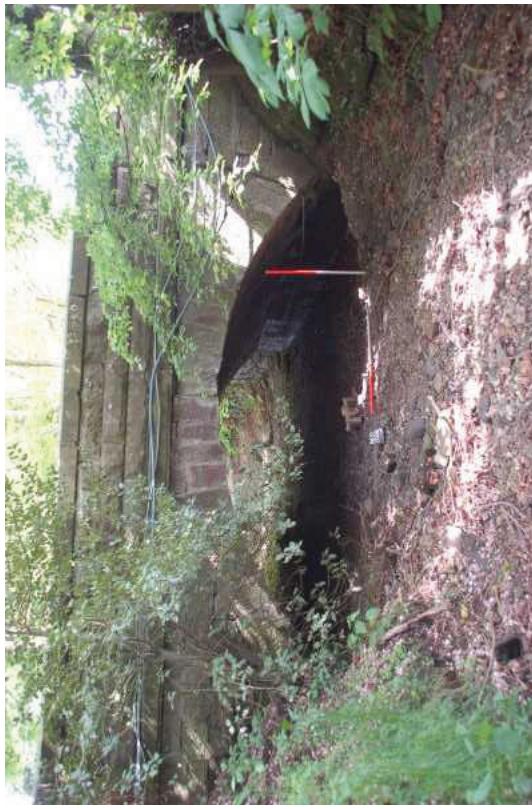
207	Huntingtower Hotel Girder Bridges	Bridges	1901-32	-	-	NO 07404 and 07418	25559 and 25566
<p><i>Walkover Description:</i> Two bridges constructed from steel girders and concrete which cross the E and W lade channels to the S of Huntingtower Hotel. The concrete has been set over corrugated iron which forms the arches between the girders. The W bridge appears to be constructed in two phases as there is a second set of girders on top of the first crossing the lade at a slight angle.</p> <p><i>Interpretation:</i> The E bridge lies on the site of an earlier bridge shown on the 1st edition OS map. This bridge provided access for house NW of Huntingtower Mill. The bridge was replaced in the early 20th century by the current structure. The bridges seem to have been built to create a new route for general traffic accessing the house which later became Huntingtower Hotel. In this phase the older access route to the house and estate buildings (including the wide bridge at site 209) seems to have become part of the estate gardens. In this phase the route crossing the bridges at sites 207 and 211 appears to have to have been retained as the formal driveway and approach to the house.</p> <p><i>Relevant site from DB4:</i> Huntingtower Bleachworks (34)</p>

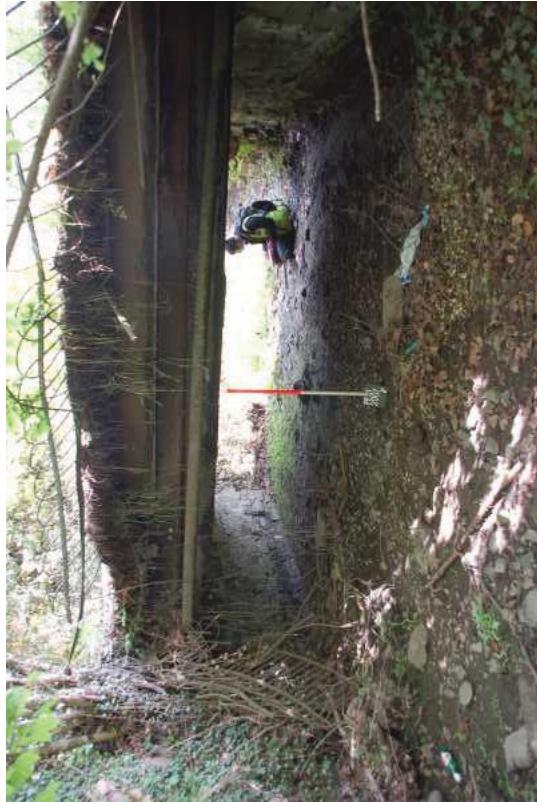
208	Huntingtower Mill Junction	Junction	19 th century	-	-	NO 07417	25536
<p><i>Walkover Description:</i> A major junction on the lade to the NW of Huntingtower Mill where the two routes of the lade running around Huntingtower Bleachworks join. The lade then splits again, one route running S towards Shepherd's Mill, the other running E towards Huntingtower Mill. At the entrance to the former channel there is a large double sluice which was raised by rack and pinion mechanisms. The sluice is fixed into slots cut into large pointed sandstone blocks on either side of the channel entrance. There are similar slots on the stonework at the entrance to the latter channel, though no signs of a sluice. Instead, a low wall constructed from concrete blocks forms a small weir between the slots. To the S of the sluice is a small steel girder bridge over the S route of the lade. A stone next to the bridge is engraved 'Cobby Bridge', and on the reverse side there are two possible masons' marks.</p> <p><i>Interpretation:</i> The slots on the stonework by the entrance to the E channel are for another sluice which would have been similar in design to that of the S channel. The sluices controlled water flowing towards both Huntingtower Mill and Shepherd's Mill. The sluice controlling water to the S channel appears to have been installed earlier than that to the E, as it appears on the 1st edition OS map. Both sluices were in place by the late 19th century as they are shown on the 2nd edition OS map. The creation of a sluice for the Huntingtower Mill channel was probably needed after the lade was culverted under the mill in the late 19th century, as it would have enabled water to be shut off for inspections and cleaning to be carried out in the culvert. The weir at the location of the sluice was created in the late 20th century, presumably to raise the water level upstream. There was a footbridge on the site of Cobby Bridge by the late 19th century which would have been used for accessing the sluices at the junction. The current bridge, however, has been widened for vehicular access in the late 20th century.</p> <p><i>Relevant sites from DBA: Huntingtower Mill (33)</i></p>

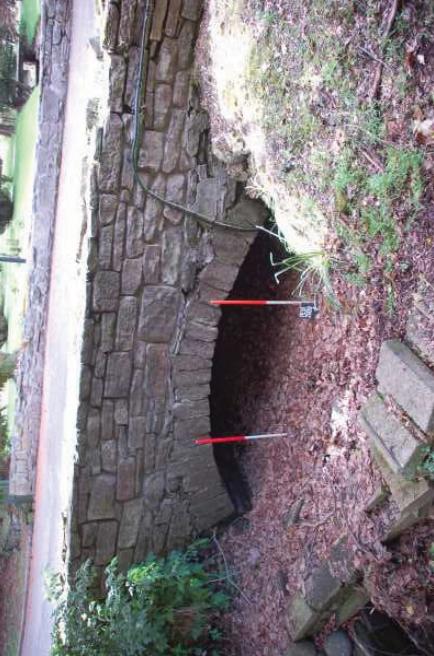
210	Huntingtower Hotel Water Feature 1	Water Feature	20 th century	-	-	-	NO 07387	25650
		<p><i>Walkover Description:</i> A small stone built island situated in the middle lade in the grounds of Huntingtower Hotel. The revetting walls of the lade have been robbed nearby. There are electric cables in the centre of the island.</p> <p><i>Interpretation:</i> A water feature built from stonework robbed from the sides of the lade in the grounds of Huntingtower Hotel. The water feature would have been lit up at night.</p>

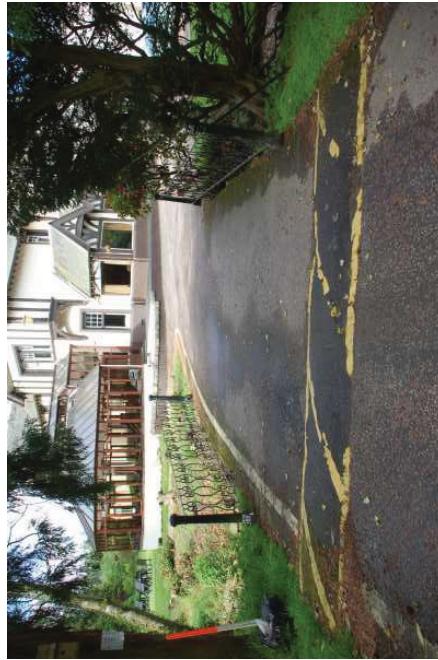
<i>Walkover Description:</i> A small stone built island situated in the middle lade in the grounds of huntingtower Hotel. The revetting walls of the lade have been robbed nearby. There are electric cables in the centre of the island.							
	<i>Interpretation:</i> A water feature built from stonework robbed from the sides of the lade in the grounds of Huntingtower Hotel. The water feature would have been lit up at night.

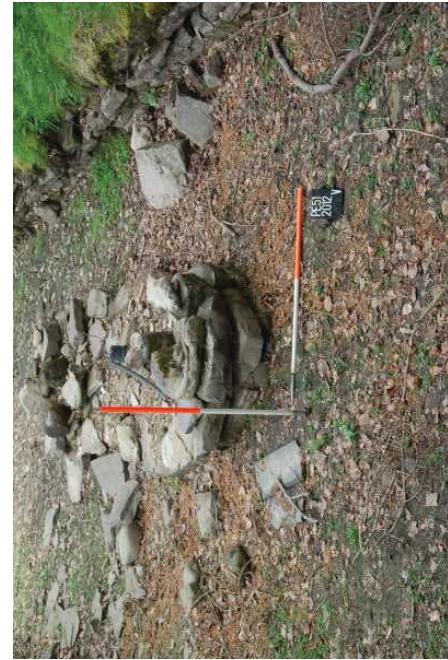
213	Huntingtower Hotel Water Feature 3	Water Feature	20 th century	-	-	-	NO 07346	25727
<i>Walkover Description:</i> A small stone built island situated in the middle lade in the grounds of huntingtower Hotel. The revetting walls of the lade have been robbed nearby. There are electric cables in the centre of the island.								
<i>Interpretation:</i> A water feature built from stonework robbed from the sides of the lade in the grounds of Huntingtower Hotel. The water feature would have been lit up at night.								
214	Huntingtower Hotel Water Feature 4	Water Features	20 th century	-	-	-	NO 07332	25739
<i>Walkover Description:</i> Several water features extending along a c 25m length of lade in the gardens of Huntingtower Hotel. The drystone revetting wall on the NE side of the lade has been robbed. Features comprise a cascade, constrictions and an island. Some of the features have been cemented.

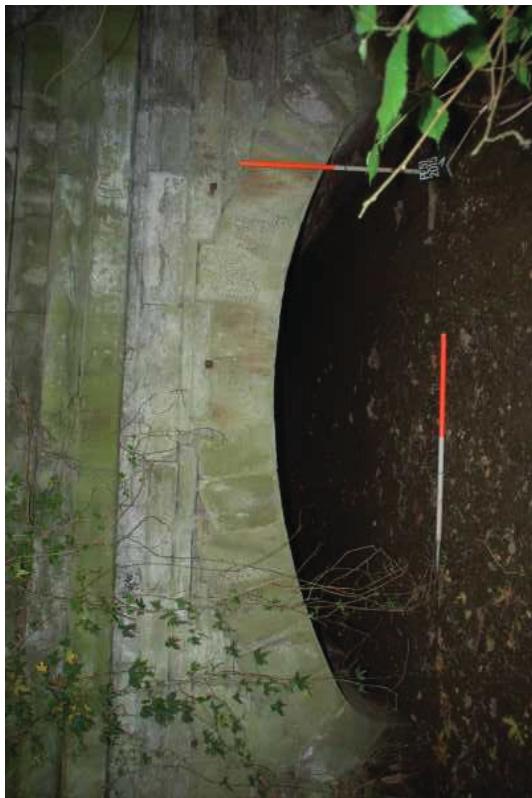
215	Huntingtower Bleachworks Culvert Exit	Culvert exit	19 th century	MPK 5326 NO02NE 84/0,1	NO 07273	25764	
<p><i>Walkover Description:</i> The exit of the culvert under the former Huntingtower Bleachworks industrial complex. A c 0.7m high arch constructed from well shaped, pointed (pecked) sandstone voussoirs. The arch wall is divided in half horizontally by a c 0.25m high ledge. Stonework below comprises small blocks of squared off sandstone which are smooth and built to level beds; hat above comprises large bull-faced blocks of sandstone built to level beds.</p>

<p><i>Interpretation:</i> Exit of the culvert. Essentially this is one side of a bridge for the road running along the E side of Huntingtower Bleachworks that was been built against one side of the factory culvert. The bridge dates to the 19th century. The walls of the culvert presumably become straight sided on the other side of the bridge. The culvert itself was not investigated for obvious health and safety reasons.</p>		<p><i>Relevant site from DB4: Huntingtower Bleachworks (34)</i></p>

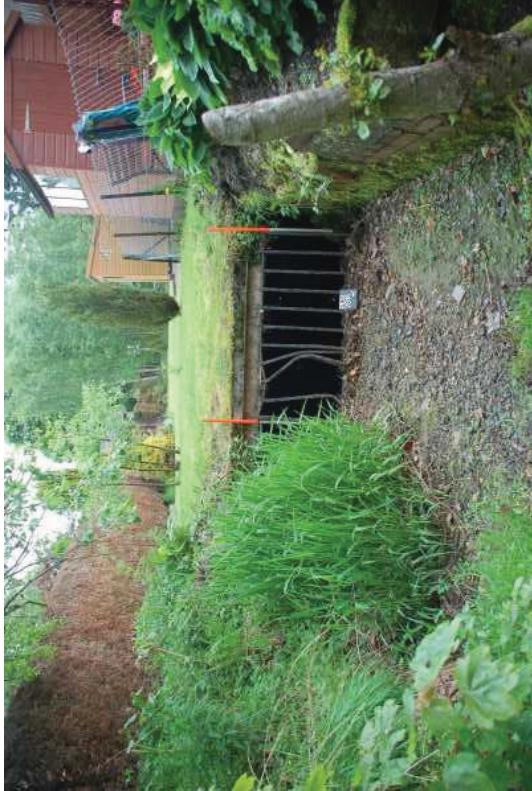
216	Huntingtower Bleachworks Culvert Entrance	Culvert entrance	19 th century	MPK 5326 NO02NE 84/0,1	NO 07199	25744	
<i>Walkover Description:</i> Entrance to the culvert under the former Huntingtower Bleachworks industrial complex. On approach to the entrance, a fairly narrow horizontal slab of whinstone can be found across the floor of the lade. On the S bank, just to the E of this slab is a revetting wall c. 0.7m tall constructed from 19 th century bricks. On top of this wall at the W end is a rectangular block of worked stone which supports a cast iron feature (now broken). The level of the lade drops roughly 1.4m over a brick wall as it enters the culvert. The brick wall has been constructed in a gentle curve to resist the pressure of the water flow. Beyond this wall the N wall of the culvert is brick lined for a metre or so, but after this both walls of the culvert are stone built. The site of the factory buildings have been cleared away over the culvert to form the back yards for new housing. The roof of the culver however appears to be intact and is constructed from concrete reinforced with steel girders. A grille has been placed over the 0.5m high entrance to the culvert.

Interpretation: The lade appears to have been culverted over here since the 1st edition OS map (1860s). The current concrete roof of though probably dates to the early to mid 20th century. Originally the lade here may have powered another waterwheel for the factory but if so the later alterations have erased any traces. The function of the iron feature on the S side of the lade is unclear, perhaps it marked one side of a structure for accessing a sluice or walkway over the culvert entrance. The N side of the lade at this point has unfortunately been altered during the redevelopment of the site.

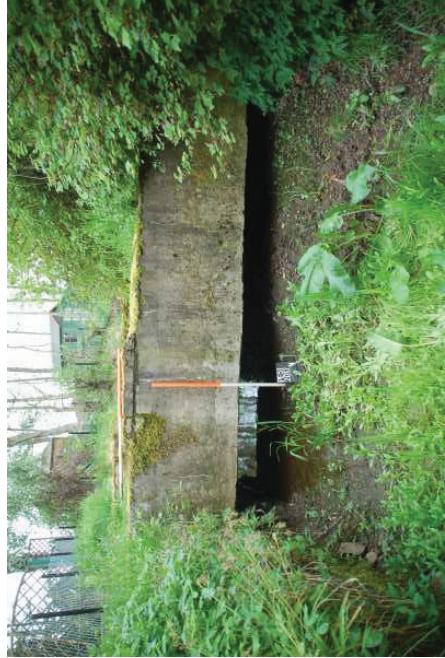
217	Huntingtower Bleachworks Bridge	Bridge	Mid 20 th century	MPK 5326 NO02NE 84/0,1	NO 07180 25719
<i>Walkover Description:</i> A heavily built concrete bridge with parts of the parapets surviving, constructed from colliery bricks.

<i>Interpretation:</i> The structure is clearly an industrial bridge built in the 20 th century for Huntingtower Bleachworks. There are two bridges shown on this bend by the 1968 OS map: An early bridge (wide) first shown on the 1901 OS map and a later one (narrower) first shown on the 1968 map. It seems likely, given the extensive application of concrete, that we are looking at the latter bridge, probably built in the 1940s or 1950s. The bridge is clearly built to support heavy loads crossing the lade, presumably between the industrial buildings that were in existence on either side of the lade by this date.

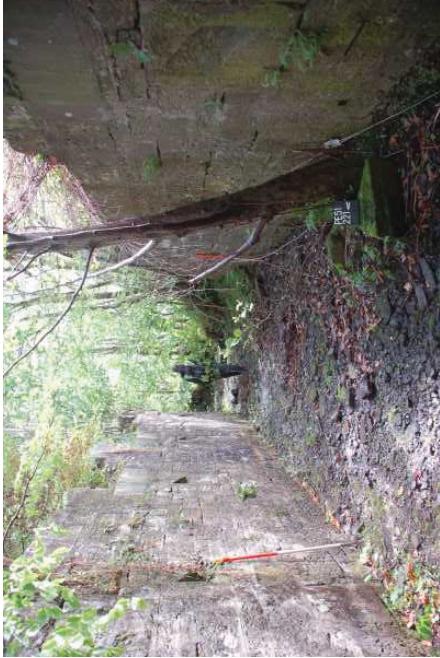
221	Mill Cottage Railway Bridge	Railway Bridge	1850s	-	-	NO 07592	25490
<i>Walkover Description:</i> Two parallel, but offset squared rubble walls for a railway bridge. Along the tops of each wall are four slots for the beams of the bridge. These correspond to diagonal slots half way up each of the walls which presumably held steel bracing for the main bridge structure. There are vertical grooves at the ends of each wall.

<i>Interpretation:</i> Railway bridge for the main Crieff line. The grooves may have held barriers on either side to prevent access to the underside of the bridge.							
<i>Relevant site from DB4:</i> Shepherds Mill (31)							
222	Shepherds Mill Revetting	Stone revetting	19 th century	-	-	NO 07714	25539
<i>Walkover Description:</i> A short length of poorly mortared stone revetting on the N side of the lade upstream from Shepherd's mill. The wall is constructed from roughly pecked and squared sandstone blocks built approximately to level beds. The wall is c 4m long and 0.5m tall.

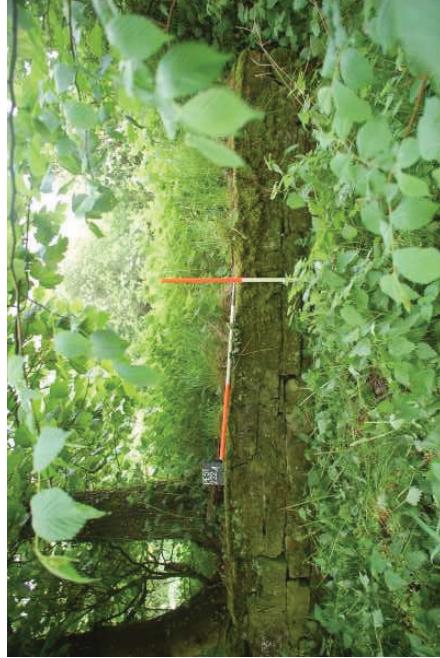
<i>Interpretation:</i> The function of this wall is unknown. There is no revetting on this side of the lade between here and Shepherd's mill. The lack of any corresponding wall on the S bank suggests it was probably not part of a bridge.							
<i>Relevant site from DB4:</i> Shepherds Mill (31)

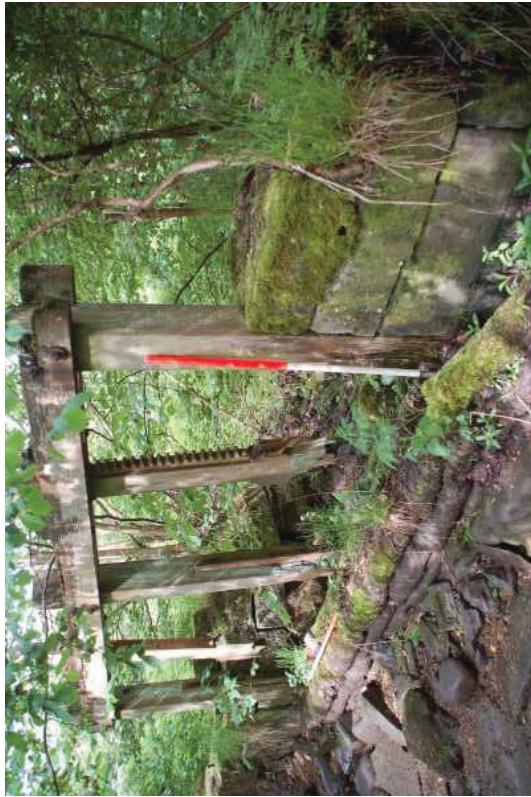
223	Shepherds Mill	Mill	19 th century	MPK 8012	NO02SW 132.02	NO 07758	25547
<p><i>Walkover Description:</i> On the outside corner of a sharp bend on the road through Ruthvenfield are the ruined remains of Shepherd's mill which comprises two lade overflow channels, the ruined mill building, a waterwheel and a small building to the SW of the waterwheel. Very little of the main mill building survives, the structure having been redeveloped into yards and storage for the nearby Shepherd's mill cottages. The SW gable wall stands to more than 5m high and is constructed from blocks of sandstone, well squared with pointed (pecked) surfaces. The other walls have been demolished or survive as low footings only (the NW wall). The waterwheel is undershot and still in situ, located against the outside of the gable. It is of two bayed construction made from cast iron sections bolted together; the wooden paddles have since decayed or have been removed. The lade channel running below is lined with stone paving slabs which are placed to create a curving descent down to the base of the wheel. Water entering the wheel channel was controlled via a wooden sluice which could be raised via a rack and pinion mechanism.</p> <p>After the wheel, the lade is culverted where it runs under the access drive for Shepherd's mill cottages. One side of the wheel's axle is connected centrally in the gable of the mill while the other rests on a c. 1.5m high stone wall. SW of this wall is a building initially constructed from stone and later extended further SW in early 20th century brick. The NW, SW and SE walls of this building stand c 2.6m high and there is a doorway for access facing the road. The interior of this building contains a high pressure water pipe connected to a turbine and dynamo of early to mid 20th century date. W of this building is a partly buried chamber covered by upright stone slabs. Upstream of the waterwheel the lade is lined in cobbles with an ashlar revetting wall to the N. Two overflow channels extend northwards, that to the SE apparently open and that to the NW controlled by a double sluice. Both overflow channels extend northwards to join the N route of the lade close to the railway bridge (site 226). They each pass under low arched bridges at the back of the mill.</p> <p><i>Interpretation:</i> The main mill building appears to be 19th century in date and according to the OS map was used for grinding flour. The waterwheel axle must have driven a series of grindstones in the main mill building to the N. By the 2nd edition OS map (1901) the main mill building appears to have been largely demolished, though the wheel and gable wall were left intact. The original stone building to the SW of the gable was probably a roofed annex to house the waterwheel. In the 20th century this seems to have been extended in brick to the SW to house the hydroelectric equipment, possibly installed to power electric lighting in Shepherd's mill cottages</p>

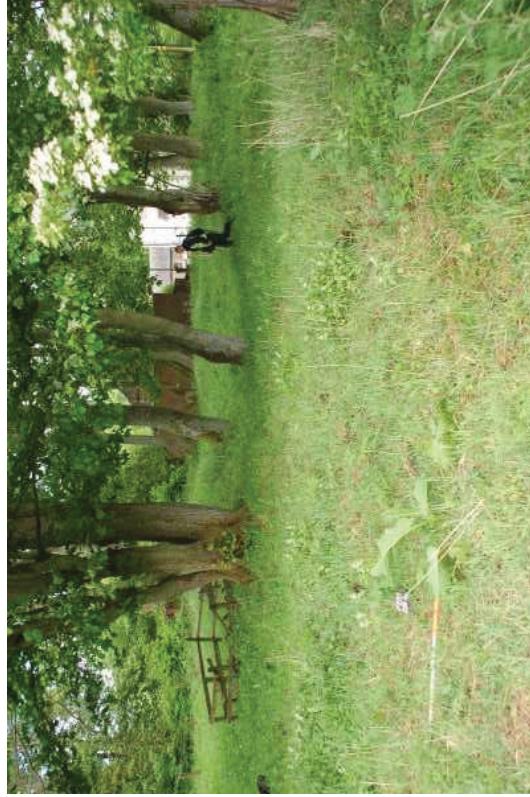
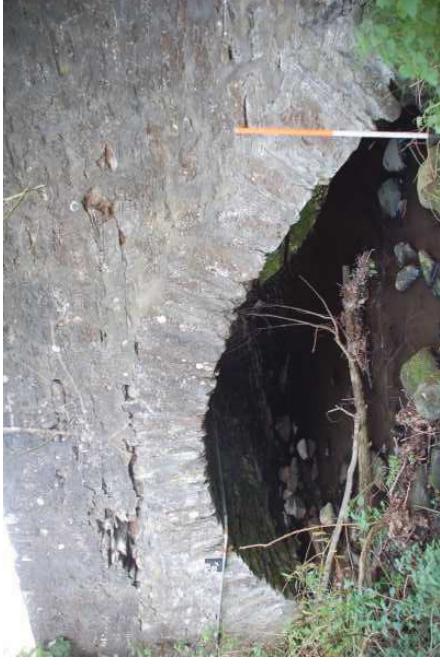
225	Ruthven Farm Bridge	Bridge	19 th century	-	-	-	NO 07881	25487
<i>Walkover Description:</i> A low arched road bridge over the lade S of Ruthven Farm. The bridge is heavily pointed with lime mortar and cement and is composed of random rubble (sandstone) with rather narrow voussoirs. The arch is 1m tall.

<i>Interpretation:</i> This bridge was probably constructed for Ruthven Farm. In style it seems different from many of the bridges along the lade, being constructed from much more random rubble. The bridge possibly dates to the late 18 th century though the lack of any evidence for widening suggests an early 19 th century date.

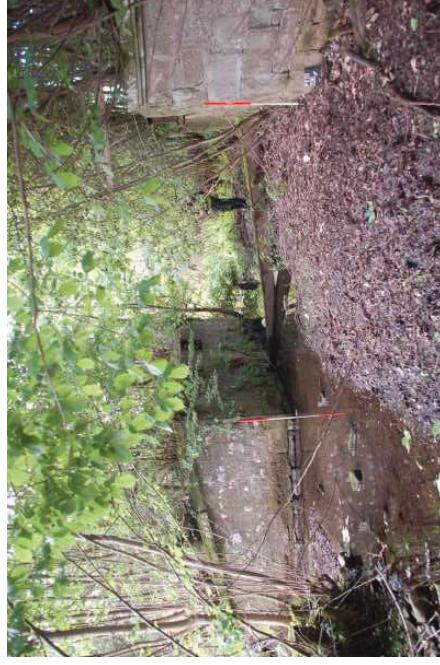
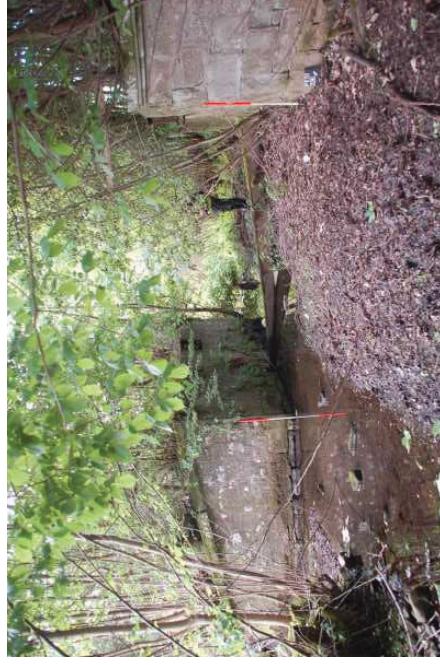
226	Shepherds Mill Railway Bridge	Railway Bridge	1850s	MPK 6724	-	-	NO 07762	25609
<i>Walkover Description:</i> Two well preserved sections of wall marking the location of a railway bridge over the lade. The walls cross the lade at an angle and are composed from large well squared blocks of sandstone built to roughly level beds. In each wall are four sets of slots along the top edge. In the two central slots in either wall are sawn off girders, the remains of the main beams for the bridge. Running vertically up the four corners of the walls are smooth grooves in the stonework.

<i>Interpretation:</i> Railway bridge for the main Crieff line. The grooves may have held barriers on either side to prevent access to the underside of the bridge.								
<i>Relevant site from DBA: Railway Bridge (37)</i>

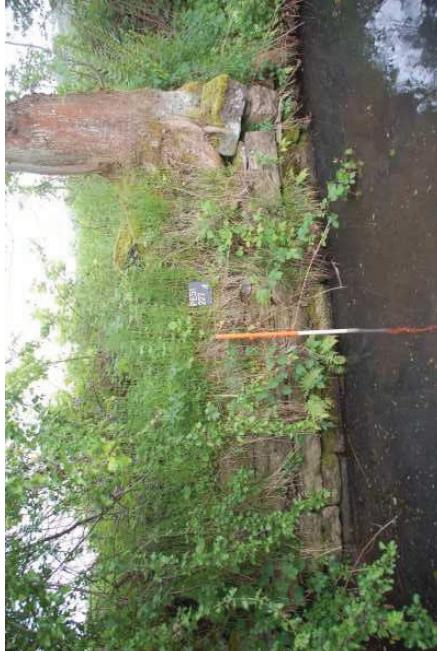
227	Ladeside Cottage	Bridge	19 th century	-	-	NO 07687	25612
<i>Walkover Description:</i> Two short lengths of wall on either side of the lade near 'The Kennels'. The N wall stands c 1m high and is constructed from unmortared squared blocks of pink sandstone. The wall on the S bank is less well preserved, standing 0.5m high.

<i>Interpretation:</i> These walls mark the location of a late 19 th century bridge first shown on the 2 nd edition OS map. The bridge was presumably built to provide easy access to the isolated field to the S which lay in between the railway line and the lade. The bridge seems to have collapsed or been removed during the 1990s or 2000s.

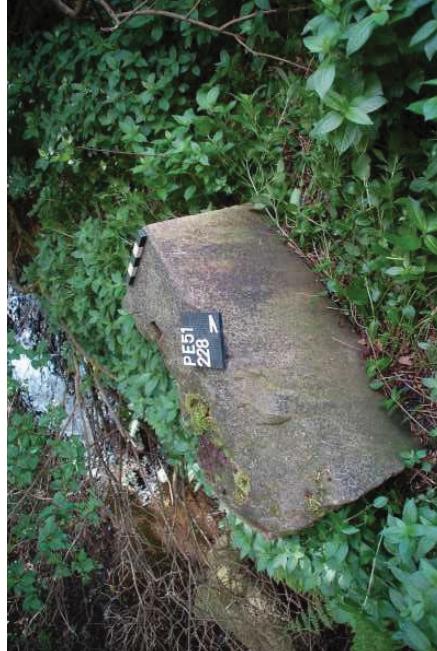
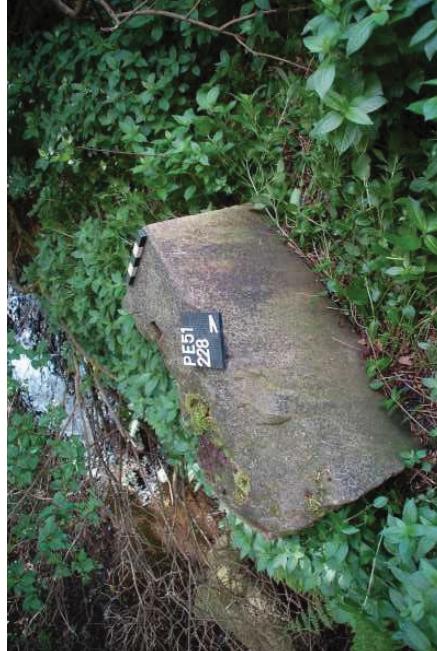
228	Huntingtower Mill	Stones, fencepost	19 th century	-	-	NO 07559	25500
<i>Walkover Description:</i> Three features located on a bend in the lade just to the E of Huntingtower Mill: A 19 th century iron tensioner post, a partially worked block of sandstone on the floor of the lade, and a rectangular block of worked sandstone on the N bank of the lade.

<i>Interpretation:</i> These features are of little significance, being examples of rubbish and debris which ended up in the lade at the back of the mill.							<i>Relevant site from DBA: Huntingtower Mill (33)</i>

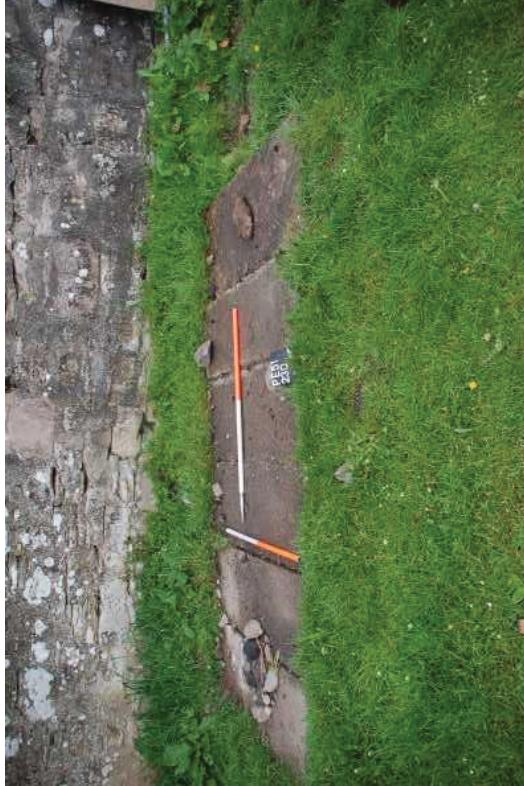
<p><i>Walkover Description:</i> A drain (N portion recently disturbed) running along the E side of the boundary S of the primary school at Ruthvenfield. Various manholes and concrete slabs were noted alongside the boundary.</p> <p><i>Interpretation:</i> The drain and boundary mark the rough location of a narrow water channel which branched off from the lade just N of the site of the current school on the 1st edition OS map. No real evidence of an open channel was found however.</p>

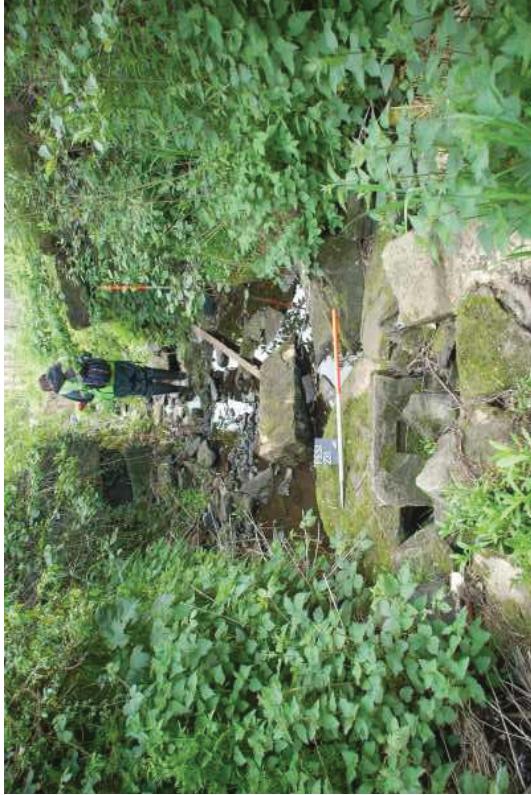
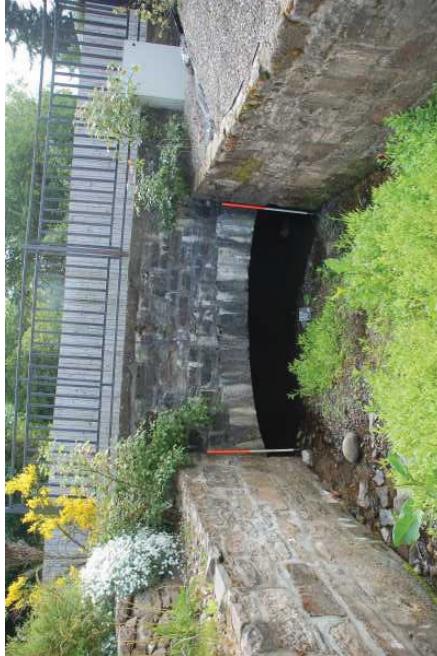
232	Ruthvenfield Bleachworks	Bridge	19 th century	MPK 17940	-	NO 08166	25358
<i>Walkover Description:</i> A wide, low arched bridge just to the E of the site of the western factory at Ruthvenfield. The bridge is constructed from approximately squared off blocks of pointed (pecked) sandstone built to roughly level beds, with very regular pointed (pecked) voussoirs. The visible NW face of the bridge has been heavily repointed in cement. The SE side of the bridge has been buried during the redevelopment of the site and the lade culverted in a concrete tube for a short distance to the E.

<i>Interpretation:</i> The bridge appears on both the 1 st and 2 nd OS maps. Originally it provided access to the terraced houses to the N which were probably factory workers cottages. After the Ruthvenfield Print Works factory complex was abandoned in the late 19 th century these cottages were demolished and the new western factory built just to the W. The bridge then served as the main crossing point on the lade for the new factory.

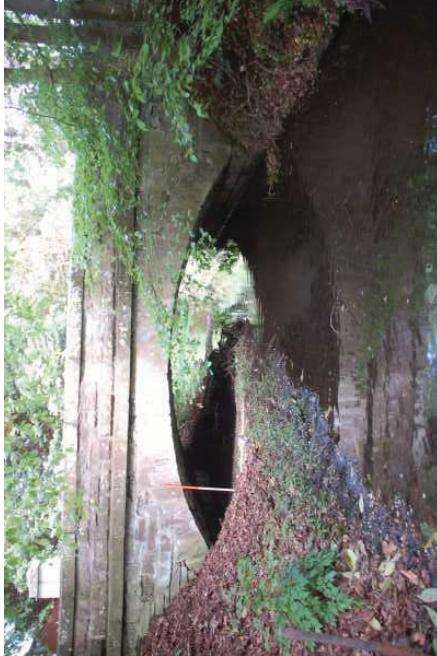
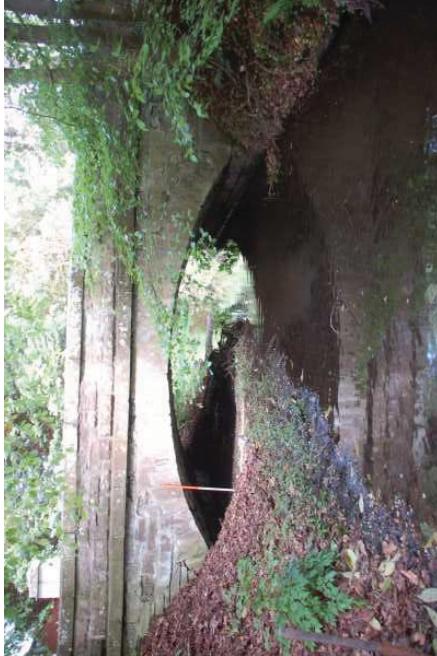
233	Ruthvenfield Print Works	Bridge	19 th century	MPK 17940	-	NO 08240	25313
<i>Walkover Description:</i> A low arched road bridge crossing the lade on the main driveway to Ruthvenfield House. The bridge is of 19 th century date and is constructed from fairly regular sandstone blocks built to roughly level beds.

<i>Interpretation:</i> The bridge appears on the 1 st and 2 nd OS map and would have acted, as it does today, as the main bridge over the lade along the driveway to Ruthvenfield House. However, in the mid to late 19 th century the bridge also provided access to the Ruthvenfield Printworks factory.

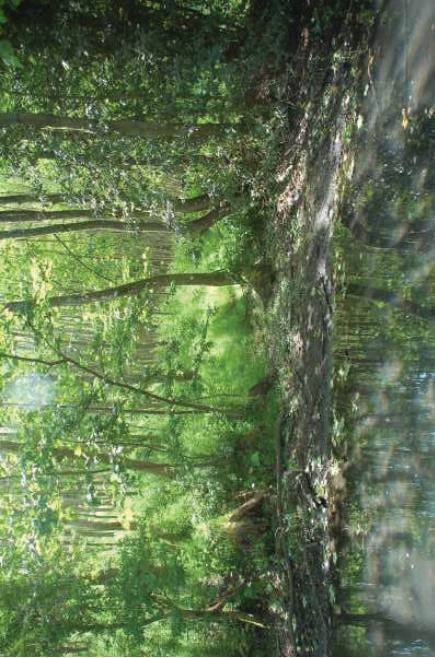
236	Ruthvenfield House	Channel	Unknown	MPK2084	NO02NE 59	NO 08538	25186	
<i>Walkover Description:</i> At the E end of the haugh to the N of Huntingtower Castle is a curving channel running down into the lade from the hillside to the S. The channel could not be measured due to the difficulty of crossing the lade at this location, but it was roughly 4m wide and 2m high.

<i>Interpretation:</i> This channel may be the remains of a water feature or track. The channel roughly lines up with a cropmark in the field to the N - a large plantation bank belonging to the designed landscape of Ruthvenfield House. It is possible that this feature (whether track or water channel) was created to draw the eye along the plantation.

Channel near Huntingtower Castle (236)	This feature should be should be walked and mapped to ascertain its likely date and function.
Clay Pits (238)	We recommend that these pits are surveyed as part of a community project to record their exact form, location and to see if they are associated with any other features. Through this survey it may be possible to gain a better idea of their date.
Gasometer (239) and Building (240)	These features could be cleaned back, consolidated and be interpreted as part of a historical lade walk. Such interpretation could include information about Newton House which was located where Perth Crematorium now stands. Further historical research is needed however to discover the precise function of the rectangular building.
Culverted parts of the lade	<p>For health and safety reasons this project has been limited to the surveying the open sections of the lade. However, there will be features of historical interest along the culverted parts of the lade below the city centre of Perth. Investigations of these culverted parts could potentially reveal:</p> <ul style="list-style-type: none"> • The intakes, outflows and foundations of now demolished mills which were once located along the lade in the City centre. • Phasing and the different techniques used in the construction of the culvert. • The nature of major divisions and junctions along the route. <p>If access was granted, such investigations could be carried out using voluntary archaeologists associated with the Grampian Speleological Group who are experienced in underground investigations, and who are closely associated with the Scottish Cave Rescue Organisation.</p>

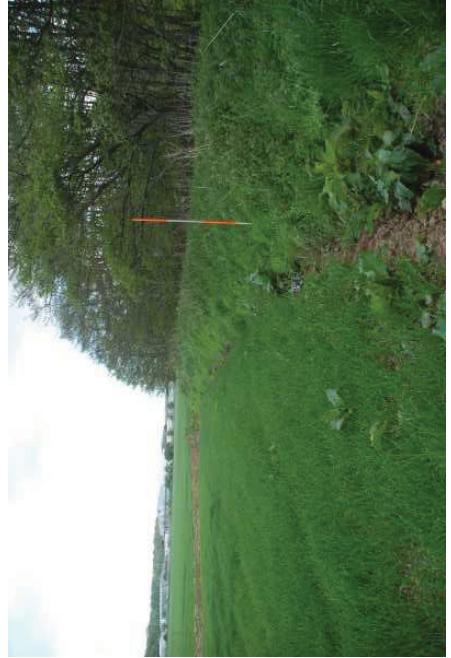
237	Ruthvenfield House	Embankment	Unknown, possibly modern	-	-	NO 08607	252221	
<i>Walkover Description:</i> An embankment on one side of the lade (the NW) where it turns steeply to the NE near the A9 dual carriageway. The embankment is 1.2m tall and 8m wide in places with a gently rounded profile.

<i>Interpretation:</i> A modern machine made bank created when the lade was diverted during the construction of the A9 dual carriageway.

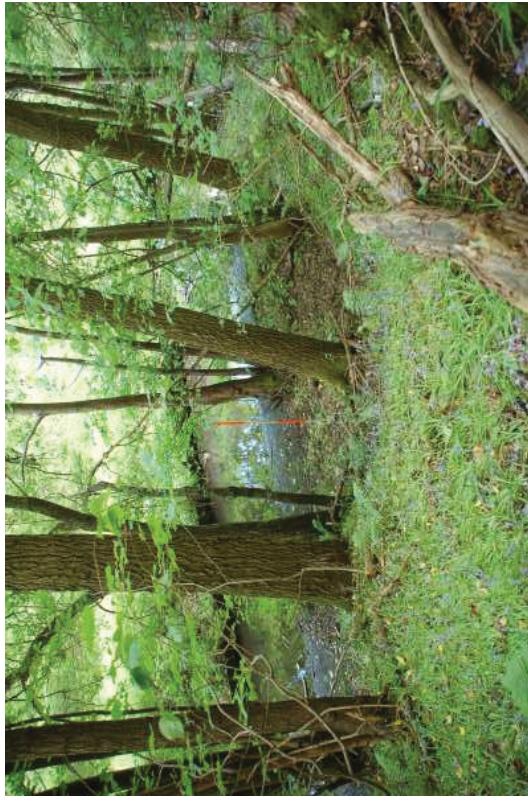
239	McDiarmid Park Bank	Gasometer	19 th century	-	-	-	NO 08976	25502
<i>Walkover Description:</i> Remains of a gasometer. Under the woodland leaf litter can be seen a roughly circular depression, flanked on three sides by large worked trapezoid stones with cut off iron pins rising vertically from each. On inspection the inside edge of the depression can be seen to lined in glazed white bricks. The circular depression measures c 3.5m in diameter.								
<i>Interpretation:</i> This feature is the foundation for a gasometer marked on the 2 nd edition OS map. The gas holding cylinder and iron frame of the structure has been removed, possibly for iron during WW2. The white tiled depression marks the location of the water tank under the gas cylinder which created the gas tight seal. This gasometer was presumably built by the owners of Newton House (which used to stand where the crematorium is now located) for a local private gas supply. The structure is of late 19 th century date.

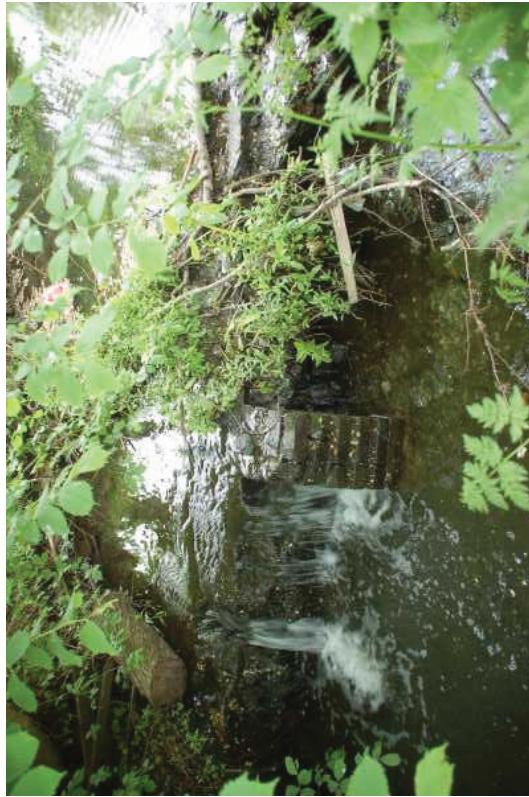
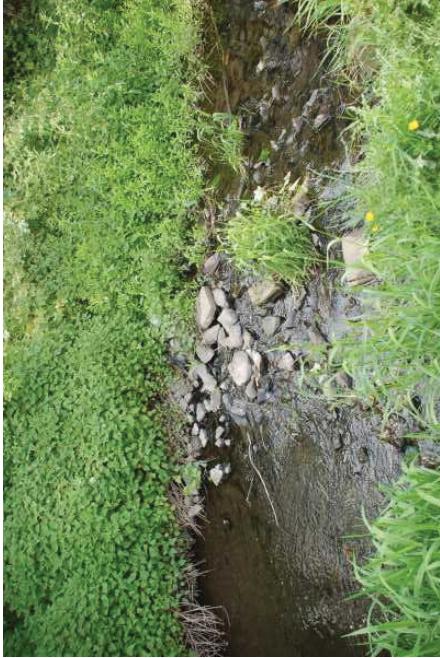
244	Tulloch Bleachworks Stones	Possible crossing point	19 th century	MPK 7922	-	NO 10095	25162
<i>Walkover Description:</i> A rocky shallow area in the lade N of site 245. The feature is c 2m wide and composed mainly of angular stones c 0.20 x 0.10 x 0.05 m dia.

<i>Interpretation:</i> It was initially thought that this feature may have been a crossing point on the lade. However, a subsequent visit to this site the next day during higher water levels showed that this feature had become submerged.							
<i>Relevant site from DBA:</i> Tulloch Bleachworks (28)							
245	Tulloch Bleachworks Junction	Lade Junction	19 th century	MPK 7922	-	NO 10098	25104
<i>Walkover Description:</i> An area of red brick revetting (c 1.5m high) on the W side of the lade which curves steeply 90 degrees to the W. The bank S of the curve has been infilled and is covered with vegetation making inspection difficult. There is a brick revetting wall with rounded off sandstone kerbstones on the E side of the lade. To the S of the curved wall is a large girder and an iron water pipe crossing the lade at 90 degrees.

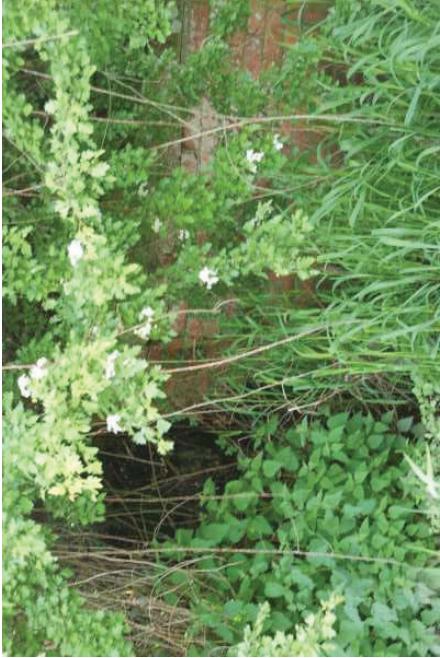
<i>Interpretation:</i> The curved wall marks the location of a lade channel which exited Tulloch Bleachworks. The channel is marked on 1 st and 2 nd edition OS maps and was one of the main outflows from the diversion of the lade through the heart of Tulloch Bleachworks (the diversion began at the weir to the N – site 243). There is now no trace of this diverted portion of the lade as the main part of Tulloch Bleachworks has been redeveloped. The water pipe is presumably associated with the works.							
<i>Relevant site from DBA:</i> Tulloch Bleachworks (28)

Tulloch Bleachworks (243, 245, 246, 247)	Tulloch Bleachworks is a key industrial site. The most important and impressive historical feature now remaining is the long block of factory buildings built by Pullars in the 19 th century. As the buildings are the sole survivors from the factory, they have considerable significance for the cultural heritage of the lade and the social history of this part of Perth. Their lack of protected status is a concern. We recommend further historical research into these structures to identify if a community based recording project is worthwhile. Such research could also include inquiries into the possibility of getting this building listed, a worthwhile consideration bearing in mind that these buildings make up the largest brick-built Victorian factory complex still standing in Perth. Little further work is recommended for nearby sites identified in the survey, though the vegetation could be cleaned back at the outflow channel to enable a better view of the brick edging from the lade path.

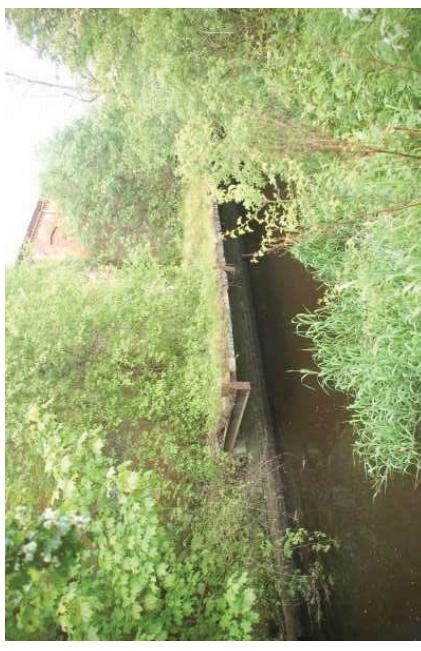
246	Tulloch Bleachworks Platform	Platform	20 th century	MPK 7922 -	NO 10149	25018
<i>Walkover Description:</i> A rectangular concrete platform cantilevered out c 1m over the W bank of the lade on the E side of the remaining 19 th century Tulloch Bleachworks buildings. The concrete platform is 0.2m thick and is supported on 10 steel girders which run into the W bank. The original brickwork revetting for the bank (which is capped with rounded off sandstone kerbstones) has been raised up under the platform with later brickwork. The girders extend into this course of brickwork. At the SE corner of the structure is a steel upright post that has been cut off low down. The platform is located next to a rectangular brick structure which has been built in front of a doorway in W wall of the 19 th century buildings.

<i>Interpretation:</i> This platform appears to be the foundation for a small and relatively light building associated with Tulloch Bleachworks. The brick structure to one side was probably a set of stairs leading down to the platform from the 19 th century buildings. One of the mechanics in the garage now located inside the 19 th century buildings remembers that that when he was a boy the platform was a canteen for the factory, constructed from corrugated iron. The 19 th century buildings behind this were built by Pullars in the late 19 th century; they were too large to survey as part of this project.

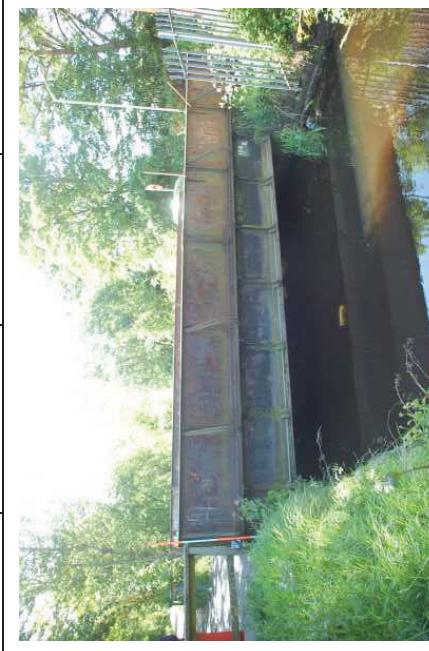
<i>Relevant site from DB4: Tulloch Bleachworks (28)</i>						
247	Tulloch Bleachworks Bridge	Bridge	20 th century	MPK 7922 -	NO 10173	24996
<i>Walkover Description:</i> Bridge over the lade near the existing 19 th century Tulloch Bleachworks buildings. The bridge is constructed from riveted steel girders and sheet steel with ornamental curved bracing to support the parapets. In plan the bridge is trapezoidal, being wider at the E side opposite the marshalling yard.

<i>Interpretation:</i> In design the bridge appears to be late 19 th or early 20 th century in date and was probably built for Pullars when they took over Tulloch Bleachworks. However, the bridge shown in this location on historic OS maps up till the 1950s has parallel sides. It is not until the 1960s OS map that the bridge appears in its current form, being wider on the W side than the E. It is therefore likely that the bridge was altered and widened at one end in the 1950s or 1960s when the marshalling yards were created to the E.

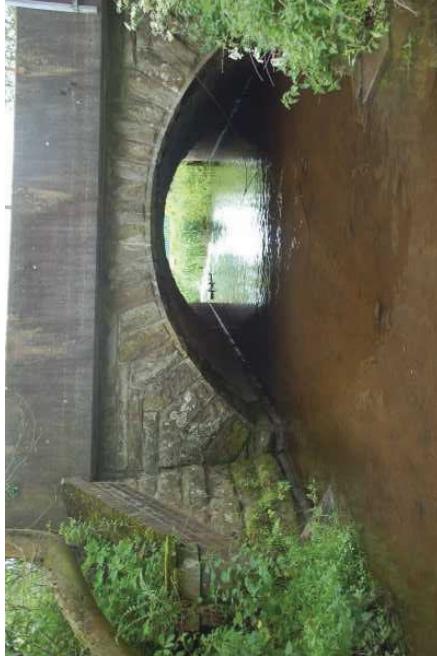
<i>Interpretation:</i> It is unclear where the water from this sluice was being diverted.							
249	Tulloch/Letham Railway Bridge	Railway Bridge	19 th century	-	-	NO 10583	24762
<i>Walkover Description:</i> Railway bridge (Inverness line). A relatively high arched stone bridge built using regular bull-faced sandstone blocks. The bridge has been widened (doubled in width) to the W by a concrete structure, probably built in the 1950s or 1960s. The parapets of the 19 th century bridge were partly reconstructed in concrete during this work.

<i>Interpretation:</i> The widening of the bridge coincides with the creation of the marshalling yards E of Tulloch in the 2 nd half of the 20 th century.
