**An Archaeological Survey
of the Town Lade
PERTH**

**AN ARCHAEOLOGICAL
SURVEY OF
THE TOWN LADE
PERTH**

Alder Archaeology Ltd was commissioned by Tulloch NET and PKHT to carry out an archaeological walkover survey and basic desk-based assessment of the Perth's historic lade to give an overview of its cultural heritage. The city lade runs for some 4.5 miles from a weir known as Low's Work on the River Almond by Huntingtower, through Tulloch estate and onwards to Perth city centre where it exits into the River Tay by the Old Tay Bridge. The entire non-culverted length of the lade was surveyed over four days between the 10th and 24th of May 2011. The recent winter flooding had caused damage to the weir at the intake on the River Almond and this meant that upper portions of the lade were dry during the survey. As well as recording the general conditions and alterations to the mills along the lade, the survey identified several new features including earthworks near Ruthvenfield and various clay pits of unknown date below Perth crematorium.

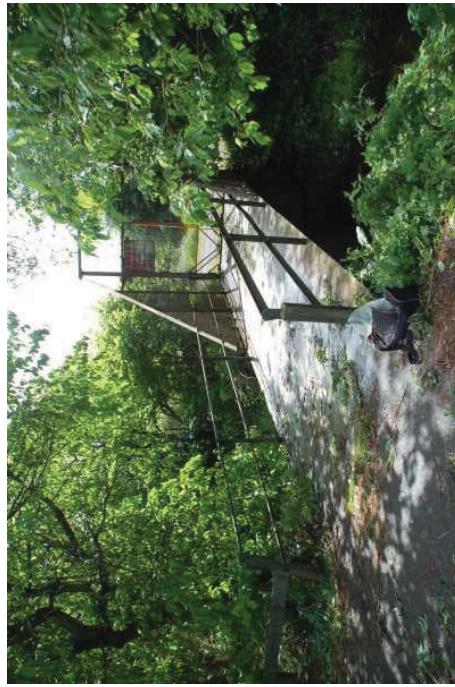
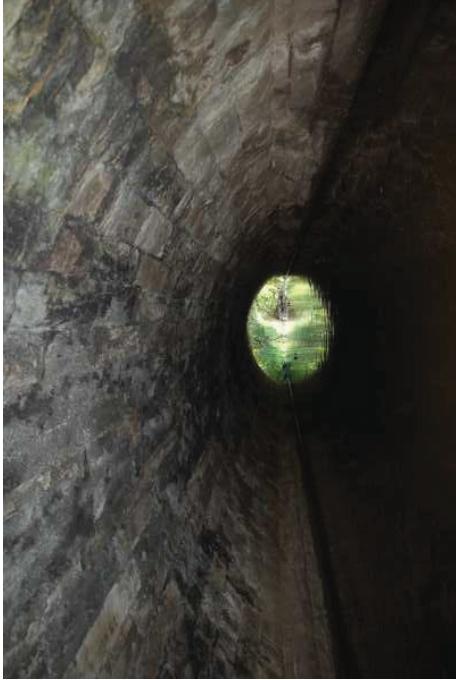
252	Crieff Road Embankment	Tunnel	19 th century	-	-	NO 10818	24450
<i>Walkover Description:</i> Lade tunnel under the Crieff Road embankment. Entrances constructed largely from bull-faced blocks of sandstone. Internal tunnel walls constructed from bull-faced blocks of sandstone (2-3 courses high) with roughly pointed (pecked) flat blocks of sandstone for the roof of the tunnel.

<i>Interpretation:</i> Lade tunnel created in the mid 19 th century for the Crieff Road embankment. The Crieff Road embankment was built to for the crossing of the nearby railway line.							
253	Boot of Balhousie Bridge	Bridge	19 th century	-	-	NO 10865	24398
<i>Walkover Description:</i> An old road bridge just to the NW of Boot of Balhousie. The bridge is c 7m wide (NW-SE) with a very low arch made with tooled voussoirs. The original fabric of the bridge is sandstone rubble, but this has been repaired with brick and concrete, probably in the 20 th century.

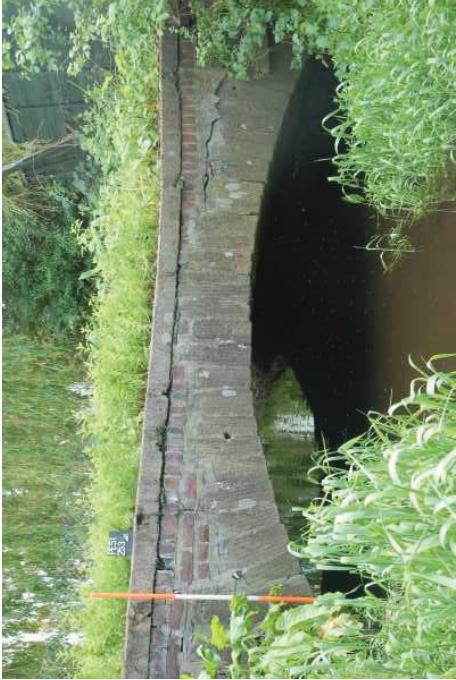
<i>Interpretation:</i> This bridge originally belonged to a road which ran from the lodge N of Wellshill cemetery across to the Crieff Road. It is clear from the 1 st edition OS map that this route became effectively cut off by the creation of the Crieff Road embankment over the railway. We can therefore assume that little traffic past over this bridge after the creation of the embankment in the middle of the 19 th century. However, the bridge was presumably still used after this date for crossing the lade to access the Boot of Balhousie sluice.							
<i>Relevant site from DBA: Boot of Balhousie (26)</i>

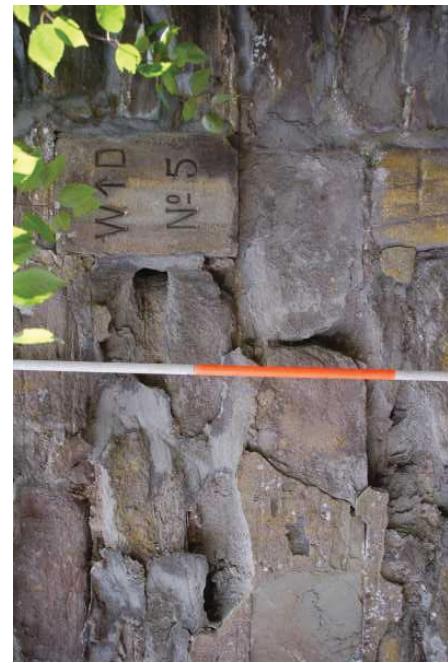
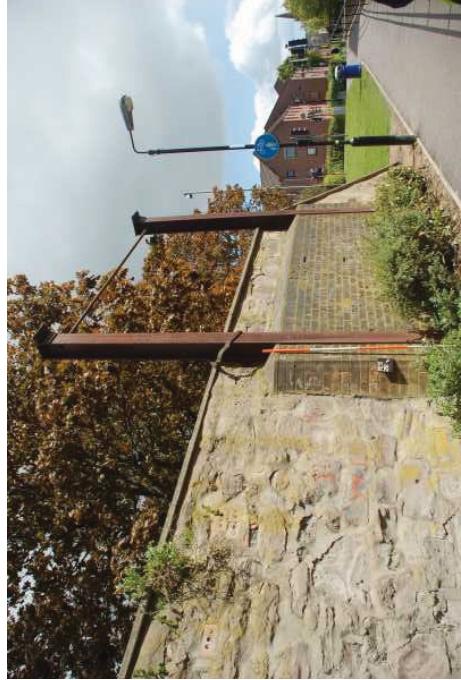
258	Caledonian Road Structure	Structure	19 th or early 20 th century	-	-	NO 11340	23874
<i>Walkover Description:</i> On the NE side of the lade against the wall running behind Perth Police Station are two vertical steel girders joined together at the top by a horizontal steel rod. Girders measure c 4.2m in height, c 3m apart and are painted brownish-red. The girders have been built into a neat short length (c 3.4m) of brick wall which runs alongside the rubble wall running behind the police station. Steel plates have been riveted to the tops of each of the girders. There are four holes on each girder some c 3.2m up on the sides facing the lade.

<i>Interpretation:</i> This structure is possibly the remains of a gantry which crossed the lade to the Monax Glassworks. Upper plates may have supported beams which crossed over the lade. The holes in the girders may have been for bracing.
