Archaeological Evaluation  
Skernieland Road  
Fenwick  
EAST AYRSHIRE  
FE01

# **ARCHAEOLOGICAL EVALUATION SKERNIELAND ROAD, FENWICK EAST AYRSHIRE FE01**

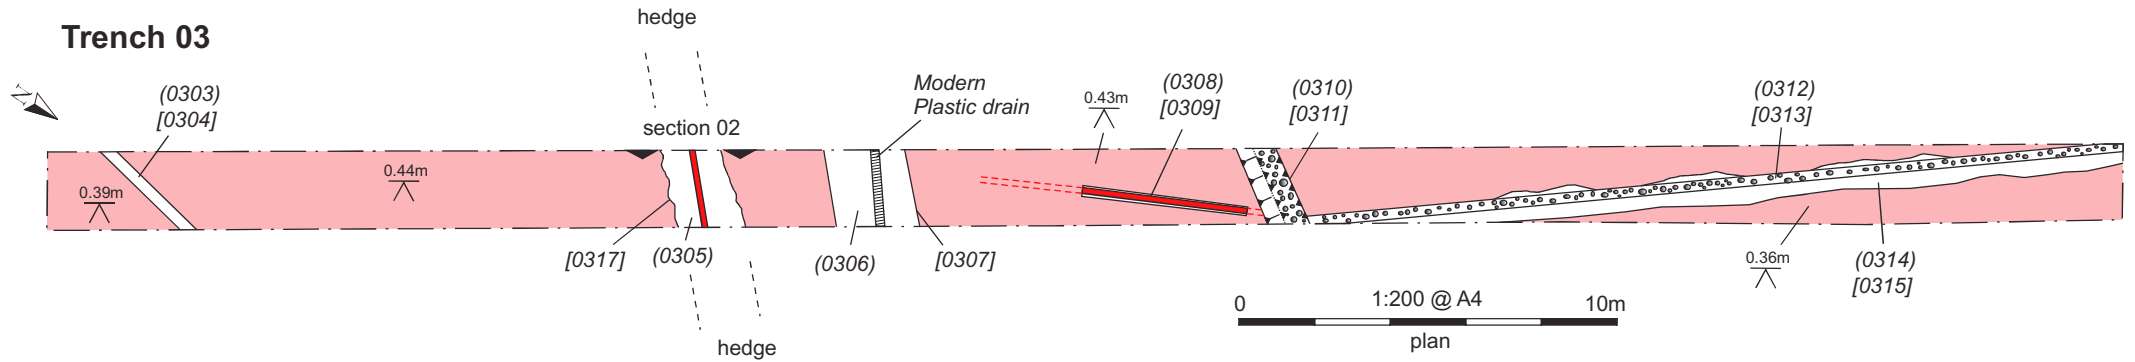
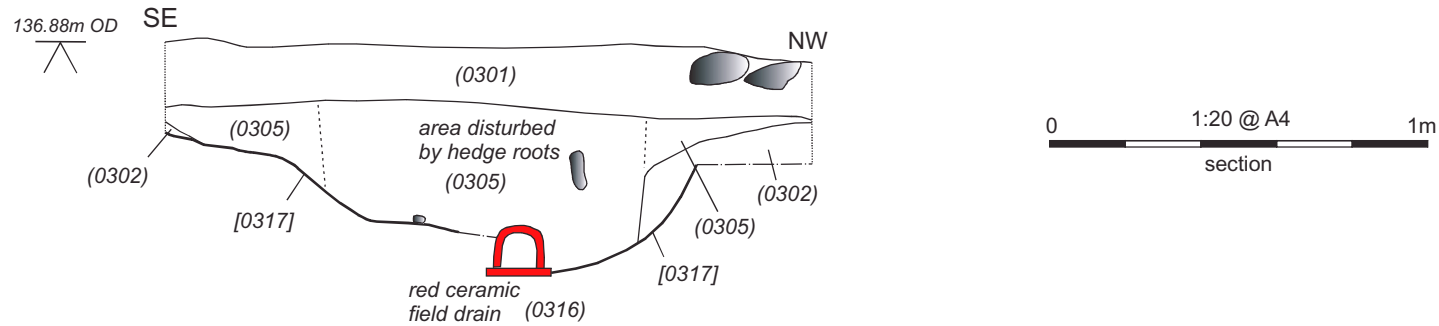
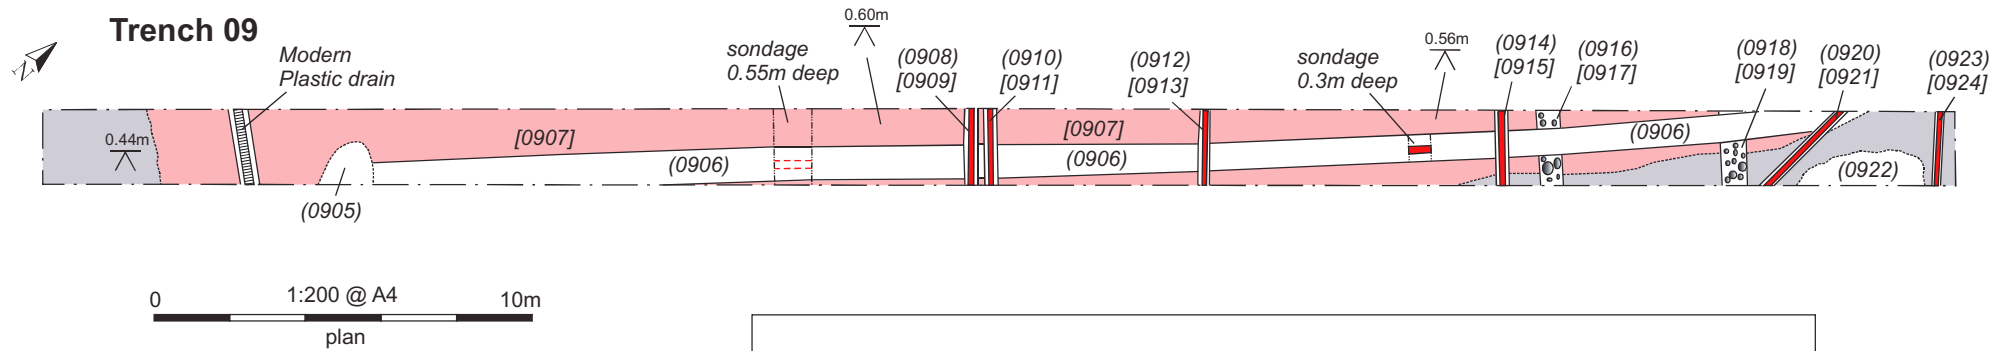
**Trench 03, section 02**

*Illustration 3: Selected Trench Plans and Sections (Trench 03; Trench 03 section 2)*

Trench 03 was located to the N of trench 02. The trench was 52m in length and aligned NW-SE. The S part of this trench, a length of 15m, was in the SuDS area, but crossed the hedgerow into the main area of the site. It reached a depth of 0.44m at the S end and 0.36m at the N end. This trench contained a complex of field drains. There were three rubble or field cobble drains, two red ceramic drains, and one plastic drain. One of the rubble drains (0312) extend diagonally across the trench from 30m to 50m northwards up the trench. On the E side of (0312) was a deposit of brown silt clay (0314) which appeared to represent the bottom of a furrow. Where the trench crossed the line of the hedgerow was a deposit of reddish brown silt 2m wide (0305) containing many roots. Excavation into this deposit revealed a red ceramic field drain of the inverted horseshoe type set on a separate flat ceramic base. The ceramic field drain

below the hedgerow indicates that the hedge was planted over the drain in relatively modern times. No features of archaeological significance were found in this trench.

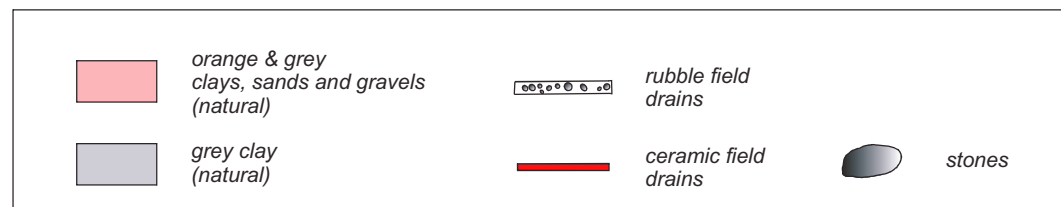
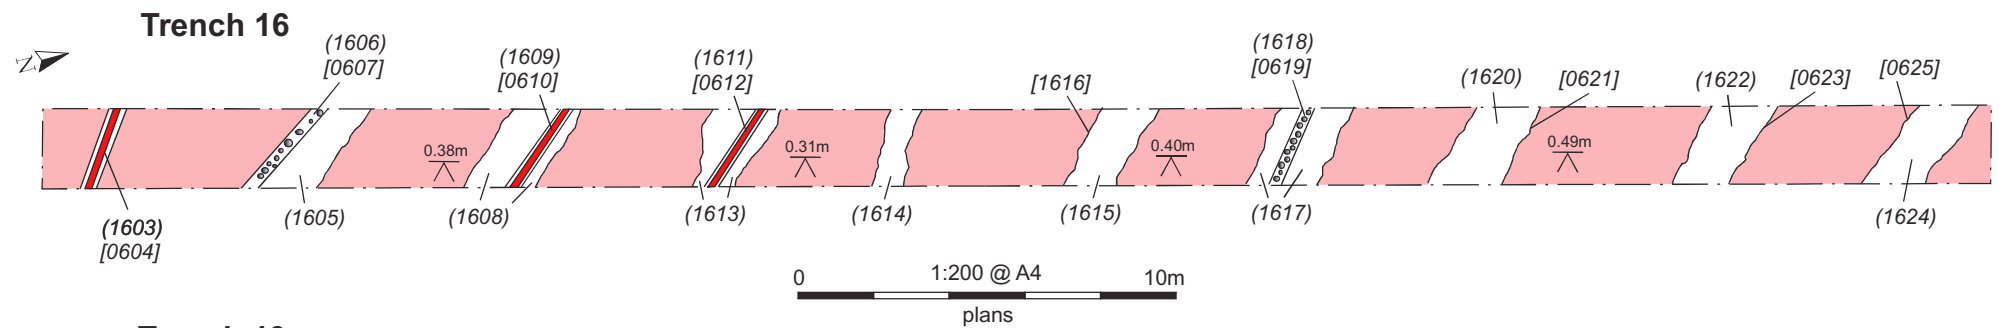
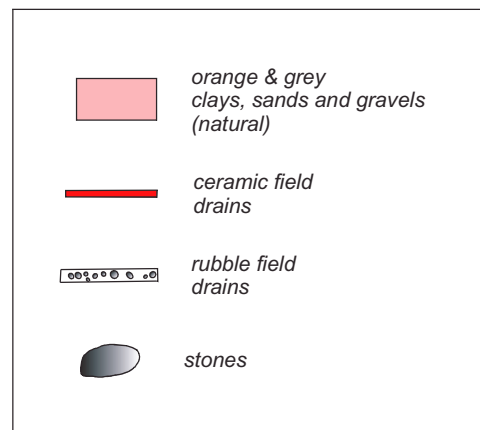
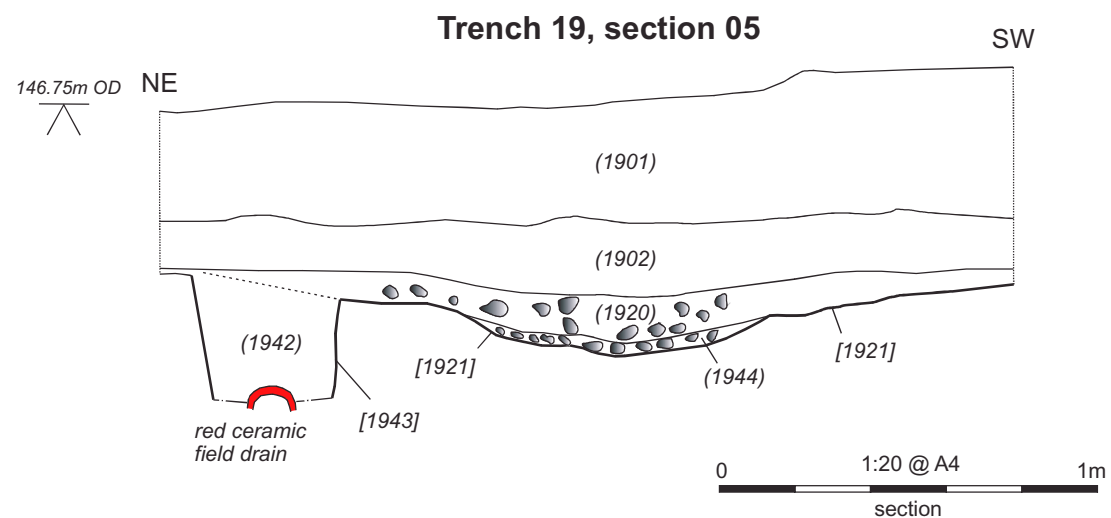
*Illustration 4: Select Trench Plans and Section (Trench 16; Trench 19; Trench 19 section05)*

Trench 16 was 51m long and located on the W side of the site above trench 12. It was aligned NE-SW. Topsoil was 0.10-0.24m thick and subsoil 0.10-14.0m thick. The trench reached a depth of 0.36m at the SW end and 0.43m deep at the NE end. The trench revealed three cobble drains and three red ceramic drains. The trench also revealed 9 strips or bands of light brown clayey silt running NNW-SSE across the trench floor; these were interpreted as the bottom of furrows (rig and furrow). Four of the furrows had field drains running through them. The furrows varied between 0.70 and 1.90m in width, with the majority in the wider category. No other features of archaeological significance were found in this trench.

Trench 19 was located to the N of trench 17. It was 52m in length and aligned NE-SW across the width of the site. The trench reached a depth 0.44m at the NE end and 0.50m at the SW end. Topsoil varied between 0.30m and 0.44m in depth. Nine red ceramic drains were revealed, mainly aligned N-S. One field drain was aligned diagonally across the trench in a NW-SE direction. Seven furrows (rig and furrow) were found varying in width between 0.40m wide and 2.60m wide. No features of archaeological significance were found in this trench.

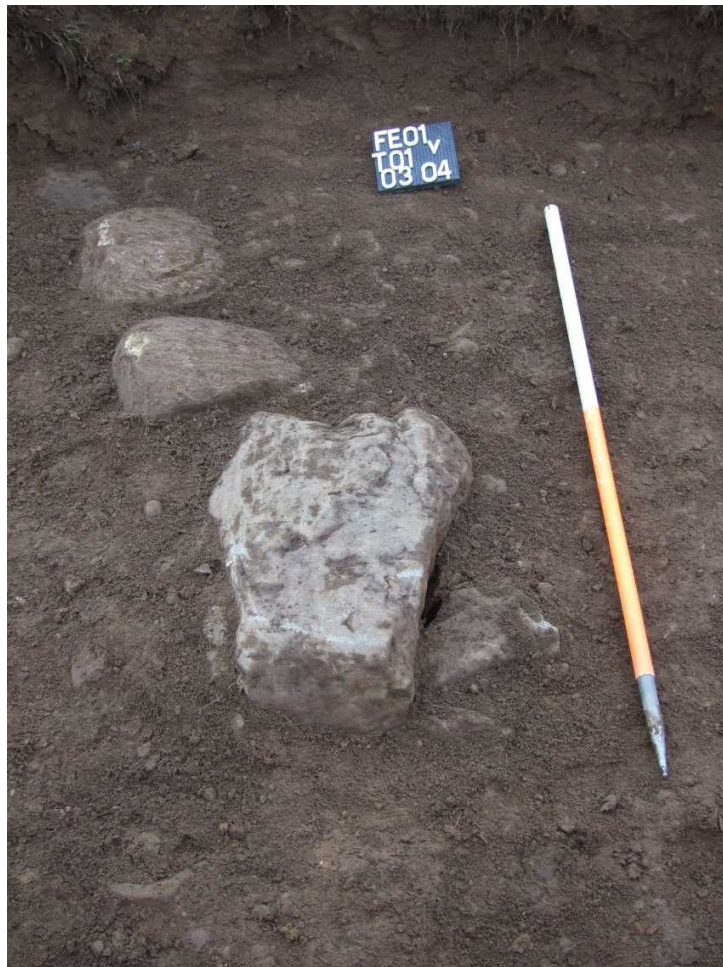
Illus 6: Trench 01, line of stones possible edging for road to Creelshaugh, view S

Trench 01 was located in the SuDS area. It was 25m in length and reached a maximum depth of 0.70m onto boulder clay comprising orange brown sandy clay and some grey clay. Towards the W end was a modern red ceramic field drain. At 23m to the W of the E end of the trench below topsoil was a NW-SE alignment of large fieldstone comprising three stones (0103), and adjacent on the W side was a spread of small/medium sized field stone (0104) which appeared to form a rough surface or road metalling at least 2.50m wide. The alignment of large stones and the adjacent spread of small stones appear to represent the E edge of the roadway that leads southwards towards the farmstead of Creelsheugh as marked on the 1st edition OS map. No other features of archaeological significance were found in this trench.

According to the OS 1st edition, the site of the farmstead of Creelshaugh was situated just to the south of the SuDS area and was therefore not encountered on the evaluation. It was, however, considered that the E side of the road to the farmstead was found in trench 01 in the form of road edging 0103 and metalling 0104.

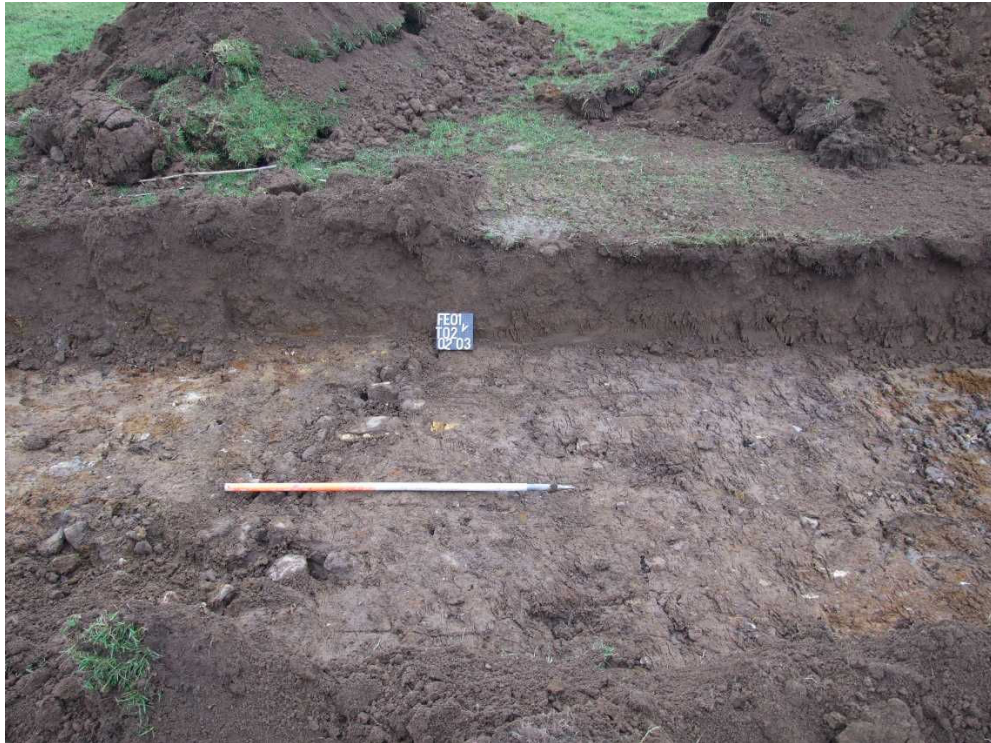
Illus 7: Trench 02 cobble field drain 0202 and furrow, view S

Trench 02 was 26m in length and located to the N of trench 1 in the area. It reached a depth of 0.41m at the E end and 0.36m at the W end. At the E end of trench was a cultivation furrow (rig and furrow) which had been cut on the E side by a rubble drain. Towards the E end the trench was crossed by modern narrow plough mark filled with brown silt. No features of archaeological significance were found in this trench.

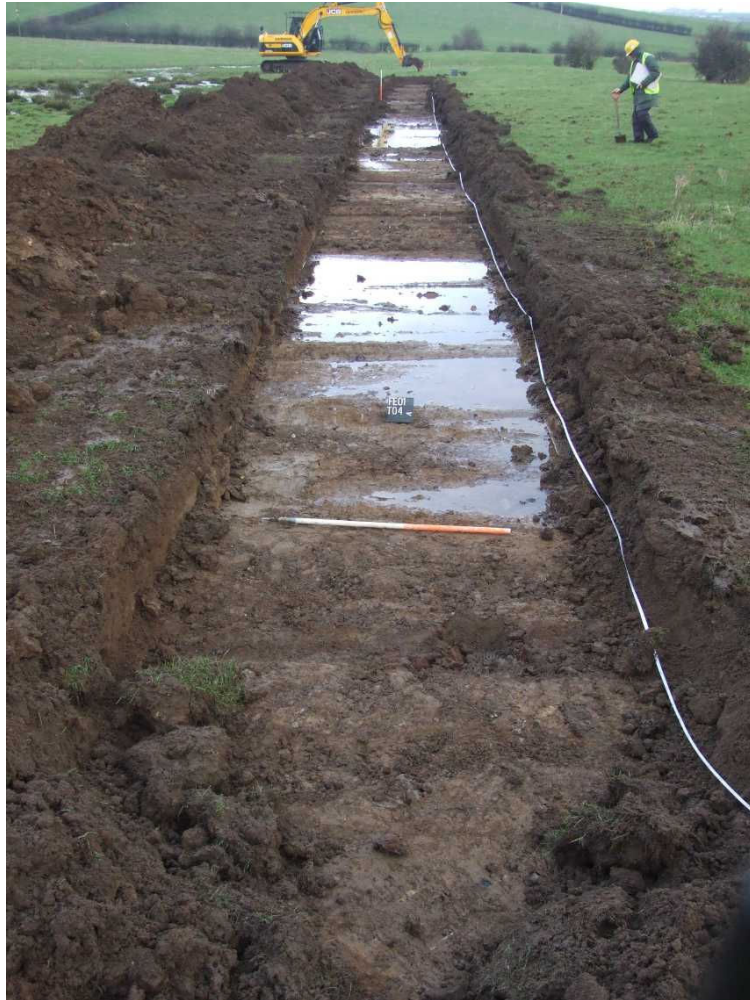
Illus 9: Trench 04 general showing waterlogging, view NE

Trench 04 was located to the E of trench 03 and aligned NE-SW, close to the S boundary of the site. The trench was 52.5m in length and reached depths of 0.50m and 0.40m at the W and E ends respectively. The topsoil was 0.24-0.35m thick. Natural orange-brown boulder clay formed the floor of the trench. The trench was waterlogged from 26-33.5m and from 44-50m (measured from the trench E end). The waterlogging did not initially affect the recording, but after a short period these areas were inundated.

This trench, and subsequent trenches on the same NE-SW alignment, crossed almost at right angles, the many field drains that over the years had been inserted down the N-S axis of the field. The trench revealed 7 field drains of the red ceramic type, 1 cobble drain, 1 gravel drain and 4 plastic drains. One small shallow feature in the NE corner of the trench comprised black organic clay in a small depression which was considered to be caused by natural plant root action. No features of archaeological significance were found in this trench.

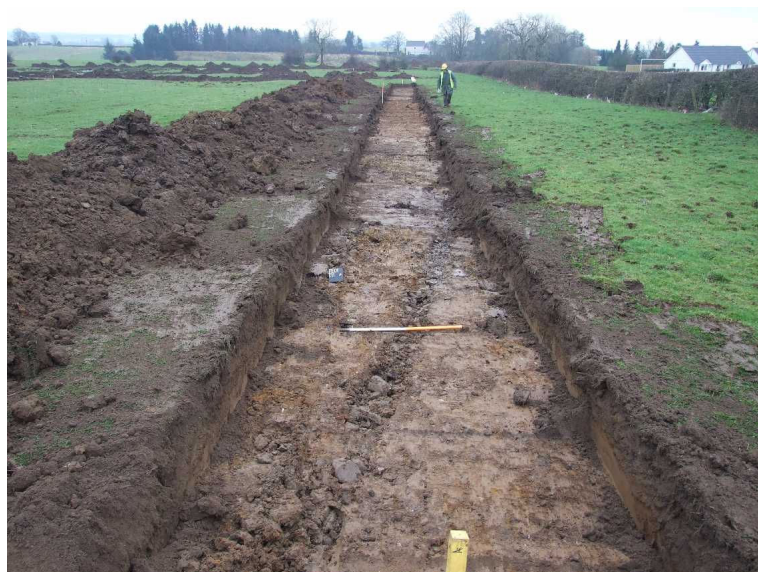
Illus 10: Trench 11 showing cobble field drain 1109, view SE

Trench 11 was located close to the site's W boundary to the W of trench 10. It was 51m in length and aligned NW-SE. Topsoil varied between 0.25m and 0.33m. Natural, a mixed light brown and orange brown boulder clay, formed the floor of the trench. Three cobble field drains were recorded at a depth of 0.45m. No features of archaeological significance were found in this trench.

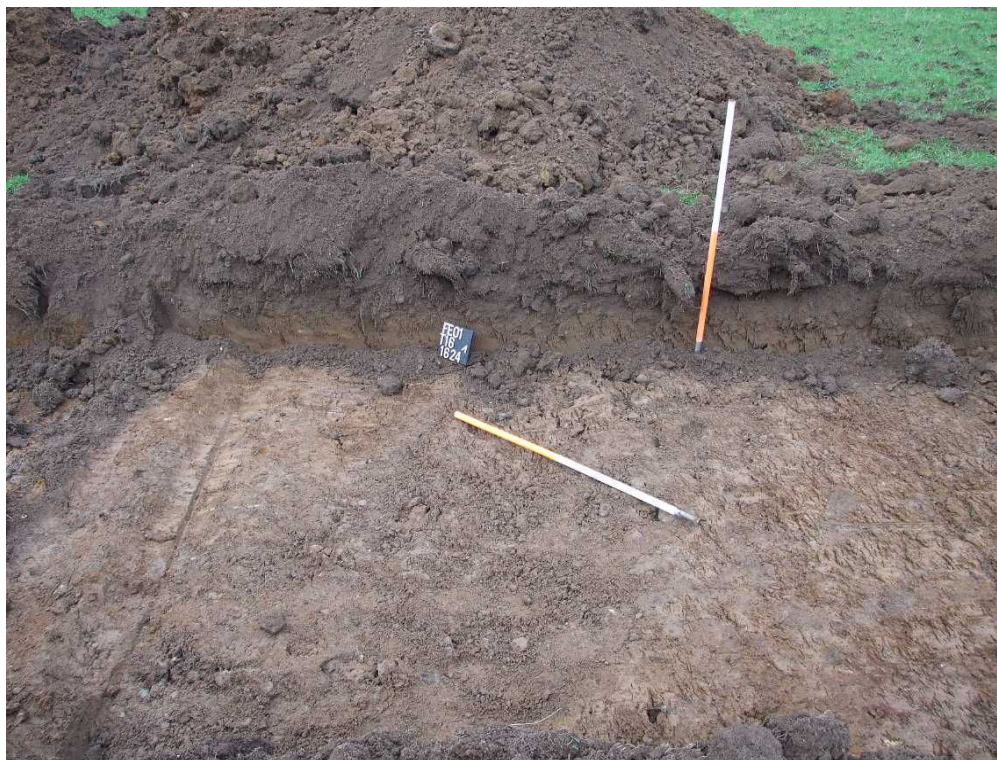
Illus 11: Trench 16 furrow 1624, view NW

The rig and furrow cultivation was most evident in evaluation trenches that were placed across the site contour aligned NE-SW or in the case of trench 16 aligned NNE-SSW. Trench 16 contained the bases of 9 furrows, trench 19 contained 7 furrows, and trench 21 contained 3 furrows.

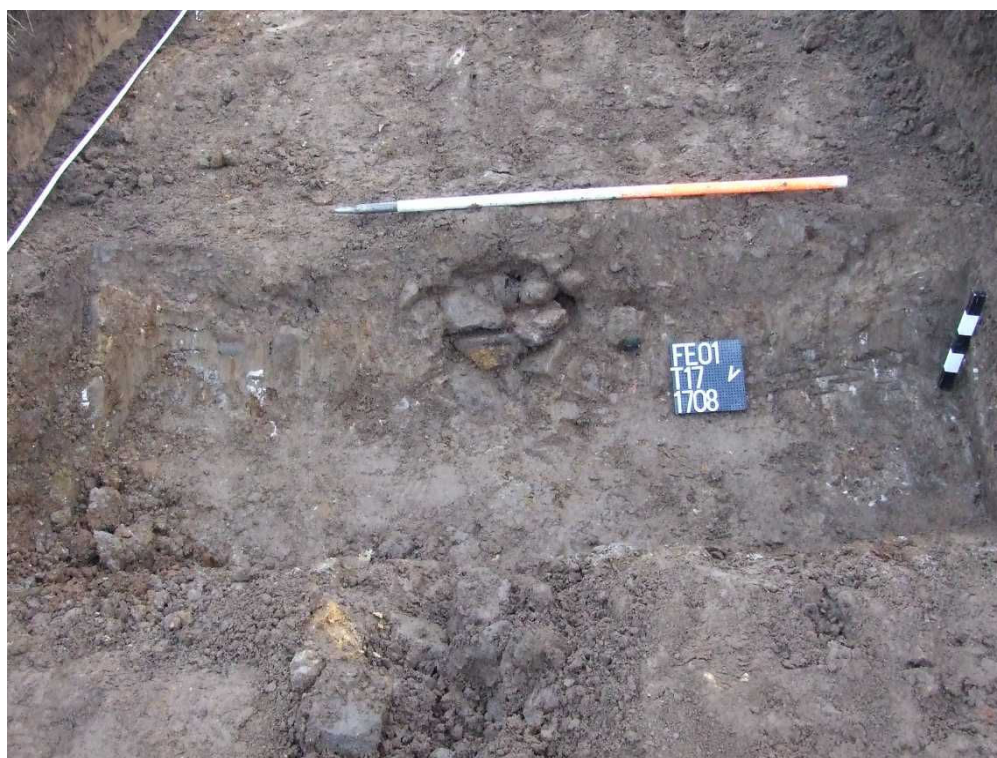
Illus 12: Trench 17 showing cobble field drain 1708 cut into furrow 1702, view SE

Trench 17 was located on the NW side of trench 15. It was 52m long and aligned NW-SE. Topsoil was 0.30-0.33m thick. The trench had a depth of 0.33m at the SE end and 0.56m at the NE end. Natural boulder clay comprised mixed brown and orange brown clay. A ceramic field drain was encountered at the SW end of the trench on the W side. The trench was realigned to the E at 10m to the N of the SW end to avoid the ceramic drain. One cobble field drain crossed the trench E-W. A furrow (rig and furrow),

comprising light brown silty clay, extended N-S up the trench towards the NW. The furrow contained a cobble field drain. No features of archaeological significance were found in this trench.

After the rig and furrow system was established, more formal cobble drains were inserted between some of the furrows. A good example of this was in trench 17, where a cobble drain, (1708), 0.35m across and 0.35 in depth had been set, seemingly, between furrows. In trench 16 there was a cobble drain (1618) situated between furrows and one (1606) at the edge of a furrow. There were also many cobble drains that had been cut into the natural and were not seen to be draining between furrows, most likely because they had been cut more deeply into the natural boulder clay.
