**Leys of Dun  
Archaeological Watching Brief  
During Construction of Wind Turbine  
MONTROSE  
MT28**

**ARCHAEOLOGICAL WATCHING BRIEF**  
**LEYS OF DUN**  
**MONTROSE**

**MT28**

***ABSTRACT***

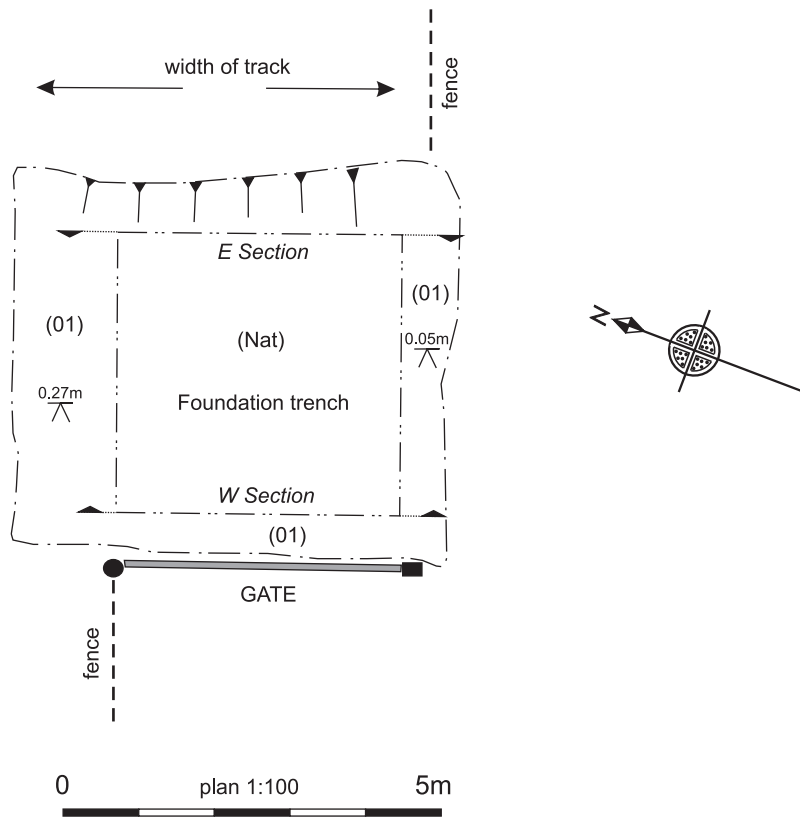
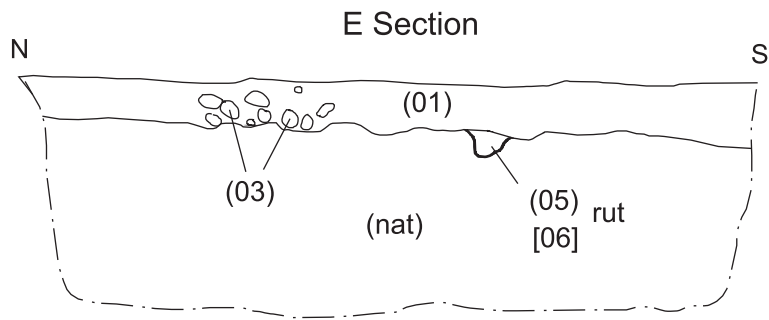
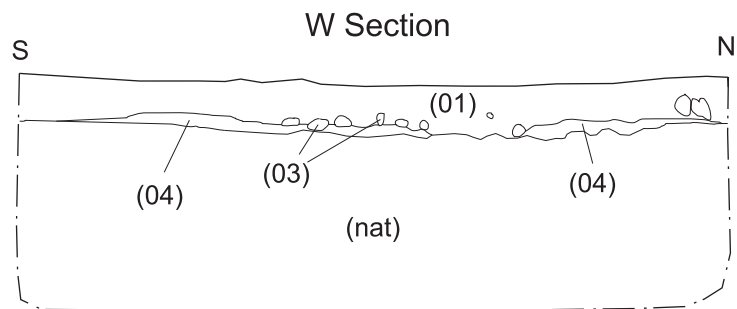
Illus 3

The excavation of the foundation trench revealed a section through the track. A cobble layer (03) represented rough metalling presumably to fill in puddles and pot holes. A dark organic silty mud had formed in places at the base of the track. This was presumably caused by water having filled up depressions. This layer was particularly noticeable near the gate (see W section, illustration 3). A very small feature was found dug or pressed into the natural in the E section of the foundation trench. This was interpreted as a rut created by farm vehicles.

Plan and Sections

The archaeological monitoring of the foundation trench did not reveal any significant archaeological remains. There are no recommendations for further work relating to this development.
