Historic Building Recording
Sheiling Cottage, the Smithy
& Smithy House
Rait
Perth and Kinross
RT03(HBR)

**HISTORIC BUILDING RECORDING
SHEILING COTTAGE, THE SMITHY &
SMITHY HOUSE
RAIT
PERTH AND KINROSS**

RT03 (HBR)

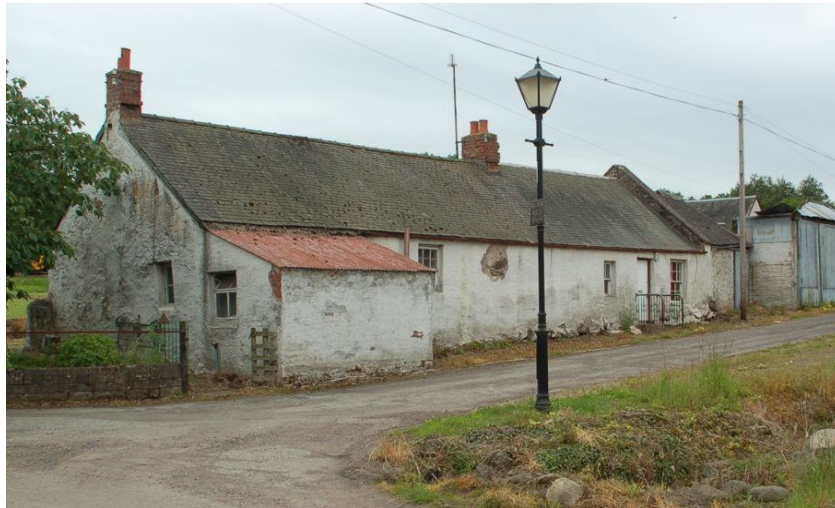
Sheiling Cottage is a long narrow rectangular building with thick walls and very large foundation stones (boulders) for the long side walls. The walls are constructed from fieldstone (rounded to sub-rounded) coated in at least two layers of lime harling, painted white. In one or two places the render has cracked off revealing that the stones are bonded with clay.

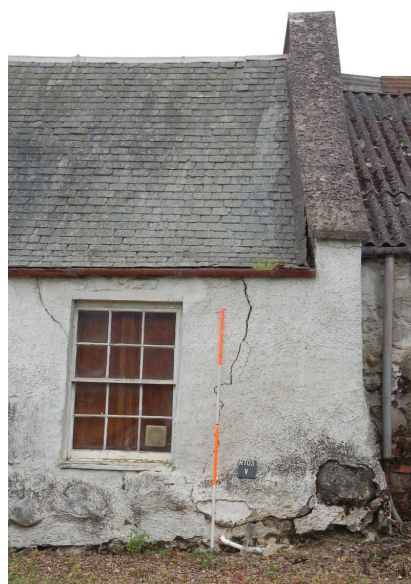
Shot showing foundation stones low down in the N wall

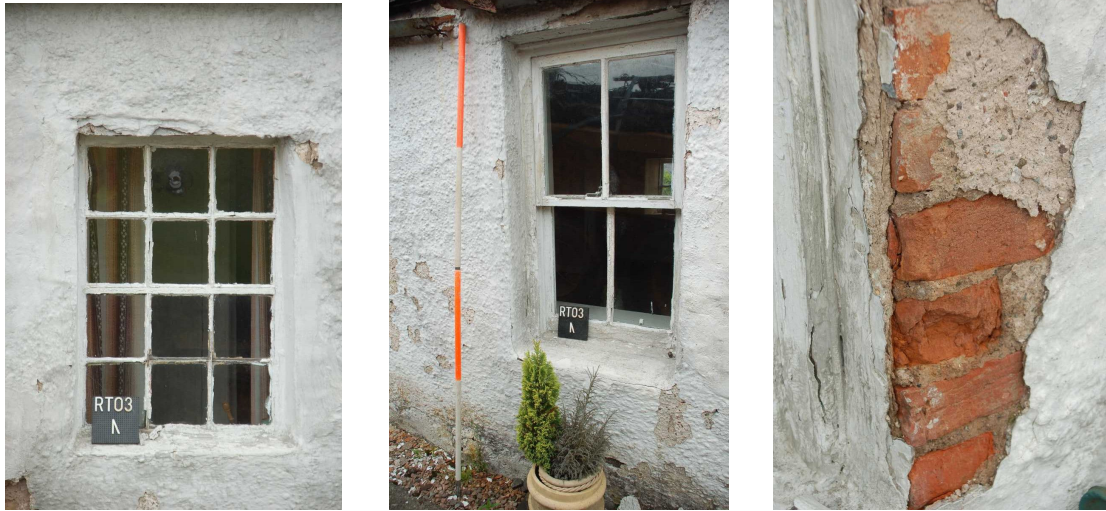
An early fixed 12 pane window (left), mid-late 19th century window (middle) and brick repairs (right)

Brick and mortar repairs can be seen around some of the doors and windows, a sign that apertures in clay bonded structures are easily eroded and often required repairs. The repairs appear to have been carried out using 19th century clamp bricks, presumably local.

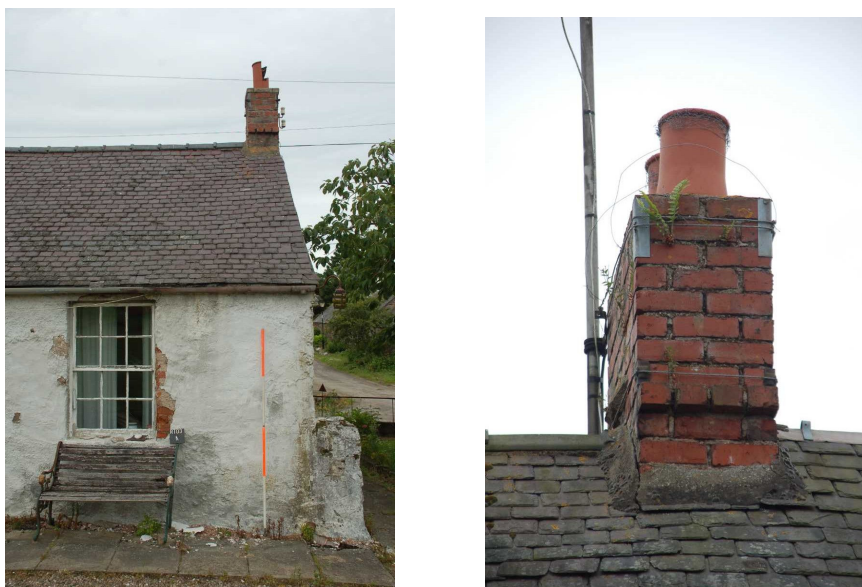
The roof the cottage has been slated, but slates on the S pitch appear more recent than those on the N. All slates are of equal size, suggesting that the roof is recent, probably put on in the late 19th century to replace former thatch. The gutters and downpipes are cast iron and the roof ridge is galvanised steel or sheet Zink. Chimney stacks are constructed from early 20th / late 19th century red brick (one partly capped with stone slabs) and have red ceramic chimney pots. Cement flashing has been applied around the stacks. The top of the E gable has been protected with cast concrete.

The E end of the S elevation and the central chimney stack

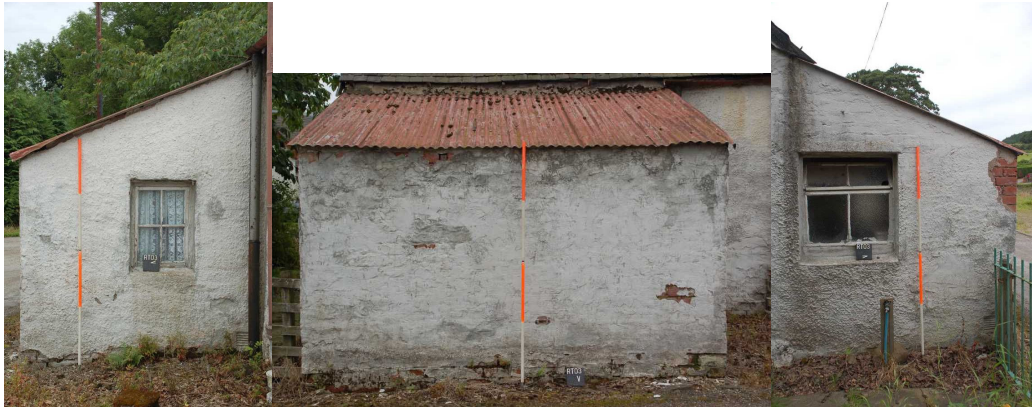
An extension to the cottage has been built against the E end of the N wall in the late 19th / early 20th century. This is constructed from red brick (painted white) with a corrugated iron roof. There are two windows in the E and W walls, one with a fixed frame (4 panes – similar to that those of Bedroom 1) and one fitted with a frame that pivots inwards at the top. The former is likely to have been the original and possibly only window in this extension which may have been built originally as a simple scullery. The second window is later and is likely to have been inserted when this extension later became a kitchen and more light was needed.

Photos of the extension

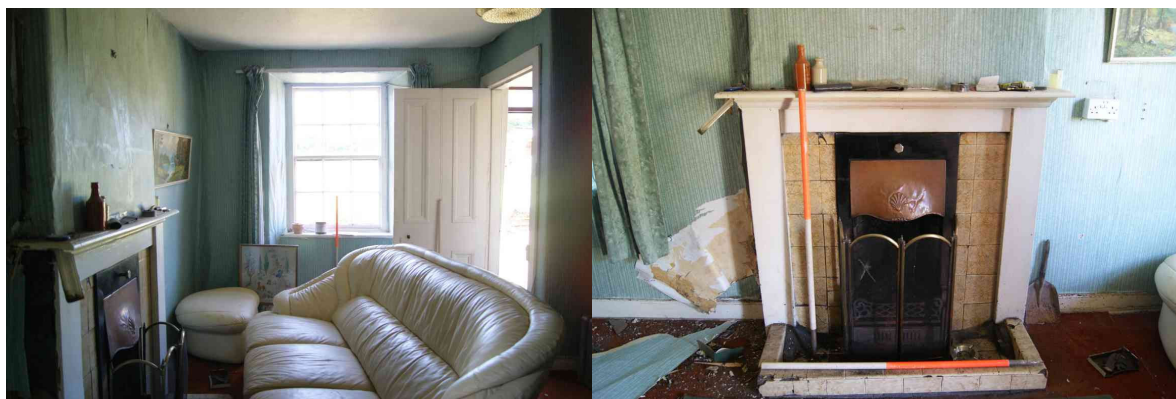
The living room

The wallpaper is loose due to dampness and in the NE corner it has come away to reveal earlier decorative schemes. Above, high up in this corner is evidence of a cupboard that has

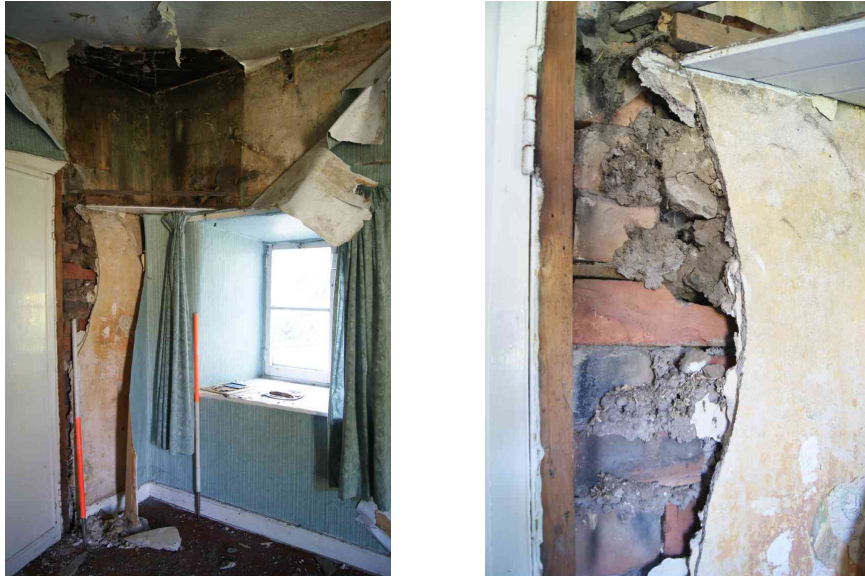
been removed, presumably to hold pipes for a hot water tank? Next to the door into the extension, the wall plaster has come away exposing the brick lining of this aperture and clay bonding. The fireplace in the E gable dates to the 1930s; the door into the living room is of two-leaf panelled design, 19th century date.

The corner cupboard and bricks with clay bonding next to the extension doorway

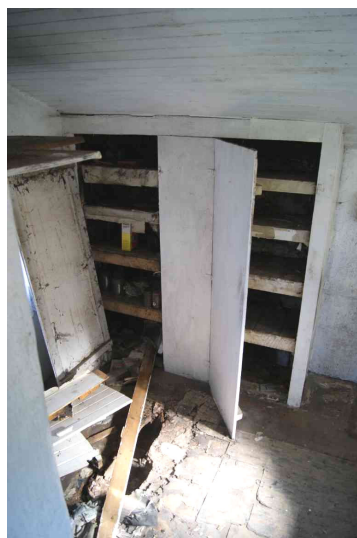
Shelving in the Extension

Concrete steps lead down into the extension. Its walls are plastered and painted white; the roof panelled with thin horizontal pine planks. On the E side below the large window is a kitchen sink, side board and cupboards. Next to the sink on the S wall is a vertical line in the paintwork showing where water pipes ran down from the corner cupboard next door. Along the N wall is a fitted cupboard with two doors and 4 shelves, presumably for kitchen storage. The floor, comprising joists and floorboards latterly covered in linoleum squares, has rotted in places. High up in the SW corner is a corner shelving unit.

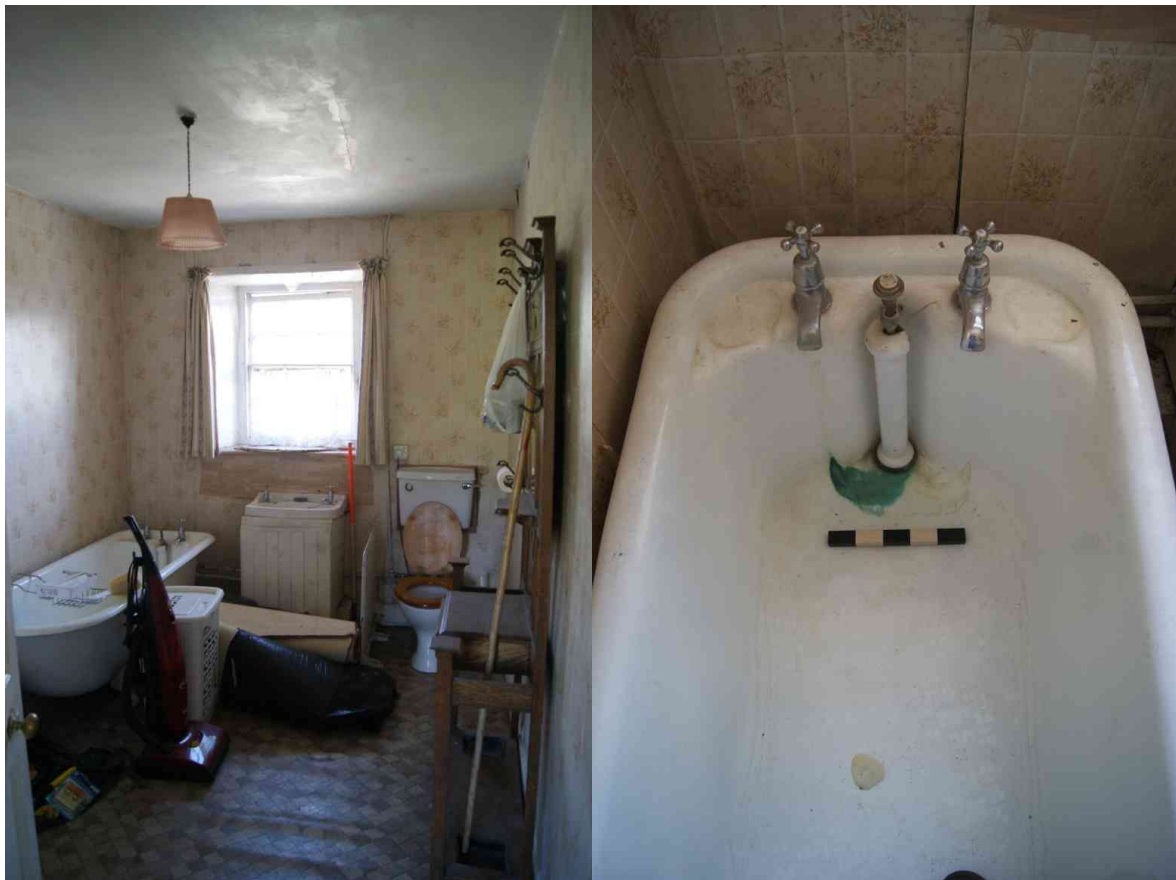
The bathroom has a linoleum floor and yellowish mock-tile patterned wallpaper. The bath, which dates to the 1930s or possibly 1920s has an interesting combined plug and internal waste pipe which can be locked into position. The sink, which appears later in date, is boxed in with pine planking to hide the plumbing. A fibreboard cupboard is built into the SW corner of the room, presumably for towels, toiletries etc. The door to the bathroom is panelled, of 19th century or early 20th date.

The bathroom and bath

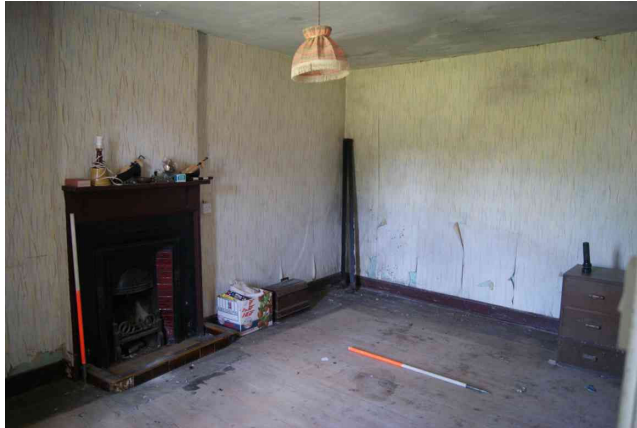
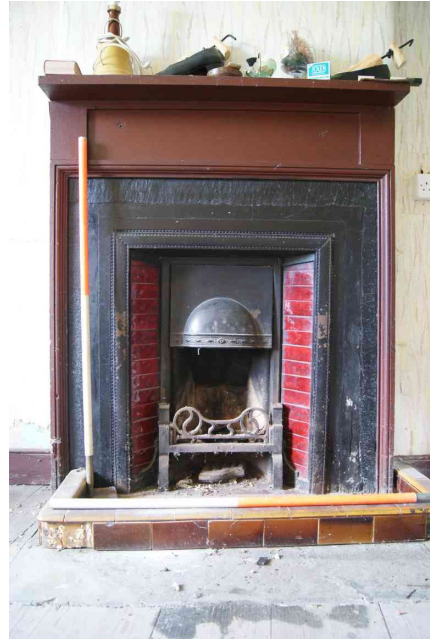
Bedroom 2, the NW corner and fireplace

Bedroom 2 is an irregularly shaped room caused by the internal gable being at an angle to the main walls of the house. The floorboards are pine and there was formerly a carpet in the centre of the room. The skirting board and floorboards not covered by the carpet are painted dark brown. This same paint has been applied to the doors and fire surround.

At least two layers of wallpaper can be seen on the N, W and E walls, the earlier one light blue in colour and the later one much lighter with wavy vertical lines in blue, yellow and brown. The S wall has been covered in wallpaper with a varnished pine design though this has peeled away under the window. The fireplace in the E wall appears to be of late 19th century date with red tiles, though the brown tiled fender is later.

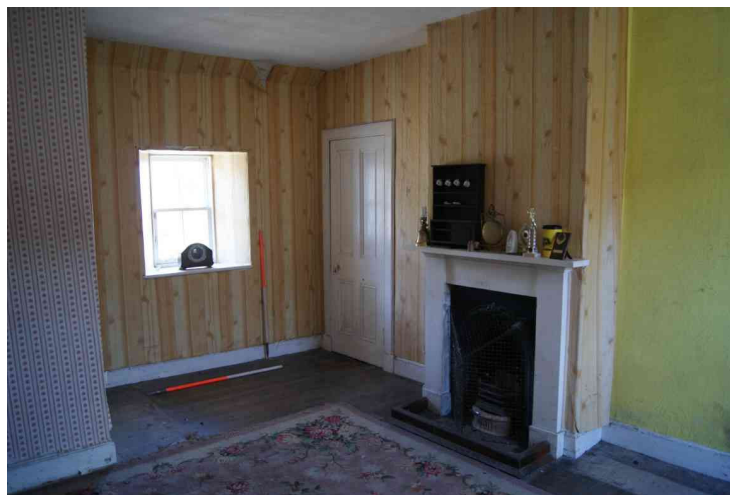
Bedroom 2, looking towards the cupboard

The skirting boards, fire surround and doors are painted white and the S and W walls covered in wallpaper with a red striped design. The N and E walls are covered with the same pine wallpaper noted in Bedroom 2. The two doors, one through to Bedroom 2 and the other for a press are 19th century. The press is panelled in varnished pine and has 3 shelves. To the S of the fireplace is a patch where the floorboards are un-varnished and the wallpaper is different, painted yellow. This was probably once the location of a cupboard. A similar patch to the W of the window in the N wall was probably reflects another similar cupboard. The fireplace is fully cast iron of mid to late 19th century date.

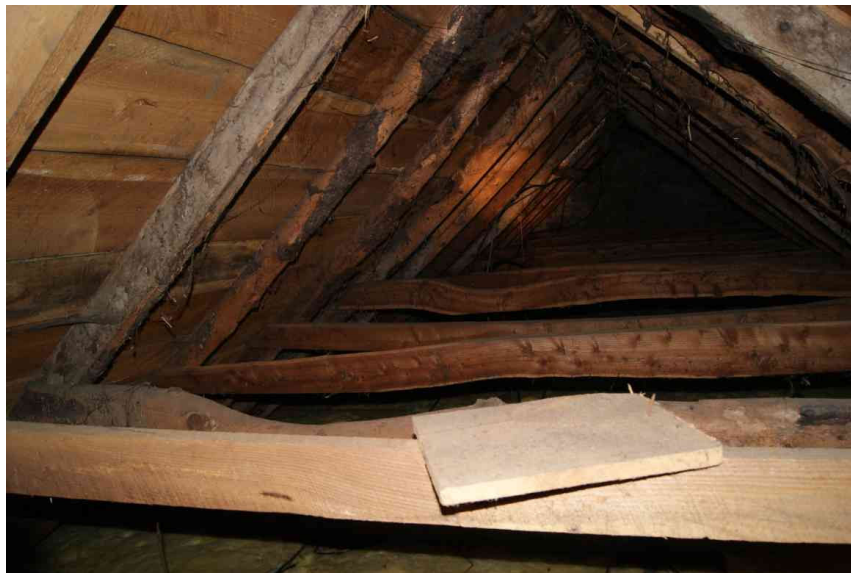
During the survey the roof spaces on either side of the internal gable / chimney stack were viewed. The roof above the living room, bathroom and Bedroom 2 was found to be of common collared form with rafter pairs (lap jointed) connected by collars (nailed) resting on wall plates. These timbers are Scots pine from logs cut with a circular saw into a number of slabs, bark left on. The number of slabs from a single log seems to vary from 2 to perhaps 4. The collars are much more irregular and wavy compared to the rafters, a sign that this timber came from Scots pines that had grown outside a plantation.

The roof in the E part of the cottage showing irregularly shaped collars

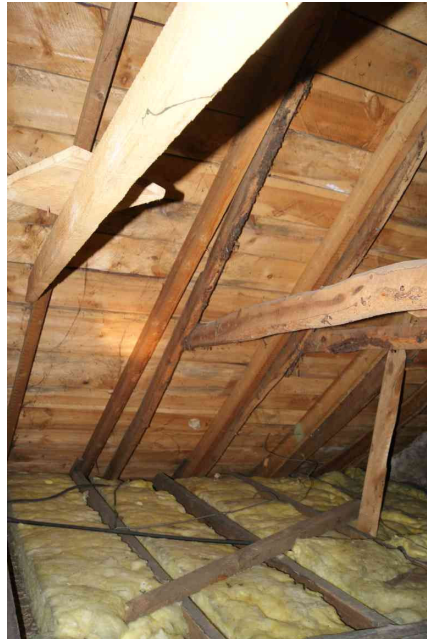
The Joists supporting the lath and plaster ceiling below are not connected to original rafters but instead simply span the wall plates. These joists are very regularly cut and are not made of Scots pine suggesting the current ceiling is a 19th century replacement. In various places the original rafters have been replaced or strengthened with more modern timber. Vertical

struts have also been added with more modern timber between the apex and the joists, probably to help stop the roof from sagging. The sarking boards are replacements made of circular sawn Scots pine.

Shot showing floor joists, original rafters and later rafter replacements

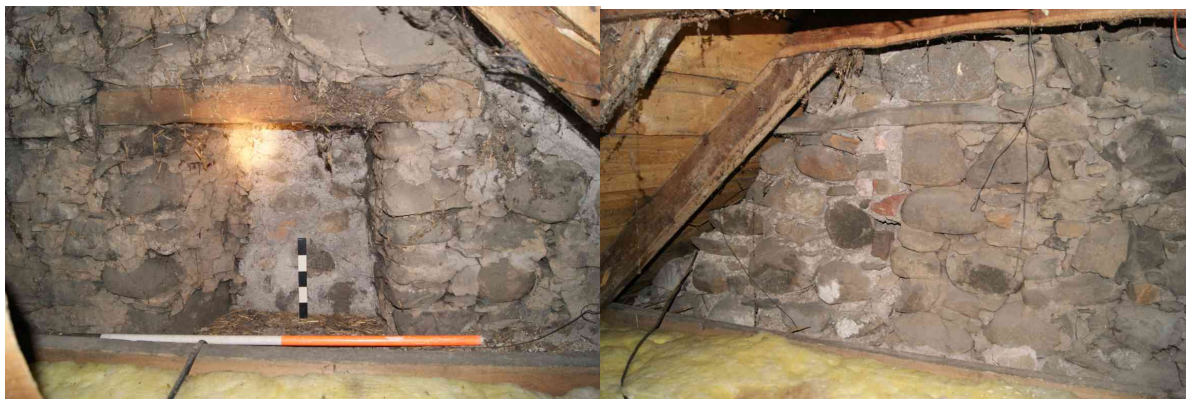
Inspection of the E gable showed that there had once been a small window to the S of the main chimney. A roughly cut and possibly hewn piece of wood formed the lintel. The window had been blocked with rubble and mortar from the outside. On the central gable there is another horizontal piece of wood almost symmetrically opposite the blocked window in the E. Below this piece of wood the wall has been re-built using lime mortar rather than clay bonding. This may have once been the location of a window, but it may also simply reflect the re-building of the gable here due to water damage.

The blocked window in the E gable (left) and the timber in the central gable (right)

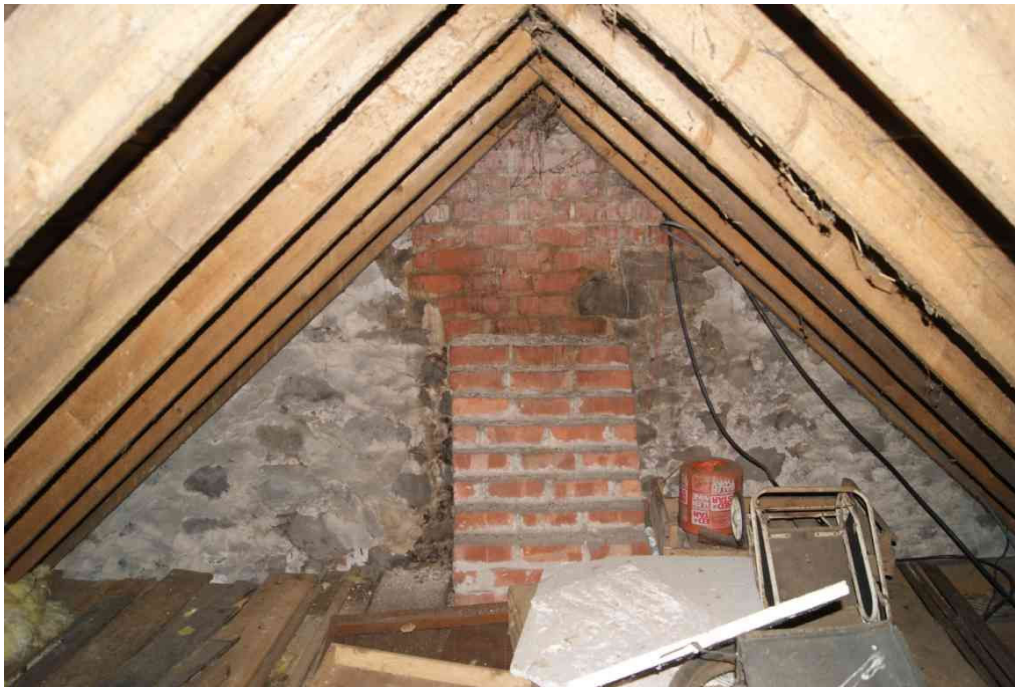
The roof above Bedroom 1 and the Stores was found to be a later replacement - common collared, made of circular sawn softwood dating to the late 19th / 20th century. Rafters extend below the ceiling joists forming coved ceilings in the rooms below. This suggests that the ceiling of the rooms below were possibly raised when the roof was replaced. This raising may possibly relate to the higher floor levels in Bedroom 1 and the Stores. The sarking here

was largely modern though there were a few earlier planks towards the apex, much narrower and having darkened with age.

The E gable above Bedroom 1 showing the red brick chimney stack

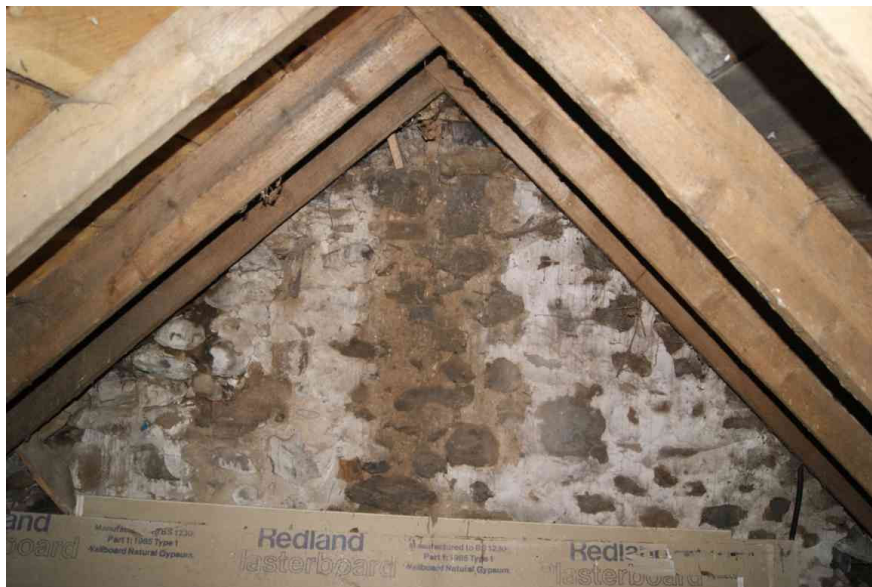
The W face of the central gable has been heavily rendered in lime mortar and a rather substantial red brick chimney stack has been incorporated into it. The W gable is clay bonded with lime render on its E face though rain has penetrated the roof at the apex here and run down eroding the clay.

The W gable above the Stores

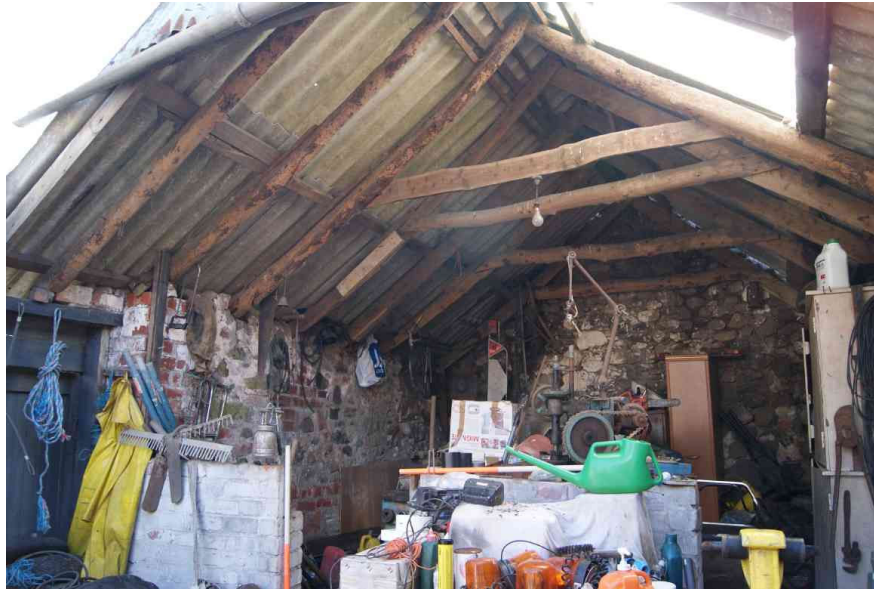
The interior of the narrow building

Against the W gable of the cottage is a narrow building with an open end and heavily altered walls. This is currently being used as a workshop which made it difficult to view all the walls comprehensively.

The building has a lower and shallower roof than Sheiling cottage. Rafters and collars are made from circular sawn Scots pine cut into slabs, with the bark showing. Modern purlins have been added to support the asbestos cement roof. The main roofed part of the building is floored in concrete. The N wall is constructed from lime mortar, various red bricks and rubble; breeze blocks have also been incorporated low down on the outer face.

The narrow building to the W of Sheiling Cottage is due to be demolished as part of the new development. A short watching Brief is recommended on the demolition of this structure to understand its stratigraphic relationship with Sheiling Cottage which it may pre-date, as well as the nature of its wall fabric and foundations; however the final decision ultimately rests with Perth and Kinross Heritage Trust.

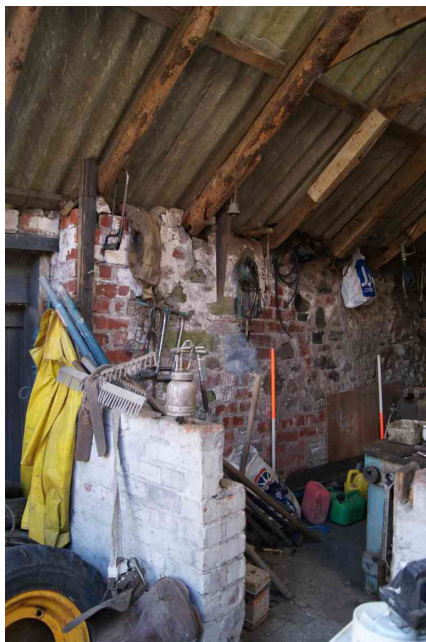
Internal face of the N wall (left) and the E end of the S (right)

The E end of this wall appears to be the earlier as more stone has been used and its core is likely to be clay bonded.

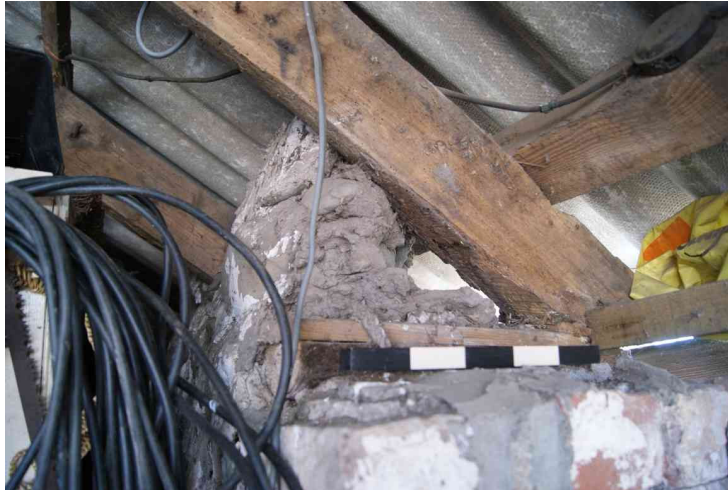
The S wall has clearly been built over several phases. Next to the gable is a rubble and clay bonded section of wall 80cm wide with its upper third built from brick. This ends abruptly in a vertical line marking either a new structure or a blocked aperture. To the W this the wall continues to full height in clay bonded rubble though its W end has been partly re-built in brick. On the wall head clay has been used to fill the gap between the wall and the roof.

Clay fill on the top of the S wall

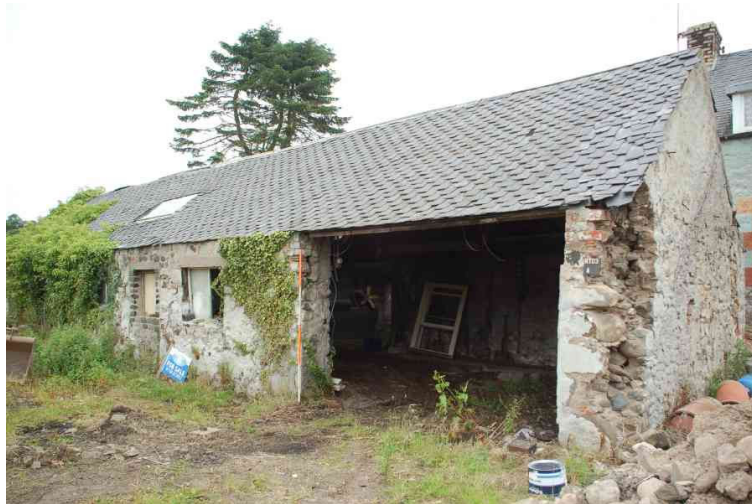
The Workshop end of the Smithy

This is the main part of the Smithy, a highly regular rectangular structure with walls built of sub-rounded / rounded fieldstones and boulders (some roughly faced on the principal elevation) bonded with a reddish brown lime mortar. Pieces of brick and tile have been incorporated into the E gable wall and high up in the S wall. The external wall faces have been heavily pointed in lime mortar and cement and are covered in a thin layer of white lime render (now cracking off). The roof is covered by slate in 'hit and miss' / open slating style. The roof ridge is galvanized steel or sheet zink and the gutters (where surviving) are cast iron. A large double skylight dating to the 20th century has been inserted into the S pitch of the roof.

There are several apertures in the S wall. To the E is a large opening (c. 3.7m wide) which is clearly an entrance for carts and motor vehicles. The E side of this opening is original, but there are no proper rybats, just heavily mortared rounded field stones on the W side, suggesting that the entrance has been widened. On both sides the upper portions of the opening are built in brick, one side with red brick, the other with grey. To the W of this opening are two windows on either side of a blocked doorway. Both windows are the same type, each with two large panes, non opening. The rybats for the windows are made from shaped blocks of whinstone and the lintel from concrete. The central doorway has similar rybats and is blocked with rubble faced on the outside with road cassies (still with tar adhering). A square window has been incorporated into the doorway with a concrete lintel.

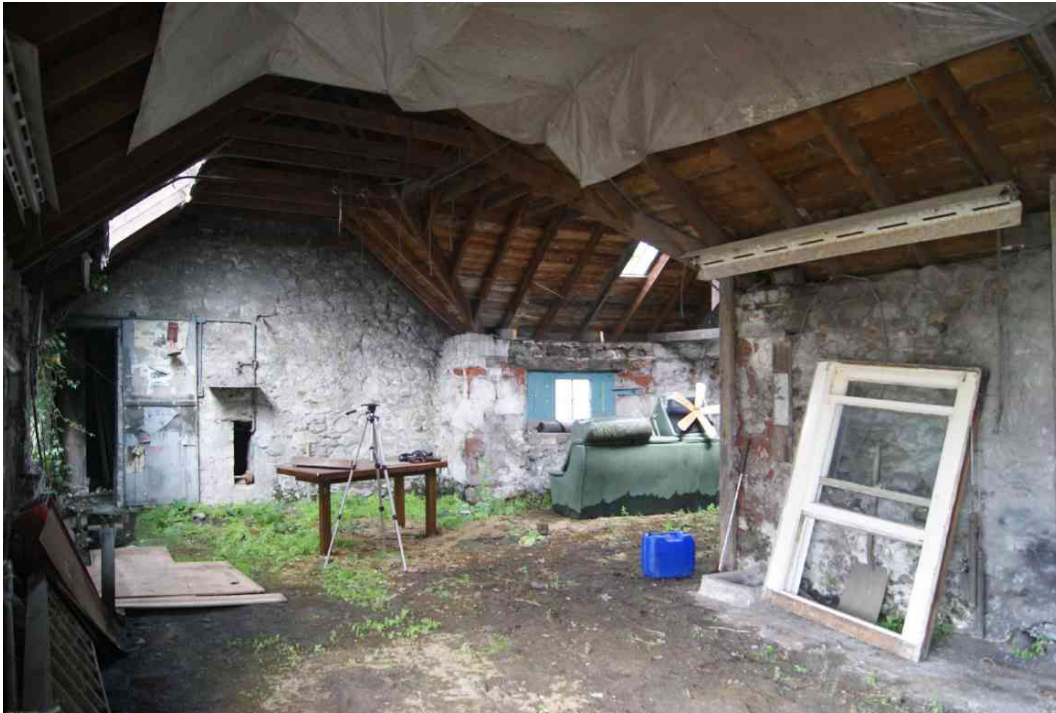
The floor inside the cart entrance has been lowered and is of compacted earth. Traces of thin concrete over rubble remain against the N wall, possibly the remains of the former floor. This floor is likely to have been removed / lowered to allow high vehicles to enter the workshop. The floor to the W in the main part of the workshop is at a higher level composed of compacted grit. Internal faces of the walls are covered in liberal lime render and whitewashed. To the W of the W window in the S wall is a curved alcove c. >20cm deep reaching from the ground to the height of the window lintel. In the gable wall between the

workshop and the store there is a narrow vertical slot running through the gable with an axle attached to a belt wheel. This feature presumably allowed power to be transferred between the two buildings via a rotating belt.

Inside the workshop looking NE

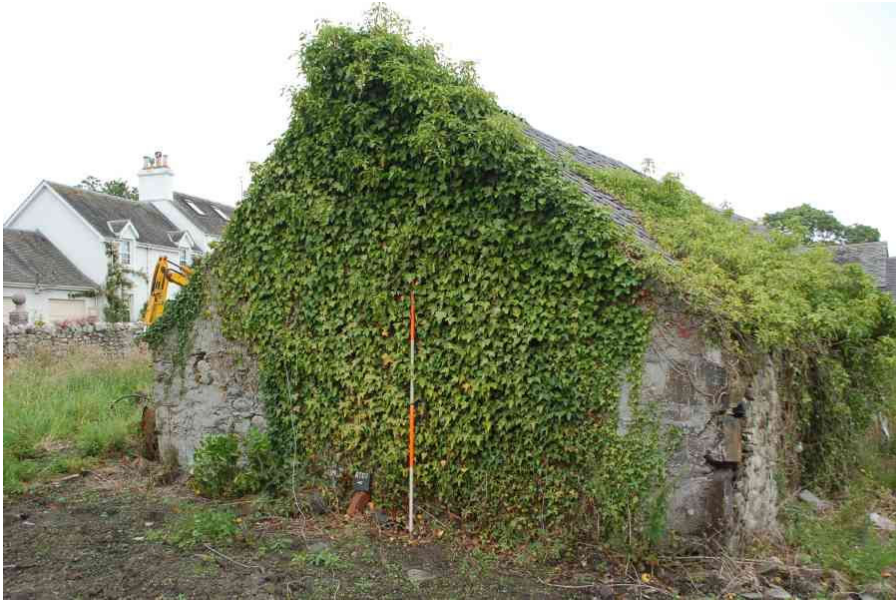
This is a square room to the W of the workshop and was originally accessed via two opposing doorways against the W gable of the workshop. The N doorway has been later blocked with rubble though ivy on the outside of the building makes this hard to see on the external elevation. There is also a doorway in the gable which provided access directly to the workshop. This internal doorway is lined in brick and is obviously not part of the original building design. The composition of the walls is practically the same as the workshop, sub-rounded fieldstone and roughly shaped boulders, lime mortared and heavily rendered on external faces with cement and lime harling.

The W gable of the store

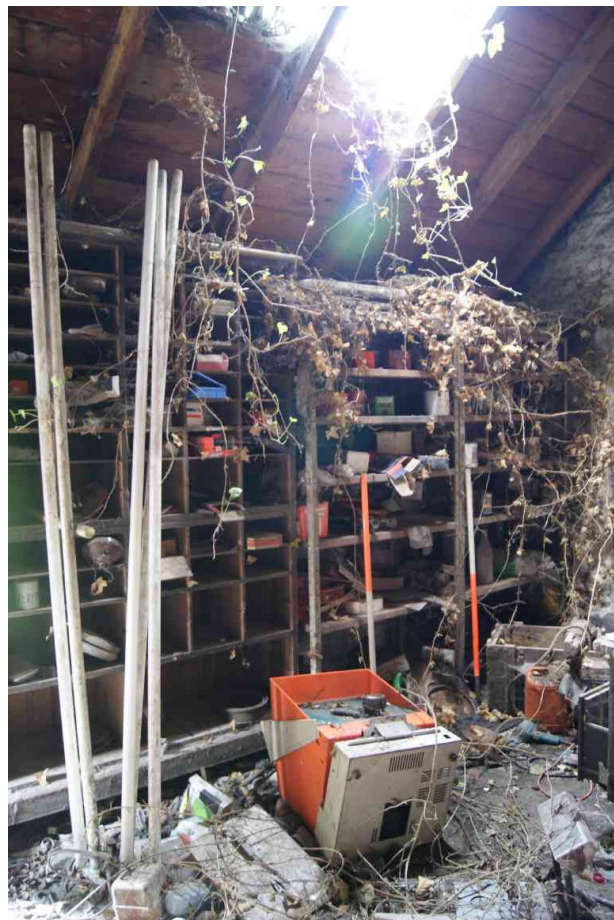
Interior of the Store

Cornerstones of this structure have been cut from large sandstone and whinstone blocks and the upper part of the wall has been built in brick. The roof of the store is identical to the workshop with a possible ivy obscured skylight in the S pitch. Inside the S wall is lined with two shelving units, one containing pigeonholes full of spare vehicle parts and other tools.

The internal faces of walls, where they could be viewed (through the equipment lying around), were heavily rendered in lime and cement, whitewashed. The N doorway (blocked) is lined in wooden planking and its W side is made entirely of brick, a sign it was repaired before being blocked. The floor of the store is concrete.

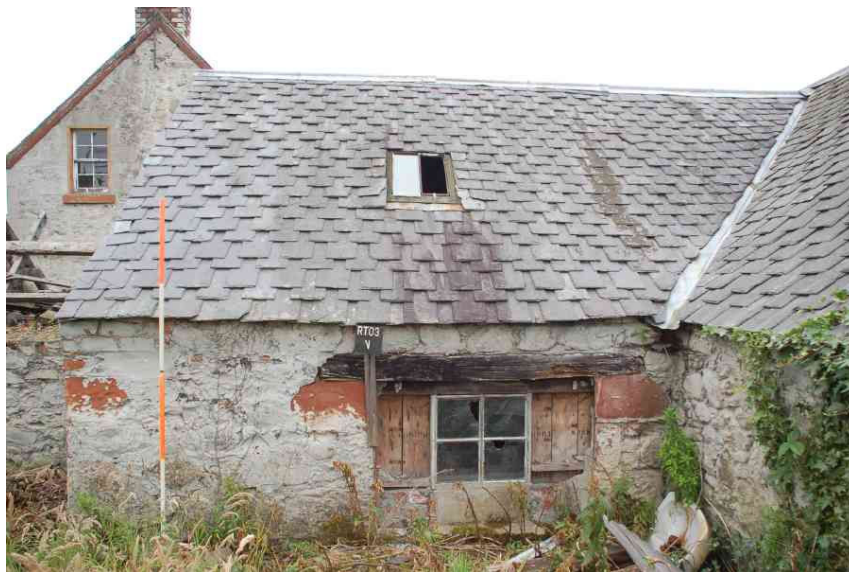
This is a N projecting extension to the workshop built in a different style. The walls are made of sub-rounded fieldstones, roughly shaped, lime mortared but the door rybats and cornerstones are composed of well shaped (squared) blocks of red sandstone. The tops of the E and W walls have been finished in brick. The outside faces of these walls have been coated in thin lime render and whitewashed.

Extension 1

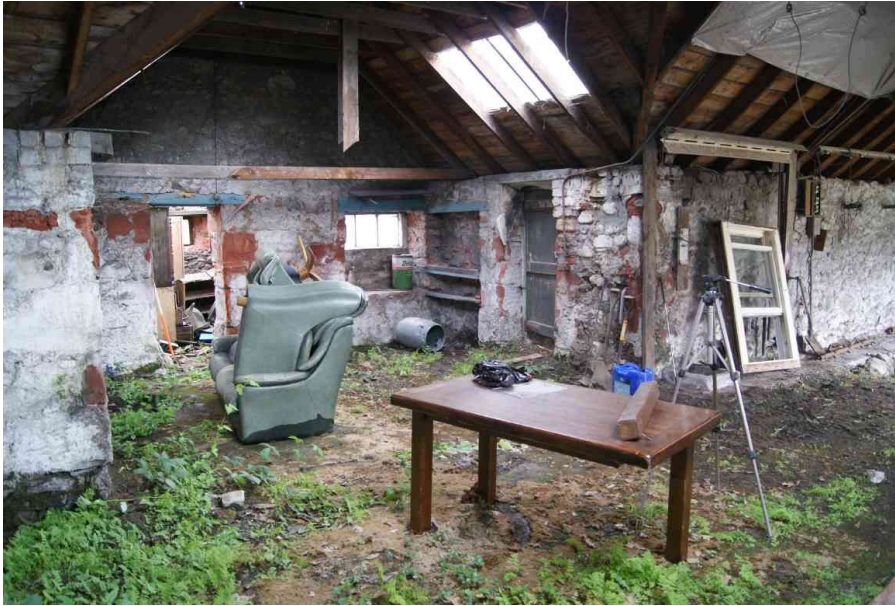
There is a doorway in the E wall, a large bricked up window in the N wall (converted into a smaller window in the 20th century), a doorway in the N wall providing access to another extension, and a wide window in the W wall. The latter has an original wooden lintel but the wall has been raised above this with mortared rubble and tile. The sill of this window has been raised or replaced with bricks, cement and cassies. The window case is centrally placed with four small panes; the spaces either side boarded up. A closer look at the window shows it to be made from sawing in half an original 8 pane window and rotating it 90 degrees.

Looking into the interior of Extension 1

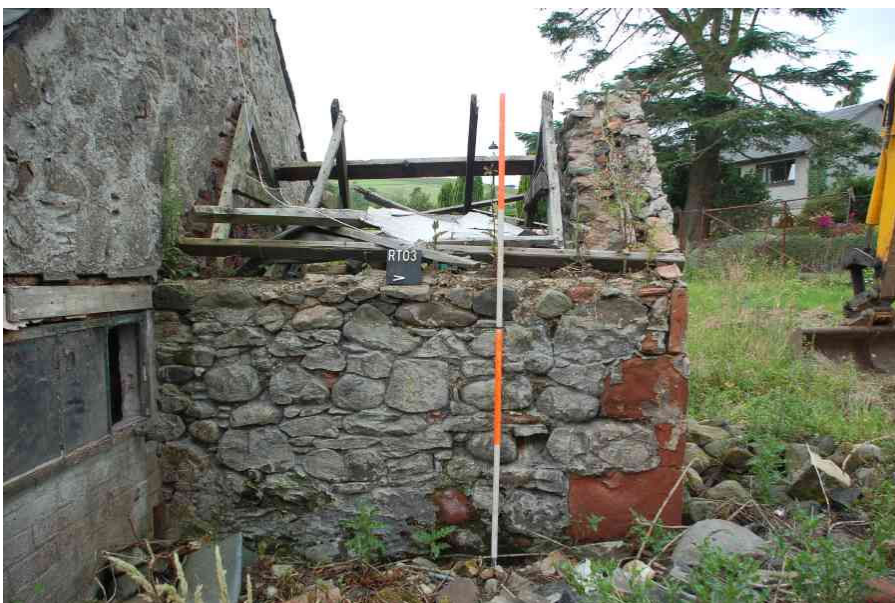
This is a small squared building built against extension 2 constructed from lime mortared roughly shaped sub-rounded to sub-angular fieldstones and squared rectangular blocks of red sandstone matching those of extension 1. There is a central window in the N wall (single pane, not original). The roof is missing, but the roof timbers are still present, circular sawn softwood planks, regularly sized. Inside the walls have not been rendered. In the S wall (the N wall of extension 1) is a recess which corresponds to the blocked slot noted above.

Extension 2, E elevation

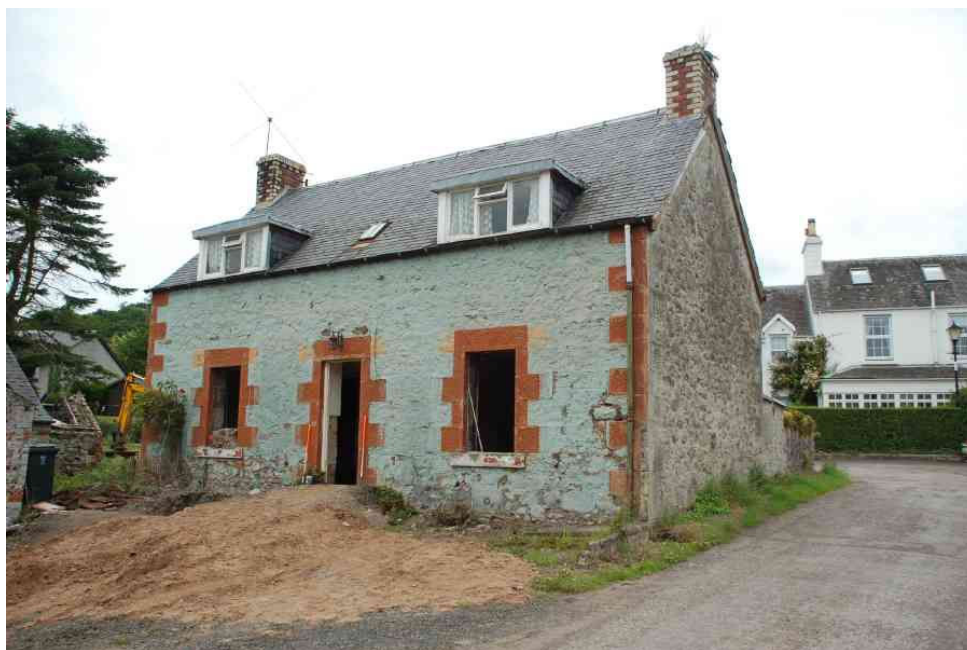
Smithy House, S elevation

This rectangular building lies to the NE of the Smithy and is clearly later in date. The walls are constructed from sub-rounded fieldstones (lime mortared); cornerstones and rybats have been made from highly regular tooled blocks of red sandstone. The roof is slated with cast iron gutters and the apex is galvanized steel or sheet zink. The chimneys have been made from red brick with cream bricks used for the corners and upper courses. Centrally placed in both the N and S pitches are traditional cast iron skylights. Two box dormers have been inserted into the S pitch in the 20th century on either side of the skylight. The S (principal) elevation has two windows on either side of a doorway, though the door and windows frames are missing. There is an original window at upper floor level in the W wall to the N of the chimney stack. This is of sash and case design with 8 panes.

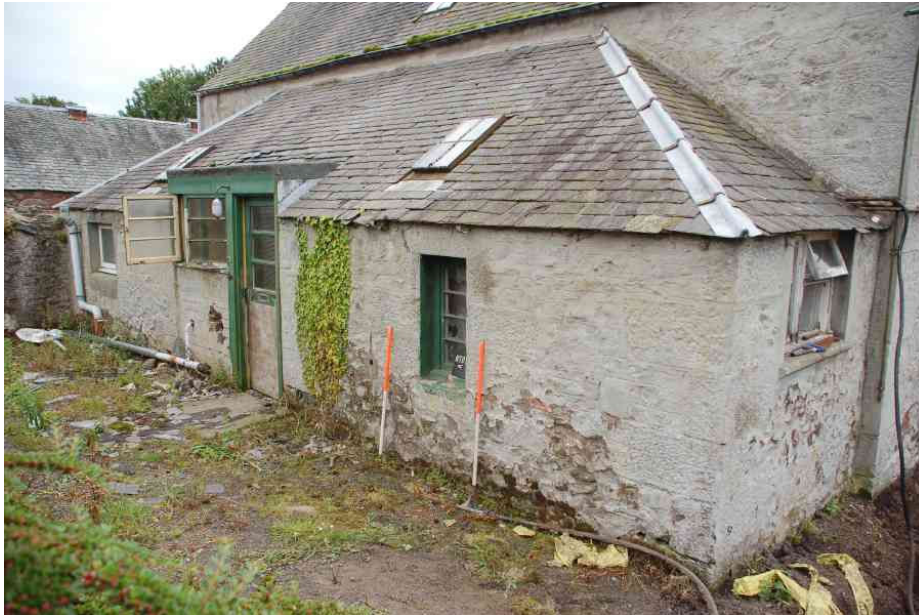
There is a single story stone-built extension on the N side of the building which has been modified heavily in the 20th century. This was originally symmetrical with two narrow windows on either side of two central doorways and cast iron skylights on either side in the slated roof. The window aperture on the W side is original (though the window case possibly not) and blocked, but that on the E has been replaced by a wide bathroom window in the 2nd half of the 20th century.

The extension on Smithy House

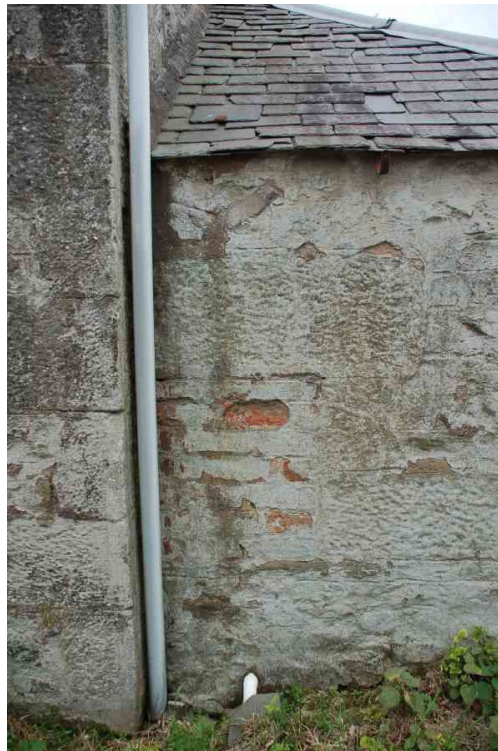
Only the E side of the original E doorway and W side of the original W doorway survive, the rest having been removed and replaced with a brick wall and a single door in the 1930s. A window has been knocked through the W wall of the extension possibly in the 1960s. In the E wall of the extension is a small window blocked in red brick looking onto the road.

The bricked up window looking onto the road

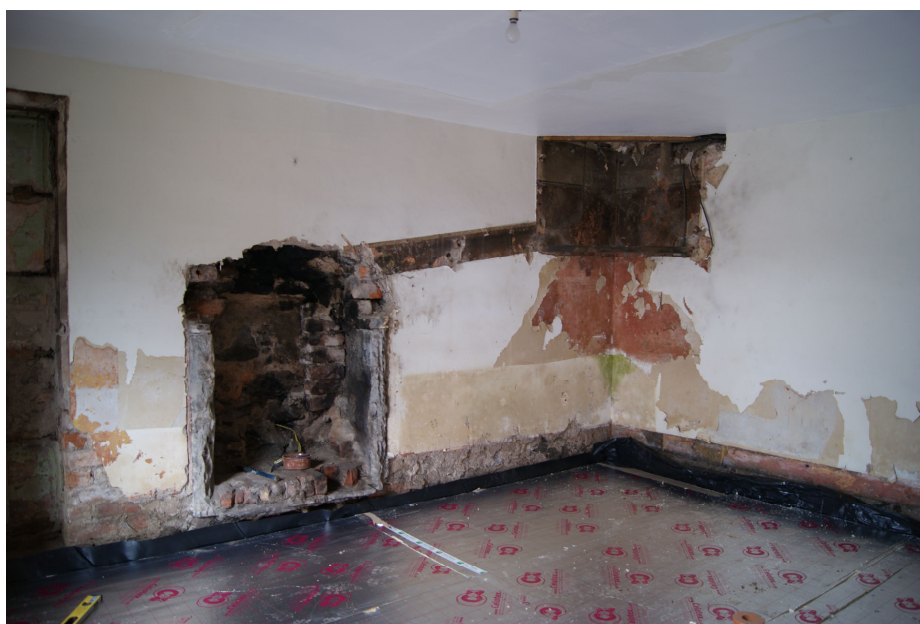
Internally the house is split into two rooms on the ground floor with two bedrooms above and a hall / staircase in between. The floors of the two lower rooms and lower hall had been removed on arrival as had the two fireplace fittings. The W room probably originally

contained a range with a water boiler as a diagonal stain to the N of the fireplace marks where water pipes fed into a corner cupboard immediately below a water tank upstairs. Outside were the remains of an early 20th century range which had been broken up during the current renovations. On the S side of the chimney stacks in both rooms were recesses for presses. The internal walls were entirely constructed from red brick as were internal faces of doors and windows. The only part of the building retaining its original floor was a small section under the stairs. The floor here was a thin layer of concrete over rubble. Opposite the cupboard under the stairs was an original sash and case window which had been blocked when the extension was created.

The W room downstairs showing marks on wall for water pipes and corner cupboard
