Archaeological Watching Brief
Development South Side of
16-18 Abbey Street
Arbroath

**ARCHAEOLOGICAL WATCHING BRIEF
DEVELOPMENT SOUTH SIDE OF
16-18 ABBEY STREET
ARBROATH**

AB26

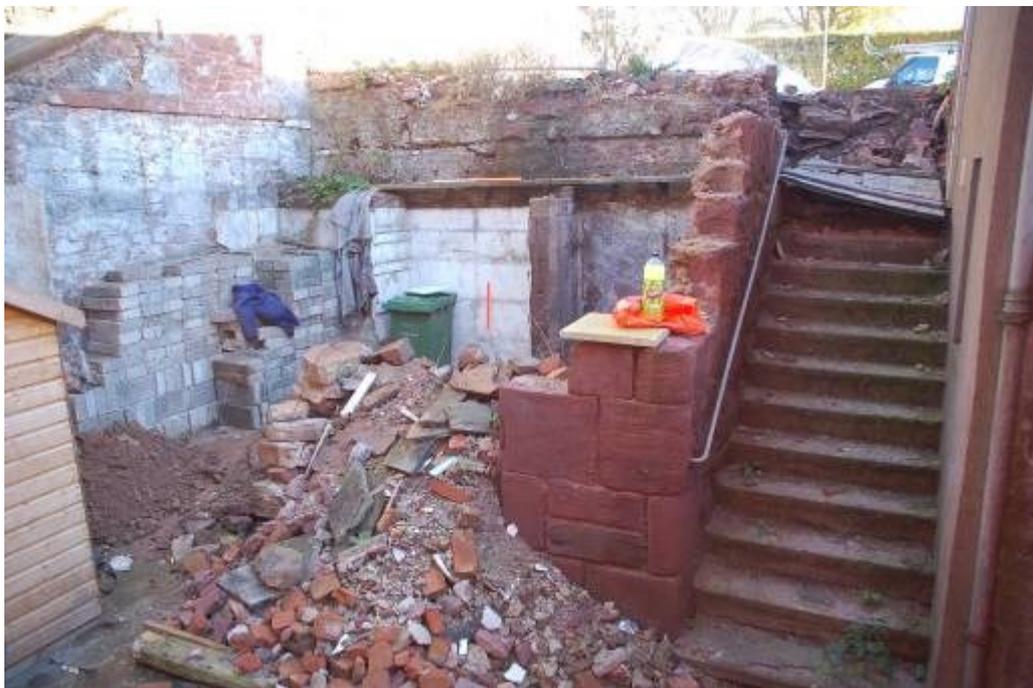
Limited excavation for a new stairwell on the lower part of the site revealed natural deposits below makeup (03) and (04) for flagstones within a partly demolished outhouse. It was evident that at the lower level of the site the ground slope had been reduced down to the natural deposits for the yard at the rear of the High Street properties. Of interest was a mason's mark in the form of a star found on stonework for the S door jamb of the outhouse building, adjacent to the N side of the central stair extending from the upper to the lower part of the site.

Working on lower area of site

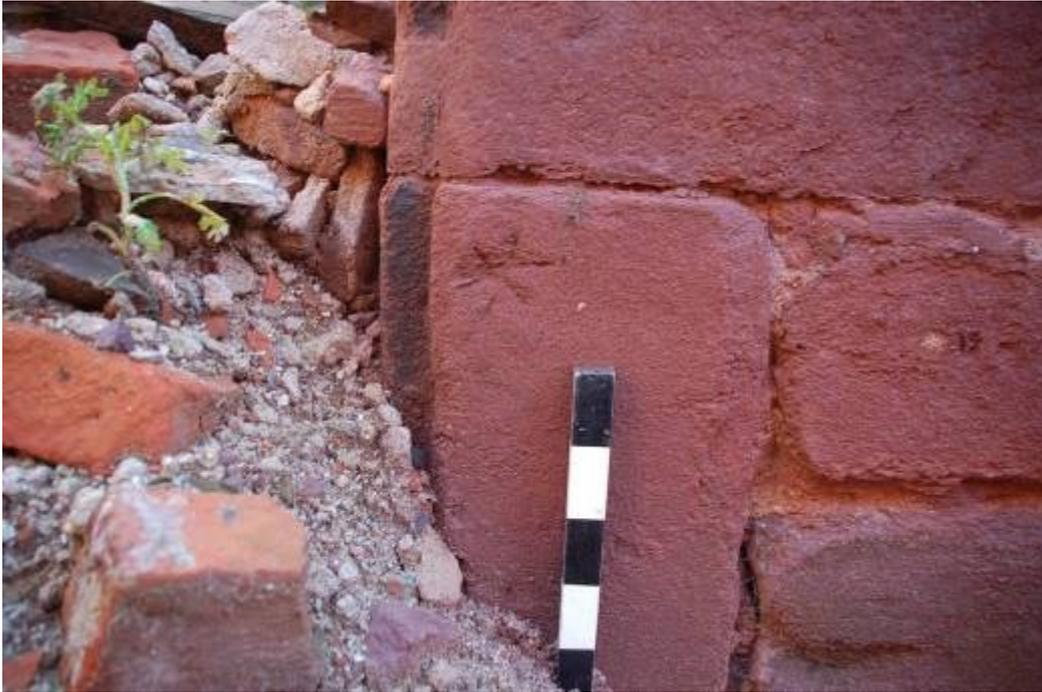
Mason's mark on door jamb on lower area of site

Limited excavation in the rear of the High Street property revealed that any early archaeological deposits had been removed down to natural deposits to create a level open courtyard and outhouses, most likely in the 19th century. With regard to the mason's mark found on the door jamb for an outhouse; the stonework in question had the appearance of 19th century work and did not look medieval. The mason's mark was most likely inscribed by the mason when the outhouse was being erected and was not on medieval stonework recovered from the abbey site.

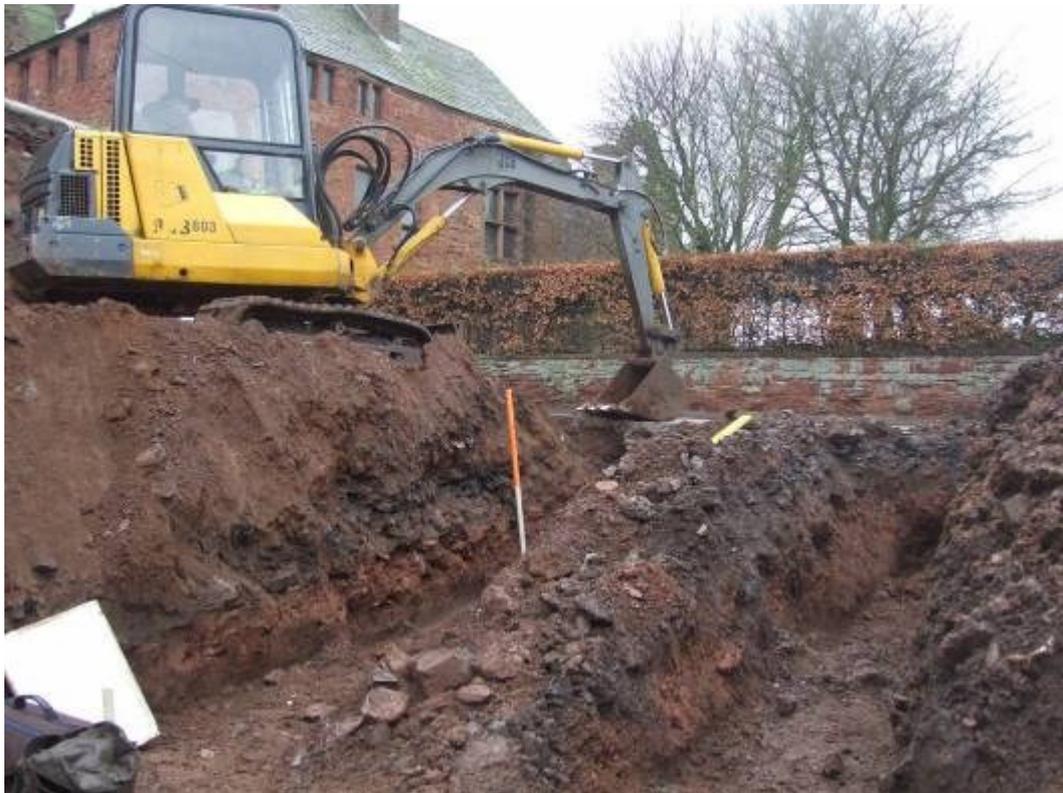
Working on upper area of site with Abbot's House in background

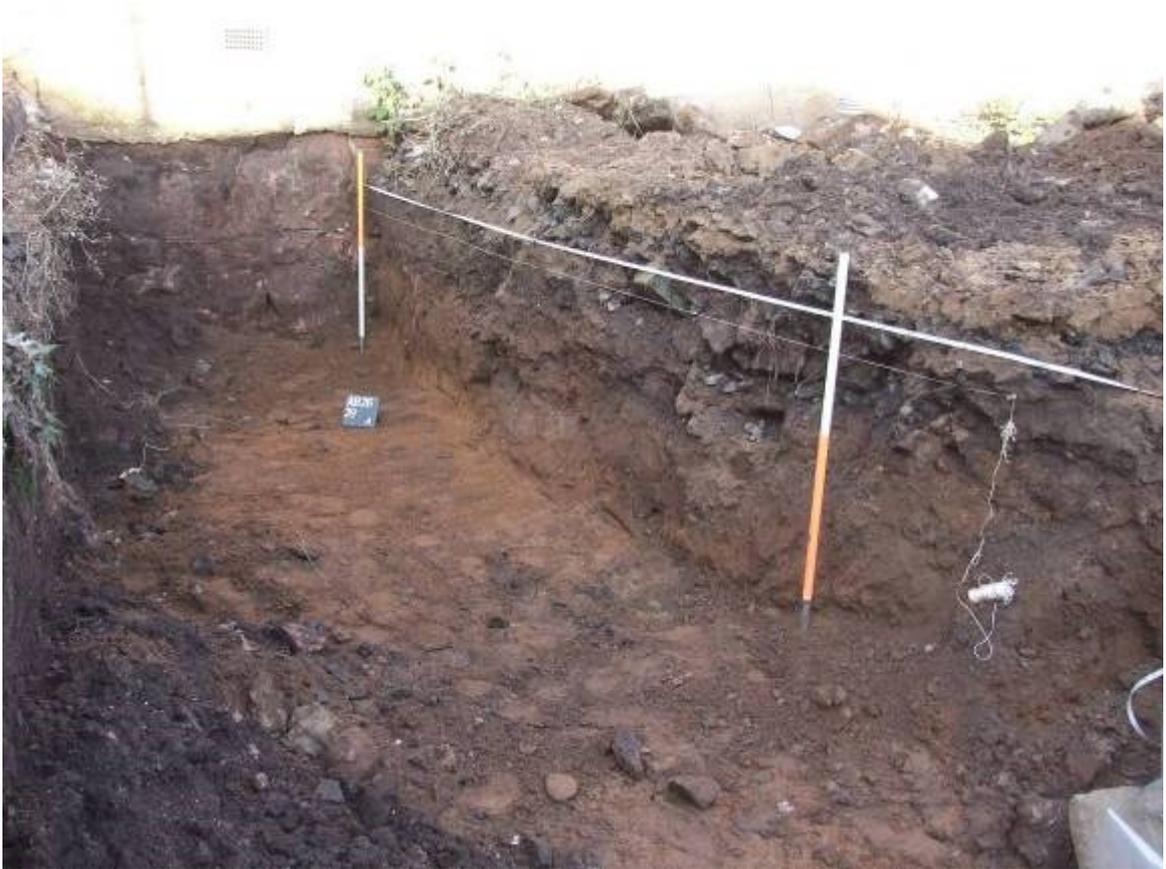
Upper part of site showing section 02

Section 02 was W facing on the N part of the site at the W end, on the E side of removed wall (27). This section revealed modern site surface hardcore and garden soil deposits with a pit containing a modern fill (35). An earlier surface (38), comprising red sandstone fragments, was identified below the garden soil. Surface (38) was possibly medieval. Below (38) was a subsoil (39) of mid brown fine silt. Cut into the subsoil was a small pit with a fill (42) containing fine silt with butchered animal bone comprising cattle, sheep and pig as well as oyster shell (see finds register below). The style of the butchering of the bone in the fill indicated a likely medieval date for this pit feature.

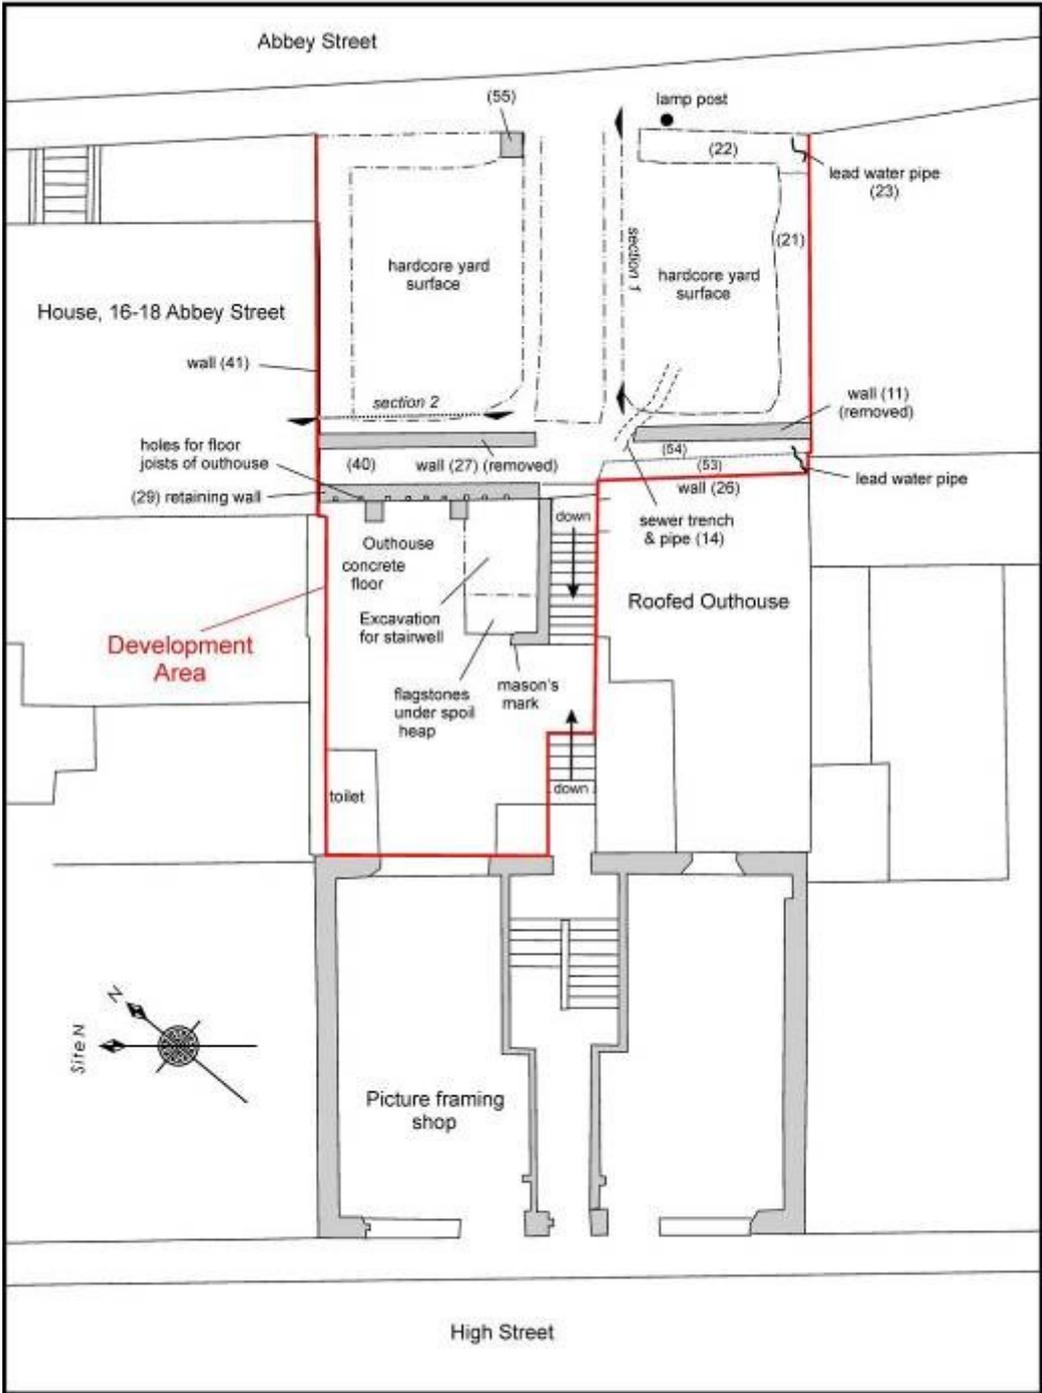
Illus 2 Features found during Watching Brief

The upper area of the site had foundation trenches cut along all four sides and two parallel trenches cut for a passageway through the centre of the site. The foundation trenches were approximately 0.70m wide and 1m in depth. However, at the SW corner of the site, foundation excavation below wall (26) extended to a depth of 2.20m below site surface level onto loose stone (53) below the wall's scarcement. On the W side of the site, two earlier revetting walls (11) and (27) were found approximately 1m forward of the main structural walls dividing the upper and lower half of the site which were removed. These revetting walls are shown on the Ordnance Survey plan Arbroath 1859. Walls (11) and (27) had over time become buried and the passageway between the two sets of walls had been infilled with silty deposits (13) and (28) which contained abundant large sherds of 19/20th C pottery (not retained).

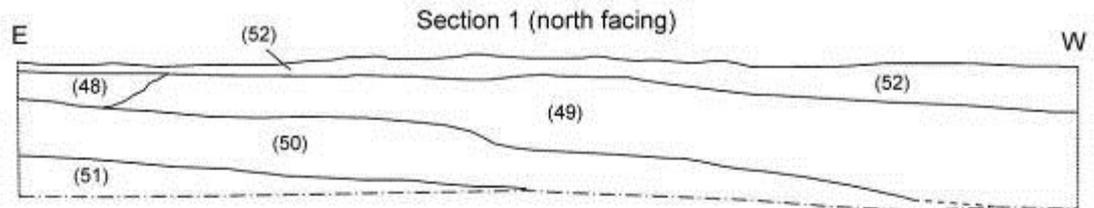
Illus 3

Section 01 was N facing on the N side of the S part of the site. This section revealed modern hardcore surface and disturbed garden soil over a layer of sandstone fragments (50). The sandstone fragments appeared to represent an earlier surface possibly medieval. Deposit (50) was identified as deposit (38) in section 2. Below the sandstone fragments was a silty subsoil (51) equivalent to deposit (39) in section 2.

- (48) Mixed disturbed deposits, modern
- (49) Mid brown fine silty loam, garden soil
- (50) Layer of medium sand and stone fragments with frags of oyster shell, old ground surface, possibly Medieval
- (51) Mid orange brown silty subsoil
- (52) Make-up, hardcore forming site surface

Sections recorded in foundation trenches on the upper part of the site revealed a modern surface over earlier garden soil deposits. Of interest was a deposit of small/medium sized red sandstone fragments which indicated an earlier, probable medieval surface previously identified during the excavation for the new visitor's centre in 2000 and again on the watching brief in Abbey Street on excavations for a new water main in 2001. Predating the sandstone fragments was a small pit cut into the subsoil with butchered animal bone considered to date from the medieval period. One sherd of unstratified medieval pottery was recovered from loose spoil.

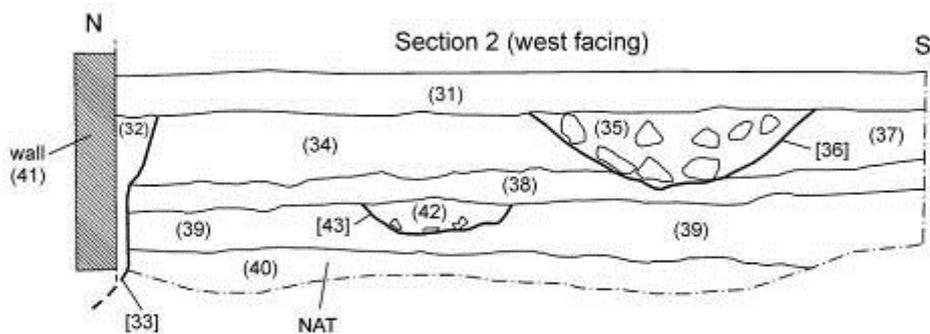
- (31) Modern site surface hardcore
- (32) Fill for wall cut [33]
- (33) Wall cut
- (34) Recent garden soil, grey silty loam with small sandstone fragments
- (35) Modern fill - brick and large fragments of red sandstone
- [36] Cut for (35)
- (37) Modern make-up, hardcore chippings
- (38) Mid red brown silty clay with abundant rounded stones and small-med sandstone frags, old surface possibly Medieval
- (39) Subsoil, mid brown fine silt
- (40) Bright orange-brown fine silt, natural
- (41) Wall, large blocks of red sandstone
- (42) Fill of pit [43], bone and oyster shell.
- [43] Pit
