Archaeological Building Recording  
Pittiely Burn  
ABERFELDY

**ARCHAEOLOGICAL BUILDING RECORDING**  
**PITTIELY BURN**  
**ABERFELDY**

**AF 12**

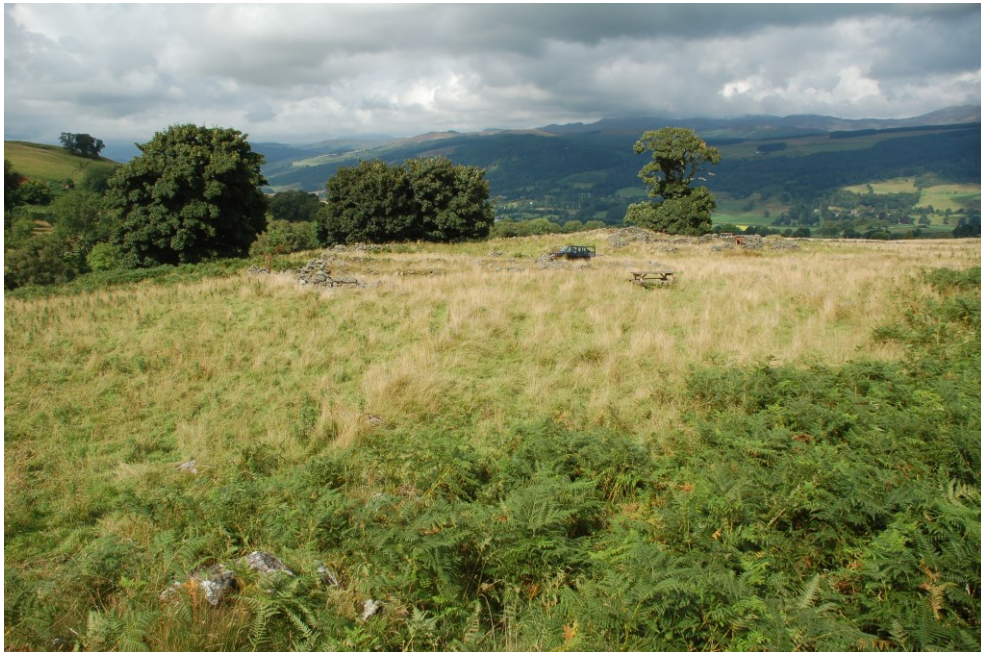
*Looking over the farmstead from the higher ground in the E of the site*

To the E of the farmstead the ground slopes up gradually towards the eastern boundary of the site. Numerous small rock outcrops can be found upslope of the farmstead illustrating that bedrock is close to the surface in many parts of the site. The lime kilns are located approximately 100m directly S of the main farmstead on steeper slopes above the Pittiely Burn (at approximately 256m OD).

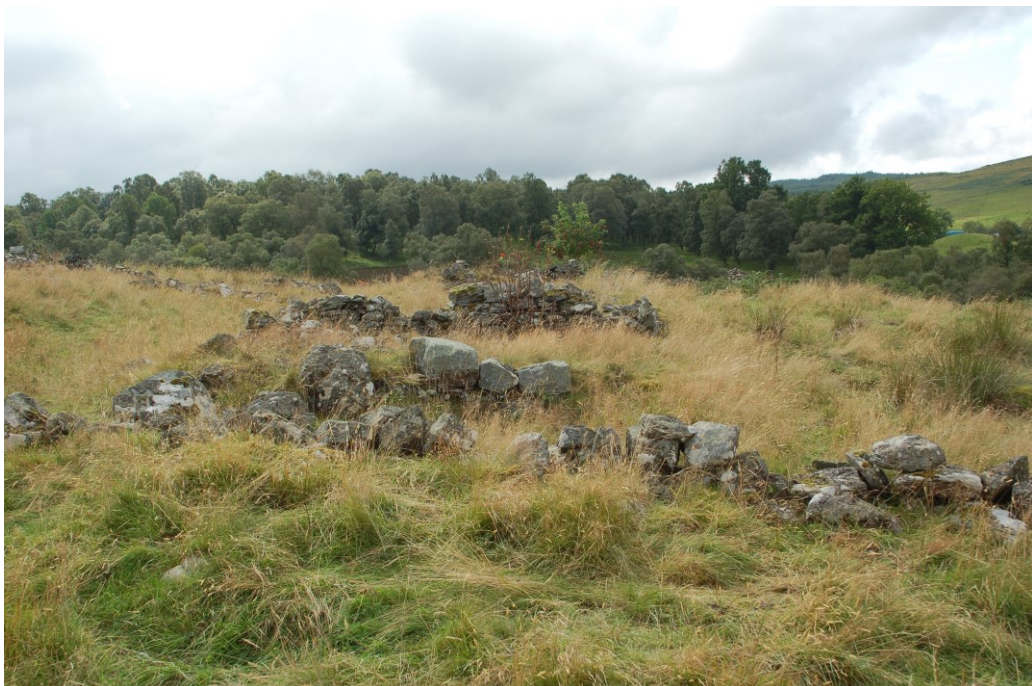
A NW-SE aligned drystone wall passes very close to the N end of this structure. Two phases of construction were identified in the survey, with a later addition butting up against the S wall of the original rectangular building. This original building is divided into three separate spaces; two square rooms in the N and a larger rectangular space. Turf has grown over much of the interior and some of the walls of this building, obscuring internal detail. This fact together with large spreads of rubble means that it is difficult, in many cases, to identify features such as entrances.

***Looking S along the length of the larger building***

This structure and indeed all the others on the site are constructed in drystone using locally occurring grey granite stone of varying shapes and sizes. White quartz inclusions are present in much of this granite and this is the same type of rock that outcrops slightly upslope from the site (as marked on Illus 2). Some massive stones have been employed as corner stones but neither these, nor any other of the building material, has been dressed in any way.

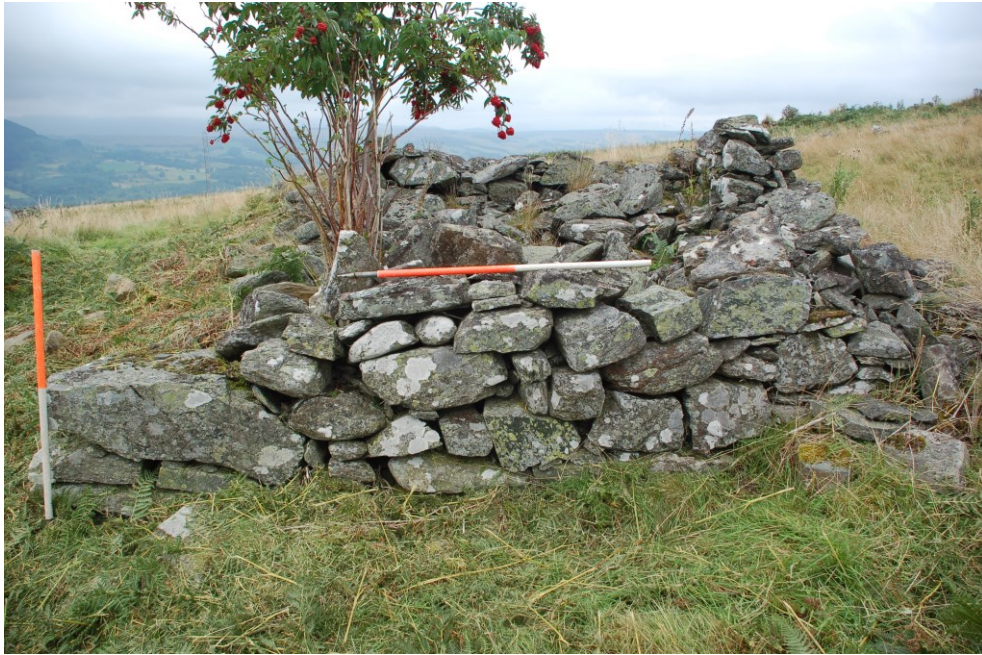
The turf has not grown over this structure to the same extent as in the rest of this building. For this reason more of the wall structure and internal rubble collapse is visible. The N wall of this structure butts up against the S wall of the existing building indicating that this is a later addition. This structure is also narrower than the existing building being 4.4m wide instead of 5.7m. The S gable of this room is constructed of some large boulders, the largest of these being the quoins which are up to 1.1m in length and 0.6m in width.

*The S gable of the N-S aligned building*

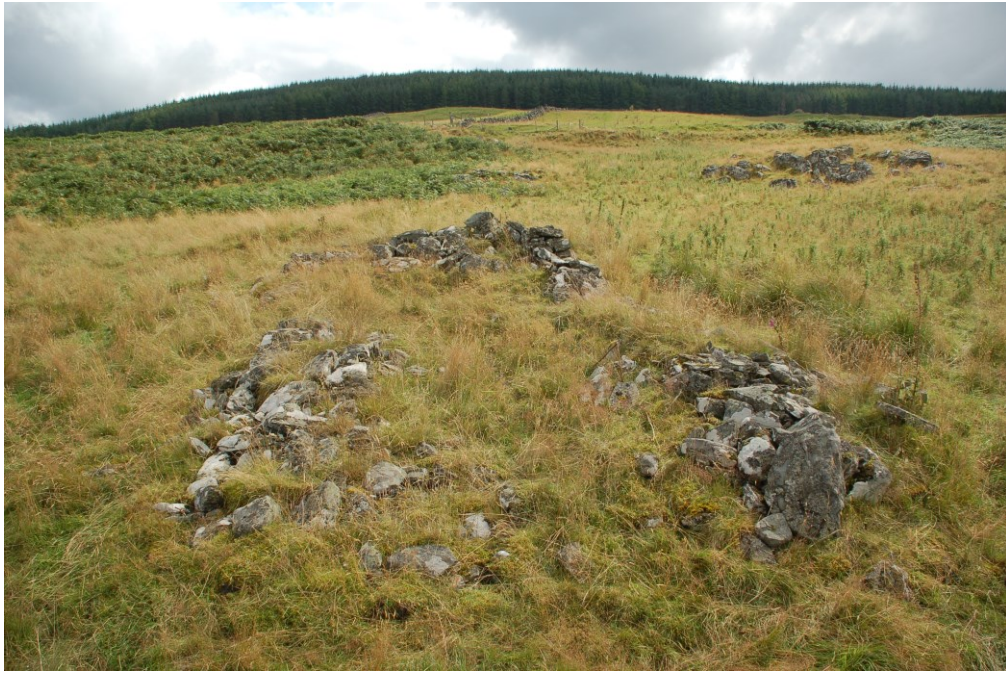
This is located just to the E of the N-S aligned building and together they form an L-shaped arrangement when seen in plan (see Illus 2). The whole building is in a ruinous state and is overgrown in places with rough grass. The presence of thick turf at the W end of the building makes it particularly difficult to trace the line of the gable wall. In terms of its layout the building is formed of two spaces, a larger rectangular room at the W end (measuring approximately 9.1m in length and 4.1m in width) and a smaller rectangular space at the E end with a length of 2.8m and a width the same as the main structure.

The maximum height that the walls survive to is 0.8m, a similar level of preservation to that seen in the N-S aligned building. The same techniques of drystone construction were used for this structure as recorded for the N-S aligned building. In general terms it could be said that the level of preservation of this structure was very similar to that seen in the neighbouring larger building. A very heavily overgrown and indistinct wall was observed near the E end of this structure. The line of this wall has been picked up on the site survey (Illus 2).

*Looking E along the length of the smaller building*
