Archaeological Building Recording
Pittiely Burn
ABERFELDY

ARCHAEOLOGICAL BUILDING RECORDING
PITTIELY BURN
ABERFELDY

AF 12

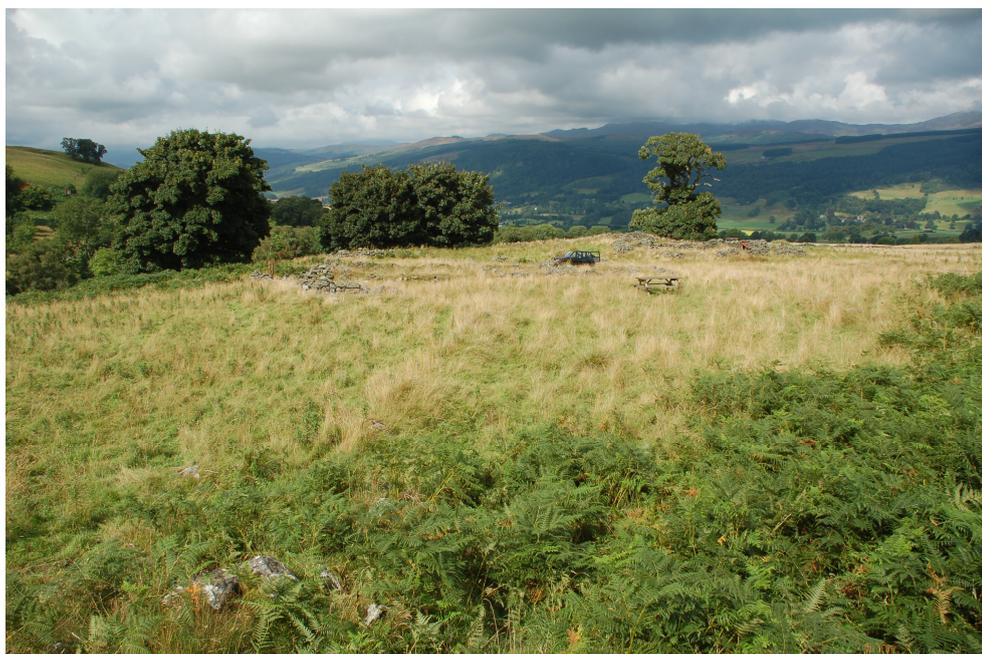
Looking over the farmstead from the higher ground in the E of the site

To the E of the farmstead the ground slopes up gradually towards the eastern boundary of the site. Numerous small rock outcrops can be found upslope of the farmstead illustrating that bedrock is close to the surface in many parts of the site. The lime kilns are located approximately 100m directly S of the main farmstead on steeper slopes above the Pittiely Burn (at approximately 256m OD).

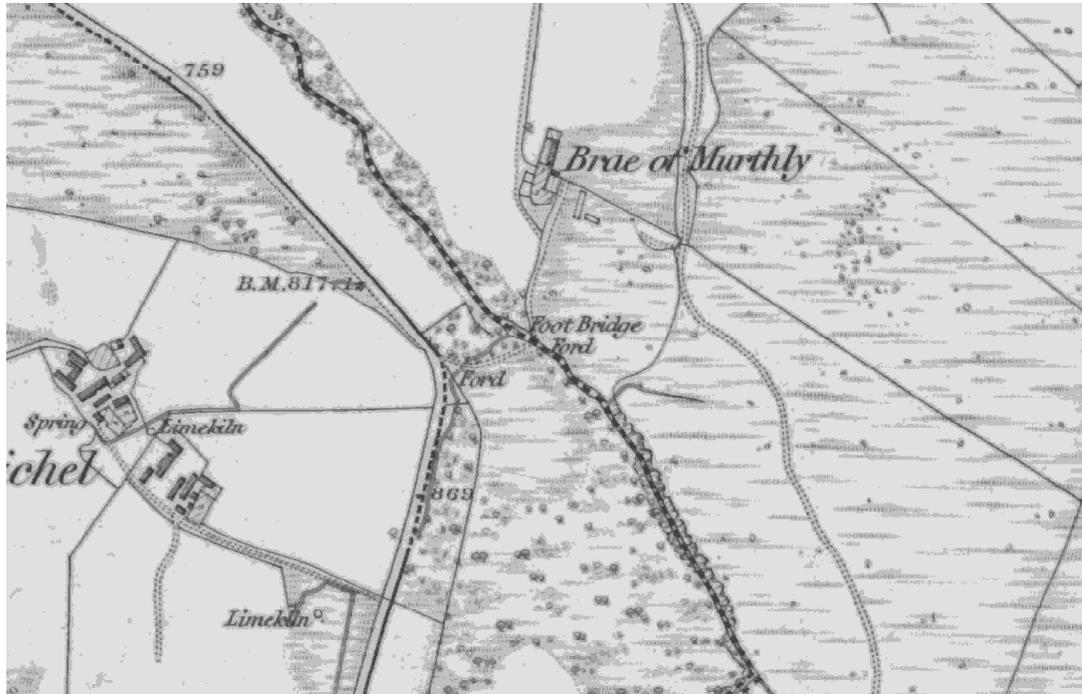
The farmstead at Pittiely Burn, known as 'Brae of Murthly', appears on the 1st Edition Ordnance Survey 6 inch map (Ordnance Survey 1862). This map shows an arrangement of buildings and enclosure walls similar to what can be observed on the ground today. This map shows several things about this settlement that are of interest for the purposes of this report. Firstly, two of the main farmstead buildings are shown as being roofed. The two structures in the SE of the site are depicted but they are not shown as being roofed or indeed having internal divisions. The three structures in the NE part of the site are not shown on this map at all.

An extract from the 1st Edition OS map showing Brae of Murthly

It is clear from the map evidence that the settlement known as Brae of Murthly predates the first Ordnance Survey mapping in the 1860's though by how much is not possible to say. This settlement went out of use in the later part of the 19th century prior to the 1899 resurvey. The buildings in the SE part of the site are shown on both OS editions but these maps don't record any other information about the function of these structures.

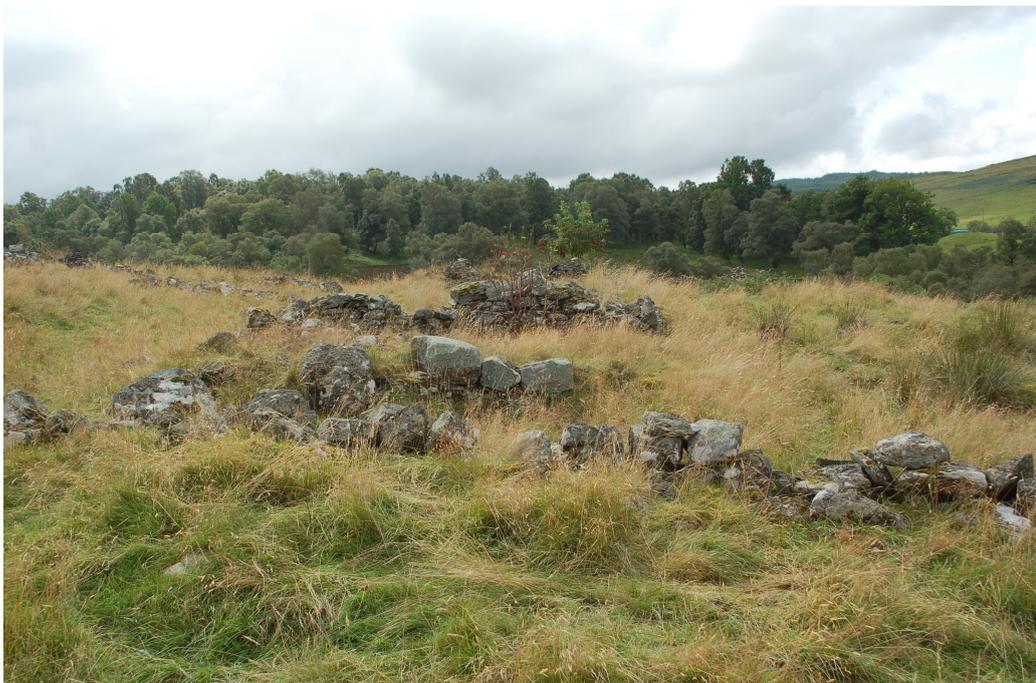
A NW-SE aligned drystone wall passes very close to the N end of this structure. Two phases of construction were identified in the survey, with a later addition butting up against the S wall of the original rectangular building. This original building is divided into three separate spaces; two square rooms in the N and a larger rectangular space. Turf has grown over much of the interior and some of the walls of this building, obscuring internal detail. This fact together with large spreads of rubble means that it is difficult, in many cases, to identify features such as entrances.

Looking S along the length of the larger building

This structure and indeed all the others on the site are constructed in drystone using locally occurring grey granite stone of varying shapes and sizes. White quartz inclusions are present in much of this granite and this is the same type of rock that outcrops slightly upslope from the site (as marked on Illus 2). Some massive stones have been employed as corner stones but neither these, nor any other of the building material, has been dressed in any way.

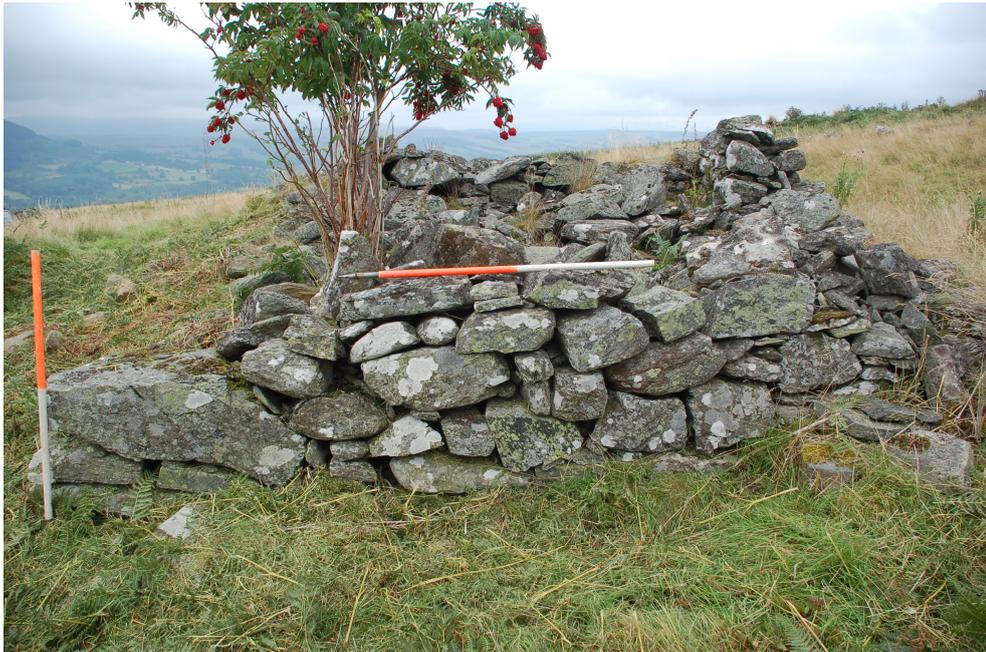
The turf has not grown over this structure to the same extent as in the rest of this building. For this reason more of the wall structure and internal rubble collapse is visible. The N wall of this structure butts up against the S wall of the existing building indicating that this is a later addition. This structure is also narrower than the existing building being 4.4m wide instead of 5.7m. The S gable of this room is constructed of some large boulders, the largest of these being the quoins which are up to 1.1m in length and 0.6m in width.

The S gable of the N-S aligned building

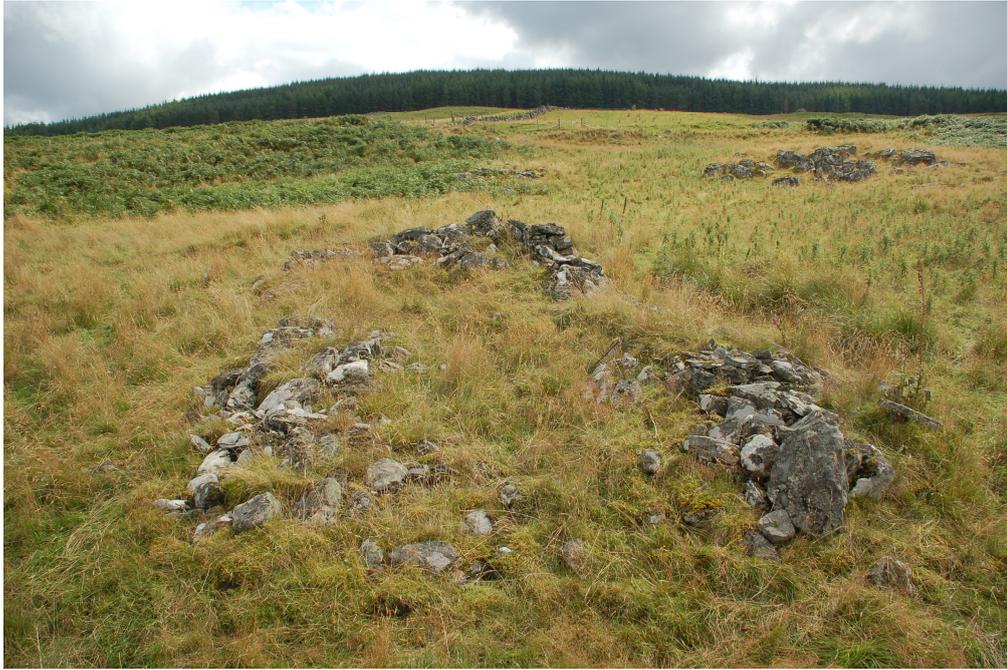
This is located just to the E of the N-S aligned building and together they form an L-shaped arrangement when seen in plan (see Illus 2). The whole building is in a ruinous state and is overgrown in places with rough grass. The presence of thick turf at the W end of the building makes it particularly difficult to trace the line of the gable wall. In terms of its layout the building is formed of two spaces, a larger rectangular room at the W end (measuring approximately 9.1m in length and 4.1m in width) and a smaller rectangular space at the E end with a length of 2.8m and a width the same as the main structure.

The maximum height that the walls survive to is 0.8m, a similar level of preservation to that seen in the N-S aligned building. The same techniques of drystone construction were used for this structure as recorded for the N-S aligned building. In general terms it could be said that the level of preservation of this structure was very similar to that seen in the neighbouring larger building. A very heavily overgrown and indistinct wall was observed near the E end of this structure. The line of this wall has been picked up on the site survey (Illus 2).

Looking E along the length of the smaller building

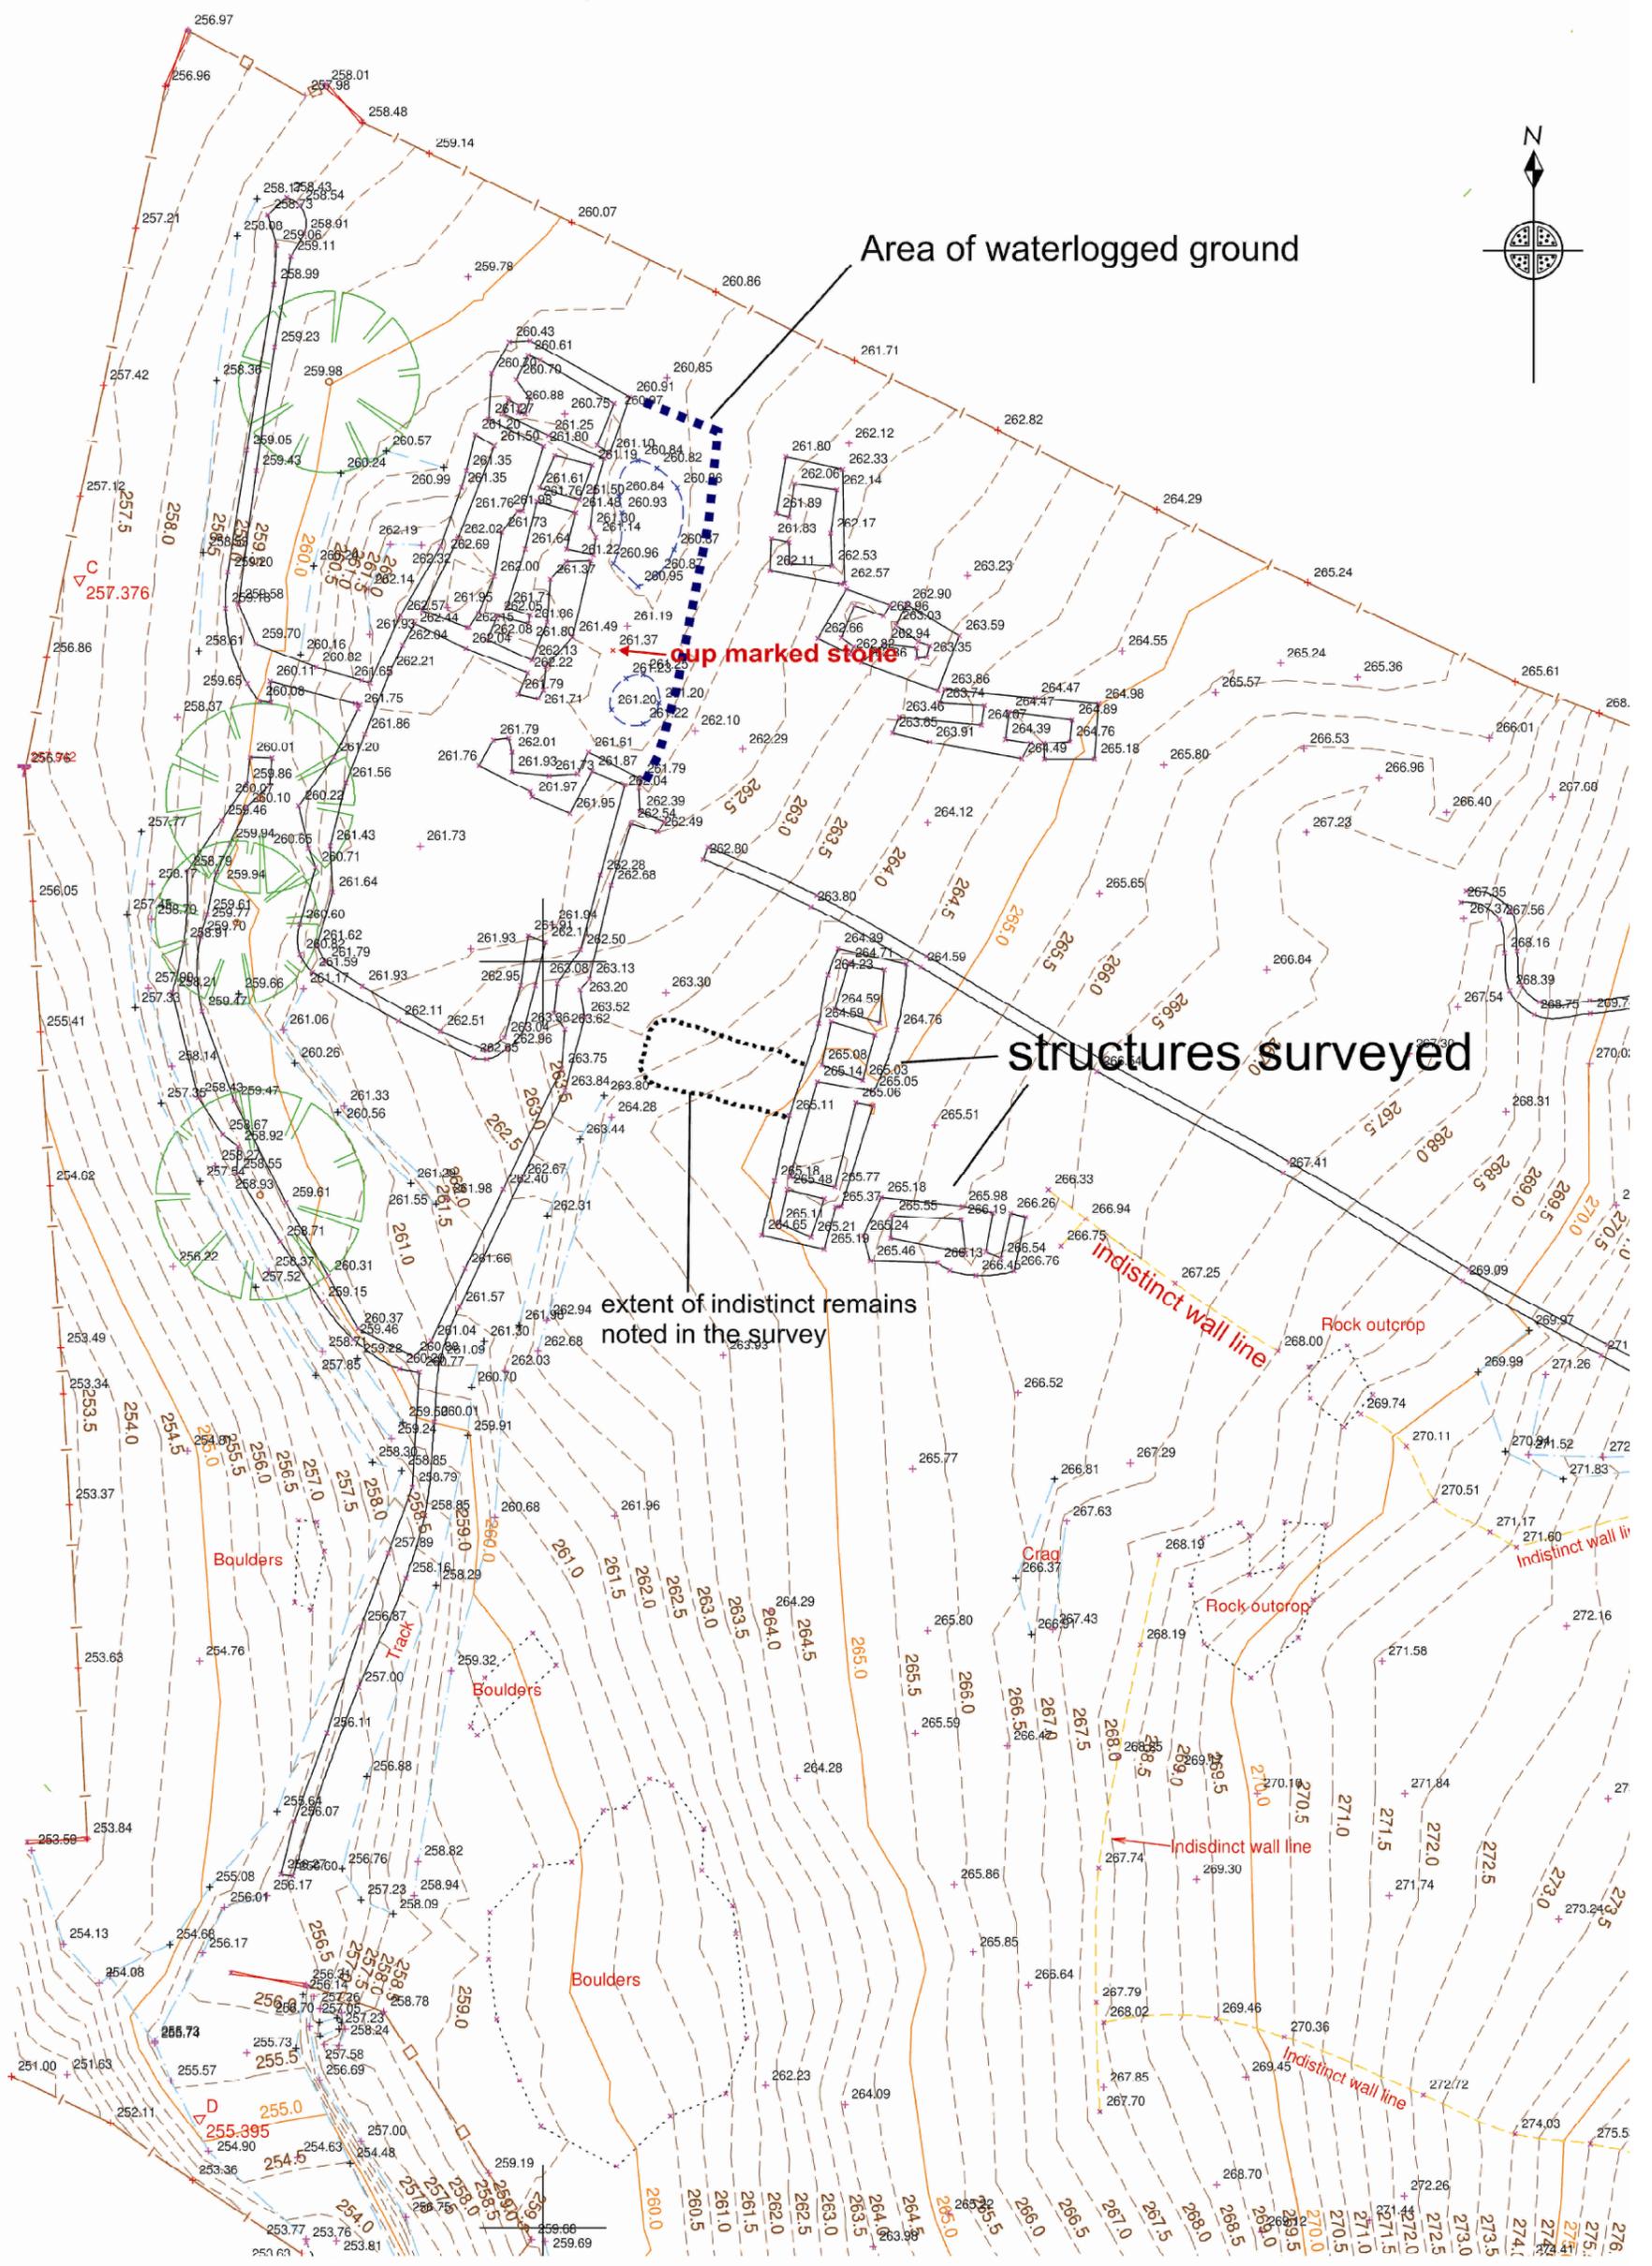
Illus 2 Plan of farmstead based on site survey

A series of measurements and observations were made to add to the detail already recorded on the site survey (Illus 2). Although not originally made for this purpose the site survey contains a good level of detail about the surviving archaeological remains. For this reason it made an ideal base plan for the archaeological building recording.

Based on existing ground survey by Ian Stokes dated 13.1.12

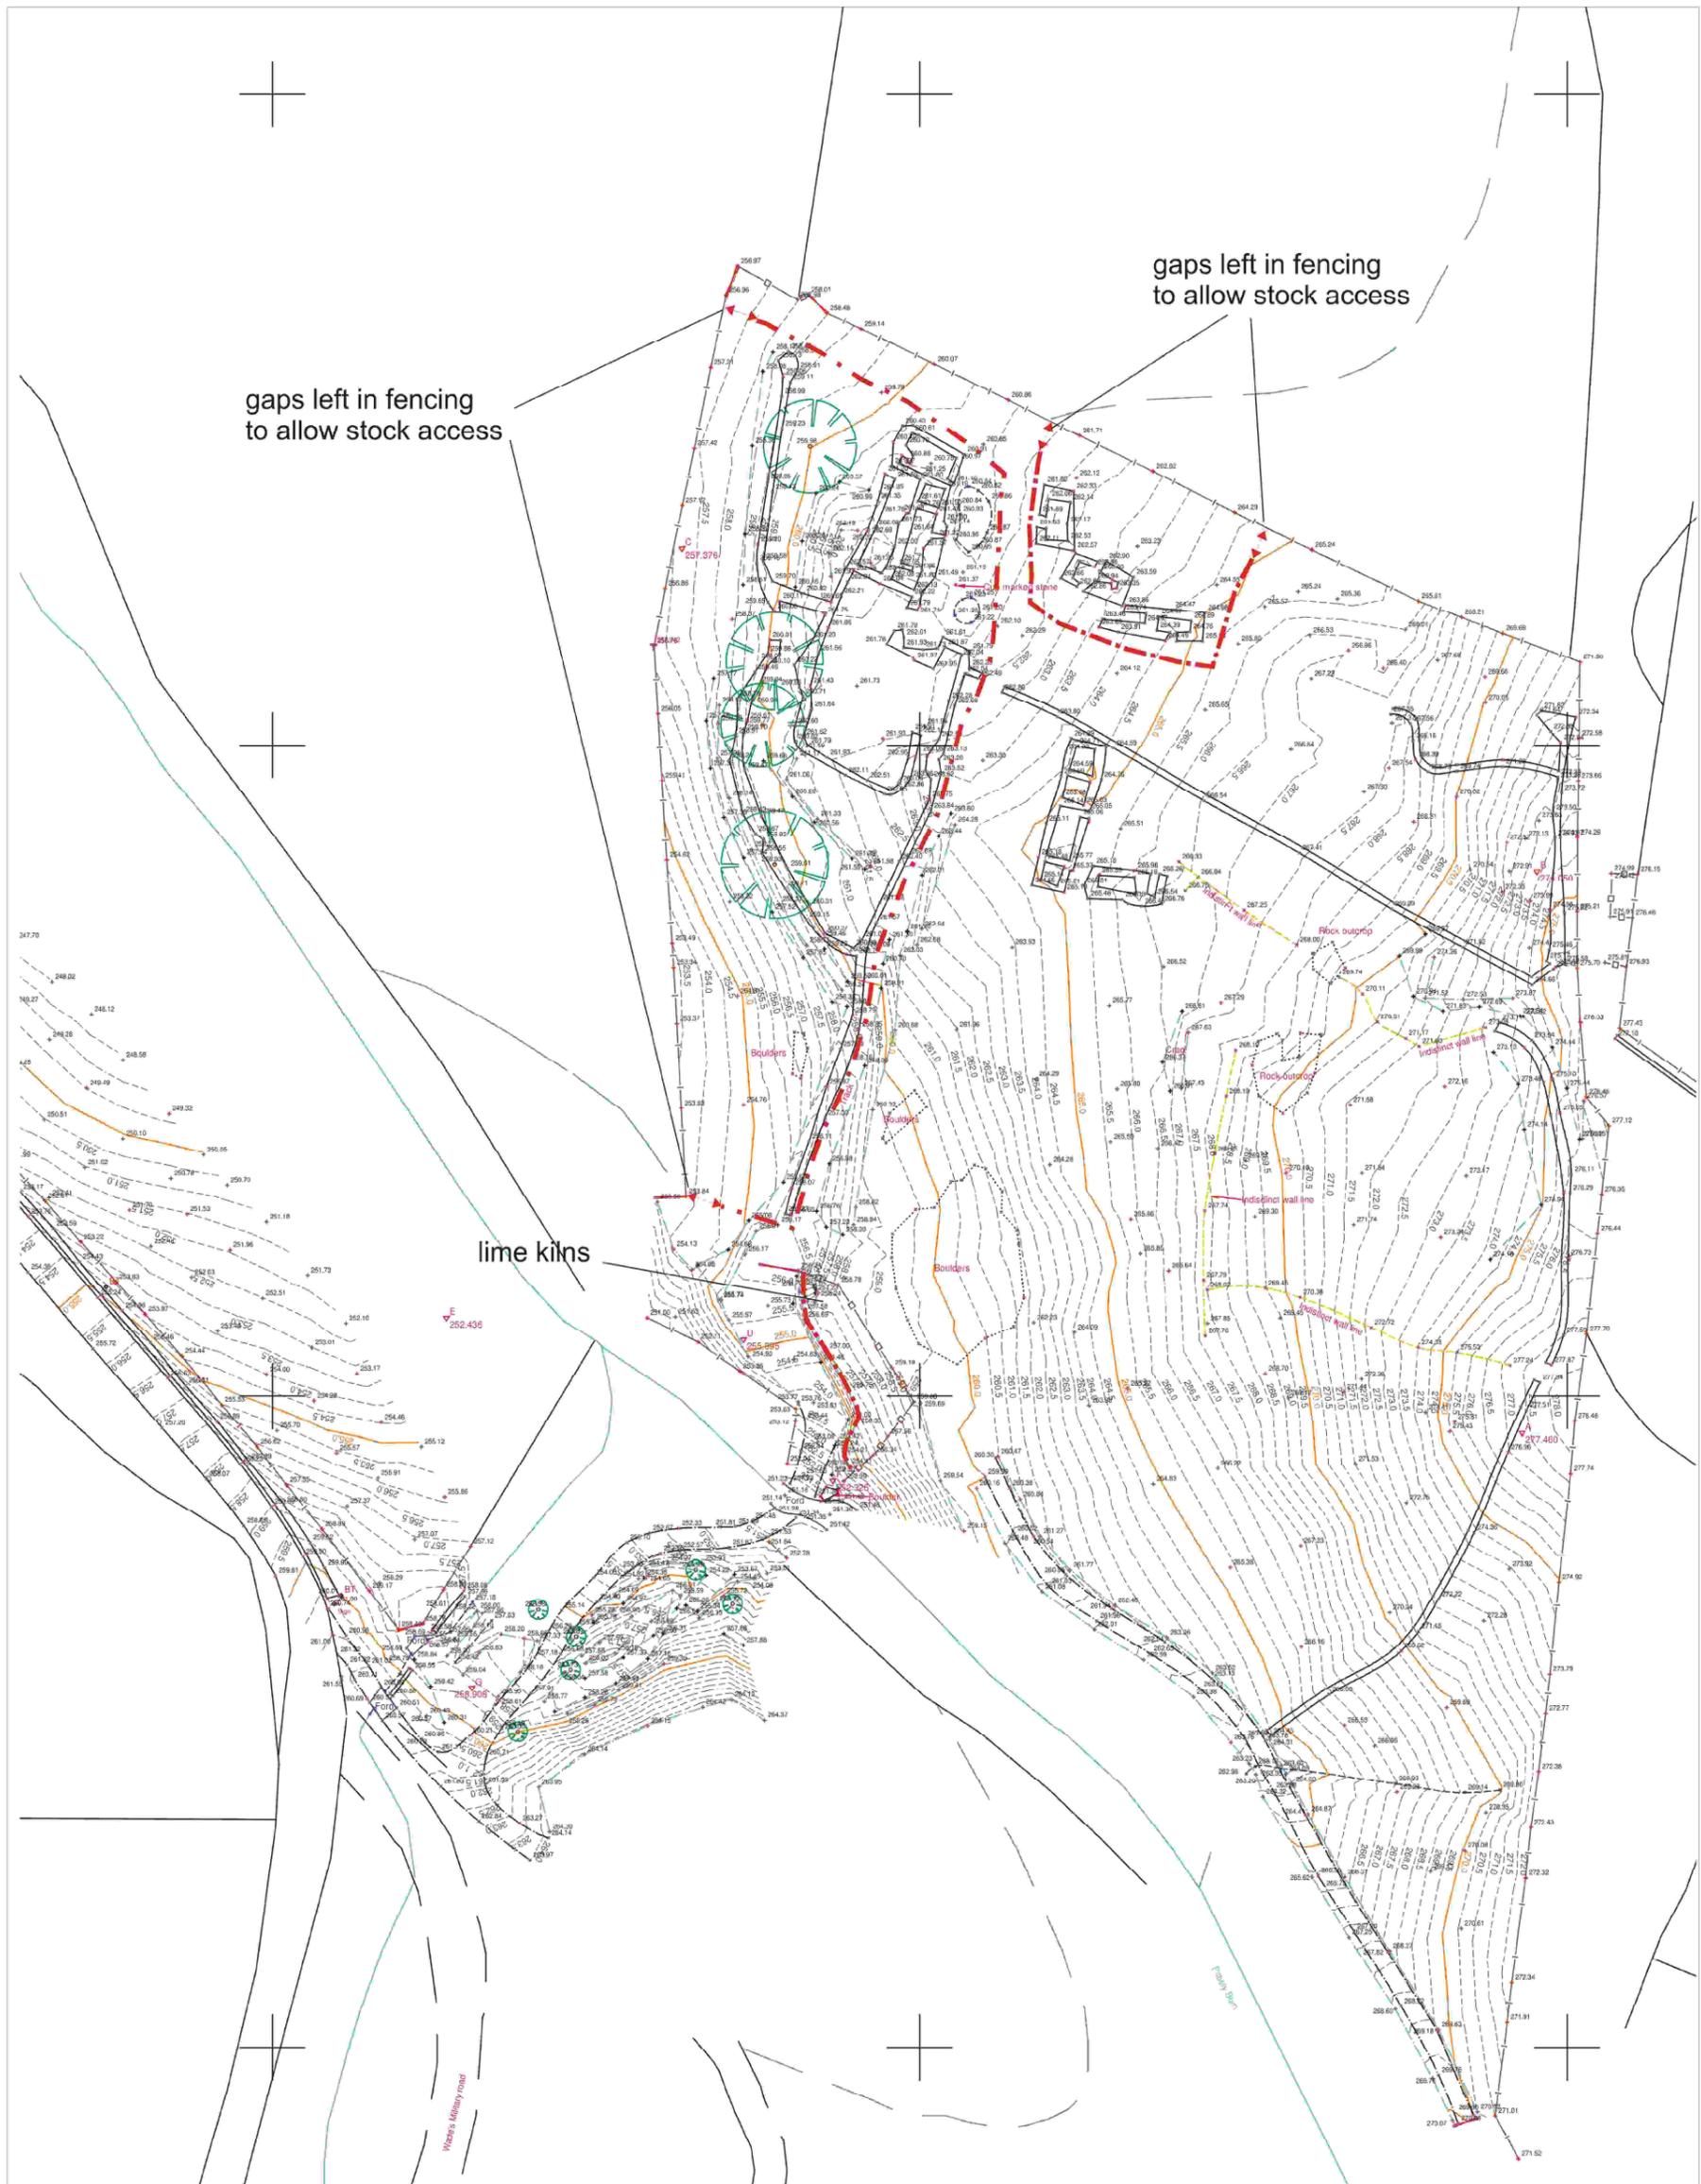
Illus 3 Proposed fence line Pittielly Burn, Aberfeldy (App Ref 13/00187/FLL)

- 1) The proposed line includes all existing structures except for those buildings in the SE of the site which are to be demolished and which have been recorded. The line has been worked out by Alder Archaeology following a site visit and discussions with the developer.

- 2) The fencing in the S part of the site encloses the remains of the lime kilns.
- 3) The fence will be formed of metal road irons and rope with high viz pendant bunting. Plastic mesh fencing is not suitable for the weather conditions seen on this exposed site in winter.

- 4) Wherever possible existing post and wire fences have been used to complete the circuit.
- 5) ~5m wide gaps will be left where temporary fencing meets post and wire to allow stock access in order to maintain existing grazing regime and prevent excessive growth of vegetation.

Alder Archaeology Ltd carried out a monitoring visit on 02nd September 2013 to check the fence line erected by the developer against the approved plan (Illus 3). This visit confirmed that the fence had been erected in the specified location. The developer will maintain the fence throughout the development process. No further archaeological work is necessary in connection with this development.

- 6) The developer will put up the approved fence line. This will be checked by Alder Archaeology.
