Archaeological Walkover Survey
Camserney
Aberfeldy
PERTH&KINROSS

AF13

**ARCHAEOLOGICAL WALKOVER
SURVEY
CAMSERNEY
AF13**

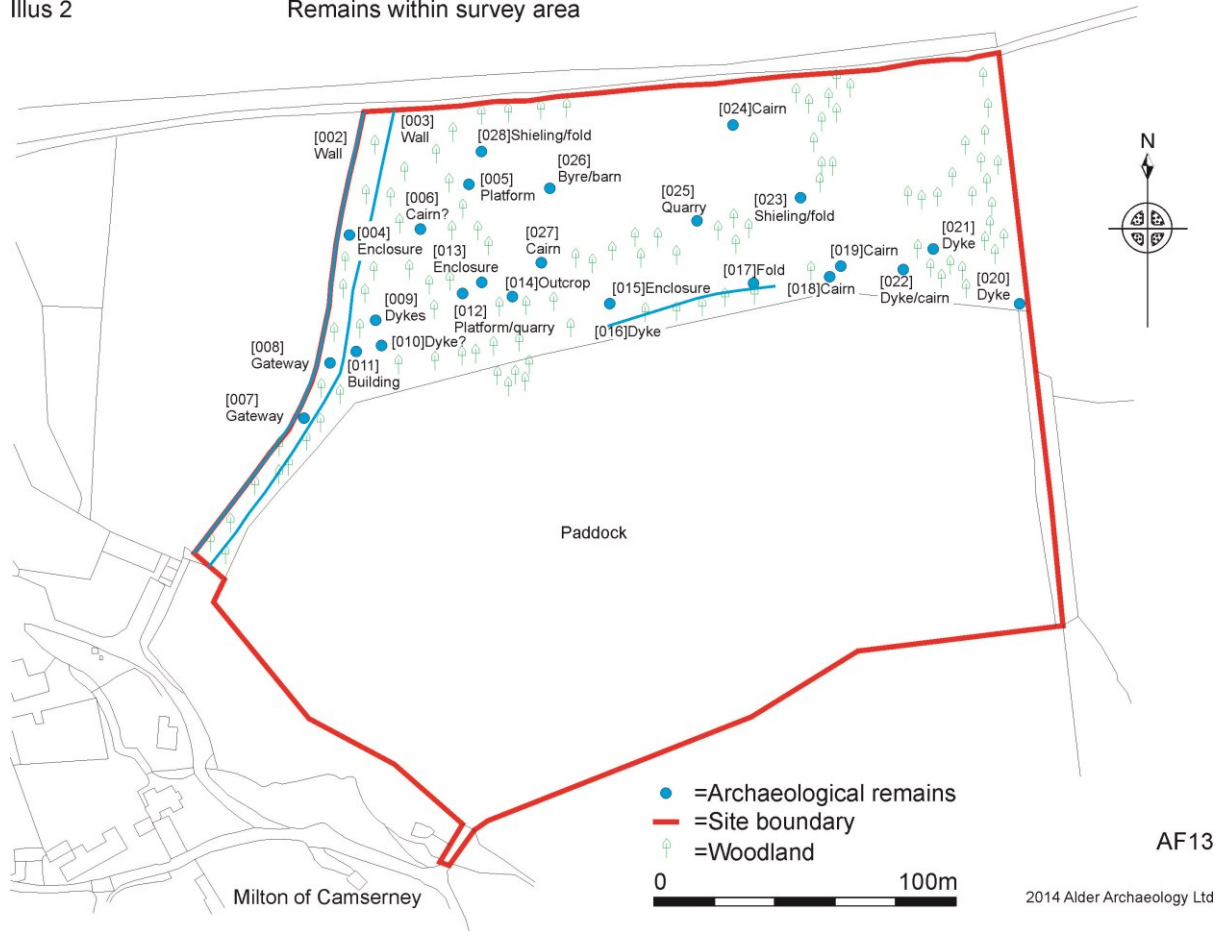
Illus 2

Remains recorded are here listed in gazetteer form by context number; a detailed description of each site follows beneath. See Illustration 3 for locations. It should be noted that in the absence of dating evidence, such as diagnostic artefacts, it is possible only to suggest a broad period for the remains described. Some features may in fact be of earlier date than suggested here, but this could not be verified without further investigation. Conditions of preservation, weathering, vegetation cover and construction materials and method were considered, together with comparison with remains, or site types, of known date.

Remains within survey area
