Archaeological Watching Brief
Trench for Electric Cable
North of Castle Mains Farm
Auchterarder

AA13

**ARCHAEOLOGICAL MONITORING
FOR ELECTRIC CABLE TRENCH
NORTH OF CASTLE MAINS FARM
AUCHTERARDER**

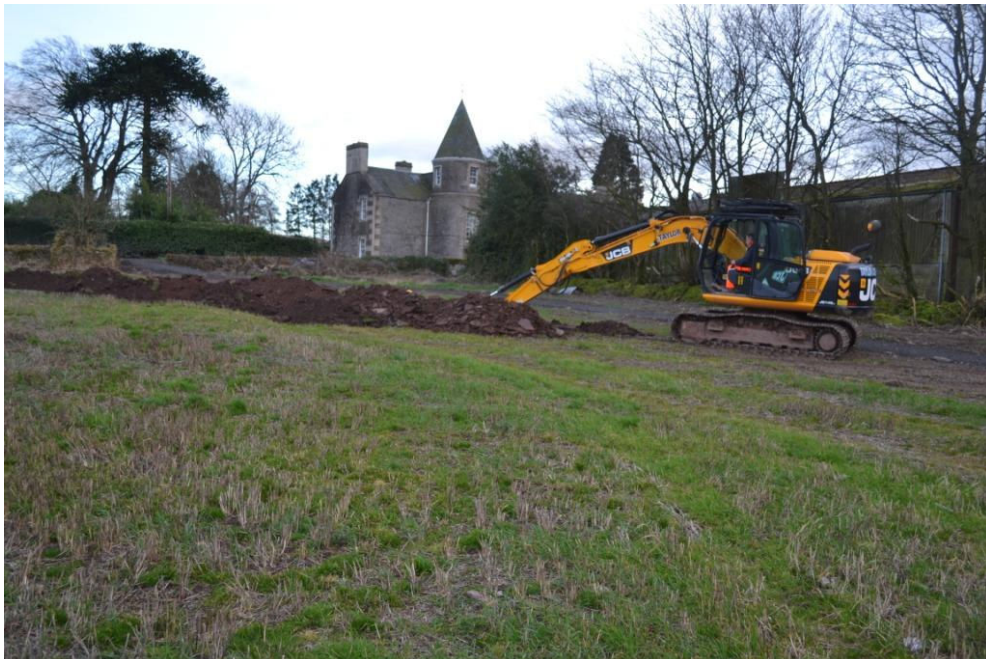
AA13_057 Excavating trench B, view SW

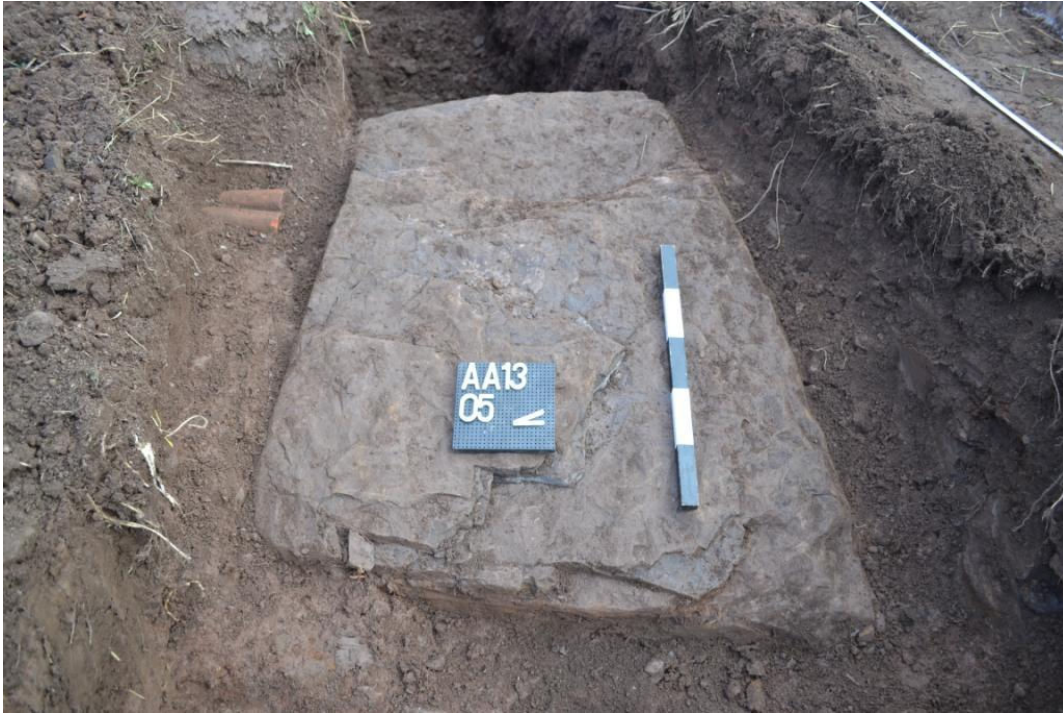
At 25.30m from the trench E end a large rectangular stone (05) which appeared to have been quarried was found just below the top soil. It had dimensions of 1.33 X 0.75 m and was 0.40 to 0.50m thick; it was resting on smaller broken rock and clay, with some smaller stone set against its edge. Stone (05) was overlain by a pair of red ceramic field drains (07) aligned N-S. Adjacent to stone (05) on its W side was a second large stone (06) with dimensions of 0.66 X 0.33m and 0.30m thick. It entered the S edge of the trench. Both of the stones were unworked and had been quarried from the natural local bedrock. The function of these stones was not ascertained.

AA13_015 Detail of large stone ctx 05, view SW

Trench A revealed two large quarried stone blocks (05) and (07) laying horizontally just below topsoil towards the trench E end. There were no distinguishing marks on these stones. A pair of red ceramic field drains, most likely 19th C, extended over the top of block (05) indicating that the stones had arrived at their location before the insertion of the field drains. It is uncertain why these stones should be at this location. As the stones are close to the S boundary of the field it is possible that they have been moved here as field clearance removed from further into the field.

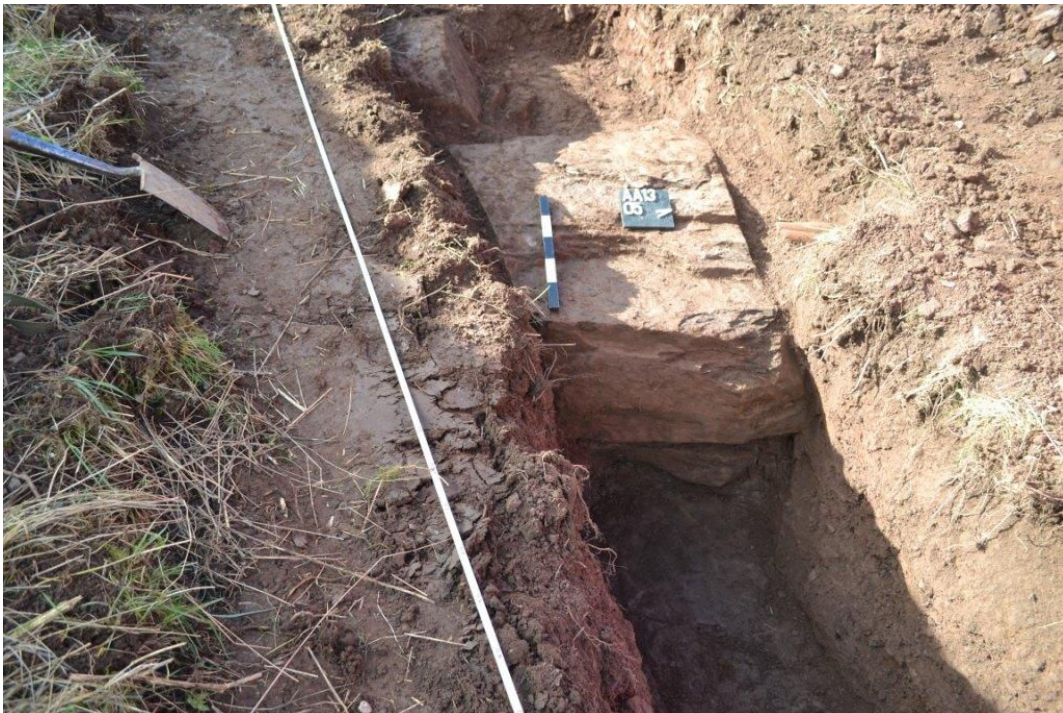
AA13_017 General of large stone ctx 05 view NW

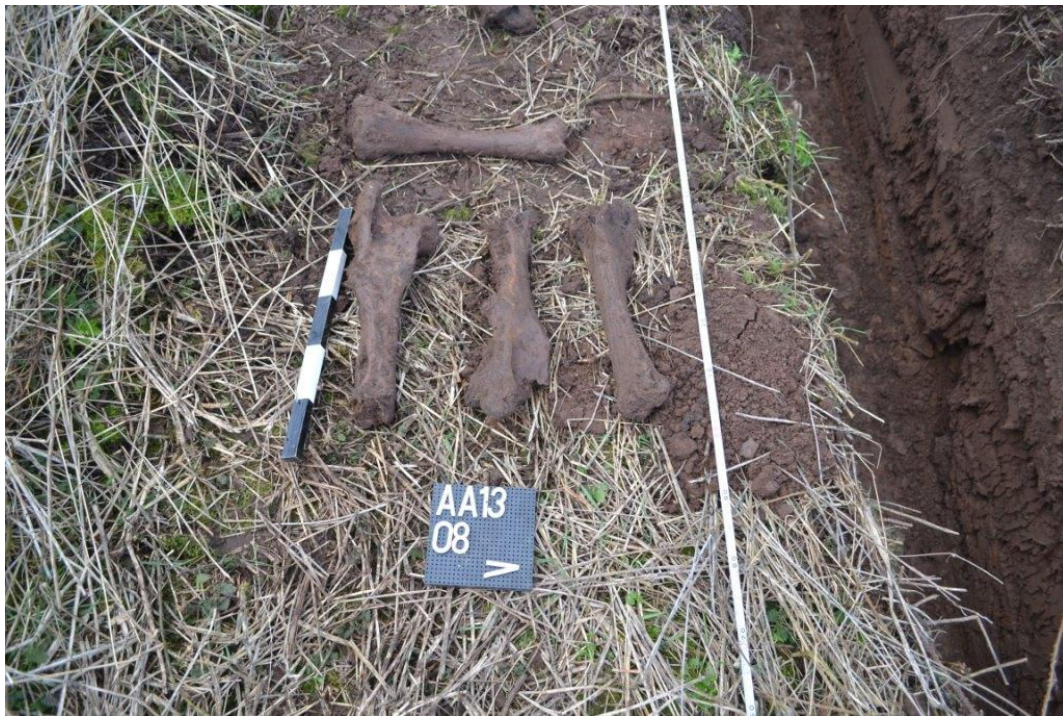
To the W of stones (05) and (06) at 53m from the E end of the start of the trench was a soft deposit of silty loam (08) between topsoil and bedrock, comprising a mix of topsoil and subsoil which appeared similar to subsoil (02). This deposit continued westwards for 9.5m and was about 0.70m in depth. Deposit (08) appeared to be a fill of a large cut into the sub soil but the actual cut was difficult to discern. It was considered that this deposit may represent the fill of a ditch but was located slightly to the W of where the moat was thought to be. Some modern horse bones, were recovered from deposit (08) (see finds Appendix 4 below).

AA13_039 Animal bones recovered from trench A in deposit ctx 08, view W

Context	Material type	Details
08	Animal bone	Horse right tibia lateral length (Ll)=413mm estimated withers height =17:2 hands
16	Pottery	1 TGE jar fragment; buff fabric, glazed white 1 TGE rim sherd; buff fabric, glazed white 1 TGE base sherd; white fabric, glazed white; very abraded (water-rolled) 1 post- medieval/modern redware sherd; glazed yellow
16	CBM	2 redware sherds, possibly floor tile 1 redware ?pantile or drainpipe fragment
16	Fe	1 nail; square sectioned shaft, head flat oval or rectangular; Type A (medieval to 19th century)
16	Animal bone: cattle	1 left tibia; both ends unfused, juvenile 1 left tibia; both ends unfused; neonate or juvenile 1 right calcaneum; neonate or juvenile 1 metatarsal; neonate or juvenile 1 distal femur; neonate or juvenile, gnaw marks on shaft

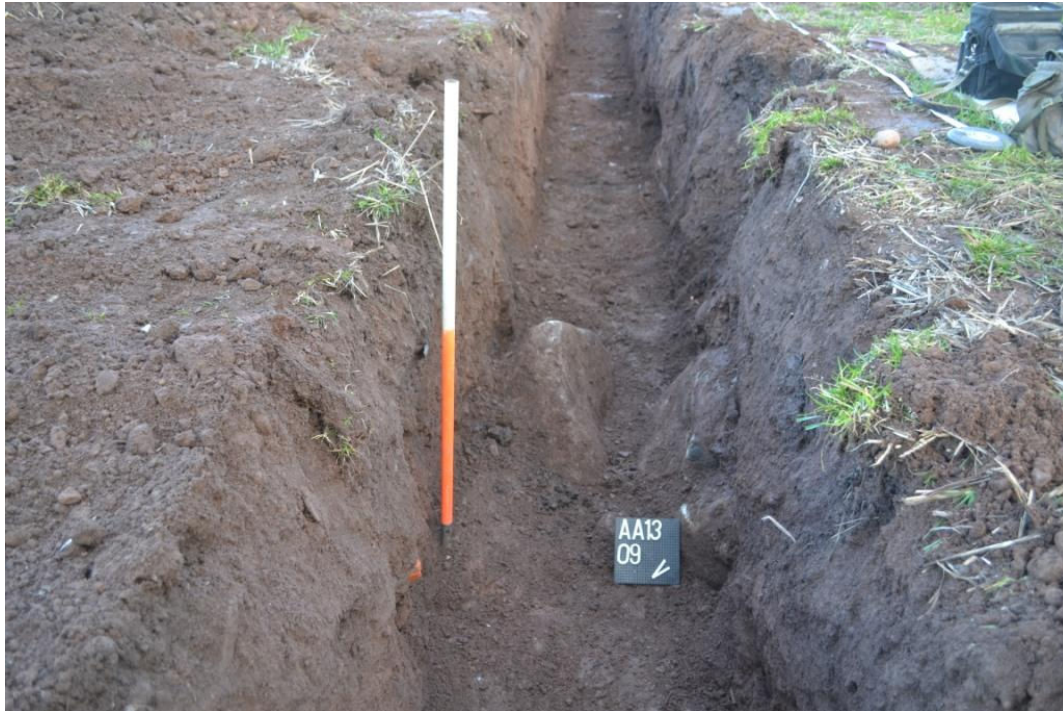
At 15.70m to the NW of the trench SE end a group of large sub rounded loose stones or small boulders (09) crossed the trench close to the base of the topsoil. A typical sized stone measured 0.86 X 0.54 X 0.65m. There were four such boulders within the confines of the trench and further boulders extended into both sides of the trench. These boulders appear to have formed a rough wall probably part of an enclosure.

AA13_047 Stones in trench B, ctx 09 partially excavated, view NW

Trench B revealed a group of loose sub rounded small boulders (09) crossing the trench towards the SE end. The function and date of deposition of these boulders is not clear but it is possible that they formed the base of a wall of unknown date. Such a wall may have subdivided the field prior to 19th century land improvements.

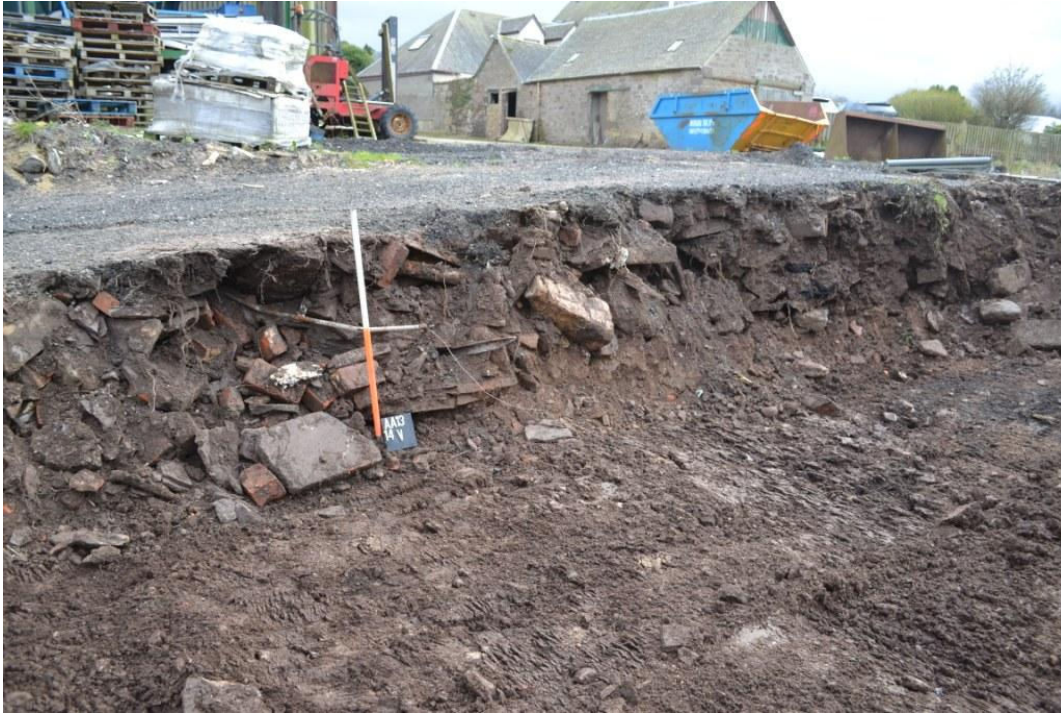
AA13_090 S edge of trench C showing character of ctx 14, view SW

The dumped material (14) included demolition material of brick, stone, wood, rubble and soil and general farm waste and building waste which had a maximum depth of at least 1.80m. Deposit (14) had been dumped mainly over former topsoil and natural silty clay, but partly over the mortar floor of a small 19th C building (18). The floor (18) was 0.20m thick and overlay an earlier yard surface (16). The yard surface (16) comprised cobbles in a matrix of black silty loam with inclusions of animal bone and 19th C pottery 0.30m thick over bedrock (15). Below the cobbles of (16) was an accumulated deposit of black organic silt with twigs and small fragments of wood (19). In general natural bedrock (15) was located only 0.25-0.30m below the reduced level of the site surface, and was reduced by pecking to form the cable trench 1m in depth.

Trench C at its E end was cut through deep modern midden (14) which reached a maximum depth of 1.80m. Below the midden the remains of the floor of a building (18) a cobbled yard surface (16) and an organic deposit (19) were found. These deposits, which contained modern pottery, were considered to relate to two 19th C buildings which are shown at this location on the OS 25 inch 2nd edition 1901.

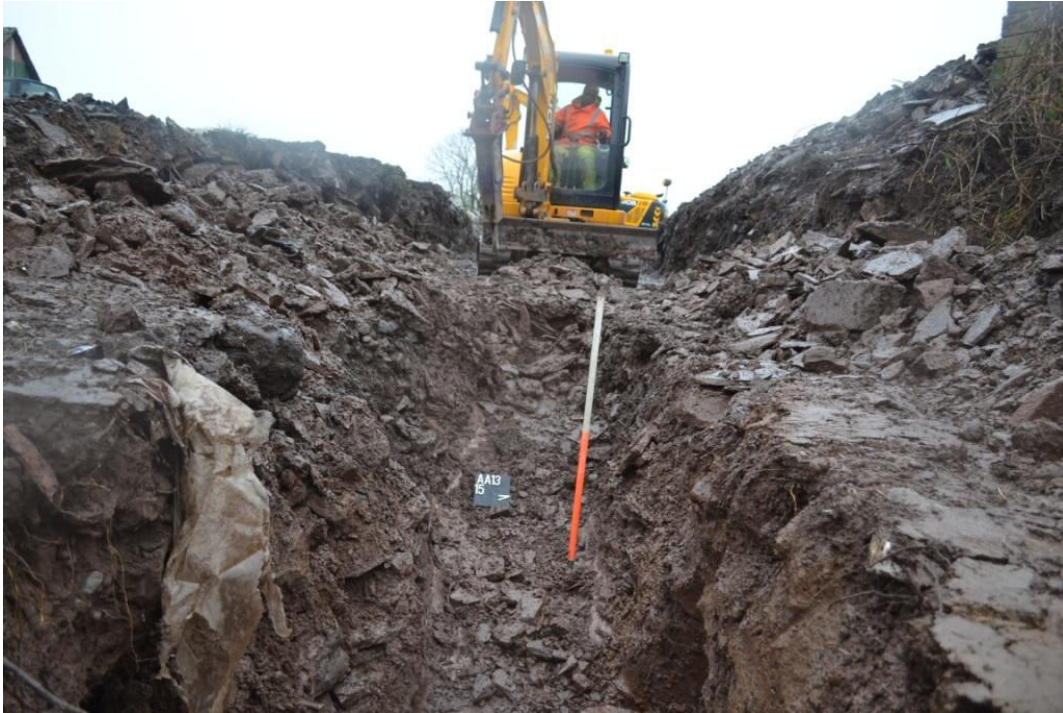
AA13_097 Pecking out bedrock trench C, ctx 15, view W

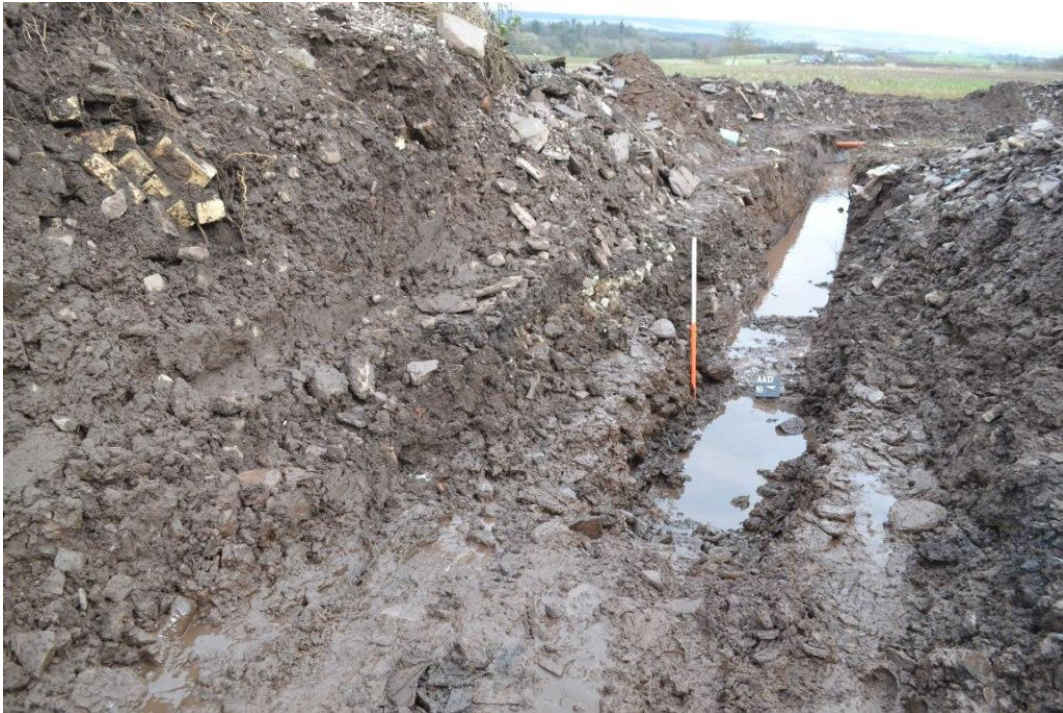
AA13_126 Trench C, ctx 19, black organic silt, view E

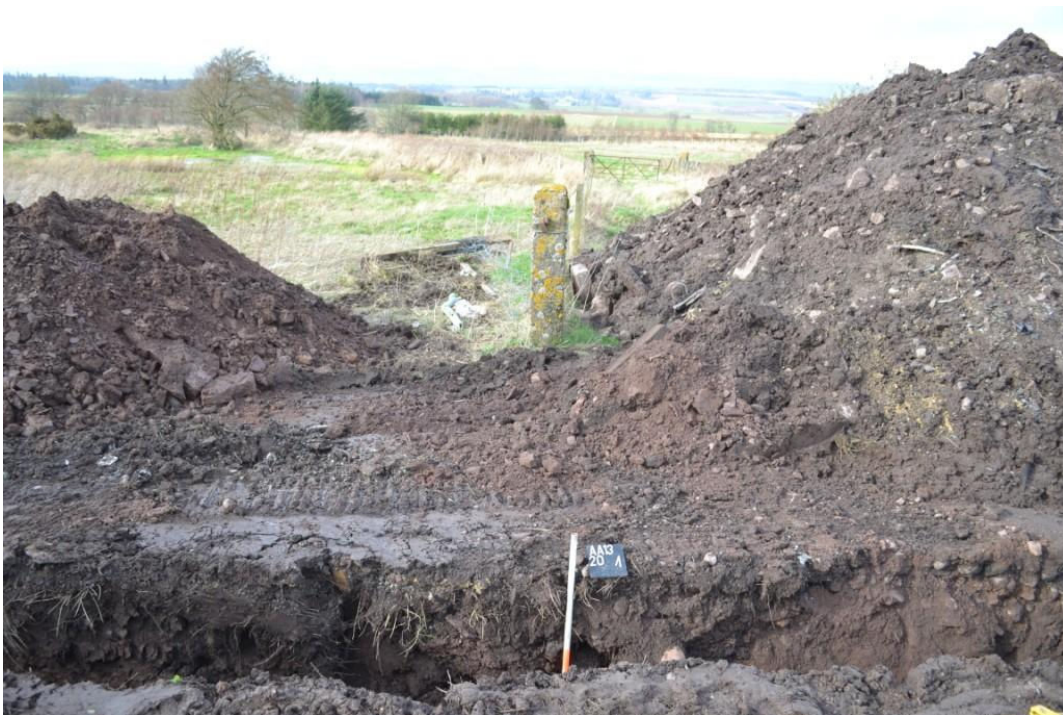
At a distance of 22m from the E end of the trench two ceramic drains ran alongside each other into a septic tank located on the N side of the trench.

AA13_134 Trench C ctx 20, pipes crossing cable trench to septic tank, view N

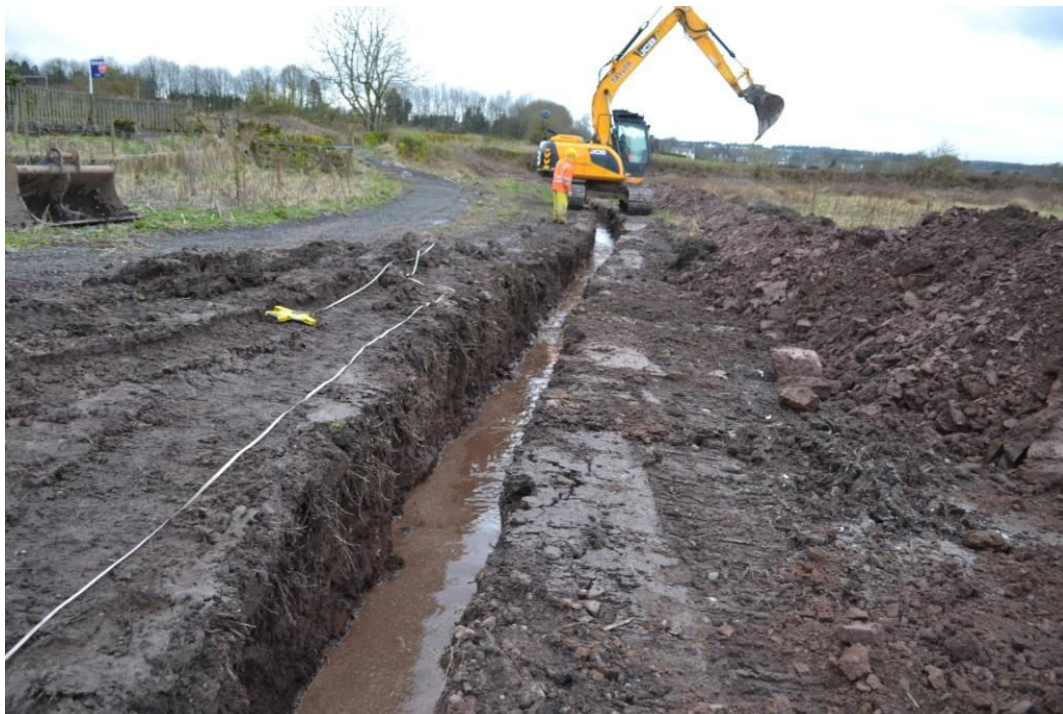
Trench D was the westward extension of trench C from the midden deposit (14) to the field boundary wall at the W end of the watching brief area of interest, a distance of 56m. Topsoil here was 0.30m in depth over subsoil, orange brown silty clay down to 0.75m onto stony compacted clay over friable easily fragmented natural rock at a depth of 1m. Three rubble field drains were recorded in trench D. The field drains were located by measuring from the E end of trench D. The field drains were located at 3.50m at a depth of 0.90m, at 9.50m, at a depth of 0.90m and at 17m where the rubble drain was 0.60m wide and 0.40m deep and at a depth of 0.40m bottoming onto the subsoil. Due to the wet weather conditions water accumulated in the trench and it flooded almost as soon as it was excavated. Apart from rubble drains nothing of archaeological significance was recorded in this trench.

AA13_135 Cable trench flooding, W end of trench C and E end trench D, view W

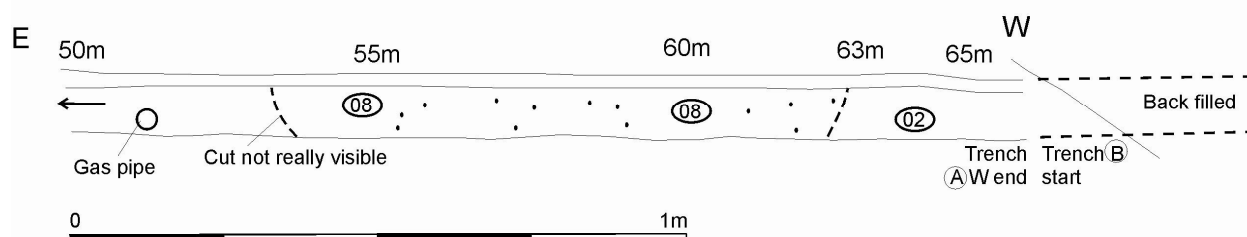
Illus3 North facing section of Trench A, location at 08

Illustration 3: N facing section trench A possible ditch deposit ctx 08

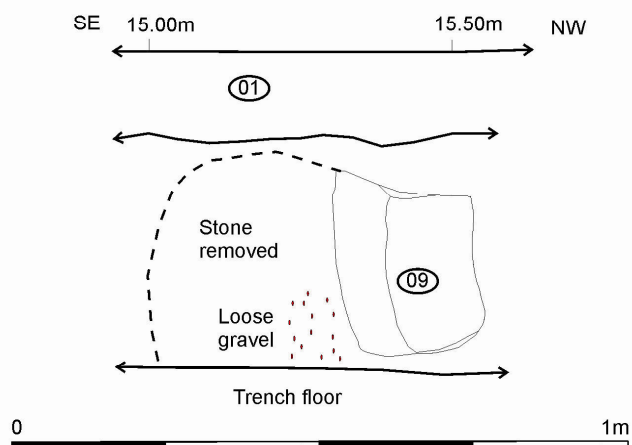
Illus4 Northeast facing section of Trench B, large stone ctx 09

Illustration 4: NE facing section trench B stones ctx 09
