Archaeological Watching Brief
A93 / B951 Lair Junction Improvement
Glenshee
PERTH AND KINROSS
BL02

**ARCHAEOLOGICAL WATCHING BRIEF
A93 / B951 LAIR JUNCTION
IMPROVEMENT
GLENSHEE, PERTH AND KINROSS**

BL02

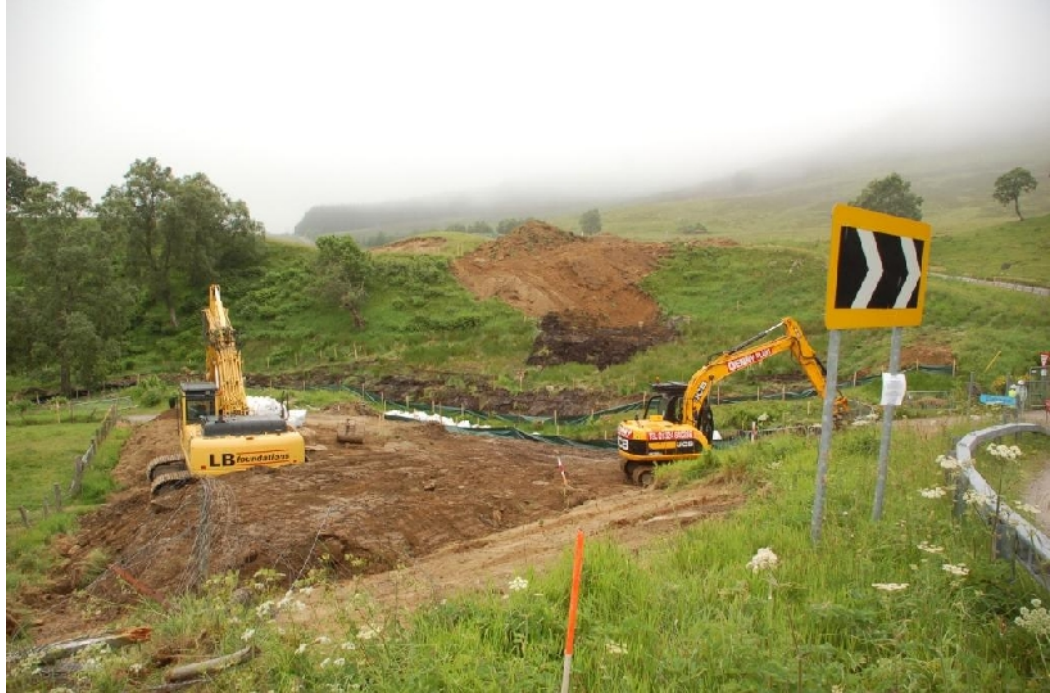
BL02_219: Groundworks over Allt an Lair to E of Lair bridge, view S.

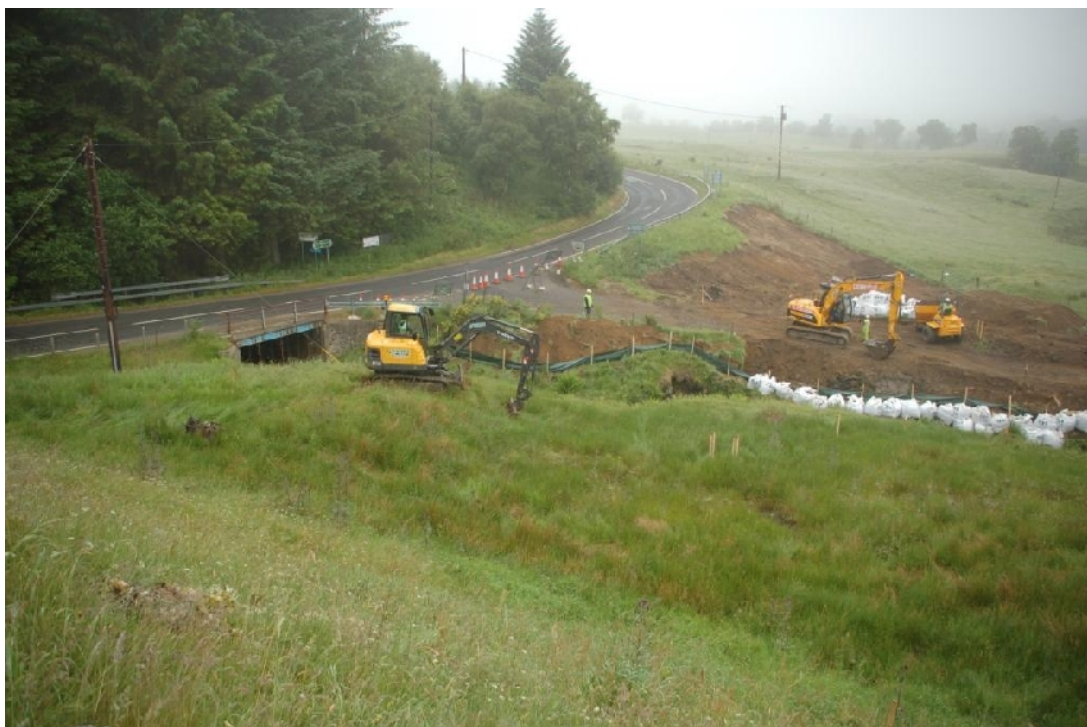
BL02_159: General groundworks over Allt an Lair, view N.

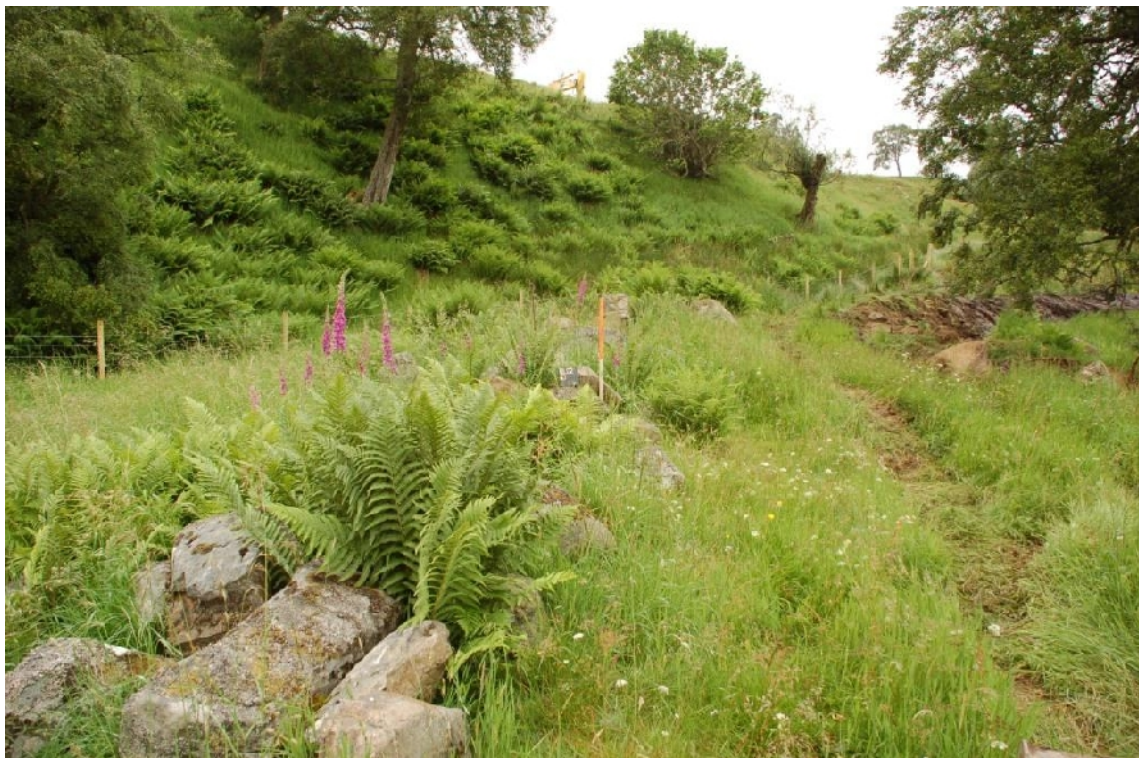
BL02_189: Row of field clearance boulders (10), in field on S side of Allt an Lair, view W.

10	Boulders, line 30m long and 3m wide appears to be field clearance for a small flat area between steeply sloping ground to the S and the Allt an Lair: at NO 14278 63240 to NO14250 63237
11	Bridge, original bridge at Lair Junction , original stone arch forming core of bridge, 4.50m wide 1.75m high, stonework recently sealed; later extended by 2.40 on each side with steel beams and stone abutments, total width 9.20m; at time of visit the bridge was supported with acrow props
12	Blue grey clay, modern clay plug in recent borehole 0.42 X 0.33m and to a depth of at least 0.60m at first seemed to be significant but upon further investigation was deemed to be part of geotechnical works for new road works NO 14281 63278
13	Stony area in field opposite gate on N side of B951; accumulation of fieldstones of various sizes forming hard standing in field at gate site, dumped and natural stones, area approximately 4 X 2m at NO 14250 63290

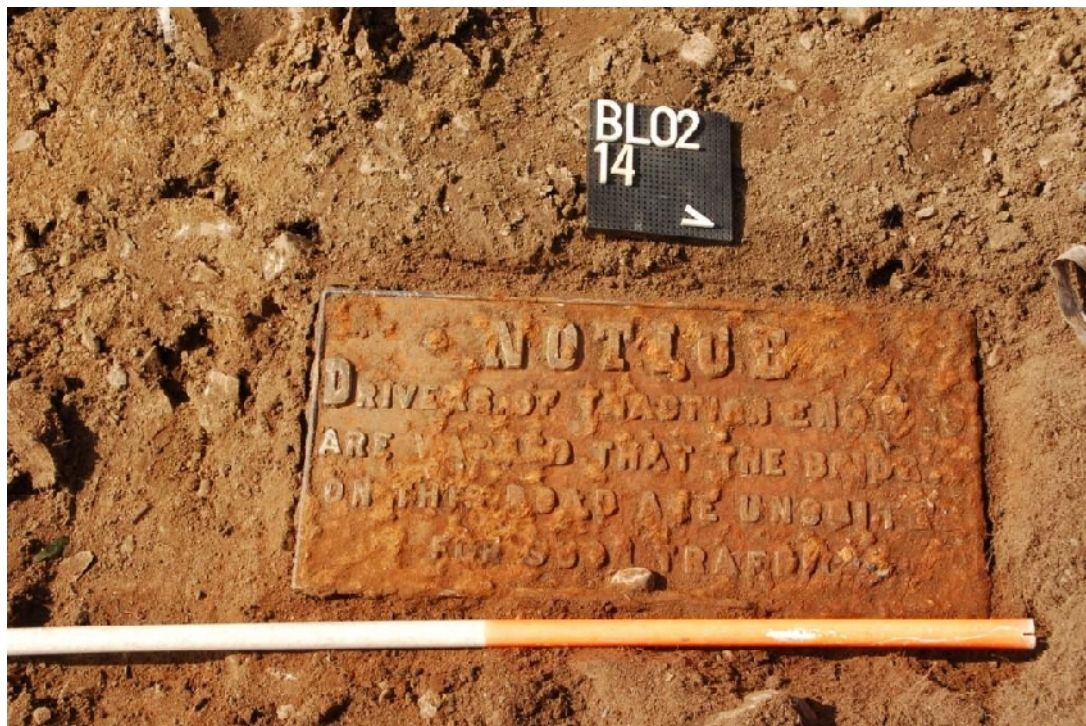
BL02_244: Context 14, metal sign warning traction engines of unsuitable bends.

14	Cast iron road sign, somewhat corroded, measuring 0.63 X 0.32m and 0.003m thick; 'NOTICE Drivers of Traction Engines are Warned that the Bends on this Road are Unsuitable for Some Traffic' located at NO 14330 63261, just below topsoil, approx 1.3 M of fence line on N side of B951
15	Find, horseshoe in topsoil located approximately at NO 14248 63447, Horseshoe. Toe area worn. Calkins absent, length 117mm, breadth 115mm, thickness 7.4mm most probably 19 th C
16	Cut for modern test pit 2.20 X 0.65m not bottomed but at least 0.60m deep, backfilled with sand (17), located at NO 14244 63416
17	Clean sand backfilling into modern test pit cut (16)
18	Dark silty loam, deposit created by runoff from road, two layers of cobbles covered by this deposit on its S side, runoff has created erosion at edge of A93
19	Metal conduit running below A93 N of ctx 18, modern drain to carry excess water from W side of road to field on E side of road in field at NO 14249 63409

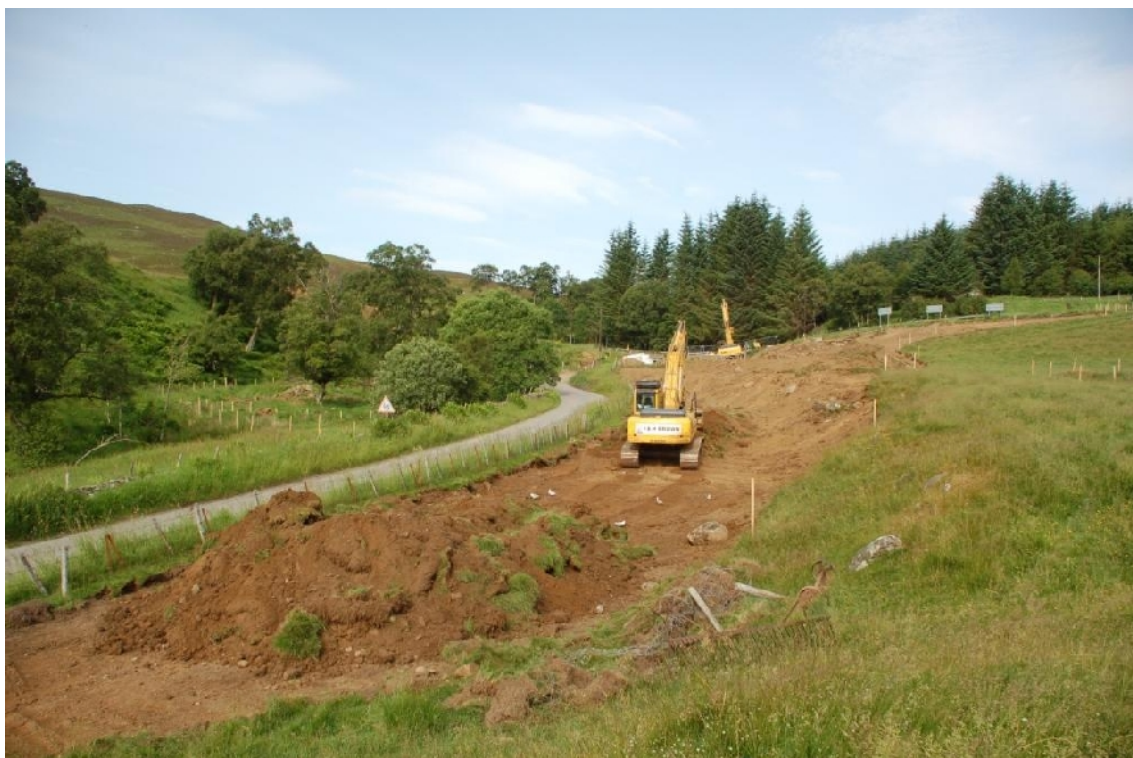
BL02_242: General working on the N side of the B951 and Allt an Lair, view W.

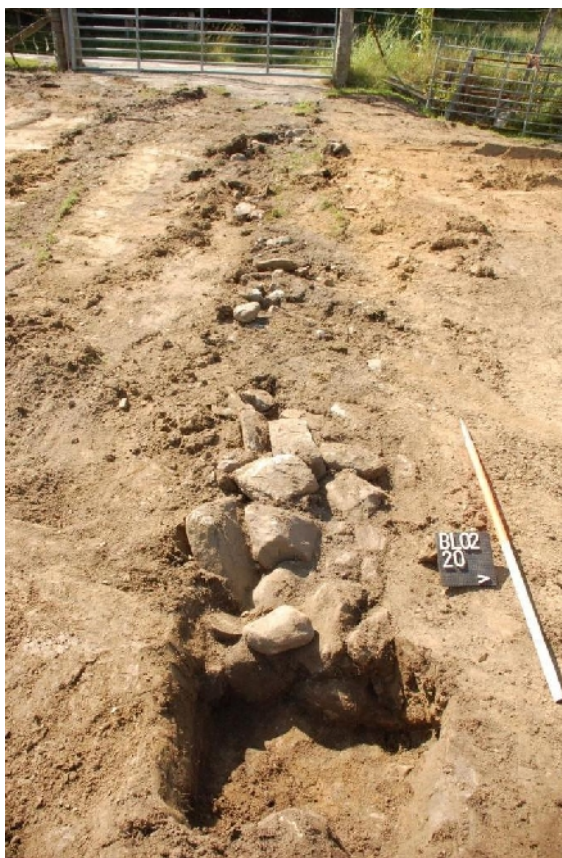
BL02_282: Cobble drain (20), view W.

20	Line of large cobbles forming drain two layers deep, running into field from E edge of A93, to take runoff from the road into the field, field drain 0.50-0.60m wide extending 16.30m into field as measured from field gate edge, aligned NE-SW; to channel water washing down the slope of old military road on W side of A93, no finds
21	Cut for cobbles 20, steep sides flat bottom 0.50-0.60m wide and 0.30m deep, cut into subsoil and natural, aligned NE-SW
22	Tarmac surface of A93, 0.28m thick over type one bottoming deposit, observed in trench, 0.70m deep excavated across the road for drain
23	Compacted stones 0.22m thick below tarmac 22, overlying natural sandy clay bottoming for tarmac, no earlier road metalling at this location
24-29	Not used
	Old military road formation of new field gate entrance
30	Orange brown clayey subsoil below topsoil
31	Brown sandy clay and silt containig a leather shoe or boot at south end of excavated area for new field entrance, in cut 40

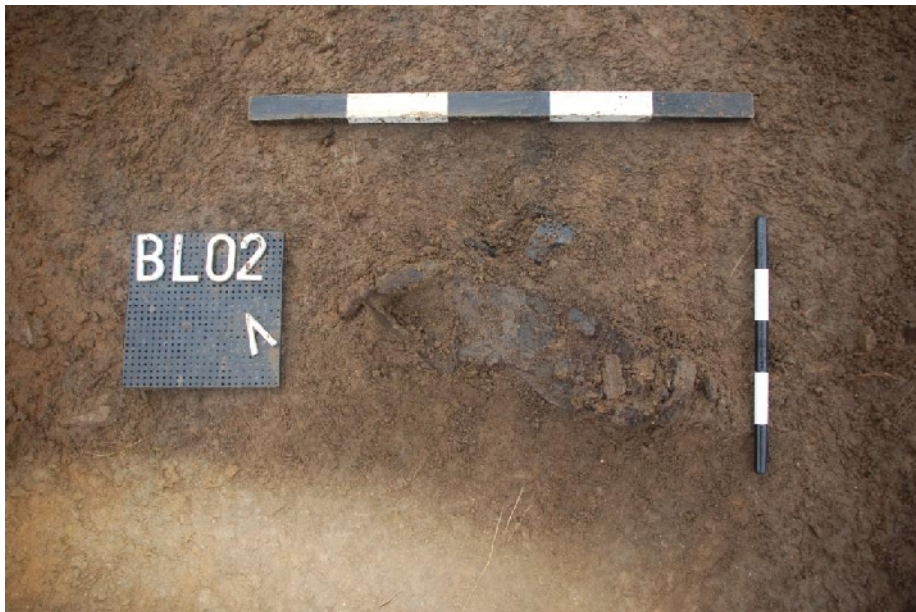
BL02_366: A boot or shoe found on E side of old military road embankment.

Further work was undertaken on 4 April 2014 to remove the boot and to clean and plan the exposed area. Further heavy cleaning of the ground revealed the presence of four pits cut into the yellow brown silty clay subsoil (34). These pits appear to have formed parts of a shallow ditch with a V-shaped profile on the E side of the embankment of the old military road.

The southernmost pit (cut 40 and fill 31) contained the boot. The pit measured 1.60m x 1m and had an uneven base. It was 0.08-0.15m in depth, subcircular and filled with brown sandy clay and silt (31). Apart from the boot, bottle fragments, some modern pottery sherds and a corroded metal staple were found within fill (31). The S end of this pit extended into the S baulk of the excavated area.

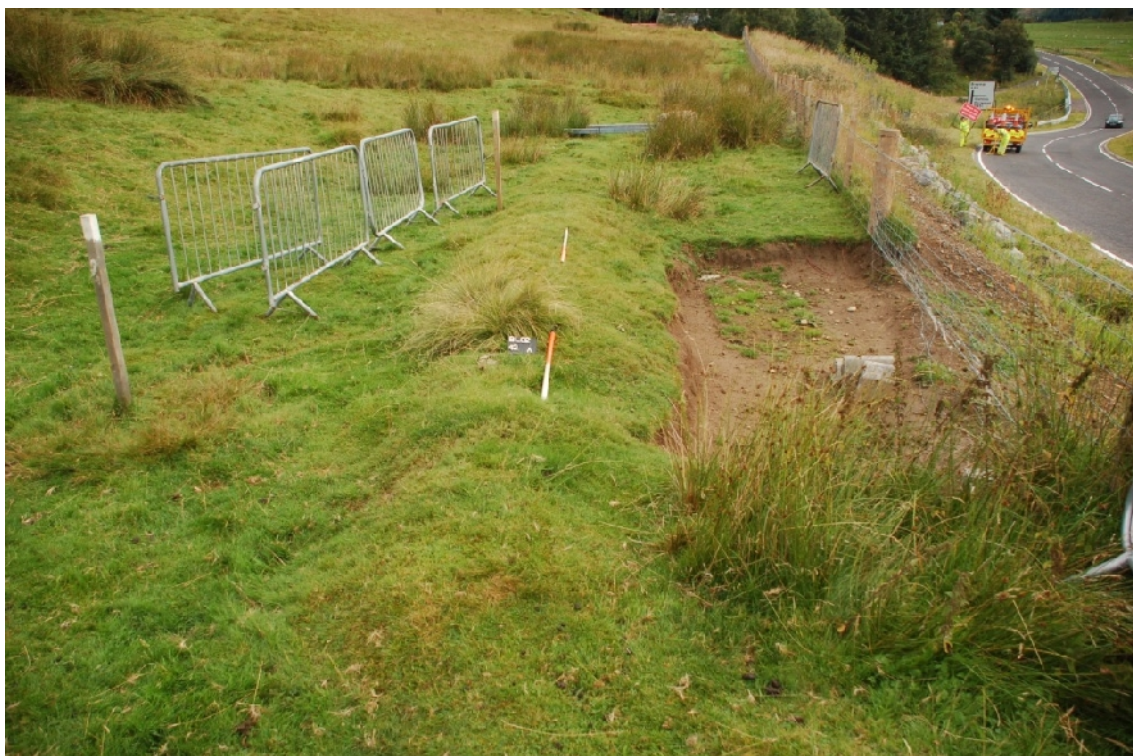
BL02_370: Old military road embankment (42) with previously reduced area on the E side, view N.

The embankment was made up of a deposit of homogeneous orange brown silt or silty clay (42), interpreted as redeposited subsoil. Within the deposit were inclusions of small to large field stones (43) intermittently and loosely set centrally within the bank; these stones did not form a comprehensive core for the embankment but seem to have been placed rather randomly as the road was being constructed. The base of the cut revealed subsoil virtually the same as (43) but about 0.02m below this subsoil was a natural deposit of very light orange silt, seen in a small sondage.

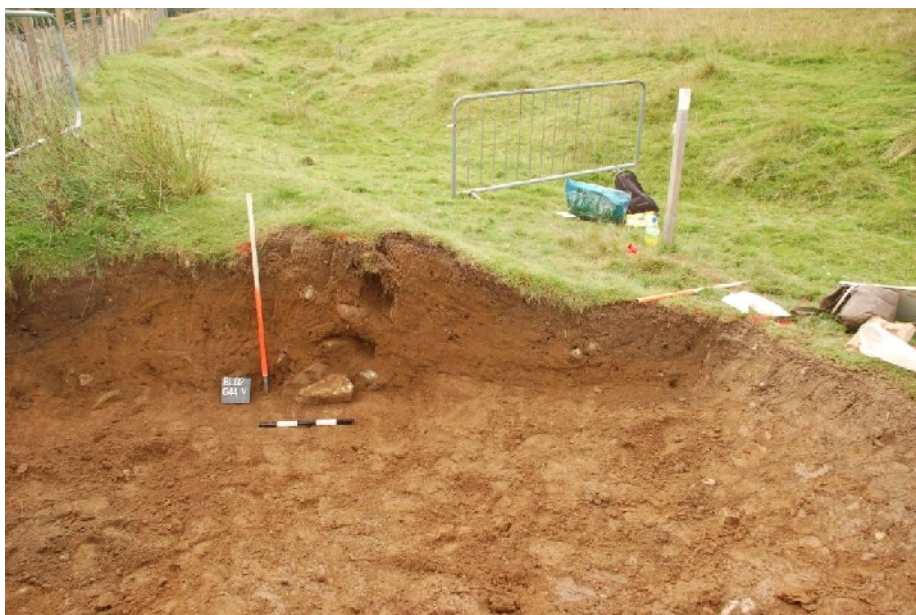
BL02_419: North-facing section of old military road embankment, view S

On the W side of the embankment, the edge of the carriageway had been cut and revealed a deposit (45) of dark grey, loose, silty loam, 0.30m thick, with a moderate amount of stone inclusions. This deposit did not conform to what may have been expected of a road carriageway as there was no metalling; it can only be assumed that the metalling had been stripped out, probably for reuse when the A93 was constructed. This would have made sense since this section of the old road is adjacent to the later realignment.

On the E side of the embankment it could be seen that the embankment had been partially cut away (cut 50). The redeposited fill in the cut, grey silty loam (49), contained modern material such as plastic cord. This cutting may have occurred as part of the construction of the A93 which superseded the old military road.

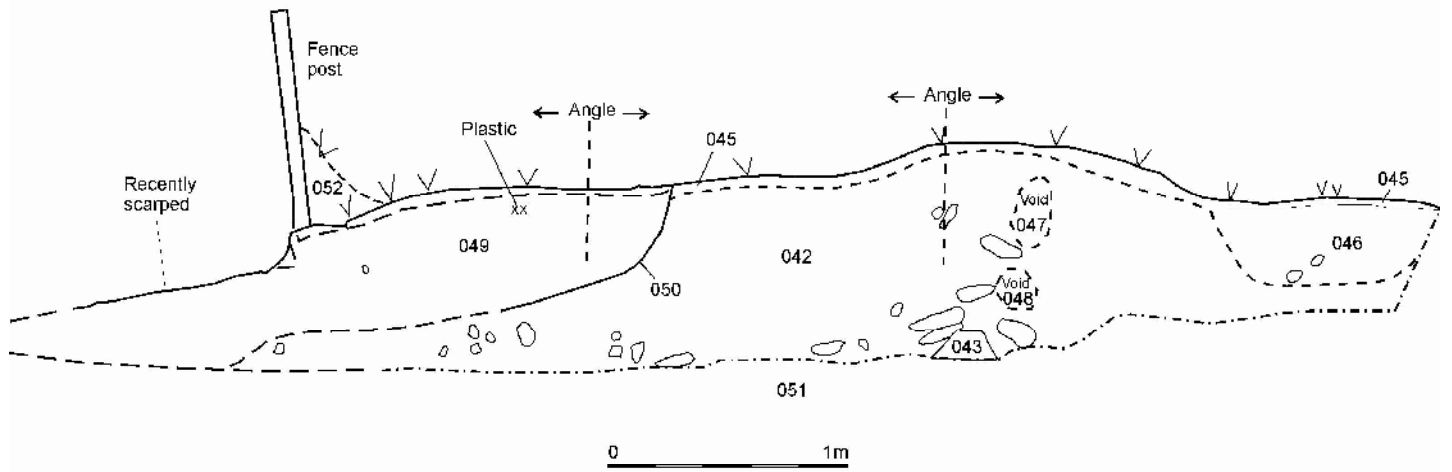
Illus4

Section 05, North-facing section, South side of ground reduction
for new field entrance through old road embankment
