Archaeological Building Recording
Old Lodge
Straloch
BLAIRGOWRIE
BW08

**ARCHAEOLOGICAL BUILDING
RECORDING
OLD LODGE
STRALOGH
BLAIRGOWRIE**

BW08

A record of Straloch Old Lodge (NGR NO 0413 6422, site code BW08) was drawn up for Hebridean Contemporary Homes Ltd in December 2014 and January 2015.

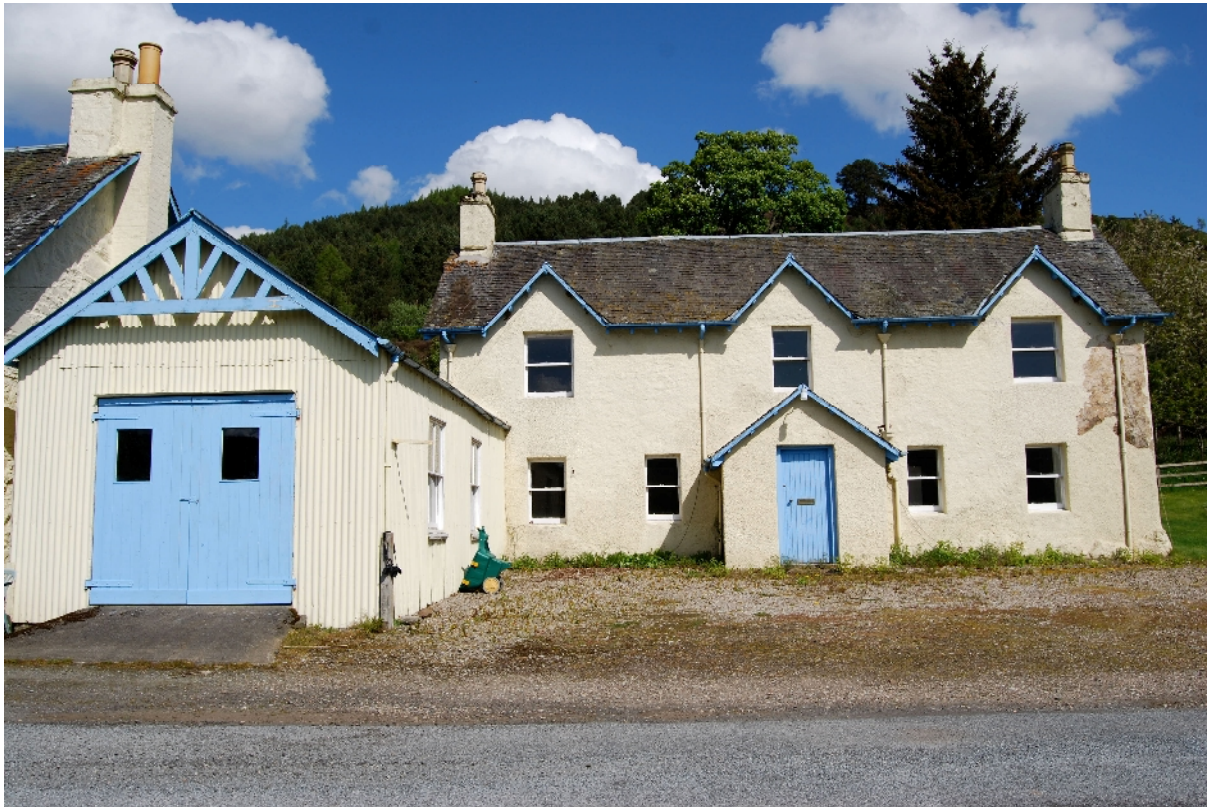
Old Lodge, S Front. Bothy to Left

005	<p>Old Lodge, S Front. Bothy to Left.</p> <p>Lodge, symmetrical layout, with central porch and four windows on ground floor, three windows on first floor, central window slightly smaller. Boulder foundation seen in E gable wall continues round to S front wall, at least as far W as first window. Not seen W of central porch.</p> <p>Roof slates possibly in diminishing courses. Some sagging of roof at either end, close to chimneys.</p>	N

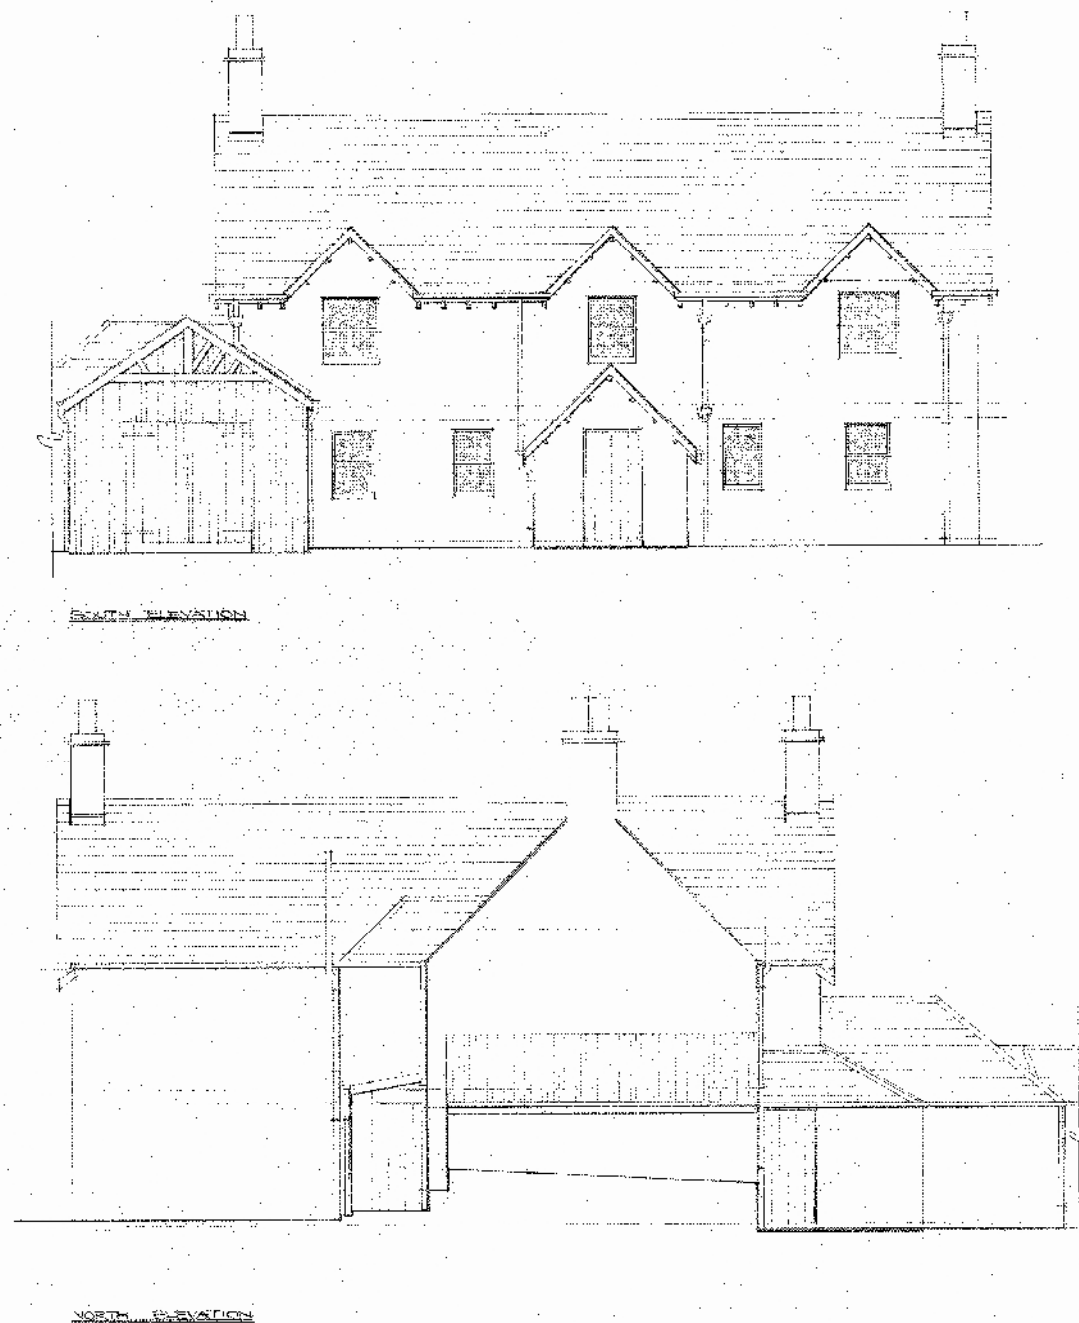
Illus 7

In the re-entrant angle between the main block and the kitchen block was a small square tower block. On the ground floor was a single windowless room with an external door but no connection to the rest of the house. This could have been an outside lavatory or a coal store. On the first floor was a single room with a small window, perhaps a box room. On the N side of the tower block had been a single-storey shed also with an external door; this shed was demolished in 1995 when a window was inserted into the adjoining kitchen wall. The roof scar of this former shed was still visible in 2014 (see Illus 5, 7, 8 and 11)

N and S elevations as drawn by Finlayson Hughes, 02 March 1995

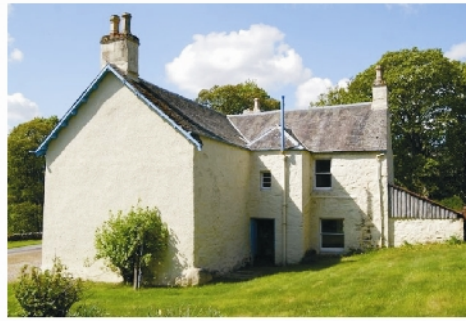
One peculiarity of construction is the visible boulder foundation in the E gable wall and adjacent parts of the N and S walls. Large boulder foundations are a traditional feature of rural buildings in Perthshire, and the visibility here may only be because the slope of ground exposes the foundations at this point. It is possible that this end of the building is a surviving fragment of an earlier phase, incorporated into an expanded building later, perhaps reflected in the transition seen in the Cartographic Evidence (3.2 above), between 1862 and 1899.

11 Old Lodge, E elevation

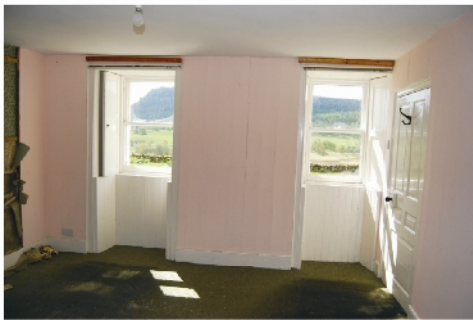
The rooms had cast-iron fireplaces in the gable end walls. Investigations prior to the recent demolition showed that the walls were generally lined with lath and plaster. On the ground floor, the W room was lined to waist height with tongue and groove boarding, while the E room had been lined from floor to ceiling, covering up mid 20th-century wallpaper on lath and plaster. Every room in the Lodge had three external stone walls. The Lodge was located about 1,000 feet above sea level, partly set into rising ground to the N, and overshadowed by Kindrogan Hill to the S. It is not difficult to guess that rising damp and bitter cold may have been recurring problems at most times of the year, to which the timber lining may have been a response.

009	Old Lodge East front room windows. Room lined with vertical wooden boards, papered and painted over. Window splays lined with narrower tongue and groove boards. Wooden shutters still in place. Late 19 th – early 20 th century? Six-panel door in SW corner of room leads to entrance hallway. .	S
010	Old Lodge East front room. East gable wall with 19 th cent fireplace in situ, tile and cast iron.. Vertical lining boards partly removed to reveal earlier wall finishes. Include mid-20 th cent wallpaper, lath and plaster, and plaster on the hard. Bottom 0.5 m of wall has solid grey cement finish behind boards and wallpaper.	NE
011	Old Lodge West sitting room from hallway. Hallway lined with vertical tongue and groove boards to shoulder height, and on ceiling. Interesting curved partition wall. Light panel door to sitting room. Sitting room has fireplace in W gable wall, with bright blue tile surround, perhaps mid 20 th -century. Tongue and grove boarding to waist height on gable wall. Door to kitchen at N end of hall, vertical planks with ledgers and diagonal brace, traditional farm cottage type.	NW

12 Ground Floor, E Room

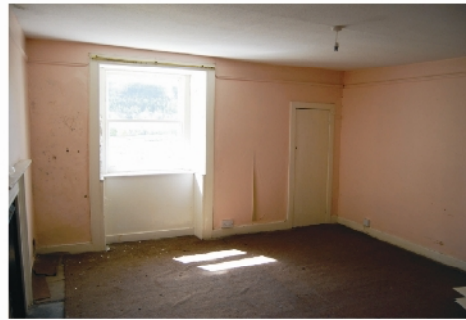
012	Old Lodge W sitting room, windows to S front. Walls lined with tongue and groove boarding to waist height. Window splays fully lined. Shutters still in place. Doorway to hall is six-panel, but lightly built.	S
013	Old Lodge W sitting room. NW corner of room. General view of tile fireplace. Lining boards removed behind storage heater to reveal air space and masonry of N wall. N wall apparently windowless, probably due to slope of ground behind.	NW
014	Old Lodge Kitchen East window (not original). Deep splay indicates thickness of wall. Low, boarded ceiling. Mid 20 th -century cupboards and fittings. N wall windowless, due to fuel store and slope of ground beyond.	NE
015	Old Lodge kitchen in rear extension. W window.	NW

13 Ground Floor, W Room

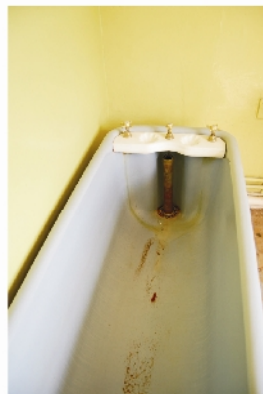
In the first-floor bathroom, the cast-iron bath tub with the distinctive arrangement of taps and remote-controlled waste pipe on a cast iron bridge at the end of the bath is a feature which has been seen in other farm cottages in Perthshire. Scotland, especially Glasgow, was an important centre for the production of sanitary wares, Shanks of Barrhead being a legendary example. The People's Palace Museum in Glasgow boasts a truly astonishing cast-iron bathtub and shower with pipes and valves to rival a fairground organ, while a very closely related example graces Kinloch Castle on the Isle of Rum, holiday home of Sir George Bullough, and frequent resort of his friend King Edward VII.

025	Old Lodge original bath. Enamelled cast iron. Cast-iron bridge supports taps and remote-operated waste plug. Ingenious but impossible to clean! Type seen in other farm cottages in Perthshire. Early 20 th century? Glasgow a major centre of production.	E

15 First Floor, Bathtub
