Archaeological Standing Building Survey
Oakbank Mill
Blairgowrie
PERTH & KINROSS

BW10

**ARCHAEOLOGICAL STANDING
BUILDING SURVEY
OAKBANK MILL
BLAIRGOWRIE**

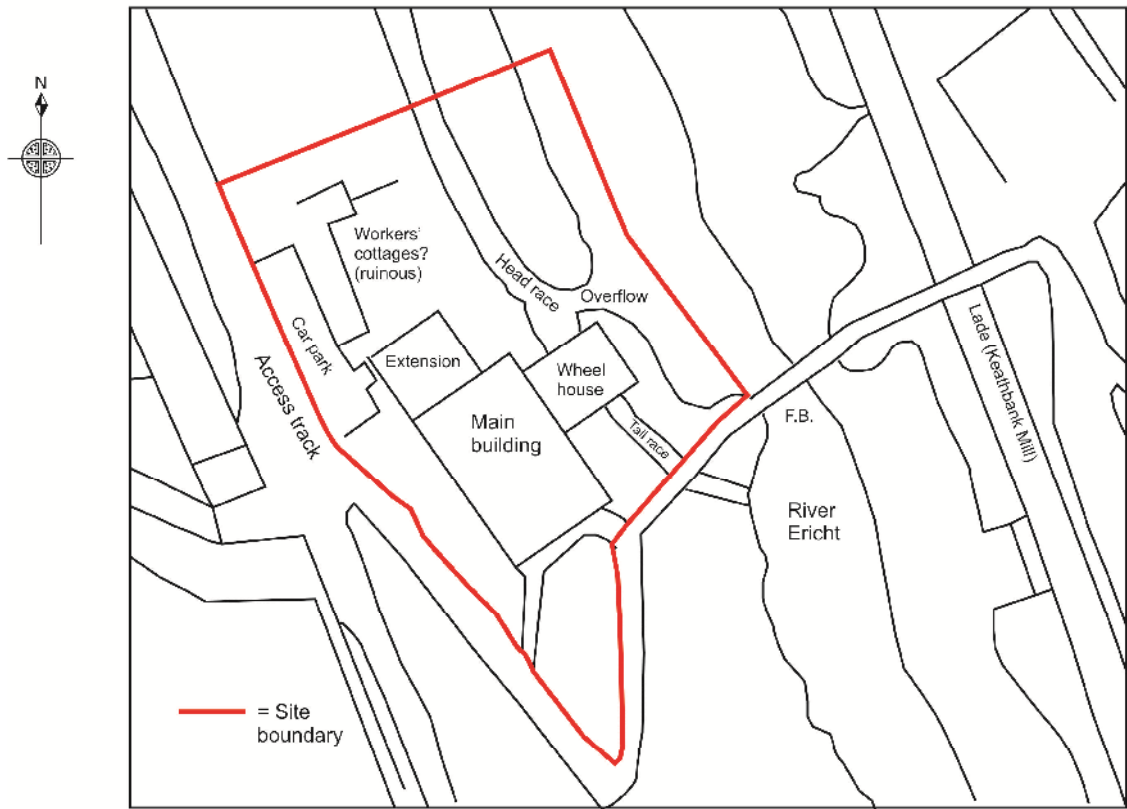
Illus 2

Oakbank Mill is situated on the west bank of the River Ericht where it runs through a gorge to the north of Blairgowrie, and somewhat to the south of the confluence of the Ericht with the Lornty Burn. This area features at least thirteen former mills dispersed along both banks of the Ericht between Craighall Bridge in the north to just south of Blairgowrie Bridge. The Oakbank Mill site is on a terrace cut into the riverbank, overlooking a modern footbridge and Keathbank Mill on the opposite bank. The mill is a single building aligned northwest-southeast.

Oakbank Mill, site plan

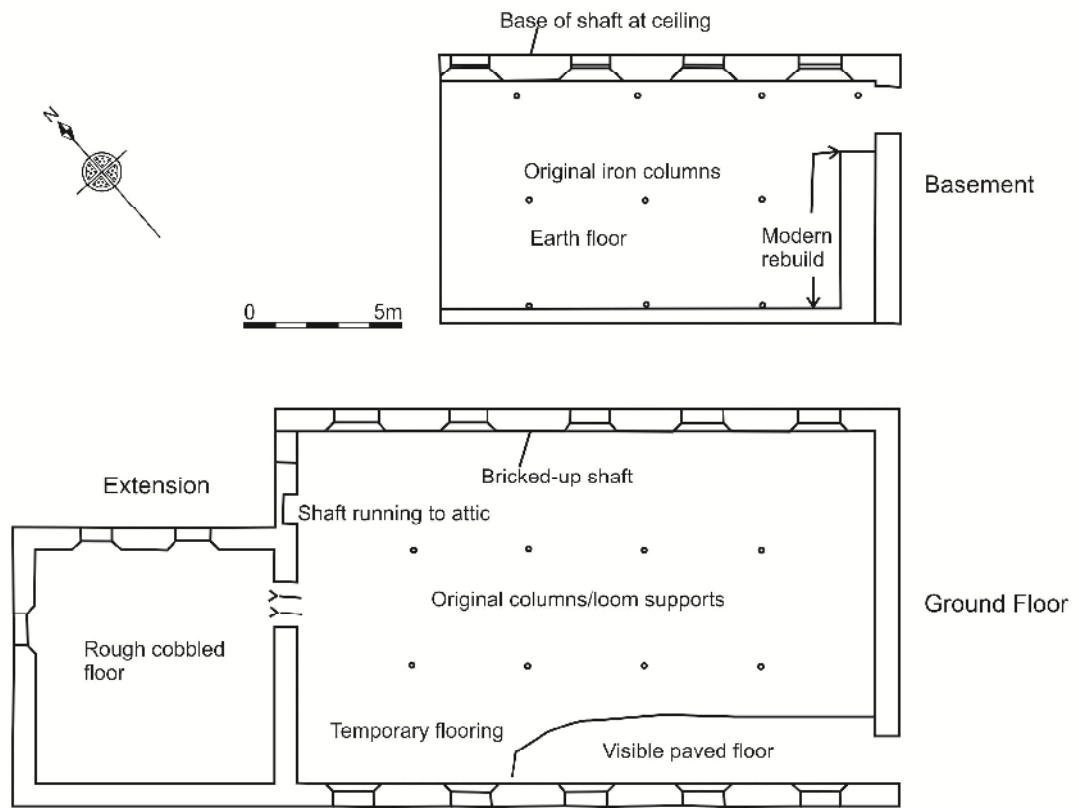
Illus 3

The single basement room (measuring 14.00m x 7.00m) had an uneven earth floor at the time of the survey, with unpainted modern blocks forming the entirety of the wall fabric in the south and west elevations from approximately 0.5m below ceiling height downwards. The north elevations was partially whitewashed, with traces of whitewash also apparent on the east elevation. The latter featured four replacement sash windows beneath replacement steel lintels within original stone embrasures measuring 0.50m deep and 1.70m wide. The base of a shaft built into the wall was noted just below ceiling height, between the two most northerly windows (see ground floor, below) Original circular cast iron pillars supported the replacement wooden ceiling joists, in three rows of three with an additional pillar just inside the doorway in the southeast corner of the room. The eastern row was slightly offset from the other two.

The ground floor main room (18.00m x 11.00m) featured original cast iron ceiling support pillars in two rows of eight, evenly dispersed along the length of the room; these also bore gallow-type crossbars below ceiling height, indicating an original function as loom supports. Severe cracking was noted along the internal south elevation of the room, which unlike the majority of the walls was whitewashed. A floor of grey

slabs was partially visible in the western half of the room, with temporary flooring covering much of the remainder. Prominent in the east elevation was the former machine/drive shaft also noted in the basement (see above), infilled with red brick and with iron bolts and washers in situ beneath a replacement joist. The shaft measured 0.75m wide, running from floor to ceiling. A second shaft or slot 0.86m wide and 0.26m deep, also extending from floor to ceiling, was noted in the north elevation, to the east of the doorway connecting with the extension. This shaft remained open. A small window measuring 0.90m high x 0.80m wide was located to the east of the shaft, with a replacement frame and stone lintel. The west and east elevations both included five embrasured windows, each 1.70m wide within an embrasure 0.50m deep. All the window frames were modern replacements and were boarded internally or externally at the time of the visit.

The northern extension (7.00m x 7.00m) was accessed via a temporary up-ramp and extended only from the western half of the main building. It appeared to feature a rough cobbled floor, although this may have represented rubble in-fill. The internal elevations featured extensive concrete and brick repair, especially apparent in the upper level (equivalent to the first floor in the main building) which appeared to have been almost entirely rebuilt internally. Two replacement windows were present at ground floor level in the east elevation, within embrasures 0.50m deep and 1.50m wide. Both embrasures featured extensive modern repair. At first floor level in the west elevation were a square window with narrow doorway to the south, both measuring 1m across. These faced out onto an external ground level- it should be noted that the extension was cut into a south-facing slope of the river bank, at the top of which was a level plateau above the level of the ground floor of the main building. Two first floor-level windows in the internal north elevation of the extension were of the same dimensions as those at ground floor level. The south elevation was whitewashed and graffiti was noted on the whitewash to the right of the lintel over the entrance at first floor level; this read "JT 1898 AO 1898". The wall fabric within the extension was somewhat more compact rubble, the majority grey stone rather than red, suggesting that the extension did indeed represent a different phase of construction from the main building.

Basement and Ground Floor plans

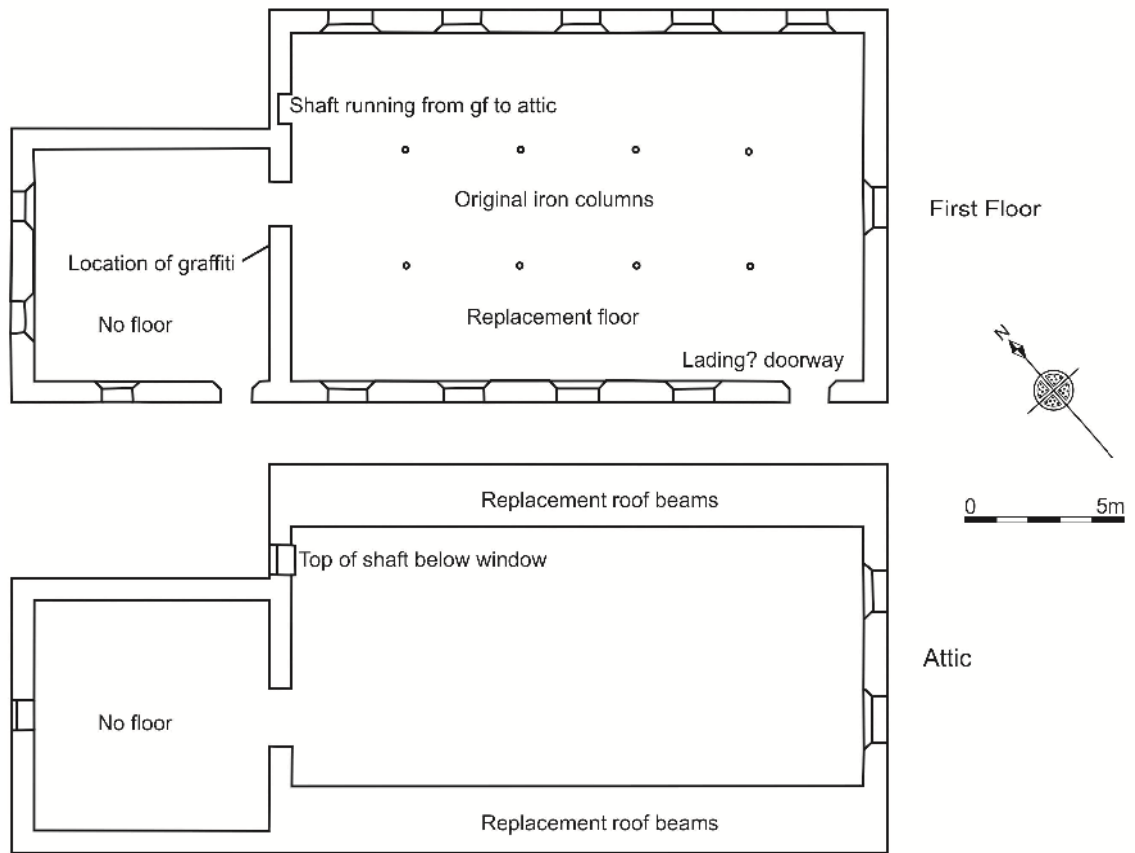
Illus 4

The first floor of the main building featured five windows in the east elevation and four in the west, with a doorway at the south end of the latter instead of a fifth window. This presumably reflected either a former external staircase or a service access for loading or removing raw material or spun jute via a crane or hoist. The window embrasures were as on the ground floor, while the doorway measured 1.54m wide and extended from floor to ceiling. The majority of windows and the doorway featured replacement steel lintels, and concrete brick repairs were apparent below the ceiling beams. The shaft in the north elevation continued from floor to ceiling, but the bricked-up shaft in the east elevation did not extend beyond the ground floor.

The attic room included the exposed replacement beams and A-frames of the modern slate roof. Two windows in the south elevation and one in the north were probably original, but featured replacement frames. To the west of the north window, a floor to ceiling aperture accessed the extension; this probably replaced an original window which had existed prior to the construction of the extension. The extant windows measured 1.80m across, within 0.50m deep embrasures. The shaft extending from ground floor to attic terminated to the east of the north window. This probably

originally contained drive machinery (such as a drive belt) as with the similar shaft in the east wall of the ground floor.

First Floor and Attic plans

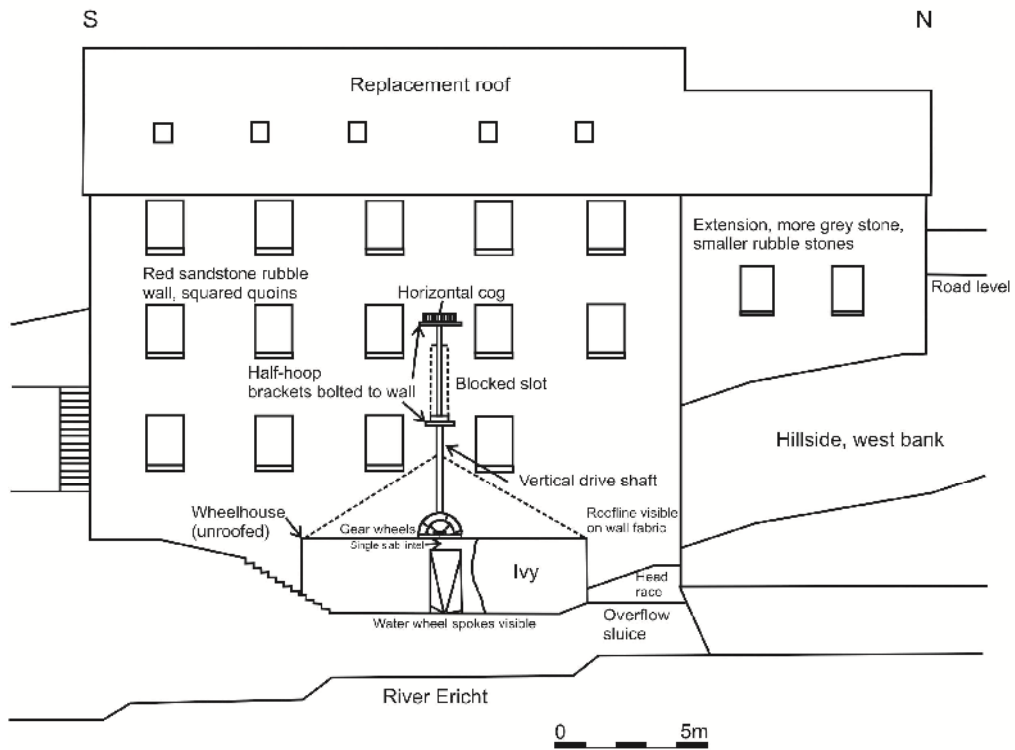
The wheelhouse, attached to the exterior face of the east wall of the building, was composed of grey rubble, with lime mortar mostly still present but occasionally eroded to dry-stone; much of the north end was overgrown with ivy. The wheel, 3.40m wide and of wrought iron, was triple, with three rims supporting wooden-slat paddles. Each rim was eight-spoked, with the two outer rims bearing riveted iron outer facings in bolted sections; the middle rim bore bolted “teeth” for retaining the wooden slats of the drive wheel, some of which were still in place. The vertical drive pin, rising to first floor level with mill teeth gears at the head and base, was bracketed to the exterior wall; traces of an open slot behind it remained at first floor level, with this having been blocked with rubble wall in-fill and having formerly allowed the connection of a drive band. This blocked shaft corresponded with the feature noted in the interior east elevation of the ground floor room and near ceiling height in the basement.

A gable roofline was visible in the exterior fabric of the main building above the wheel, indicating a formerly fully or partially enclosing roof over the wheelhouse. An arched lintel crossed the aperture connecting with the race, while a doorway opened onto the river in the east wall, measuring 1.00m wide and 1.20m high, the base being blocked with tree roots and fallen branches. The head race ran in from the north, from a junction with a main lade following a northwest-southeast course from the Lornly Burn; the race feeding the Oakbank wheel measured approximately 2.00m for much of its length, widening to 4.00m where it connected with the wheelhouse. An overflow sluice connected with the river immediately north of the wheelhouse.

Illus 5 East elevation (exterior)

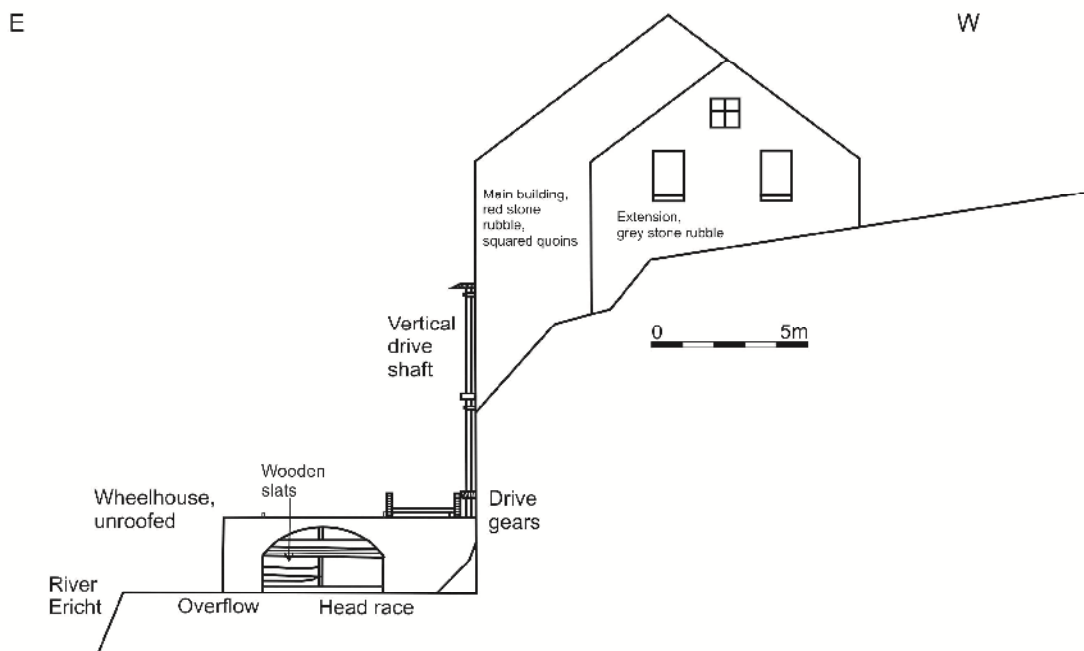
Illus 6

Base plan by Woodside Parker Kirk Architects Ltd
 North elevation (exterior)

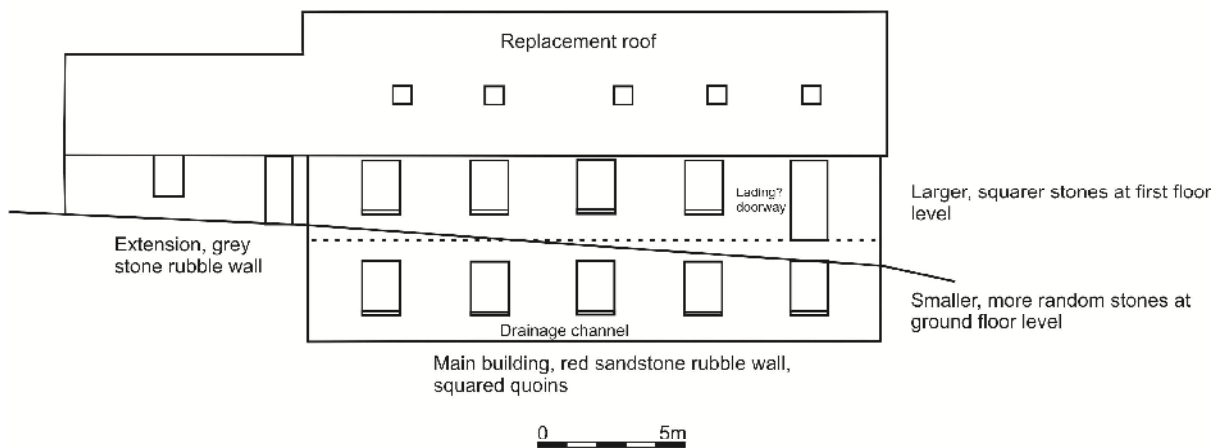
Illus 8

A difference in wall fabric of the main building was noted in the exterior of the west wall between the ground floor- featuring a large number of small, thin slabs- and the first floor- featuring more large, squared blocks. This difference was less apparent in the east wall of the building, but may represent the re-building of the mill in 1872. It is possible that the northwards extension was also added at this time.

Base drawing by Woodside Parker Kirk Architects Ltd
West elevation (exterior)
