Archaeological Evaluation Cordon Farm, Abernethy Perth and Kinross

AE19

Alder Archaeology Ltd was commissioned by Mr Wilson of Cordon Farming, Abernethy to undertake an archaeological evaluation in the fields between Hatton and Cordon Farm in advance of the development of a free range egg unit centred on NGR NO 179 174. The evaluation (site code AE19) was undertaken in response to the archaeological implications of the development as outlined in the Terms of Reference supplied by Perth and Kinross Heritage Trust. The site had potential archaeological significance due to its close proximity to the Scheduled Roman temporary camp at Carey (Scheduled Monument 9449), just to the W of the site. The evaluation was located over the area of new build and by the side of the new access road and comprised a sample of 6% of that area.

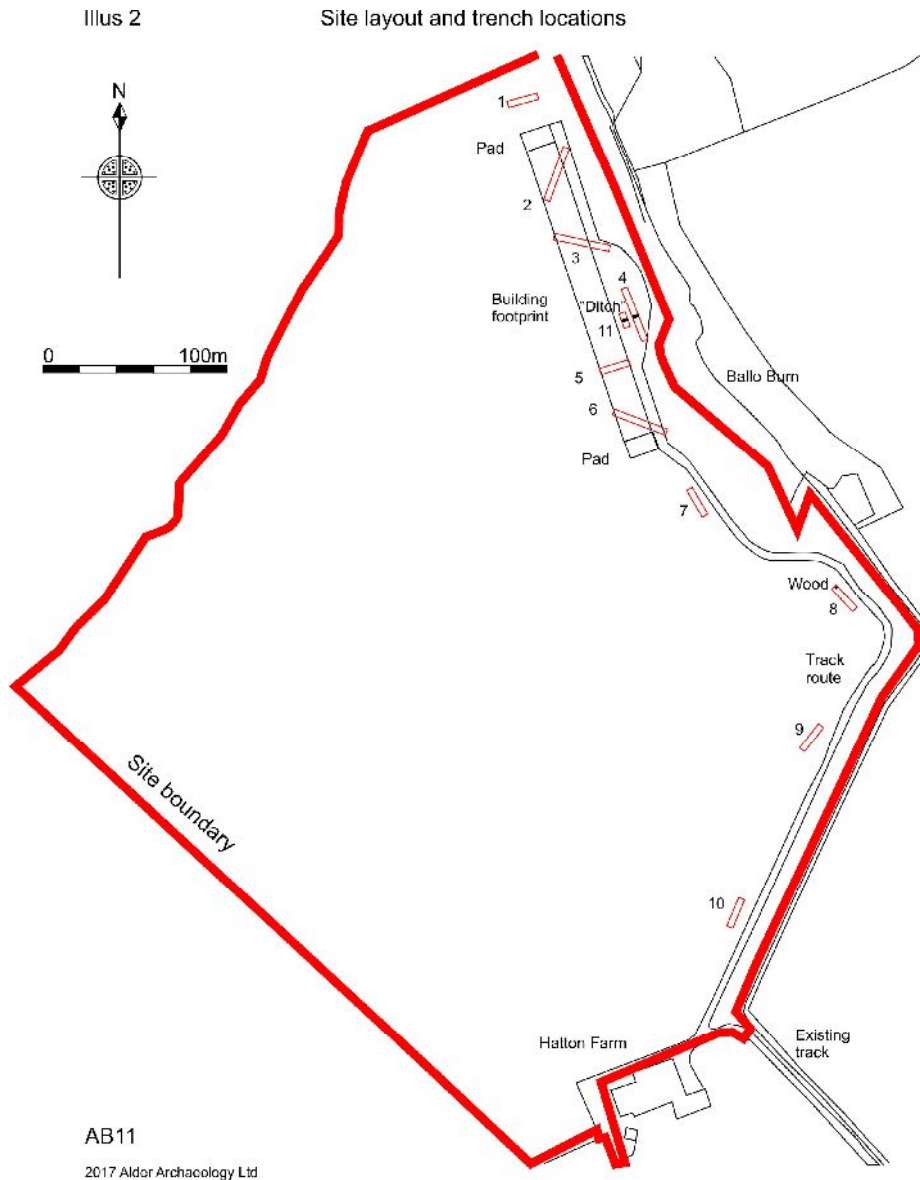
2.4 Results of Investigations (Illus 2)

See plan below for trench locations and also see context list below for more detailed descriptions of features and deposits.

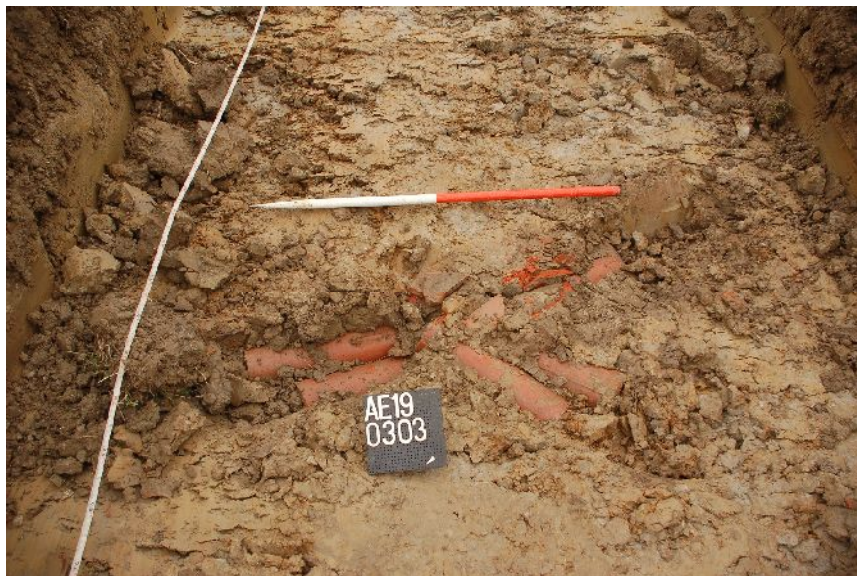
Trench 03 Illus 4

This trench was 30m in length and located to the S of trench 02 in the same grass field, aligned NNW-SSE. Topsoil, grey brown clayey silt, was 0.25m thick and was more silty than in trenches 01 and 02. The natural was stiff grey-orange clay, as in trenches 01 and 02. Close to the trench NNW end, in mid trench, was an odd feature comprising an isolated 'nest' of orange ceramic tile field drains (0303). The 'nest' consisted of 5 pipes each 0.37m in length and 0.11m in diameter at a depth of 0.60-0.68m below the site surface within a cut measuring 0.50m in diameter. These pipes did not appear to be forming cohesive channels or runs connected to each other but rather they looked more like a dump of pipes but were most probably acting as a 'soakaway' for a much deeper field drain set within the clay, (Mr Wilson pers comment). Two regular orange ceramic field drains, aligned NS, were located in mid trench and close to the trench E end. Nothing of archaeological significance was found in this trench.

Illus 4: Trench 03 detail of nest of field drain sections 0303, view SE

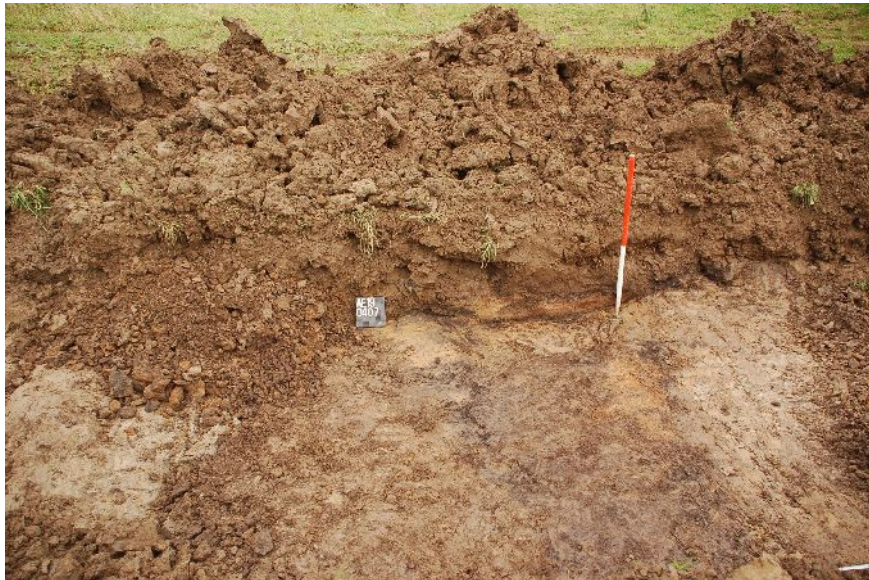
Trench 04 Illus 5

This trench was 30m in length and aligned N-S; it was located to the S of trench 03 in the grass field. Its location was close to the W edge of Ballo Burn den. Topsoil was a light brown clayey silt, c 0.30m thick. Natural subsoil, was a stiff grey, orange-brown clay as in trenches 01-03. Two orange tile ceramic field drains 0403 and 0405, cut into the top of the natural clay, crossed the N end of the trench.

Of interest in this trench, 20m to the S of the trench N end, was a ditch feature comprising deposit/fill 0407 within cut 0408, directly below the topsoil and crossing the trench in an E-W direction. The fill, deposit 0407, comprised mixed black silt, light brown clay silt and brown silty clay forming interleaved layers, which in total was c 0.18m thick. The cut for fill 0407, had uneven N and S edges and an uneven bottom, maximum depth was 0.18m with a steep S edge and shallow N edge. The cut was, sloping down slightly to the E (towards the burn) and had a maximum width of 1.10m, fanning out towards E end. Further investigation of this feature was accomplished by placing a trench (trench 11) on the W side of trench 04 to find the extent of the feature.

Illus 5: Trench 04 detail of ditch cut and silting in section 0407, view E

The only archaeological feature that could warrant some significance was the ditch feature found in trench 04 (0407/0408) and further investigated in trench 11 (1103/1104). This feature is considered to be a local shallow drainage ditch of unknown date, possibly modern but more likely earlier, pre the formal land improvement drainage. It seems to be forming a rough drainage channel fanning out and heading eastwards towards the edge of den of the Ballo Burn. The mixed nature of the fills indicate periods of still water in which silt deposits would form and plants would grow to form humic silty deposits. Later it was filled in for agricultural use by natural silting and being covered with topsoil. Although of some interest Alder considers that this feature warrants no further archaeological investigation.

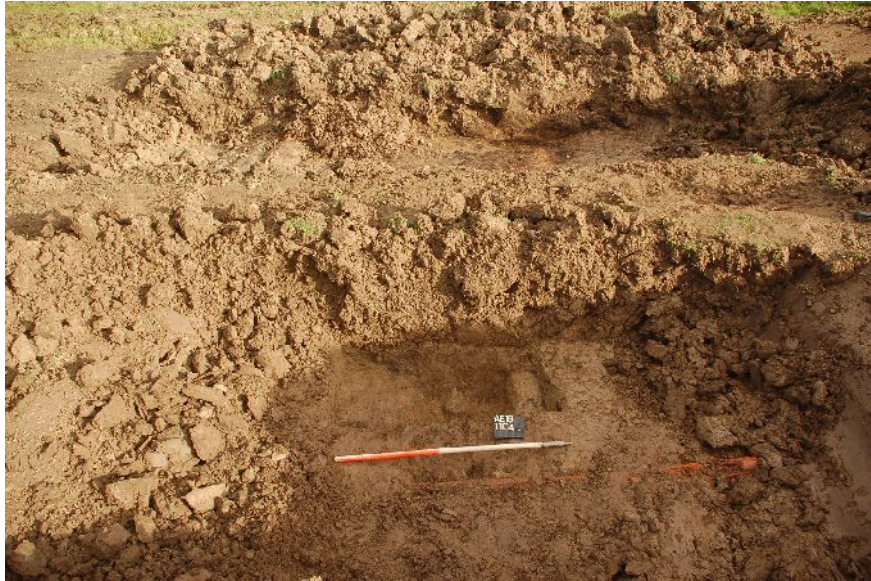
A field drain 1105 comprising orange horseshoe tiles and aligned N-S, mid trench, was cut into the natural clay and through the ditch feature which extended into trench 11.

The ditch feature, fill 1103 and cut 1104, had a width of 0.80m at the W end and was slightly wider at the E with a width of 0.88m. A 0.50m wide section was excavated against the E baulk of the trench. The fill 1103 was more homogenized than in trench 04, comprising mottled black orange-green subsoil, possibly with some decayed organic material and having a depth of 0.35m. The cut, 1104 had a straight vertical S edge and a shallow sloping N edge with an uneven base seemingly caused by root disturbance. The feature continued across the width of the trench but became much less distinct as it progressed westwards.

Illus 6: Trench 11 ditch feature 1104, ditch continuing into trench 04 view E

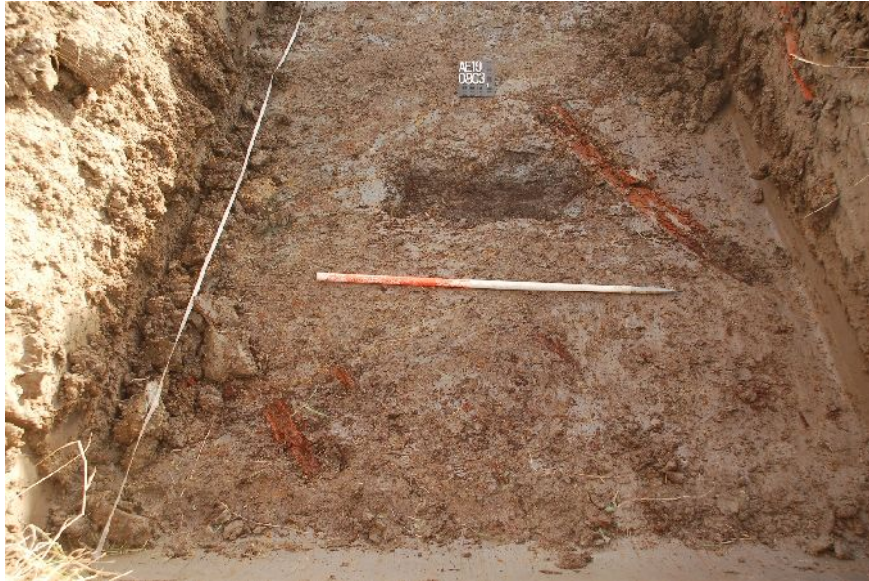
At a depth of 1.20m unworked natural wood fragments and pieces 0803 were found in the natural clay at the trench N end. The wood was dark brown, decayed and very friable. One large piece or branch was 1.22m in length and 0.14m wide, another piece measured 0.34m long and 0.08m wide, there was also a random scatter of smaller fragments. The wood 0803 was considered to have arrived at this location due to the natural process of trees dying and branches falling or possibly flooding, bringing in tree branches and burying them in the clay, possibly in prehistoric times. The wood was partially preserved by being in the anaerobic conditions of the surrounding natural clay 0802.

Illus 8: Trench 08 detail of natural wood 0803, view S

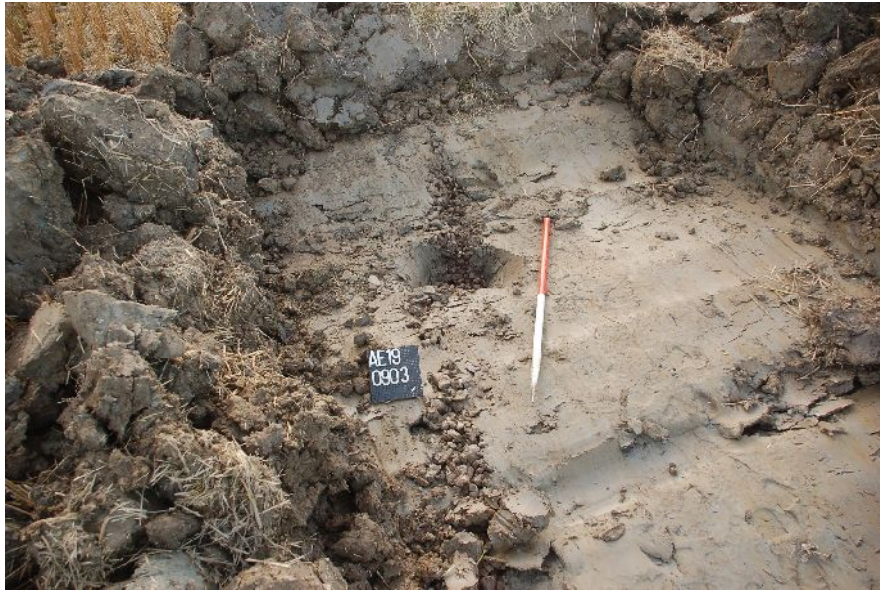
Trench 09 was 15m in length and located S of trench 08 beside the proposed new access track in a field of wheat/barley stubble. This trench was aligned NNE-SSW. Clayey loam topsoil was 0.24m thick over stiff grey-brown clay. An unusual field drain type (context 0903) was recorded at the S end of the trench. The field drain comprised a fill of small to medium sized rounded river pebbles at least 0.20m deep in a 0.20m wide cut 0904 aligned NNW-SSE. This field drain most likely predates the ceramic tile drains. Apart for the pebble field drain no other archaeological features were found.

Illus 9: Trench 09 pebble field drain 0903, view SW

agriculture. In trench 09 there was a pebble filled drain which most likely pre dates the modern tile drainage.
