Archaeological Watching Brief  
East Blair Wind Turbine  
Glenfarg  
Perth and Kinross  
GF04

**ARCHAEOLOGICAL WATCHING BRIEF  
EAST BLAIR WIND TURBINE  
GLENFARG, PERTH AND KINROSS**

**GF04**

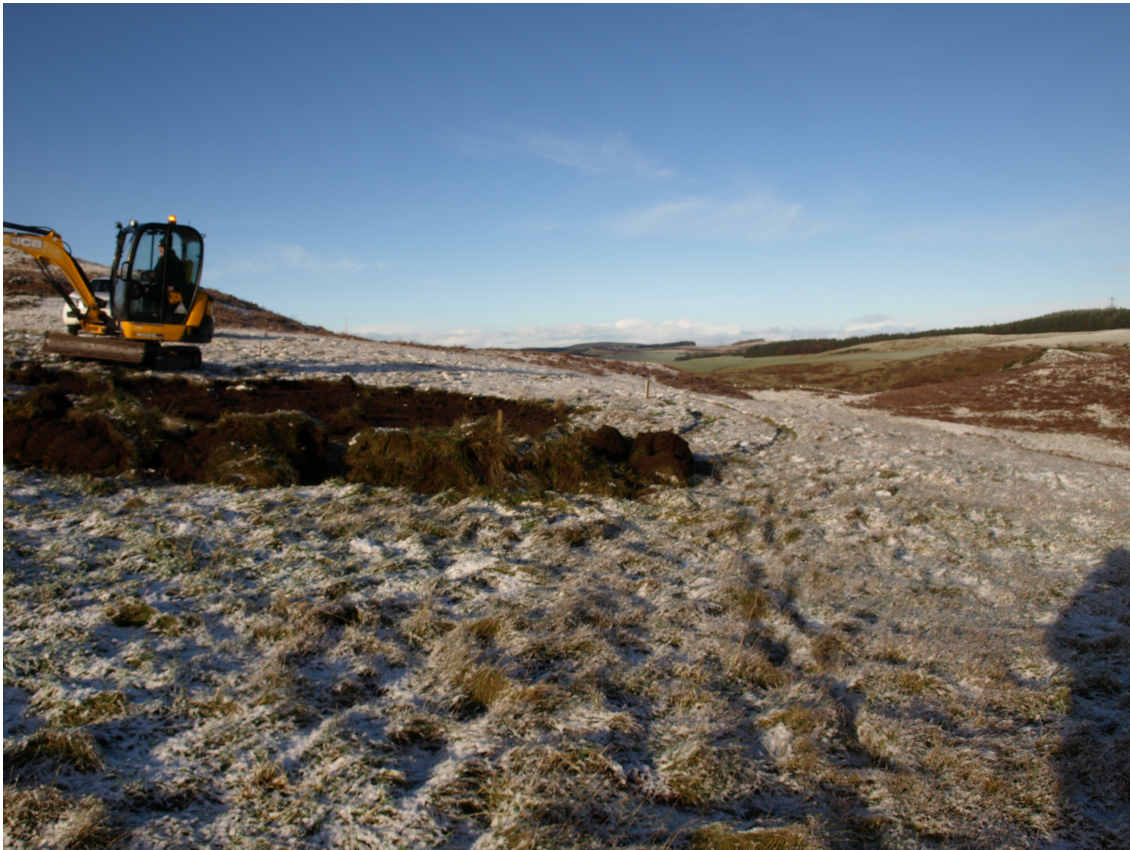
*Cover Photo: Stripping turbine base, looking N*

The area of the proposed turbine base had been marked out on the ground as a square 12 m x 12 m. This was deturfed using a small tracked mini-excavator, working from S to N. An irregular sondage was then dug by machine in the NE corner, down to what seemed to be the top of glacial deposits.

The top layer observed on the turbine base was turf and soft brown peaty topsoil 01, about 0.1 m deep. Below this was a tan sandy subsoil 02, about 0.2 m deep. Below this was light tan sand and gravel 03, apparently glacial.
