Standing Building Survey
Holemill
Whigstreet
ANGUS
FF17

**STANDING BUILDING SURVEY
HOLEMILL
ANGUS
FF17**

Alder Archaeology undertook a Level 1 Standing Building Survey of a ruined former cornmill at Holemill, Whigstreet, Angus, in advance of conversion to a new dwellinghouse. The roofless mill building, with a date stone of 1723, was centred on NGR NO 48223 43670. The work was undertaken on 14th September 2018 in clear but overcast weather conditions and comprised the creation of a full photographic and narrative record and annotated plan and elevation drawings. The mill fabric and form were entirely consistent with an eighteenth century date of construction, although manuscript evidence indicates a mill stood on or near the site as early as 1517.

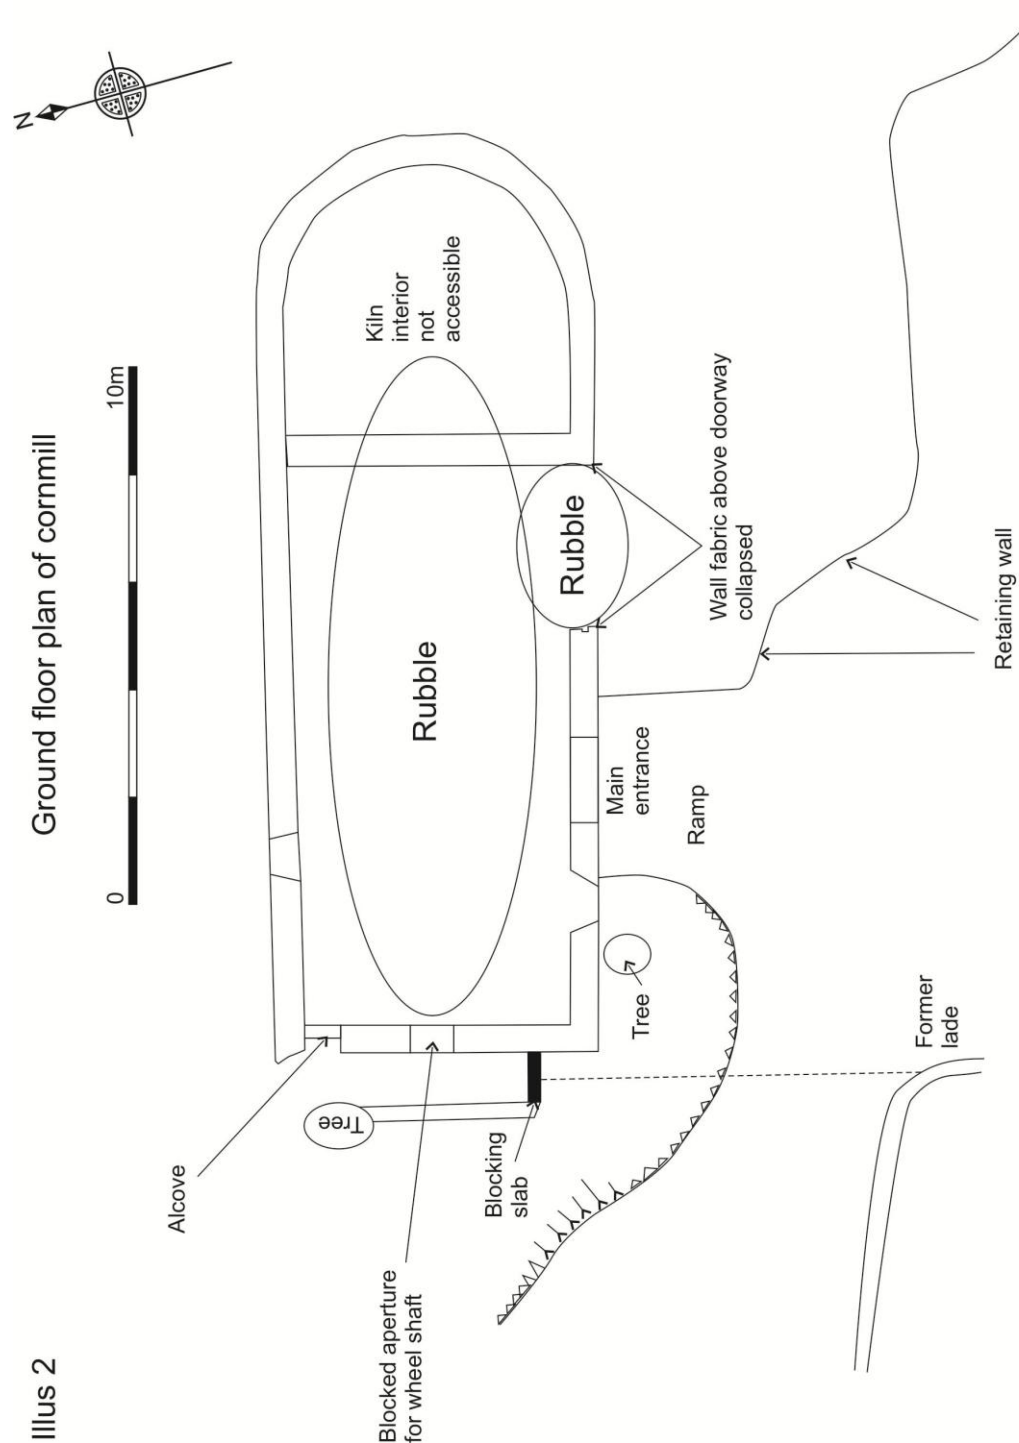
The mill was aligned approximately E-W (in reality rather more ESE-WNW) and measured 17.60m x 6.10m, with at least two floor levels. The fabric throughout was of grey stone rubble wall construction, with stugged, squared casings of doors and windows. Traces of lime mortar and possible harling were more apparent on the W and S elevations, having crumbled away across much of the remainder, particularly on the E elevation. Patches of possible whitewash were also apparent on the S elevation. Although rubble, the fabric featured fairly regular courses of rough-dressed blocks, a pattern repeated throughout the building, which bore no signs of clearly distinct phases of construction. The W, N and S elevations formed three sides of a rectangle, with a gable at the W end; the E end, however, was semi-circular, giving the building as a whole a boat-like appearance. The rounded end is believed to have contained a kiln for drying corn, incorporated into the building; however, the interior of the kiln could not be accessed due to rubble build-up. An interior N-S sub-dividing wall partitioned the kiln from the remainder of the building, but was partially obscured by rubble and undergrowth.

The interior of the main mill building W of the kiln could be accessed with care but was thickly overgrown and contained mounds of rubble. The walls were found to be unstable. The ground floor room measured approximately 10.00m long x 5.00m wide, with the partition wall at the E end dividing the main building from the kiln. Rotting,

collapsed wooden floor beams along the N and S elevations indicated the position of a wooden floor at the level of the ramp and entrance doorway in the S elevation. This may have permitted the pouring of grain down onto the millstones, the flour being extracted below, an efficient method allowing continuous milling. At the other end of the room, the drying kiln could have been fed in the same fashion.

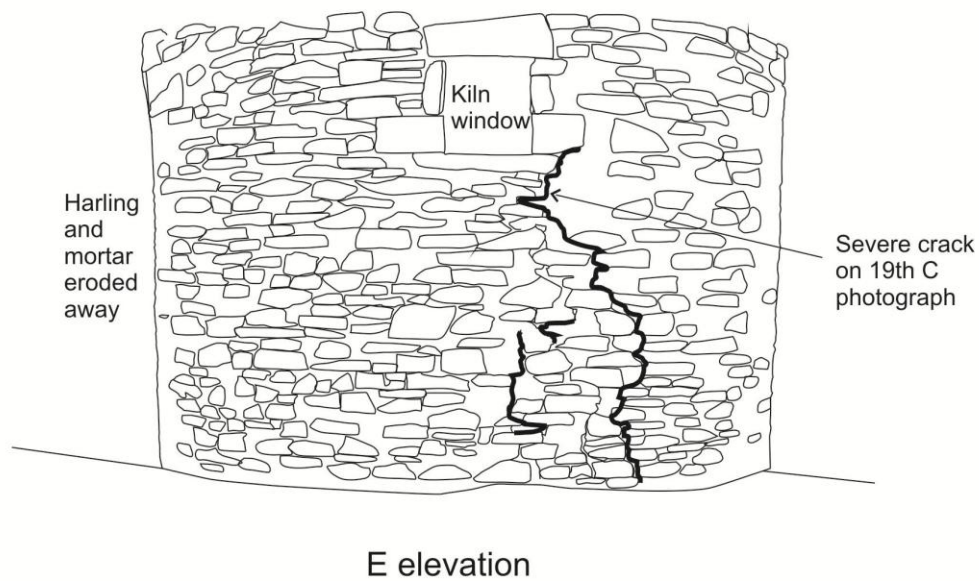
Illus 3

A window of the same dimensions was the only intentional feature of the curving E elevation, where it was set at the wallhead in the exact centre of the curve. The only other feature of note was a vertical crack running from the ground to the sill of the window, a flaw clearly visible in the 1880s photograph of the building.

The W elevation, the gable end of the building, featured slates in place on the S side of the gable, the N side being bare. At the base of the elevation was the sub-rectangular pit for the former waterwheel, located opposite the former lade which flowed S-N towards the building before turning W 8.00m S of the wheel pit, where it had been diverted away from its original course. The pit measured 1.20m wide and 5.00m long, ending at the N end of the elevation, with a 1.00m high x 1.20m wide slab blocking the S end, rubble behind obscuring the former course of the lade. The pit was an average of 1.00m deep, cut into the hillside at the S end and opening at the ground level of the meadow at the N end. A mature ash tree grew on the W retaining wall of the pit, obscuring part of its length, but the slab construction could nevertheless be seen. Within the pit, a blocked aperture in the centre of the W elevation of the mill building extended from the base level of the pit to 0.70m high x 0.63m wide and featured cement rather than the lime mortar of elsewhere in the fabric, suggesting the blocking was relatively recent. The aperture probably represented the position of the wheel axle, which would have passed through it to the milling mechanism within the building, suggesting the wheel was positioned low down against the side of the mill and overshot by the lade rather than undershot. This also suggested the wheel pit was originally considerably deeper than in its present state. An alcove set 0.32m into the wall face 1.10m N of the blocked aperture was of the same width but 0.80m high and perhaps represented an access hatch to control an outflow sluice. Two beam slots 2.50m above the base of the pit possibly represented support for a roof or retaining frame surrounding the wheel.

W and E elevations (external)

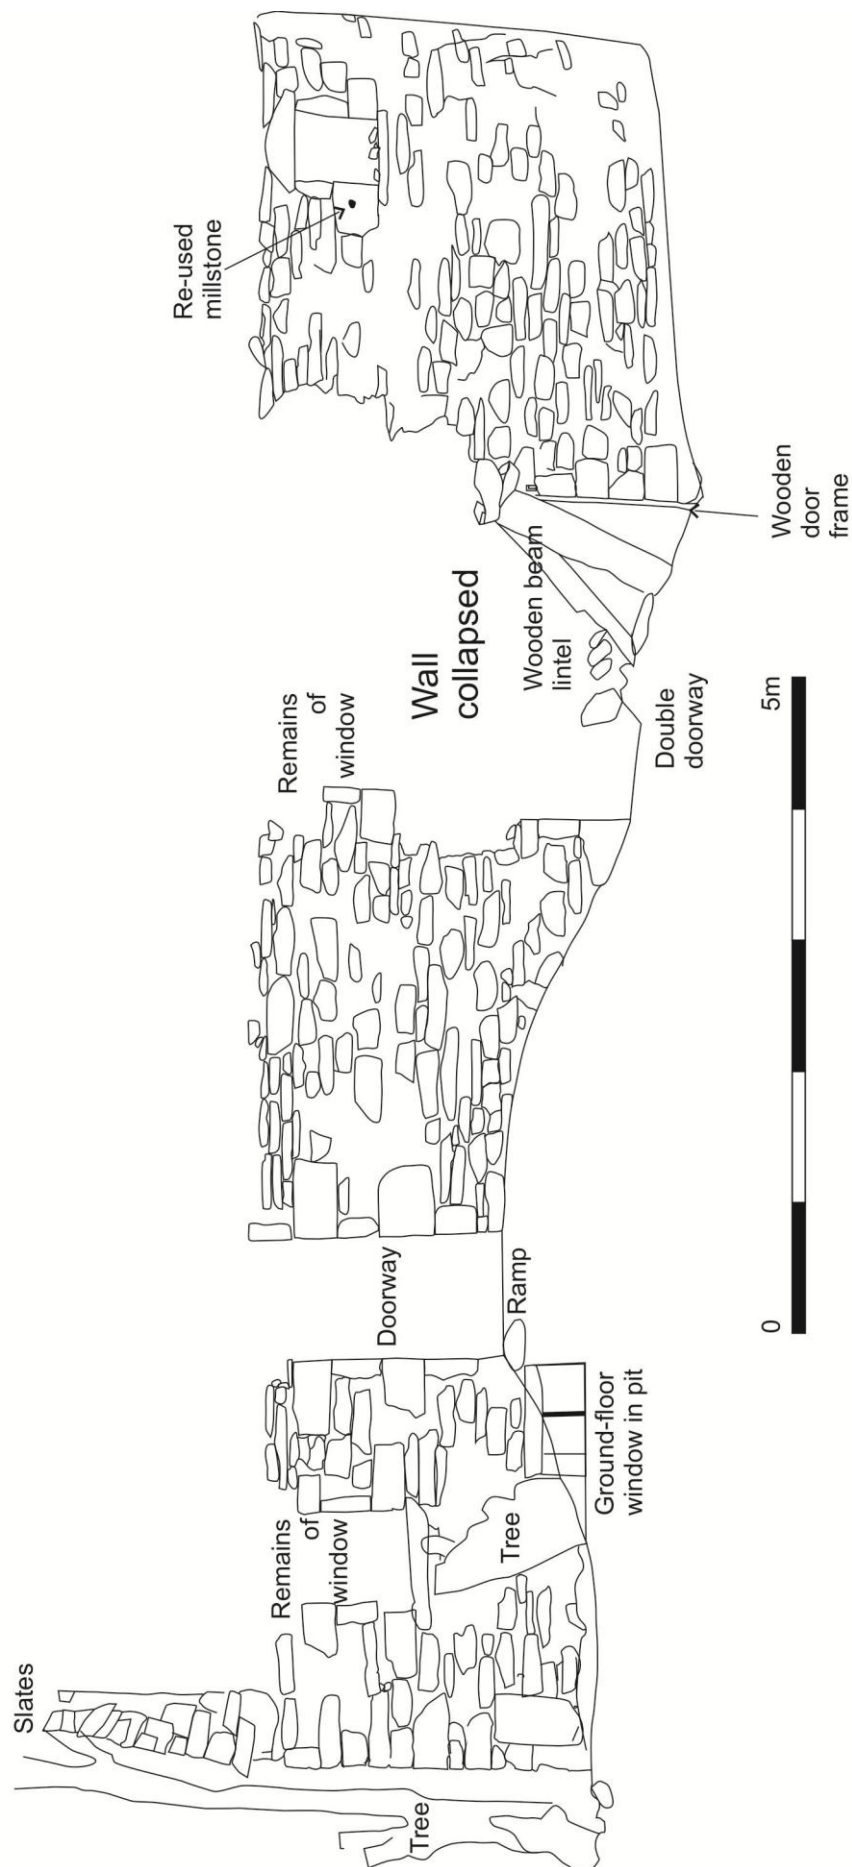
The S elevation included an extensive area of total collapse of the wall fabric, which had occurred since 2011. It featured a doorway and window at the W end on the first floor, where a 3.00m-wide earth ramp leading from the upwards slope of the natural hillside to the doorway raised the exterior ground level. The W side of the ramp was 2.50m from the W end of the elevation, with a drop of 0.90m to the ground floor, where a barred widow was set in an embrasure, the sill of which was c.1.00m above the interior ground surface (exact measurement was impossible due to rubble, silt and undergrowth). This lower window was 0.70m wide x 0.60m high. The first floor window 1.32m from the W end of the elevation was 0.75m wide and survived to 0.92m high, with its lintel and the wallhead above absent due to collapse. The stump of a mature ash tree was situated against the wall face between these two windows. The doorway, situated on the W side of the ramp at first floor level, was 1.07m wide and survived to a height of 1.95m, with lintel and wallhead collapsed. Iron hinge pins were present in the E jamb. The door was closed-off by a corroded iron frame gate, but this was clearly a recent and temporary safety measure, the interior first floor having collapsed.

To the E of the ramp, the wall fabric had collapsed leaving a 2.90m wide gap at first floor level which corresponded to the full width of a rectangular double doorway at ground floor level featuring stugged casing, a moulded jamb and a wooden frame still intact on the E side of the aperture. Moulded masonry in a debris pile in front of the doorway probably represented the lintel of a first floor window, two moulded stones representing the W side casing of this window being all that survived in situ on the W edge of the gap. Set into the jamb on either side of the doorway were two iron hinges, with two more set in the exterior wall face of the S elevation beside the doorway, suggesting either two pairs of double doors or a reconfiguration of the doors at some stage in the life of the mill. If the former, this possibly represents a security system protecting what was probably the vehicle entrance to the mill where flour sacks could

be loaded into carts for transportation, the double-skinned doors preventing unauthorised access. This part of the elevation was effectively set within a sub-rectangular pit formed by a N-S slab-built wall retaining the ramp and a similar E-W wall retaining the natural slope to the S, a third wall being the mill building itself. The space thus limited measured 5.50m N-S x 8.00m E-W, with its base at the general level of the surrounding meadow.

At the E end of the S elevation, within the rounded kiln structure, a window at the wallhead with lintel still intact measured c.1.00m x c.0.60m wide and featured a piece of broken millstone as one of its casing stones on the W side.
