Archaeological Watching Brief  
Old Fire Station  
Pearl Street  
CALLANDER  
CC02

**ARCHAEOLOGICAL WATCHING BRIEF,  
OLD FIRE STATION, PEARL STREET,  
CALLANDER**

**CC02**

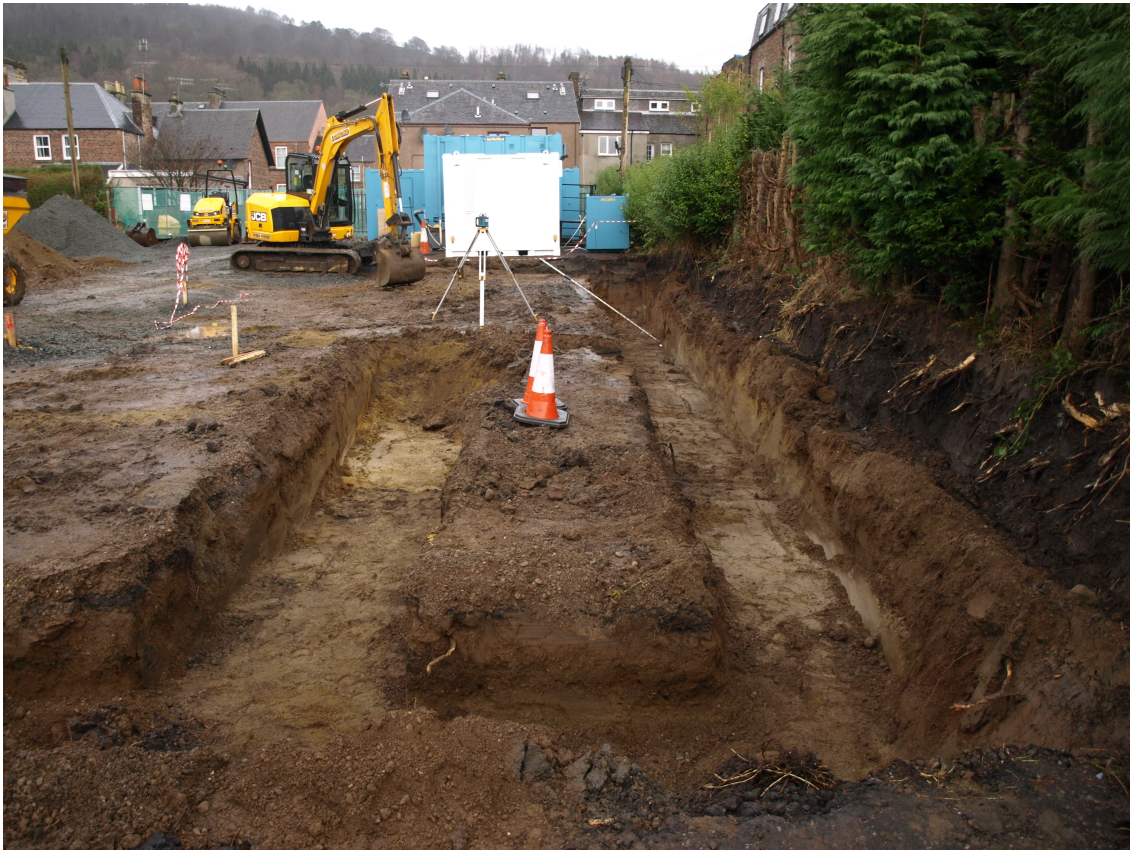
Foundation trenches in natural sand. View N from Pearl Street

*Front Cover: Foundation trenches in natural sand. View N from Pearl Street.*
