Archaeological Historic Building Record
Grundcruie Water Treatment Works
Methven
MV05

**ARCHAEOLOGICAL HISTORIC
BUILDING RECORD
GRUNDCRUIE
WATER TREATMENT WORKS
METHVEN
MV05**

Following the record of Grundcruie sawmill (Site Code MV04), near Methven, on 17th March 2017, Alder Archaeology expanded the record of the adjacent water treatment works (Site Code MV05). This was funded by the owner in advance of conversion to holiday accommodation. The water treatment works is a small rectangular building of mid-20th-century date, containing a variety of water treatment machinery, and appears to have provided the water supply for the nearby settlement of Methven. An enigmatic concrete structure in the woods to the W may also have been part of the system, or else perhaps a WWII defensive feature.

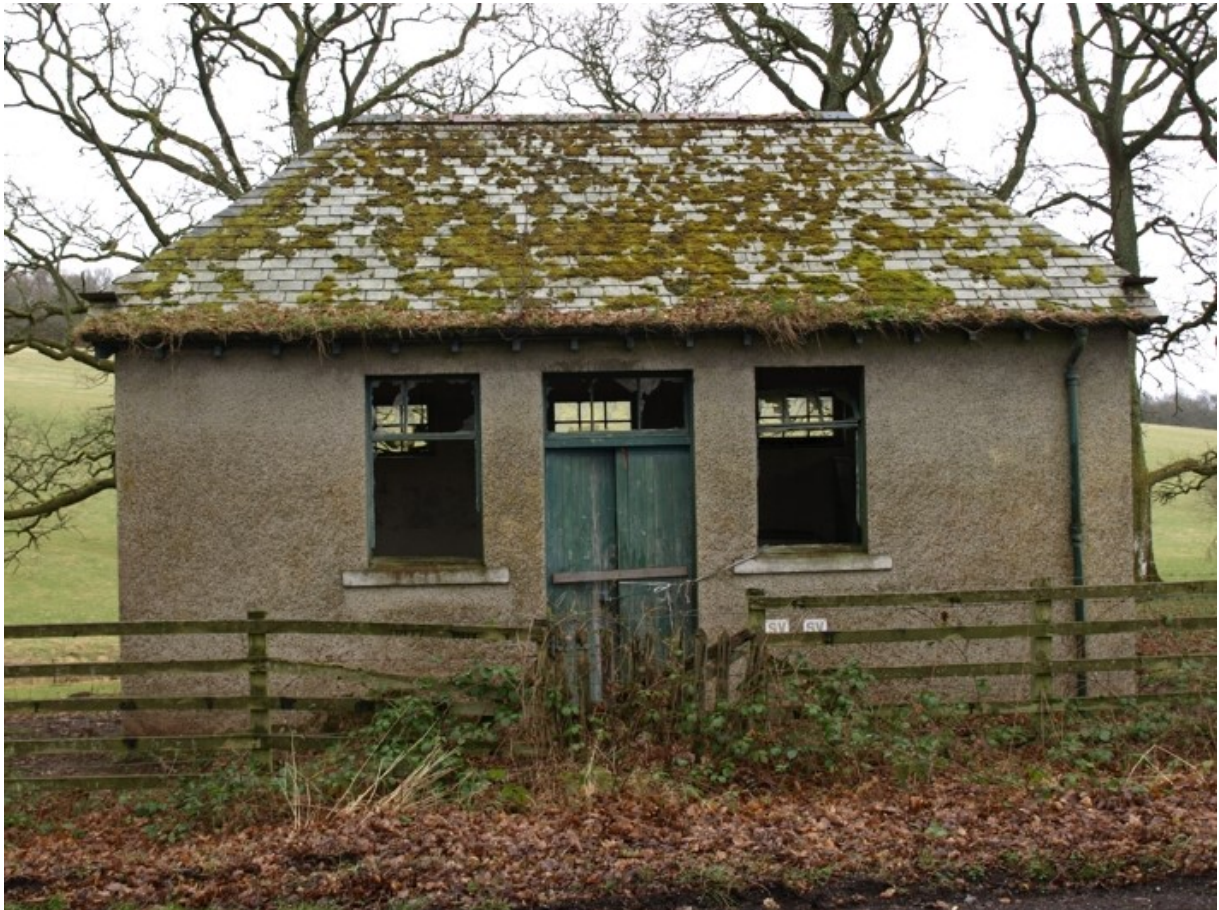
Water Treatment Works, looking N

Front cover: Water Treatment Works, looking N.

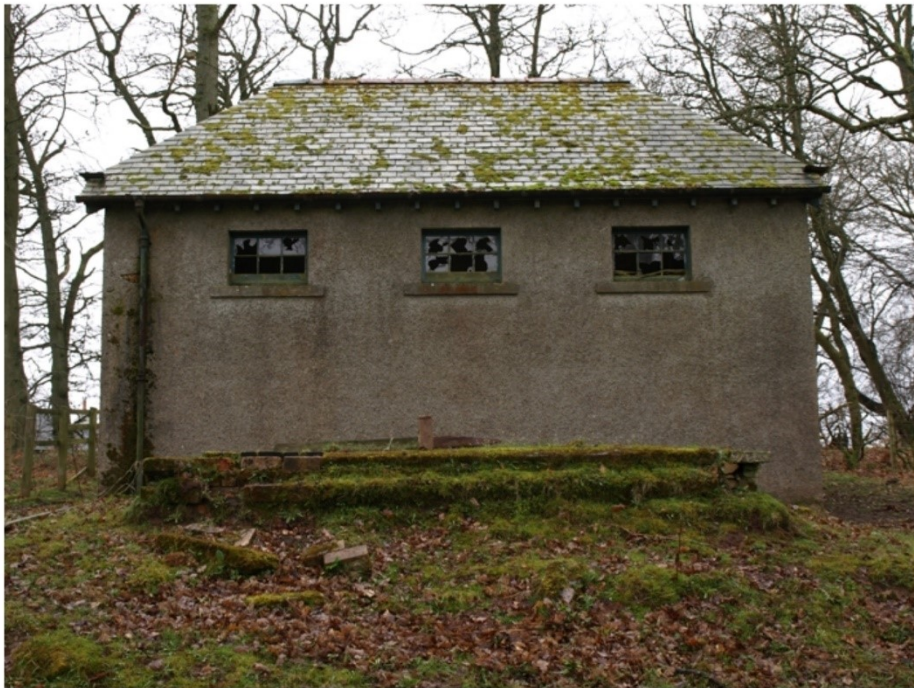
4 North elevation, with Tank Cover 37 in foreground

The Water Treatment House 34 is a simple rectangular building, 8 m x 4.5 m (about 25' x 15'), aligned nominally W – E, though strictly WNW – ESE. The external walls are covered with grey rough-cast cement render. There is a central door in the S wall, flanked by windows on either side, three small, high windows in the N wall, and single windows in the E and W walls. All the windows have concrete sills.

The roof is of mansard form, with uniform courses of slates, and red ceramic ridge tiles. The gutters are cast-iron, half-round in section, and four courses higher on the short end walls than on the long side walls. The end wall gutters wrap slightly round the corners to spill onto the slates of the long side roofs, while the long side wall gutters drain into cast iron downpipes.

About 3 m to the N of the Water Treatment House 34 is a mainly concrete deck 37 over what appears to be a reservoir or perhaps a settling tank, about 3.8 m x 3.2 m, its edges formed by red colliery bricks. A loose example bore the stamp AIRDRIE. The E end of the deck was covered with wooden planks.

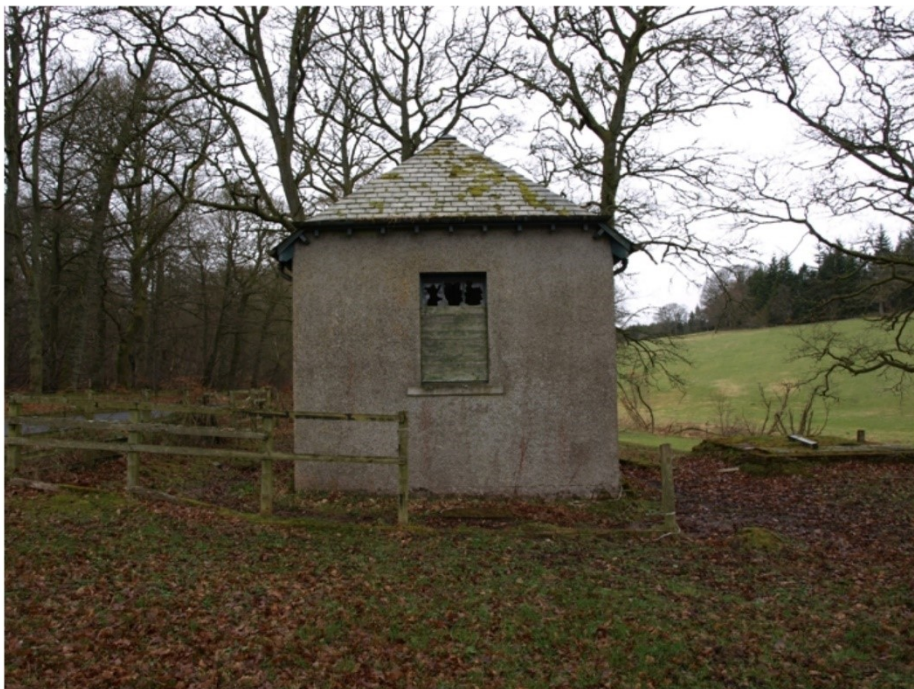
5 East elevation

134	E elevation of Water Treatment House 34, with Water Tank 37 to R. E wall similar to W. Window mostly boarder over, except for top three panes.	WNW

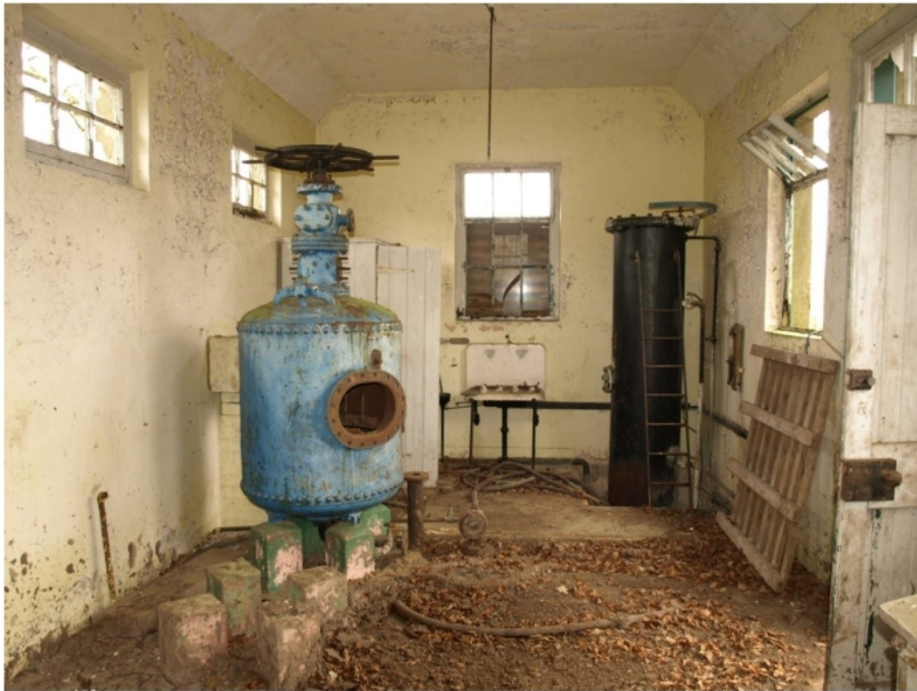
6 Interior, E, with Mixer 38 and other machinery

Internally, the Treatment House 34 contained various items of water processing machinery. Most notable was a mixing drum 38, of riveted steel painted blue, with an arrangement of mixing arms or paddles inside, presumably for mixing soluble chemical powders into the water. The riveted construction strongly suggests a mid 20th-century date; compare for example the boilers of 1950s and early 1960s steam locomotives. Riveting has almost entirely been superseded by welding in modern pressure vessels. An arrangement of concrete blocks to the W suggested the base of another similar machine, now removed.

Other machinery included upright steel or cast-iron cylinders, 42 and 43, with various pipes and valves attached. Their heavy construction suggested high pressure. They could have been used to inject a measured volume of water (or a chemical solution) into the system, by feeding compressed air into the top of the cylinder, or to stabilise water pressure in the system, using a volume of compressed air in the upper half of the cylinder to absorb pressure surges or smooth out the pulsating output of a mechanical pump and avoid damage to water mains.

139	Interior. White coombed ceiling. Internal view of boarded up E window. Treatment mixer 38 and other machinery. Tall dark Cylinder 43 on R perhaps pressure stabiliser. Foreground right, corner of low wooden bins 44 containing traces of white powder.	SE
140	Detail of Cylinder 43. Compare image 275 below.	SE
141 – 3	Detail of Treatment Mixer 38. Detail of flange on oval opening. Mixer blades inside oval opening. Six triangular section mixer arms bolted on to square central shank. Each arm carries two (top and bottom arms) or four (middle arms) tapering steel or iron prongs, about 15 mm diameter, pointing up and down. All apparently rotated by turning the capstan wheel above.	NE
145	S elevation of Water Treatment House 34, facing public road. Central entrance door, with two leaves of vertical boards. Three-pane window above. Two large windows either side of entrance door, with concrete sills, and remains of nine-pane window frames. Top three panes hinge for ventilation. Gutter downpipe at E end of wall. All details painted green. Low wooden fence in front of building, five unpainted timber rails. Remains of wooden gate in front of entrance door. Two 'SV' plaques on wall indicate position of shutoff valves 40 (Image 136).	NE

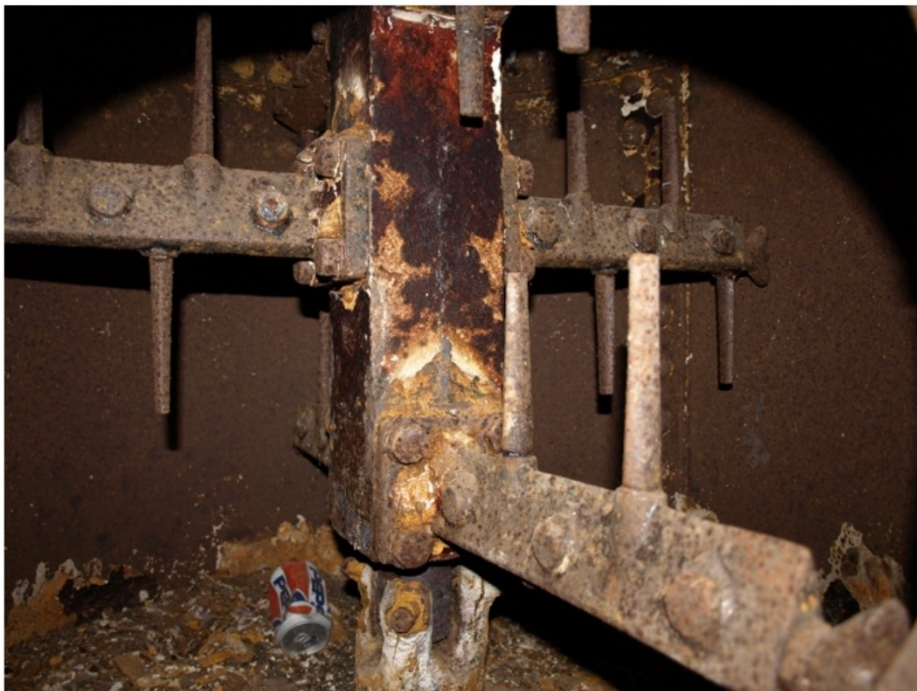
7 Detail, mixing arms inside Mixer 38
